# YUKON INN ENERGY STUDY

June, 2002

**Yukon Inn**  
4220 4<sup>th</sup> Ave  
Whitehorse, YT, Y1A 1K1

**Sinclair & Associates**  
Suite 2 – 2090 2<sup>nd</sup> Avenue  
Whitehorse, YT, Y1A 1B6  
Tel: 867-667-7205  
Fax: 867-668-7120

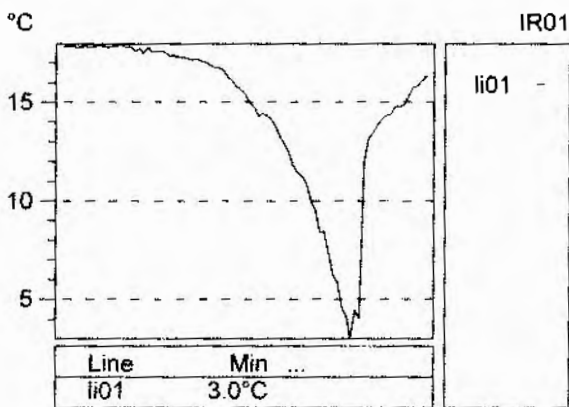
IR Text Comment	Value
Section	Room 231
Equipment	Outside Corner
Additional information	
Fault	Energy loss through framing.
Recommendation	Retrofit Exterior

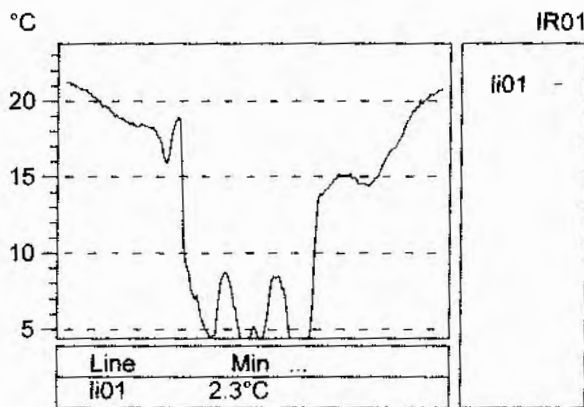
IR Text Comment	Value
Section	Room 231
Equipment	Bathroom Fan
Additional information	
Fault	Air Leakage and Poorly Installed Insulation
Recommendation	Exterior Retrofit

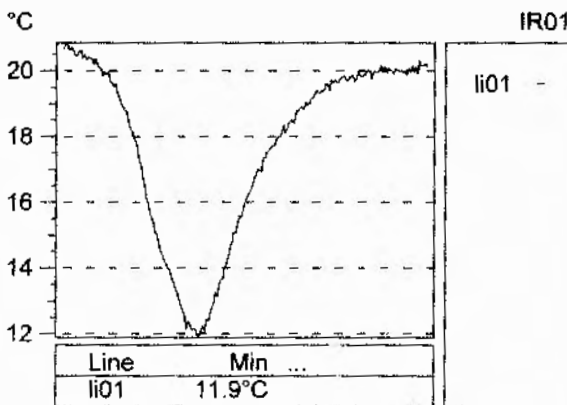
IR Text Comment	Value
Section	Room 231
Equipment	Closet Side Partition
Additional information	
Fault	Air Leakage
Recommendation	Install Air / Vapor Barrier on Exterior

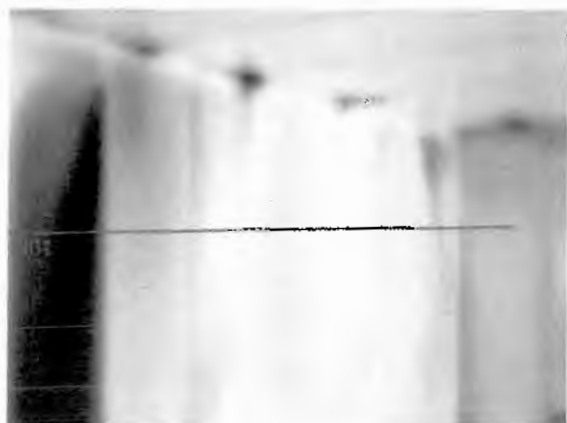
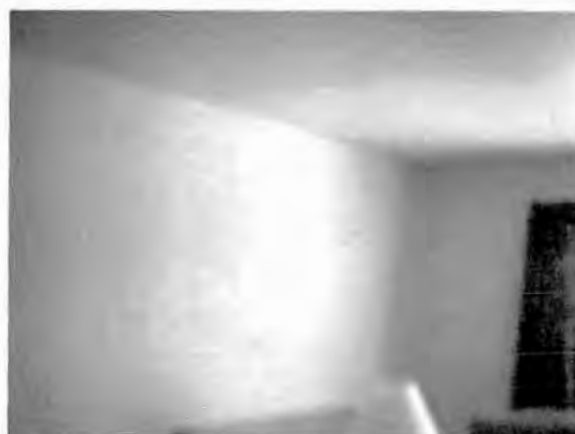
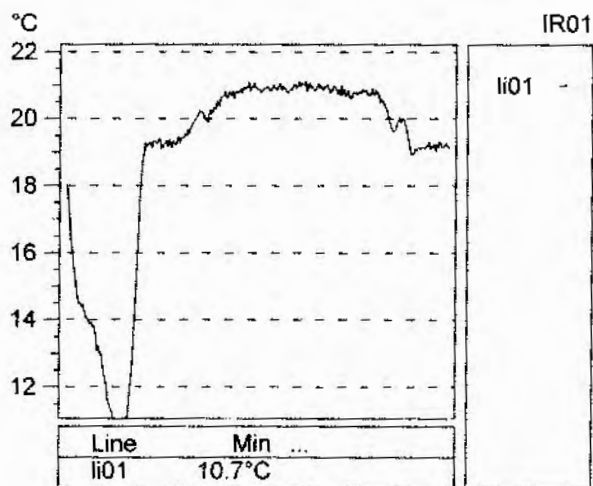
**C0312-15.img**

IR Text Comment	Value
Section	Room 231
Equipment	Phone Cavity on Interior Wall - Upper
Additional information	
Fault	Air Leakage From Outside
Recommendation	Exterior Retrofit

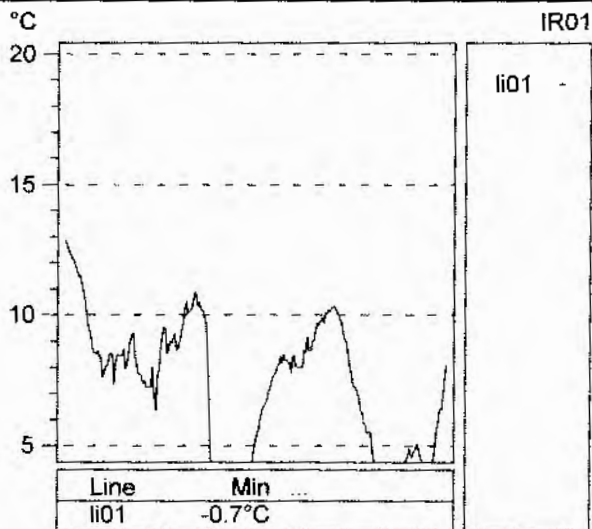
IR Text Comment	Value
Section	Room 231
Equipment	Baseboard and Bottom Plate
Additional information	Plate
Fault	Air Leakage at Bottom Plate
Recommendation	Exterior Retrofit

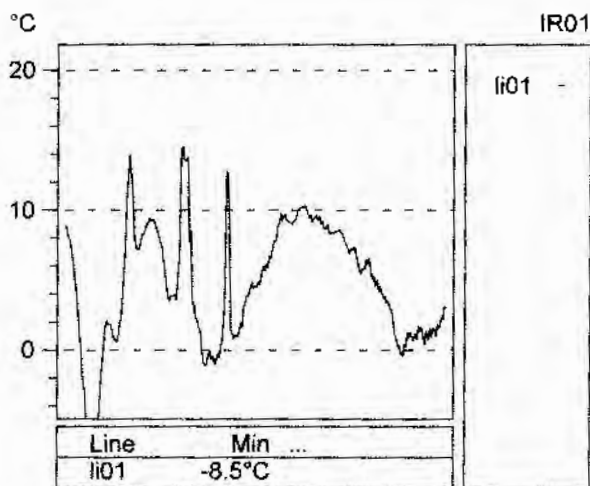
**C0312-23.img**

IR Text Comment	Value
Section	Room 231
Equipment	Exterior Wall Behind TV
Additional information	
Fault	Air Leakage and Poorly installed Insulation
Recommendation	Exterior Retrofit

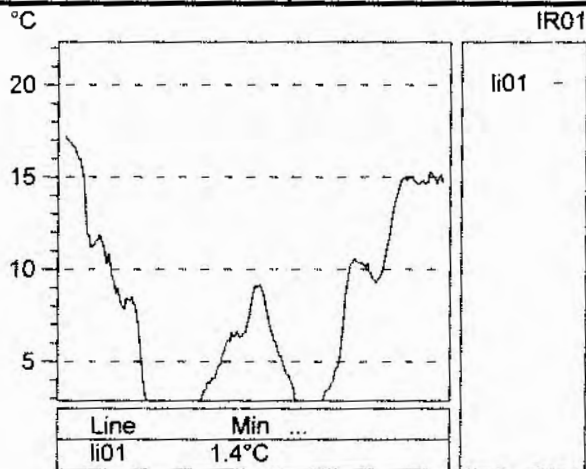
IR Text Comment	Value
Section	Room 231
Equipment	Bathroom Partition
Additional information	
Fault	Air Leakage at top plate
Recommendation	Exterior Retrofit

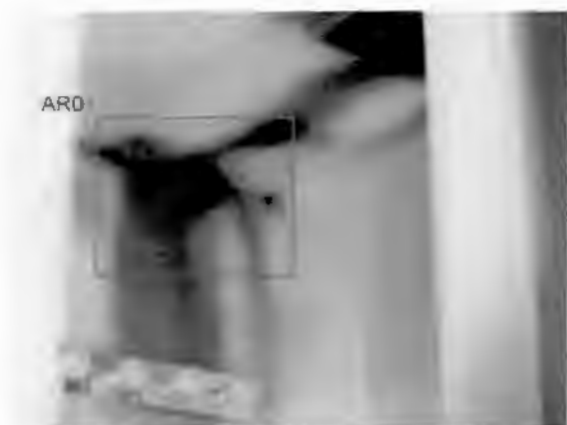
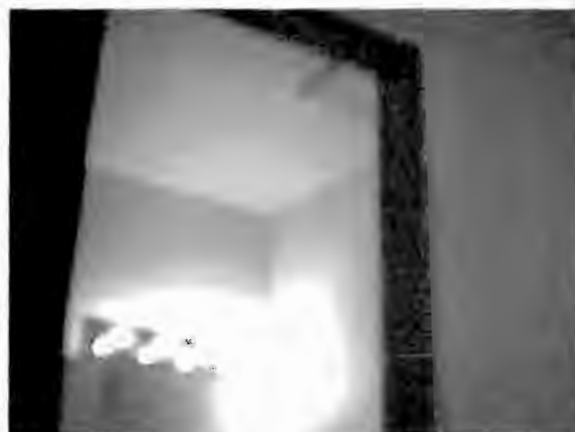
C0312-31.img

IR Text Comment	Value
Section	Room 231
Equipment	Bathroom @ Vanity
Additional information	
Fault	Air Leakage
Recommendation	Exterior Air Leakage

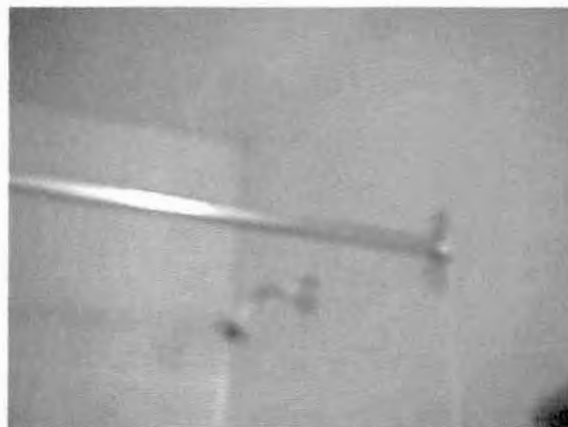
C0312-35.img

IR Text Comment	Value
Section	Room 231
Equipment	Bathroom Wall Above Towell Rack
Additional information	Towell Rack
Fault	Poorly Installed Insulation and Air Leakage
Recommendation	Exterior Retrofit

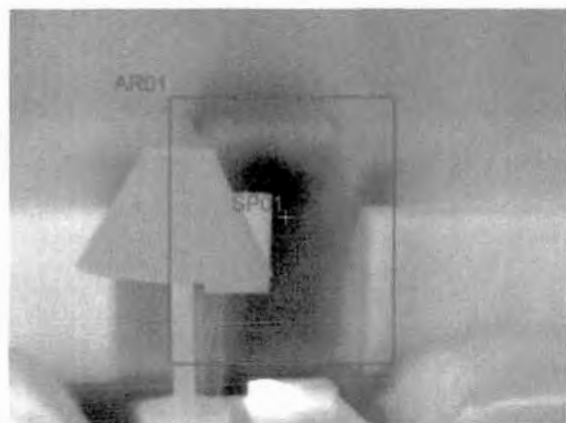
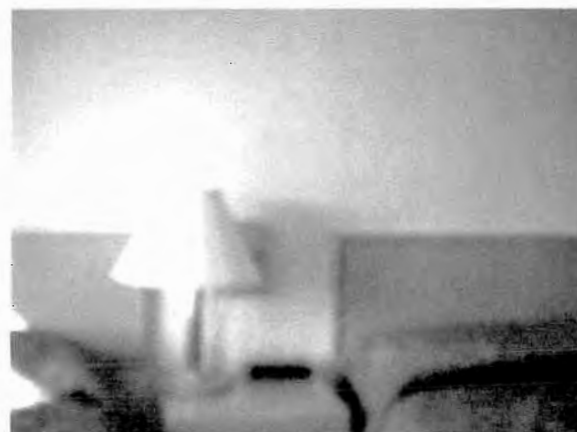
IR Text Comment	Value
Section	Room 229
Equipment	Phone Cavity Opposite Room 231
Additional information	
Fault	Excessive Air Leakage
Recommendation	Exterior Retrofit

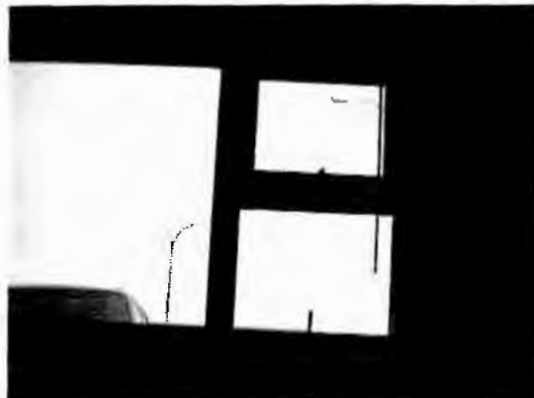
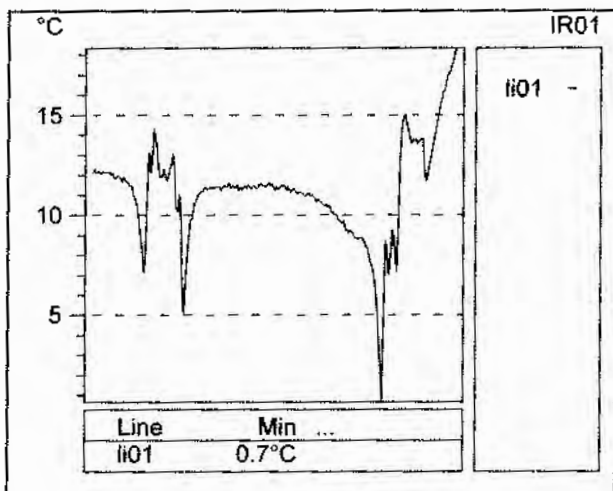
C0311-01.img

IR Text Comment	Value
Section	Room 143
Equipment	Window
Recommendation	Seal installation air leaks
Additional Information	Remove trim and air seal space between frame and rough opening.

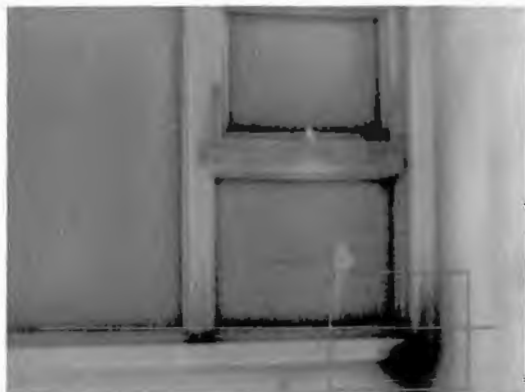
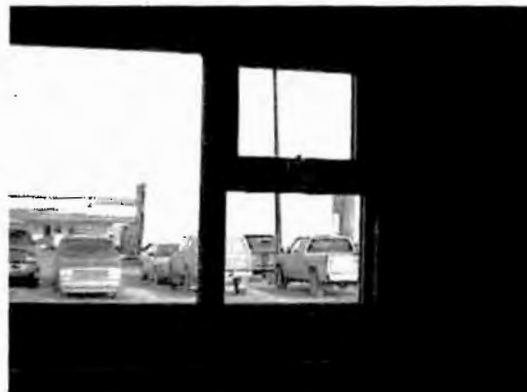
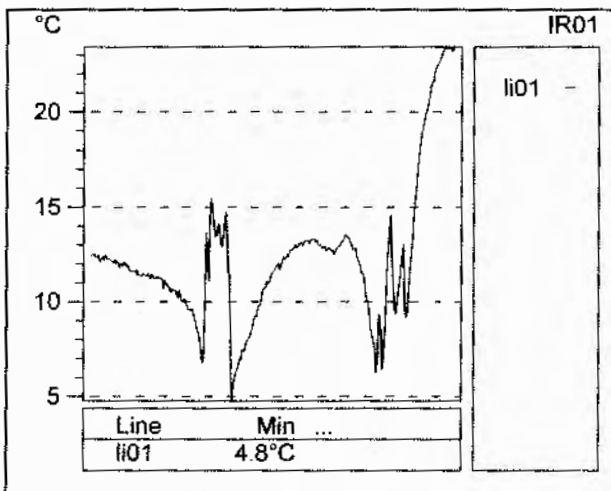
C0311-04.img

IR Text Comment	Value
Section	Room 143
Equipment	Window @ Corner
Recommendation	Seal installation air leaks
Additional Information	Seal space between frame and rough opening.

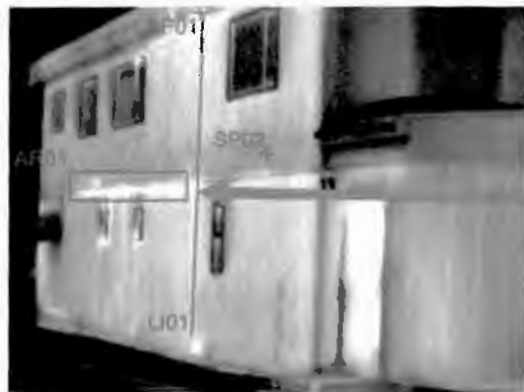
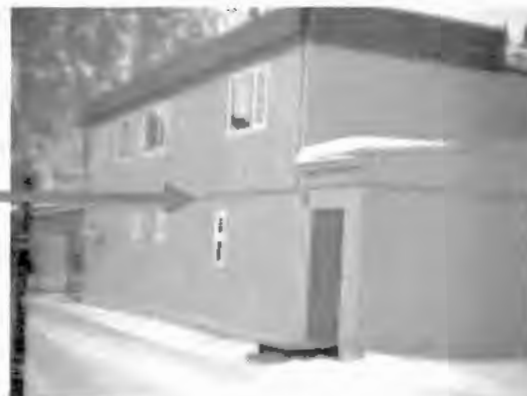
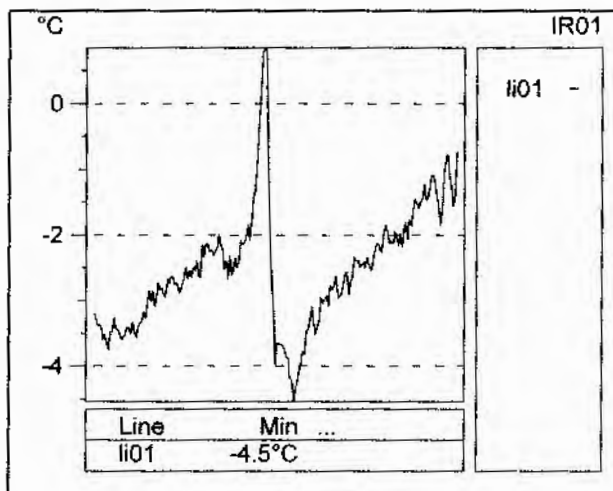
IR Text Comment	Value
Section	Exterior
Equipment	Wall (1st and 2nd level intersection)
Recommendation	Insulation on Exterior
Additional Information	Install rigid foam insulation on exterior & cover w/ new siding

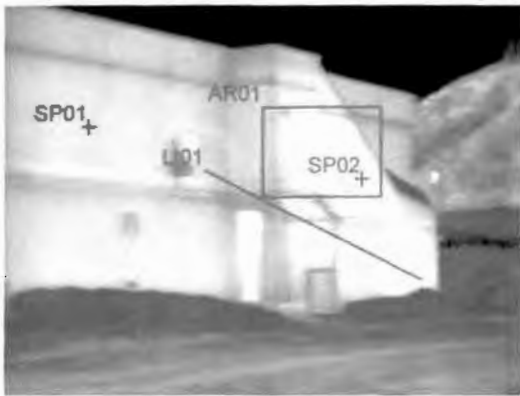
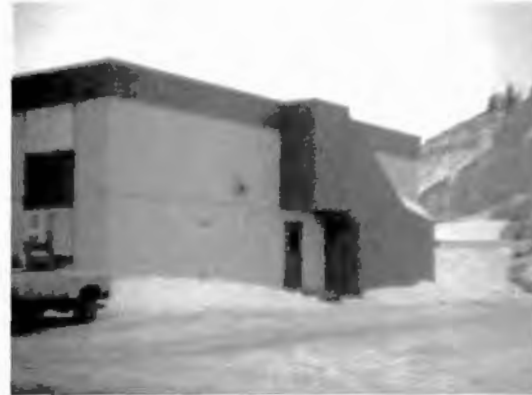
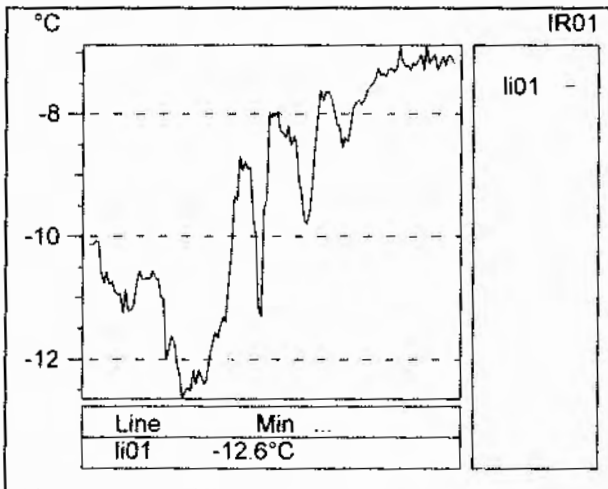
IR Text Comment	Value
Section	Exterior
Equipment	Stairwell
Recommendation	Insulation on Exterior
Additional Information	Install rigid foam insulation on exterior & cover w/ new siding

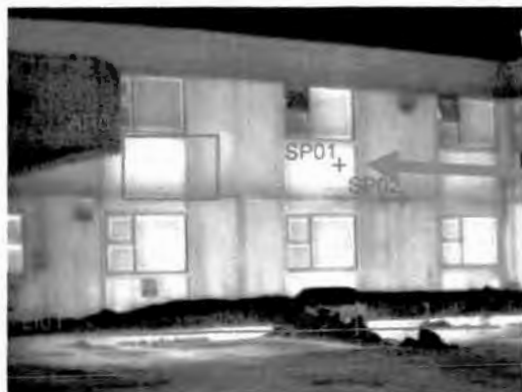
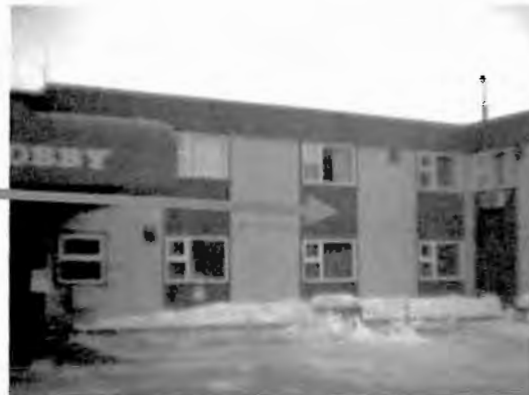
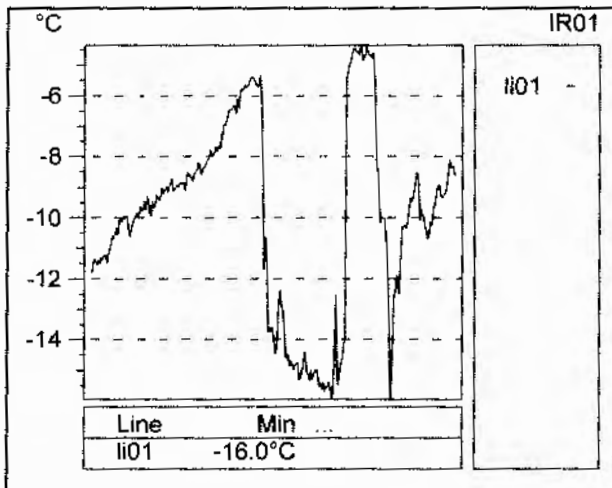
IR Text Comment	Value
Section	Exterior
Equipment	Foundation walls
Recommendation	Insulate Foundation Wall
Additional Information	Excavate .7 m & install 51mm extruded polystyrene insulation
...continued	against foundation wall.

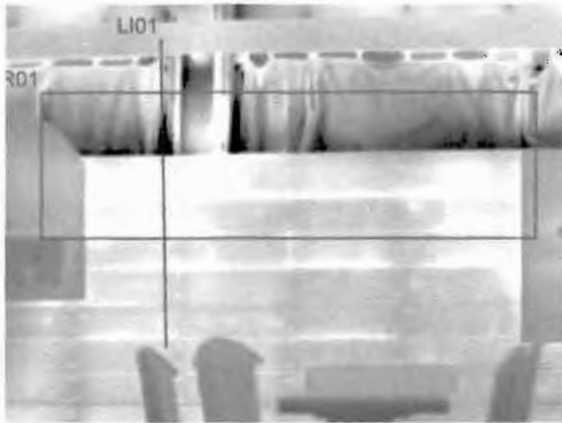
IR Text Comment	Value
Section	Boiler Room Bar
Equipment	Radiant Panel and Windows
Additional information	Room was grossly overheated due to malfunctioning zone valve.
Fault	Heat from panel is lost through double pane windows
Recommendation	Insulate exterior of basement wall and install triple pane glas

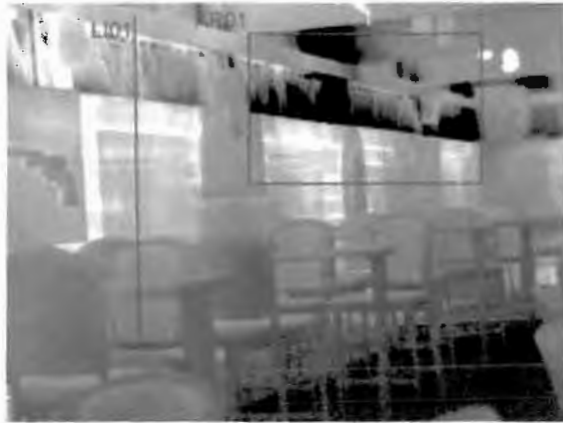
IR Text Comment	Value
Section	Boiler Room Bar
Equipment	View of exterior wall and windows.
Additional information	Room was grossly overheated due to malfunctioning zone valve.
Fault	Heat loss through windows and wall.
Recommendation	Insulate exterior of basement wall and install triple pane glas

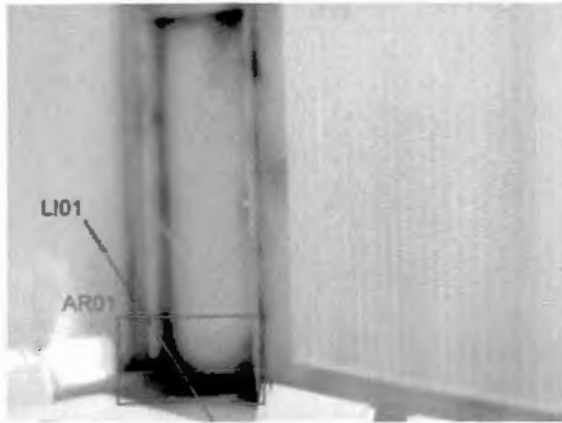
C0315-06.img

IR Text Comment	Value
Section	Boiler Room Bar
Equipment	Northern Nook and Exterior Door
Additional information	
Fault	High heat loss from air leakage around door.
Recommendation	Install tight fitting weatherstripping around doors.

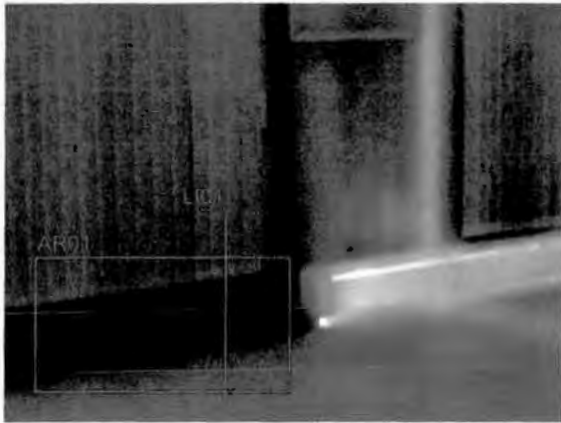
IR Text Comment	Value
Section	Boiler Room Bar
Equipment	Northern Nook Radiation at Wall / Floor
Additional information	
Fault	Elevated heat loss through wall / floor area.
Recommendation	Exterior retrofit.

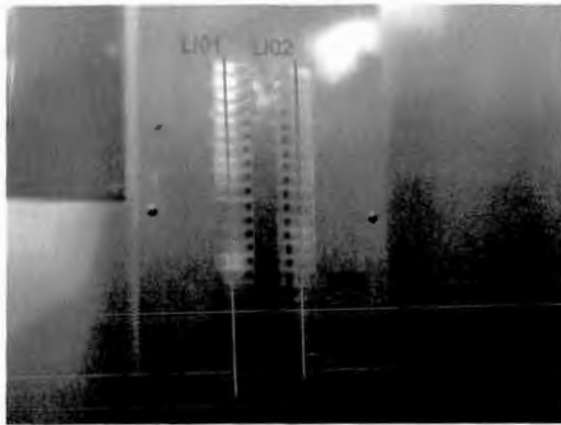
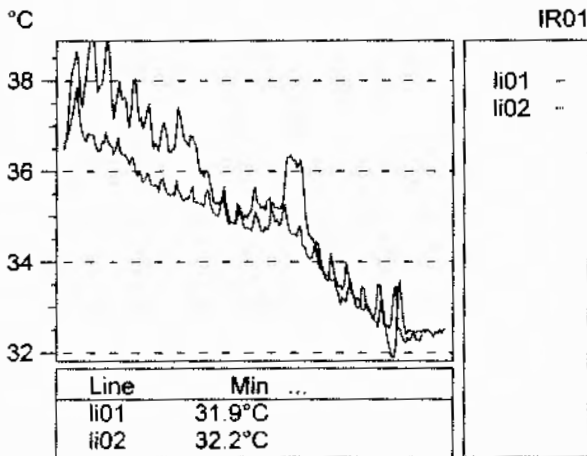
IR Text Comment	Value
Section	Hall Behind Boiler Room
Equipment	Breaker Panel
Additional information	
Fault	Hot Circuit Breaker
Recommendation	Upgrade breaker or reduce load.

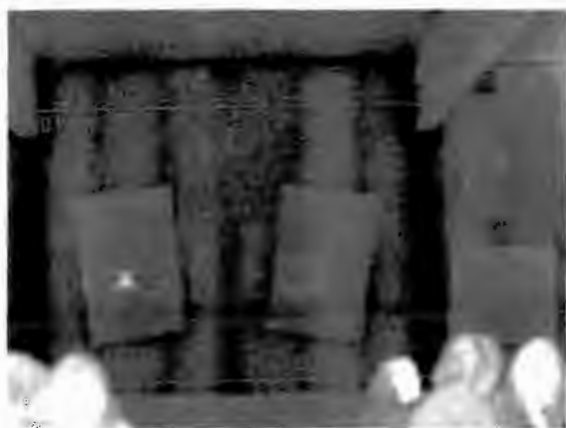
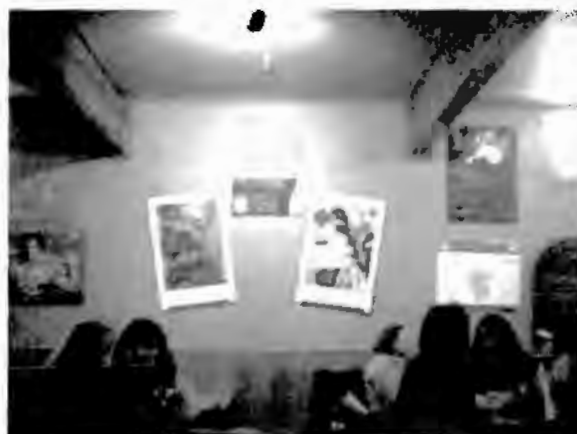
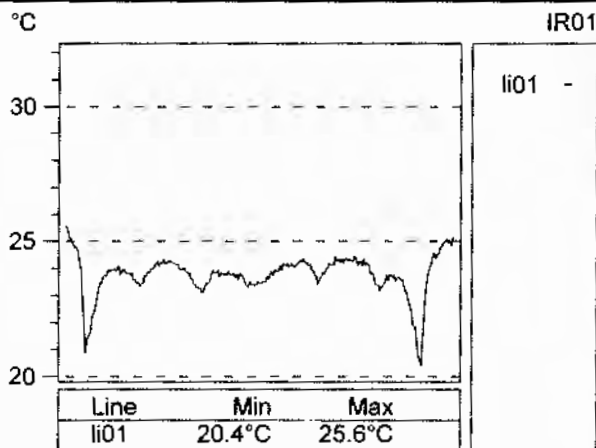
IR Text Comment	Value
Section	Sports Bar
Equipment	Exterior Wall and Beam Pocket
Additional information	
Fault	Poorly installed insulation and air leakage at beam pocket.
Recommendation	Caulk and air seal beam pocket and perform exterior retrofit.

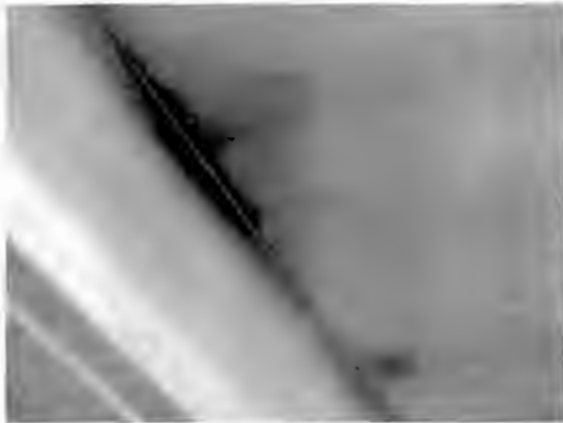
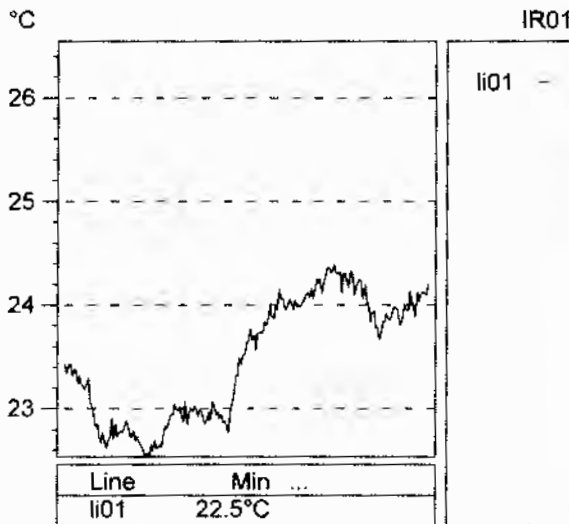
IR Text Comment	Value
Section	Sports Bar
Equipment	Ceiling Support Beam
Additional information	
Fault	Air leakage at ceiling beam
Recommendation	Air seal beam to sealing joint.

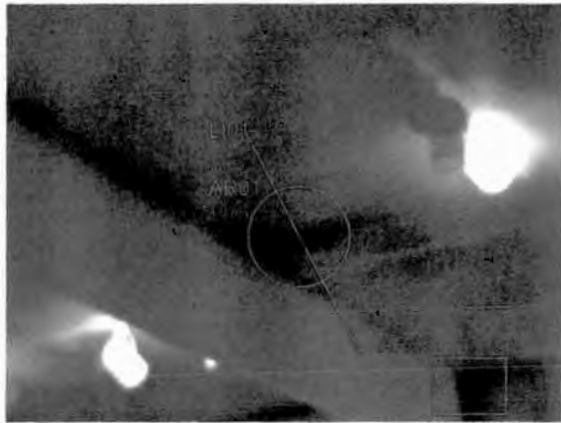
IR Text Comment	Value
Section	Sports Bar
Equipment	Ceiling
Additional information	
Fault	Insulation Flaw in Ceiling
Recommendation	Retrofit ceiling on exterior.

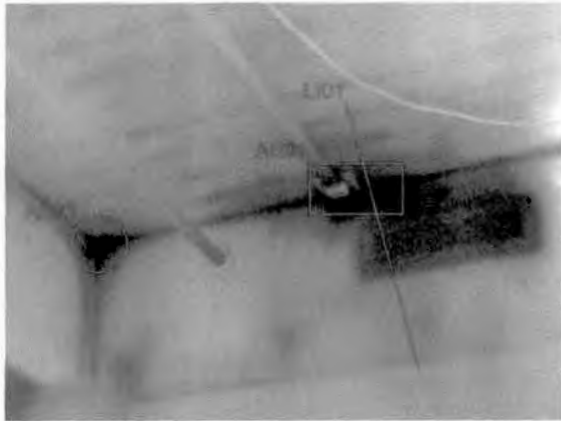
IR Text Comment	Value
Section	Sports Bar
Equipment	Ceiling / Wall Joint
Additional information	
Fault	Poorly installed insulation and air leakage.
Recommendation	Retrofit ceiling on exterior.

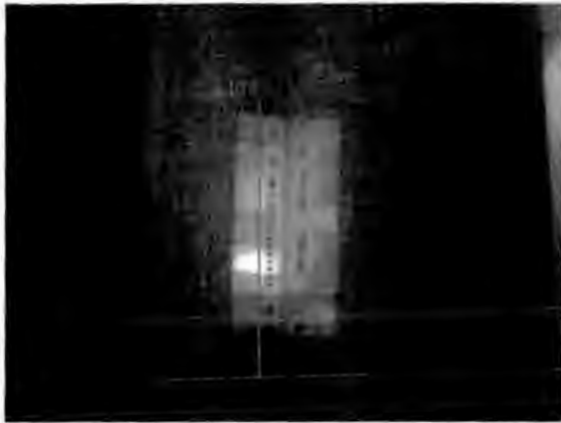
IR Text Comment	Value
Section	Yukon Inn Restaurant
Equipment	Kitchen Breaker Panel R
Additional information	
Fault	Hot Breaker
Recommendation	Replace breaker or reduce load.

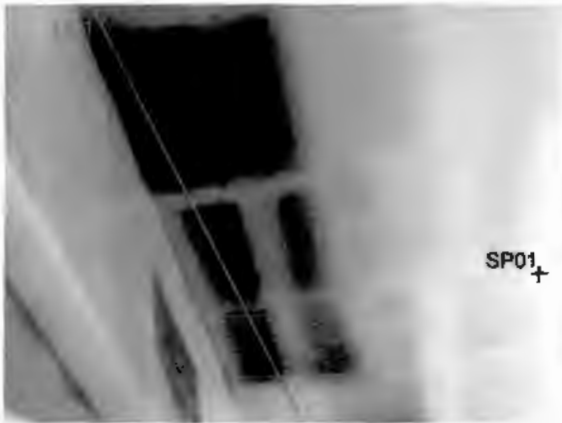
IR Text Comment	Value
Section	Kitchen
Equipment	Staff area ceiling at ventilation grille
Additional information	
Fault	Missing/wet or poorly installed insulation in ceiling.
Recommendation	Perform exterior roof retrofit.

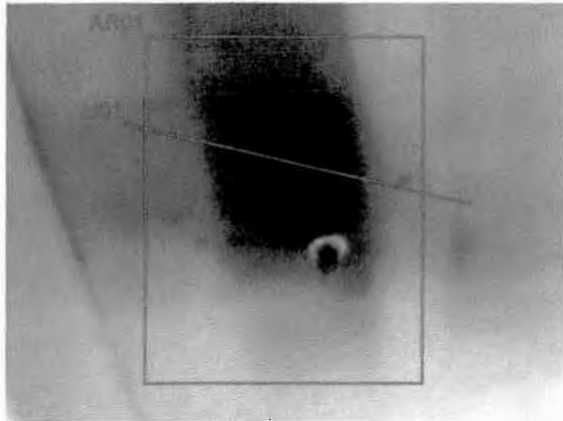
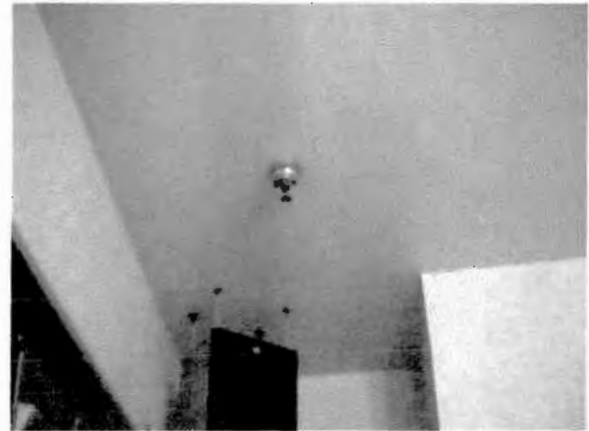
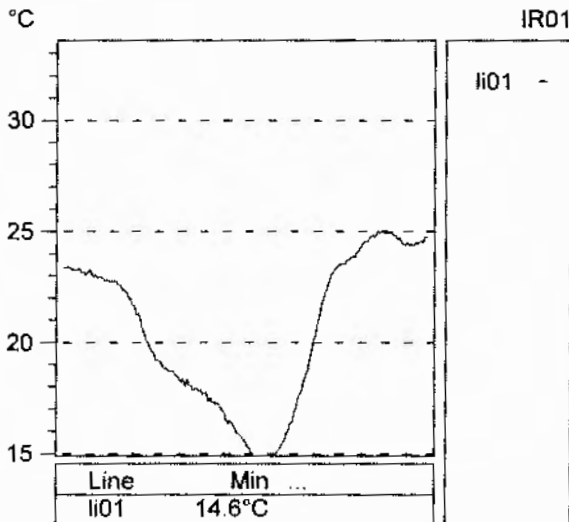
IR Text Comment	Value
Section	Kitchen
Equipment	Staff Table Area Ceilingat Sprinkler Head
Additional information	
Fault	Missing/wet or poorly installed insulation.
Recommendation	Perform exterior ceiling/roof retrofit.

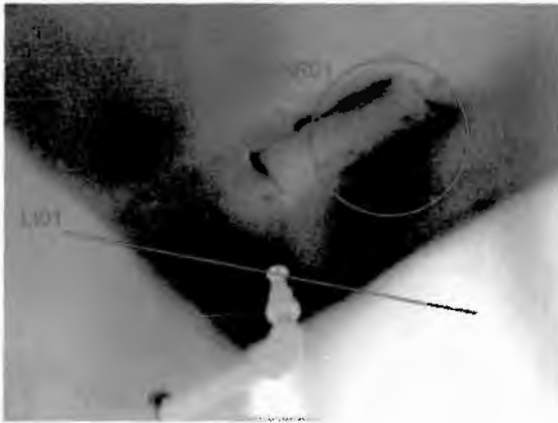
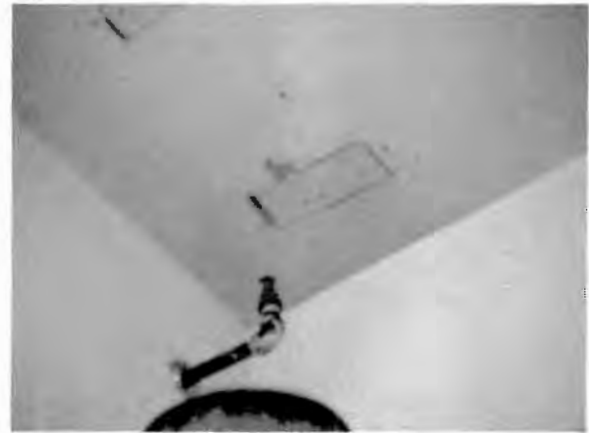
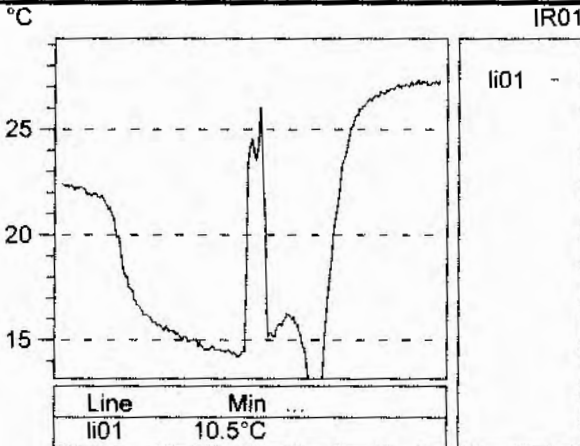
IR Text Comment	Value
Section	Kitchen
Equipment	Side Entry Ceiling
Additional information	
Fault	Missing/wet or poorly installed insulation.
Recommendation	This area has signs of damage. Perform exterior retrofit.

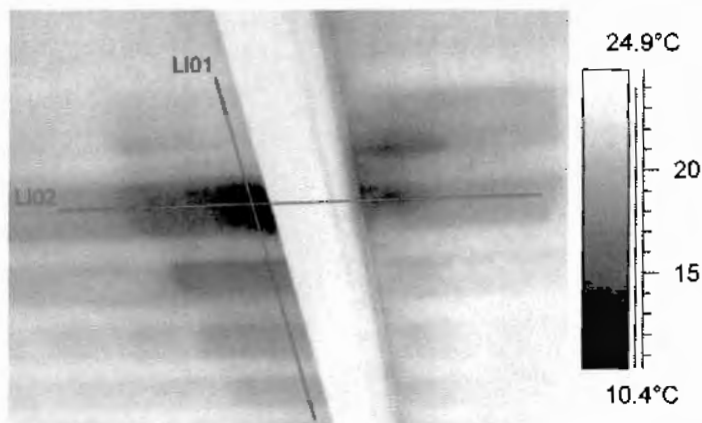
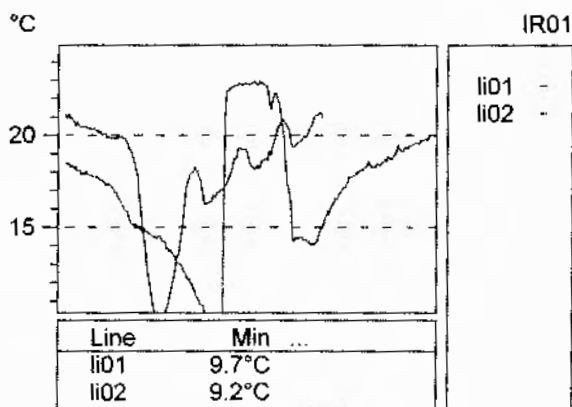
IR Text Comment	Value
Section	Dining Room
Equipment	3rd Ceiling/Beam Looking at Register
Additional information	
Fault	Poorly installed/damaged ceiling insulation.
Recommendation	Perform ceiling/roof retrofit.

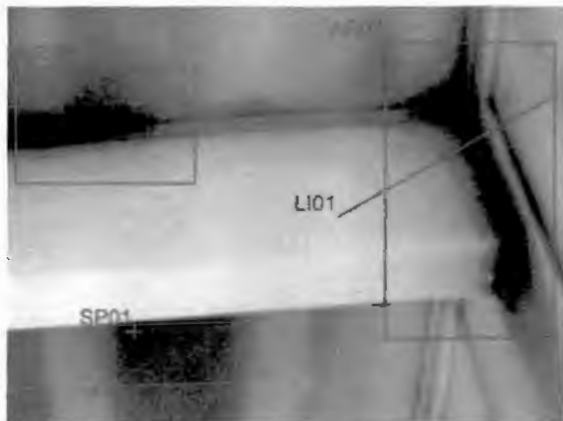
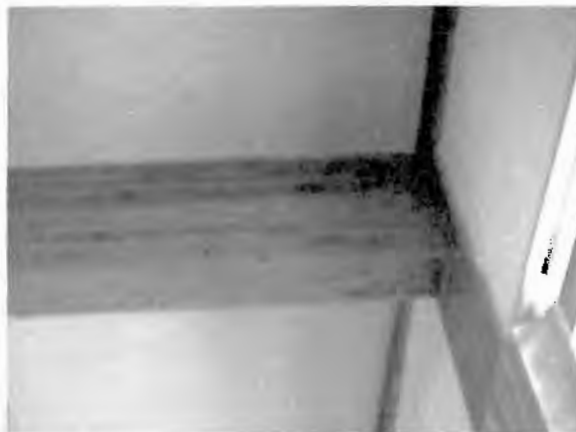
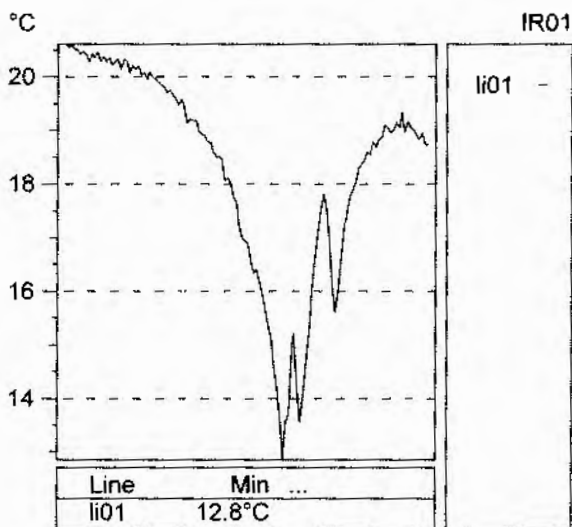
IR Text Comment	Value
Section	Dining Room
Equipment	Beam Pocket at Fourth Beam
Additional information	
Fault	Air leakage and poorly installed insulation
Recommendation	Perform exterior retrofit.

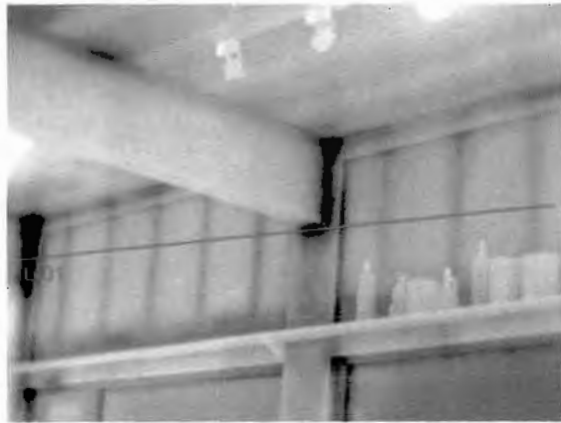
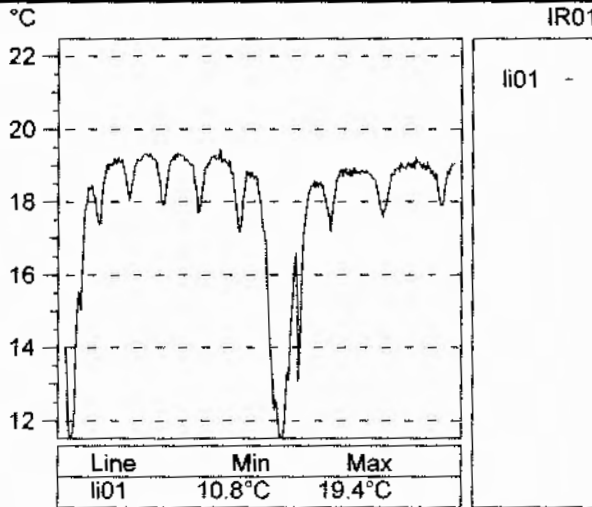
IR Text Comment	Value
Section	Coyote Room
Equipment	Wall/Header Above Windows
Additional information	
Fault	Air leakage and poorly installed insulation
Recommendation	Perform exterior retrofit.

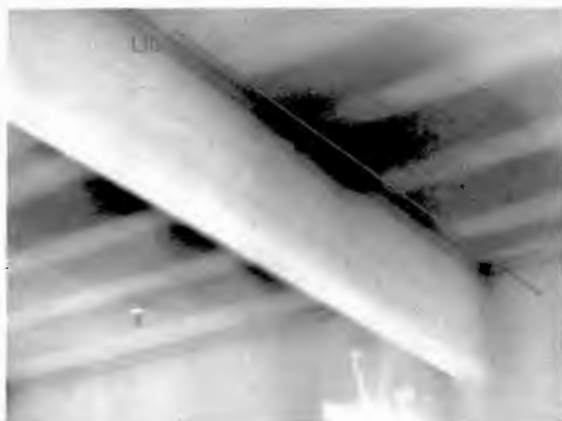
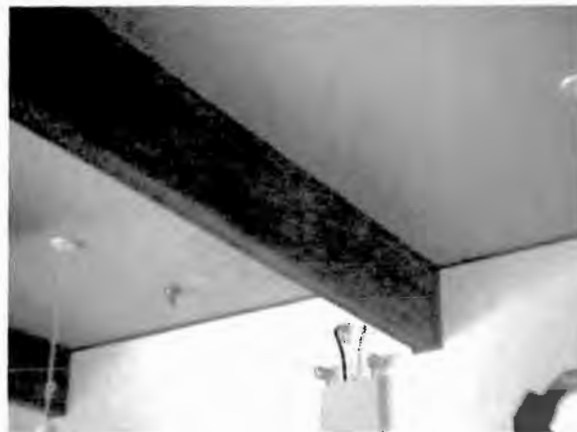
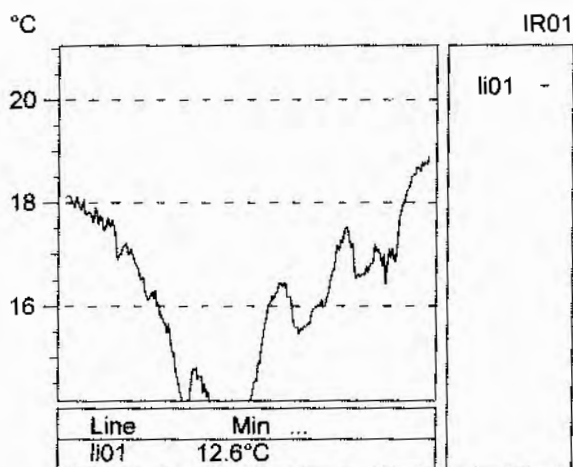
IR Text Comment	Value
Section	Coyote Room
Equipment	Ceiling/Beam
Additional information	
Fault	Damaged or poorly installed insulation above beam
Recommendation	Perform exterior retrofit.

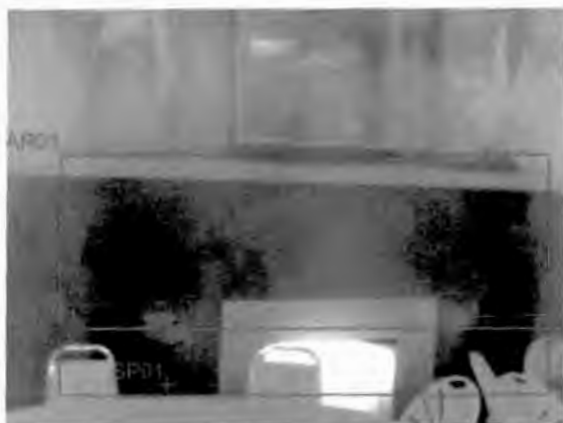
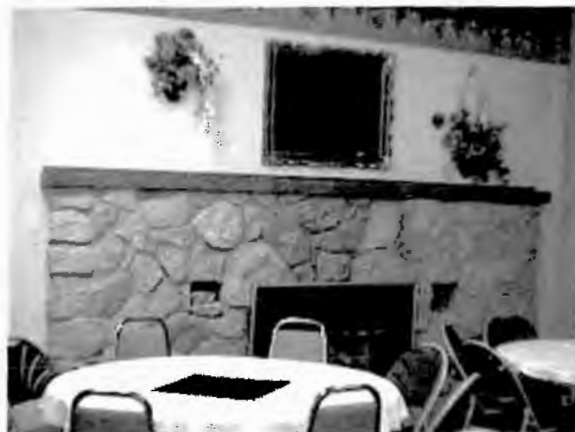
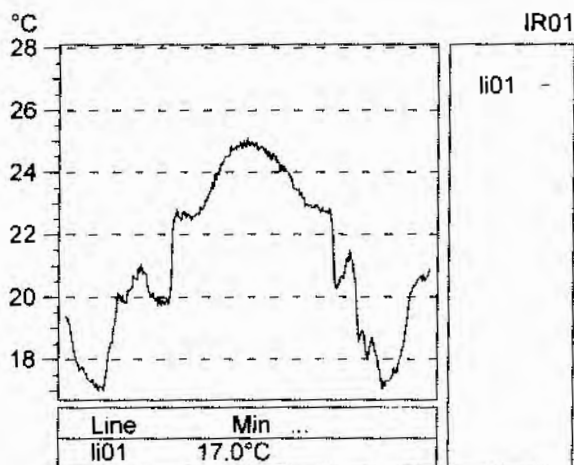
IR Text Comment	Value
Section	Banquet Room
Equipment	Fireplace Wall
Additional information	
Fault	AirLeakage around fireplace
Recommendation	Air seal all cracks and joints and perform exterior retrofit.

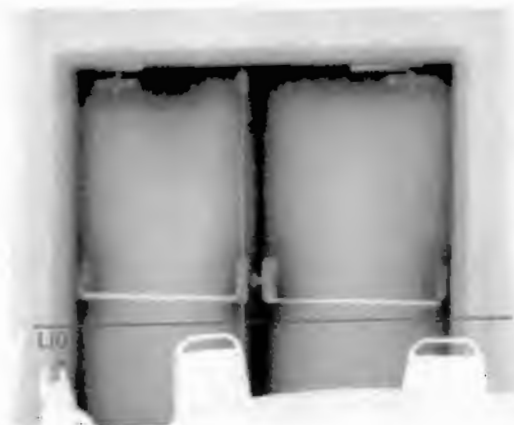
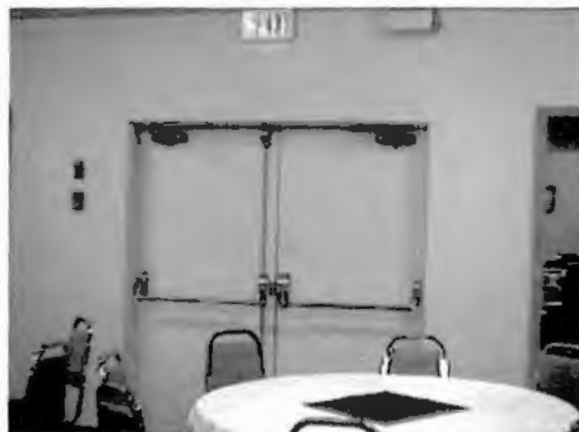
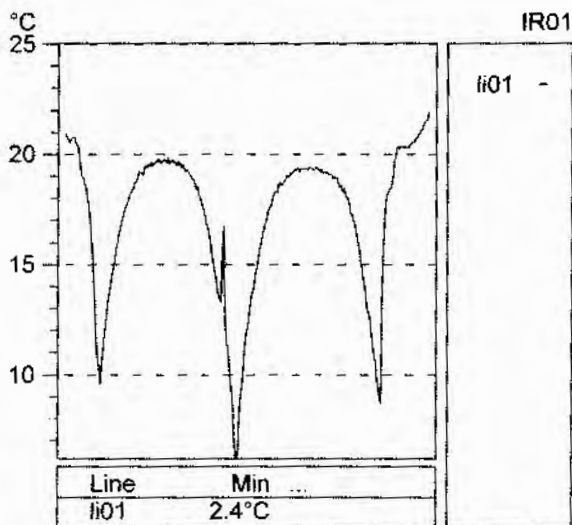
IR Text Comment	Value
Section	Banquet Room
Equipment	Exterior Exit Doors
Additional information	
Fault	Air leakage around door perimeters
Recommendation	Install/adjust weatherstripping.

Object parameter	Value	
Emissivity	0.90	-
Object distance	3.3 m	-
Ambient temperature	15.0°C	-
Reference temperature	20.4°C	-
Label	Value	Diff temperature
IR : max	31.6°C	-
IR : min	1.5°C	-
LI01 : max	21.9°C	1.5°C
LI01 : min	2.4°C	-18.0°C
LI01 : max-min	19.5°C	-

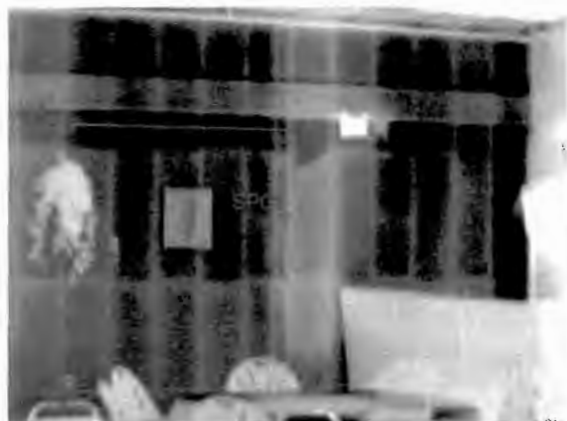
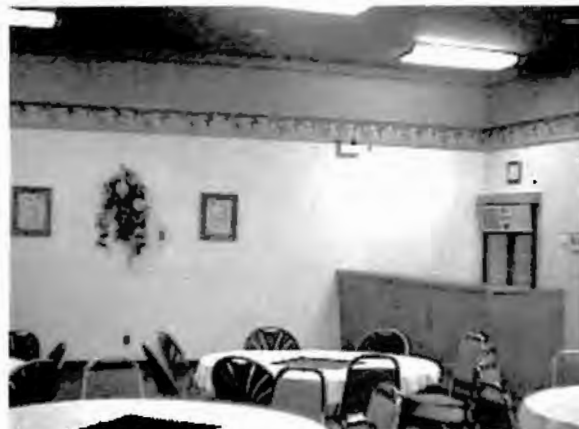
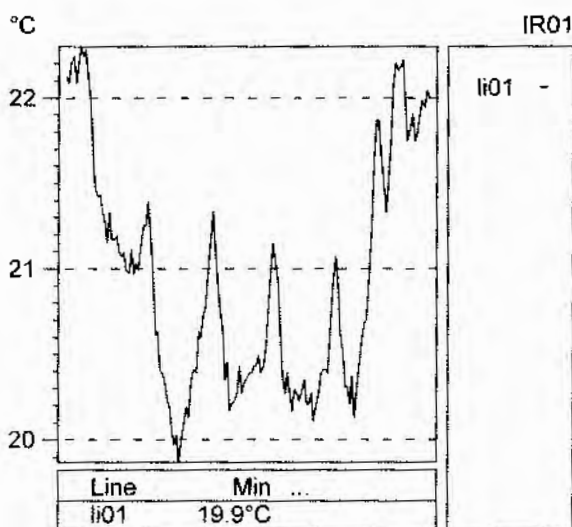
IR Text Comment	Value
Section	Banquet Room
Equipment	Exterior Wall
Additional information	
Fault	Poorly installed insulation
Recommendation	Perform Exterior Retrofit

Object parameter	Value	
Emissivity	0.90	-
Object distance	3.3 m	-
Ambient temperature	15.0°C	-
Reference temperature	20.4°C	-
Label	Value	Diff temperature
IR : max	32.3°C	-
IR : min	19.3°C	-
SP01	22.6°C	2.2°C
LI01 : max	22.3°C	1.9°C
LI01 : min	19.9°C	-0.5°C
LI01 : max-min	2.4°C	-

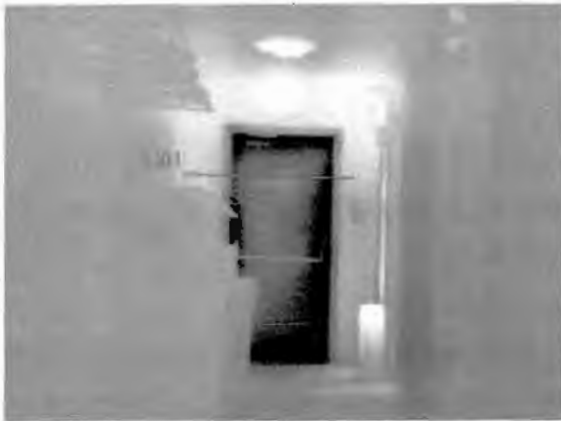
IR Text Comment	Value
Section	Hallway Exit
Equipment	Exterior Door
Additional information	
Fault	Air leakage around door
Recommendation	Adjust or replace weatherstripping.
