GEOLOGICAL SURVEY OF CANADA
BULLETIN 464

FORMATION AND FAILURE OF NATURAL DAMS IN THE CANADIAN CORDILLERA

John J. Clague and Stephen G. Evans

1994

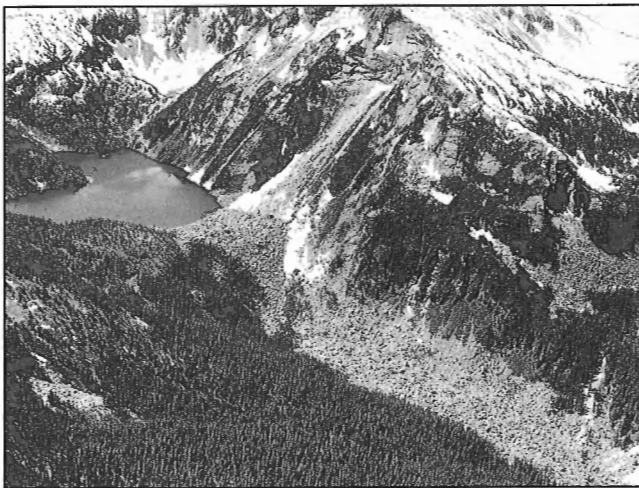
Figure 3. Landslide-dammed lake near Mount Mason in the southern Coast Mountains, British Columbia. The landslide dam comprises blocky rock debris and is stable.

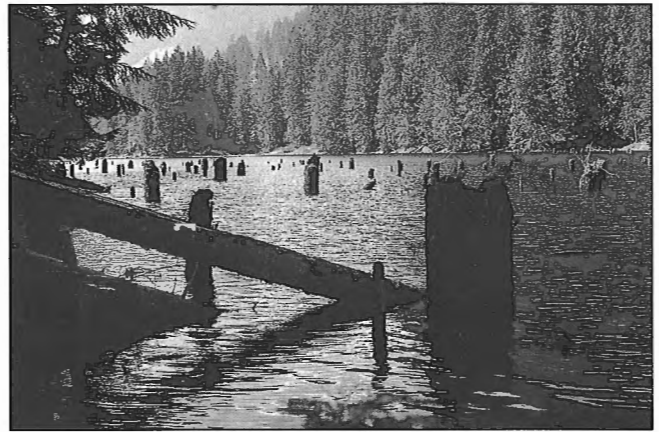
Figure 4. Drowned trees in Foley Lake, southwestern British Columbia. This lake formed and the trees were drowned when the local drainage was blocked by a rock avalanche, sometime between 150 and 310 years ago (Clague and Shilts, 1993).

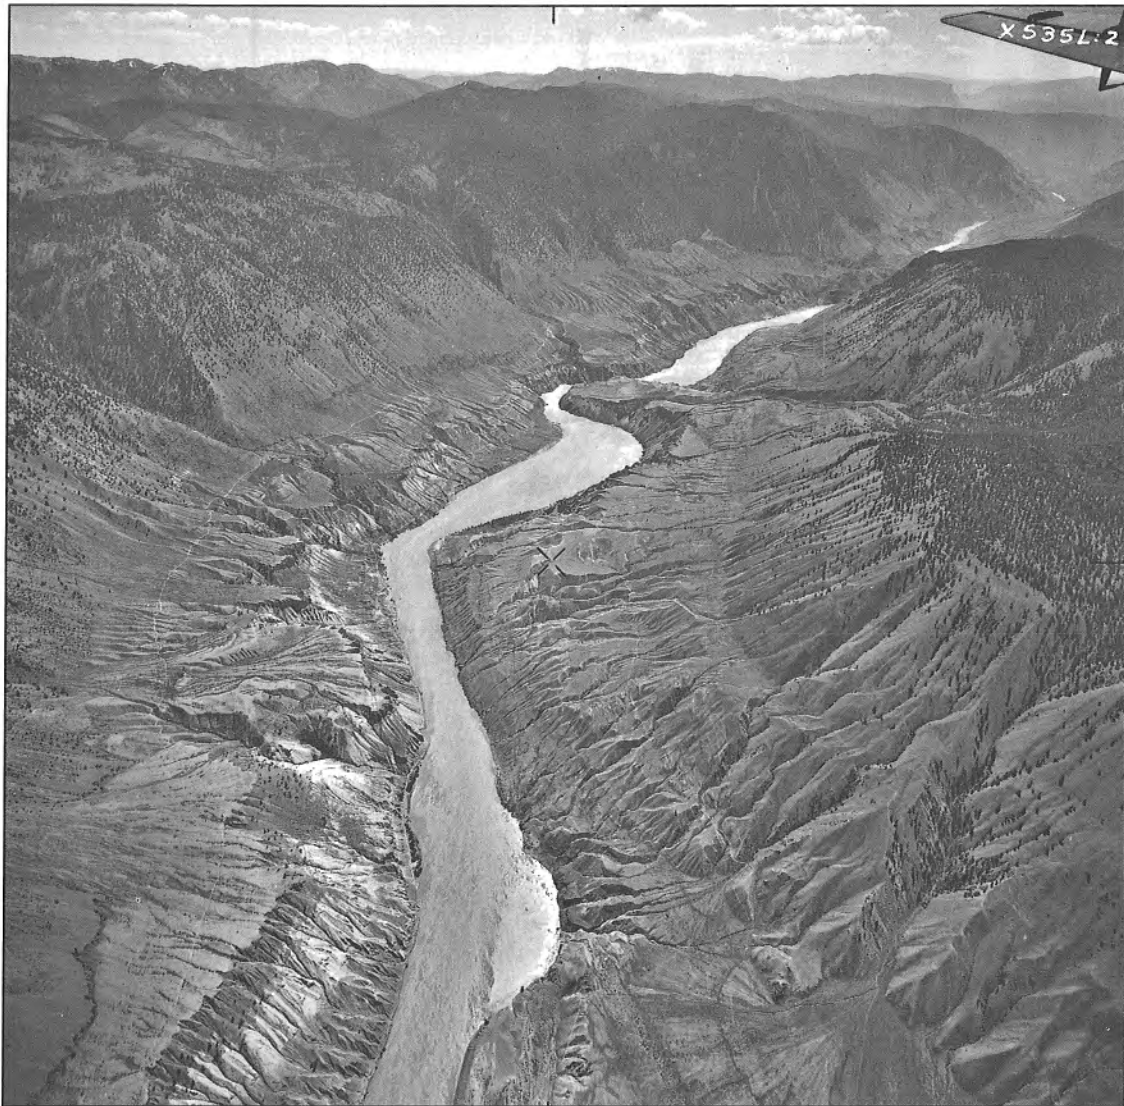
Figure 6. Dissected Quaternary fill in Fraser River valley north of Lillooet, British Columbia. Landslides from the steep bluffs bordering this and other rivers in western Canada have, on occasion, failed and impounded short-lived lakes. (Province of British Columbia airphoto BC1087-46).

glacial and nonglacial periods (Ryder and Clague, 1989). These fills were deeply incised during the Holocene, and many streams today flow in trench-like inner valleys tens or hundreds of metres below late-glacial valley floors (Fig. 6). Silty and sandy glacial lake sediments are an important component of these dissected fills in many areas, and may become unstable and slump or flow when pore pressures are elevated. This may occur during a prolonged period of heavy rainfall, due to irrigation, or as a result of natural or artificial changes in the pattern of groundwater flow. Some of the large landslides that dammed Thompson River in the late nineteenth and early twentieth centuries, for example, may have been triggered by irrigation on nearby benches (Stanton, 1898; Evans, 1984). Lakes impounded by Quaternary sediments generally drain within days of formation when the dam is overtopped and incised.

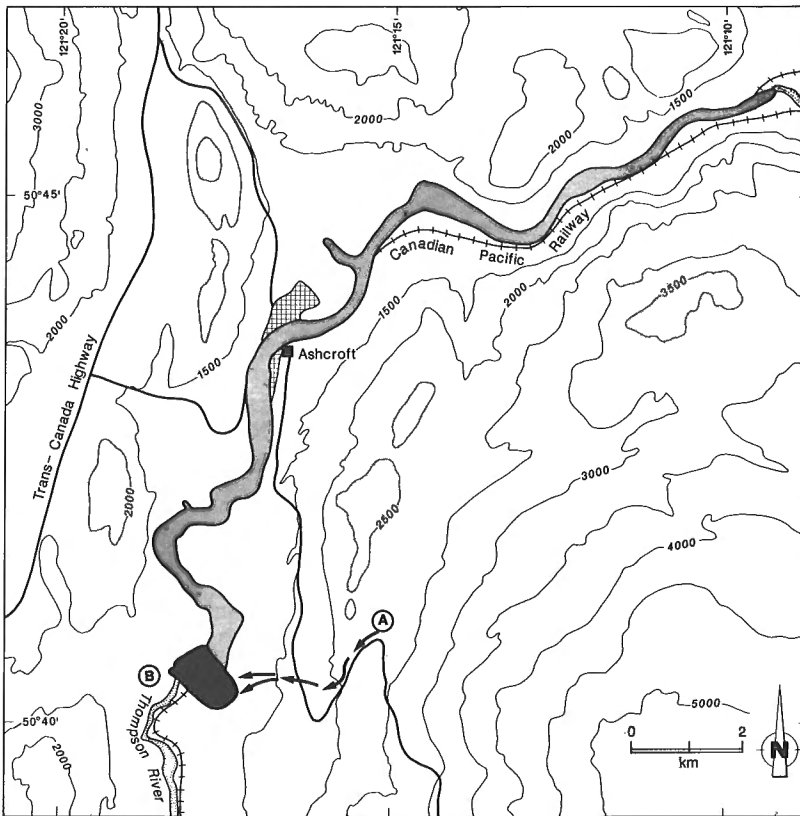
Figure 8.

suddenly failed and flowed across Thompson River, stemming its flow. A lake formed upstream of the blockage and attained a maximum depth of 18 m and a length of 14 km before it began to empty through a channel cut by workmen. The escaping waters enlarged the spillway until, two days after the landslide, the lake was empty.

Location of the 1880 landslide dam (B) in Thompson River valley, south of Ashcroft, British Columbia, and the maximum extent of the reservoir impounded behind the dam. The lake drained about two days after it formed. A is the probable location of an irrigation dam failure, suggested by Stanton (1898) as being a possible cause of the landslide; arrows mark the path of the water to the head of the landslide. Topographic contour interval = 500 feet (152 m). (Modified from Fig. 1 of Evans, 1984).

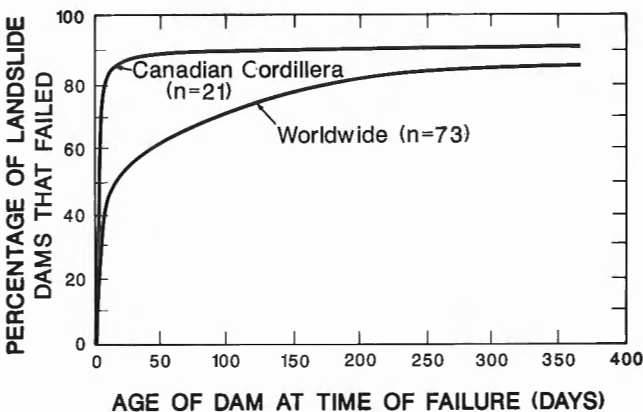
The short lifespan of historical landslide dams in the Canadian Cordillera (Fig. 12) is a consequence of the rapid filling of the reservoirs and the material properties of the dams. Most of the dams consist of loose porous sediments, which commonly are water-rich and predominantly fine grained (i.e. they have a high proportion of clay, silt, and sand). The shear strength of such materials is low, and consequently the dams are susceptible to slope failure or to erosion when overtopped. In contrast, dams consisting of blocks of competent bedrock tend to be stable because any overflowing water is incapable of eroding the coarse materials and because the dam slopes are unlikely to fail. In any case, these latter dams are so porous and permeable that there commonly is little or no overflow.

Figure 12. Length of time before failure of historical landslide dams in the Canadian Cordillera (this bulletin) and worldwide (Costa and Schuster, 1988).

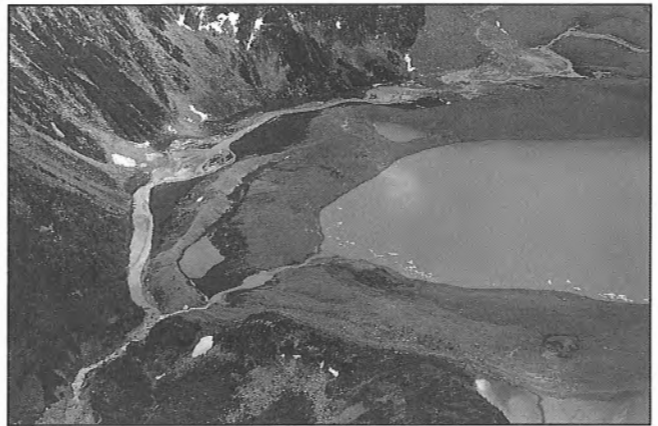
Figure 13. Unnamed moraine-dammed lake in the southern Coast Mountains, British Columbia. The large moraine impounding the lake was constructed during the Little Ice Age.

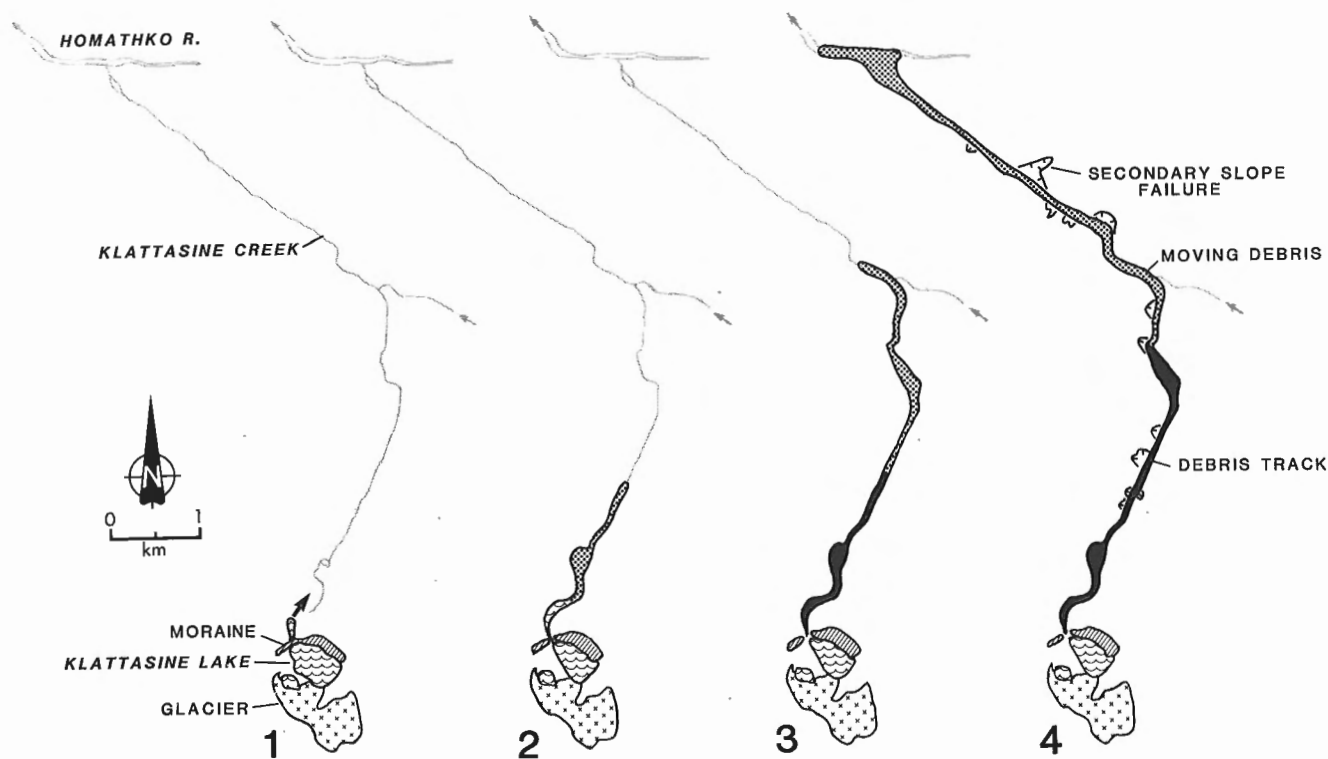
Four other historical moraine dam failures produced debris flows rather than water floods. The largest, in the valley of Klattasine Creek 35 km west of Nostetuko Lake, occurred sometime between June 1971 and September 1973 (Clague et al., 1985). It was triggered by the sudden release of about $1.7 \times 10^6 \text{ m}^3$ of water from moraine-dammed Klattasine Lake. The escaping waters breached the moraine (Fig. 19), mobilized large quantities of sediment in the valley below the lake, and generated a debris flow that travelled in one or more surges 8 km to the mouth of Klattasine Creek (Fig. 20, 21). Here, the flow deposited a sheet of coarse bouldery debris up to 20 m thick that temporarily stemmed the flow of Homathko River (Fig. 22).

Figure 21. Stages in the evolution of the Klattasine Creek debris flow. 1, the moraine damming Klattasine Lake begins to fail; 2, escaping waters mobilize large quantities of sediment, initiating a debris flow; 3, the debris flow rapidly moves downvalley and entrains additional sediment; 4, the front of the debris flow reaches Homathko River and temporarily blocks it; secondary landslides occur in Klattasine Creek valley. Stippled area = moving debris; black area = wake of debris flow.

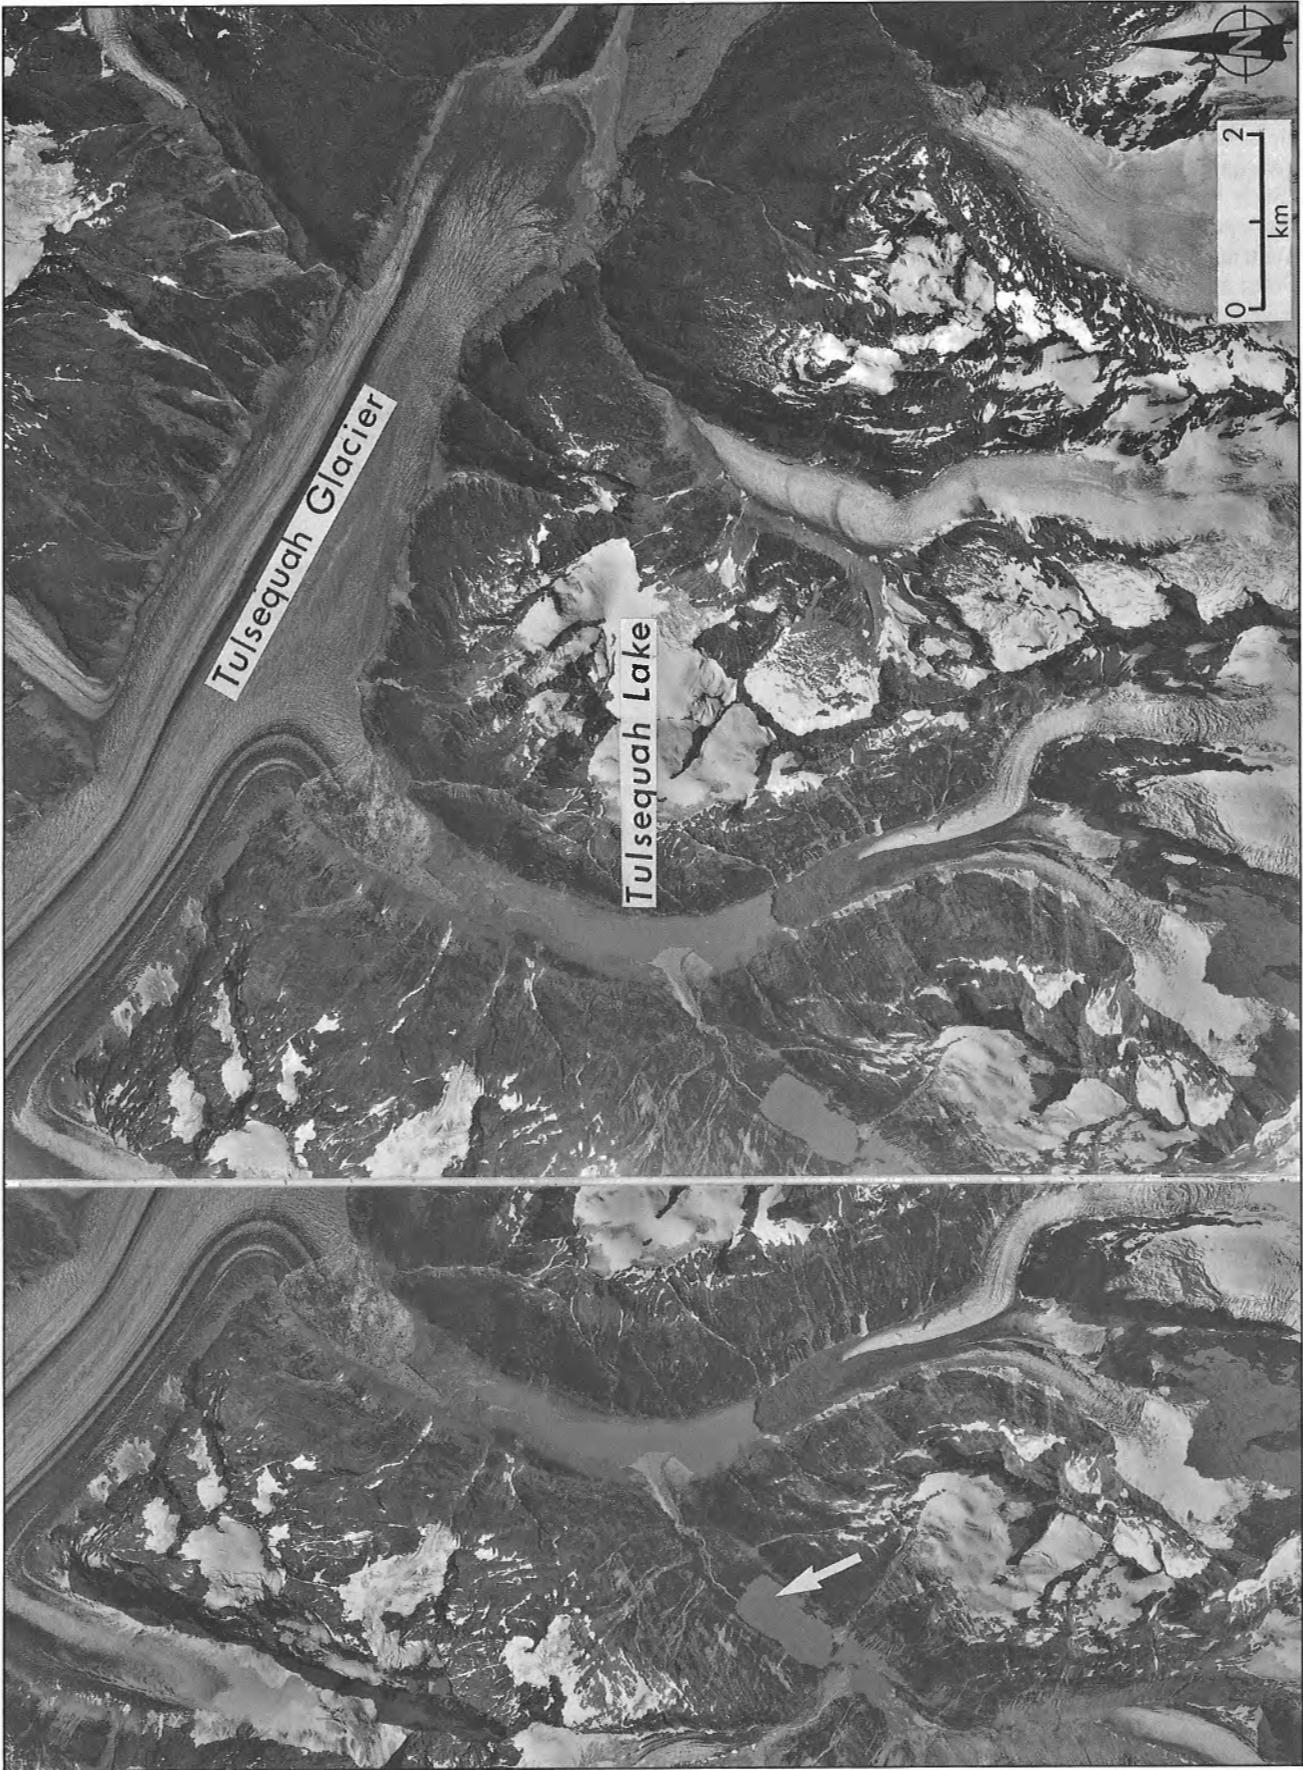
Figure 23. *Photostereogram showing Tulsequah Lake, a large glacier-dammed lake in the northern Coast Mountains, British Columbia. Note the potentially unstable, moraine-dammed lake (arrow) just west of Tulsequah Lake. (Province of British Columbia airphotos BC82009-86, -87)*

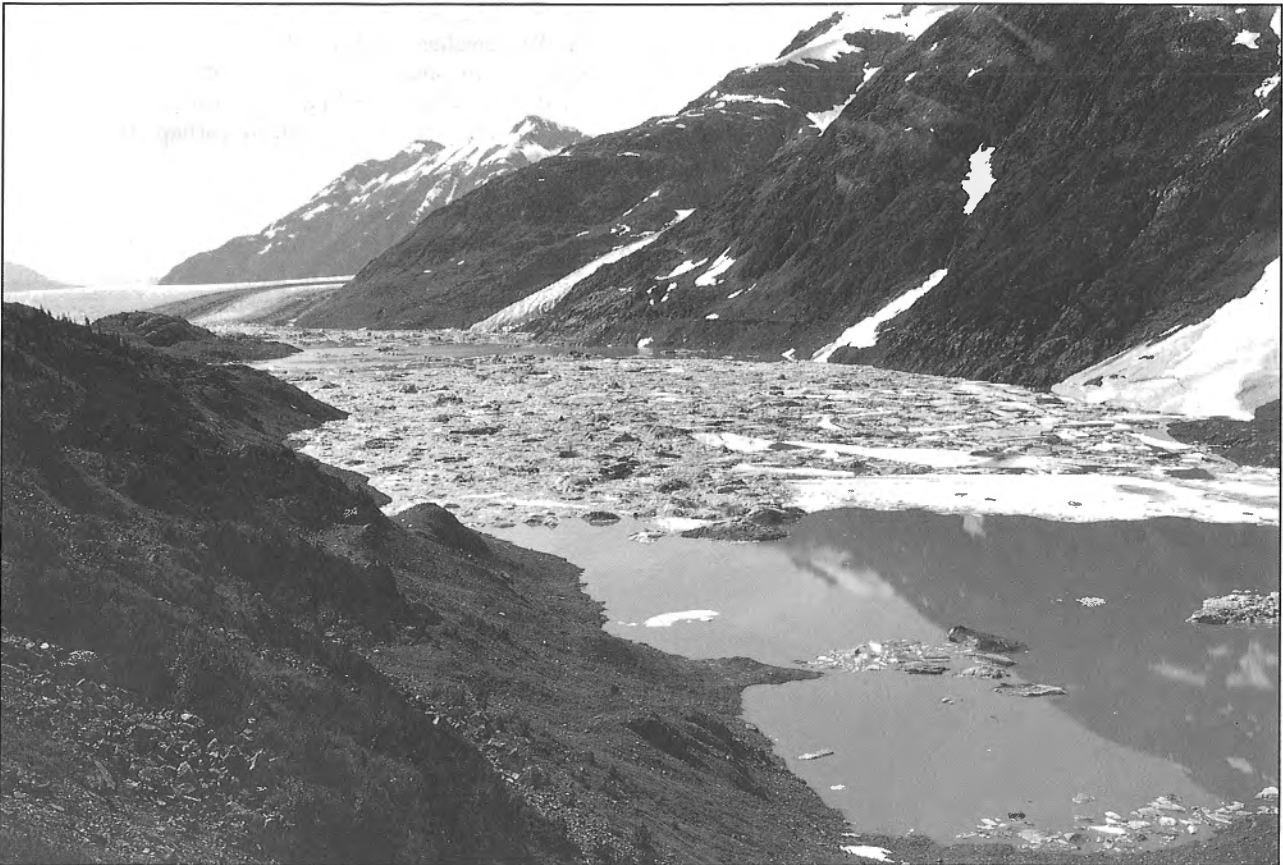
Figure 24. Summit Lake, August 1989. The lake is dammed by Salmon Glacier (visible in the distance), and empties and fills annually.

understanding of the physics of outburst floods. Jökulhlaups from Summit Lake (Fig. 24) in the northern Coast Mountains of British Columbia menaced the transportation corridor between the Granduc mine site and Hyder, Alaska, and motivated the research of W.H. Mathews (1959, 1964, 1965, 1973) and his student R. Gilbert (1969, 1971, 1972). Mathews (1973) reconstructed the 1965 and 1967 Summit Lake jökulhlaups from observations of falling lake levels, lake areas, and surface outflow, plus estimates of inflow. He showed that outflow discharge increased in proportion to a power (1.5) of the volume of water previously lost from the lake (Fig. 32). From this and from calculations of effective tunnel diameter following the jökulhlaups, Mathews concluded that the tunnels developed by melting due to heat transfer from water, rather than mechanical

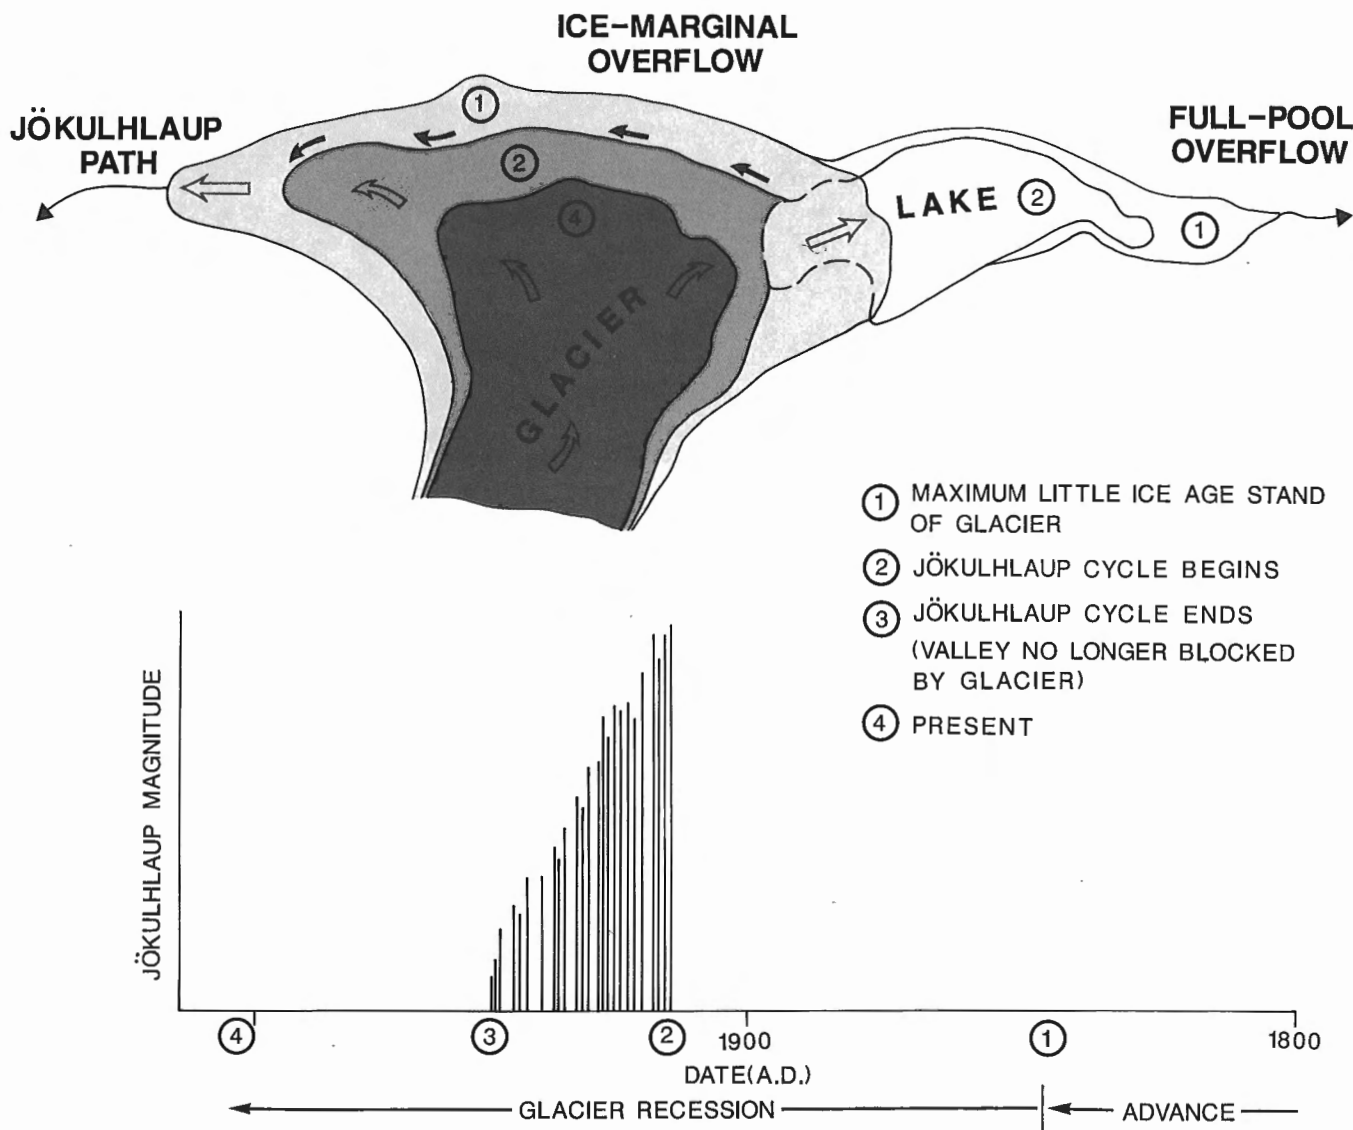
Figure 27. Pattern of jökulhlaup activity accompanying glacier retreat during the twentieth century. The top diagram is a plan view of the toe of a hypothetical glacier at three times (1, 2, 4; ice-flow directions are shown by open arrows). The bottom diagram is a plot of jökulhlaup magnitude (relative scale) versus time. At time 1, the lake impounded by the glacier is stable and drains via a stable overflow channel. Between times 1 and 2, the lake overflows along the margin of the glacier (solid arrows). The first jökulhlaup occurs at time 2, and sporadic or cyclic outburst floods continue until time 3 when the glacier has retreated to the point that it can no longer impound a lake. The glacier then continues to retreat to the present (time 4).

retreat, a critical threshold is reached when the dam can no longer continuously support the water behind it (e.g. Summit Lake, British Columbia, in December 1961; Mathews, 1965; Mathews and Clague, 1993). Thereafter, the lake drains and refills on either a regular (one or more times a year) or irregular basis. In the words of W.H. Mathews (1965), the lake becomes "self-dumping". This continues until either the glacier readvances and forms a stronger dam or, more typically, at least in this century, until it retreats to the point where it no longer impounds water (e.g. Ape and Strohn lakes, British Columbia; Mathews, 1965; Desloges et al., 1989). The frequency of dam failure is also likely to change with time. As a glacier recedes, failures may increase in frequency but decrease in magnitude, ending with the establishment of a permanent outlet (Thorarinsson, 1939; Marcus, 1960).

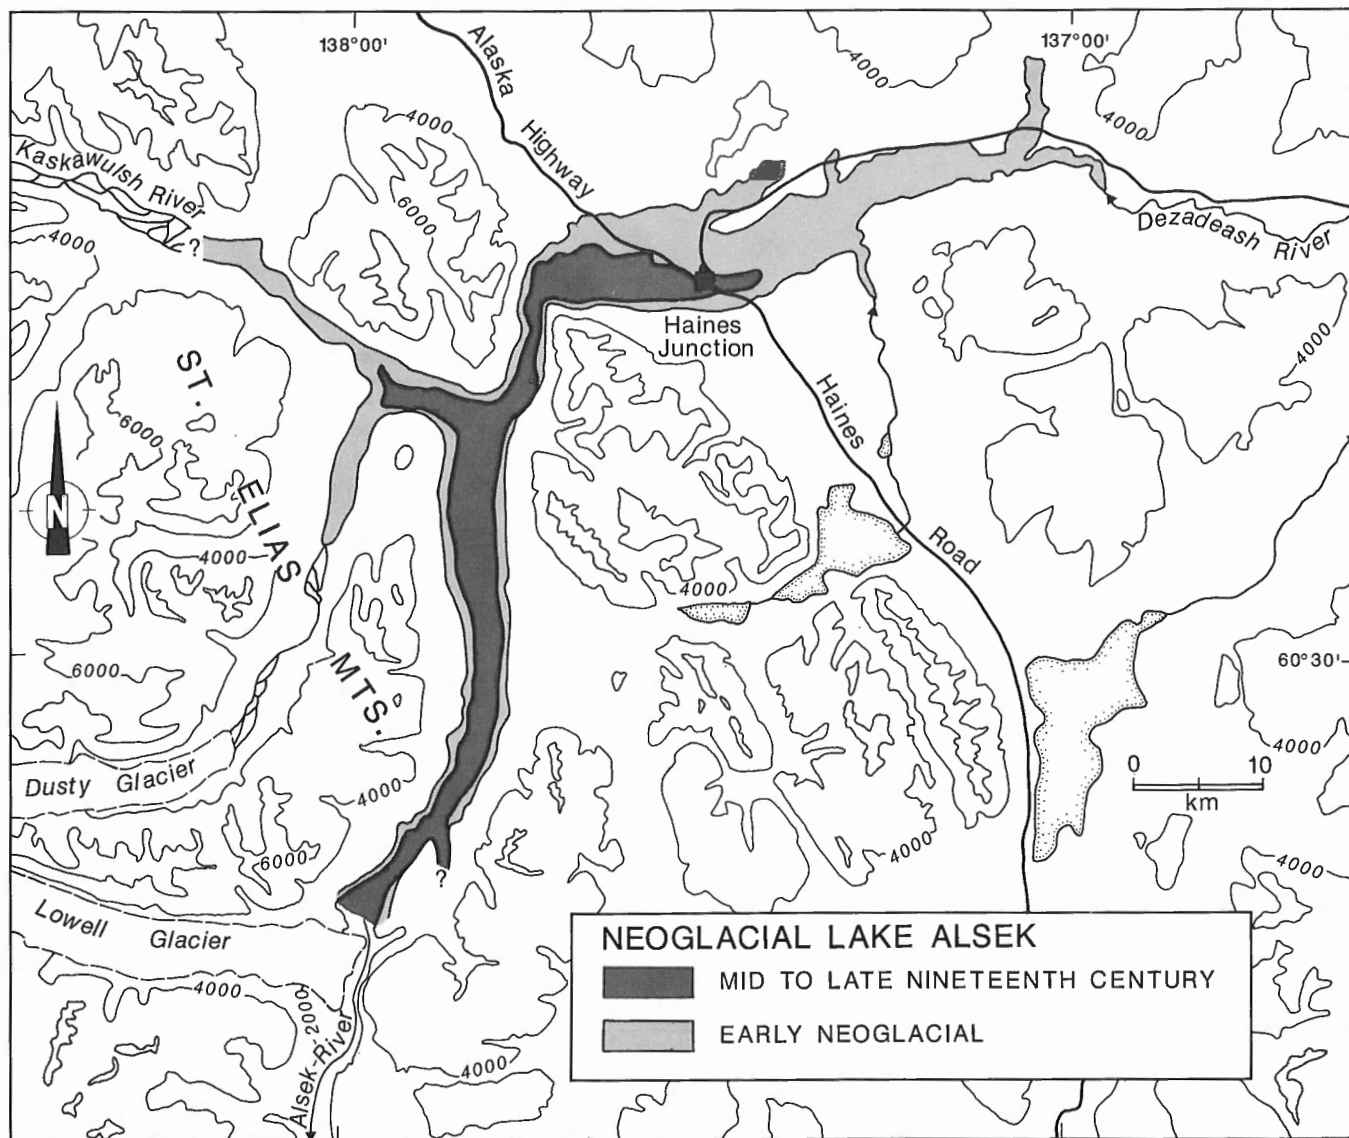
Figure 28. Maximum extent of Lake Alsek during the middle nineteenth century and earlier during the Neoglacial period (perhaps 2000-3000 years BP). The lake formed when Lowell Glacier advanced across Alsek River valley. Topographic contour interval = 2000 feet (610 m). (Modified from Fig. 3 of Clague and Rampton, 1982).

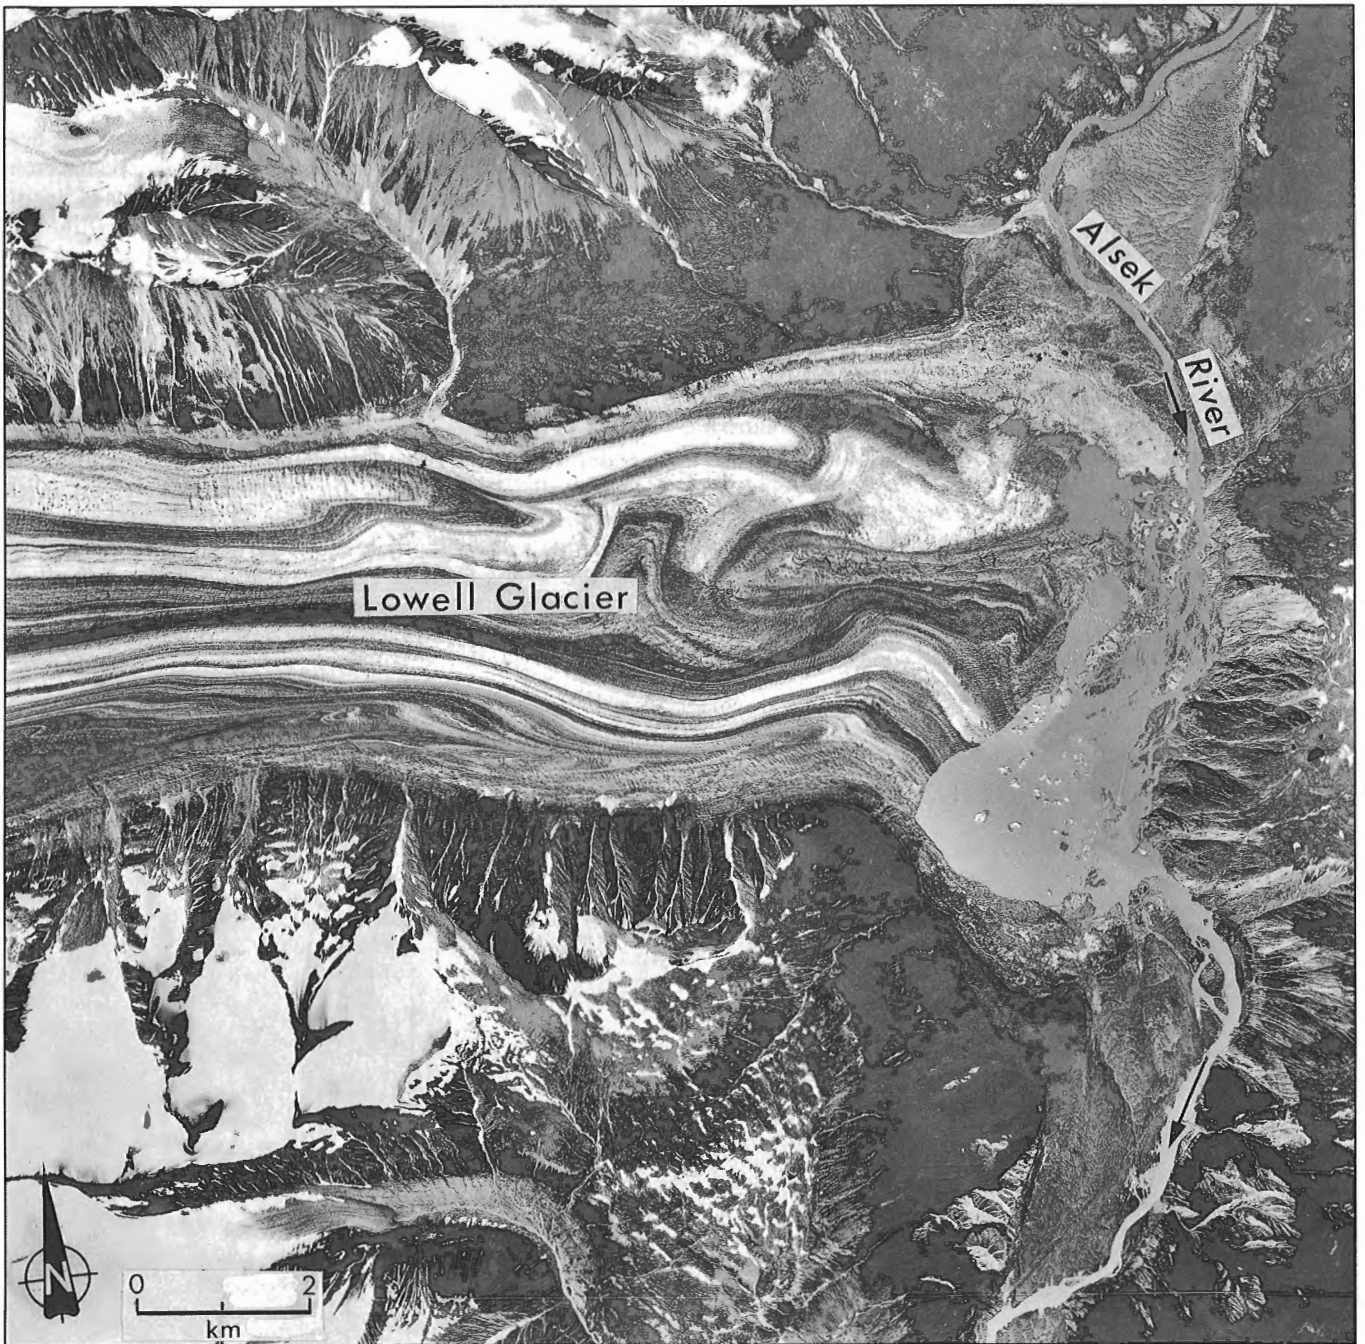
Figure 29. Aerial photograph of the lower part of Lowell Glacier and adjacent Alsek River valley, July 1976. Lake Alsek was impounded many times at this site when Lowell Glacier advanced across Alsek River valley. The lake extended north of the glacier snout (Fig. 28). (Canada Department of Energy, Mines and Resources airphoto A24515-148)

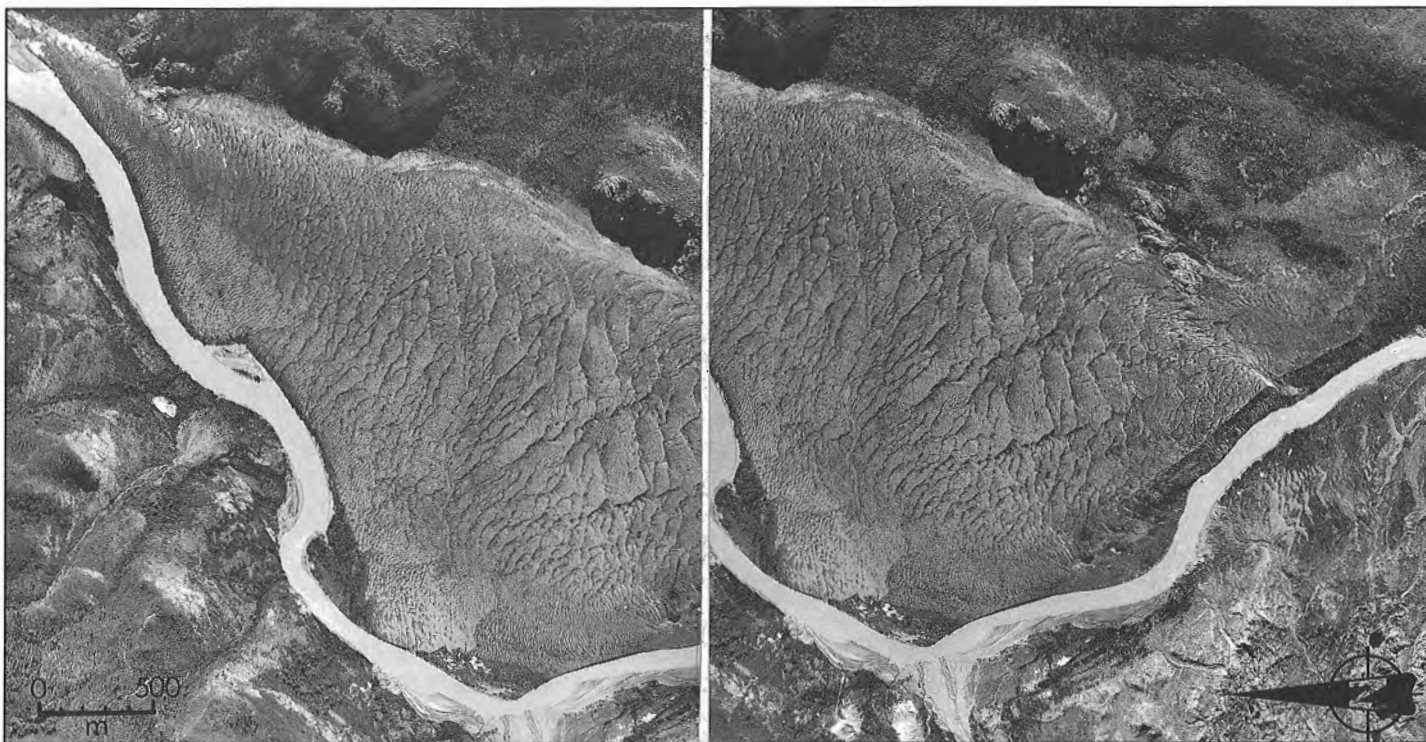
Figure 30. Photostereogram of Alsek River valley immediately upstream of the terminus of Lowell Glacier, showing large gravel dunes formed by currents during the rapid draining of Lake Alsek (the dunes are also visible in Fig. 29). The maximum dune height is about 4 m. (Canada Department of Energy, Mines and Resources airphotos A23819-49, -51)

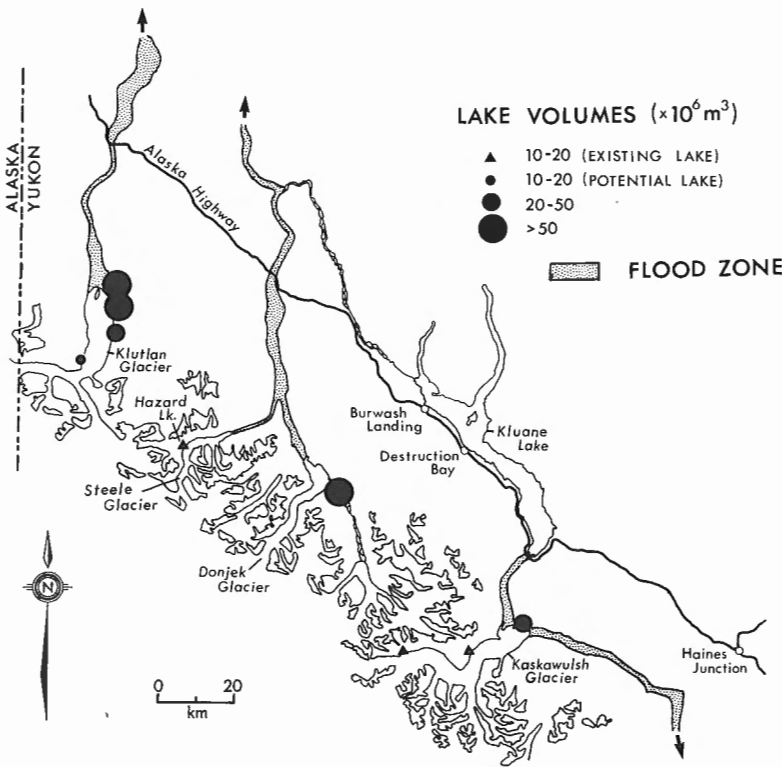
Figure 31.

Jökulhlaup zones and existing and potential glacier-dammed lakes larger than $10 \times 10^6 \text{ m}^3$ in the White, Donjek, and Slims-Kaskawulsh basins, St. Elias Mountains, Yukon Territory. Potential lakes are basins in which water would be ponded in the event of a glacier advance. Basins near the termini of Klutlan and Kaskawulsh glaciers have not held water for several centuries and are unlikely to do so in the foreseeable future. (Fig. 9 of Clague, 1982).

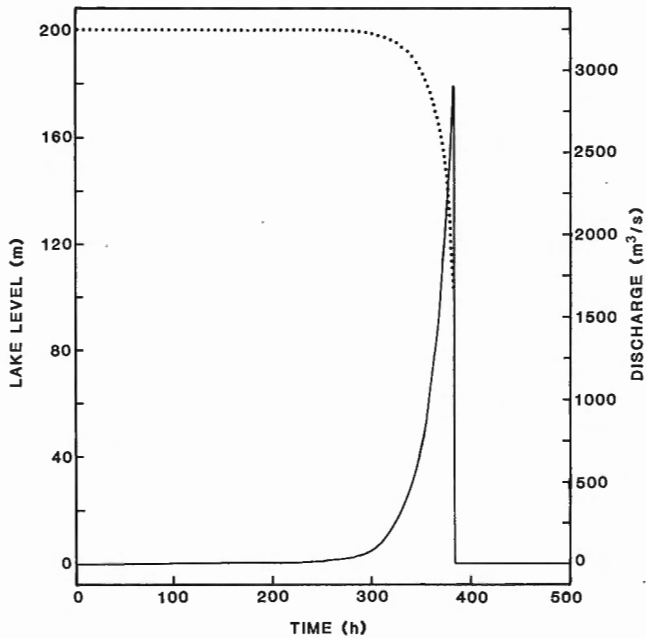
erosion. The exponential increase in discharge with time indicates a positive feedback loop in outflow from the lake: progressively larger discharges cause more heat production and melting of ice, leading to a larger tunnel, further increases in discharge, more heat, and so on until the water supply is exhausted.

Figure 32. Variations in lake level (dotted line) and discharge (solid line) for a jökulhlaup from Summit Lake (September 1967), illustrating the characteristics of a typical outburst, namely an exponential increase in discharge followed by an abrupt termination. (Fig. 4 of Mathews and Clague, 1993).

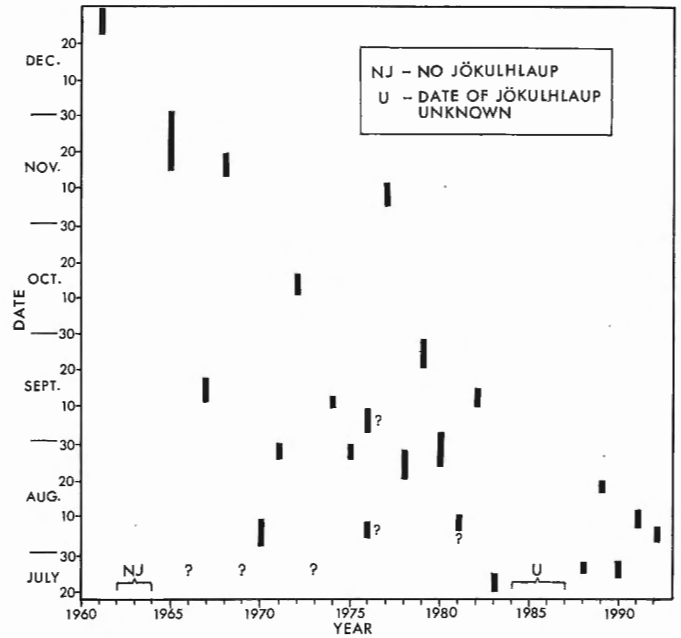
Figure 33. Dates of Summit Lake jökulhlaups, 1961-1992. There has been a tendency for the floods to occur earlier in the year with time, probably related to progressive thinning and weakening of the glacier dam. Question marks indicate uncertain jökulhlaup dates (1976, 1981) and years of small or no jökulhlaups (Fig. 8 of Mathews and Clague, 1993).

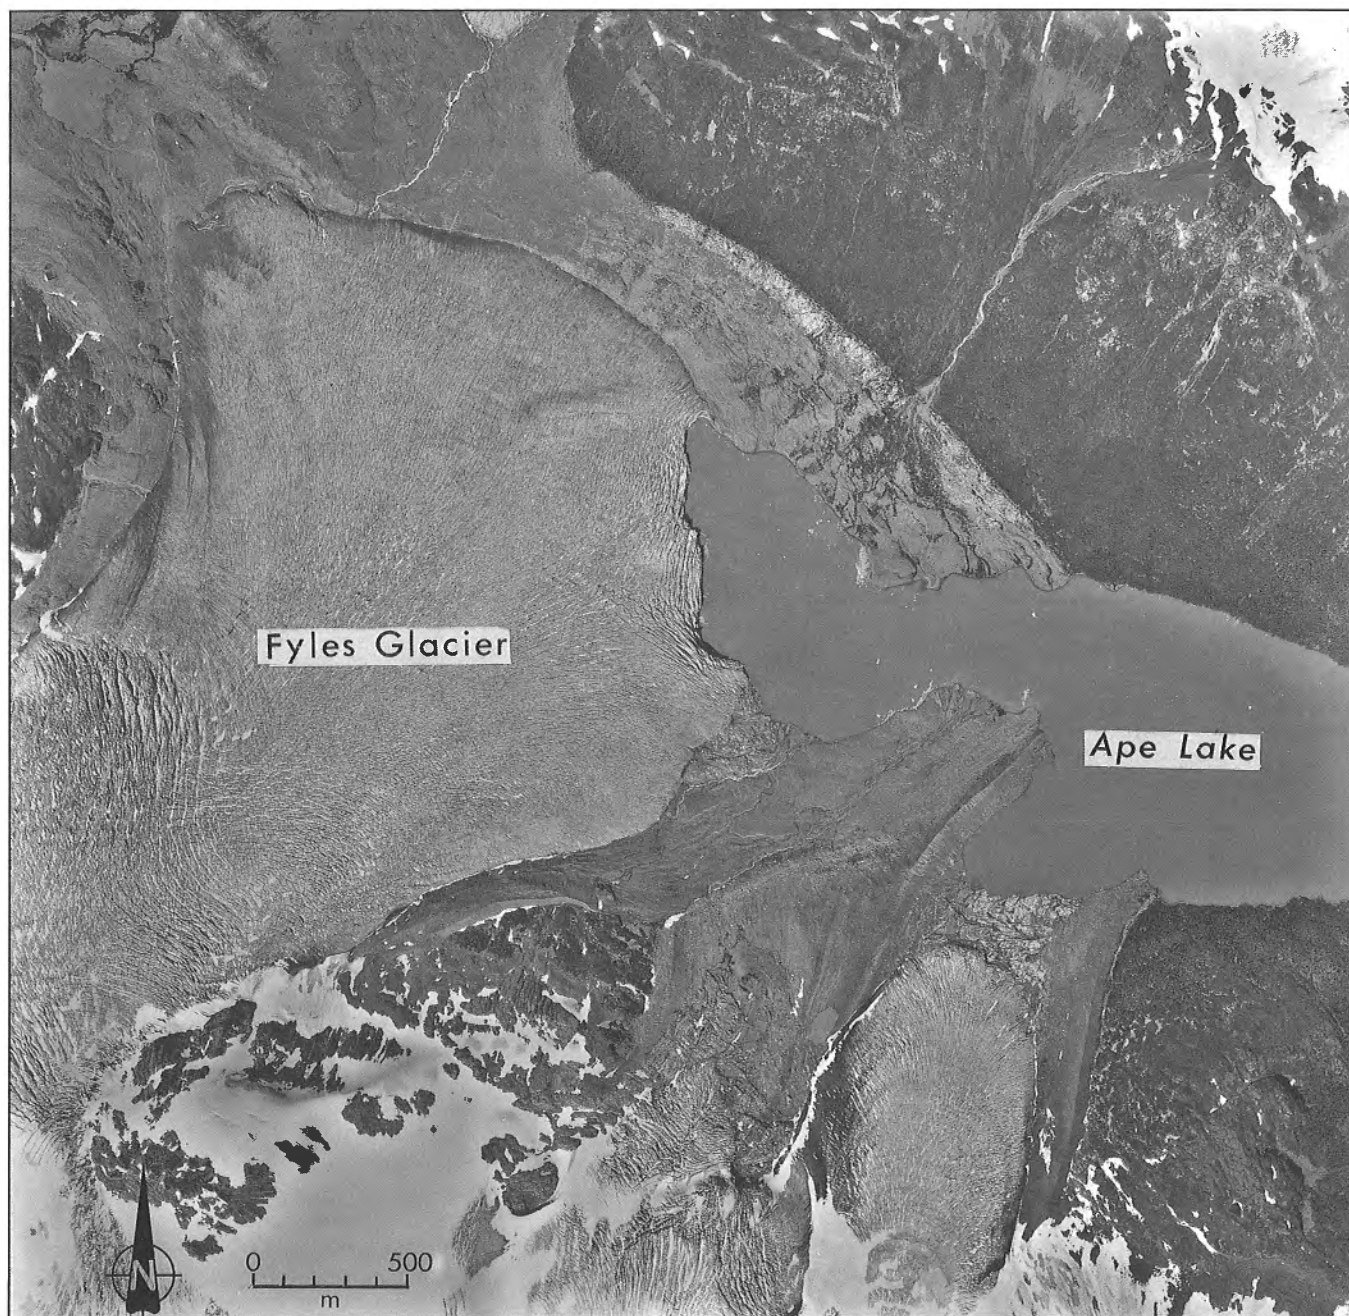
Other examples of recent jökulhlaups that have been extensively studied are those from Ape Lake in the southern Coast Mountains of British Columbia (Jones et al., 1985; Desloges et al., 1989) (Fig. 34). The first historical outburst flood from this lake occurred in October 1984 when a sub-glacial tunnel opened in the snout of Fyles Glacier. Following tunnel closure, the lake refilled in 150 days, but it drained again in August 1986. High discharges during these floods (up to about $1600 \text{ m}^3/\text{s}$) damaged forestry roads, bridges, a logging camp, and an airstrip, and caused widespread channel

and floodplain erosion. Retreat of Fyles Glacier after 1986 allowed drainage around the north edge of the ice dam and prevented the lake from refilling. No additional jökulhlaups are expected from this basin unless there is a significant readvance of Fyles Glacier. The presence of undamaged trees as old as 300 years on the floodplain below Fyles Glacier before the first flood indicates that the two recent outburst events are unique in the Little Ice Age history of the basin.

Figure 34. Aerial photograph of Ape Lake taken in 1978 prior to the first jökulhlaup (October 1984). The conspicuous trimline beyond the snout of Fyles Glacier delineates the maximum Little Ice Age extent of the glacier. (Province of British Columbia airphoto BC78125-019).

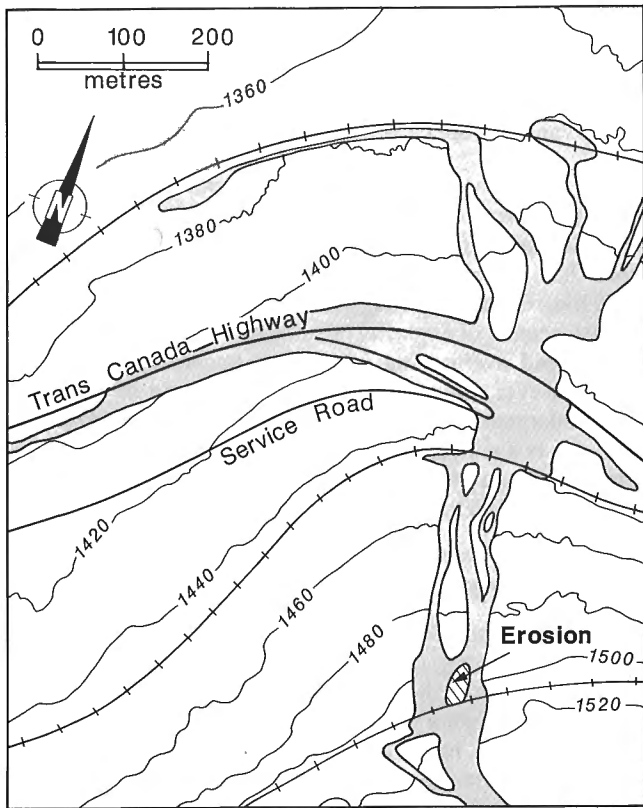
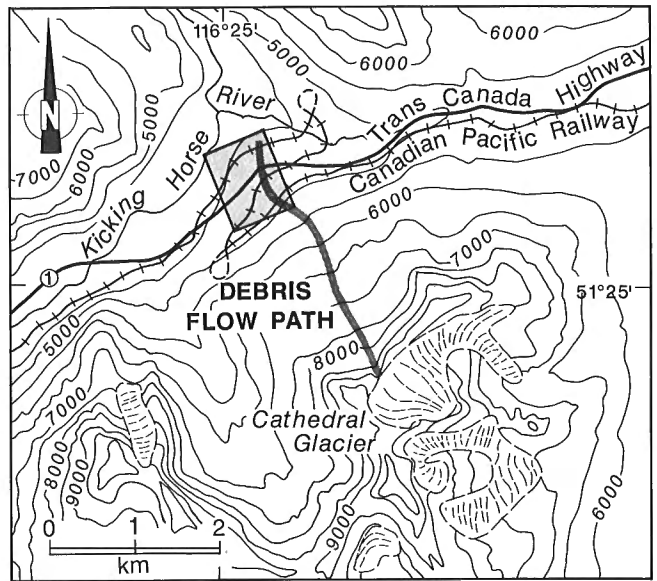
Some jökulhlaups have triggered debris flows. The best documented and most destructive are the jökulhlaups from Cathedral Glacier in the southern Rocky Mountains of British Columbia (Jackson, 1979; Jackson et al., 1989) (Fig. 35). These have resulted from the repeated sudden draining of a small ephemeral lake on the south side of Cathedral Glacier. Several times during this century, water from this lake, augmented perhaps by water stored within the glacier, emptied into a steep ravine and mobilized large volumes of glacial and colluvial sediments. This produced debris flows that travelled up to 3 km and blocked the Canadian Pacific Railroad (CPR) mainline and the Trans-Canada Highway in Kicking Horse River valley (Fig. 35, 36). The volumes of the largest debris flows are about $100\,000 \text{ m}^3$ (Table 5). Peak discharges and velocities of the flows just above the head of the fan crossed by the Trans-Canada Highway and CPR mainline are $210 \text{ m}^3/\text{s}$ and 5.5 m/s , respectively. Historical debris flow activity began in 1925 when retreat of Cathedral Glacier left

Figure 35. Extent of the debris flow in Kicking Horse River valley resulting from the Cathedral Glacier jökulhlaup of September 6, 1978. Topographic contour interval: left = 20 m; above = 500 feet (152 m). (Modified from Fig. 1 and 3 of Jackson et al., 1989).

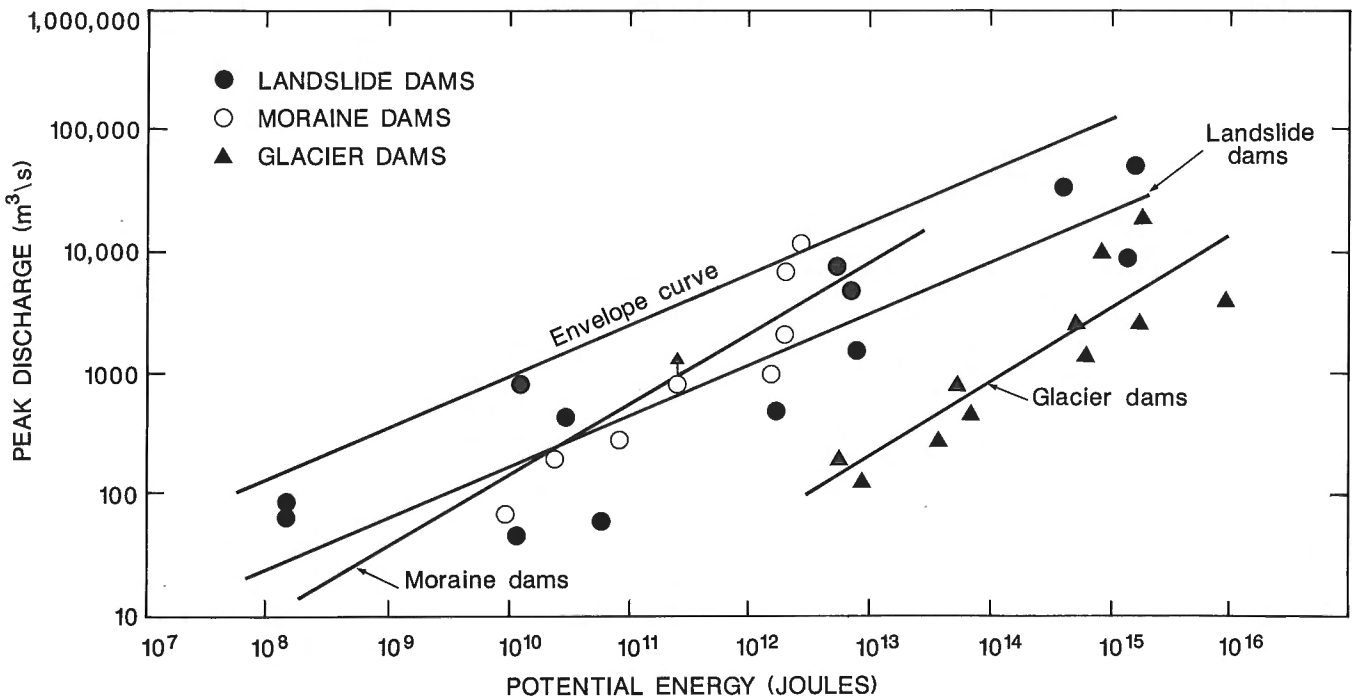
Plots of Q (peak discharge) vs. V and Q vs. PE (Fig. 37) show considerable scatter, reflecting the diverse characteristics of dams and flood paths, as well as errors in estimating peak discharges. Direct measurements of flood discharge are virtually impossible, thus a variety of indirect methods commonly are used to estimate peak discharges, including draw-down rates and measurements based on hydraulic formulae or postflood channel surveys, all of which are subject to error. Many published estimates of peak discharge come from hydrographs that are considerable distances below the dam. Such estimates generally are too small because floods attenuate away from their source.

Notwithstanding these problems, the data in Figure 37 clearly show that there are differences in peak discharges for the three types of dam failures. For the same potential energy, glacier dams produce the smallest floods. Landslide dams produce smaller peak discharges than moraine dams, probably because they are relatively low and wide.

Figure 37. Plot of potential energy of lake water versus peak discharge for selected failures of landslide, moraine, and glacier dams. Least-squares regression lines for the three types of dams and the envelope curve encompassing all plotted data ($Q = 0.063 PE^{0.42}$) are also shown. (Modified from Fig. 12 of Costa and Schuster, 1988).
