GEOLOGICAL SURVEY OF CANADA
BULLETIN 464

FORMATION AND FAILURE OF NATURAL DAMS IN THE CANADIAN CORDILLERA

John J. Clague and Stephen G. Evans

1994

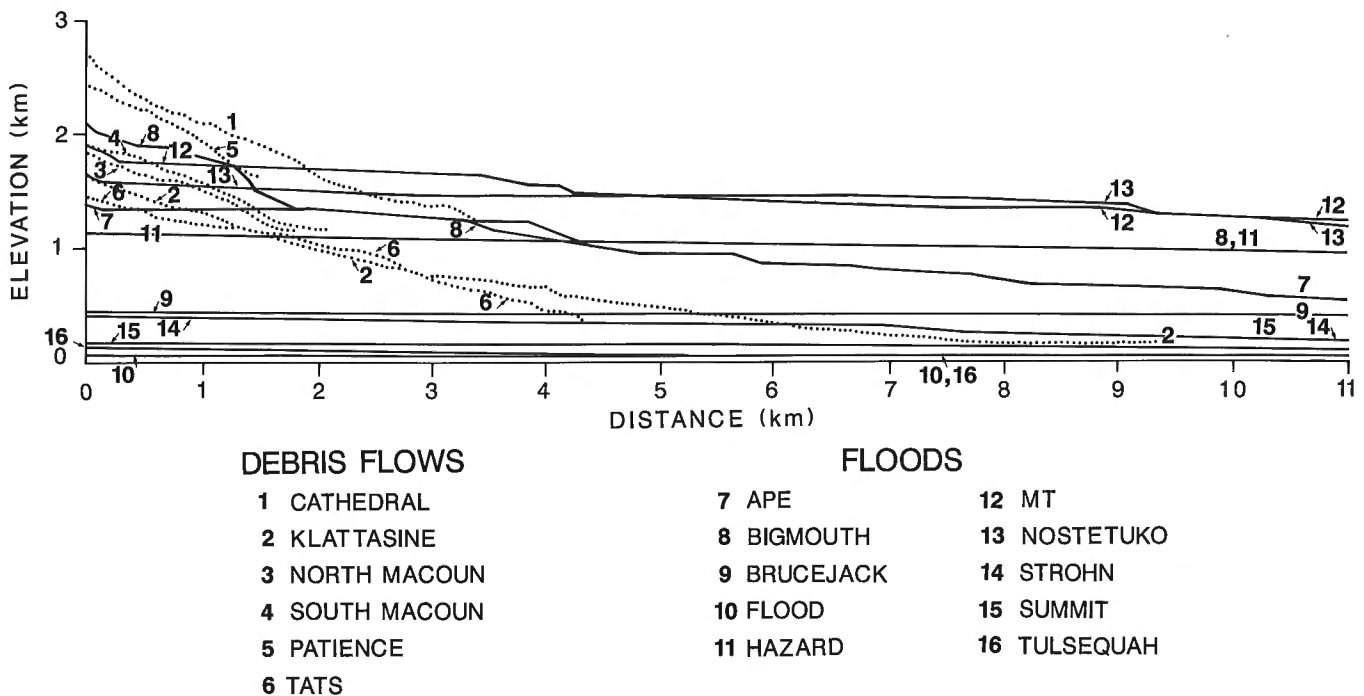
Figure 38. Profiles of the paths of historical floods (solid lines) and debris flows (dotted lines) caused by failures of moraine and glacier dams in the Canadian Cordillera. Debris flows are only generated and sustained on slopes steeper than 10-15°.
