EBA Engineering Consultants Ltd.

SMALL PUBLIC WATER SYSTEMS ASSESSMENT
 NORTHERN REGION

KENO FIRE HALL
BUILDING # 5622
SITE LOCATION DIAGRAM
WELL ID: 5622

Northern Region – Keno Firehall
Building # 5622

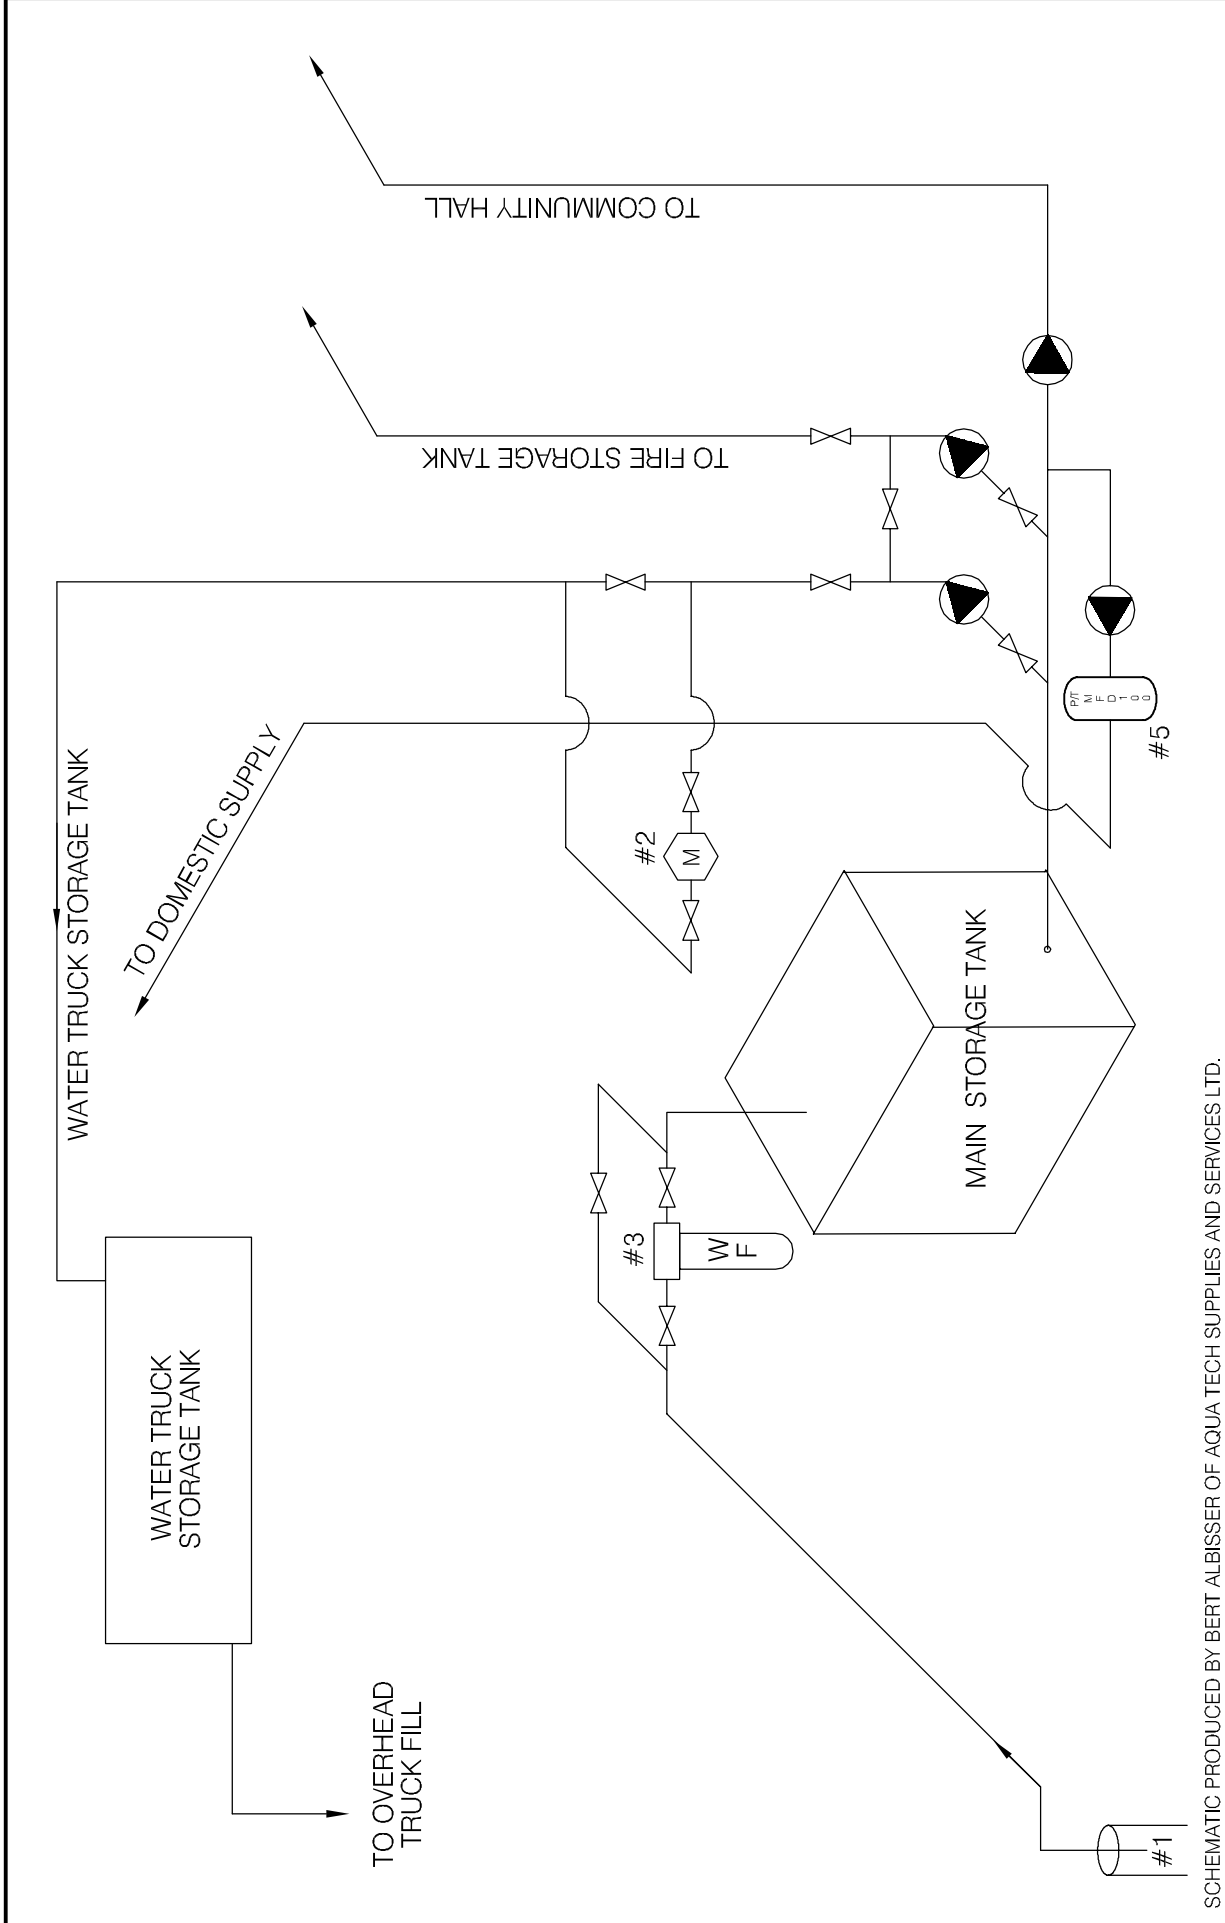
SCHMATIC PRODUCED BY BERT ALBISSER OF AQUA TECH SUPPLIES AND SERVICES LTD.

PROJECT SMALL PUBLIC WATER SYSTEMS ASSESSMENT NORTHERN REGION	
CLIENT 		TITLE WATER SYSTEM DISTRIBUTION/TREATMENT SCHEMATIC SYSTEM ID.: 5622 KENO FIRE HALL - KENO, YT.	
DATE SEPT., 2005	DWN. JSB	CHKD. RMM	FILE NO. 1260002.004
		DWG.: FIGURE 5622-B

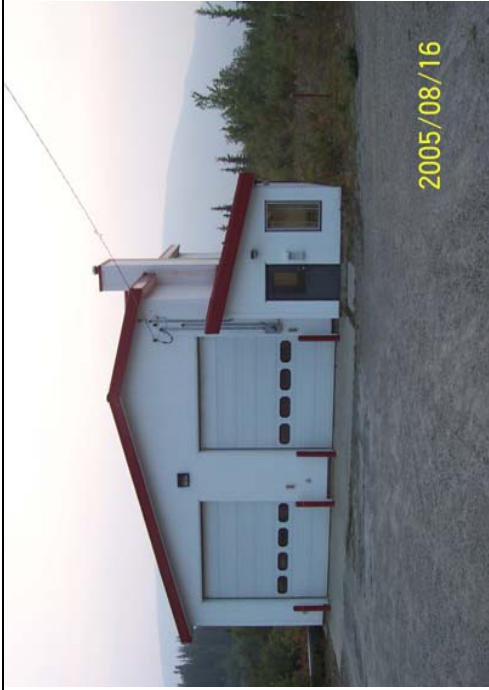
Photo 015: 5622 Keno Fire Hall facing west.
