**Small Public Water System Assessments  
Yukon Government Maintained Buildings**

***NORTHERN REGION  
DRAFT REPORT***

**EBA Project No. 1260002.004**

**March 2006**

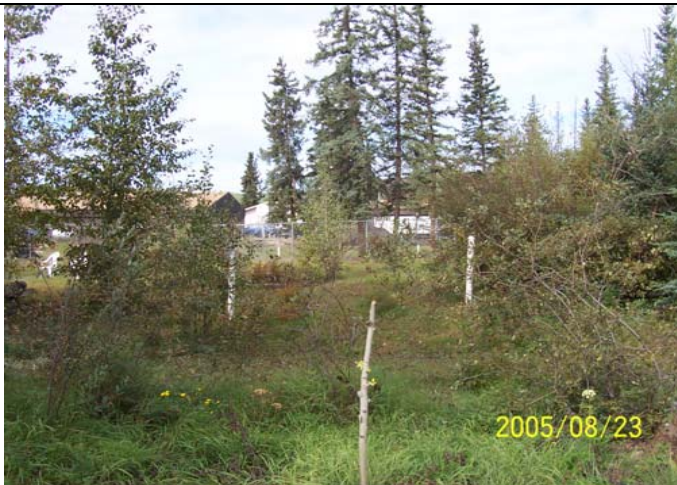
**Photo 390:** M0227 Septic system.

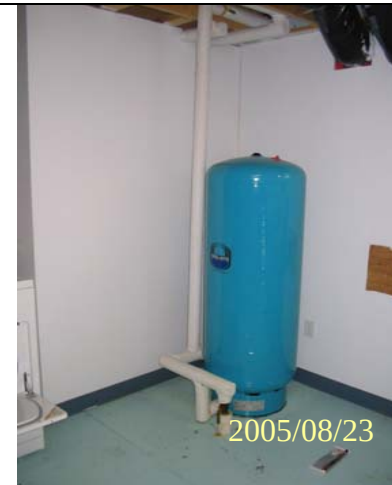
**Photo 200:** M0227 Pressure tank.

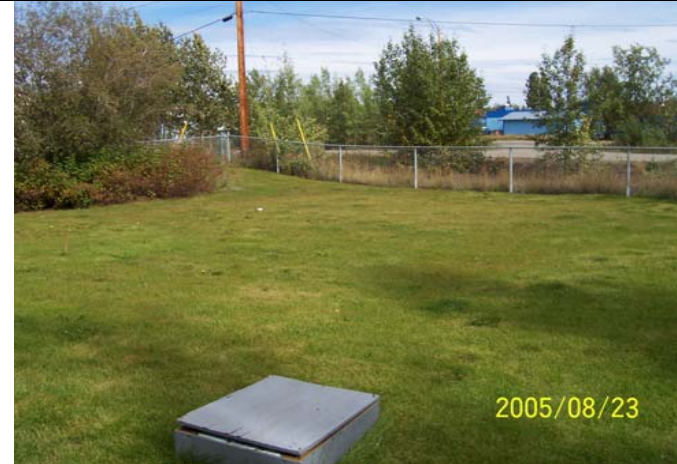
**Photo 381:** M0156/M0226 Well enclosure.

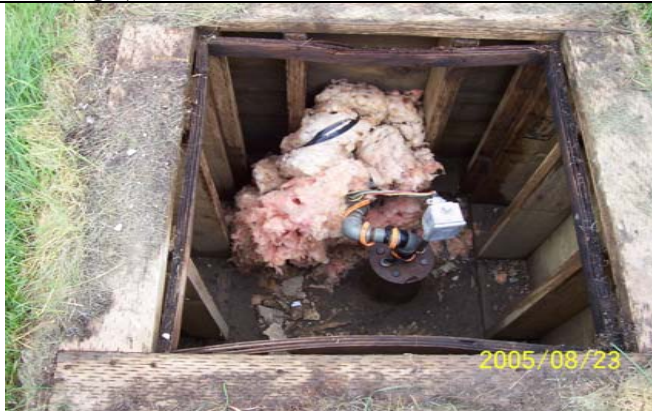
**Photo 379:** M0156/M0226 Well enclosure and wellhead.

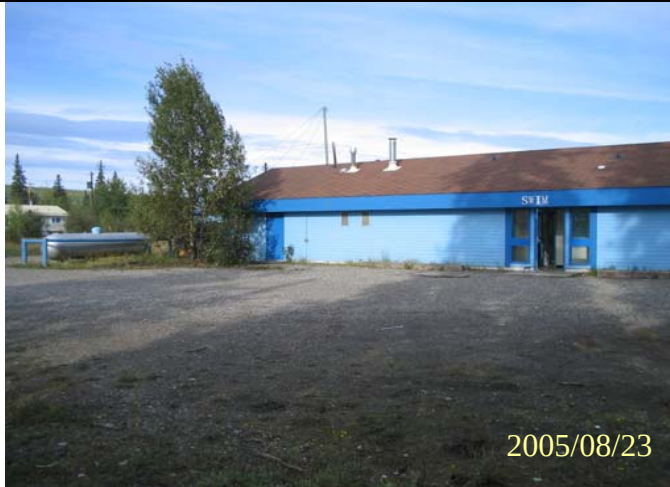
**Photo 209:** 5672 Pelly Crossing swimming pool. (northeast)

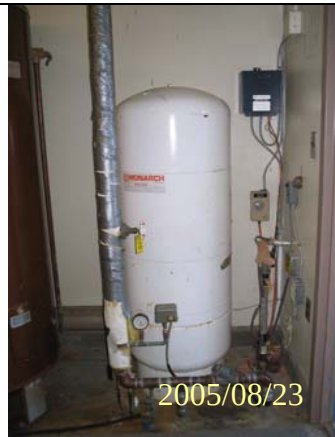
**Photo 208:** 5672 Water system. (pump controls, pressure tank)

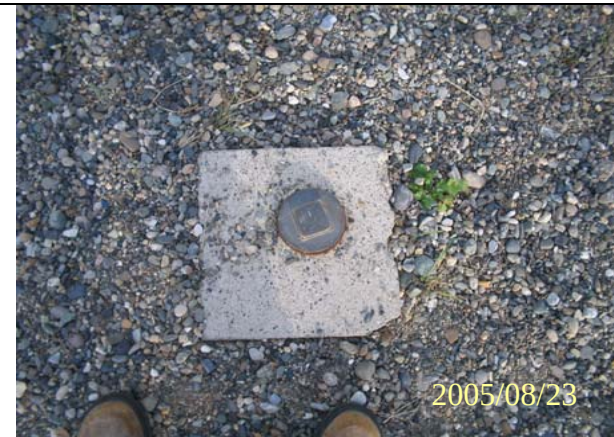
**Photo 214:** 5672 Potential septic clean out?

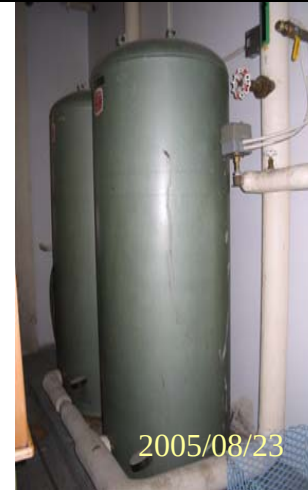
**Photo 204:** 5676 Water System. (pump controls and pressure tanks)

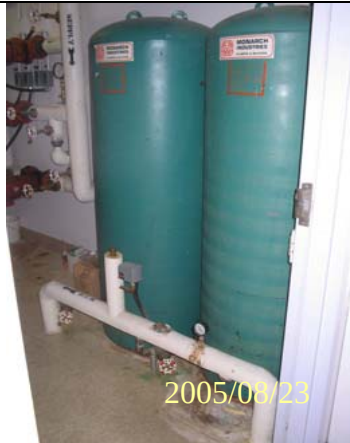
**Photo 202:** Water system. (pressure tanks & pump controls)

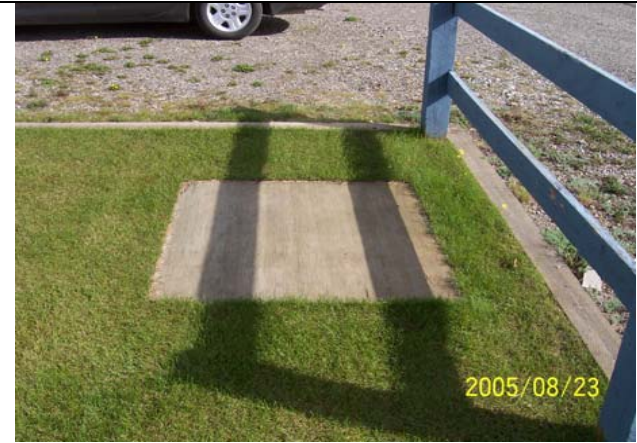
**Photo 396:** Potential location of abandoned well.

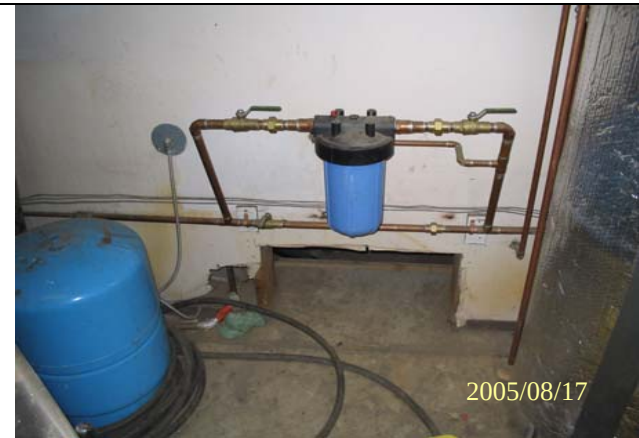
THE INSTALLATION IS SATISFACTORY  
THE PRESSURE TANK IS WATER LOGGED - IT NEEDS TO  
BE REPLACED.

**Photo 194:** 5650 Water system. (pressure tank and filter)

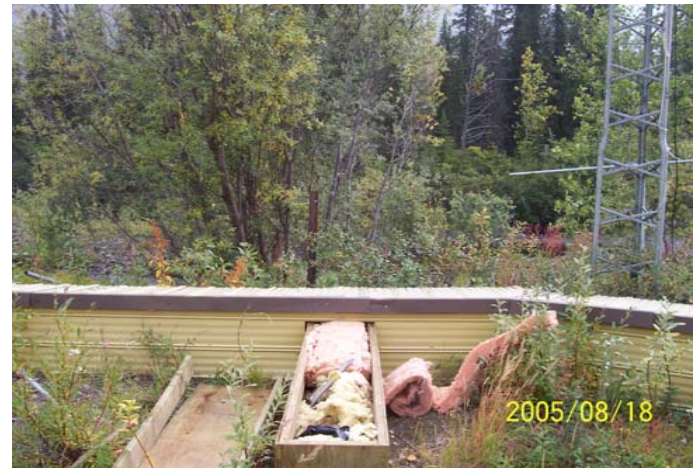
**Photo 067:** 2600 Wellhead with surrounding enclosure and utilidor.

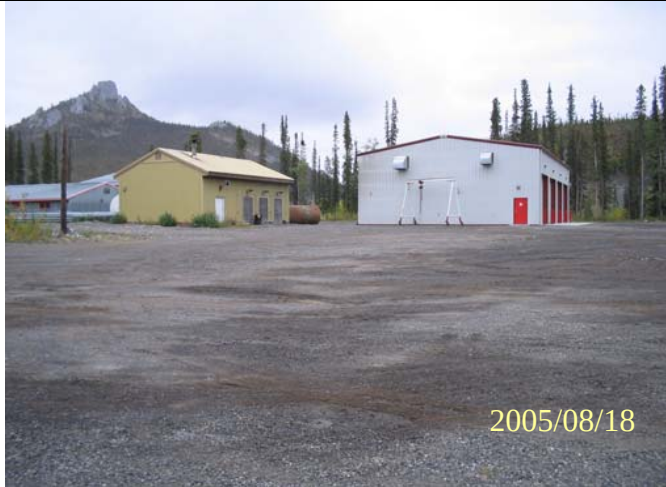
**Photo 206:** 2661 Olgilvie grader station.

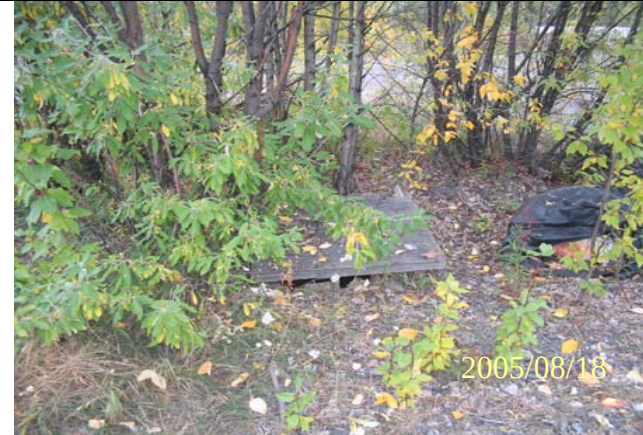
**Photo 213:** 2665 On site sewage disposal for grader station.

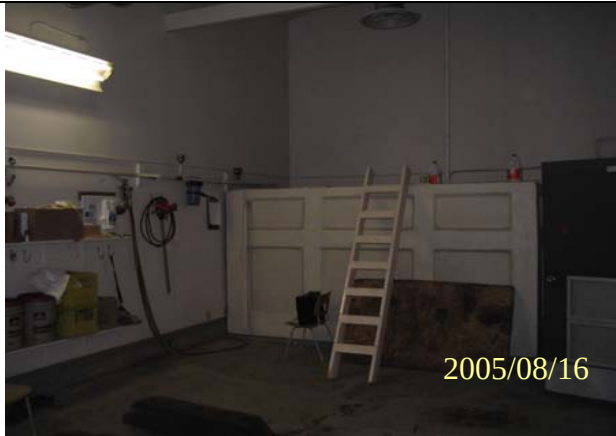
**Photo 179:** 5622 Main water storage tank.
