SMALL PUBLIC WATER SYSTEMS ASSESSMENT
 WHITEHORSE REGION

GOLDEN HORN FIRE HALL
 BUILDING 1924
 SITE LOCATION DIAGRAM
 WELL ID: 1924

**Whitehorse Region – Golden Horn Firehall
Building # 1924**

SMALL PUBLIC WATER SYSTEM ASSESSMENT

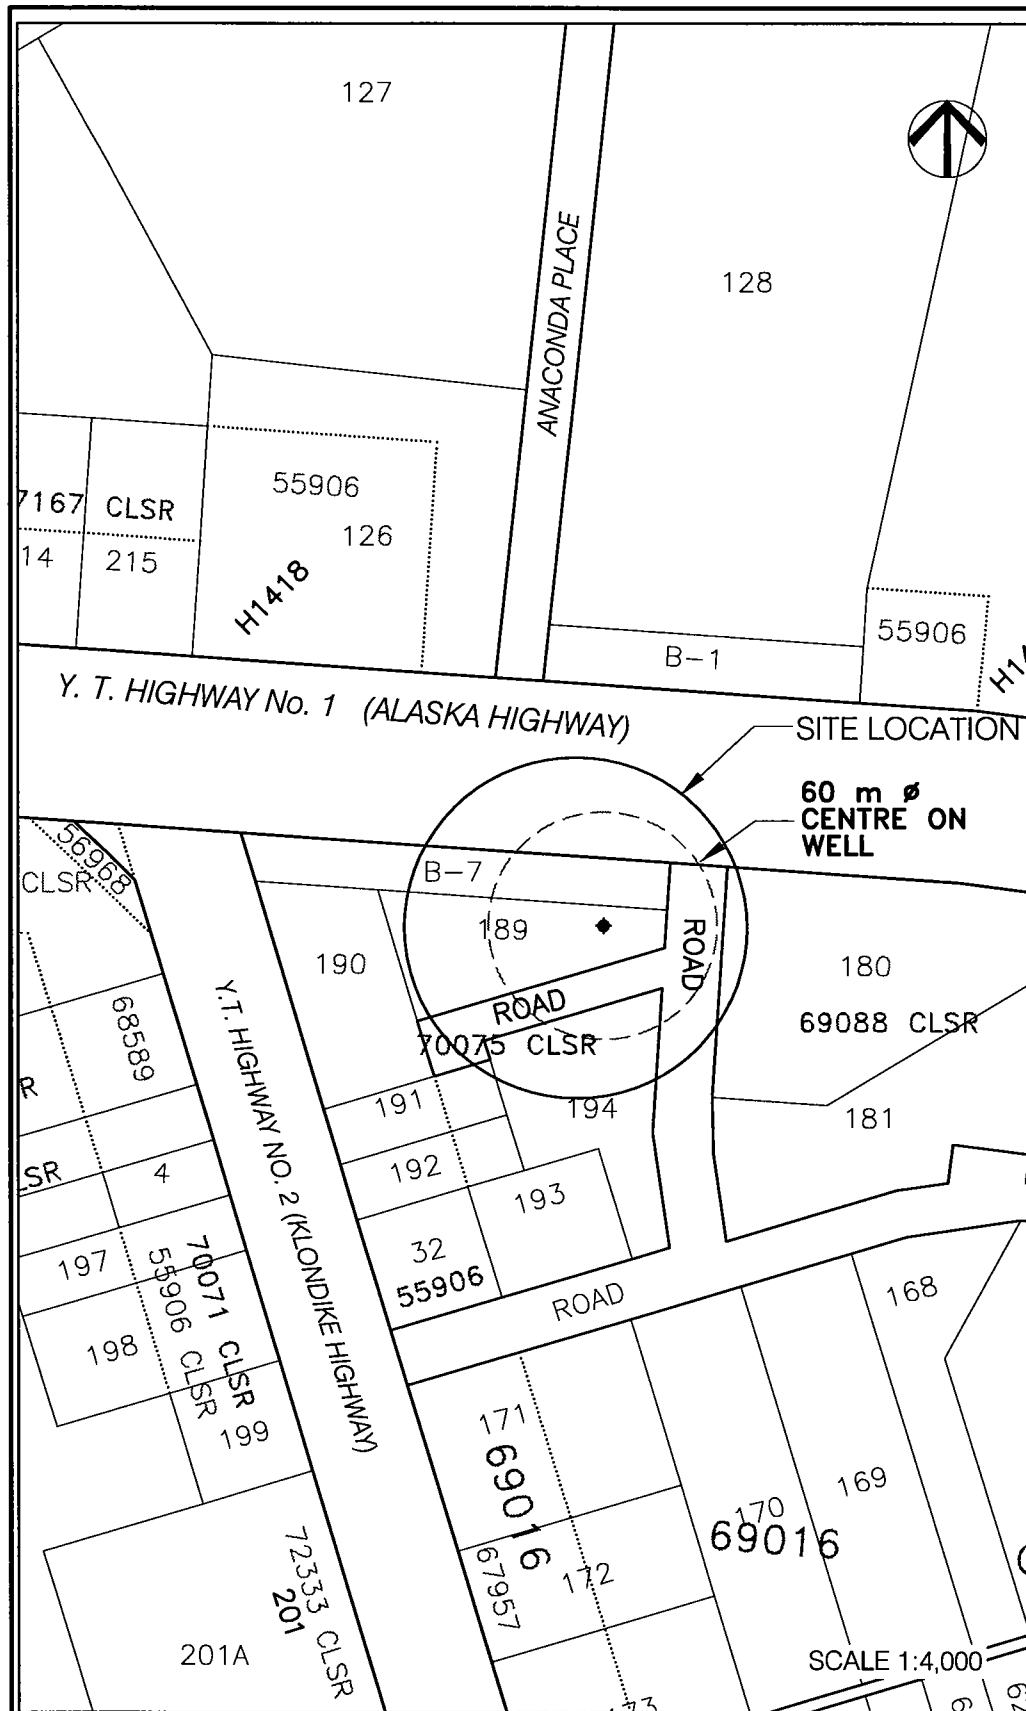
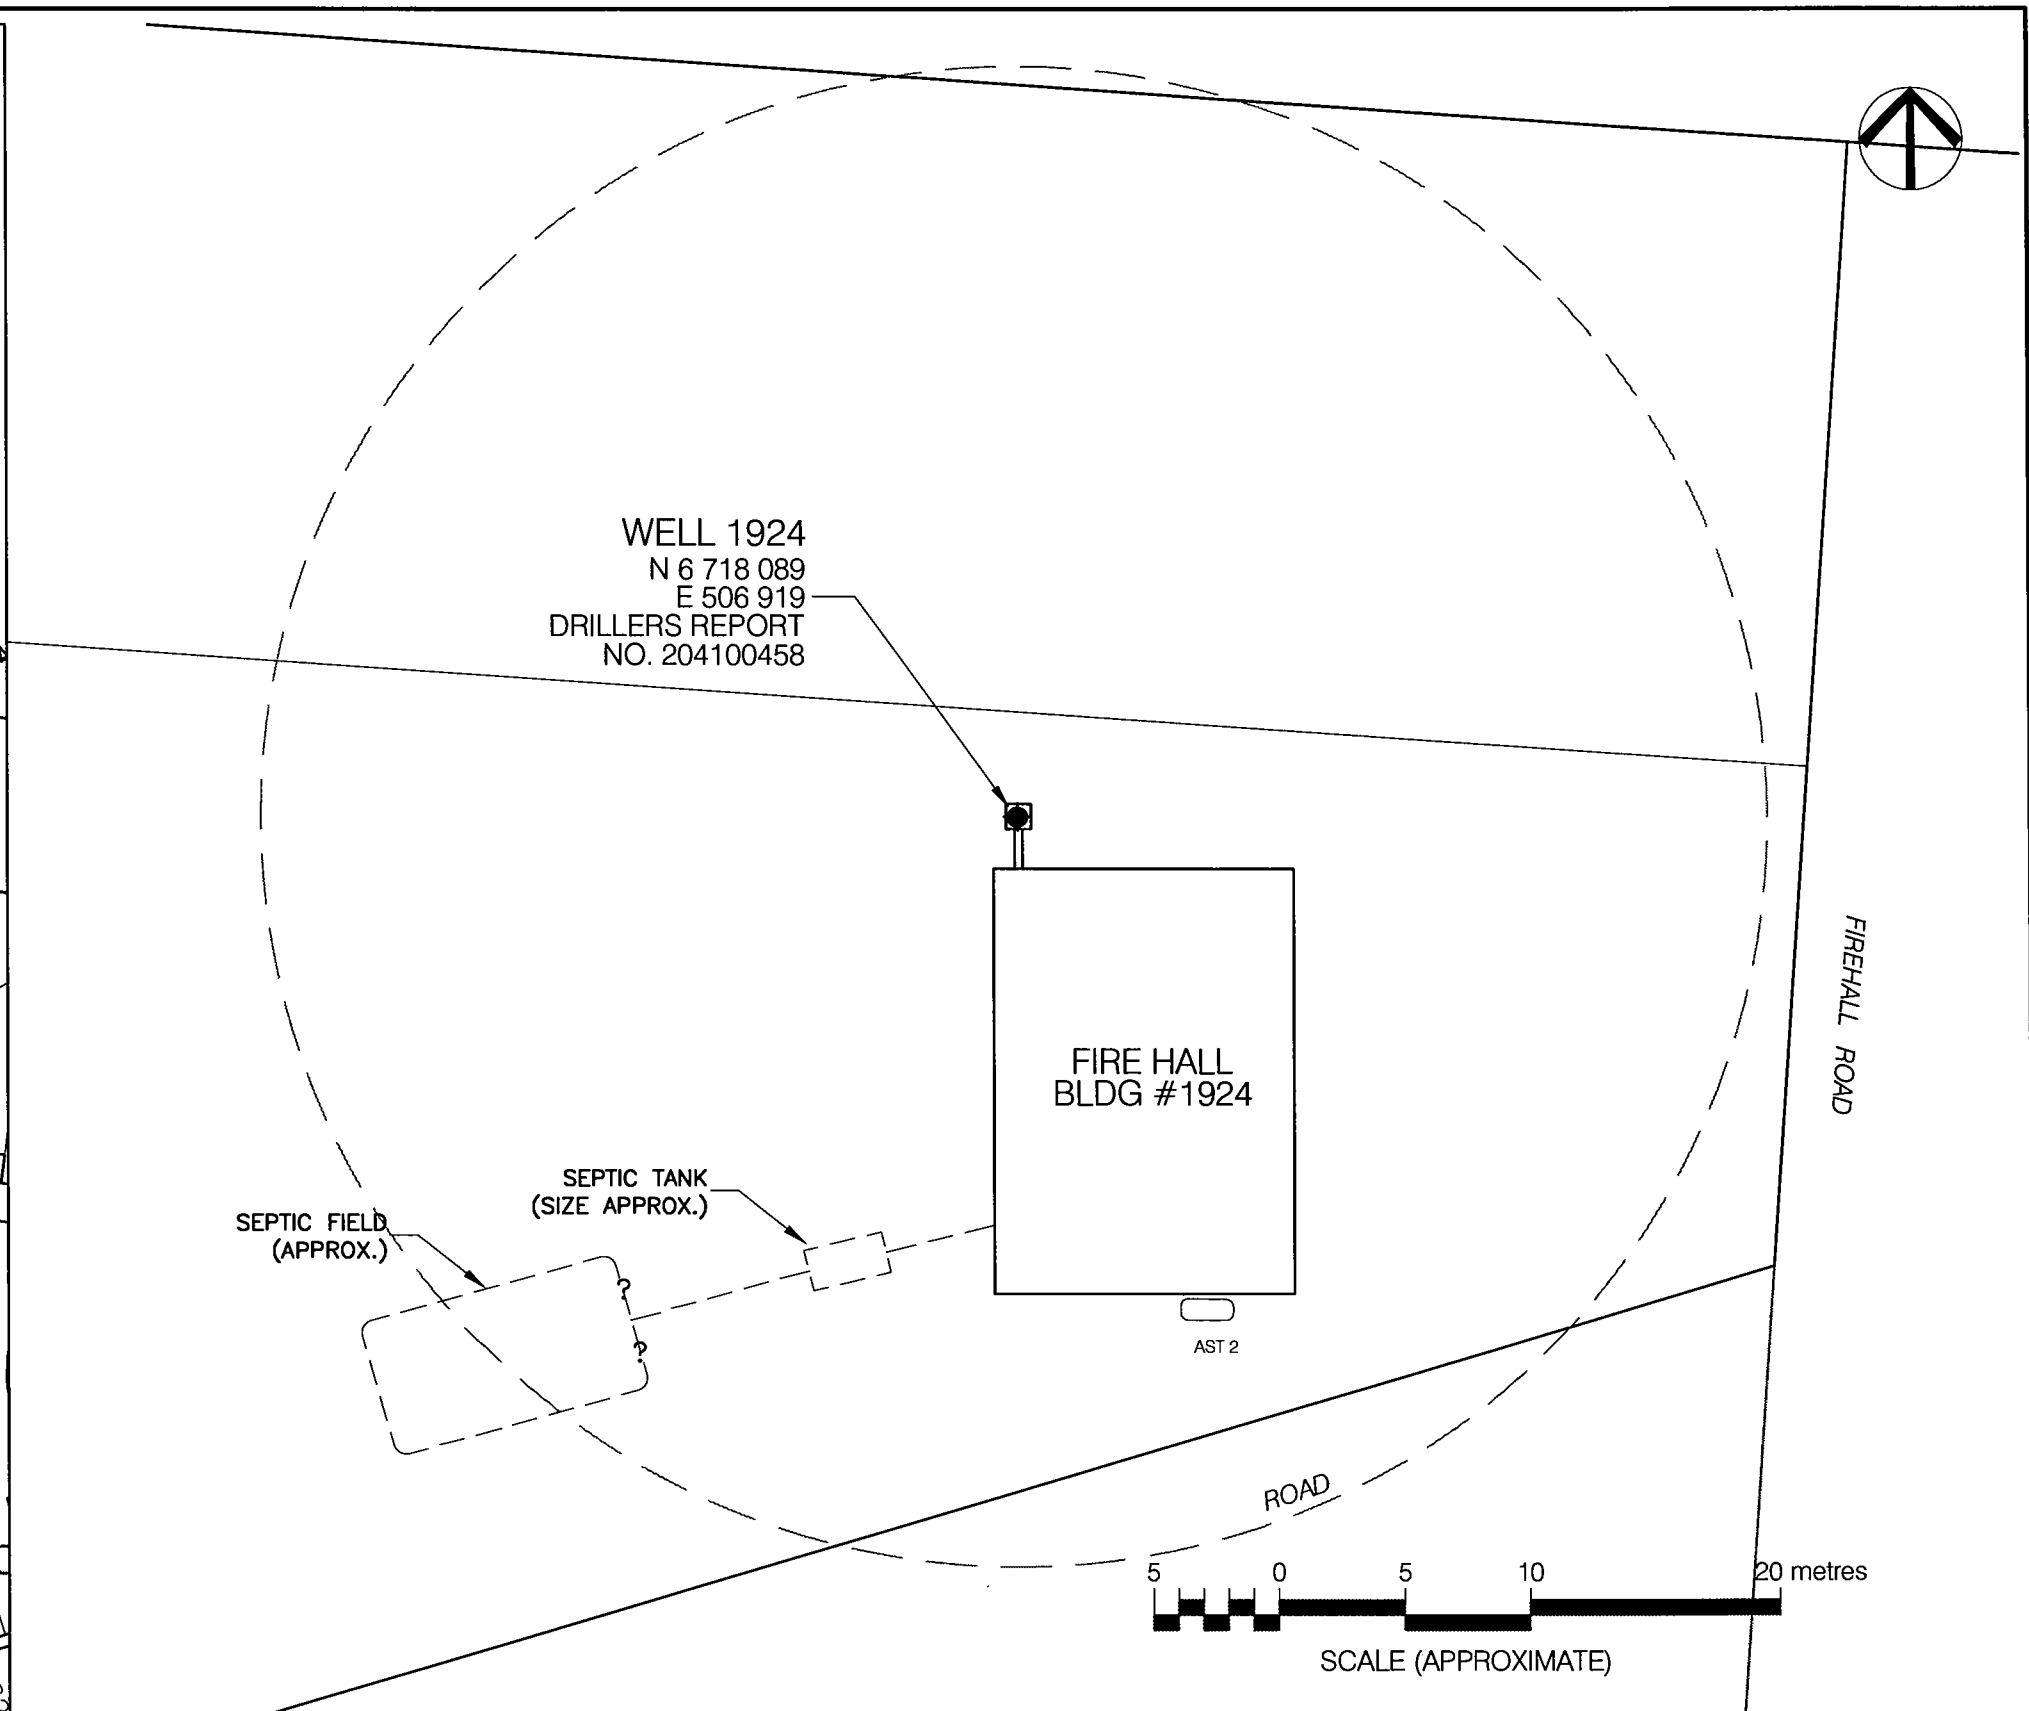
DRAWING No.
 FIGURE 1924A

30 m RADIUS FROM WATER WELL FOR CONSIDERATION OF PROXIMITY TO POTENTIAL CONTAMINANT SOURCES.

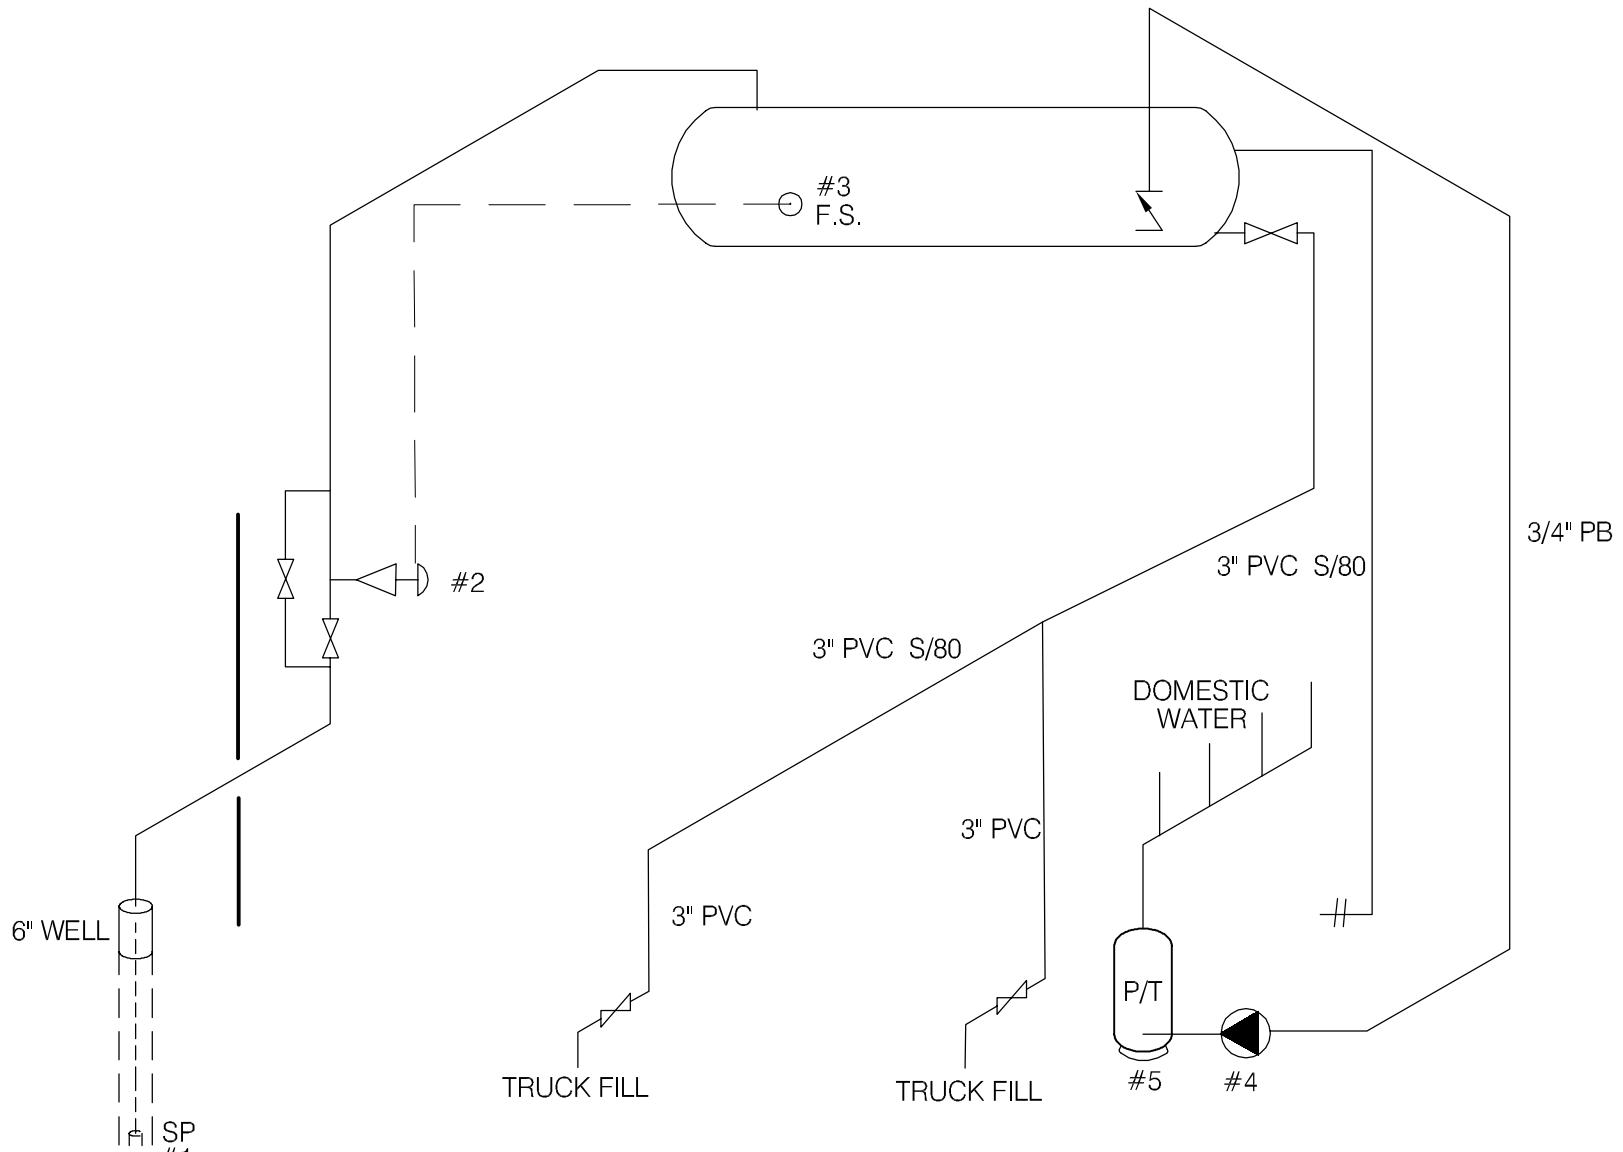
TITLE WATER SYSTEM DISTRIBUTION/TREATMENT SCHEMATIC SYSTEM ID.: 1924 GOLDEN HORN FIRE HALL	
DATE	APRIL 2006	DWN.	JSB
CHKD.	FMM	FILE NO.	1260002.001
		DWG.:	FIGURE 1924B

DOMESTIC WATER SUPPLY IS UNTREATED. THE WATER SUPPLY IS INADEQUATE FOR FIRE FIGHTING PURPOSES.
