EBA Engineering Consultants Ltd.

SMALL PUBLIC WATER SYSTEMS ASSESSMENT
 WHITEHORSE REGION

CARCROSS FIRE HALL
 BUILDING 1137
 SITE LOCATION DIAGRAM
 WELL ID: 1137

SMALL PUBLIC WATER SYSTEM ASSESSMENT

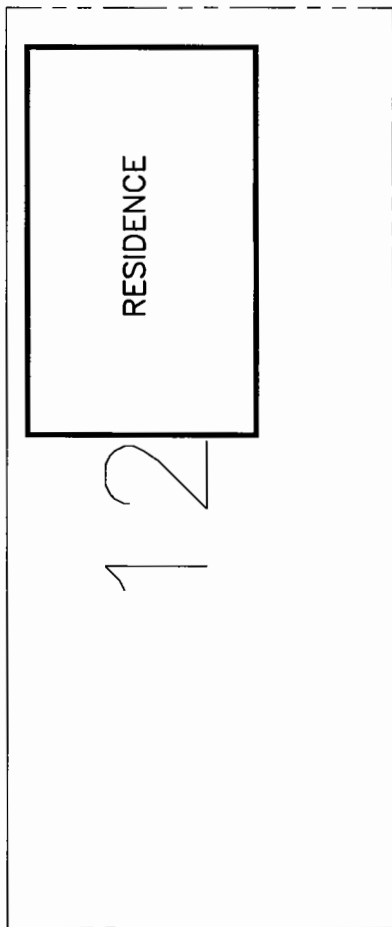
DRAWING No.
 FIGURE 1137A

WELL 1137
 N 6 670 070
 E 516 069
 DRILLERS REPORT
 NO. 204020023

DOMESTIC FUEL OIL STORAGE - GASOLINE & OIL (JERRY CANS, QUARTS OF OIL & MISC. HYDROCARBON SOURCES)

30 m RADIUS FROM WATER WELL FOR CONSIDERATION OF PROXIMITY TO POTENTIAL CONTAMINANT SOURCES.

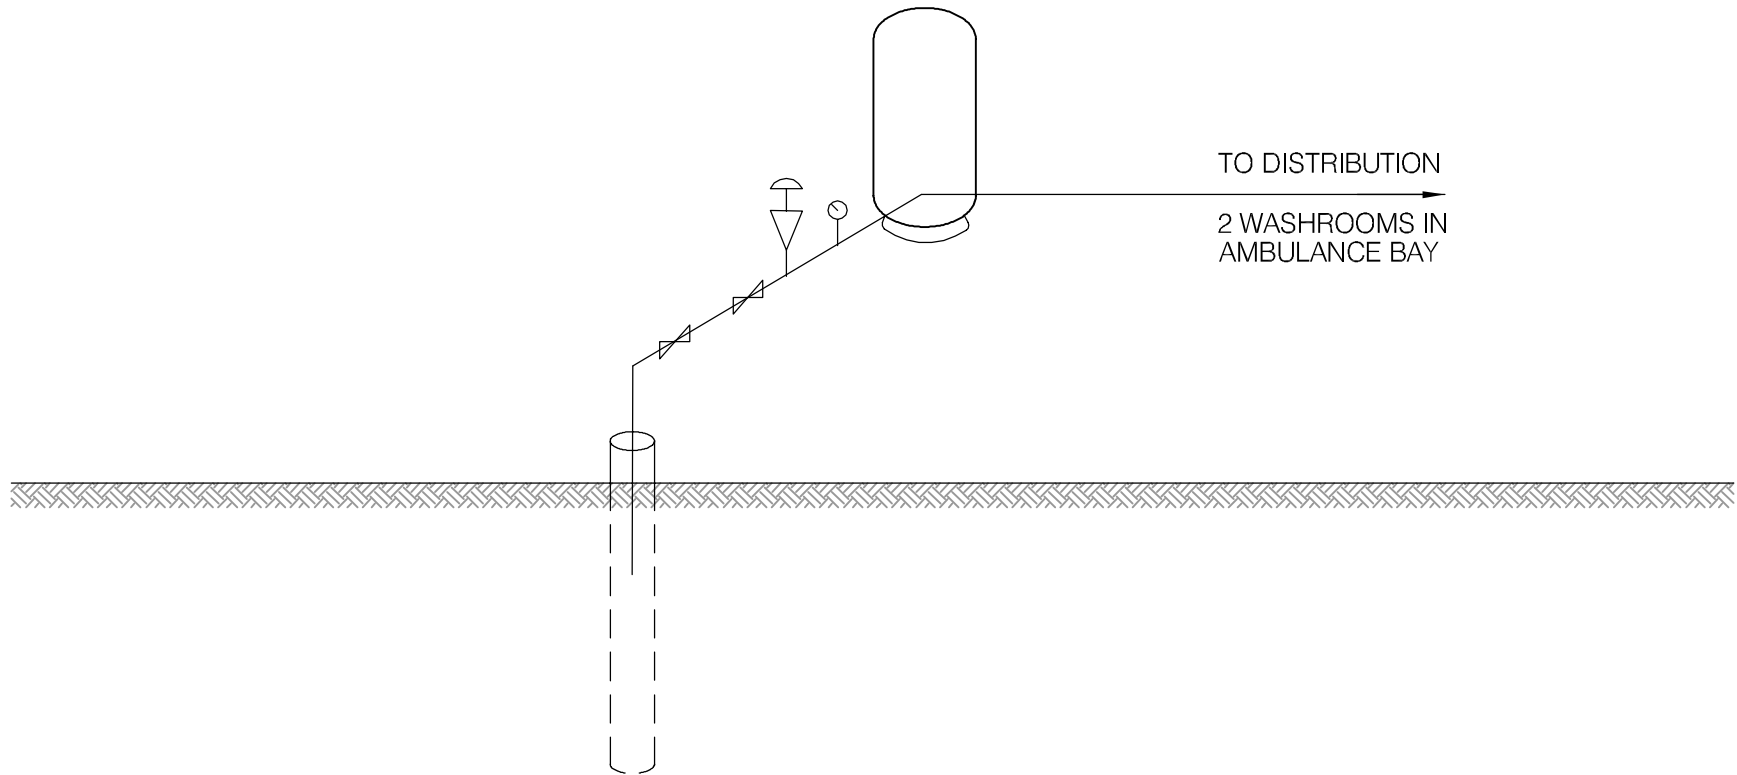
DWG.: FIGURE 1137B

WATER SYSTEM DISTRIBUTION/TREATMENT
SCHEMATIC SYSTEM ID.: 1137
CARCROSS FIRE HALL BUILDING
