**Small Public Water System Assessment  
Yukon Government Maintained Buildings**

***WHITEHORSE REGION***

**EBA Project No. 1260002.001**

**March 2006**

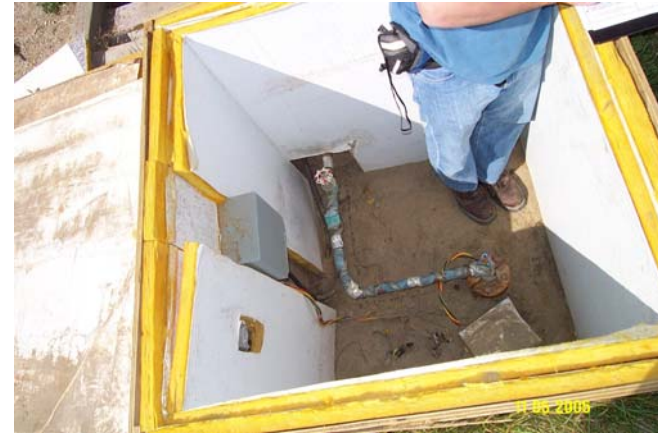
**Photo 0120:** 1134 Well 2 Well Head in Pit

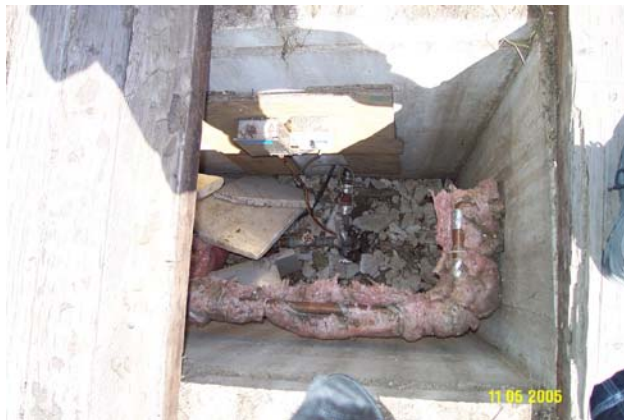
**Photo 0121:** 1134 Well 1 Well Head in Pit

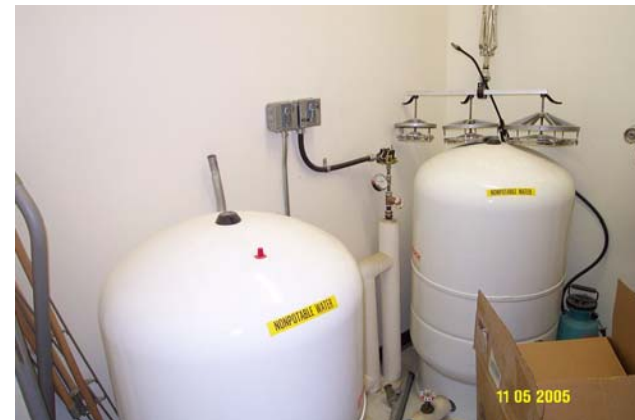
**Photo 122:** 1134 Pressure Tanks and Flow Switch

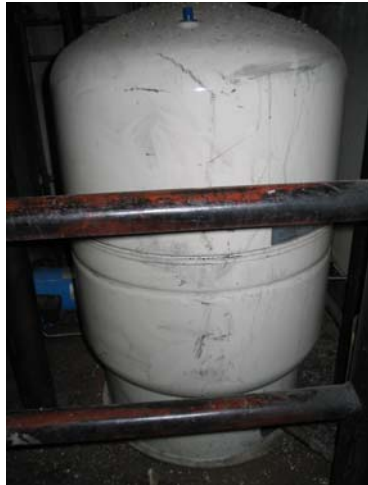
**Photo 0497:** 1134 Heating Expansion Tank

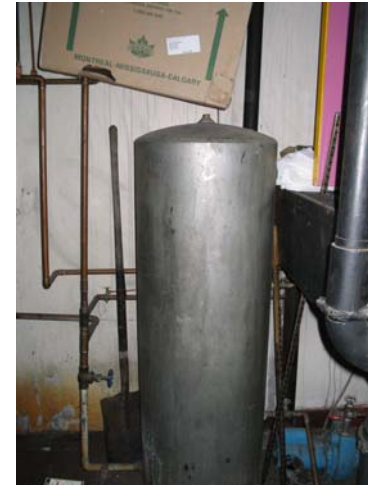
**Photo 0498:** 1134 Potable Water Pressure Tank

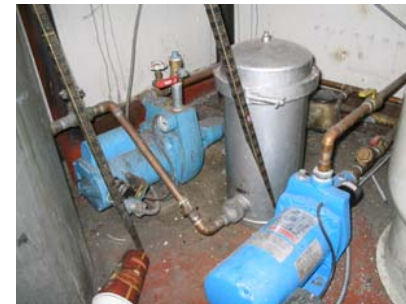
**Photo 0495:** 1134 Jet Pumps and Tank

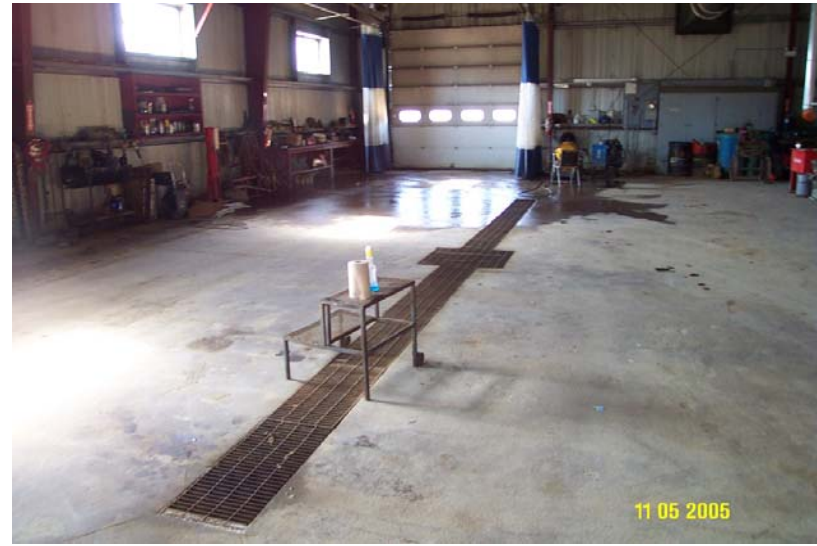
**Photo 0134:** Floor Drain System

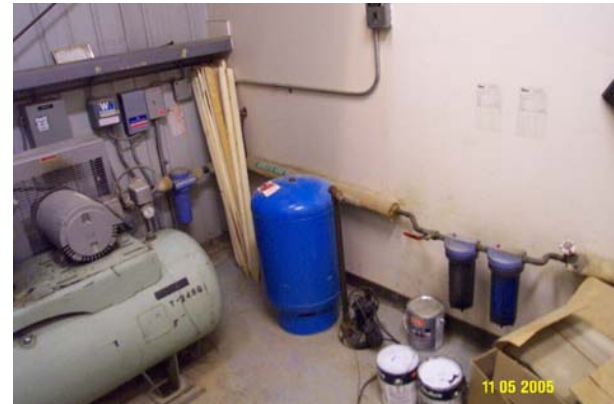
**Photo 0136:** Pressure Tank and Three In-Line Filters

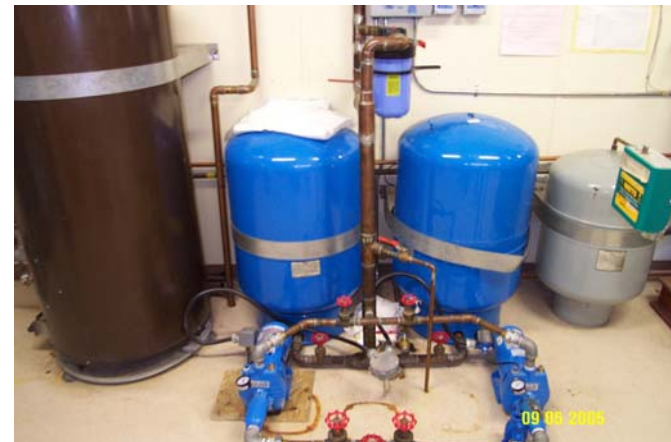
**Photo 0086:** 1322 Pressure Tanks and Filter

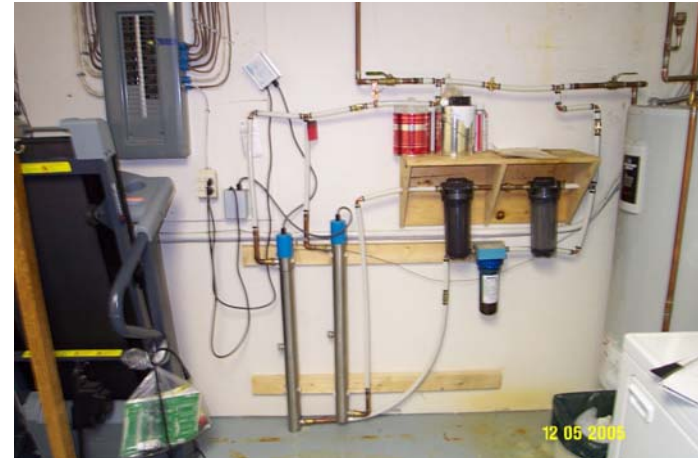
**Photo 0143:** 6975 Nursing Residence Water Treatment System

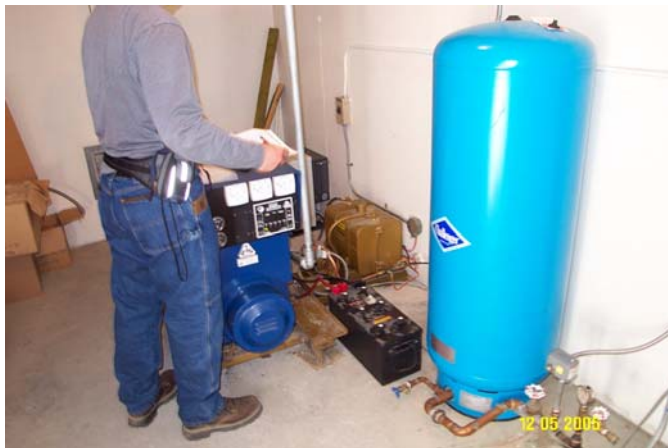
**Photo 0141:** 6975 Pressure Tank (right) and Backup Electrical Generator

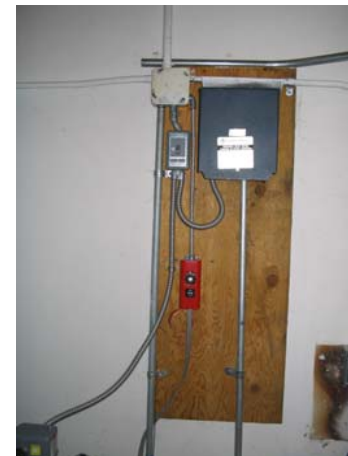
**Photo 0001:** 6975 Pump Control Box

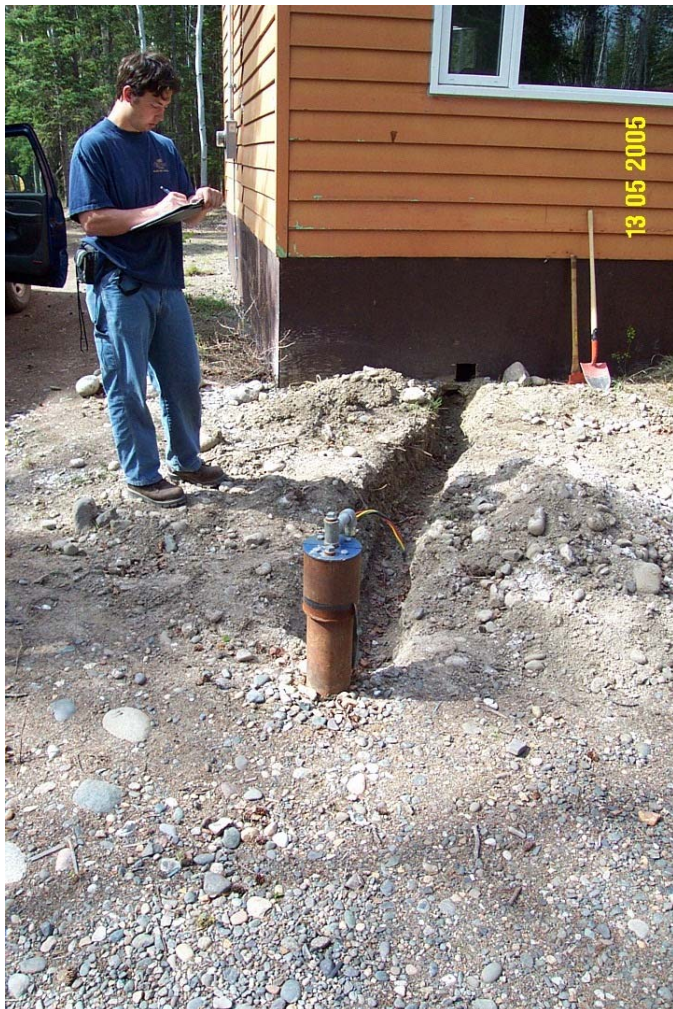
**Photo 0163:** 6536 Wellhead (front) and Forestry Crew Quarters (back)

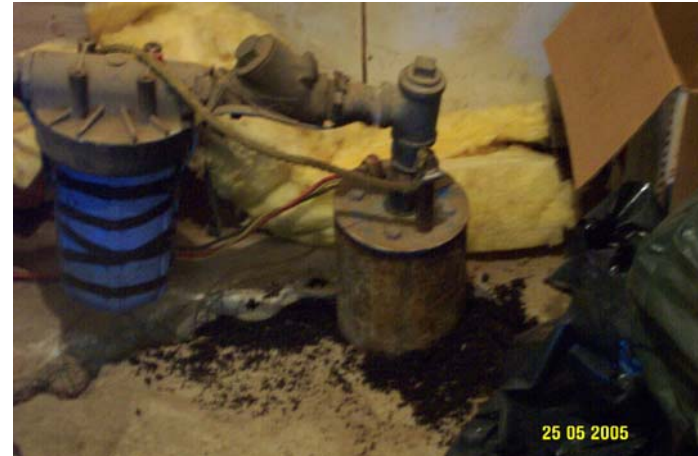
**Photo 0197:** 6512 Wellhead (center) and Filter (left)

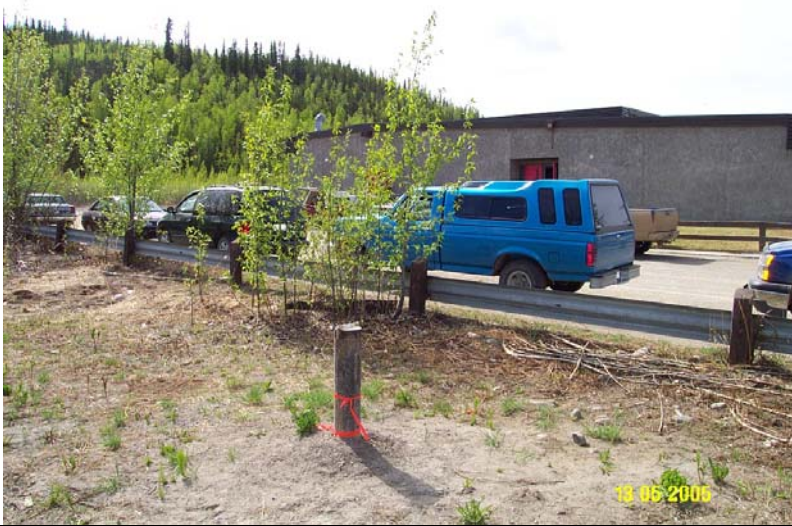
**Photo 0159:** 6511-C New Well Wellhead

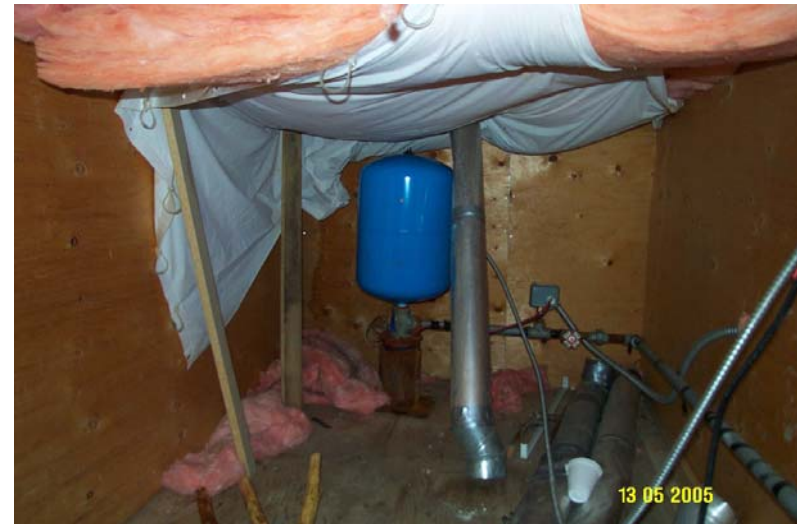
**Photo 0167:** M0201 Wellhead and Pressure Tank

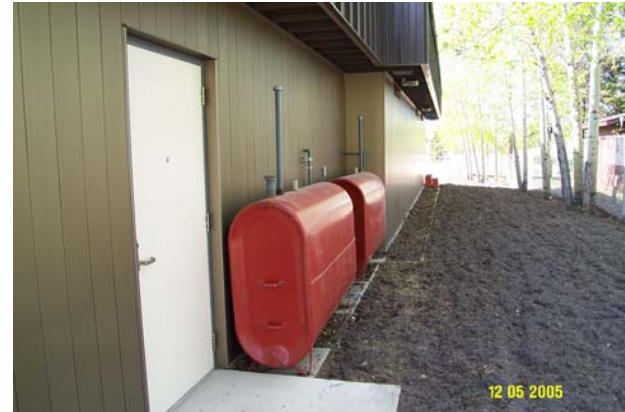
**Photo 0146:** M0093 Two Above Ground Storage Tanks

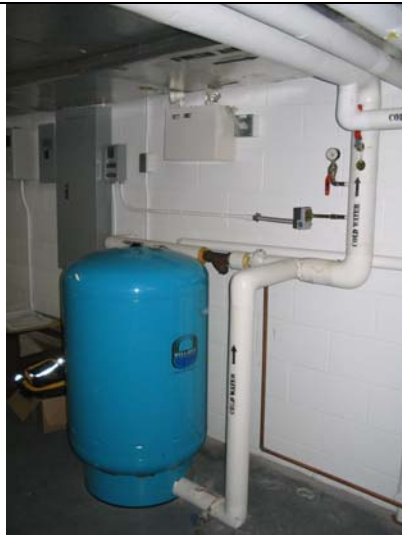
**Photo 0008:** M0093 Pressure Tank

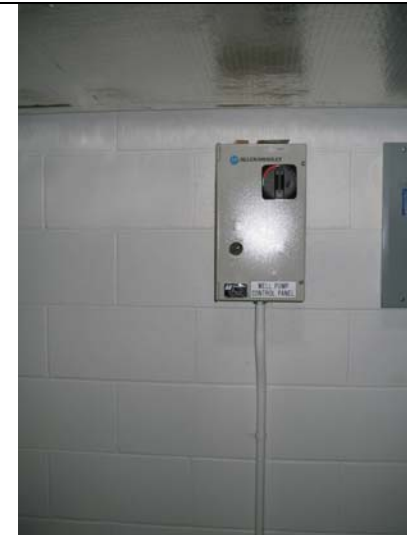
**Photo 0010:** M0093 Pump Control Panel

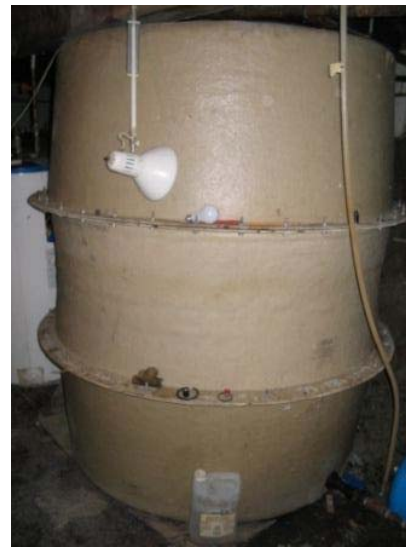
**Photo 0006:** YWP-B Trucked Water Storage Tank

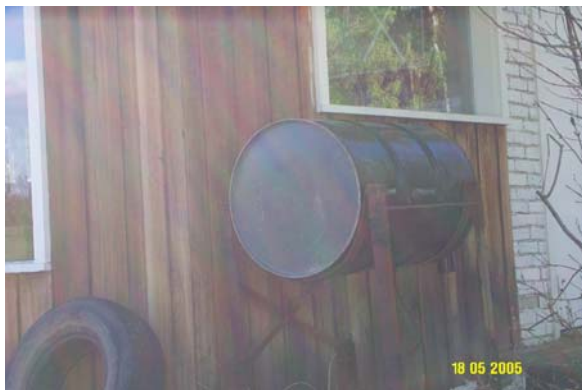
**Photo 0182:** YWP-B Above Ground Fuel Storage Tank

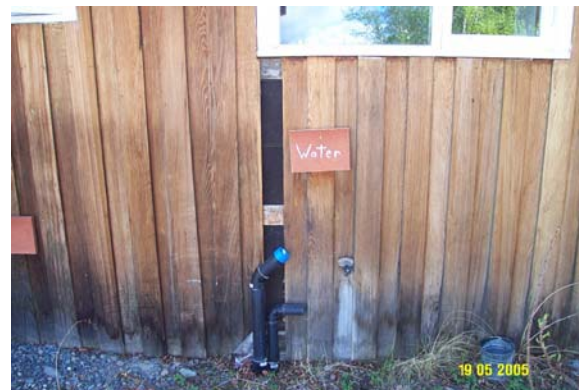
**Photo 0184:** YWP-B Trucked Water Intake

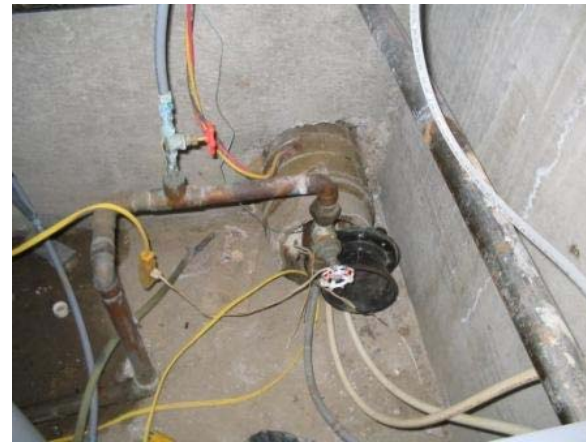
**Photo 0001:** YWP-A Piping in Building from Wellhead

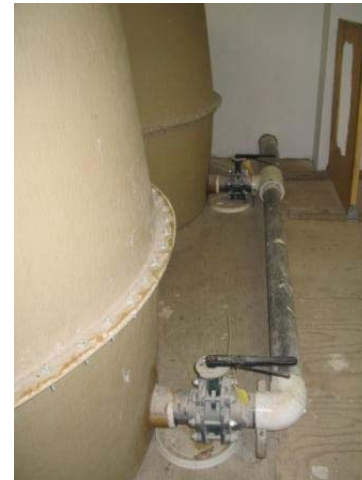
**Photo 0022:** 1955 Storage Tank Piping

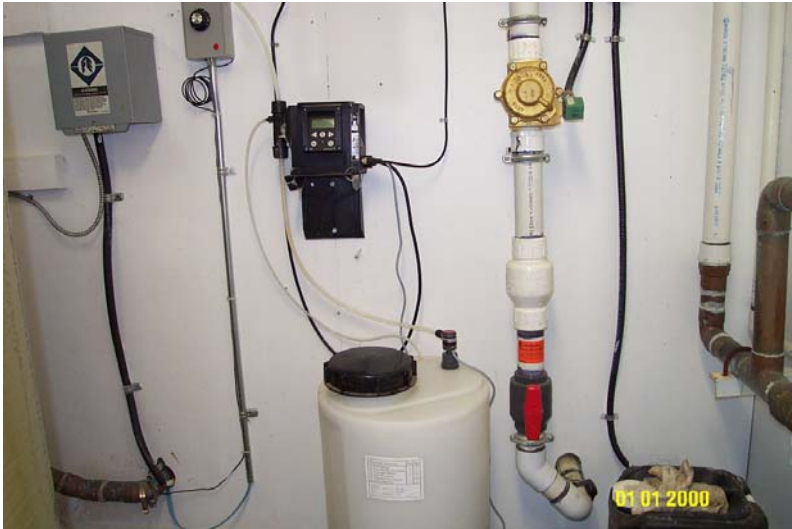
**Photo 0069:** 1953 Grundfos DME Chlorinator

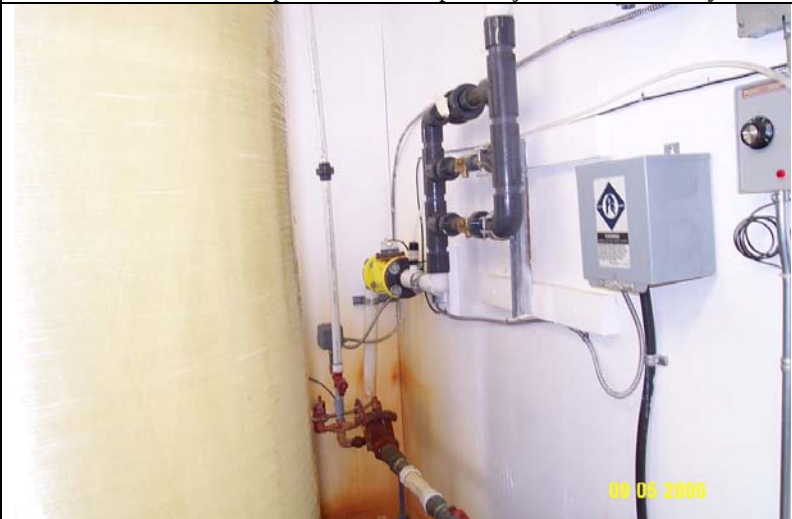
**Photo 0070:** 1953 Pumphouse Iron Duplex Injection Chlorine System

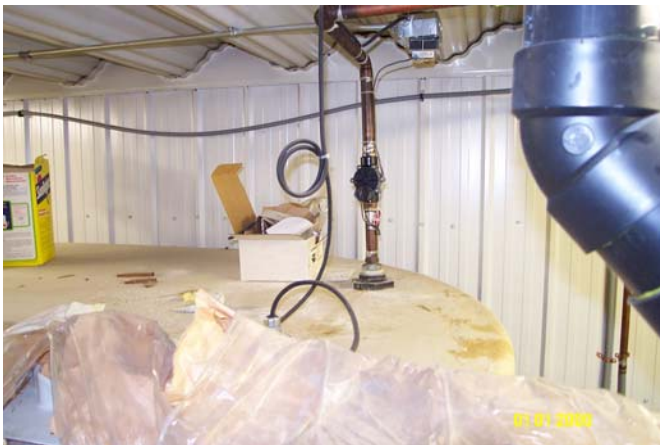
**Photo 0107:** 1950 Solenoid and Water Storage Tank

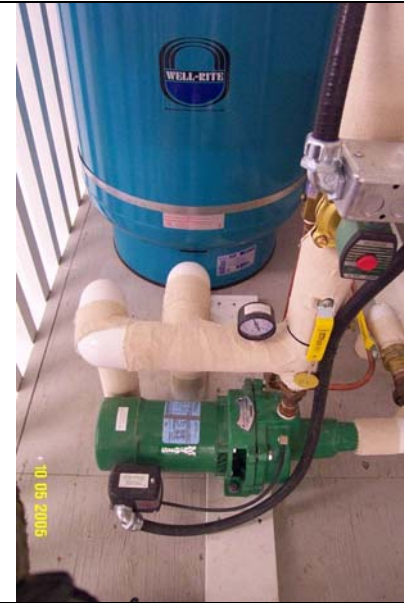
**Photo 0098:** 1421 Pressure Tank and System

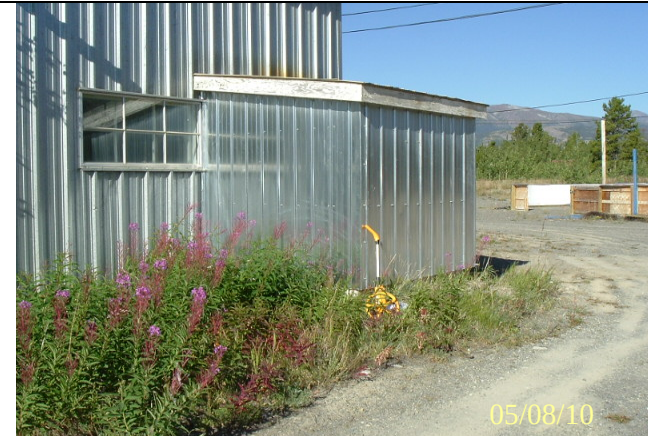
**Photo 028:** 1131 Abandoned wellhead enclosure.
