2019 ANNUAL QUARTZ MINING LICENCE REPORT

Yukon Quartz Mining Licence QML-0007

March 2020

Carmacks Copper Project, Yukon Territory

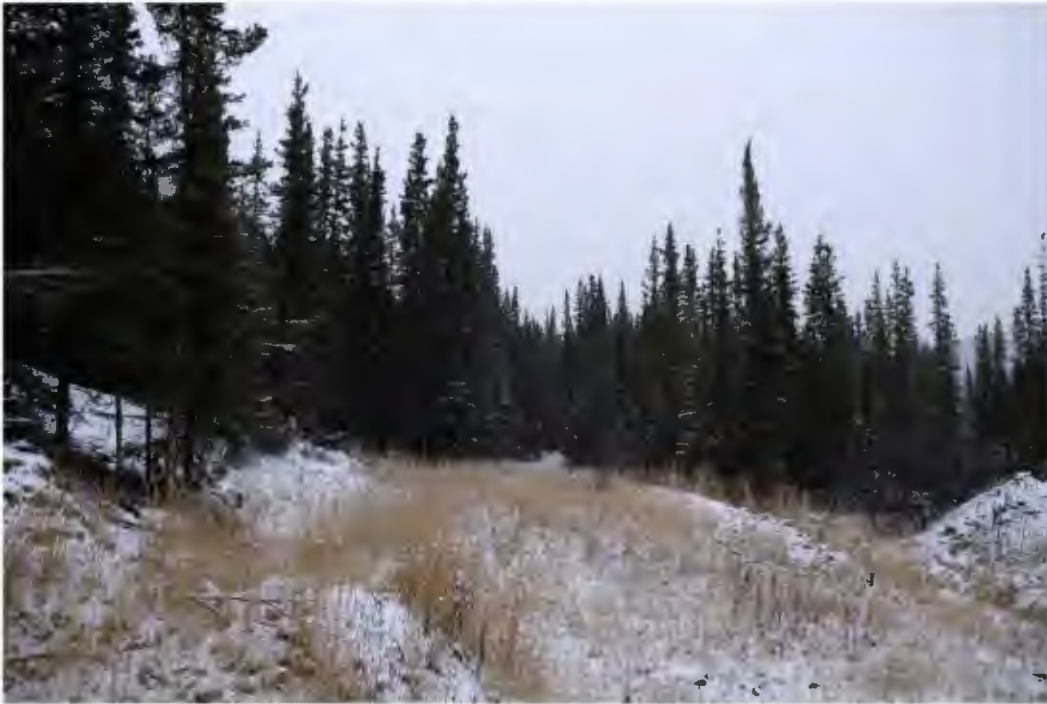
Since the initial clearing in 1997 and 1998, regrowth of vegetation has been occurring in the area. Small coniferous trees are established throughout this area. Erosion and sediment control measures in this area were initially installed in September 2008 and further maintained in September 2009 and August 2010. The sediment control measures include ditches and berms to divert water into sediment catch basins, silt fences, and vegetated areas to break up flow and reduce the potential for erosion. There continues to be some minor erosion of sediments along the access roads, however, this appears to be attenuating as vegetation growth on the access roads increases (Photograph 5).

Photograph 5: Vegetation Regrowth on Access Roads

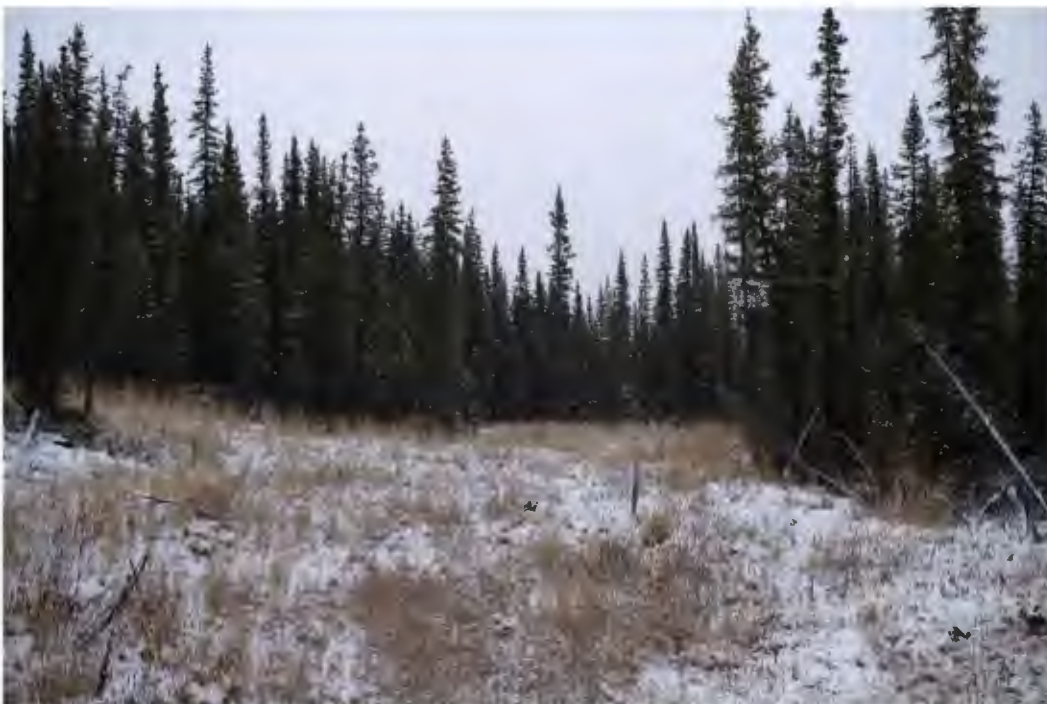
Clearing and drilling activities were carried out in 2015 and 2017 at a location down slope of the proposed heap leach facility, near the proposed water management pond (Photograph 6). Regrowth of vegetation, primarily volunteer species of grass, has mitigated loss of sediment from the former drill pads and is suitably rehabilitating.

Photograph 6: Vegetation Regrowth in 2015 Drilling Area and Proposed Water Management Pond Area

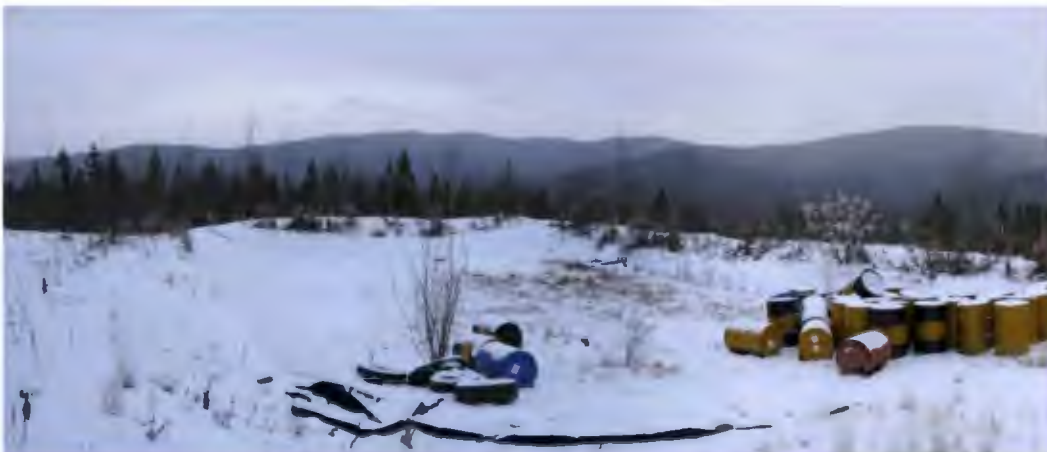
The existing fuel storage area was inspected. It comprises a bunded and lined basin constructed to contain any spilled fuel and currently a few dozen drums of diesel fuel. Approximately 0.2 m of water has accumulated in the basin (Photograph 10). The bund is less than 3 m in height and the basin capacity is less than 10,000 m³; therefore, the fuel storage area is appropriately permitted under the QML without need for a water license (Yukon Environment Dam Guide).

Photograph 10: Lined Basin at Fuel Storage Area

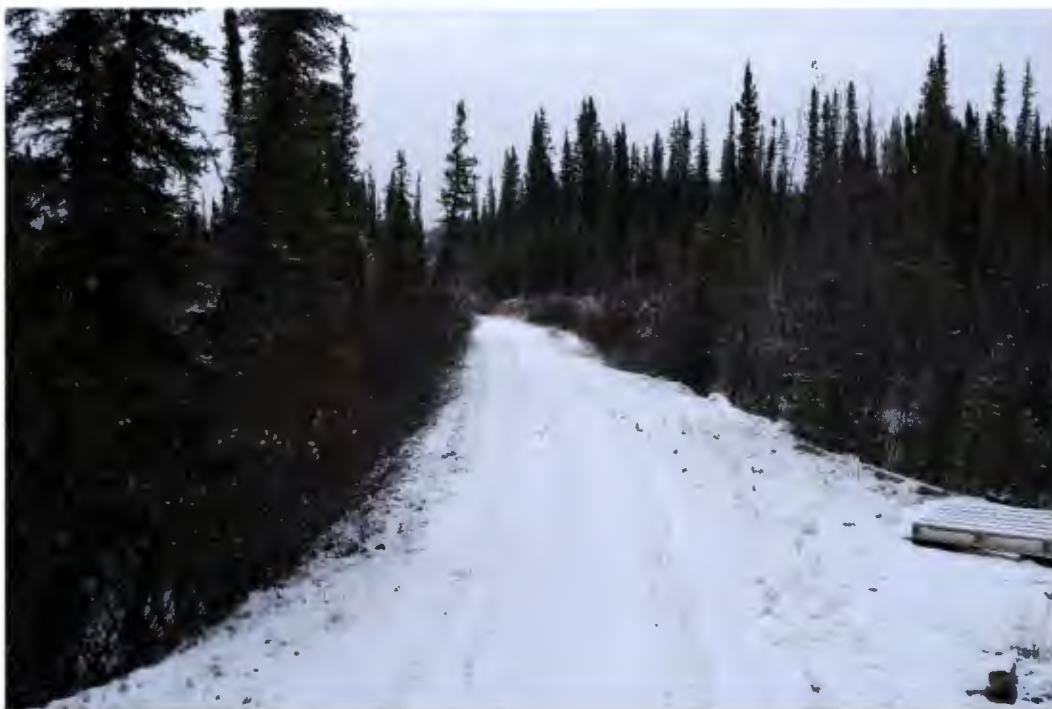
The main access road to the north of the proposed waste rock storage area was observed to be in good condition with only minor erosion observed. Damage to the road near North Williams Creek noted in the 2017 inspection report have since been repaired. The North Williams Creek culvert has undergone some crushing and has accumulated some sediment (Photographs 13 and 14). However, the culvert remains adequate to accommodate the relatively minor flows observed at the time of the inspection. There is no visual evidence to indicate that erosion is occurring near the culvert. The access road should be inspected annually and periodic maintenance of drainage features and erosion management should be anticipated.

Photograph 12: Road Near North Williams Creek

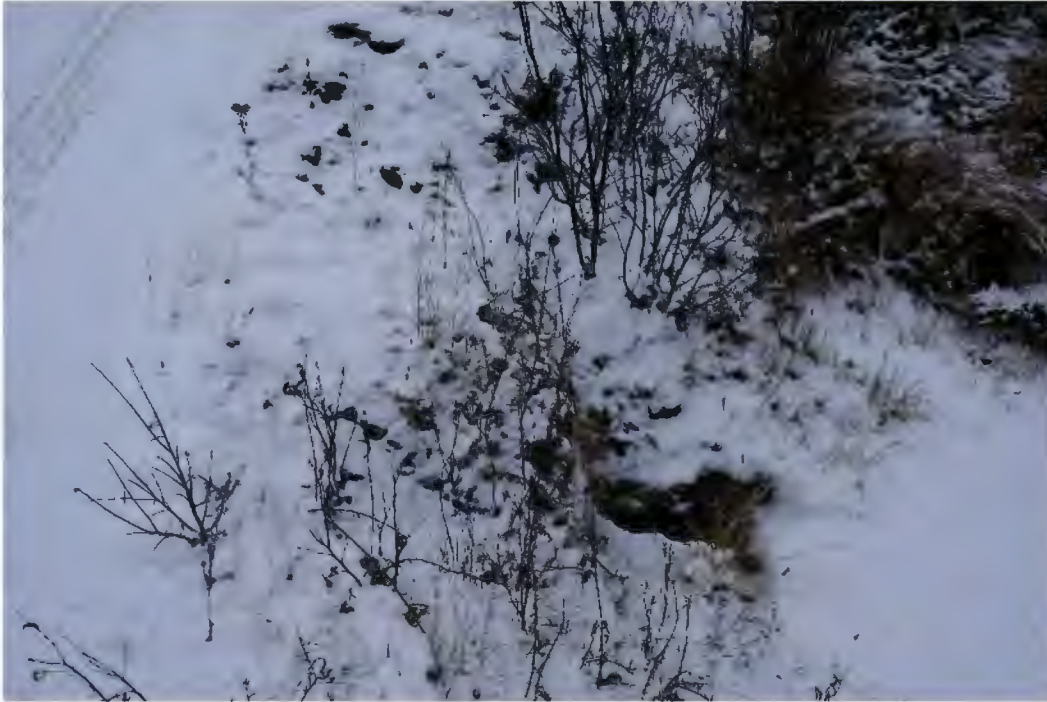
Photograph 13: Culvert Inlet beneath road at North Williams Creek

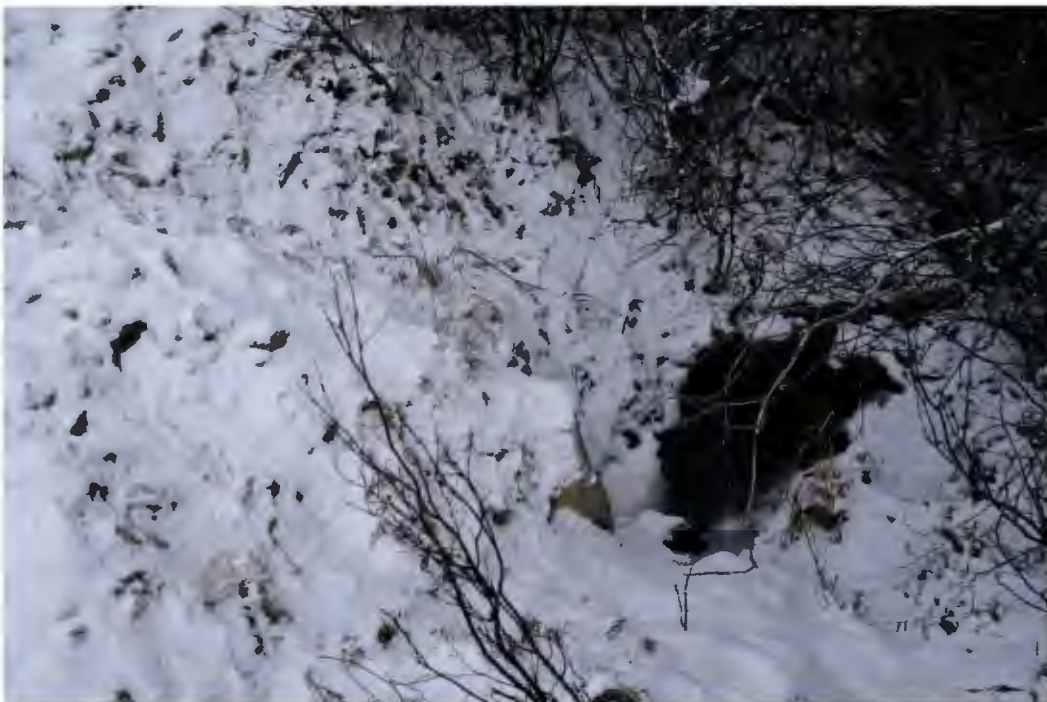
Photograph 14: Culvert Outlet beneath Road at North Williams Creek
