# 2021 Geotechnical Annual Review

Minto Mine, Yukon  
Minto Explorations Ltd.

SRK Consulting (Canada) Inc. ■ 1CM002.073 ■ October 2021

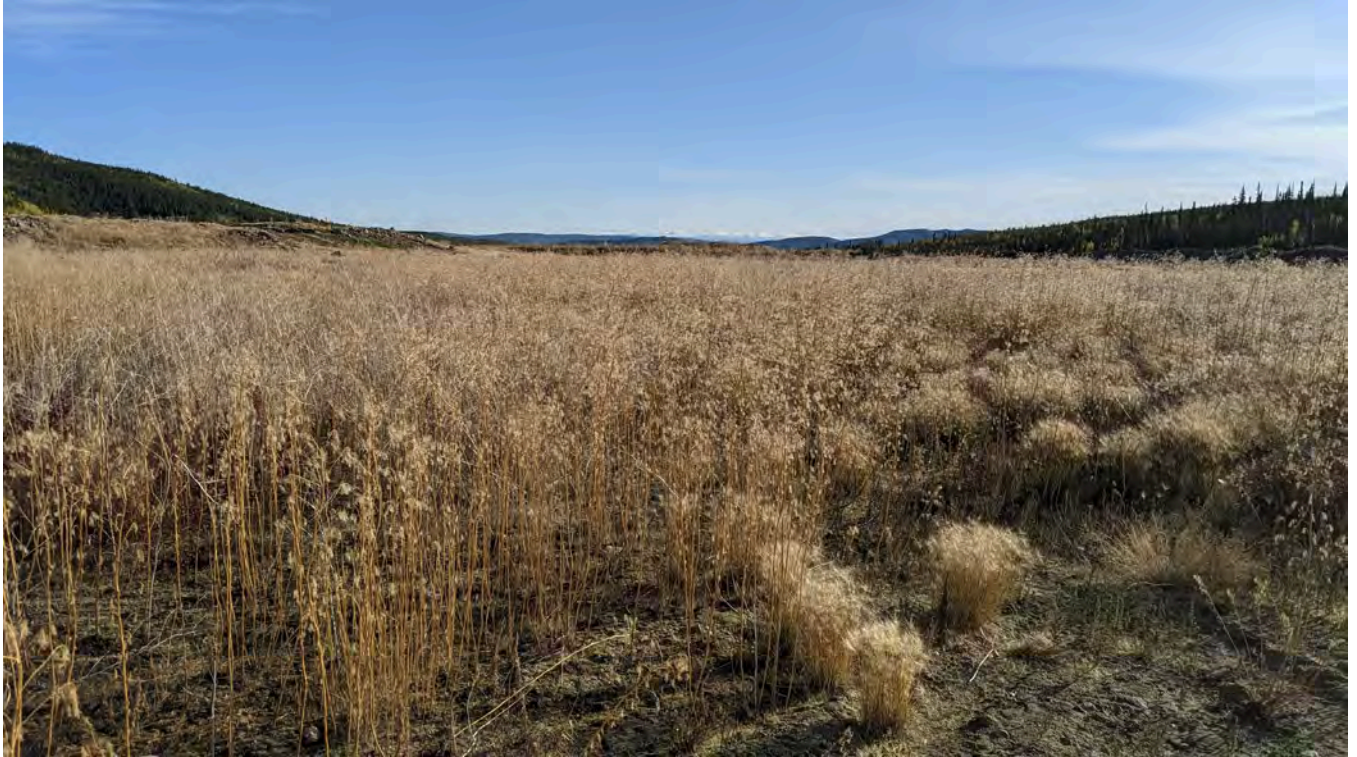
Photo 1-3: Covered DSTSF surface in a well naturally-vegetated area.

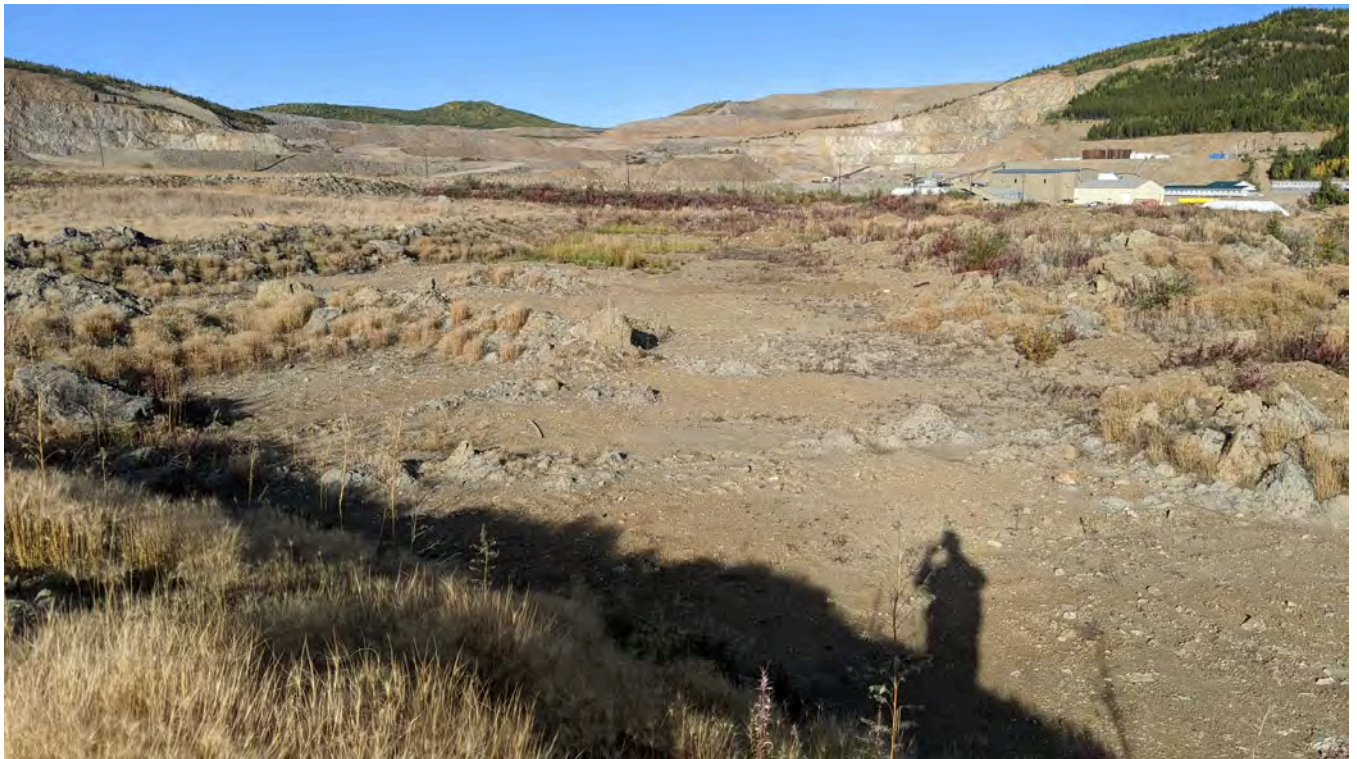
Photo 1-4: Covered DSTSF surface in an area with no vegetation.

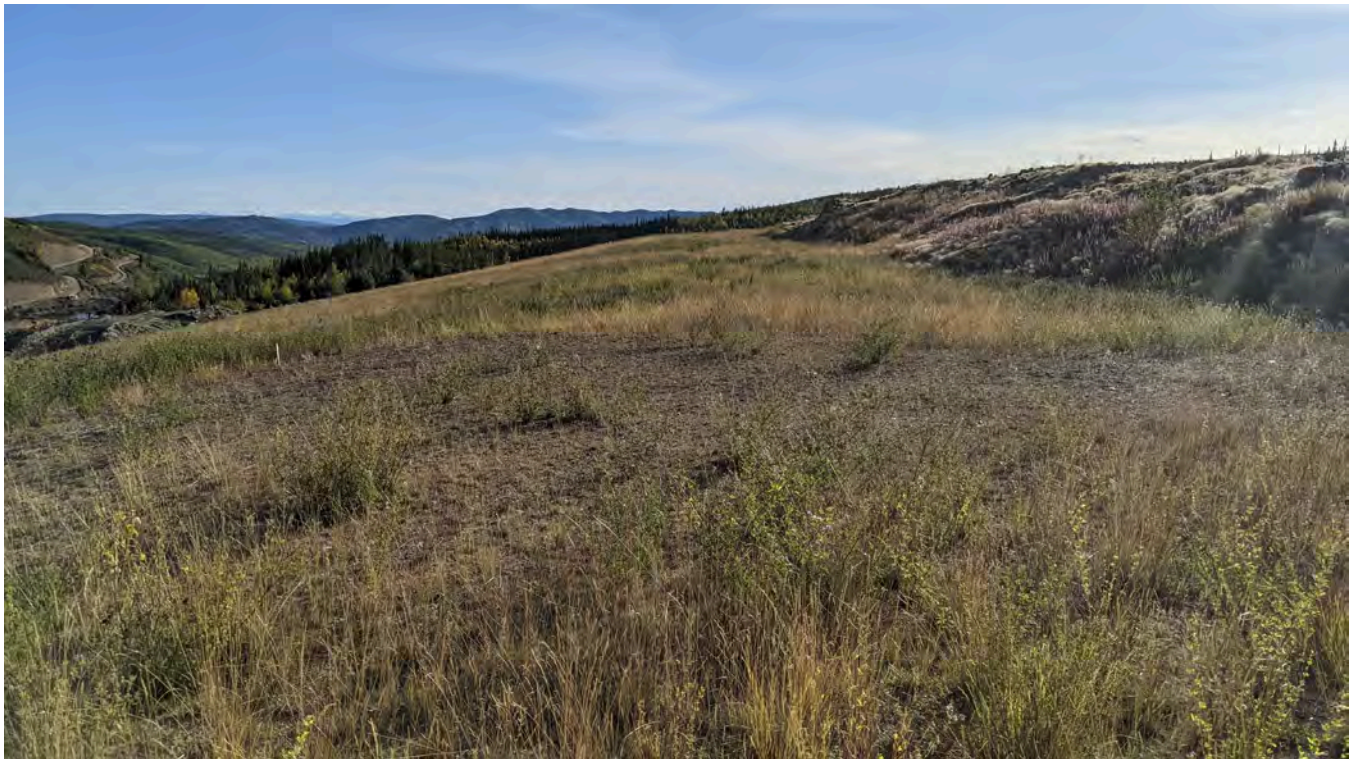
Photo 1-6: DSTSF crest along the northern end looking east. A 2m high overburden stockpile is on the right side of the picture.

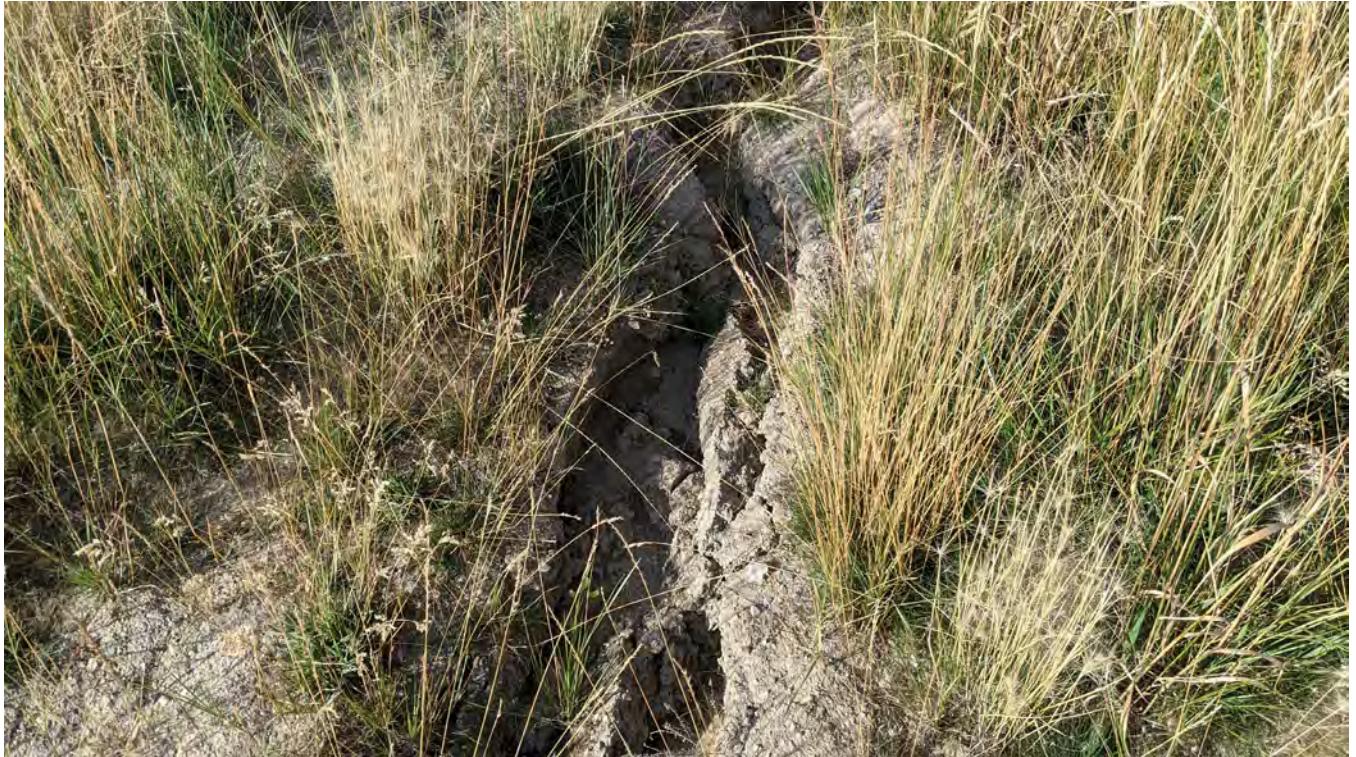
Photo 1-7: Erosion gully on regraded cover slope at the northeast corner of the DSTSF.

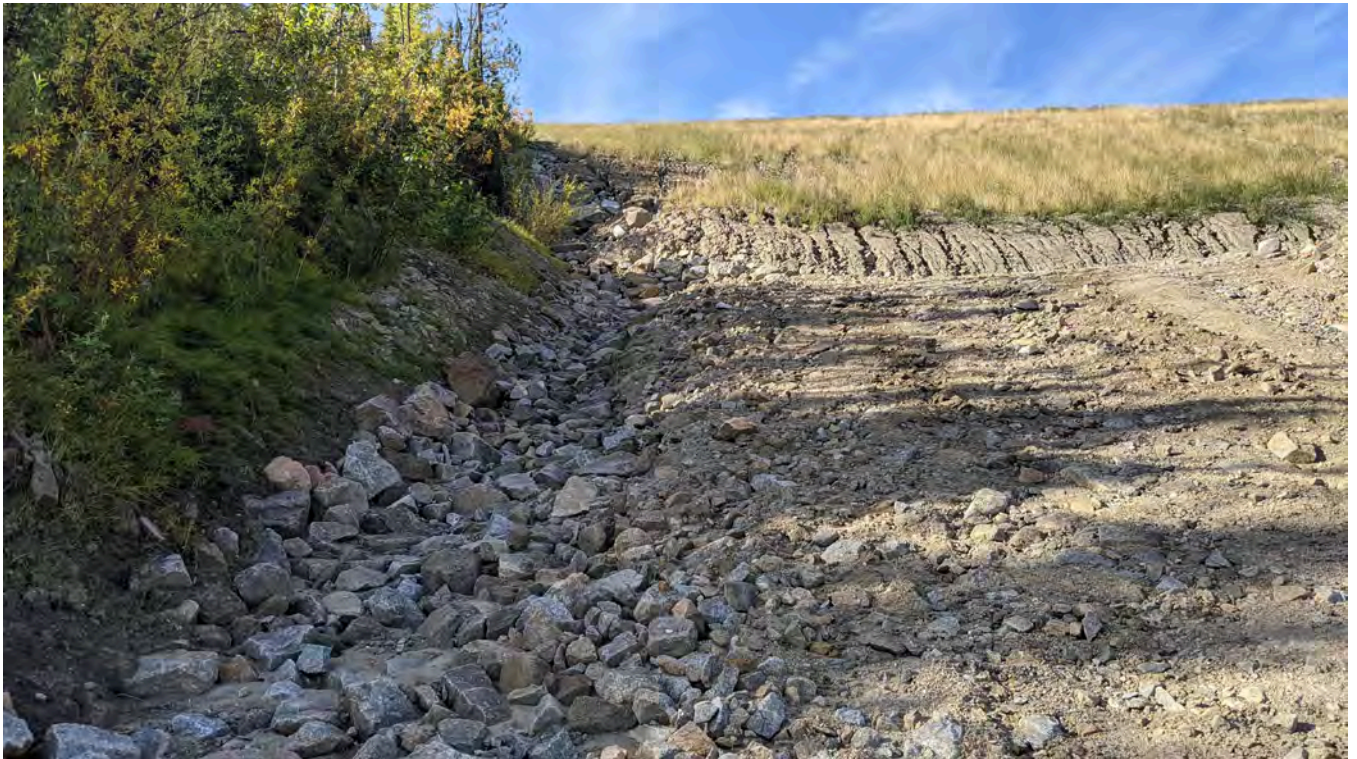
Photo 2-6: The road down to the MVFE Sump has been upgraded with a armored drainage channel constructed on the south side of the road to prevent sediment transport to the MVFE Sump area.

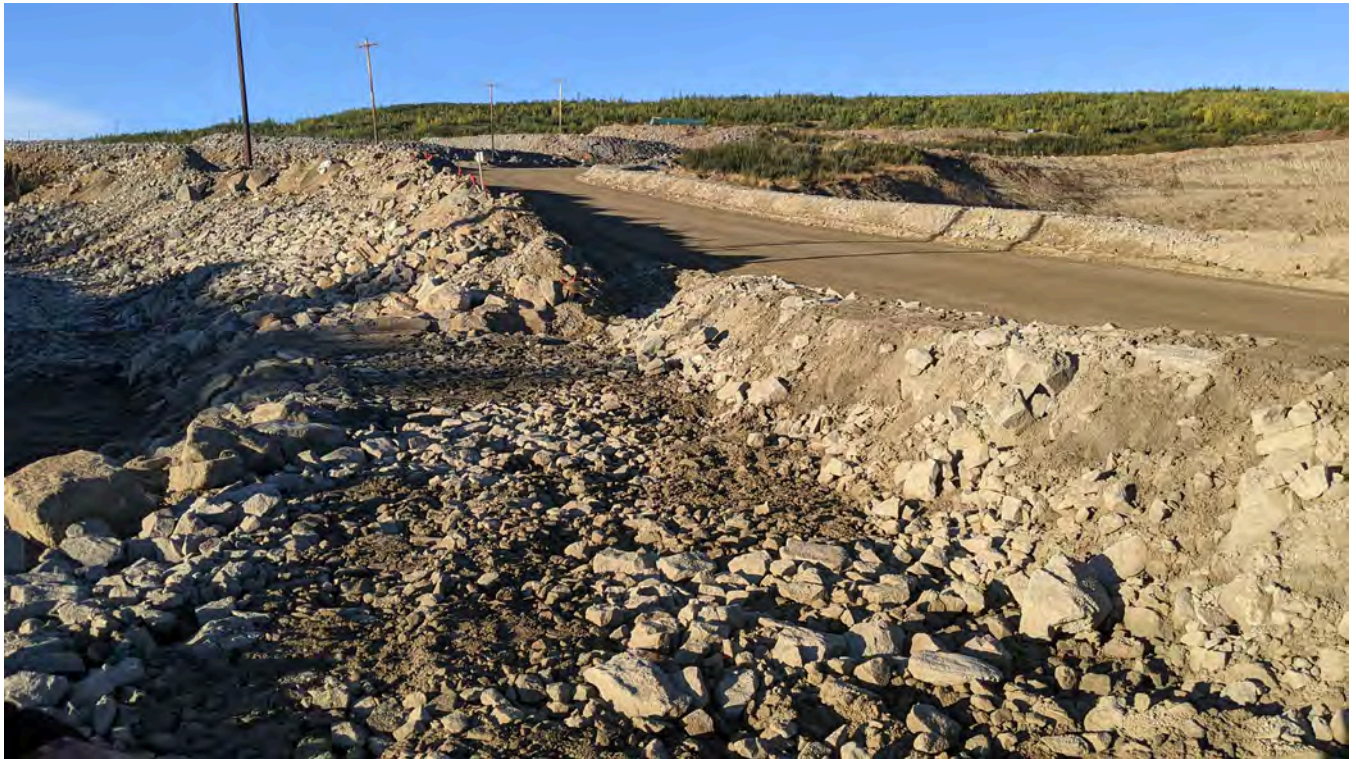
Photo 3-2: TDD Intake Channel. View of the location where the Underground Access Road runoff enters the TDD area. The overflow spillway is non functional. Flows that exceed the TDD intake will continue down the Underground access road. Most of this flow would be directed west of the DSTSF.

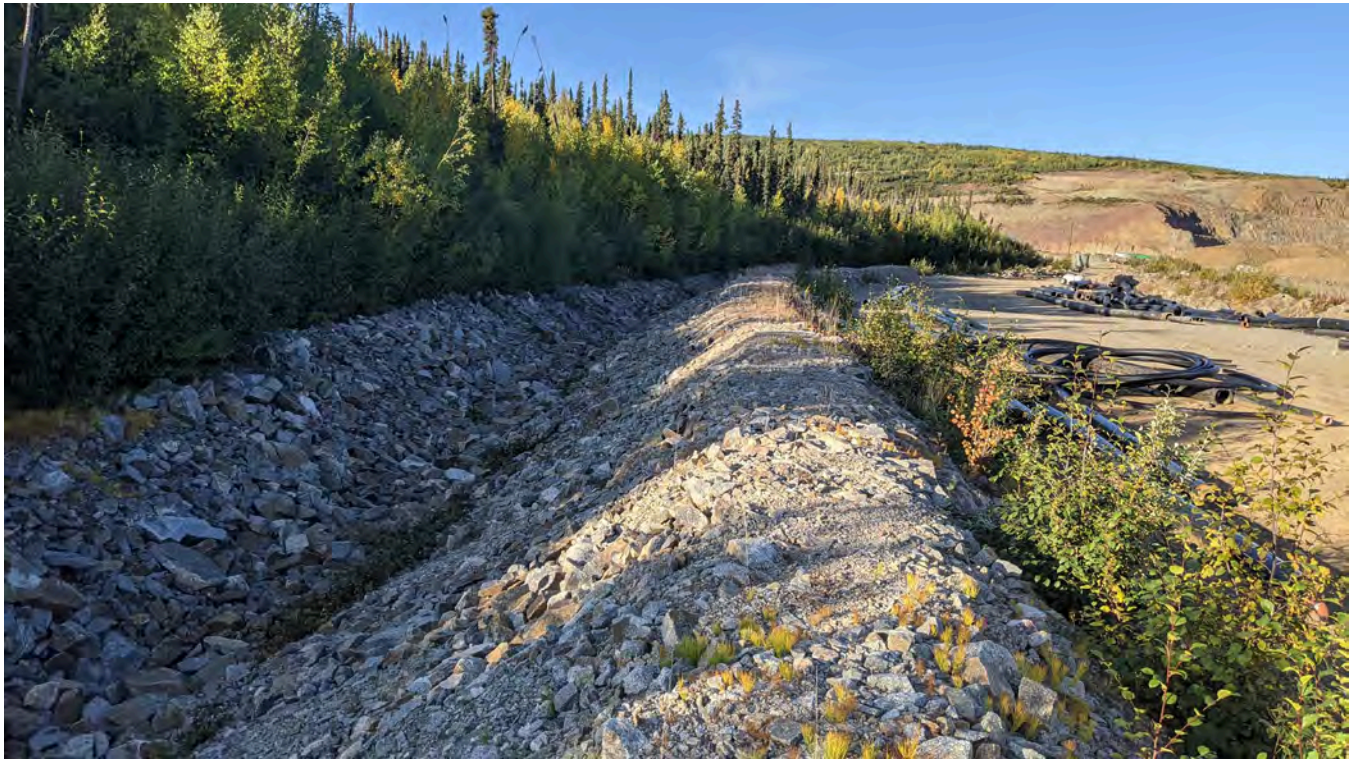
Area Number	Name	Inspection Observations
		<ul style="list-style-type: none"> <li>■ Remaining armoured portion of the ditch was generally free from vegetation (see Photo 3-5, Appendix A).</li> <li>■ TDD outlet showed no signs of instability or obstructions (see Photo 3-6, Appendix A).</li> </ul>
4	Main Waste Dump (MWD)	<ul style="list-style-type: none"> <li>■ No observations of global instability.</li> <li>■ Erosion gullies observed in cover material.</li> <li>■ Trees have been planted in portions of the MWD Expansion area where resloping and cover placement have been completed.</li> <li>■ The longitudinal crack noted in the 2019 inspection in the resloped area above the former PAG Oxide stockpile (Photo 4-23, Appendix A) was not observed in the 2020 or 2021 inspection. The cracking was approx. 50 m long with the area below the cracks appearing with a concave slope due to potential differential settlement.</li> </ul>

Photo 3-5: Typical view of the lower portion of the TDD with riprap. Sparse vegetation growing in the channel.

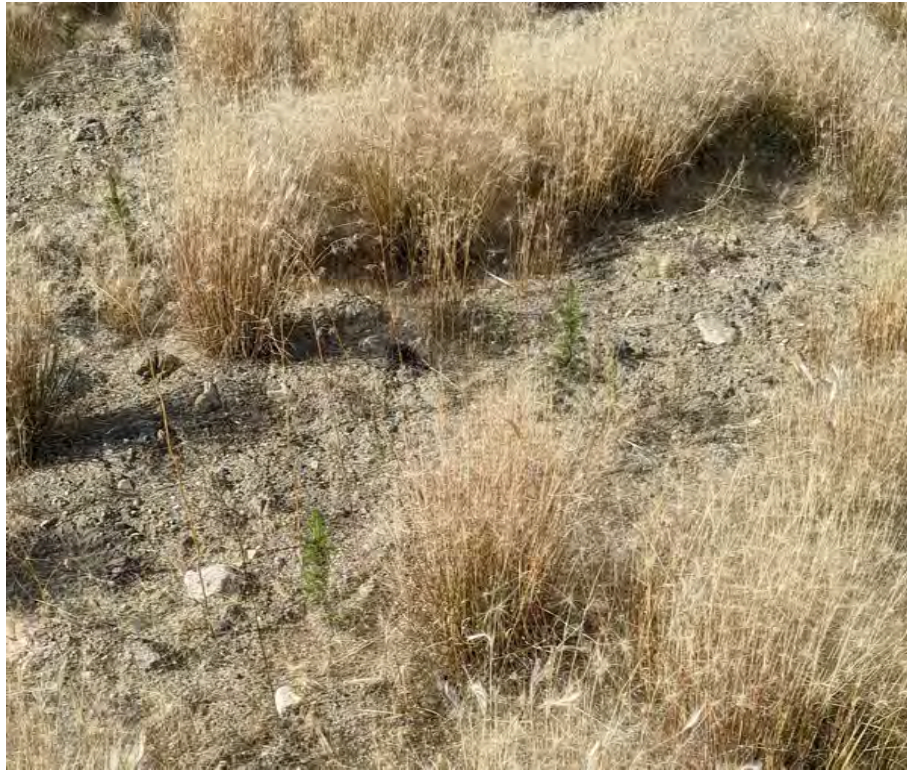
Photo 4-3: Upper portion of the MWD has been planted with trees in 2021.

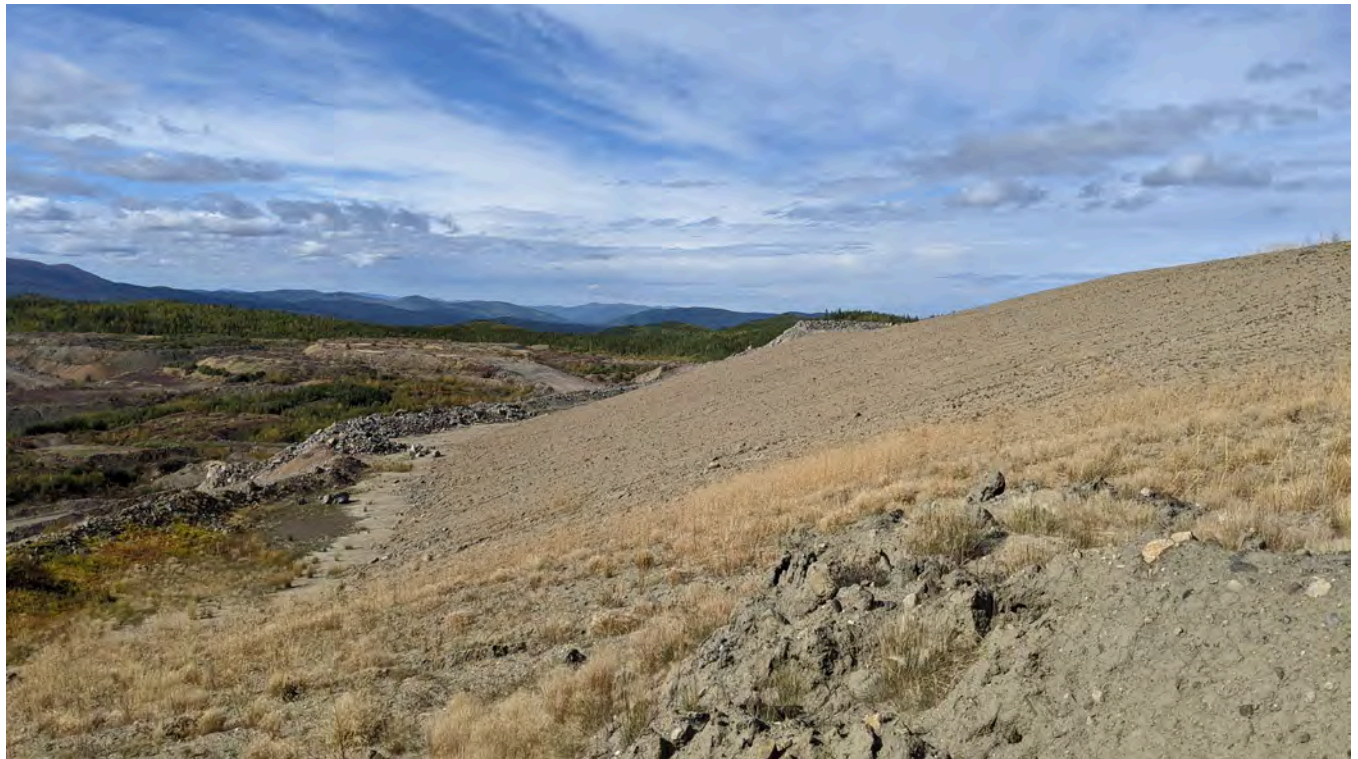
Photo 4-4: Regraded MWD slope looking towards the Reclamation Overburden Dump.

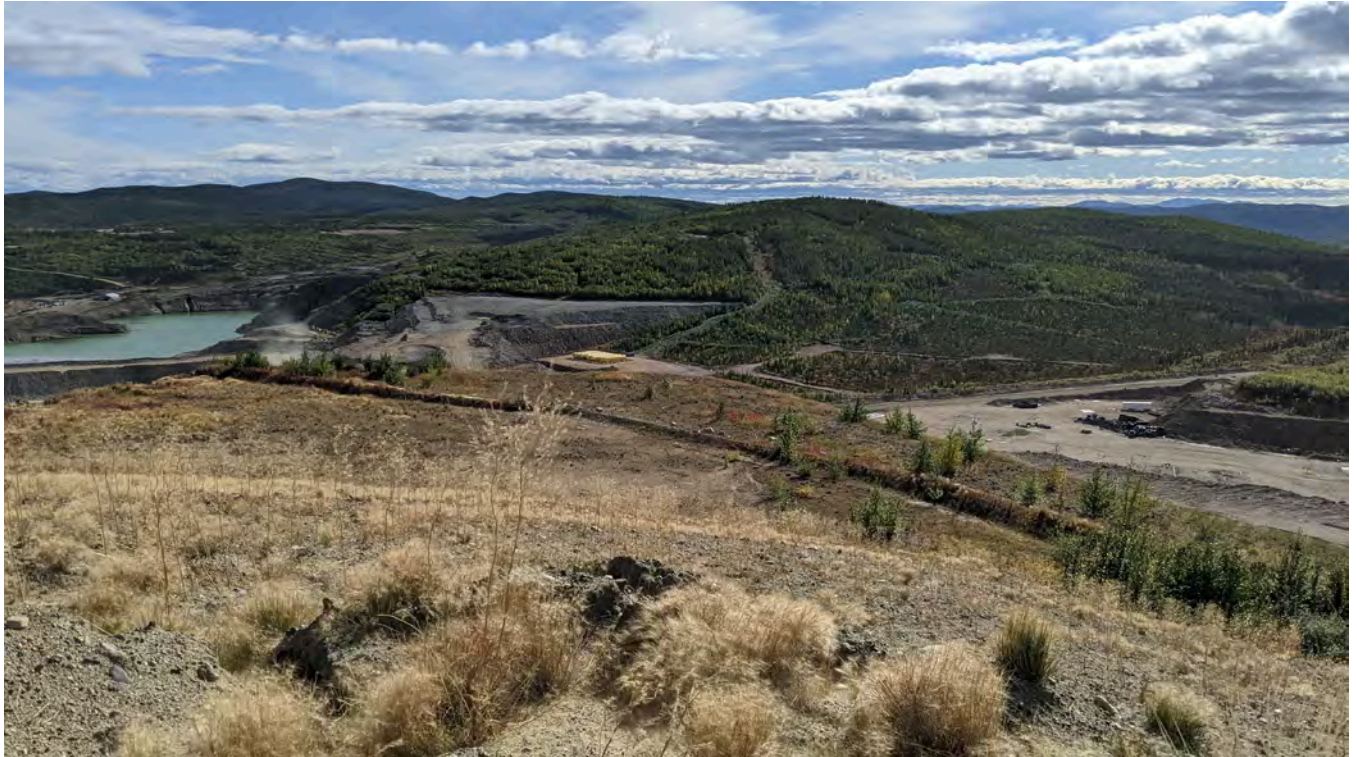
Photo 4-5: View from the top of the MWD Expansion looking down to the top of the original MWD.

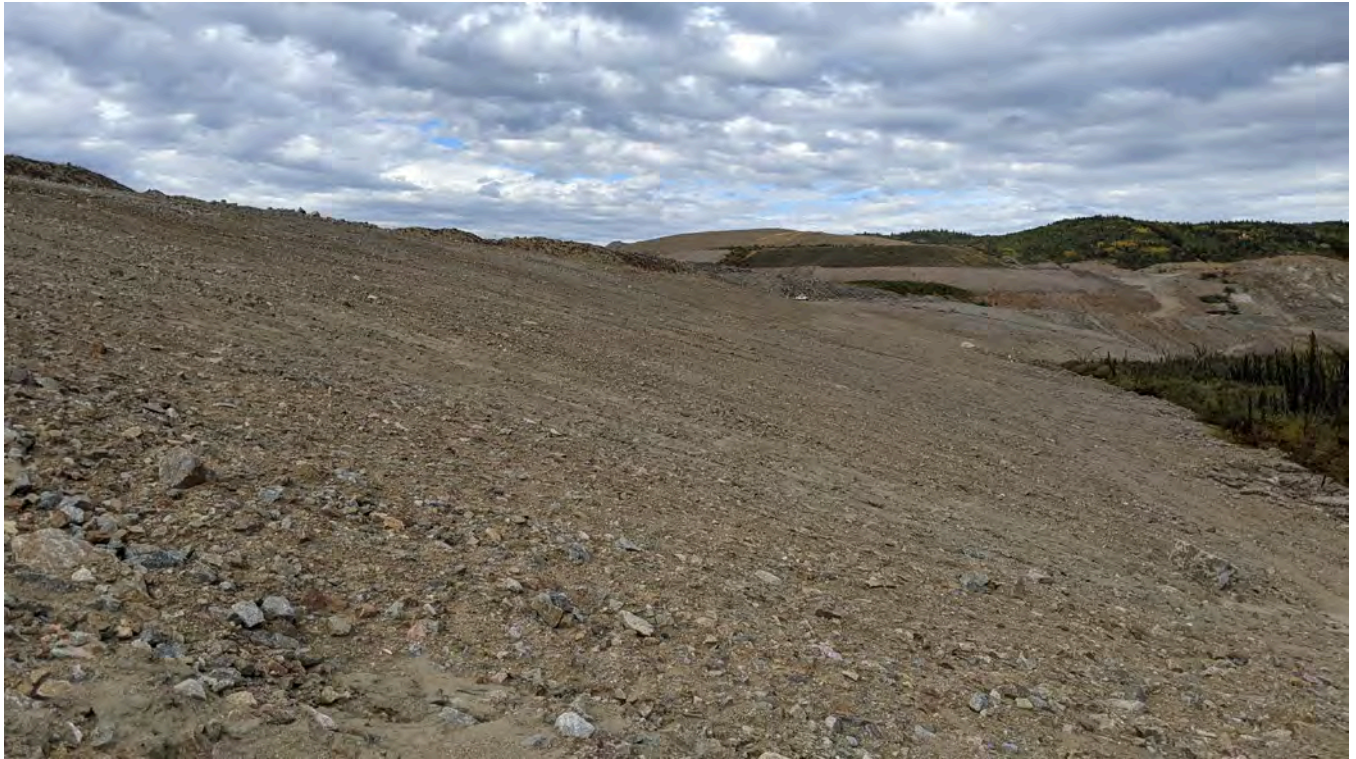
Photo 6-6: Reggraded SWD slope below the longitudinal cracks.

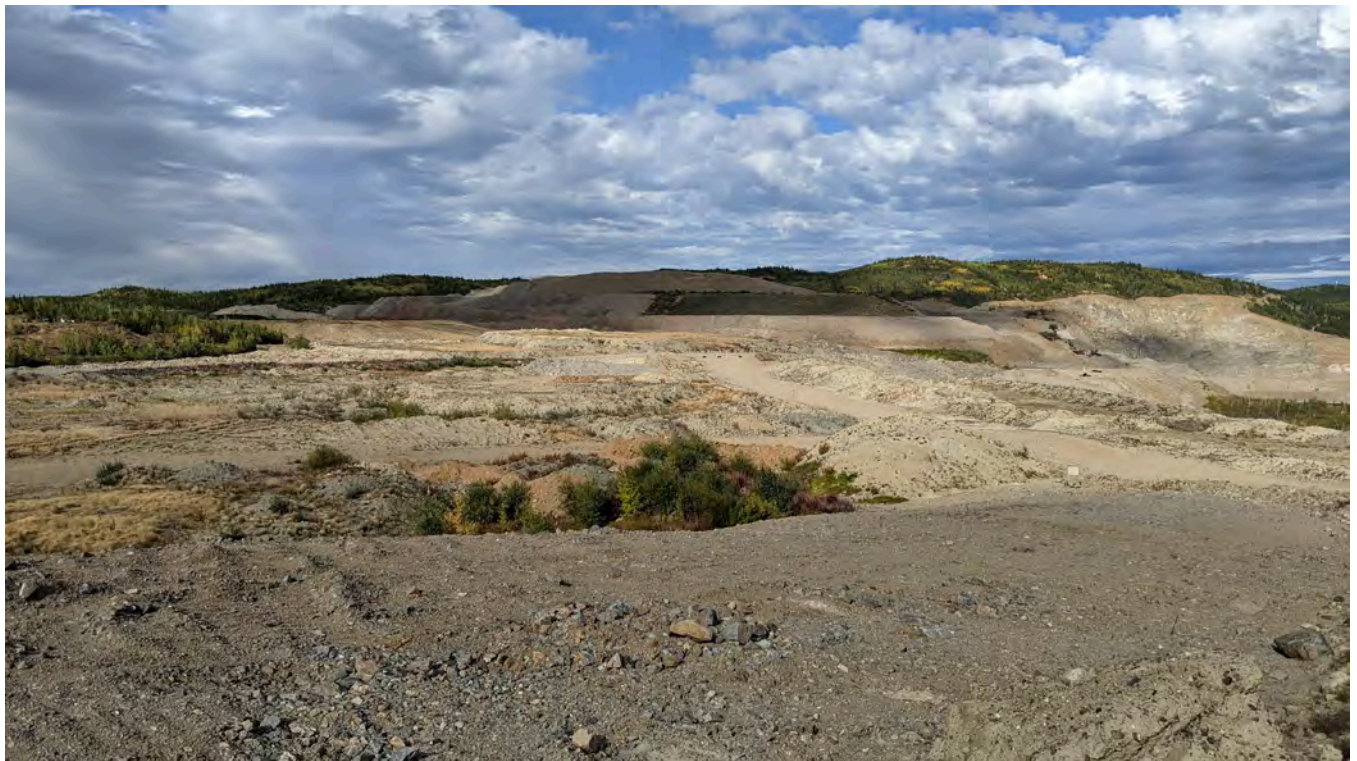
Photo 6-6: Overview of the SWD taken from the south end of the SWD..

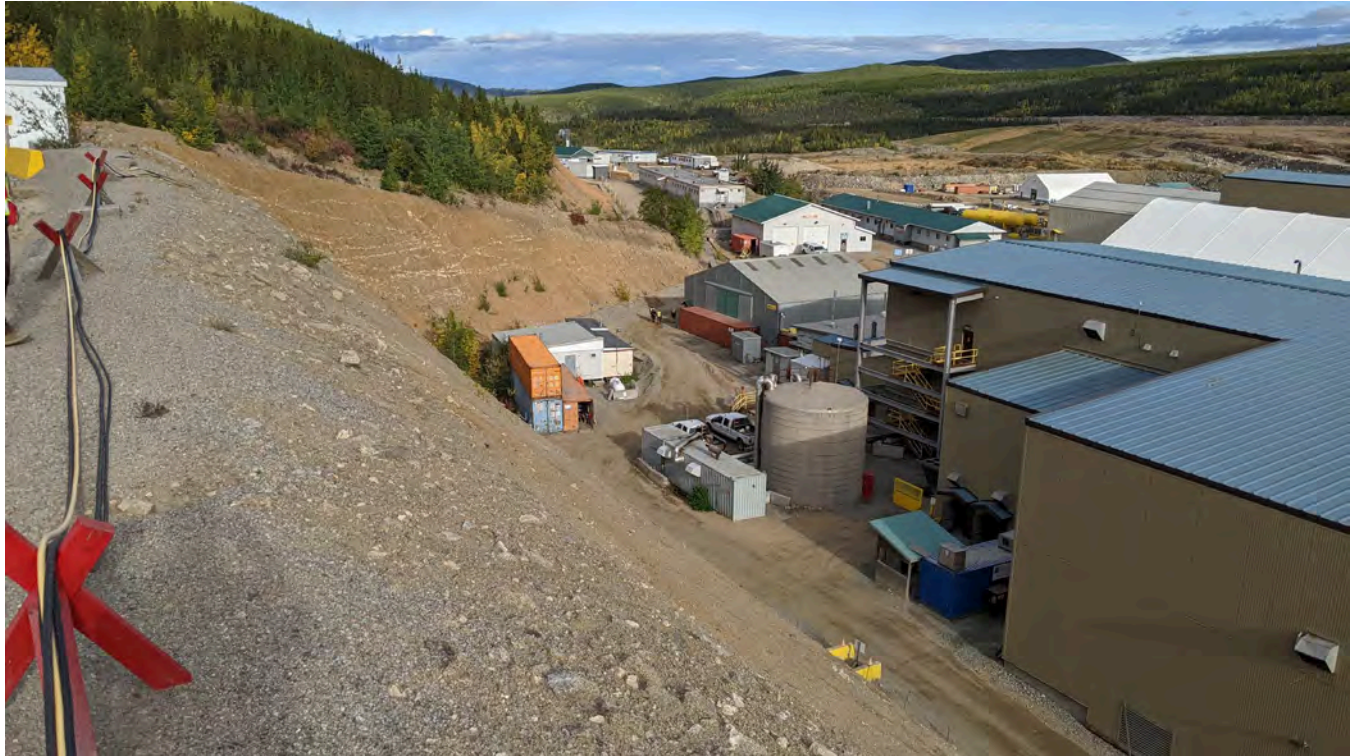
Area Number	Name	Inspection Observations
9	Mill Site	<ul style="list-style-type: none"> <li>No observations of global instability of the highwall north of the mill were observed. Minor erosion and spalling of loose rocks is ongoing. A fence was installed at the base of the slope in 2019 as a mitigation with no evidence of fence damage observed due to falling materials.</li> </ul>
10	Camp Site	<ul style="list-style-type: none"> <li>Observations were consistent with previous years' inspection.</li> <li>No signs of instability were observed.</li> <li>The erosion gully noted in the 2020 inspection was repaired with fill and the camp pad graded to direct runoff to the north (Photo 10-1, Appendix A).</li> <li>No change was observed to the erosion gullies located between the camp and main access road (Photo 10-4, Appendix A).</li> </ul>
11	Fuel Containment Facility	<ul style="list-style-type: none"> <li>The highwall to the north of the facility did not show signs of global instability.</li> <li>Significant new rutting that has exposed the base liner between the access ramp and the sump occurred within the past year (Photos 11-2 to 11-5, Appendix A). The rutting also has caused damage to the access ramp.</li> <li>Several areas of exposed geotextile were observed with one tear in the geotextile found with approximate dimensions of 5 cm x 8 cm (Photo 11-5, Appendix A). No damage to the liner beneath the liner could be felt, however liner damage cannot be ruled out. In addition, there could be other areas along the ruts where damage has occurred but could not be detected due to sloughing of the rut edges that may have covered up liner damage.</li> <li>An investigation is recommended to assess for potential damage to the liner. The damaged geosynthetics should be repaired and additional sand material should be placed within the facility to fill the ruts. The investigation should be completed carefully using hand shovels to expose the geotextile/liner along the ruts to allow for the condition of the materials to be carefully inspected.</li> <li>The equipment that caused the rutting appeared to have driven straight down the ramp to the sump, then backed up and turned around at the base of the ramp prior to traveling back up the ramp. Areas where the equipment tires turned over top of the liner would be most susceptible to damage and particular attention should be paid during the investigation in these areas.</li> <li>No change in condition of the exposed liner on the sides of the facility were observed.</li> </ul>

Photo 9-1: Highwall behind the mill area taken from the Fuel Tank Farm looking east.

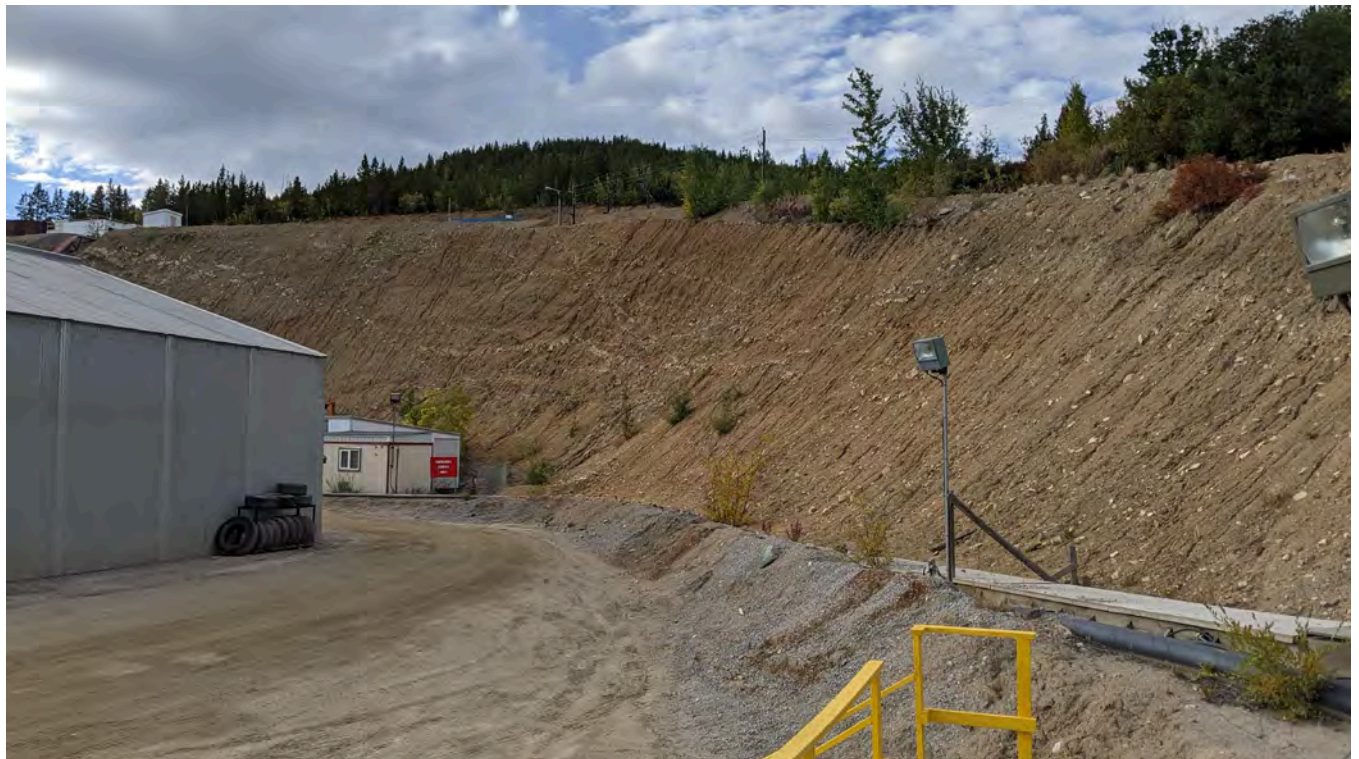
Photo 9-2: Highwall behind the mill area looking northwest from near the south end of camp.

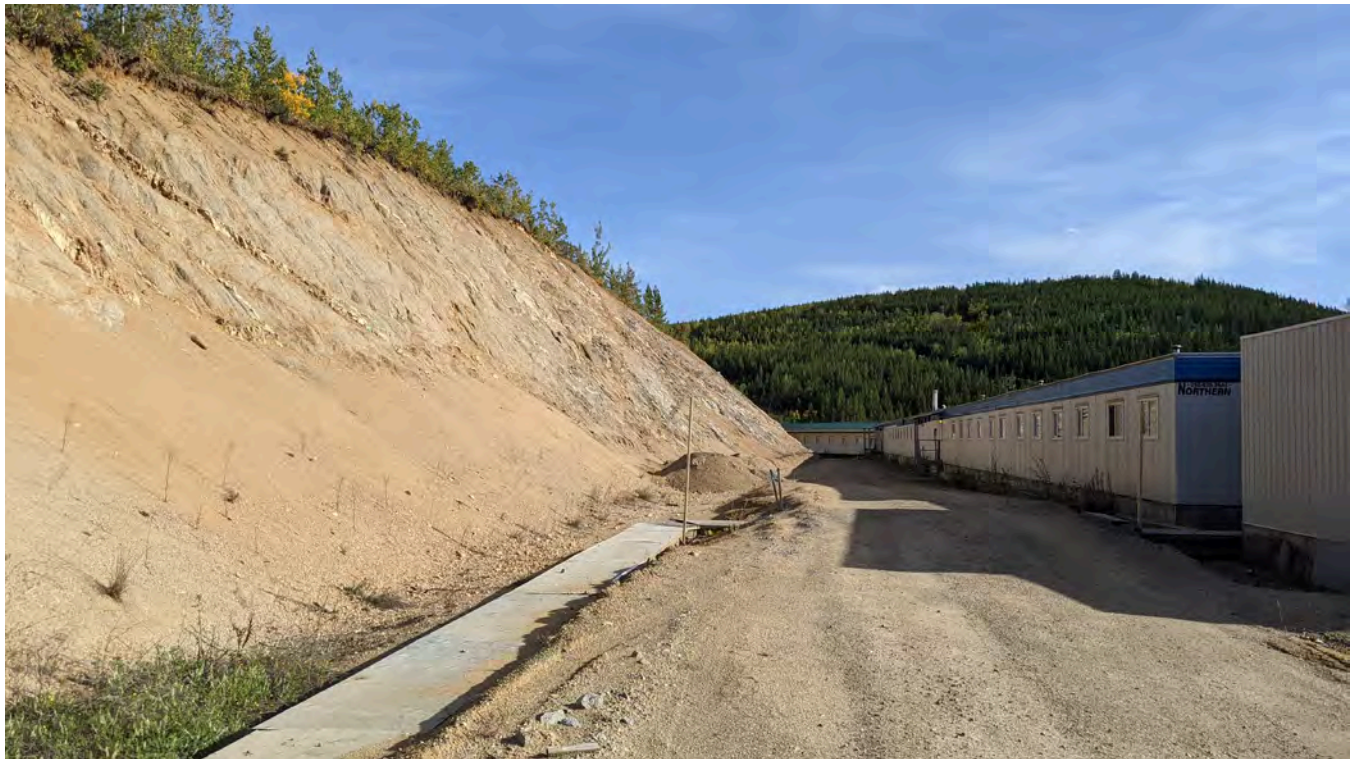
Photo 10-2: Highwall behind camp looking northwest from near the south end of camp.

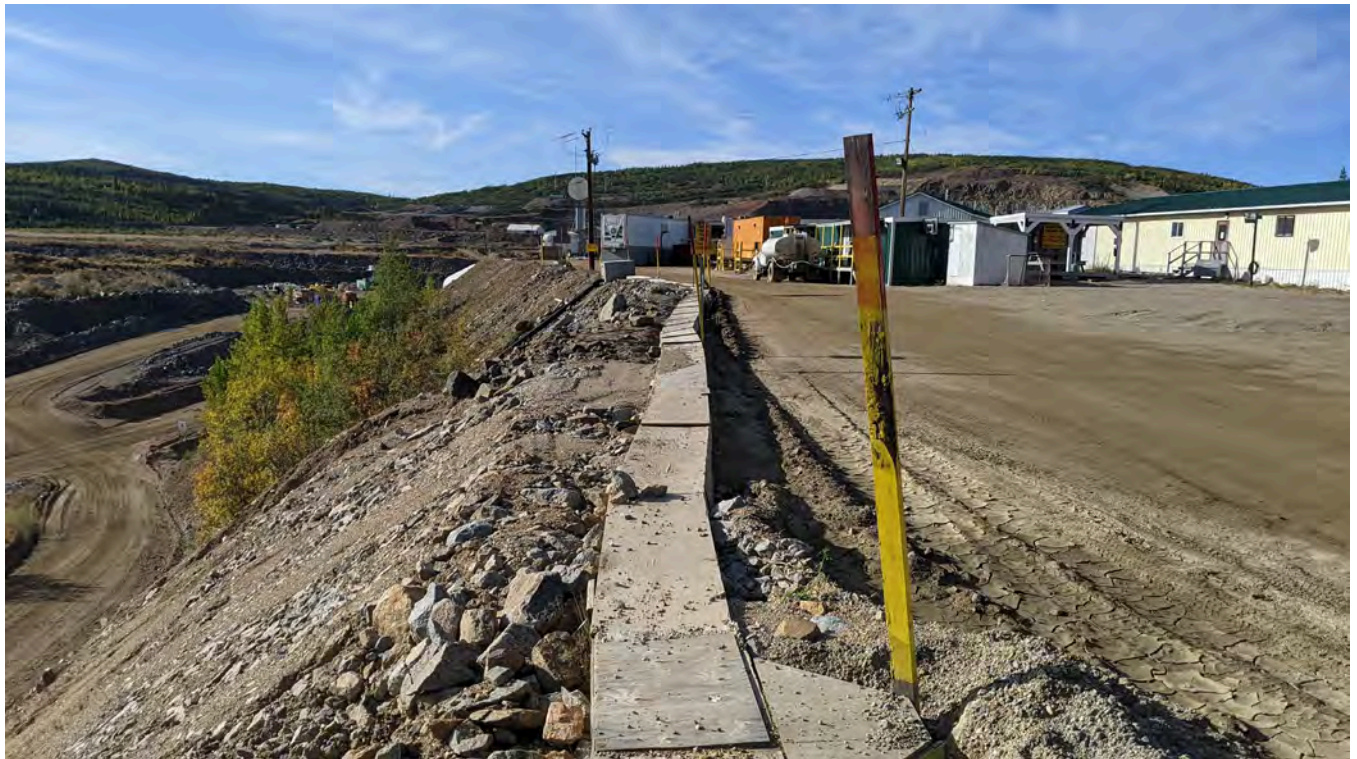
Photo 10-3: Repaired erosion gully noted in the 2020 inspection at the north end of camp. (looking south).

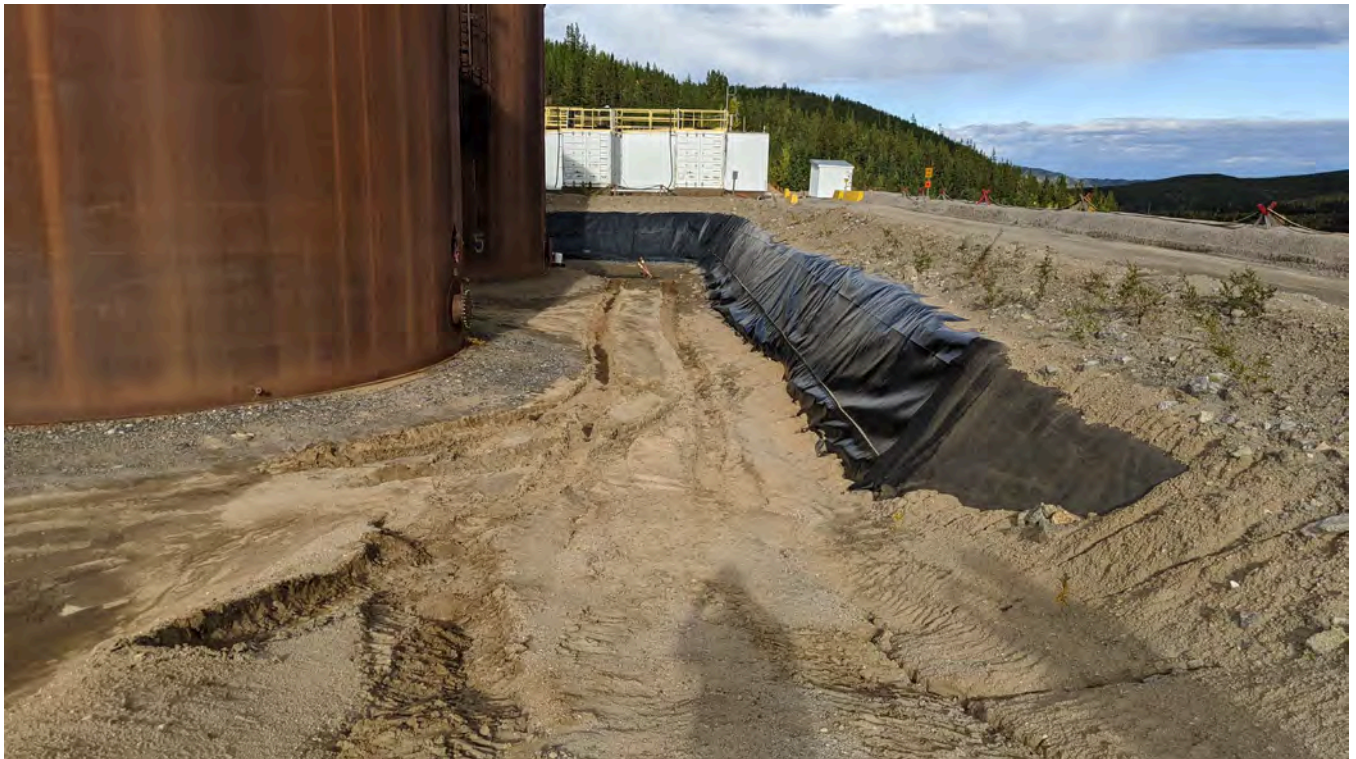
Photo 11-2: Entrance ramp to the facility with a new large rut near the edge and new rutting between the ramp and sump (far end).

Area	ID No.	Recommendations	Priority (Table 3)	Recommended Deadline
Fuel Containment Facility	2021-07	<ul style="list-style-type: none"> <li>An investigation is needed to inspect the condition of the geotextile and liner in the area along the new rutting in the facility. The inspection should be completed using hand shovels to carefully expose the geosynthetics to allow for a thorough assessment of the condition of the geosynthetic materials. All areas of damaged geosynthetics should be repaired by a qualified professional and new sand material should be used to fill in the ruts after the repairs have been made.</li> </ul>	2	Construction should be implemented as soon as practical in 2022. (Frozen ground conditions make completion of the investigation in 2021 impractical).
WSP	2021-08	<ul style="list-style-type: none"> <li>Continue to monitor the identified potential sinkhole located 5 m NW of WDT-08 as part of the routine visual inspections for any change in condition. Photographs records should be maintained to aid in monitoring.</li> </ul>	4	n/a

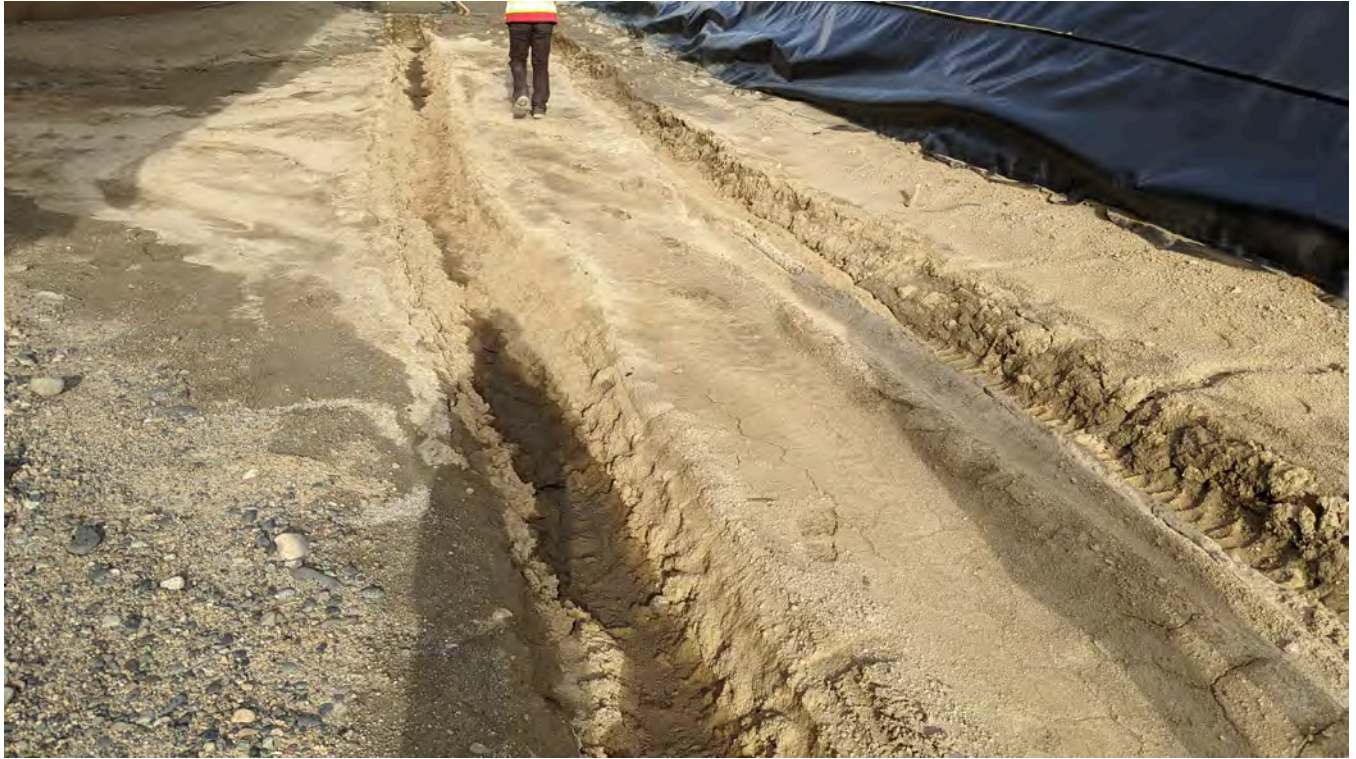
Photo 11-3: Tire ruts between the ramp and sump has exposed the base geotextile and liner in areas.

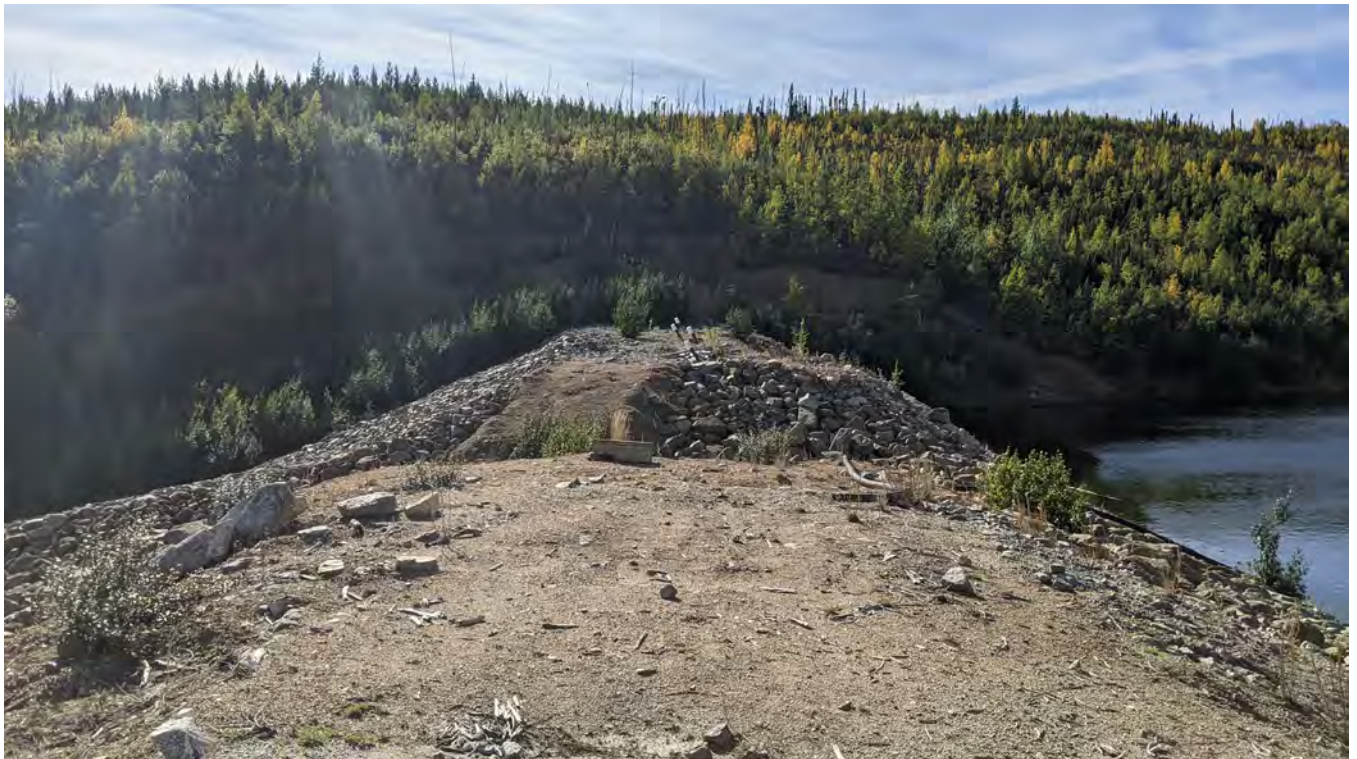
Photo 12-2: WSP Crest taken from the north abutment looking south.

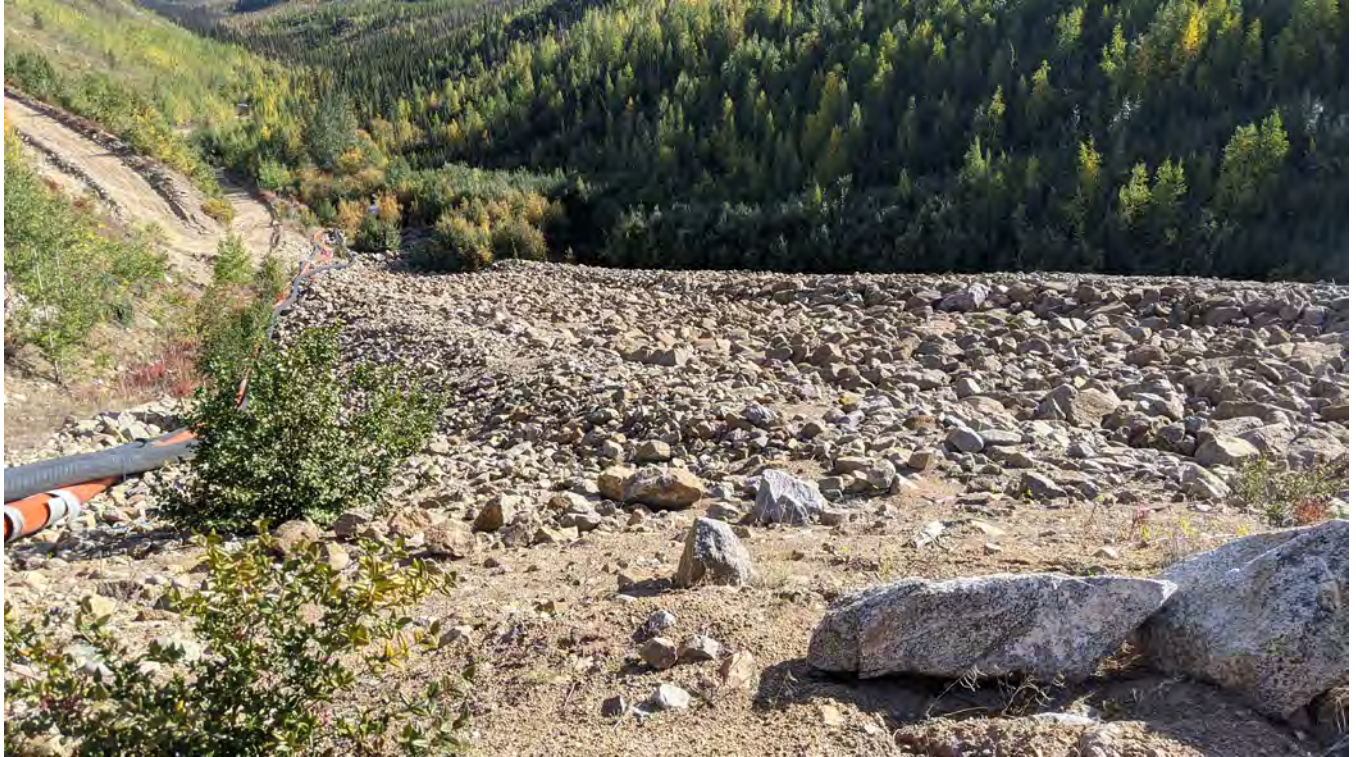
Photo 12-3: WSP spillway looking downstream.
