# 2021 Geotechnical Annual Review

Minto Mine, Yukon  
Minto Explorations Ltd.

SRK Consulting (Canada) Inc. ■ 1CM002.073 ■ October 2021

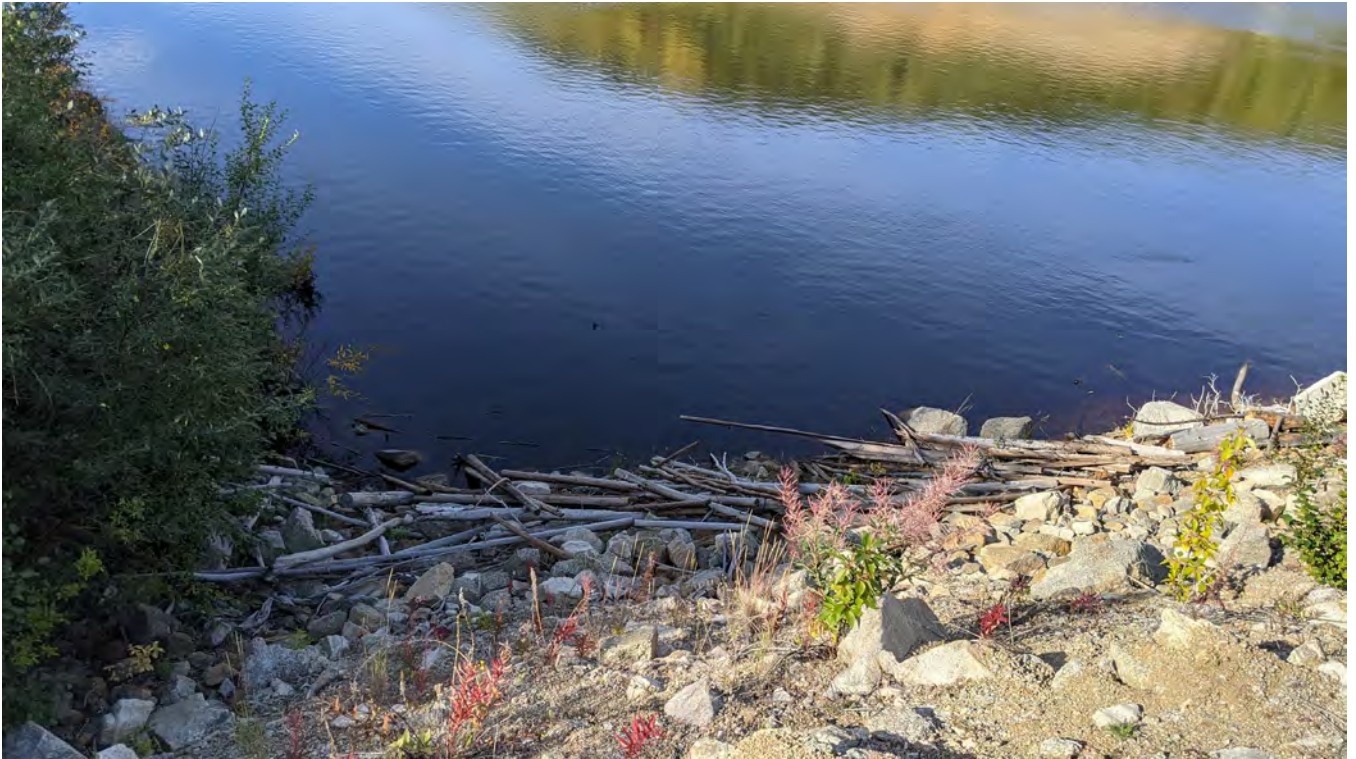
Photo 12-6: Accumulation of logs along the south abutment of the dam.

2021-09	<ul style="list-style-type: none"> <li>Deadfall/logs should be removed from the upstream face of the dam. Should any extreme precipitation event occur, the deadfall could plug/reduce the conveyance capacity of the spillway resulting in uncontrolled overtopping of the dam.</li> </ul>	3	Prior to Freshet 2022.
Main Pit Dump, SAT Dump & In-Put Dumps	2021-10	<ul style="list-style-type: none"> <li>Waste rock materials being processed for construction material should be excavated from the northern edge of the top bench instead of the south end as observed during the inspection to assist in unloading of the dump in the area currently experiencing movement.</li> </ul>	4	n/a
	2021-11	<ul style="list-style-type: none"> <li>The sinkhole north of the W15 Sump should be filled and the erosion channel graded to minimize infiltration into the pit in the event of any future overtopping of the sump.</li> </ul>	3	<b>CLOSED</b> Sinkhole filled and area graded in October 2021.

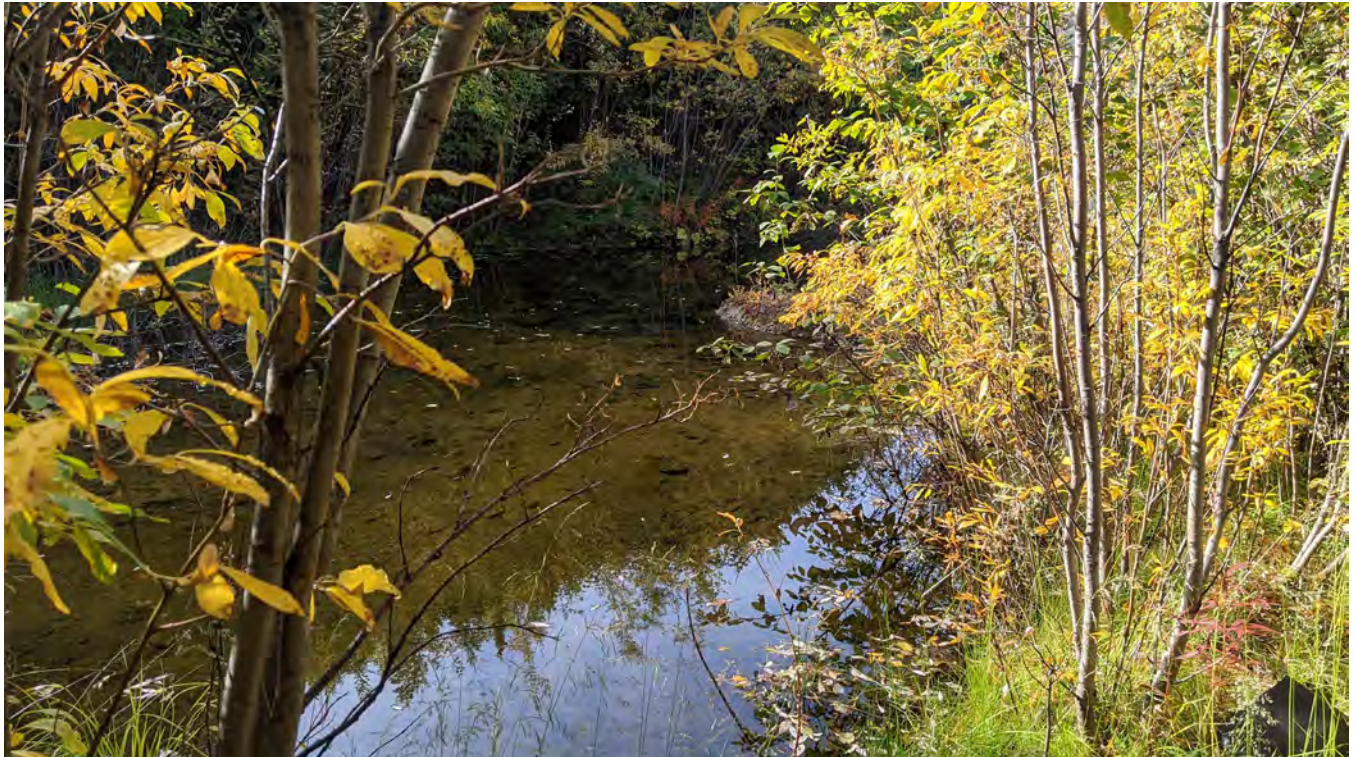
Photo 12-10: Ponding seepage downstream of the WDP Dam looking south. Seepage was clear with no signs of sediment transport.

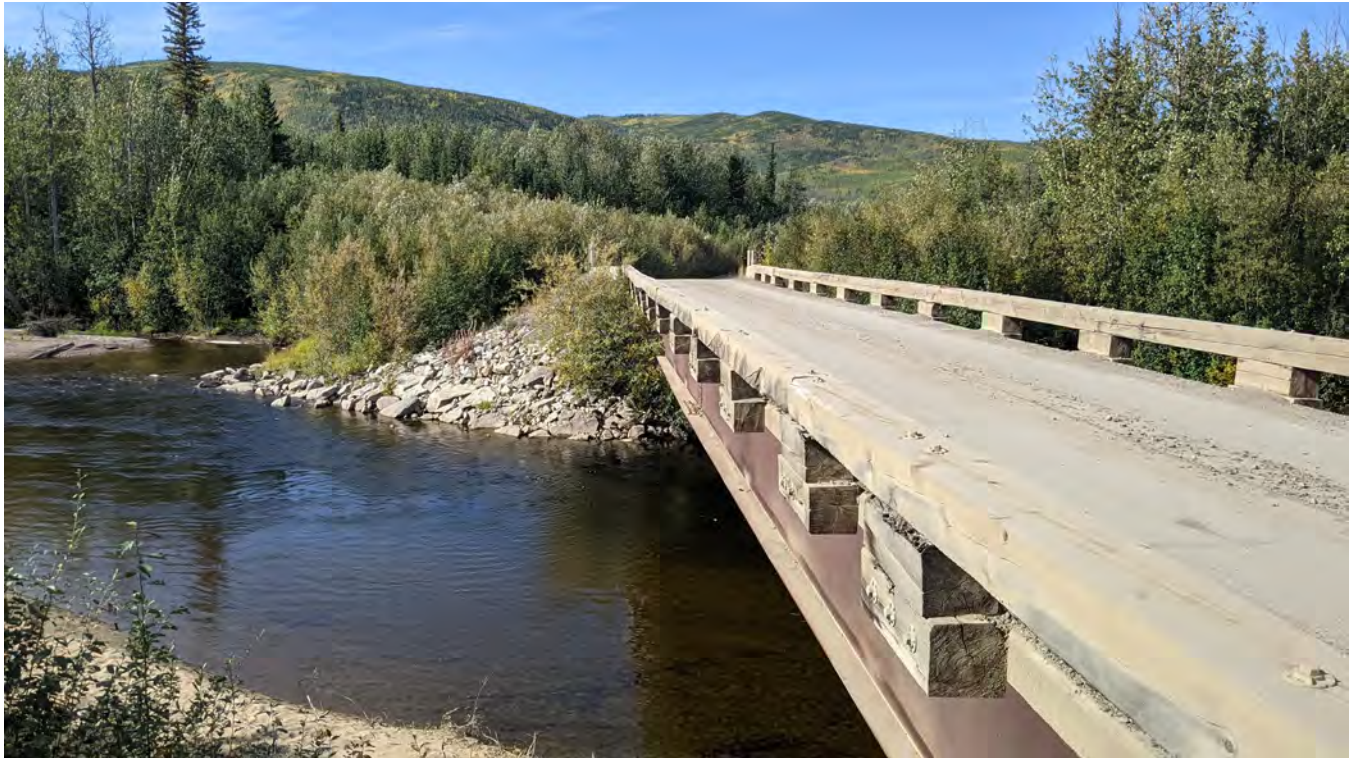
Photo 13-1: Western bridge abutment.

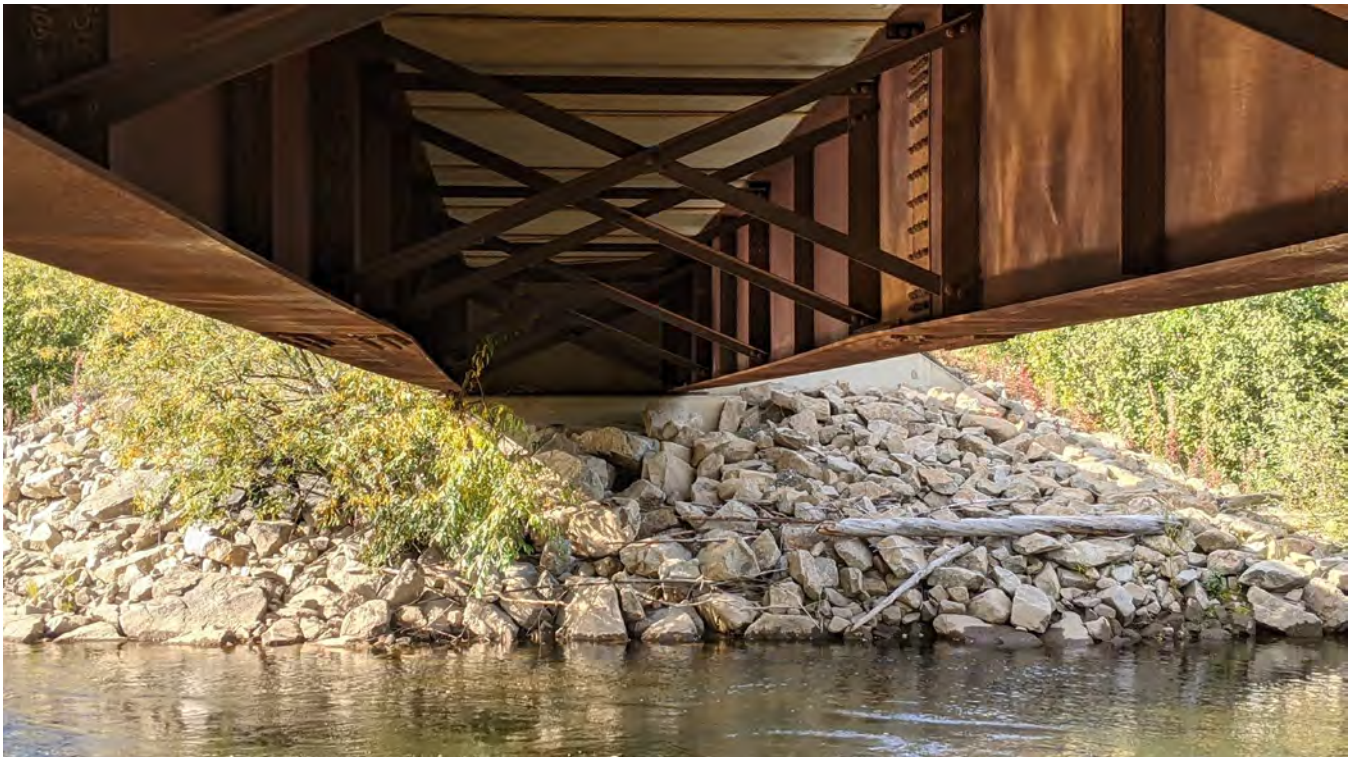
Photo 13-2: Western abutment. A Tree is growing on the upstream side of the western abutment.

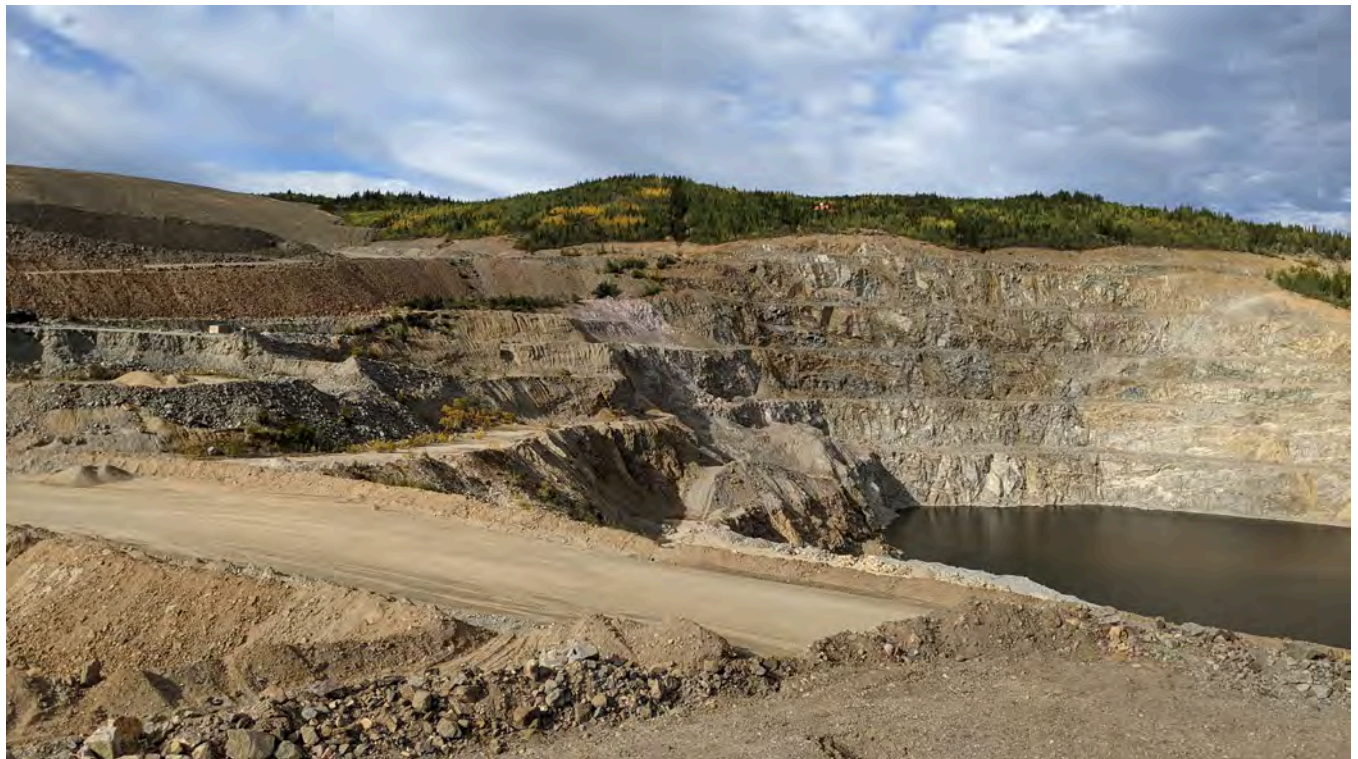
Photo 14-4: West wall of the Main Pit.

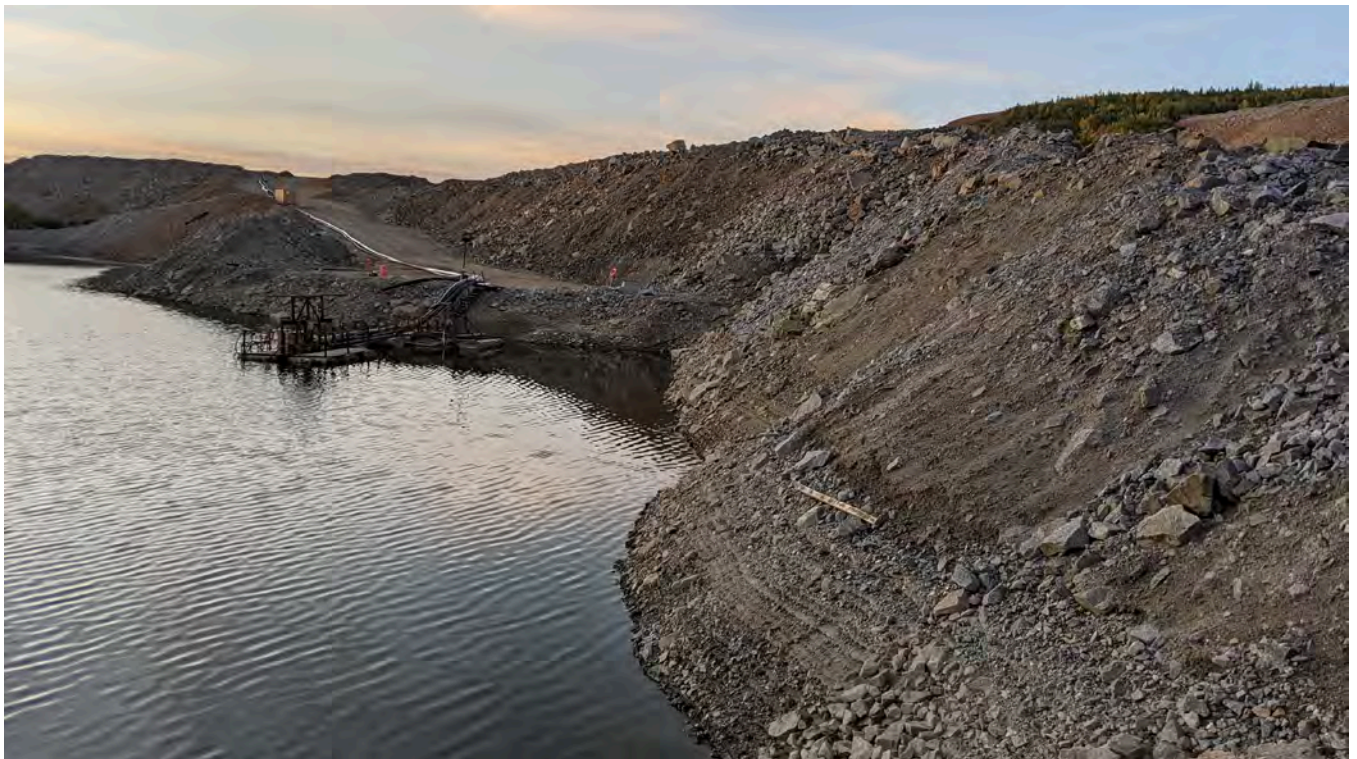
Photo 14-6: Main Pit Reclaim Barge and In-Pit Dumps.

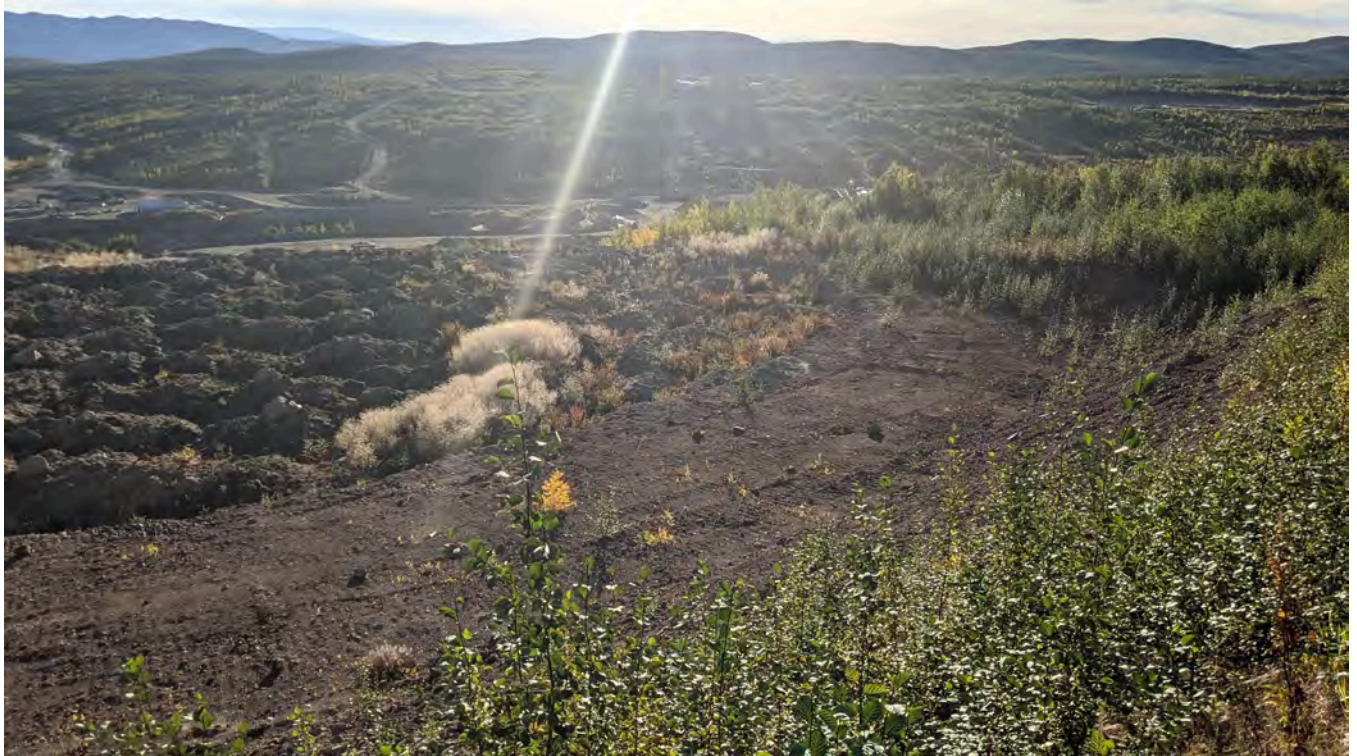
Photo 16-1: South end of the Area 118 Pit

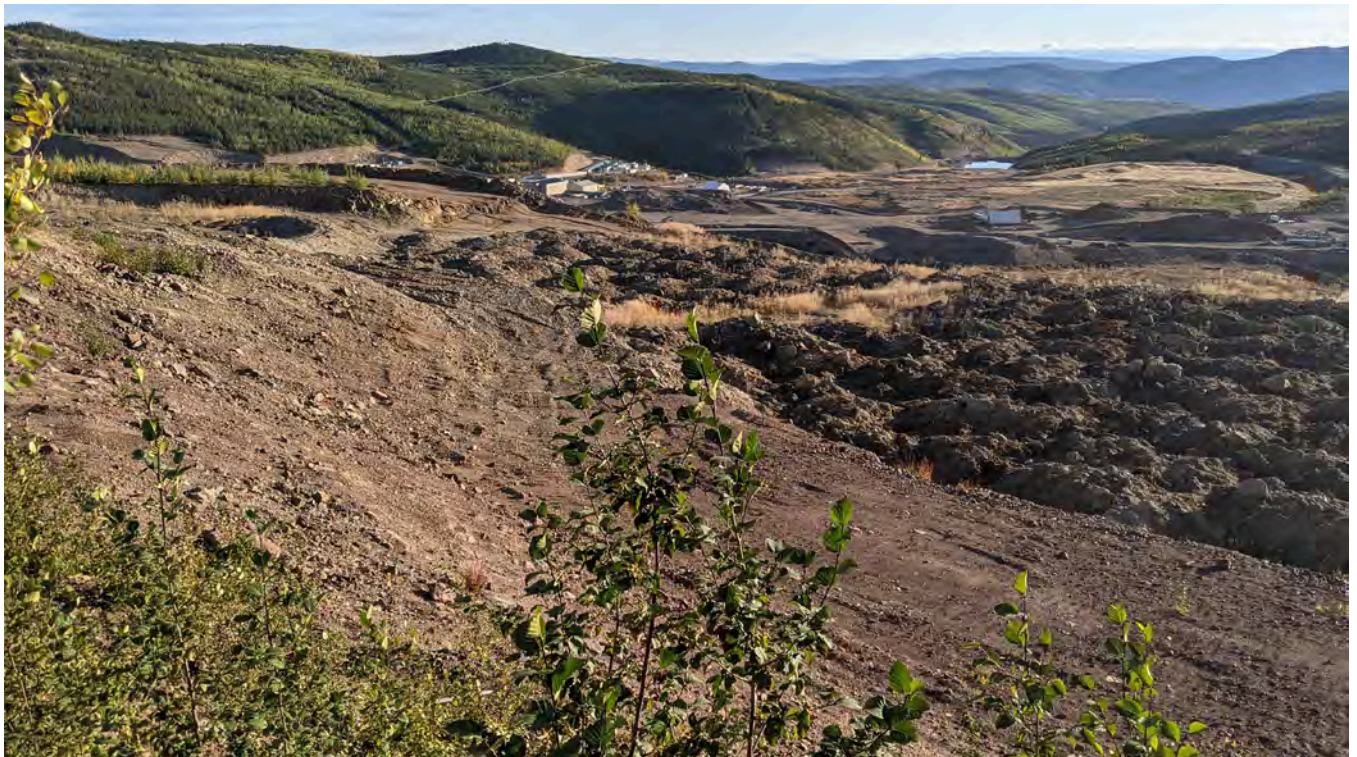
Photo 16-2: North end of the Area 118 Pit

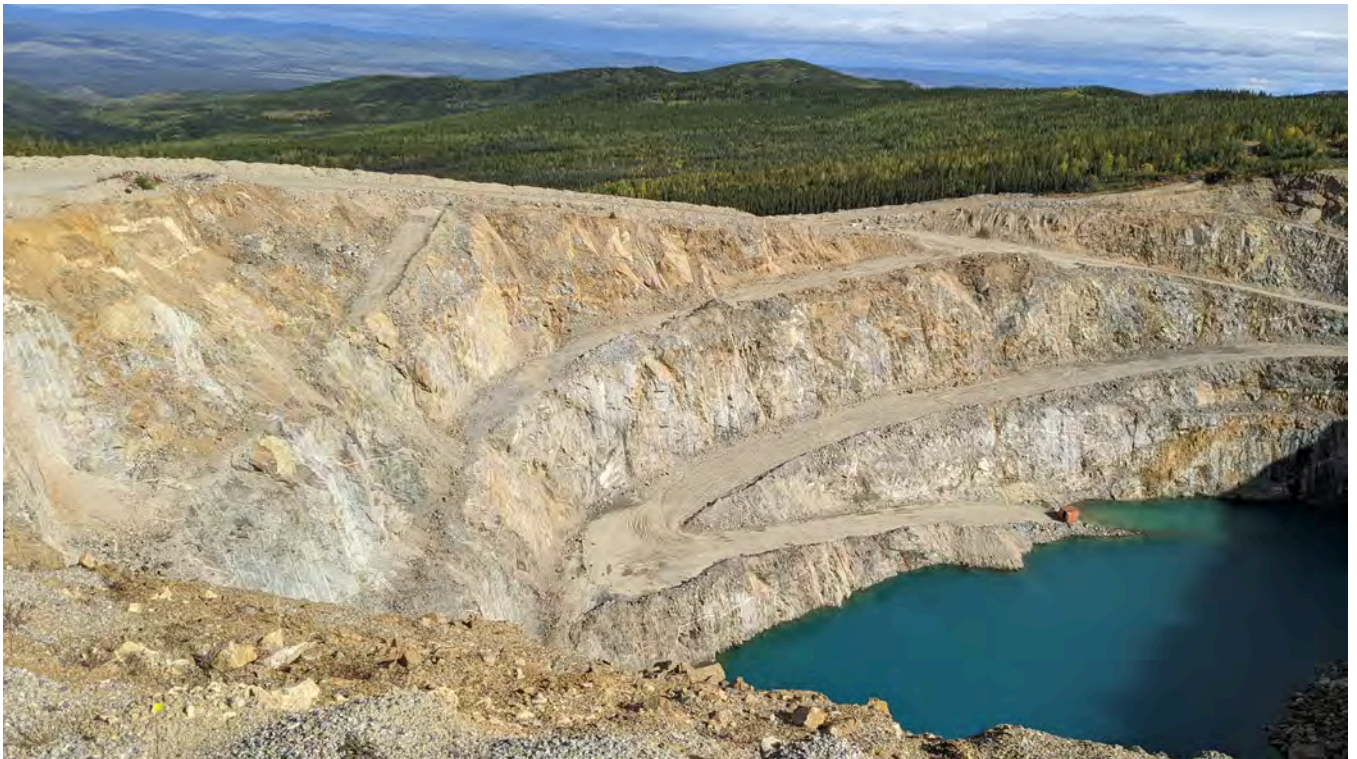
Photo 17-2: North pit wall.
