APPENDIX Q
Dry Stack Tailings Storage Facility
Update Report

September 7, 2010

**Subject: Dry Stack Tailings Storage Facility
Foundation Movement Monitoring Update, Minto Mine, YT**

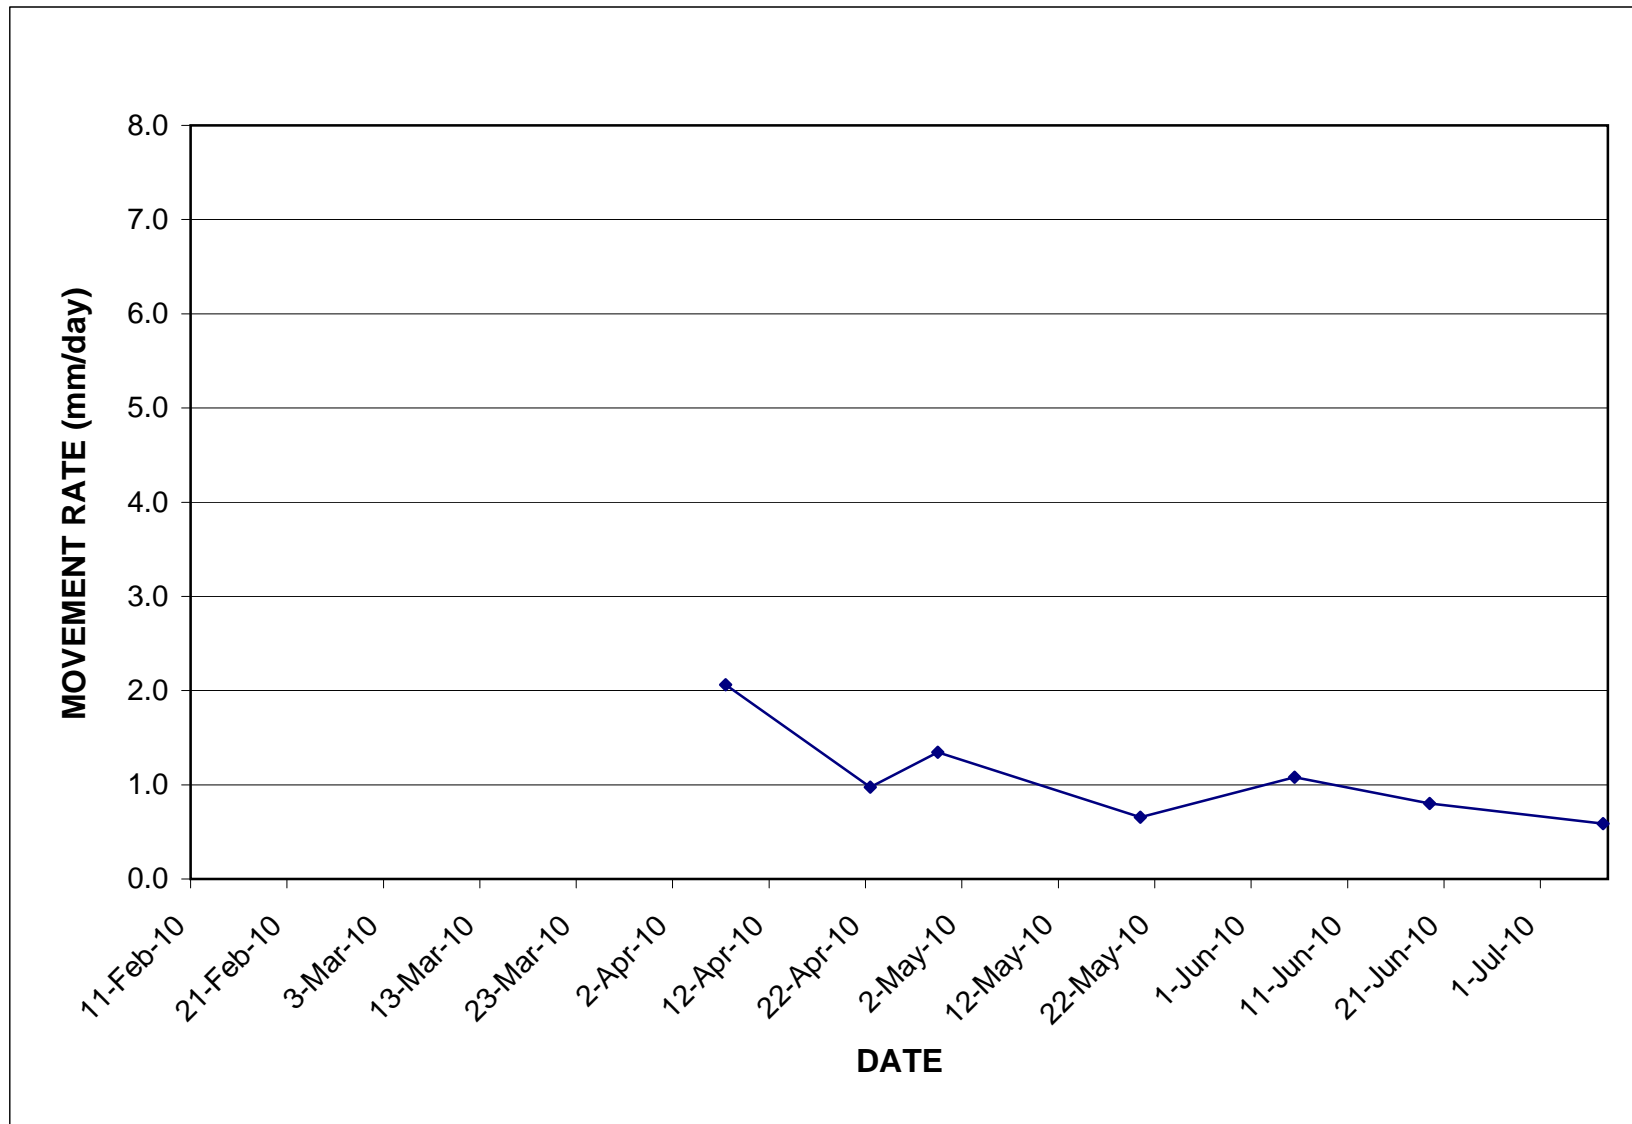
Figure I05

Dry Stack Tailings Storage Facility
DSI-5 Inclinerometer Movement Rate

- Monitor DSI-5 on a weekly basis.
- Continue to observe on a systematic basis both the valley bottom and DSTSF for signs of distress.
- Install additional survey hubs and inclinometers to delineate the extent of movement. This could be a phased approach depending on the results observed.
