## 2014 Geotechnical Inspection Tailings Management Facility Sä Dena Hes, Yukon Territory

SRK Consulting (Canada) Inc.  
1CT008.046  
December 2014

Project No: 1CT008.046

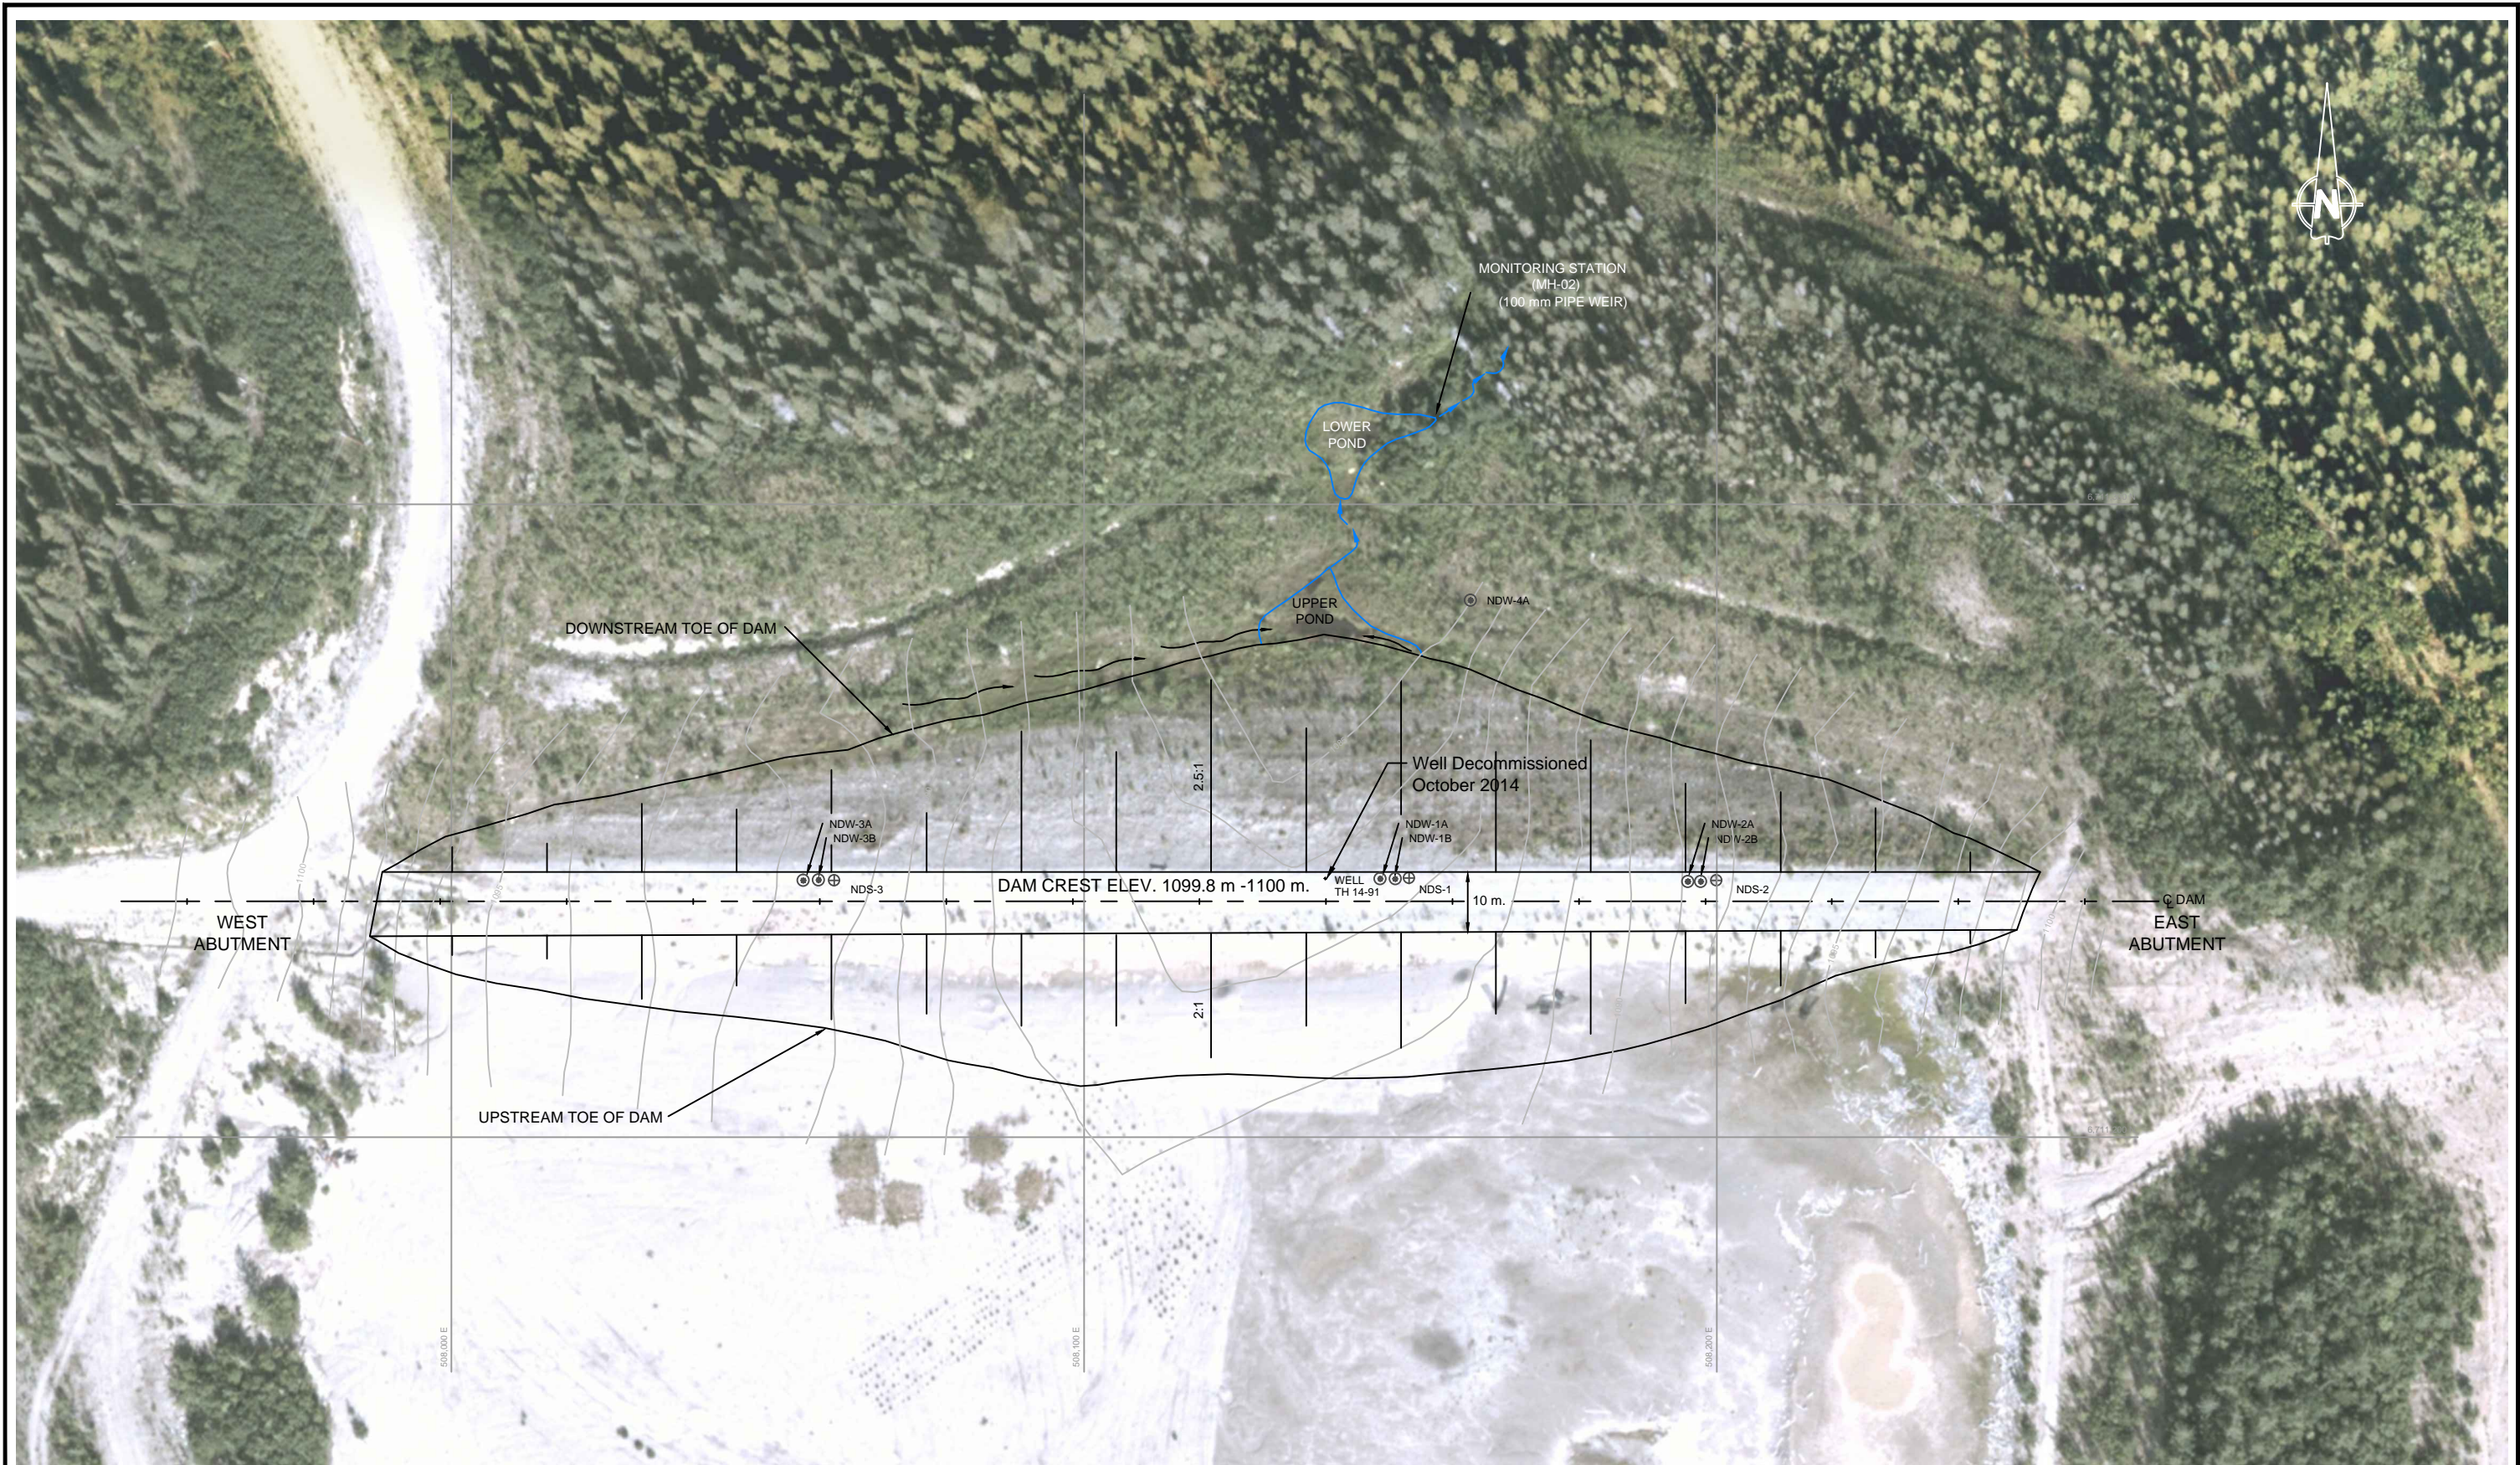
A site plan of the North Dam is presented on Figure 2 and a view of the TMF taken from the Jewelbox waste rock dump is shown in Photo 1.

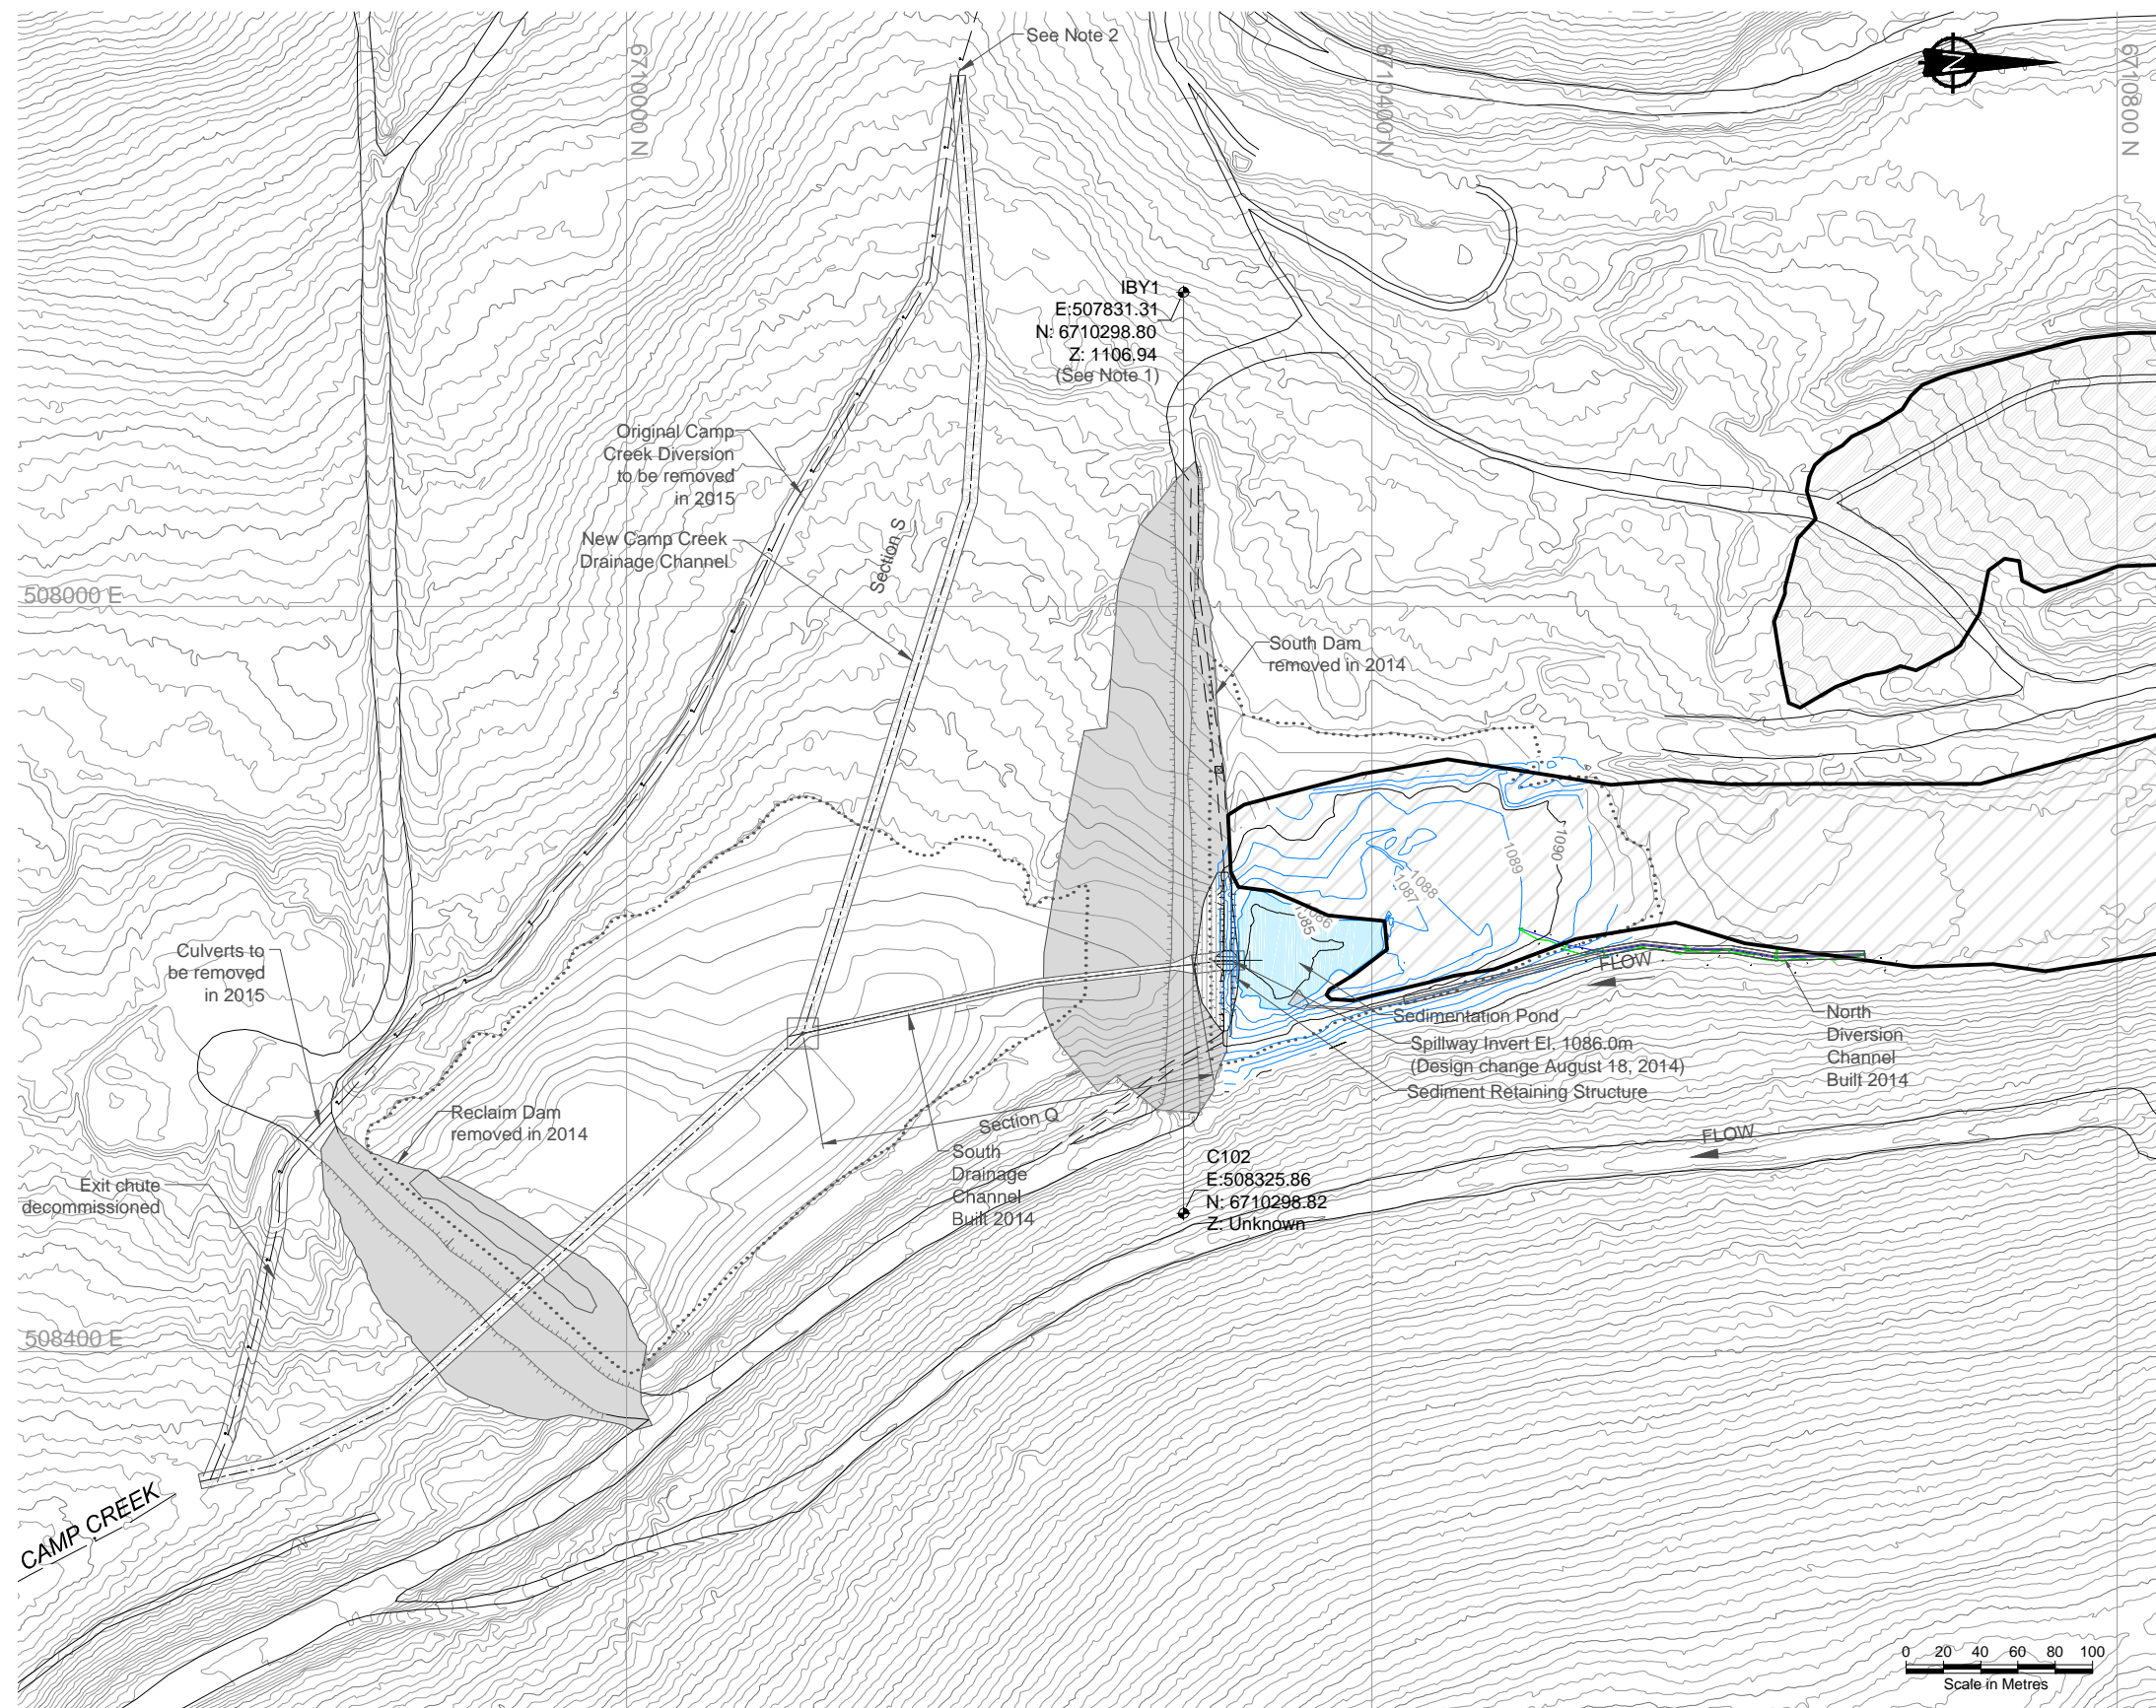
2014 Geotechnical Inspection	
	Sa Dena Hes		Tailings Management Facility	
SRK JOB NO.: 1CT008.046 Task: 1200 FILE NAME: 1CT008046-1200_Fig4.dwg		DATE: December 2014	APPROVED: P.M.H.	FIGURE: <b>4</b>

Photo 12 shows a west view of the newly constructed channel that was built to restore Camp Creek to its original alignment. A layout of this channel is shown on Figure 4.

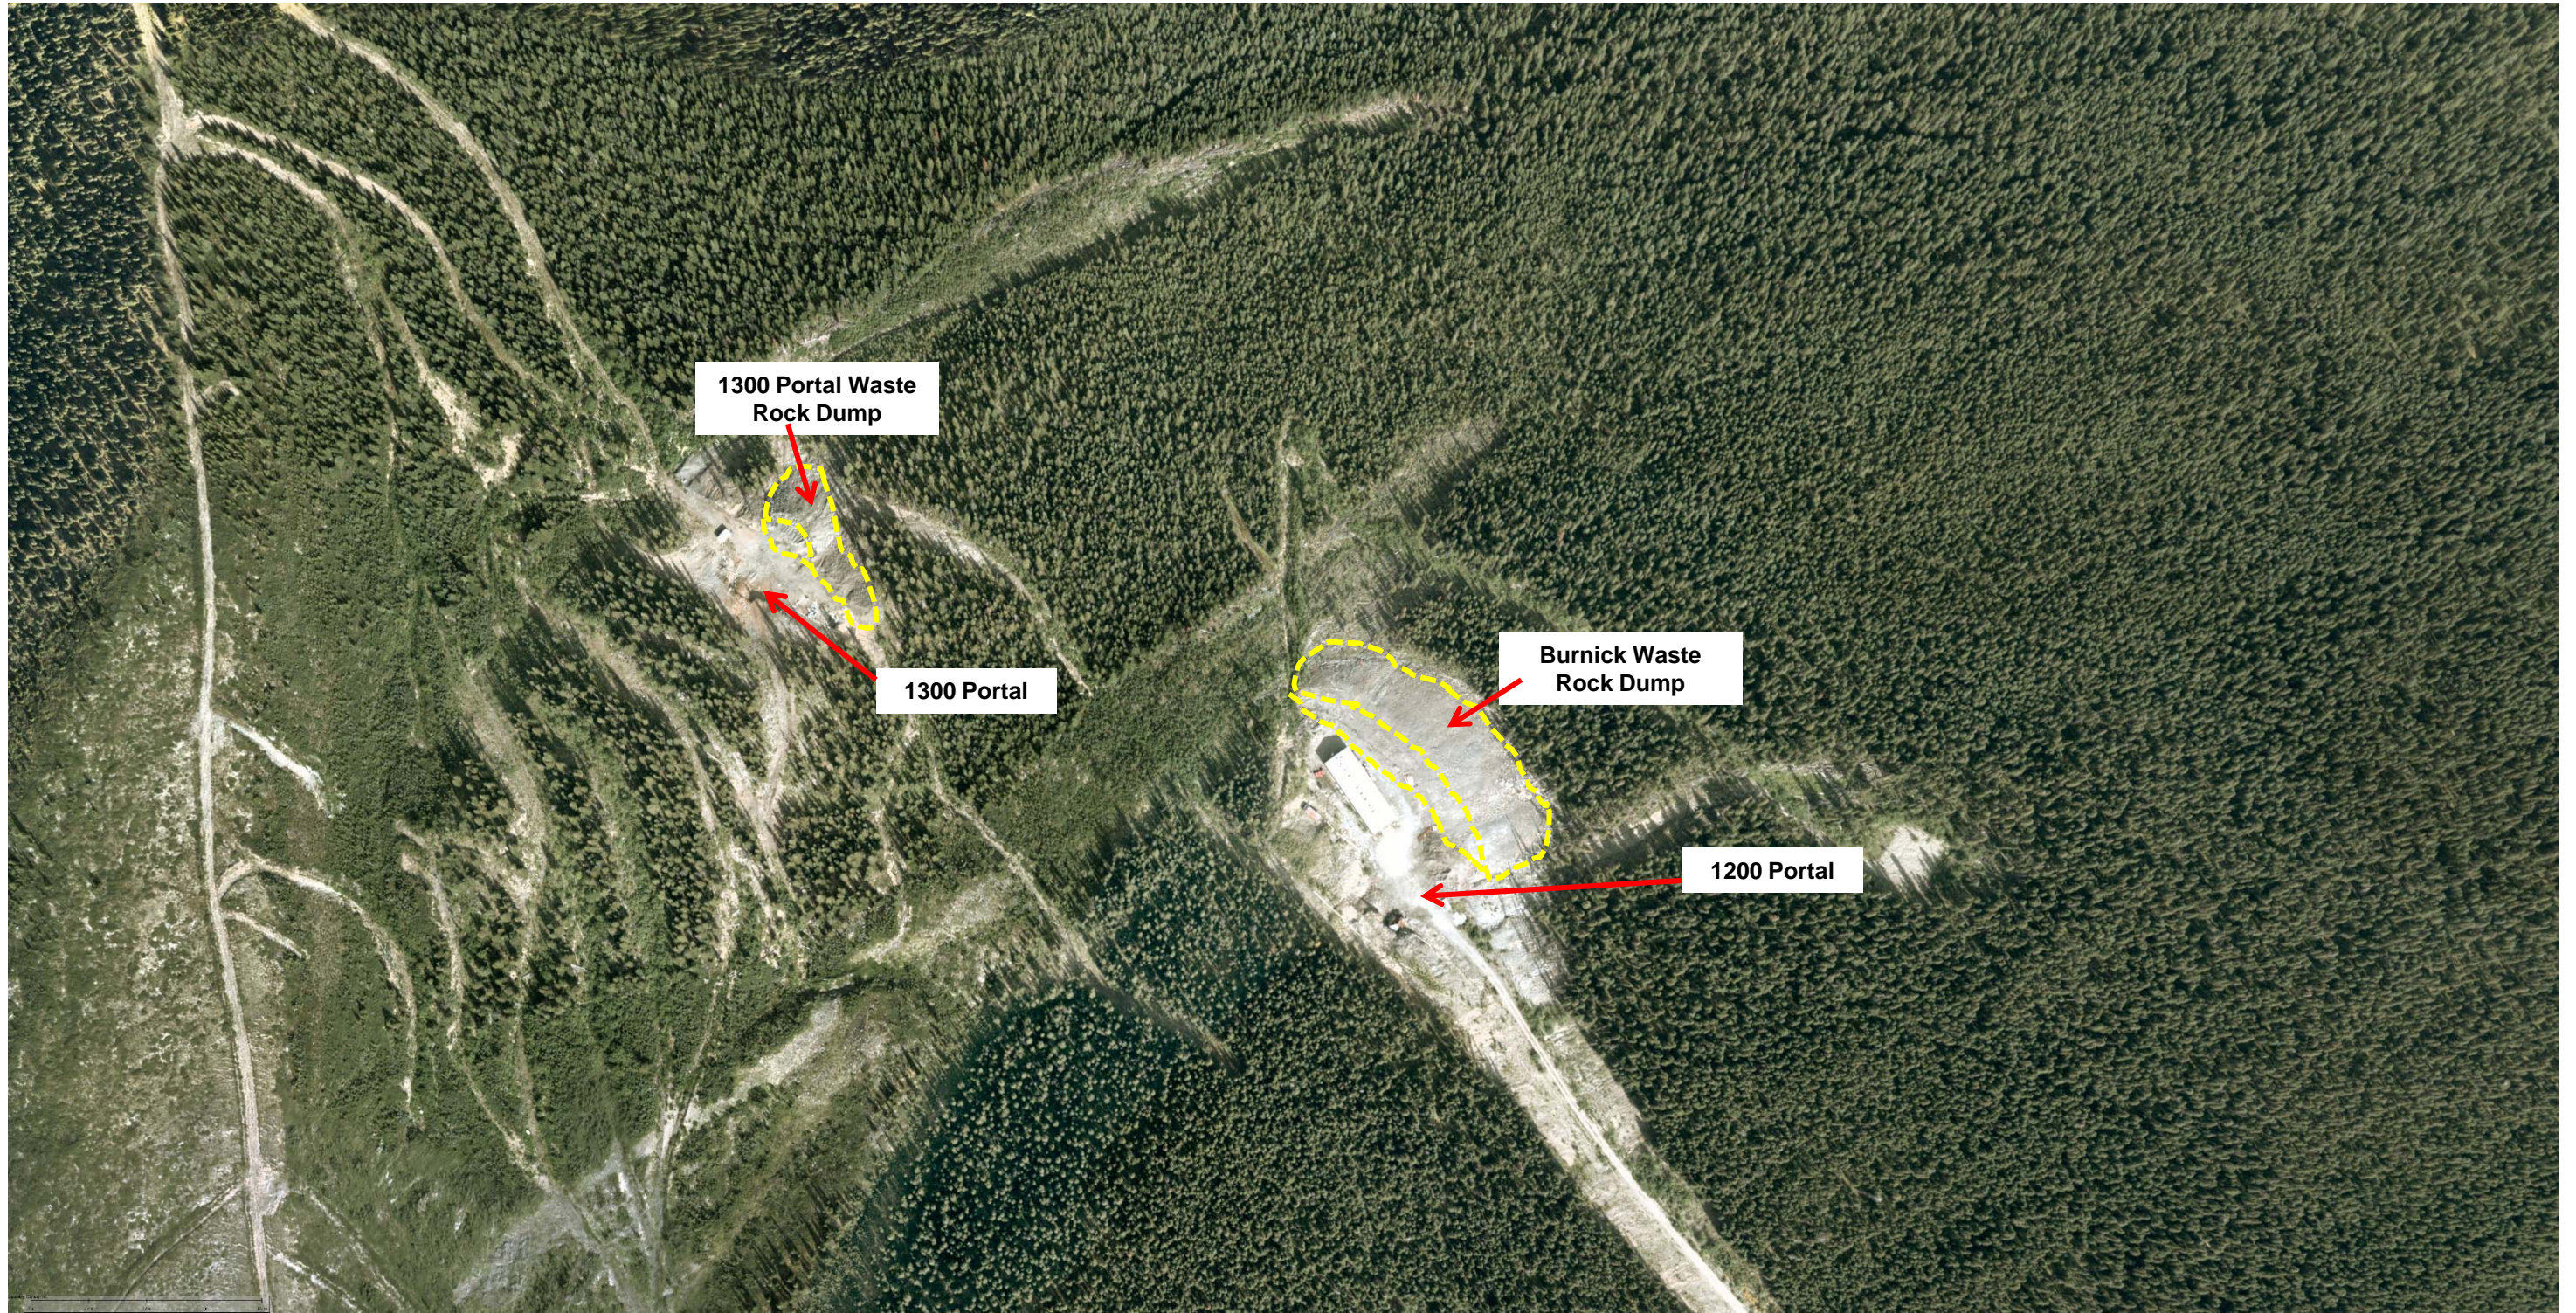
2014 Geotechnical Inspection		
		Burnick Zone Plan View		
Job No: 1CT008.046.1200 Filename: Figure 5.pptx	Sä Dena Hes	Date: December 2014	Approved: PMH	Figure: <b>5</b>

SRK inspected the Burnick waste dump at the 1200 portal (Photo 12). The location of this dump is shown in Figure 5. During the recontouring work this year, the dump face was flattened to ensure greater long term stability. No major toe movement or bulging was noted. SRK did not inspect the dump at the 1300 portal (see Figure 5) because of restricted access.
