2015 Geotechnical Inspection Tailings Management Facility Sä Dena Hes, Yukon Territory

SRK Consulting (Canada) Inc.
1CT008.053
November 2015

Project No: 1CT008.053

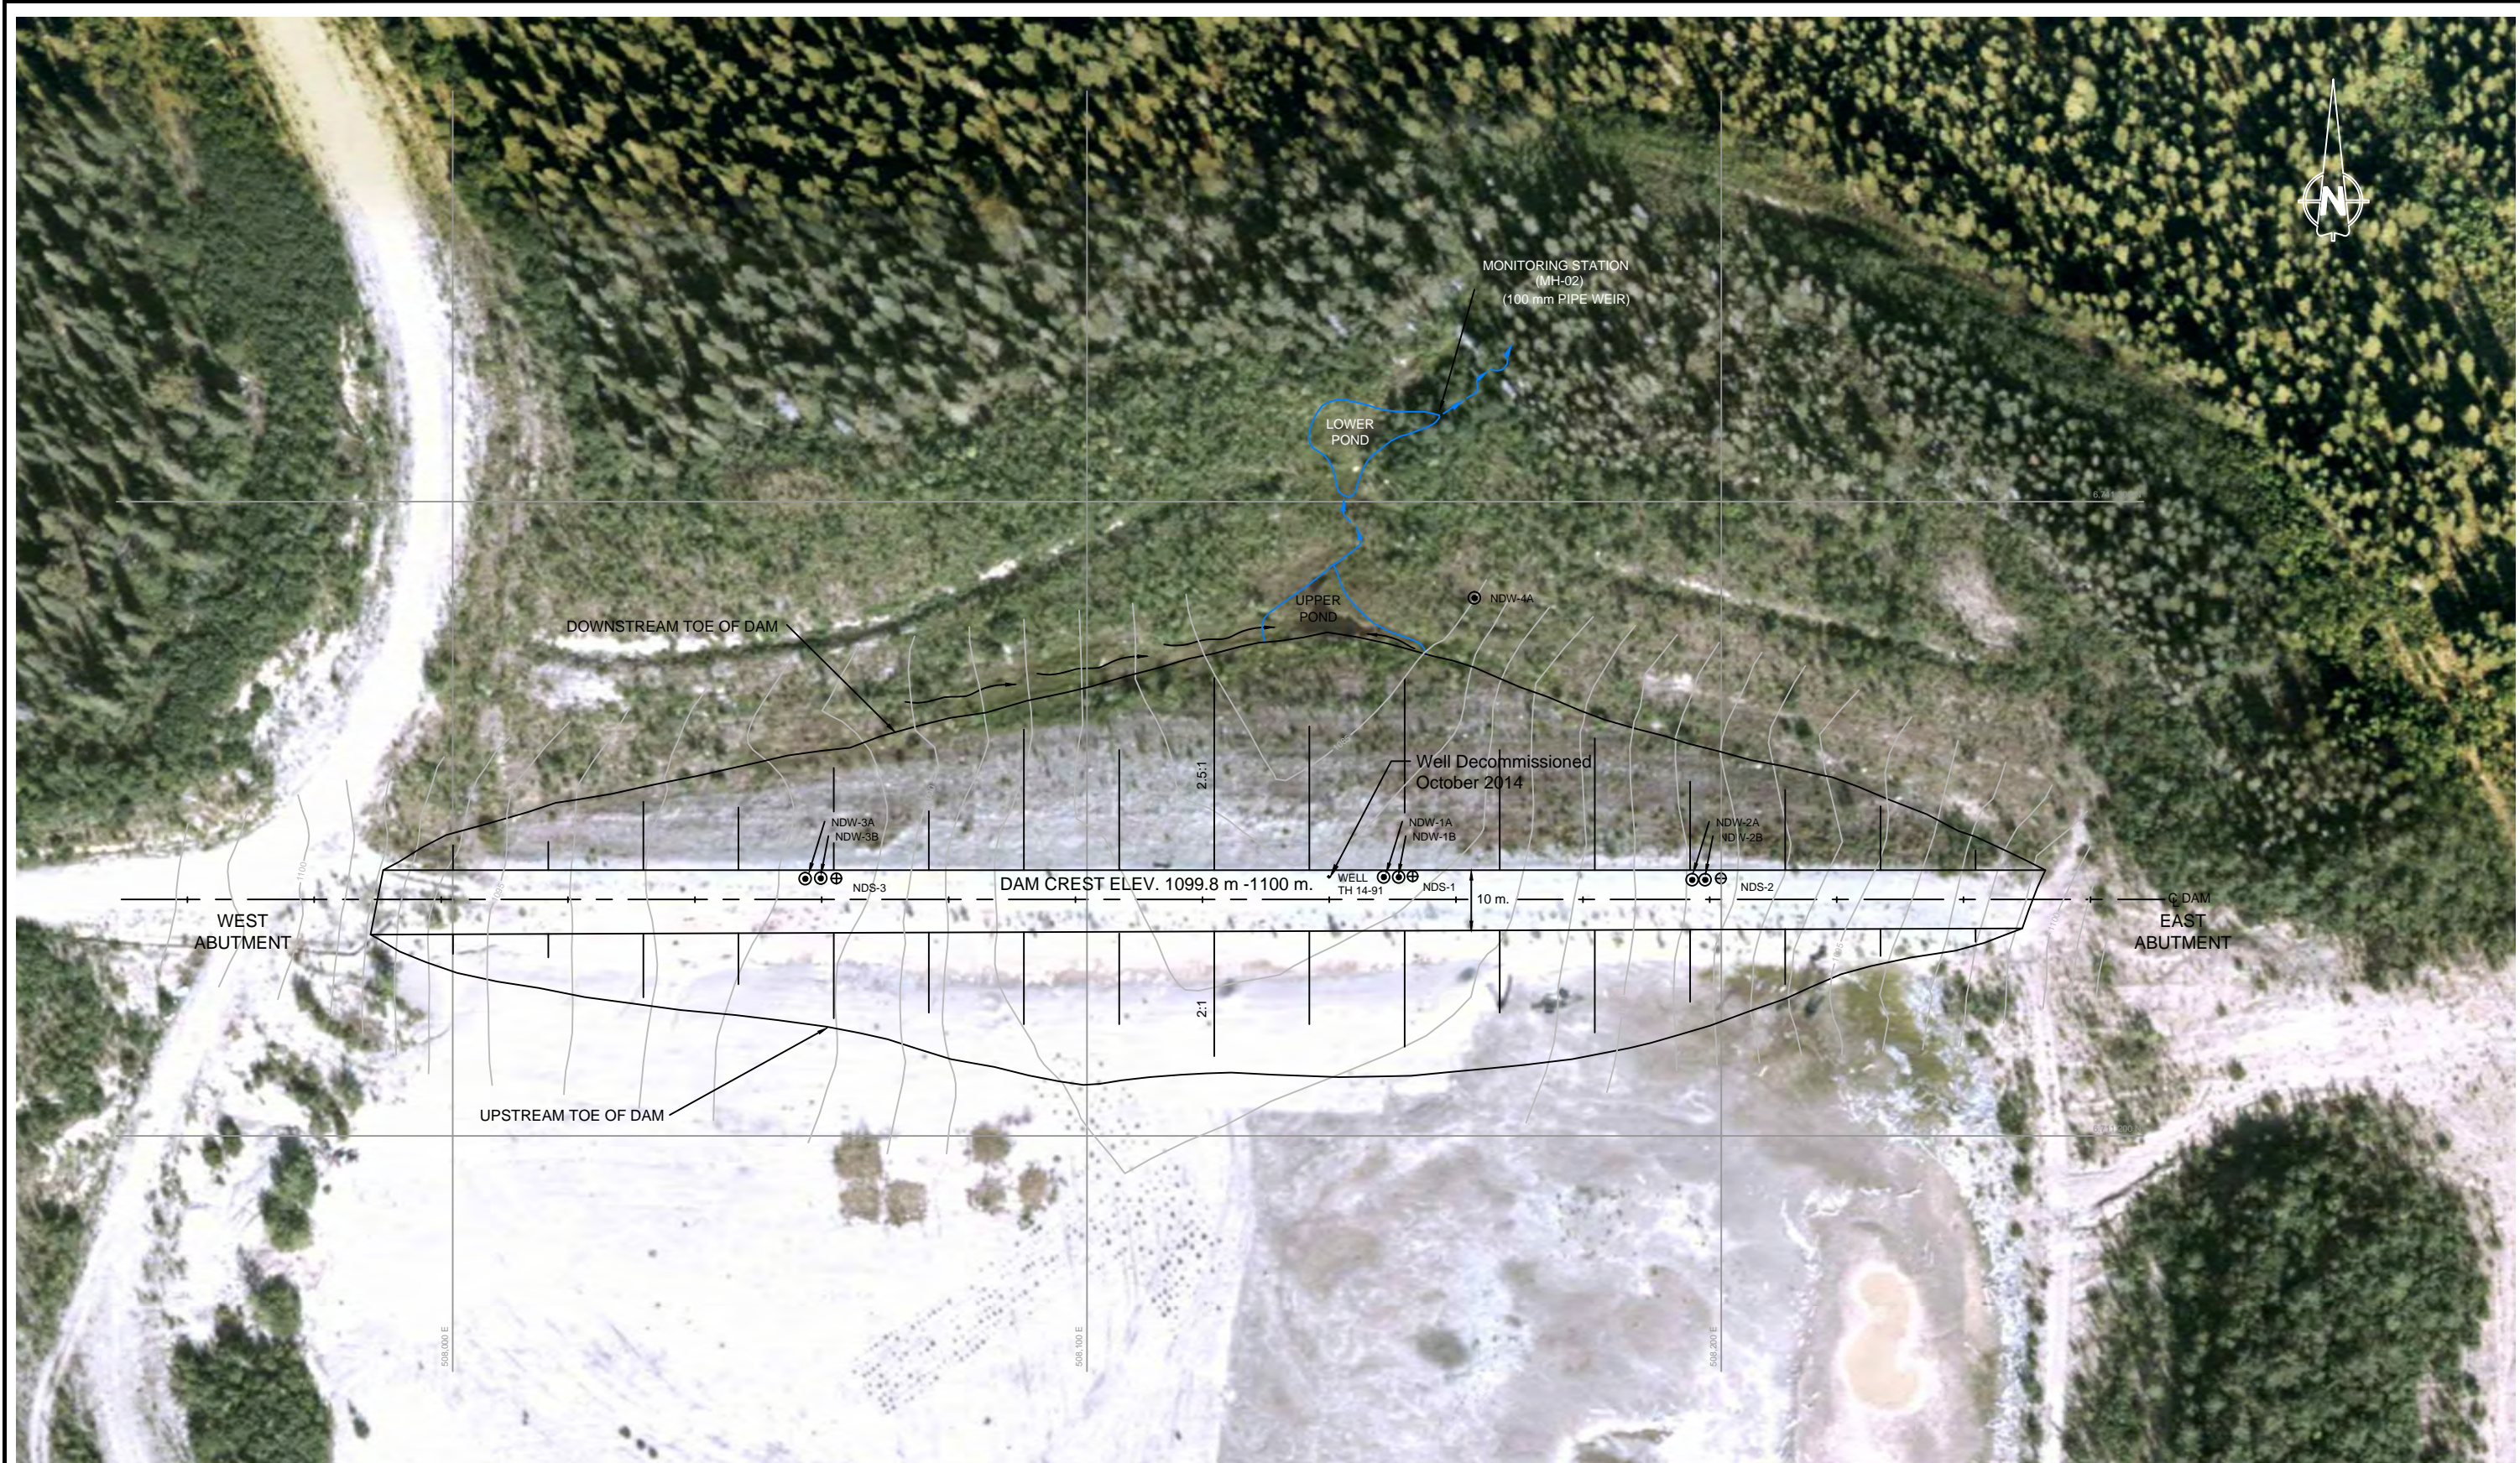
DATE: November 2015	APPROVED: P.M.H.	FIGURE: 3
------------------------	---------------------	--------------

A site plan of the North Dam is presented on Figure 3 and a view of the TMA looking south is shown in Photo 2.

The three sets of piezometers and protective caps (Photo 7) along the crest of the North Dam remain intact. Some of the deformation monitoring pins and the original settlement gauges protected by 40-gallon drums (Photo 9) are still evident on the crest of the dam but currently serve very little purpose. Labels on each of the piezometers were recently upgraded and are weathering the elements well.

- The following items should be noted during any inspections:
 - Any development of erosion on the slopes
 - Any noticeable settlement of the dam crest
 - Any subsidence on the downstream slope

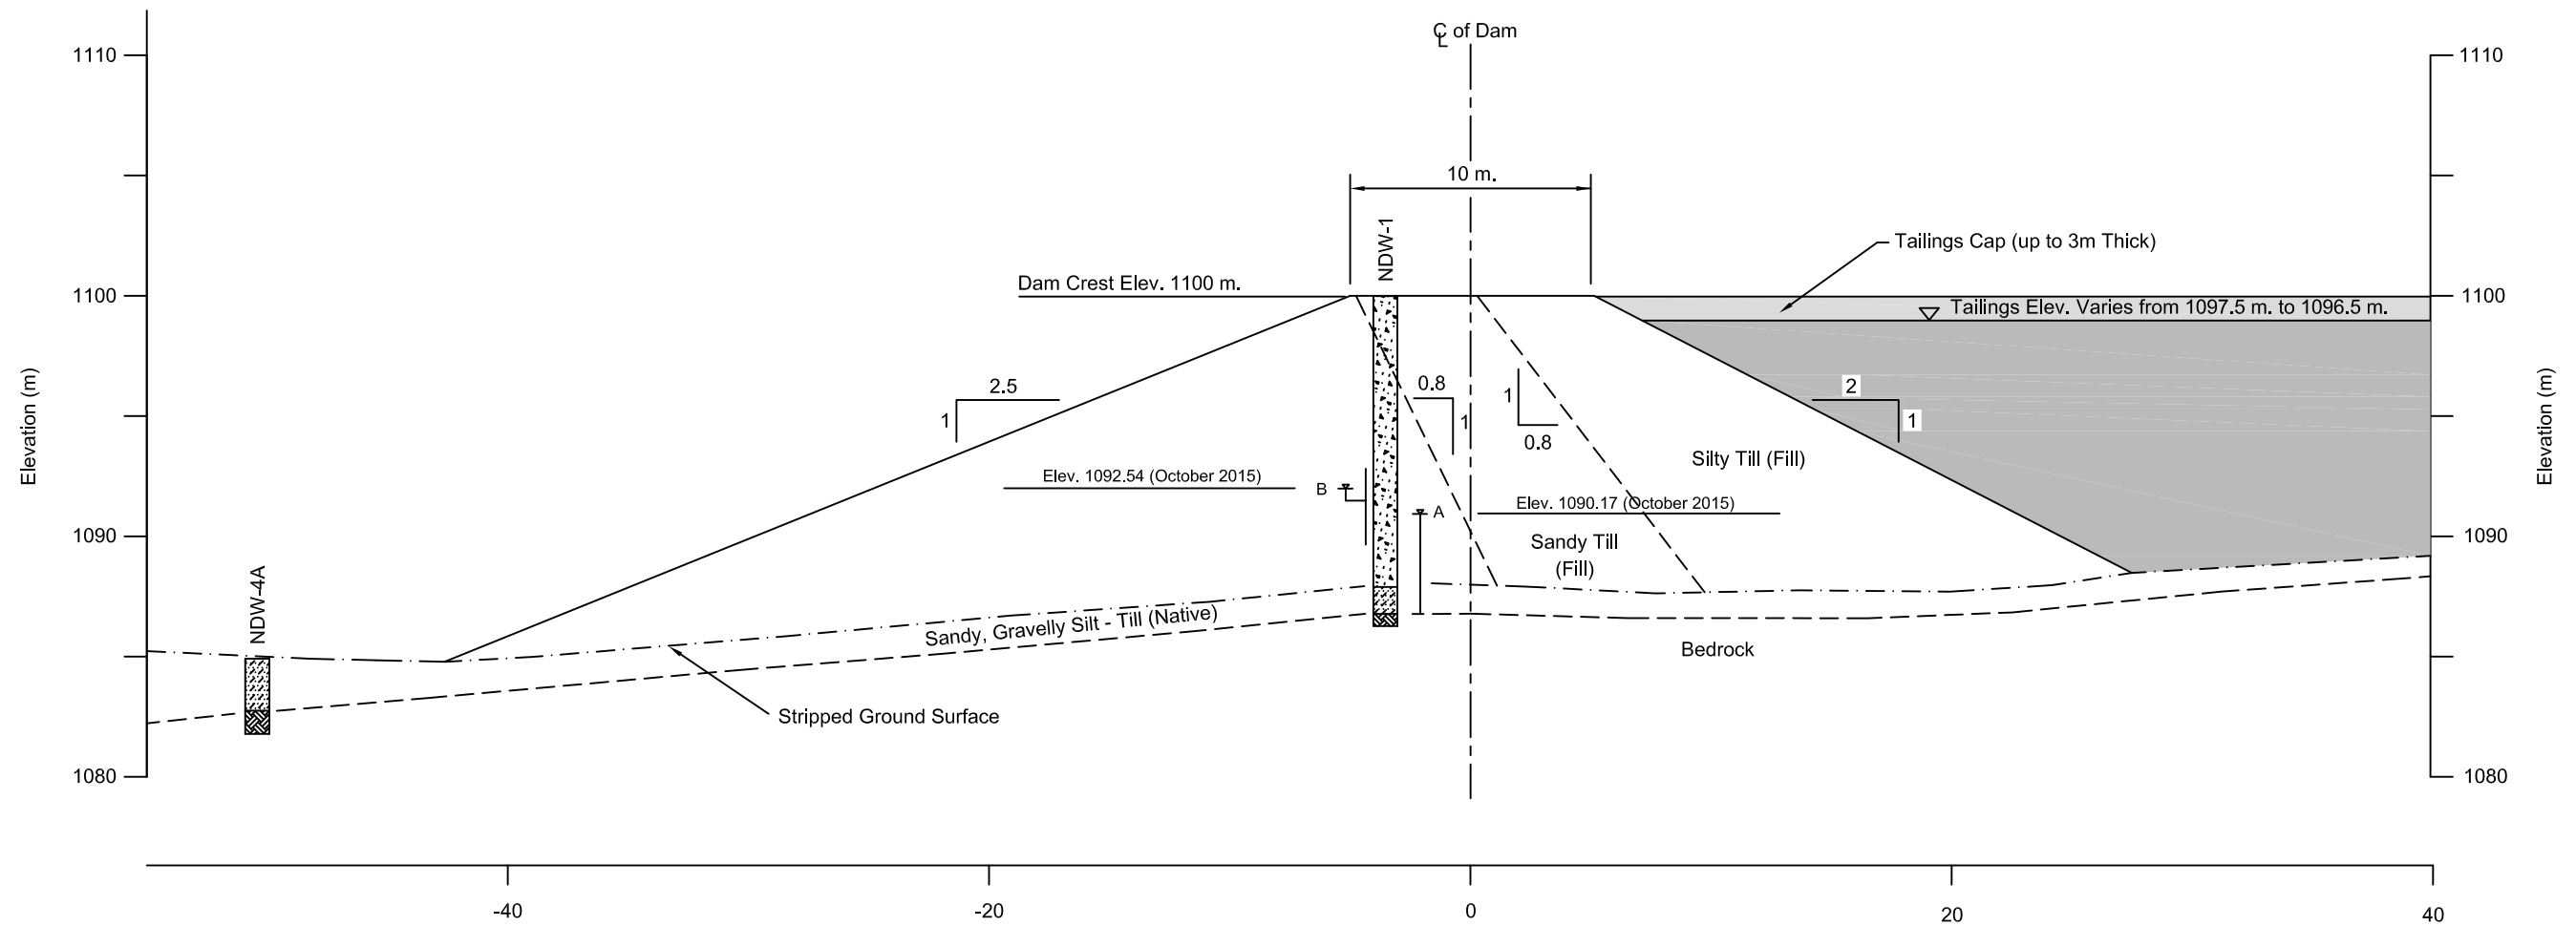
2015 Geotechnical Inspection	
		North Dam Section 0+400	
SRK JOB NO.: 1CT008.053 FILE NAME: 1CT008.053 - North Dam XS.dwg	Sä Dena Hes Project	DATE: November 2015	APPROVED: PMH
			FIGURE: 4

The water levels in the piezometers are recorded monthly and the 2015 data are presented in Appendix B. Figure B1 in Appendix B shows the seasonal water level fluctuation within the dam over the last two years. These levels preceded the completion of the till cover placement and reflect the water that seasonally ponded on the tailings surface during the freshet. Levels recorded in October, 2015 are plotted on the dam section shown on Figure 4. The seasonal fluctuations recorded this year in the piezometers are generally consistent with those in previous years and are within acceptable tolerance limits.

DATE	T.O.P.	READING	ELEV.
NDW-1B	October 2015	1100.57	8.03	1092.54
NDW-1A	October 2015	1100.69	10.52	1090.17

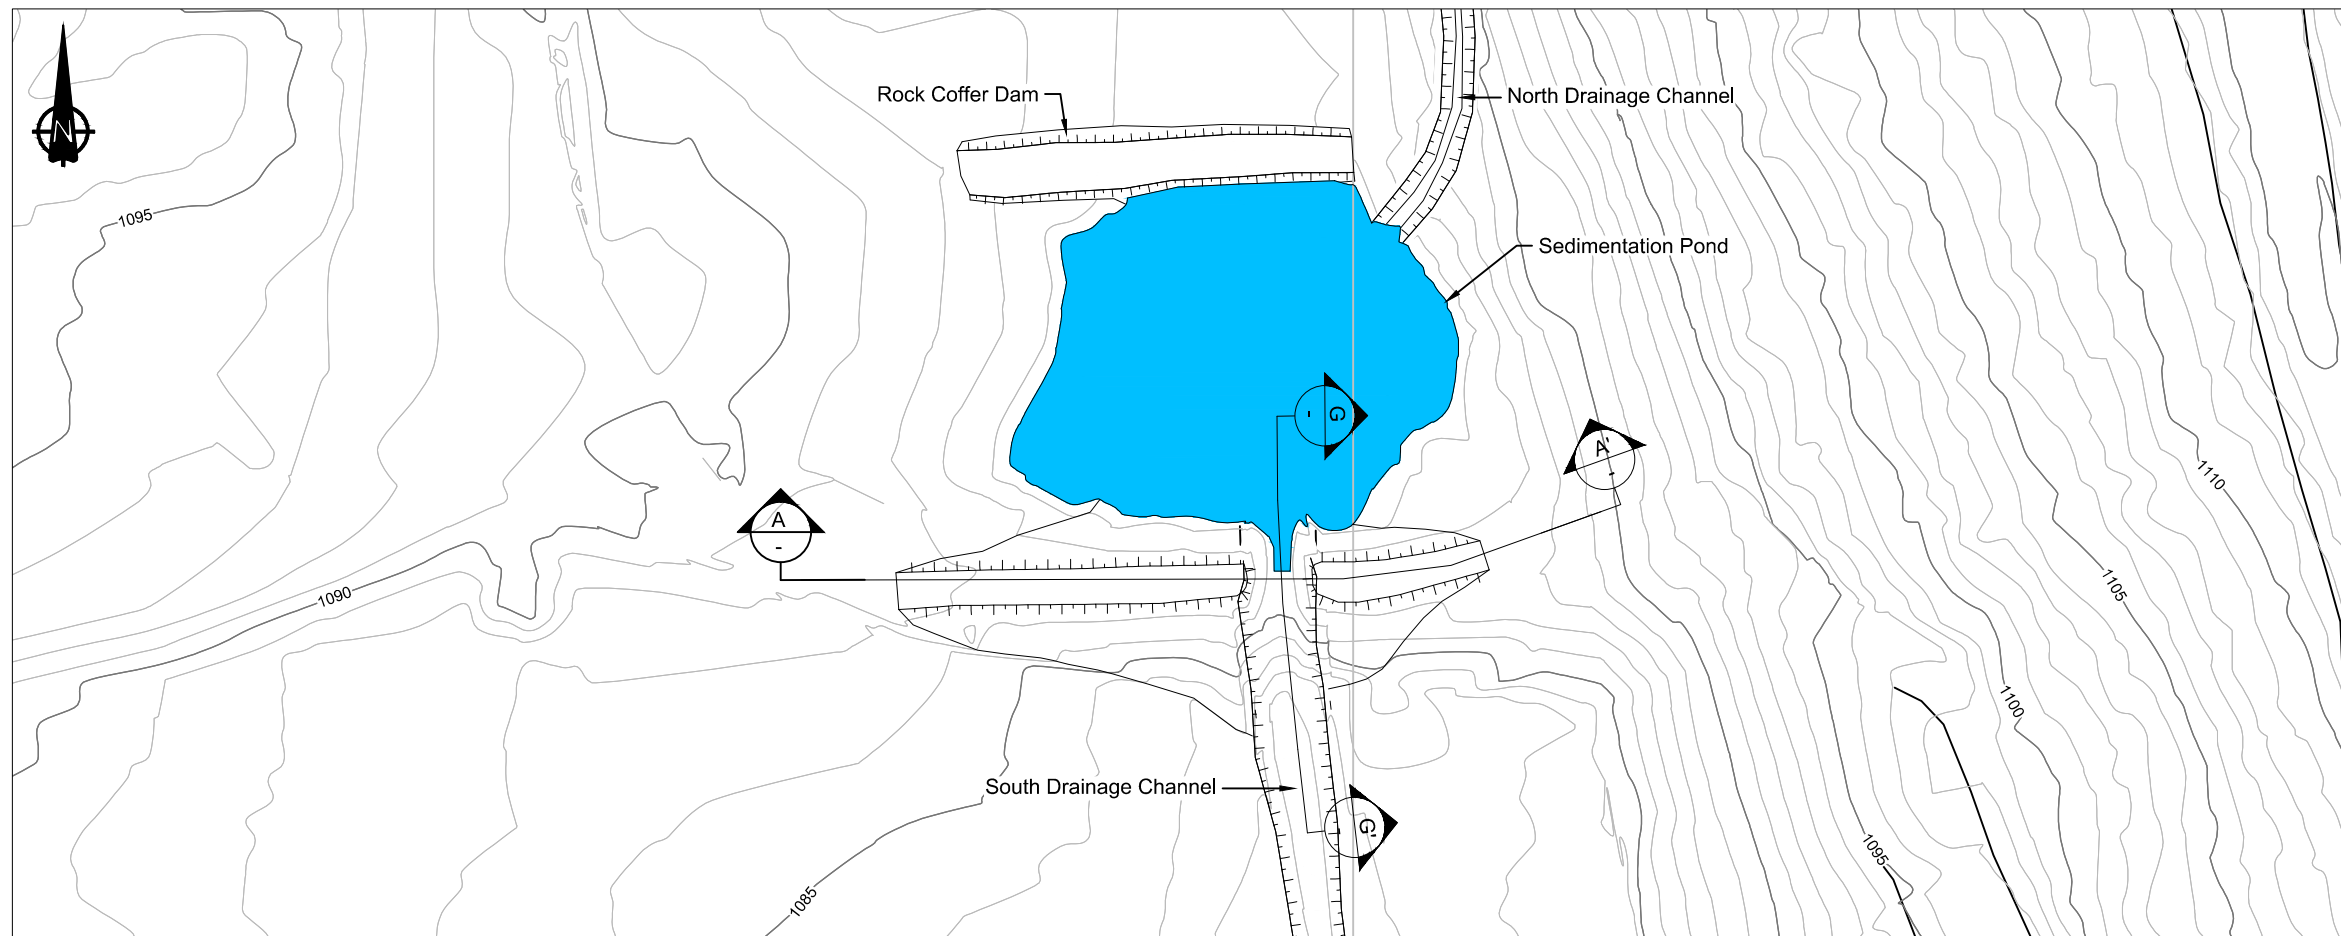
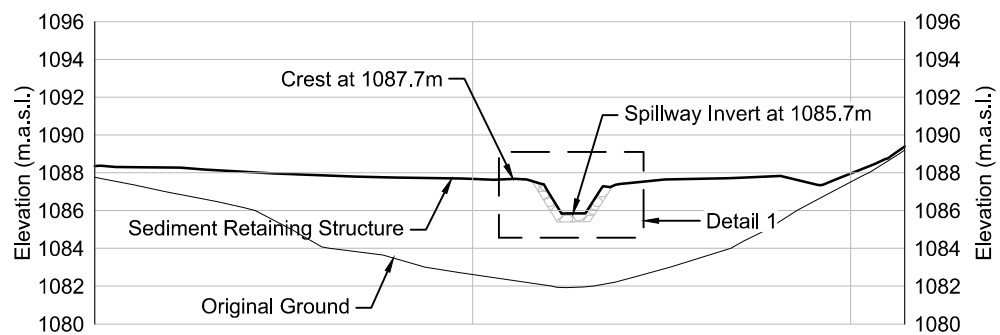
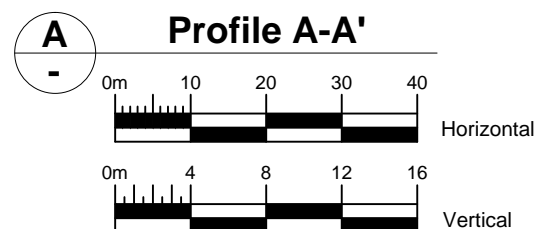
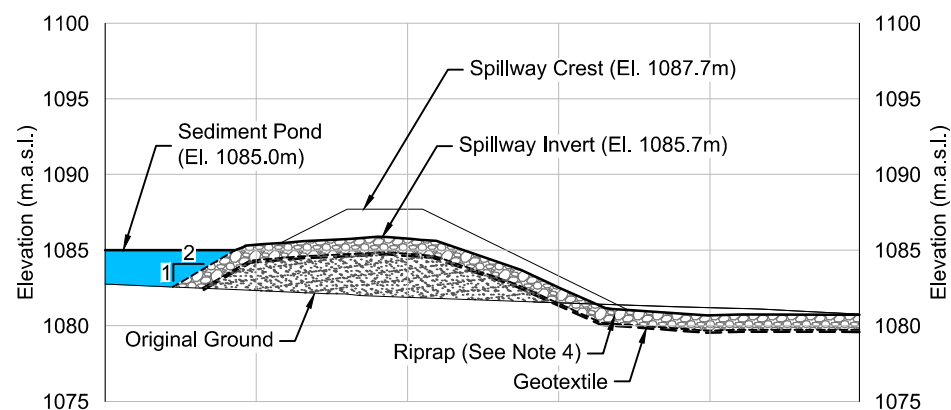
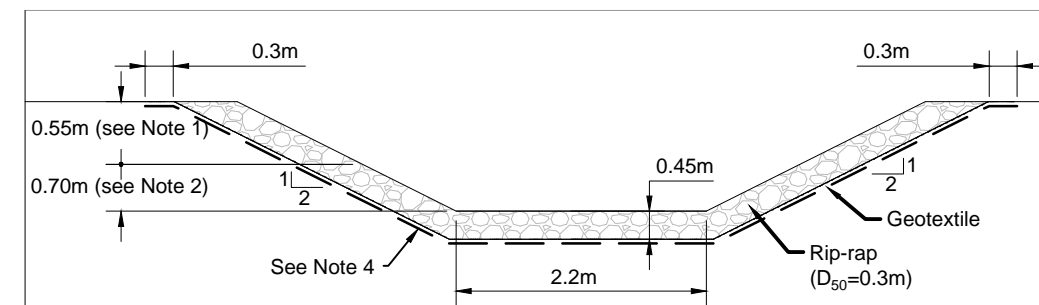
Sediment Retaining Structure
Plan and Profile

The South Dam was decommissioned during the 2014 and 2015 construction season by excavating and placing the fill material as a soil cover over the exposed tailings surface. Figures 5 and 6 provide a site plan and sections of the Sediment Retaining Structure (SRS).

An inspection of the structure in June 2015 noted that a small subsidence had occurred on the lower portion of the exit chute from the spillway. The material displaced was retained by the geotextile filter fabric and some of the riprap had moved. Furthermore seepage from the hillside to the east had created a channel along the downstream toe of the SRS which caused some erosion to occur at the toe of the slope adjacent to the spillway. Remedial action completed after the inspection involved constructing a riprapped channel along the downstream toe on the east side of the SRS and adding more riprap in the exit chute to stabilize the slopes. An erosion control blanket (GeoJute), a lightweight biodegradable net, was placed on the side slopes to add further erosion control (Photo 14).

During the placement of the till cover just above the SRS pond, a rock cofferdam (Figure 6 and Photos 13 and 14) was constructed to retain the movement of tailings that had liquefied as a result of the vibration caused by the earth moving machines. This cofferdam successfully stopped the slow moving tailings. Some of the excess riprap that was used to build the cofferdam was used to repair the spillway exit chute and to riprap the channel built along the downstream toe of the SRS.

An annual inspection of the spillway should be carried out to ensure the structural integrity of the dyke and the riprap erosion protection. The downstream sideslope of the SRS should be inspected for any sloughing, subsidence or bulging. The crest should also be inspected for tension cracks or settlement. The pond should be measured for depth and an assessment of silt buildup. Any sign of seepage along the downstream toe should also be noted. Any new seeps boils or soft areas at the toe of the dyke should be noted.

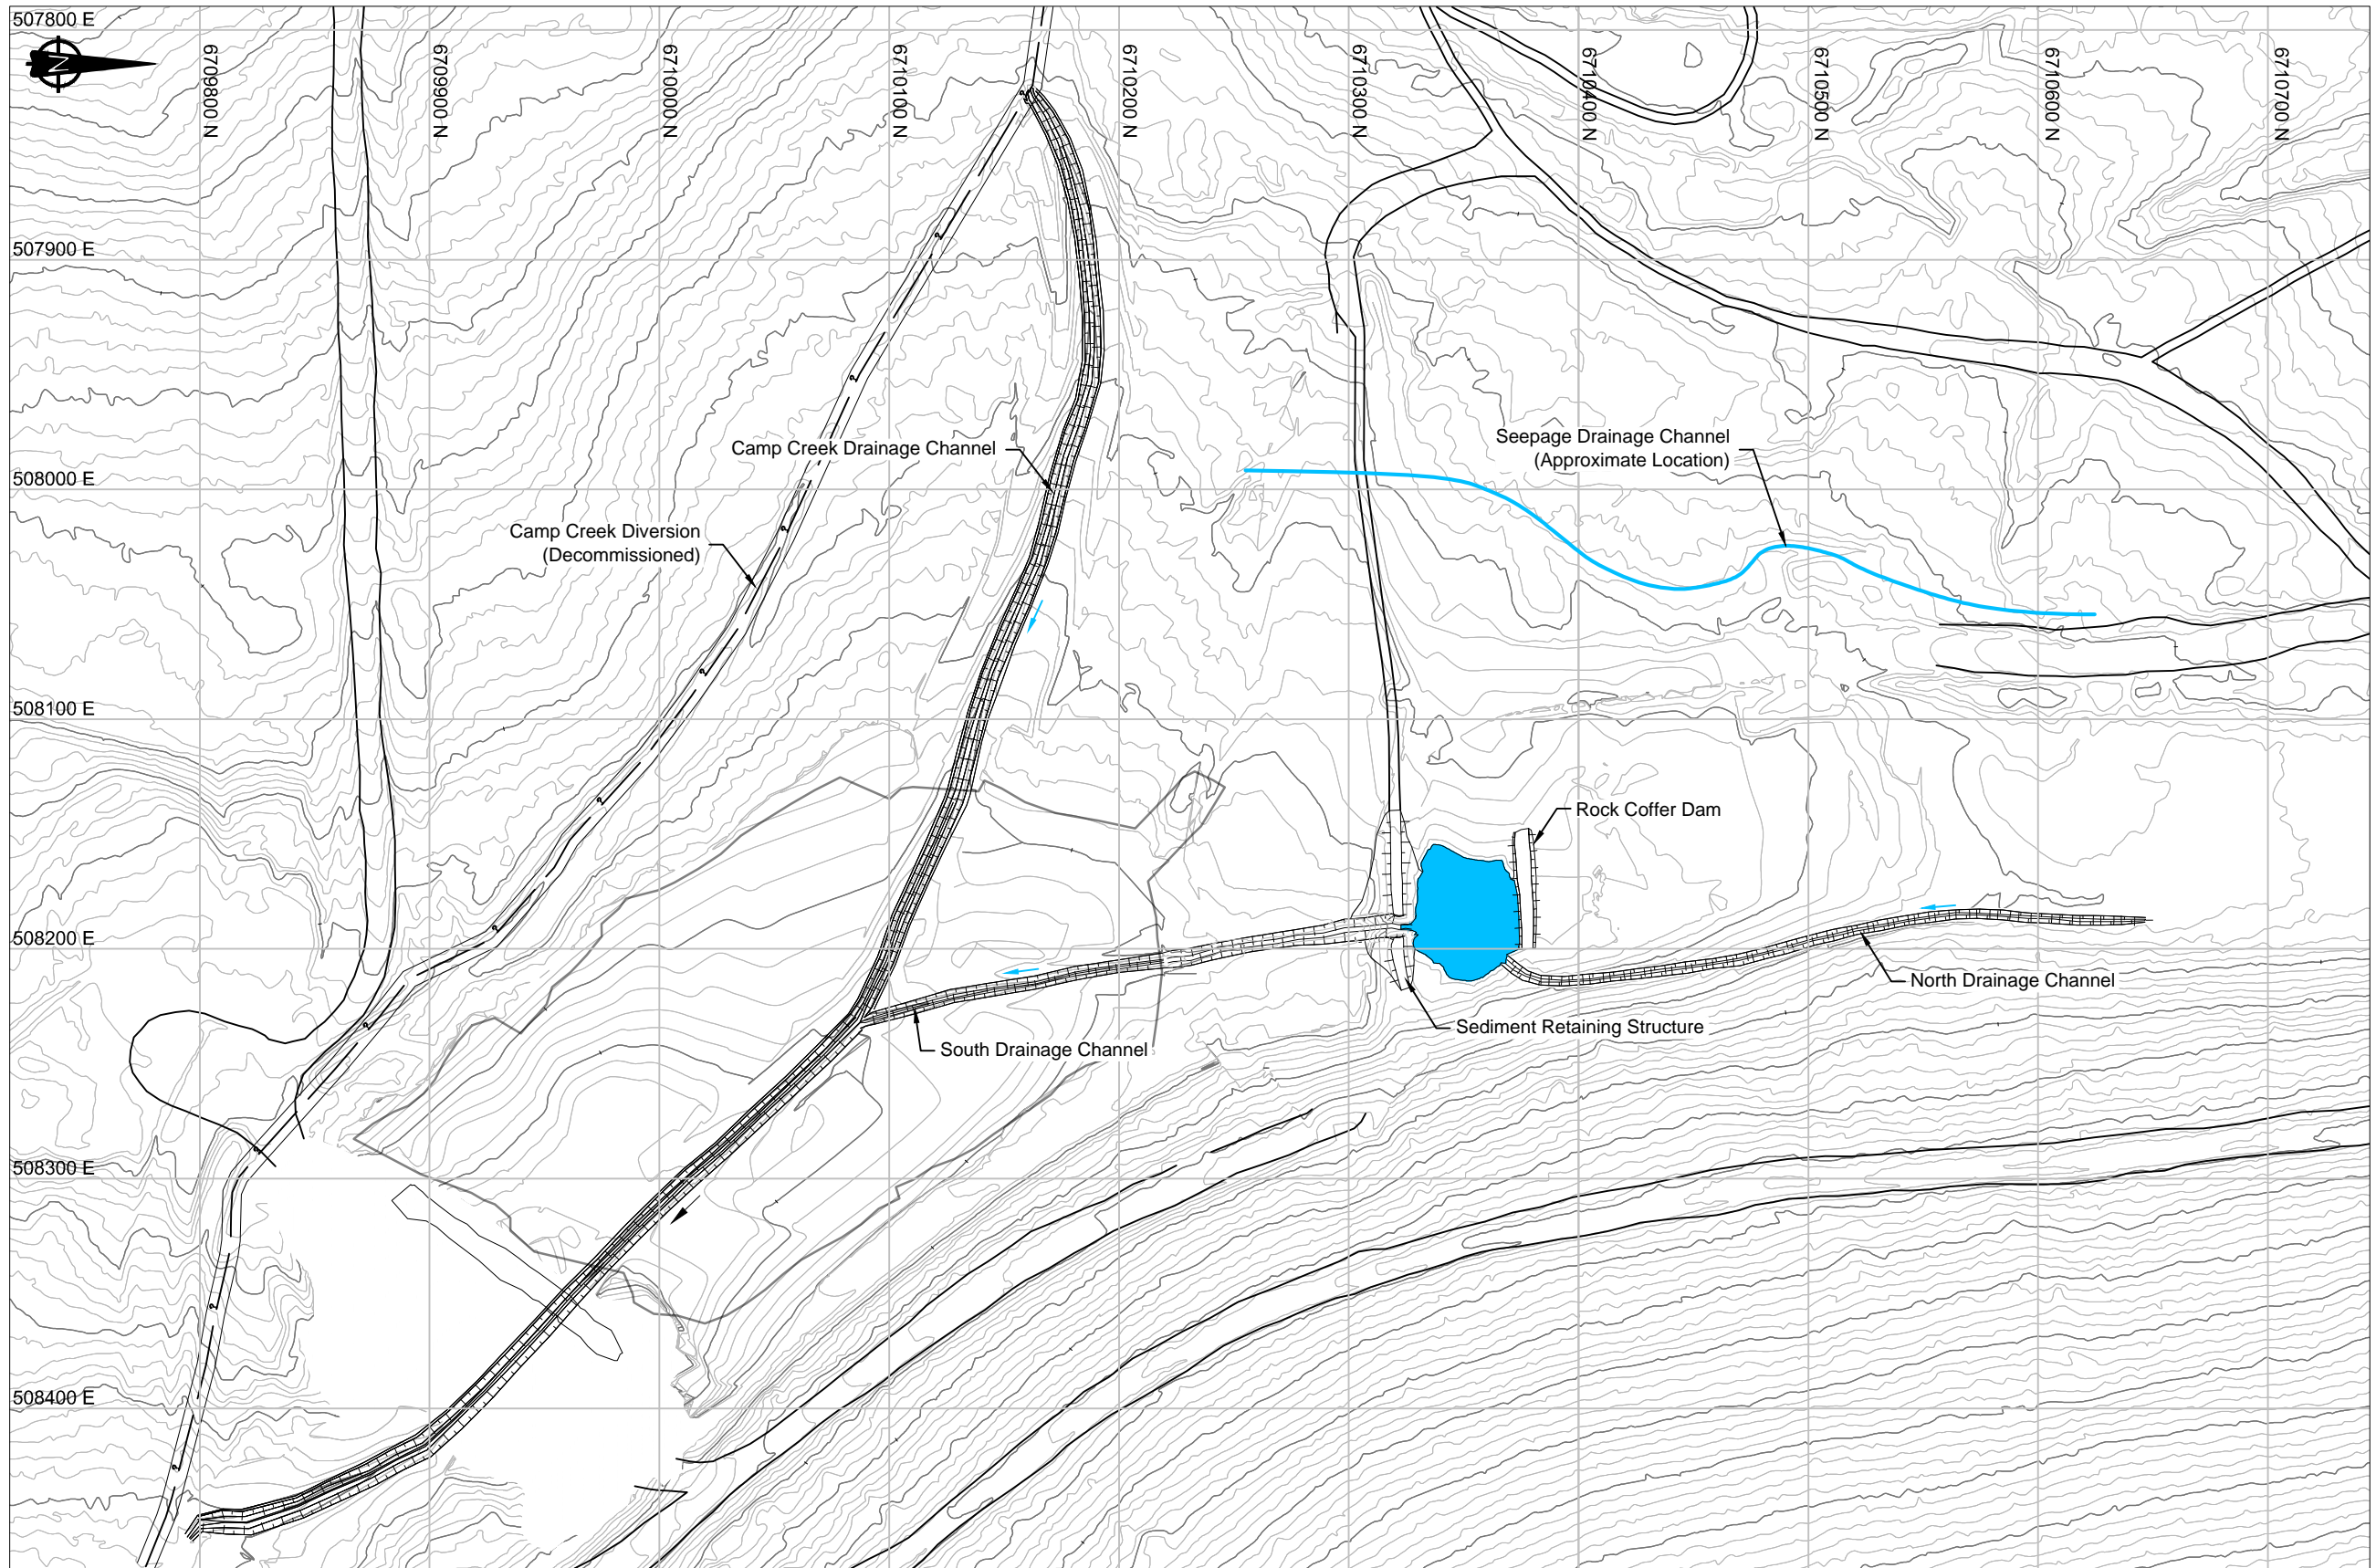
2015 Geotechnical Investigation		
		Drainage Channel Plan		
SRK JOB NO.: 1CT008.053 FILE NAME: 1CT008.053 - Drainage Channel.dwg	Sä Dena Hes Project	DATE: November 2015	APPROVED: PMH	DRAWING: 7

The new riprapped drainage channels (the North channel, the Camp Creek channel and the South channel) were constructed during the TMA decommissioning in 2014. Figure 7 provides a plan view of the three channels. SRK inspected each of the channels for any signs of subsidence and movement of the riprap erosion protection. Other than the silt build up at the toe of the exit

chute, no significant issues were noted. Photo 4 shows a northerly view of the Camp Creek and South channels.

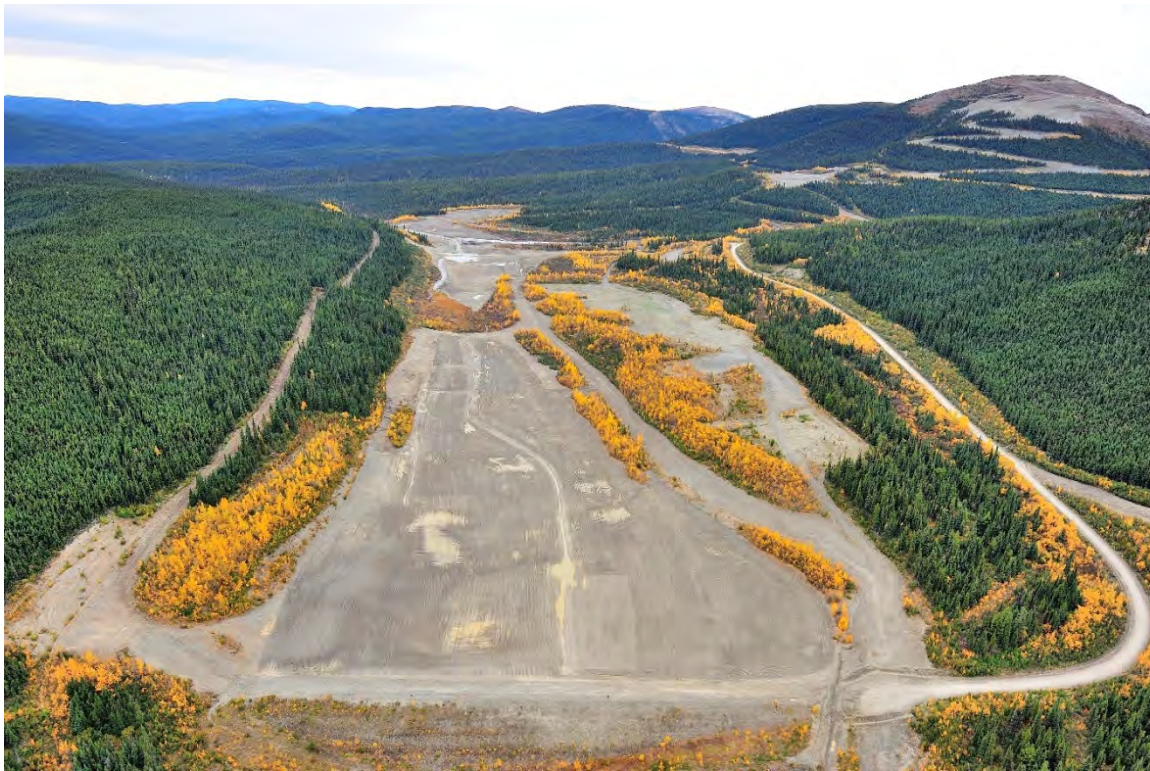
Photo 2: View south over the Tailings Management Area

Photos 2 and 5 show the soil cover that was placed in 2014 and 2015 in the TMA. Photo 10 indicates the depth of the cover in one location.
