## Sä Dena Hes Mine, Yukon Territory 2017 Dam Safety Inspection

SRK Consulting (Canada) Inc.  
December 2017

Project No: 1CT008.065

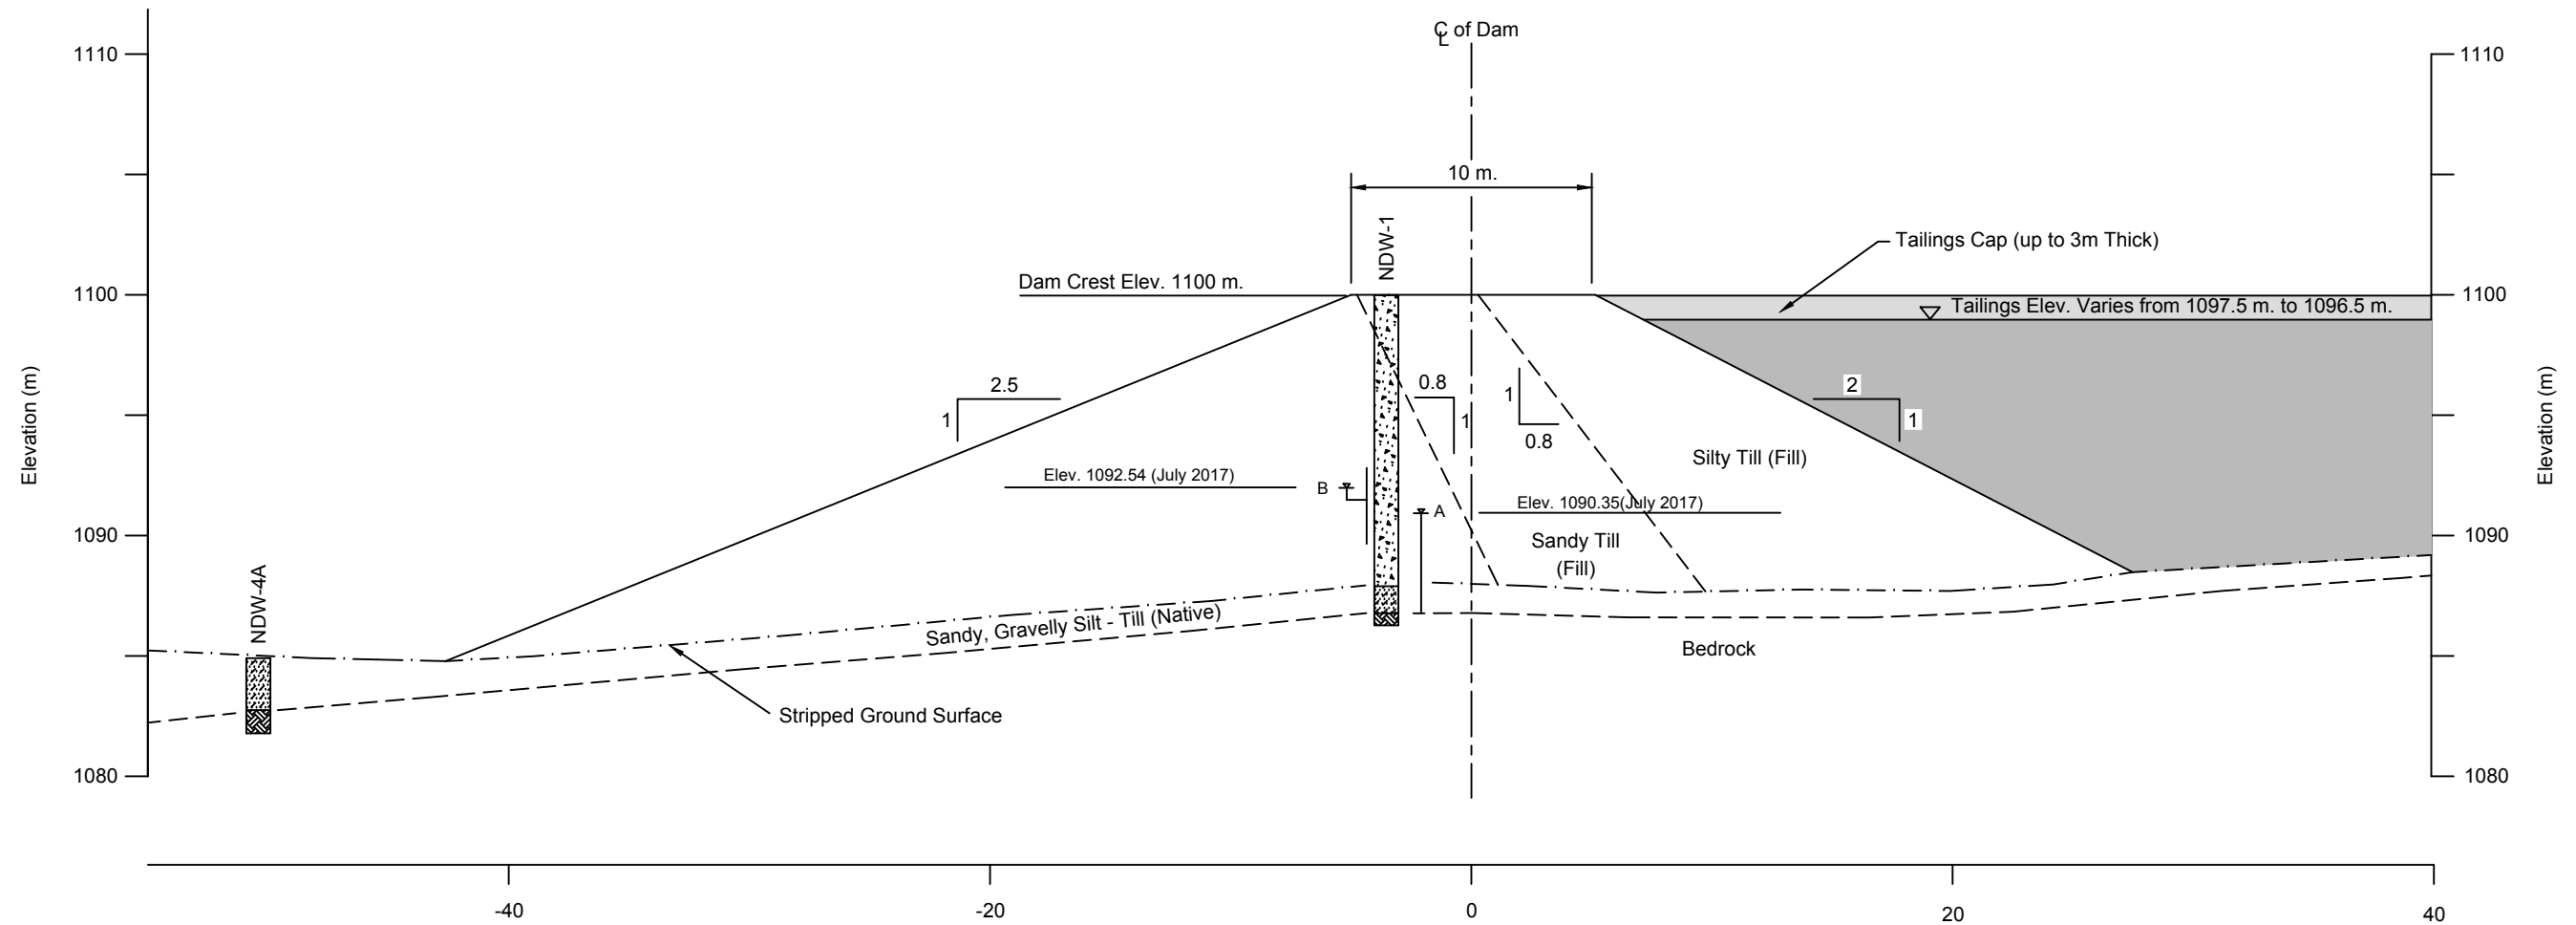
2017 Dam Safety Inspection	
		North Dam Section 0+400	
SRK JOB NO.: 1CT008.065	Sä Dena Hes Project	DATE: September 2017	APPROVED: PMH
FILE NAME: 1CT008.065 - North Dam XS.dwg		FIGURE: 4

The peak levels recorded in July 2017 are plotted on the dam section shown on Figure 4.

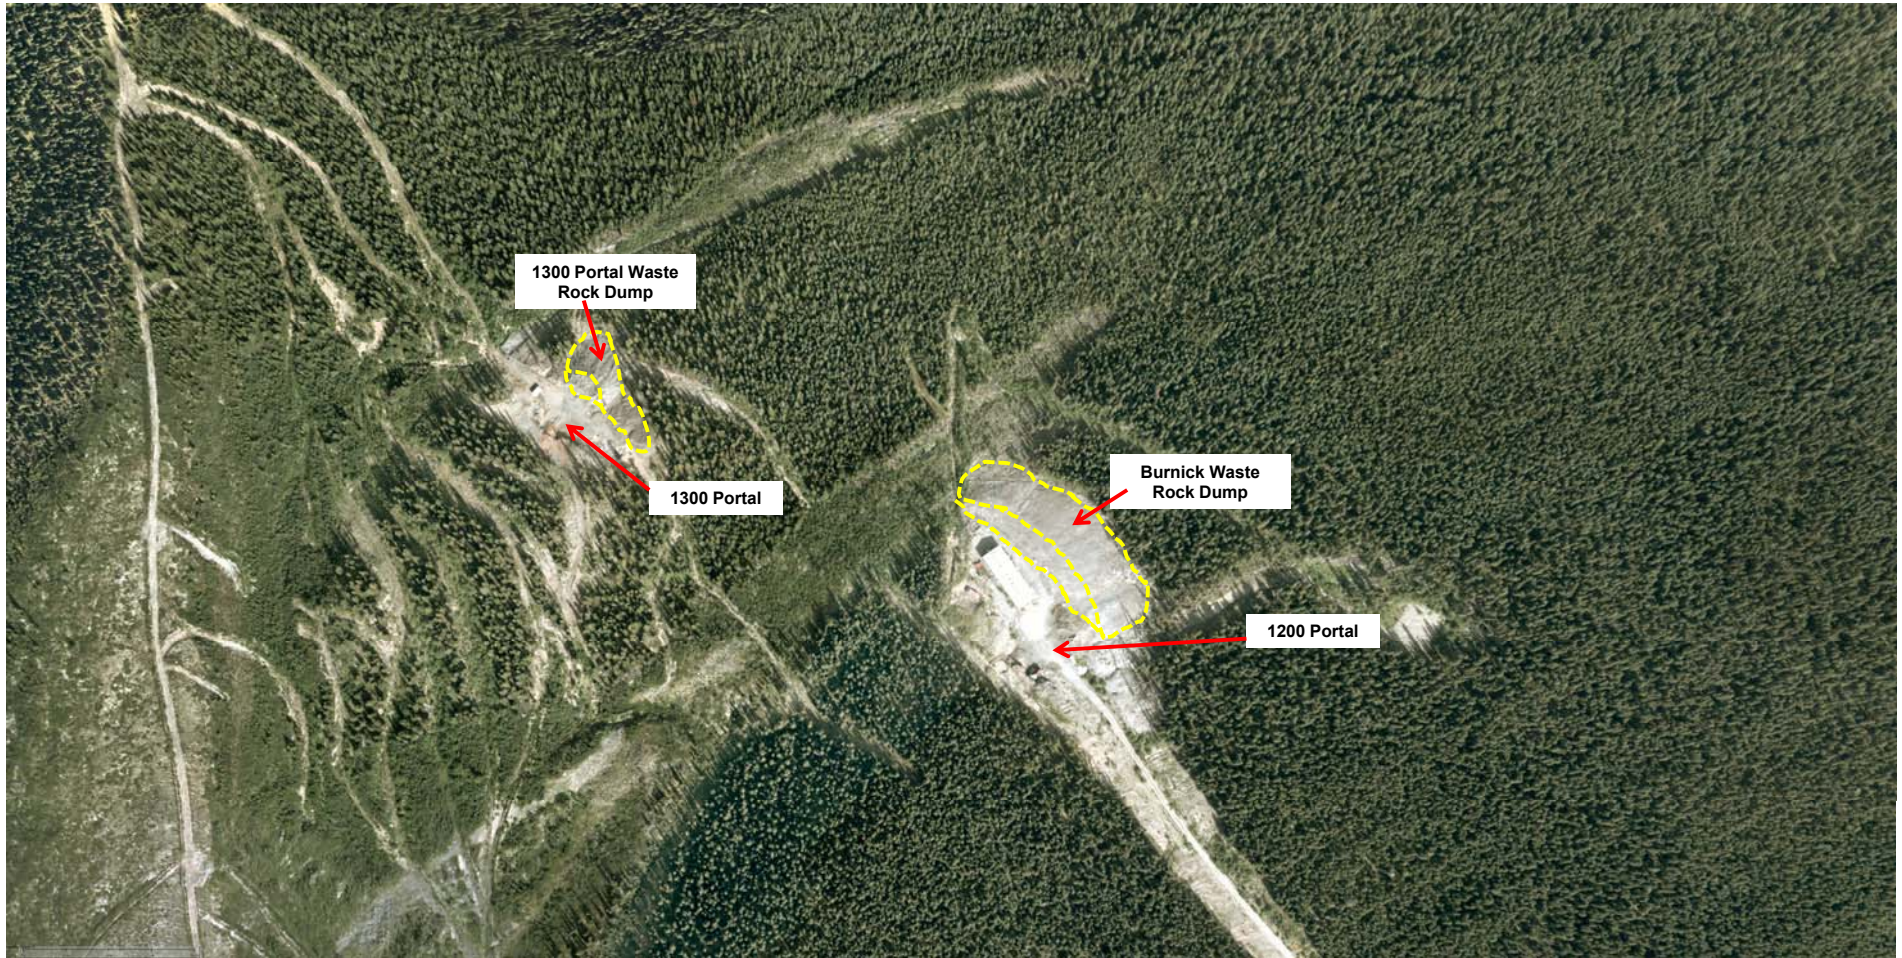
2017 Dam Safety Inspection		
		Burnick Zone Plan View		
Job No: 1CT008.054 Filename: Burnick Zone.pptx	Sä Dena Hes	Date: December 2017	Approved: PMH	Figure: <b>11</b>

SRK also inspected the Burnick waste dumps at the locations of the reclaimed 1200 and 1300 portals shown in Figure 11. The dumps were recontoured to provide added long-term stability. No subsidence of the slopes was noted.

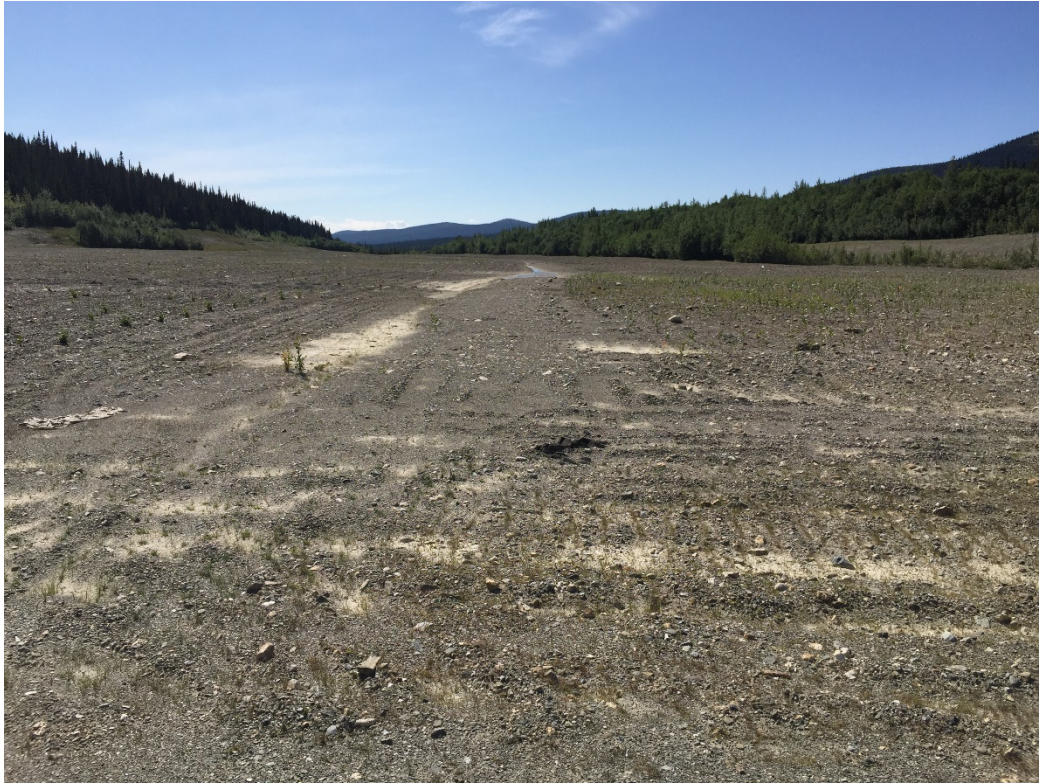
Photo 9: View looking south of drainage swale on tailings till cover

Photo 9 shows a view looking south of the tailings cover at the north end of the TMA. The cover has an overall gentle downslope gradient away from the North Dam. A drainage channel was constructed down the middle of the cover to assist in directing runoff away from the dam. At the time of the site inspection, water was flowing south along the channel, as shown in Photos 10 and 11.

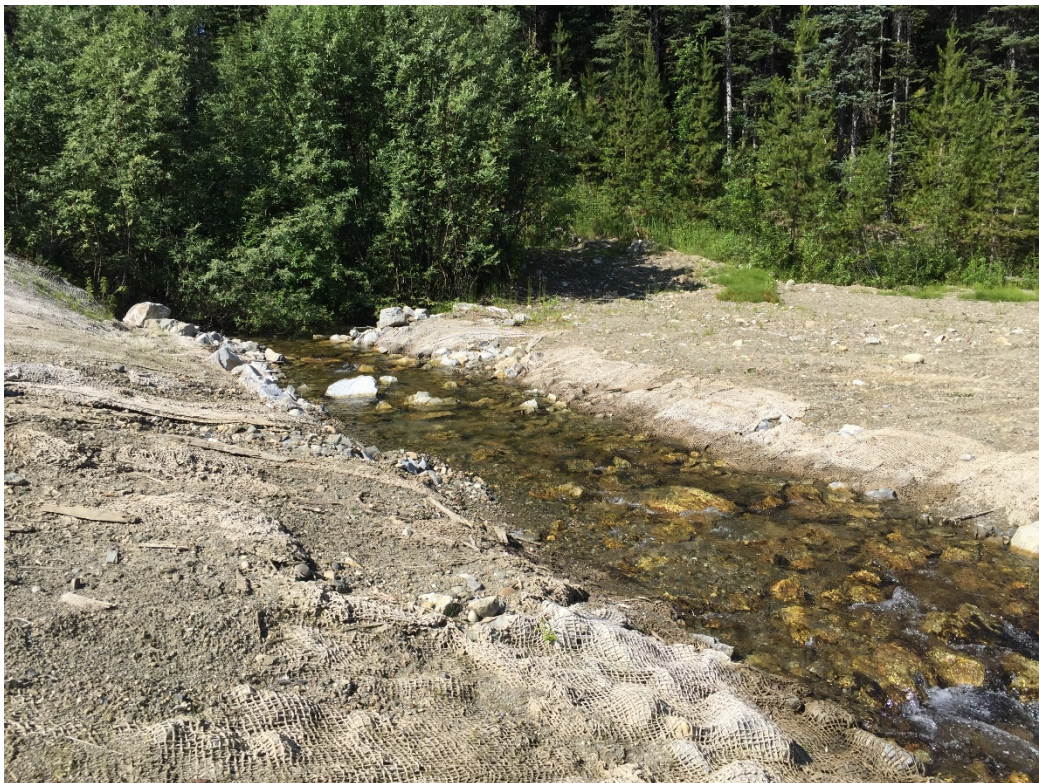
Photo 16: Second Crossing of North Creek

Below the above channel is a second riprapped channel that was built following the removal of the two culverts as part of the site reclamation (Photo 16). The channel is stable and requires no remediation.

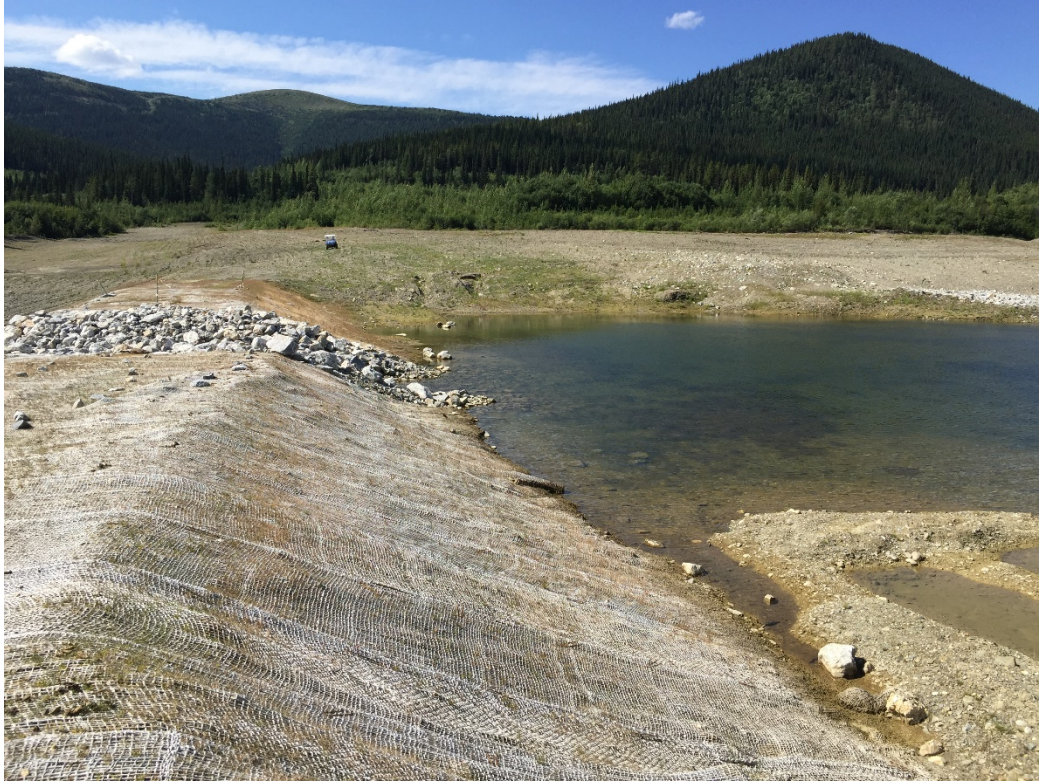
Photo 17: View looking west of the SRS and sediment pond

The GeoJute erosion protection and the riprap buttress along the downstream toe of the SRS that Teck installed last year (Photo 17) have reduced the risk of further erosion of the downstream slope or the downstream toe of the structure.

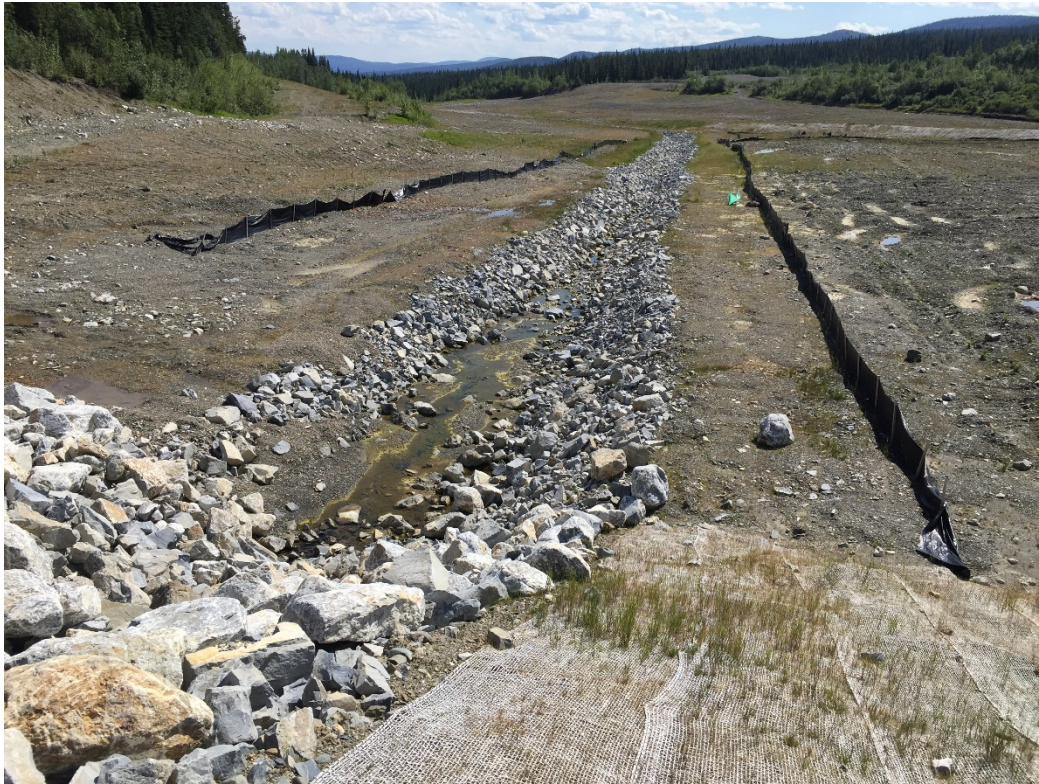
Photo 19: View of the south channel looking south from the SRS Dyke

Photo 19 shows the South Channel looking south. Photos 22 and 23 show the Camp Creek channel. No movement of the riprap or subsidence was evident in any of the channels.
