Government of Yukon, Water Resources Branch

Former Whitehorse Copper Mine Geotechnical Assessment

November, 2010

Project No: 60160522 (402.19.2.2)
Regarding: Former Whitehorse Copper Mine – 2010 Geotechnical Inspection Report

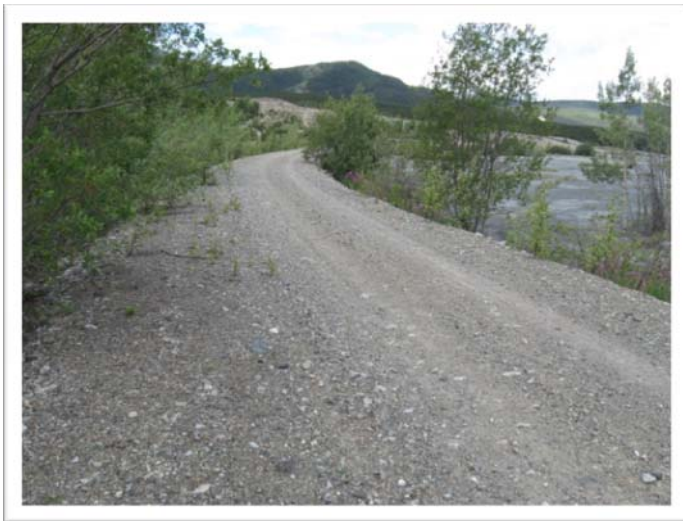
Figure 04 View W Along Dyke from WP 117

The South Extension Dyke is about 400 m long, extending west from Spillway 7 to natural high ground at the access road into the former mill site. The dyke crest is about 5 to 6.5 wide and comprised of rounded gravel and cobbles up to 100 mm diameter. The dyke height varies from 1.5 m at WP 111 to 4.4 m at WP 116 (Figure 02 and 03). Upstream and downstream sideslopes are typically about 1.5 horizontal to 1 vertical (1.5H:1V). Small clusters of vegetation including saplings have become established along sections of the upstream face (Figure 04). A 1 m wide bench has been constructed along the downstream toe from WP 117 to Spillway 7 (Figure 05). The tailings are typically about 1 to 2 m below the dyke crest. The dyke appears stable with no visible signs of cracking or deformations. Seepage was not observed along the toe.

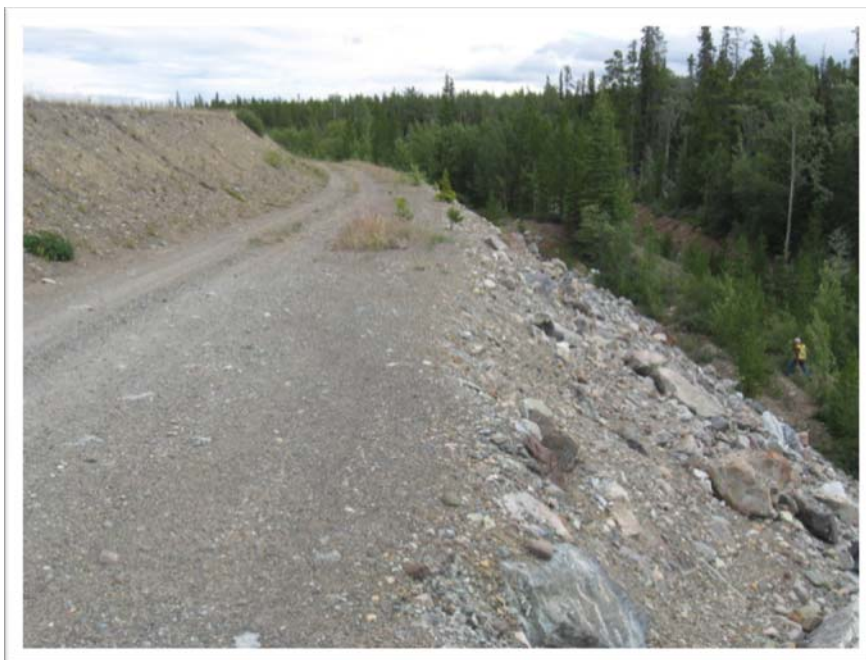
Figure 09 Downstream Face at WP 126 (View N)

The Perimeter Dyke is about 900 m long, beginning at Spillway 7 and ending at high ground at its north end (Drawing 03). The dyke height ranges from about 6 m to 14 m north of Spillway 7 immediately east of the pond (WP 121) to 18 m at the A-Valley Impoundment at WP 168. Within the high dyke section in the vicinity of WP 122 and 123, the downstream slope is supported by a toe berm built from what appears to be waste rock as illustrated on Figure 09. The berm is about 5 to 6 m wide with its top about 2.5 m below the dyke crest. The waste rock is up to 800 mm in diameter. The tailings on the upstream side are about 1.5 m below the dyke crest. Downstream slopes range from about 1.5 to 1.7H:1V. There is a noticeable tilt of the dyke crest of about 0.3 m towards the tailings at WPs 121 and 123. There is also a 5 m wide road along the downstream toe of the waste rock berm. It appears that the road was constructed with tailings.

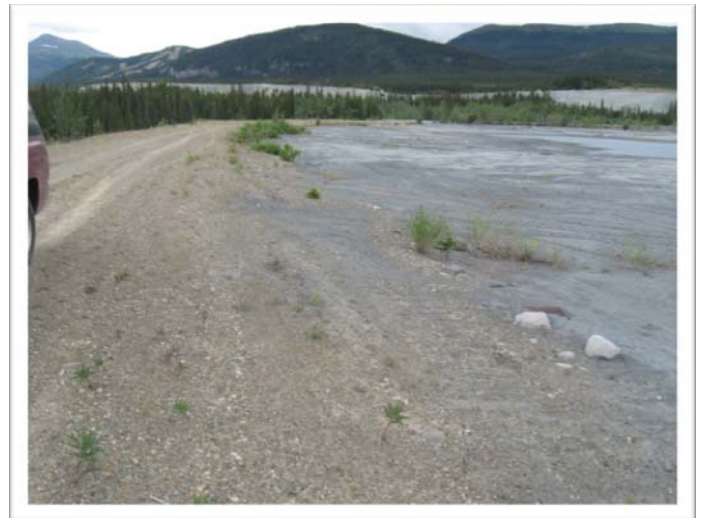
Figure 16 Dyke Crest and Upstream Tailings at WP 160

At WP 160, the dyke height is in the order of 6 m with a downstream slope of about 1.7H:1V (Figure 15). The tilted dyke crest is still visible at this location and the freeboard above the tailings is only about 0.4 m (Figure 16). There is no berm at this location nor is there any evidence of seepage at the downstream toe. The dyke is in good condition from WP 160 to 161 at which point the height decreases towards Spillway 6. The dyke height increases to about 18 m at the narrow valley northwest of Spillway 6 at WP 168 (Figure 17). The freeboard is less than 0.5 m at this location and wind-blown tailings have flattened out the upper portion of the downstream slope face to about 3H:1V (Figure 18). The slope face below the wind-blown tailings is at about 1.7H:1V.

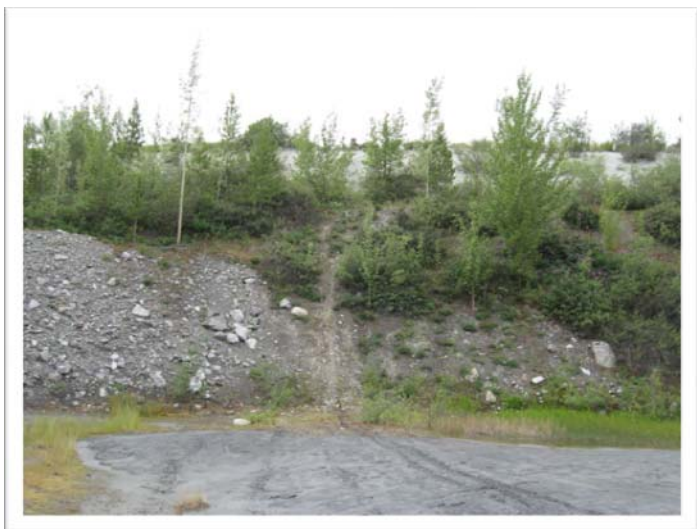
Figure 19 View SW at Perimeter Dyke from WP 166

Tailings span a narrow valley for a distance of about 50 m along the downstream toe of the dyke at WP 166. The tailings extend to the north where they form the A-Valley Impoundment between a bedrock controlled valley constriction. Tailings and the remnants of a timber flume and wood stave pipe on the east flank suggest that tailings were likely deposited across the Perimeter Dyke at Spillway 6 where they flowed or were conveyed along the toe of the dyke to WP 166. Photos taken from WP 166 are shown on Figures 19 to 22.

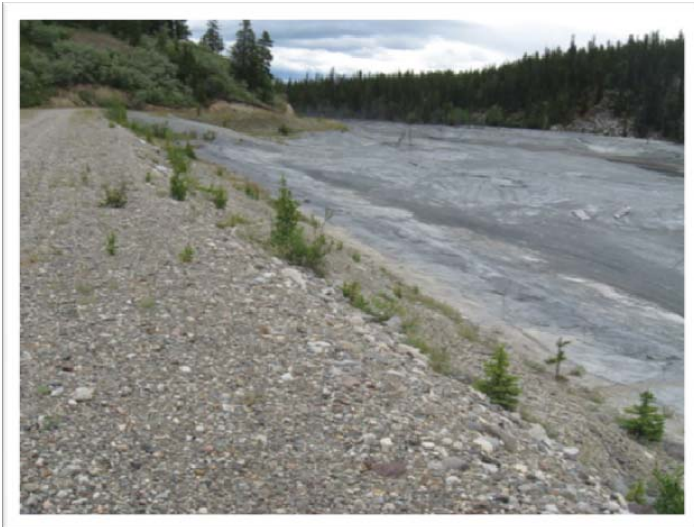
Figure 25 A-Valley Impoundment Upstream of A-Dam from WP 169

The A-Dam is located at the downstream (west) end of the A-Valley Impoundment as shown on Drawing 02. The dam is about 150 m long and 34 m high (Figure 24). The dam crest is about 8 m wide and there is about 4 m of available freeboard between the tailings and the crest on the upstream side. There is no water impounded on the upstream side of the dam (Figure 25). The downslope side of the dam is about 2H:1V with coarse gravel, cobbles and boulders visible on the surface. For scale, a derelict vehicle can be seen on the downstream slope on Figure 24. There are a number of narrow benches on the downstream face for the full width of the dam which appears stable with no visible signs of cracking or deformations. There was no evidence of seepage at the downstream toe of the dam. The former decant culverts at the downstream toe of the right abutment were not visible, having been plugged and grouted as part of decommissioning (Geo-Engineering, 1996).

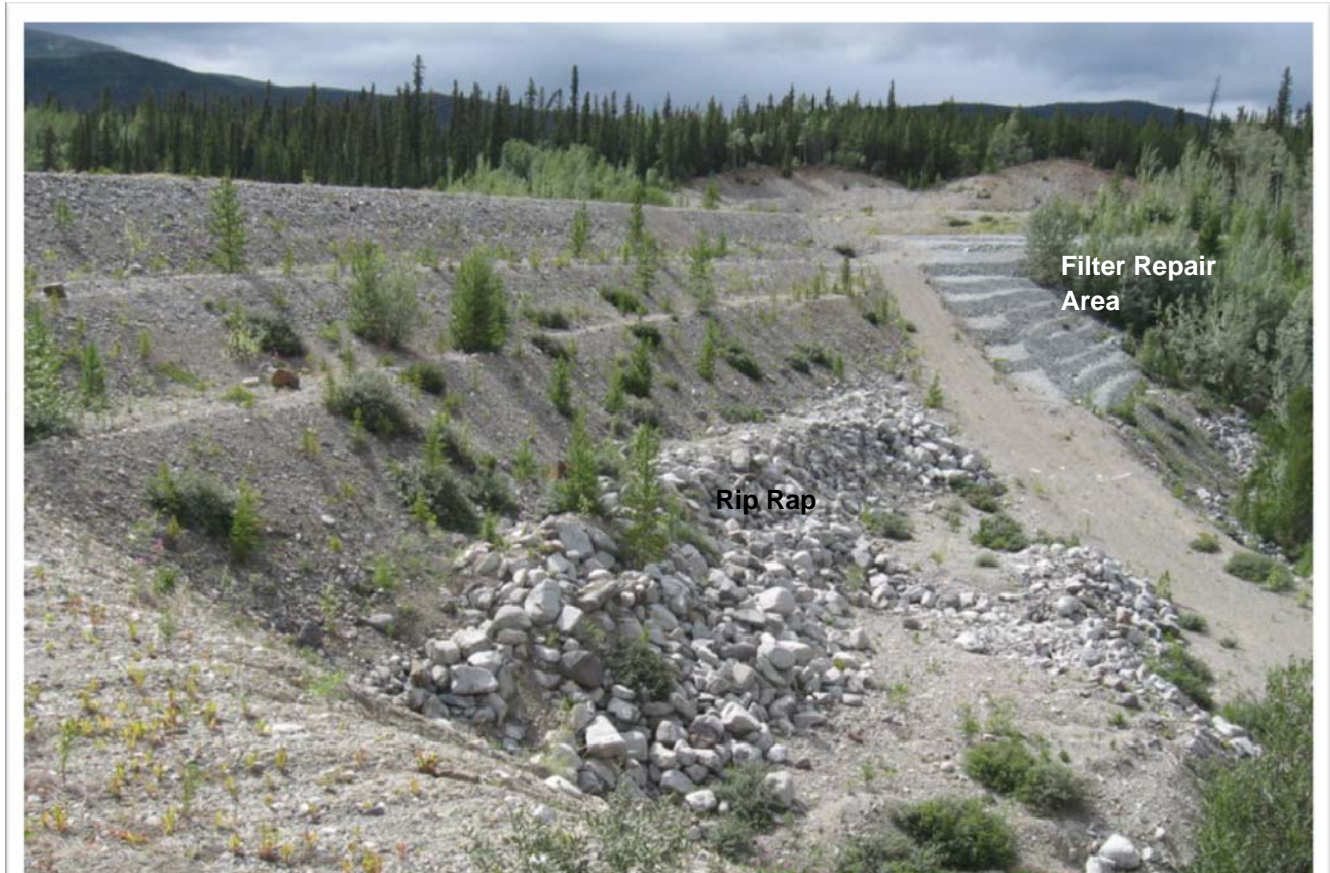
Figure 29 Downstream Side of B-Dam from WP 213, View SW

The B-Dam is located at the downstream end of the B-Valley Impoundment as shown on Drawing 03. The dam is about 150 m long and 22 m high (Figure 29). The downstream slope is made up of a series of benches with a two level rip rap buttress on the east half as shown on Figures 30 and 31. The rip rap benches are about 2 m high by 3.5 m wide (lower bench) and 4 m high by 8 m wide (upper bench). The main bench which extends the full length of

the dam is about 15 m wide and about 18 m from the dam crest (measured vertically). The dam appears to have been constructed using locally available gravel with cobbles and boulders. Water is ponded on the south side of the dam although there is several metres of freeboard. The dam appears stable with no visible signs of cracking or deformations. There is no discernable difference in the appearance of the downstream slope of the dam from 1992 with the exception of the construction of an inverted filter on the left downstream abutment and saplings are now becoming established as seen on Figure 29. There is no evidence of seepage at the downstream toe of the dam.

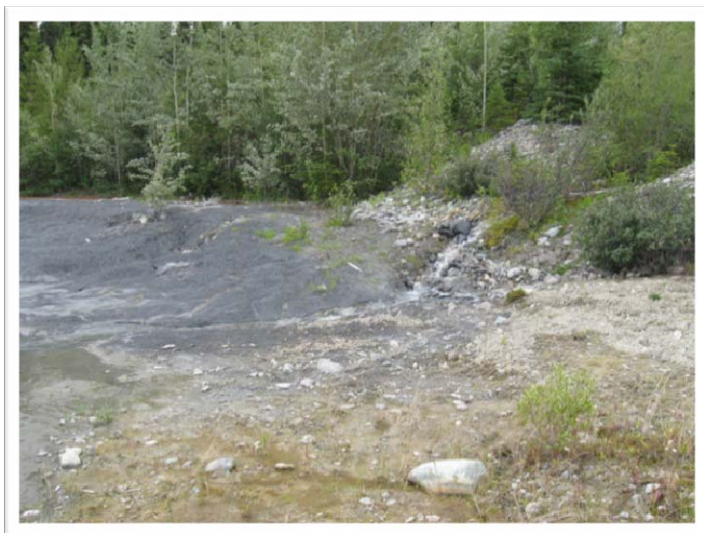
Figure 32 Drainage Ditch Outlet into Tailings Pond from WP 183

Water was seeping from the left downstream abutment at the locations shown on Drawing 03. Seep A is immediately upslope of the inverted filter constructed in 1996 on the left downstream abutment. Water from Seep A flows overland where it infiltrates the filter. Seep B is located about 30 m farther west at the upstream end of a drainage ditch on the left abutment above the B-Dam (WP 179). Seepage water from Seep B is conveyed along the ditch where it discharges into the tailings pond at WP 183 as shown on Figure 32. Flow from Seep B was estimated to be in the order of 2-3 l/sec. Seep C is located along the edge of the pond where the ground is very soft with iron staining visible (Figure 33). Flow was estimated to be in the order of 0.25 l/sec. Flow into the pond from the drainage channel was estimated to be in the order of 4-5 l/sec indicating additional seepage water enters the drainage channel downstream of Seep B.

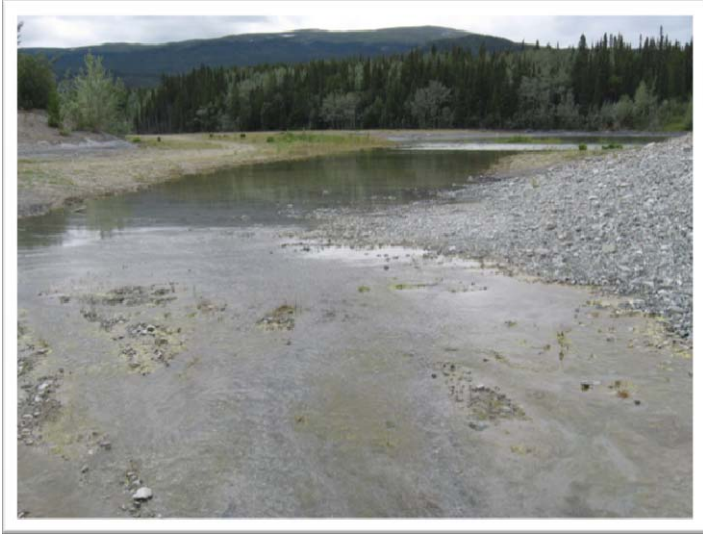
Figure 35 Entrance to Spillway from B Pond from WP 175

Water from the tailings pond during active mining and for some period after closure was discharged through 2-600 mm diameter decant pipes passing through the base of the embankment. In 1996, a rock-lined spillway was constructed at the right abutment including an armoured discharge chute. The decant pipes were plugged and grouted (Geo-Engineering, 1996). The entrance to the spillway is shown on Figure 35 and 36. The channel at this location is about 8 m wide, 2.5 m deep with 2H:1V sideslopes. The armouring material in this relatively flat section consists of 100 mm down crushed granular. There is no evidence of erosion at this location.

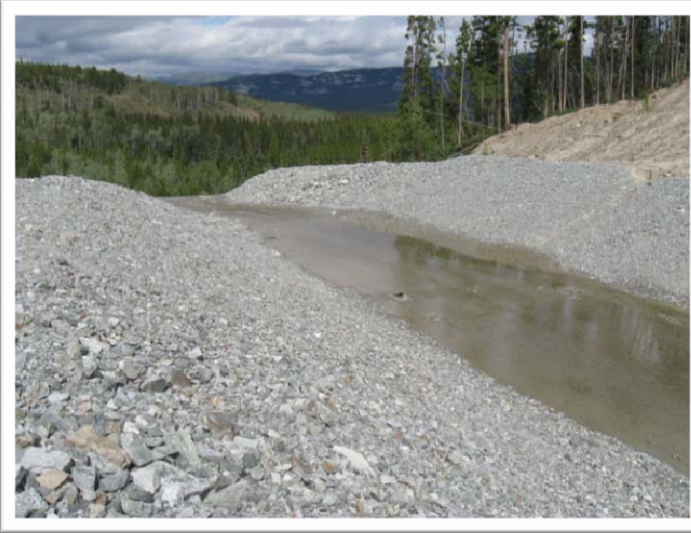
Figure 37 D/S End of Spillway Chute at Drop Section from WP 212

Discharge over the spillway was estimated to be in the order of 5 l/sec. Water discharges through the end of the chute over two benches and then onto a spillway apron about 50 m by 50 m and 11 m high. The first (upper) bench shown on Figure 37 and 38 is about 5 m below the end of the spillway chute. Water was flowing over the upper bench and had ponded on the second bench about 2.5 m lower. The water infiltrates into the bench at this location where flow become subterranean. There was no evidence of seepage at the toe of the spillway pad. Erosion gullies have formed on the sloped surfaces between the benches as seen on Figures 39 and 40. The material on the benches and spillway pad is a cobbly gravel with trace boulders up to a maximum size of about 400 mm. This material is smaller in size than originally specified (Geo-Engineering, 1996).
