**YUKON ZINC CORP.  
WOLVERINE MINE**

**TAILINGS STORAGE FACILITY AND ON-SITE  
EARTH STRUCTURES 2016 INSPECTION**

VA101-677/1-1  
Rev 0  
December 2, 2016

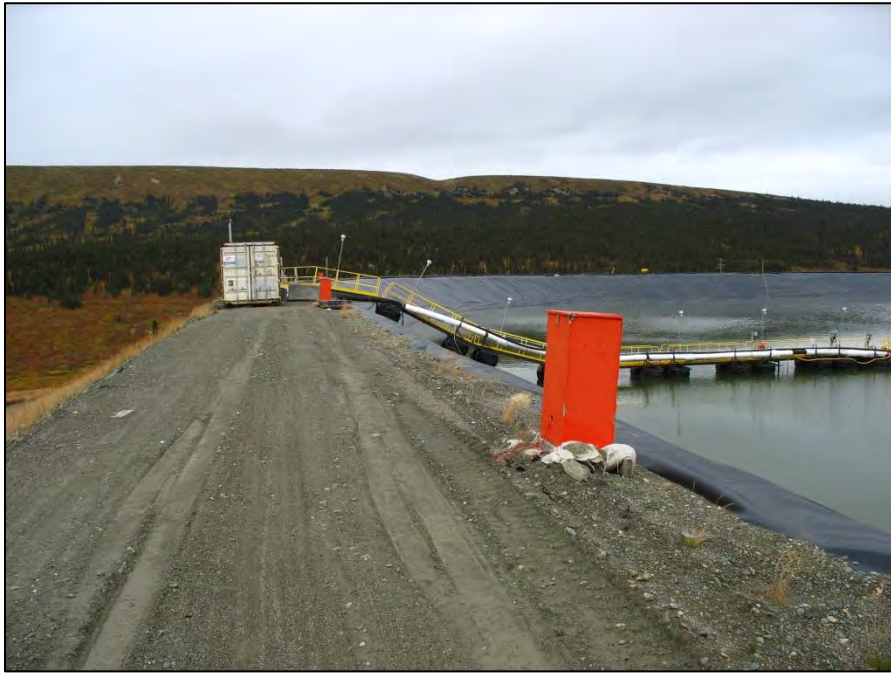
**PHOTO 1** – TSF South Embankment – Looking west. Piezometer readout box in foreground.

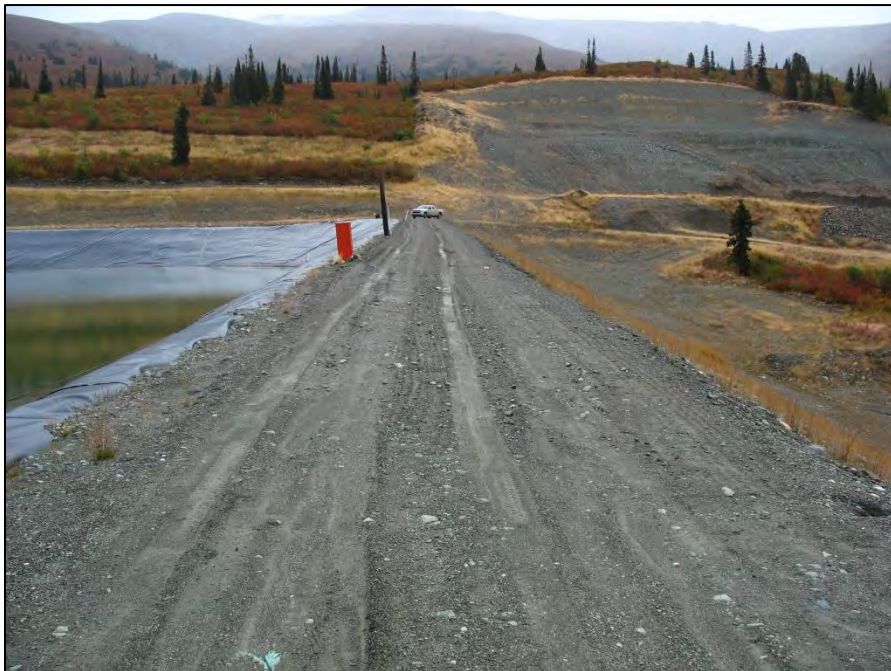
**PHOTO 2** – TSF South Embankment – Looking east.

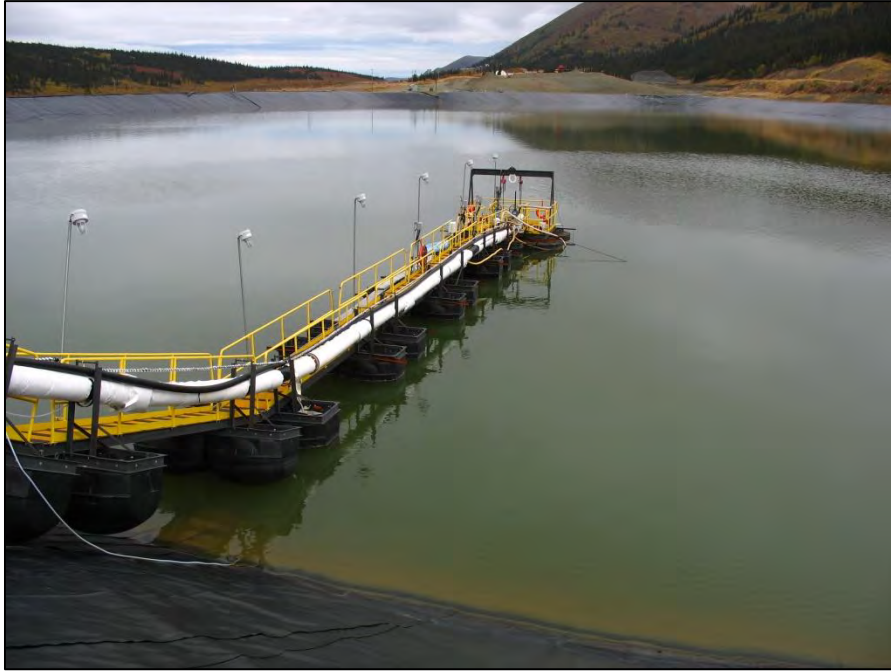
**PHOTO 3 – TSF South Embankment – Reclaim barge.**

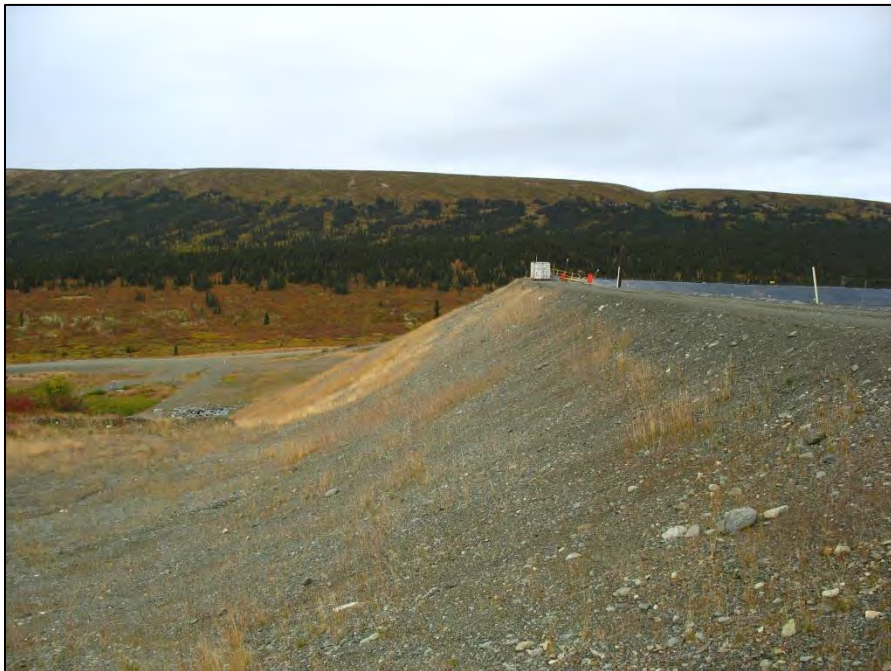
**PHOTO 4 – TSF South Embankment – Downstream slope.**

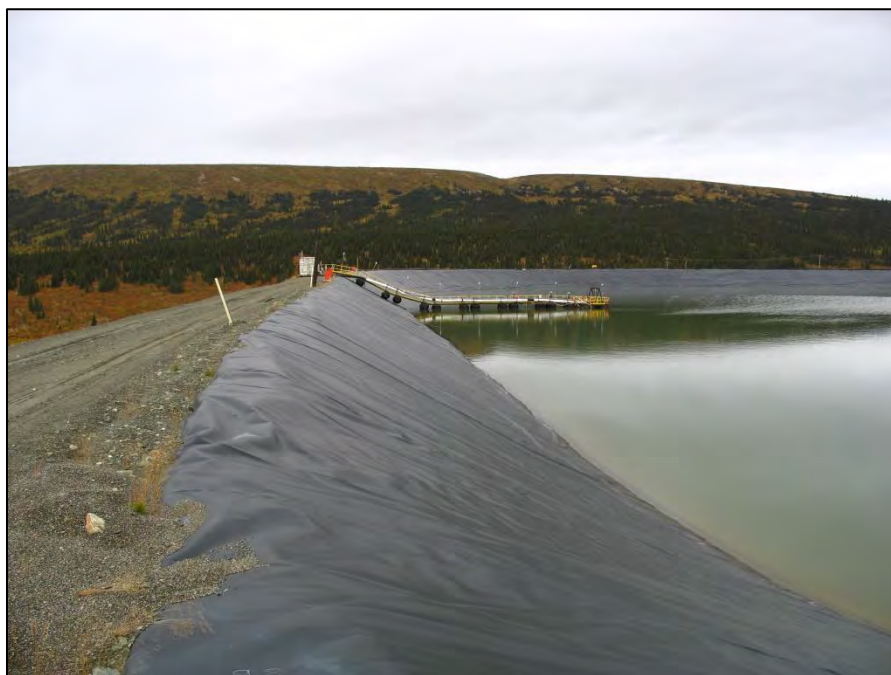
**PHOTO 9** – TSF South Embankment – Upstream slope.

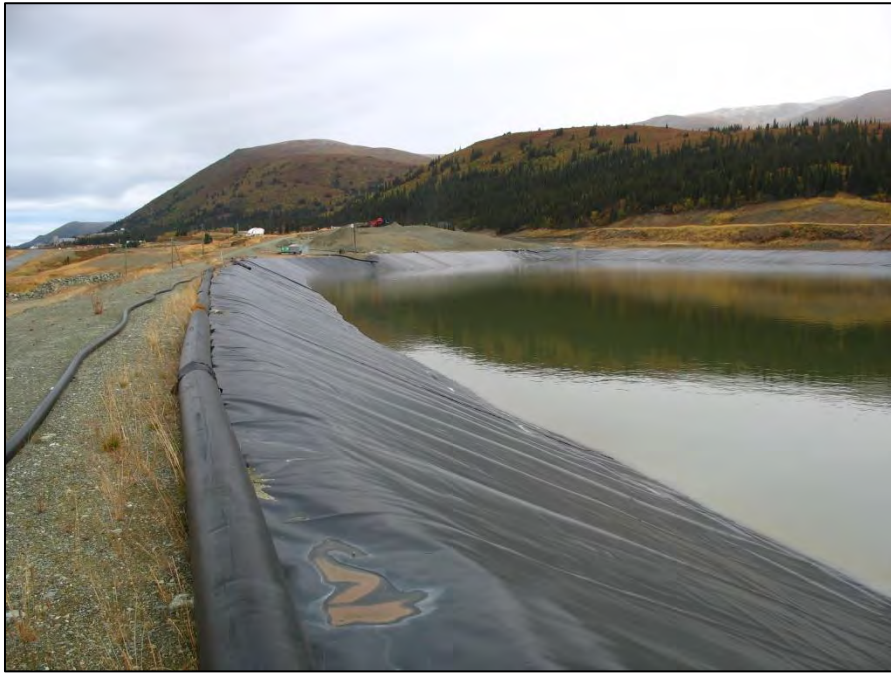
**PHOTO 11** – West Side of TSF – Upstream slope.

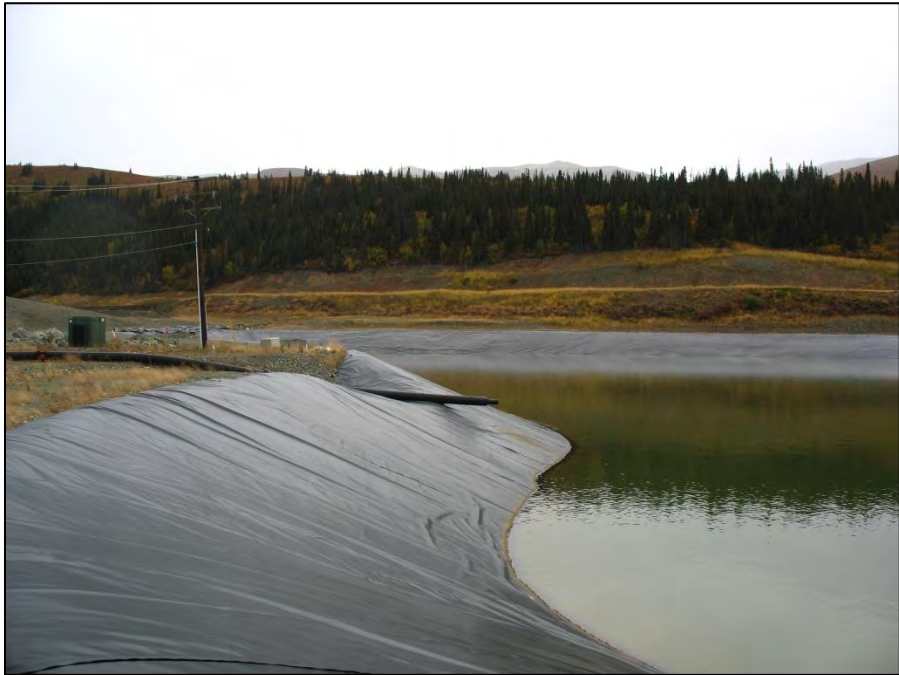
**PHOTO 13** – TSF upstream slope near spillway.

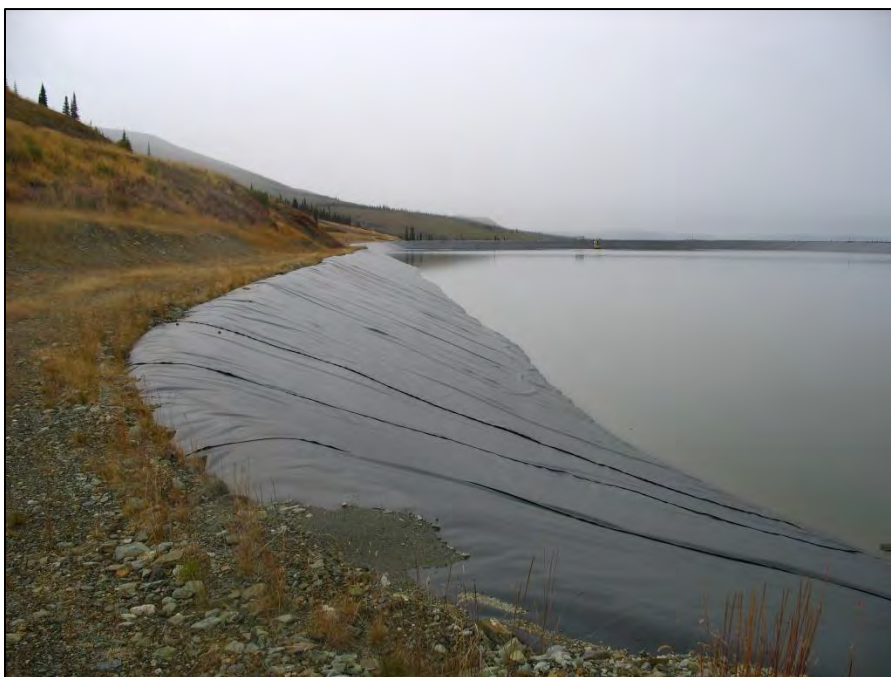
**PHOTO 20** – East side of TSF - Looking south.

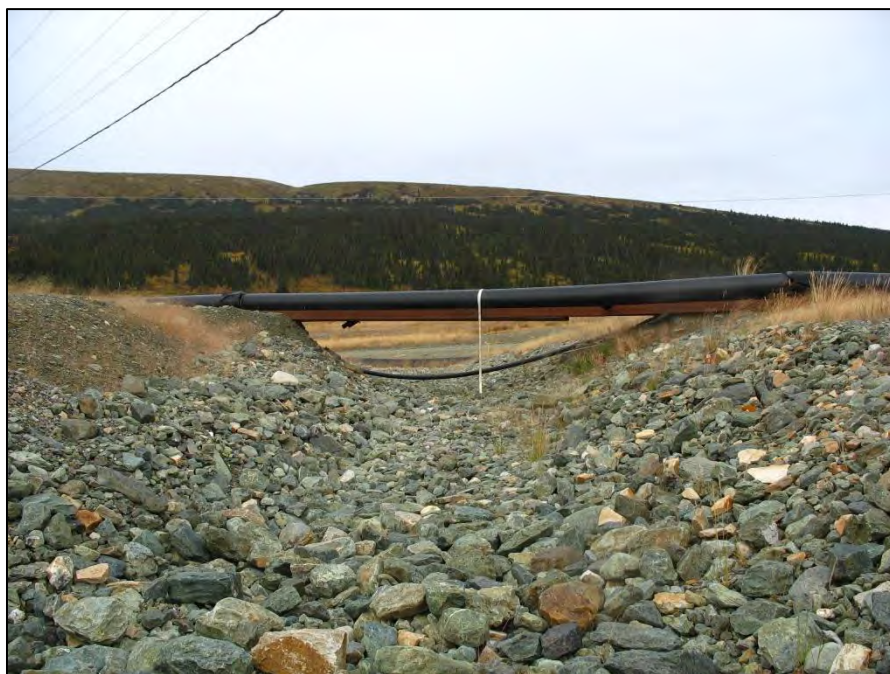
The spillway channel is located on the northwest side of the TSF and was constructed in natural ground. The spillway channel is lined with riprap. No water has been discharged through the spillway. The spillway appeared to be in good condition.

**PHOTO 21** – TSF spillway channel looking downstream.

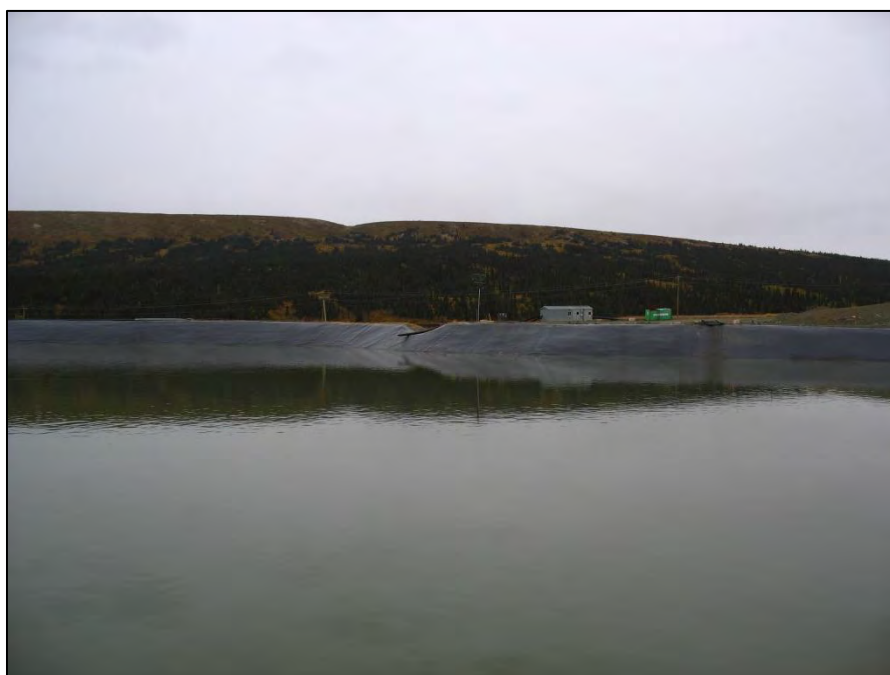
**PHOTO 22** – TSF spillway looking west.

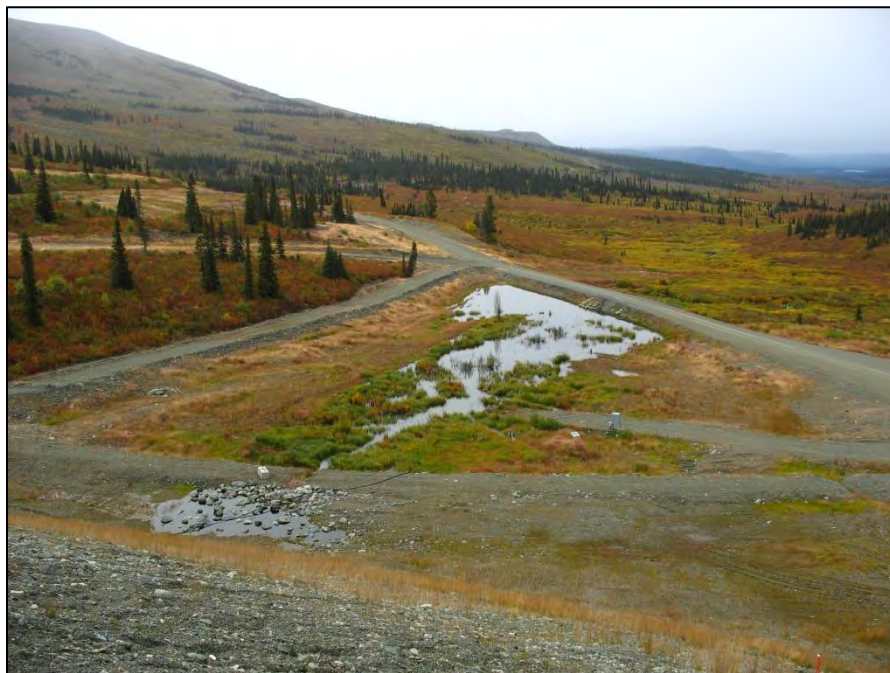
**PHOTO 23** – TSF Seepage Collection Pond.

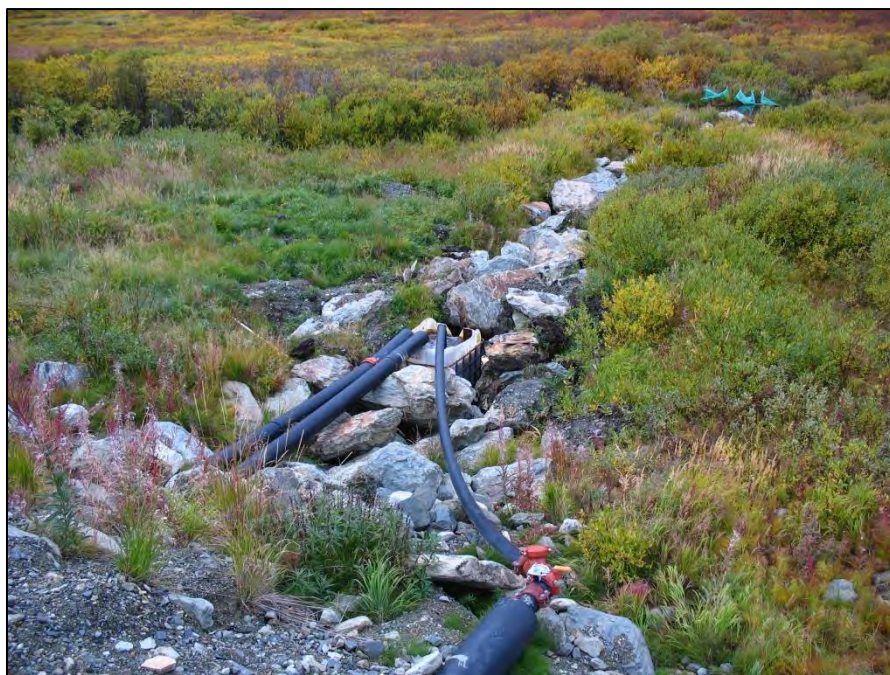
**PHOTO 24** – TSF Underdrain Discharge Area at west side of the Seepage Collection Pond.

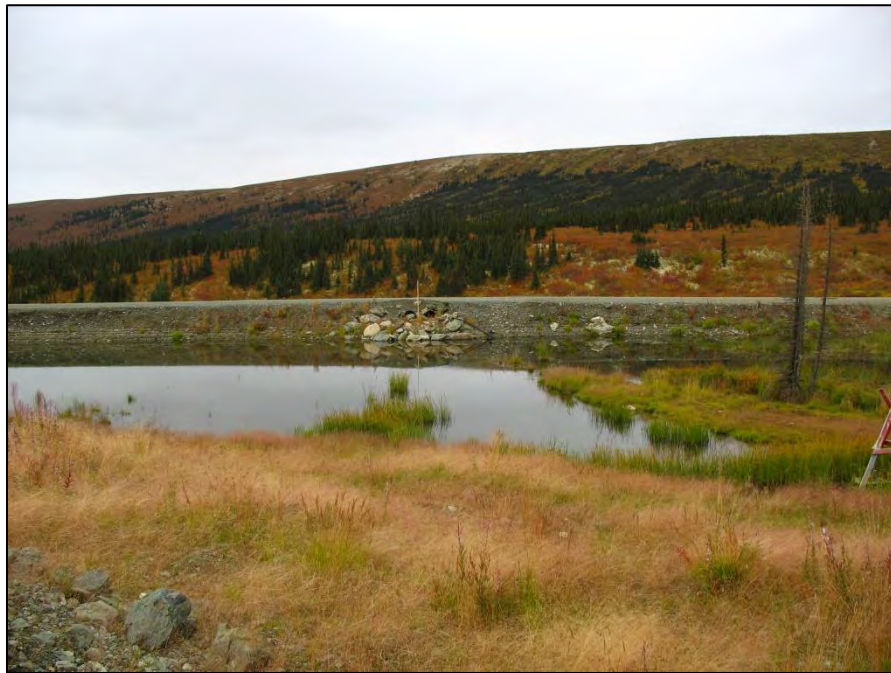
**PHOTO 25** – TSF Seepage Collection Pond looking west towards culverts.

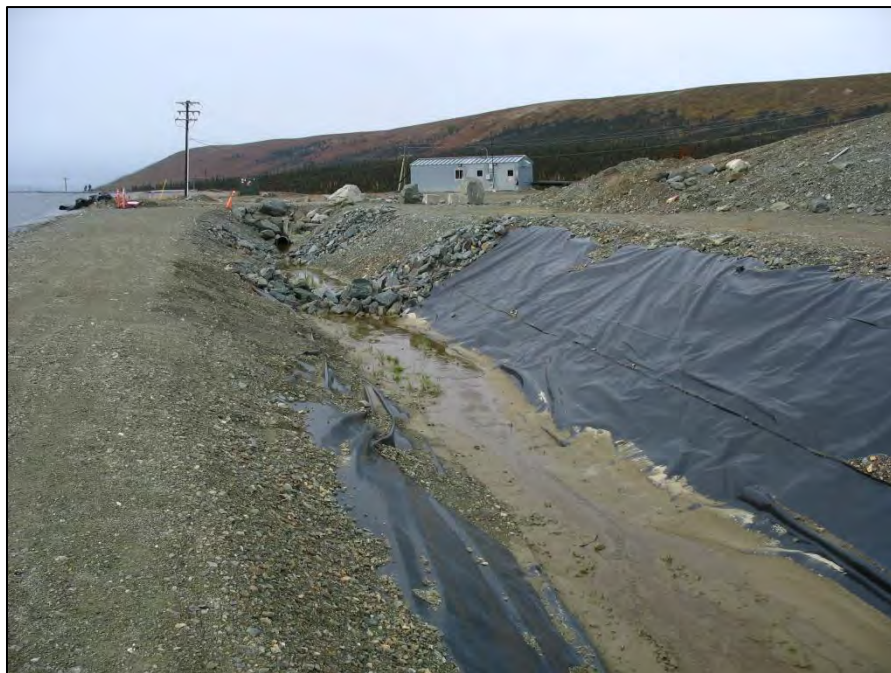
**PHOTO 26** – Ditch A at north side of TSF – Looking west.

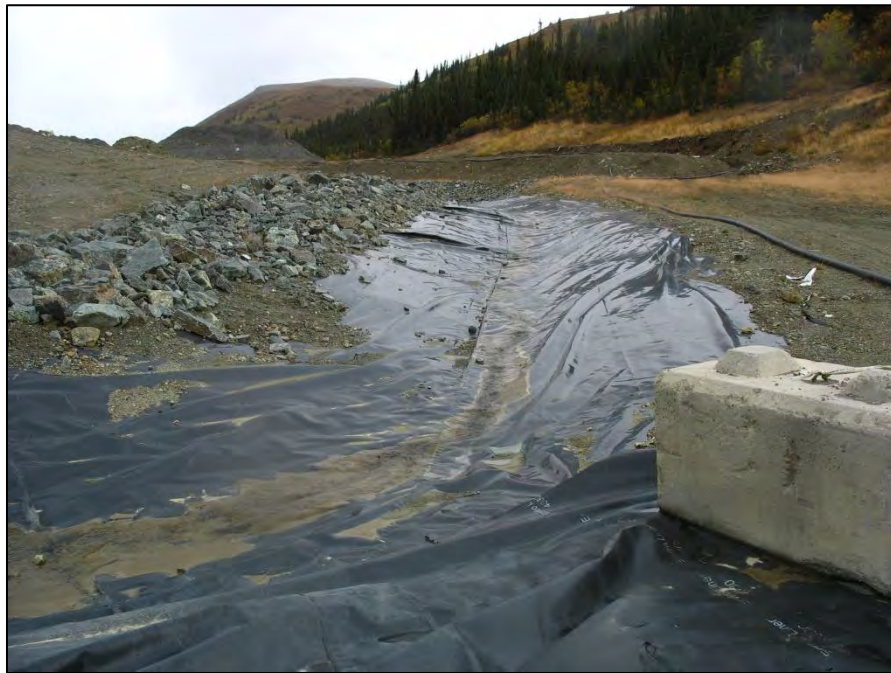
**PHOTO 27** – Ditch A at north side of TSF – Looking north towards Stilling Basin.

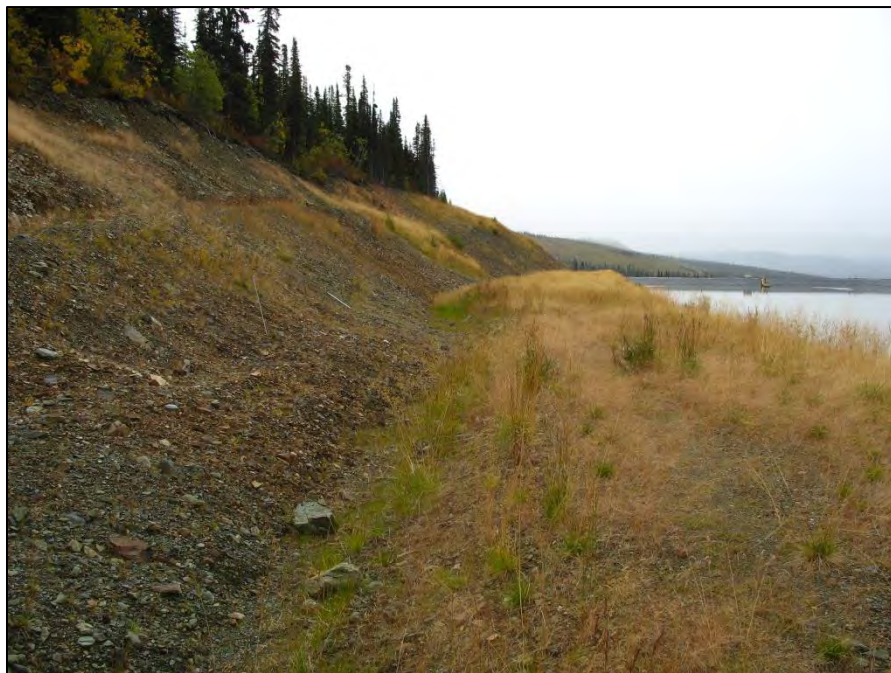
Ditch B is located on the eastern side of the TSF. Ditch B is an unlined ditch. The ditch was dry at the time of the inspection and no potential blockages were observed in the ditch.

**PHOTO 28** – Ditch B on east side of TSF - Looking south.

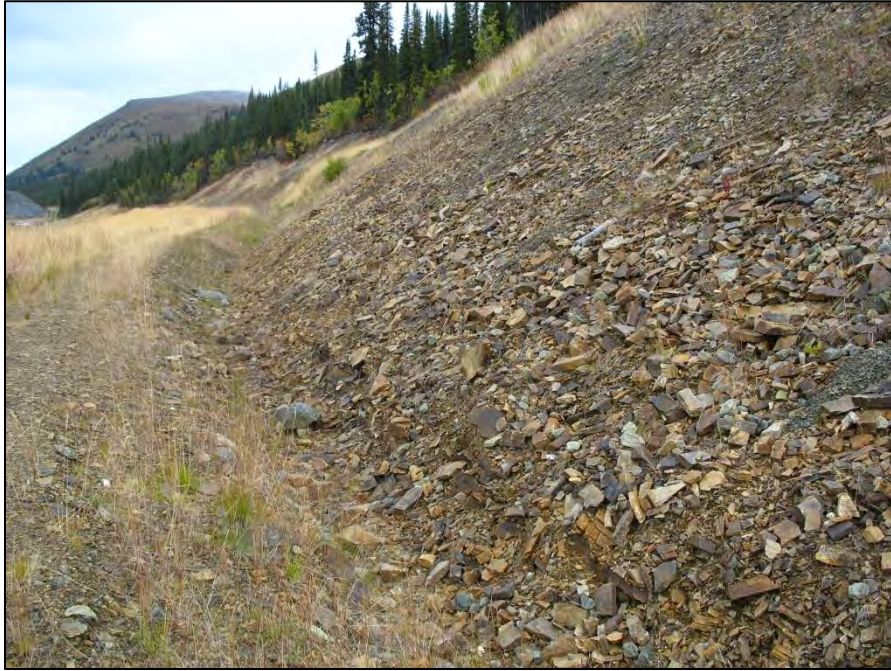
**PHOTO 29** – Ditch B on east side of TSF - Looking north.

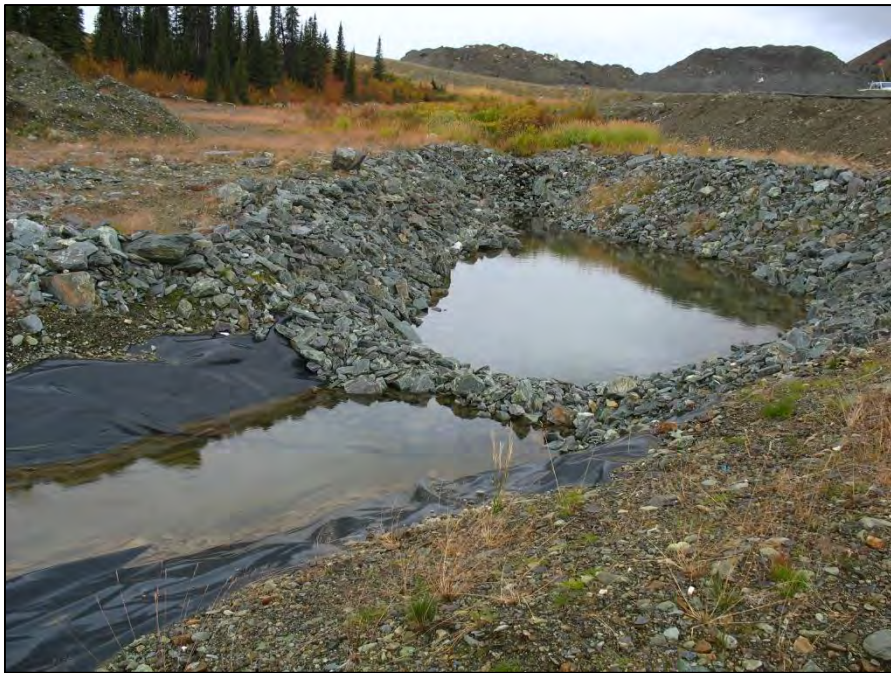
**PHOTO 30** – Stilling Basin and upstream end of Ditch A.

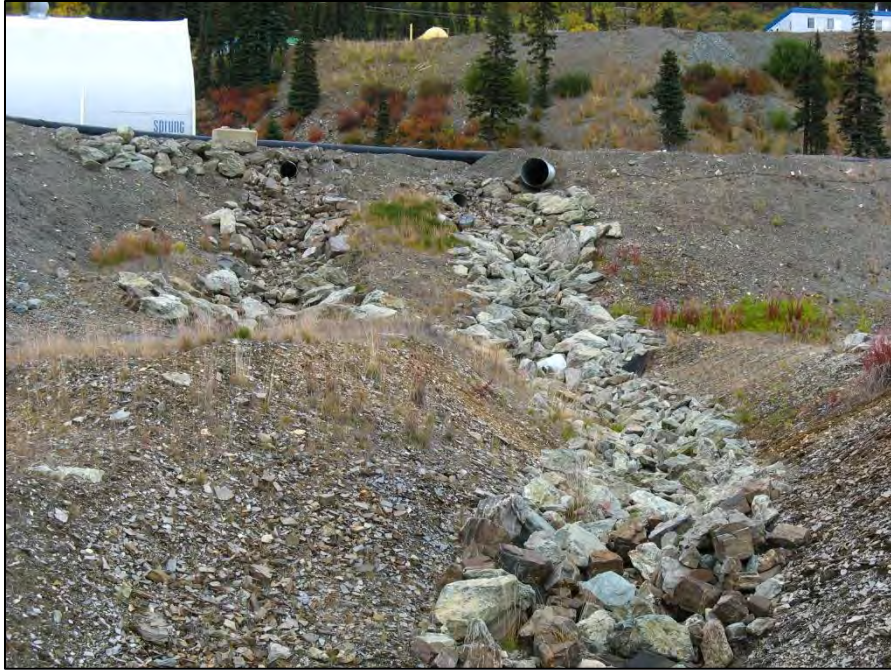
**PHOTO 49** – Drainage from Mill Pad.

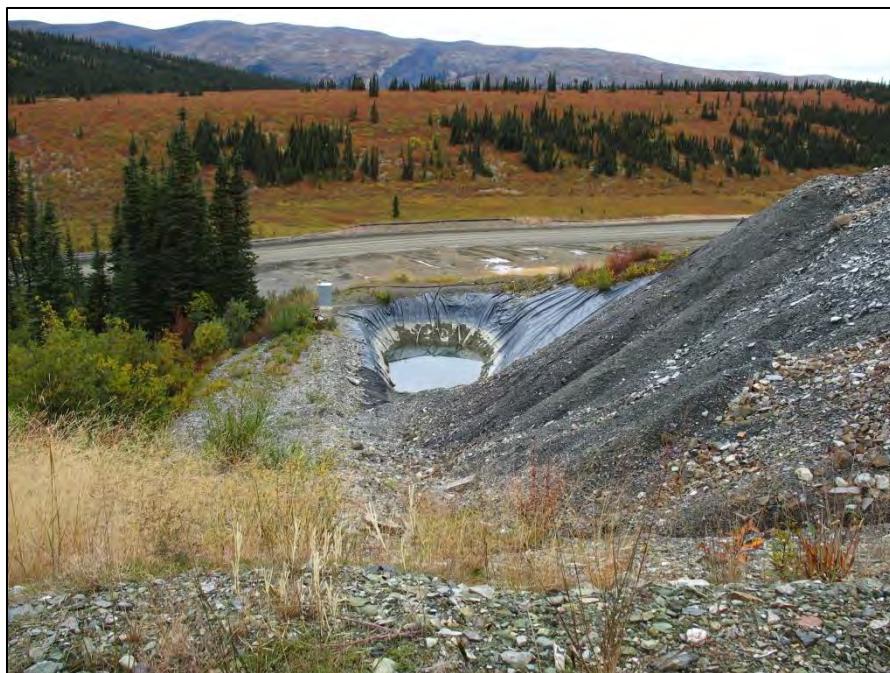
**PHOTO 55** – Waste Rock and Ore Storage Facility runoff collection sump

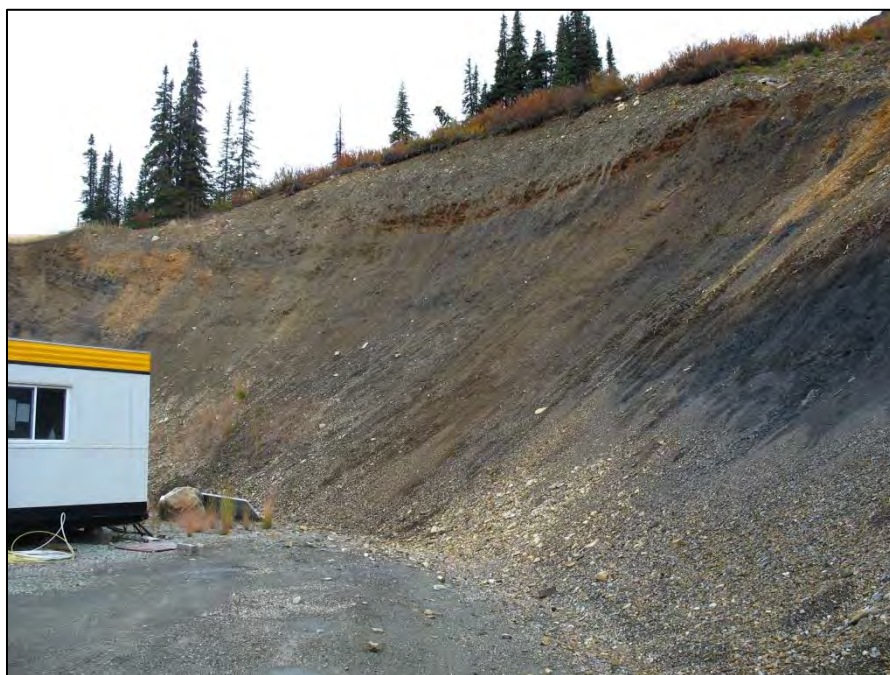
**PHOTO 56** – Slope behind Vent Raise and Underground Office
