WOLVERINE MINE

QUARTZ MINING LICENSE QML-0006

2014 ANNUAL REPORT

Prepared by:
Yukon Zinc Corporation
Vancouver, British Columbia

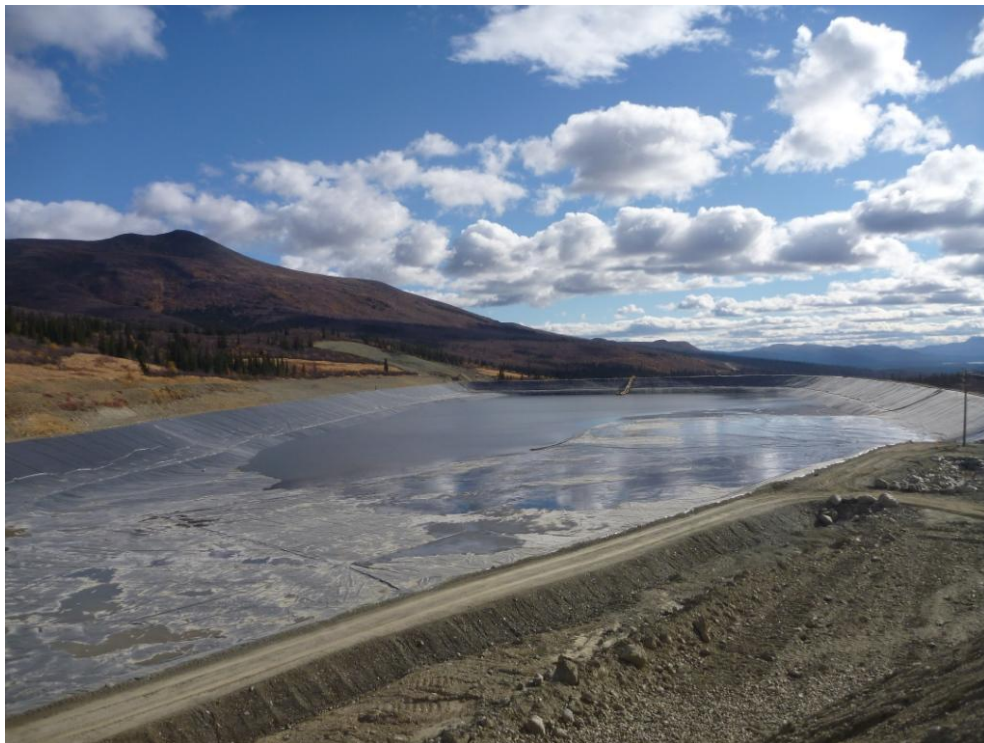
Picture 2-1: Tailings storage facility after dam lift construction project, looking east (top) and west (bottom).

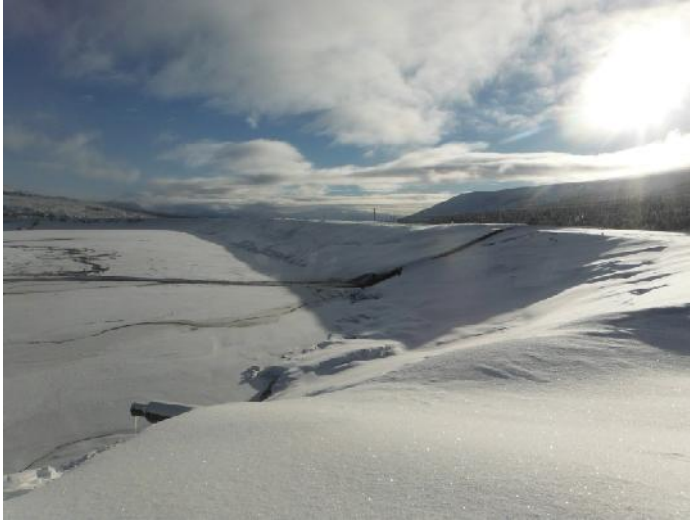
Photo 1: Looking at mill tailings discharge line with pump reclaim water pump house overflow line in foreground

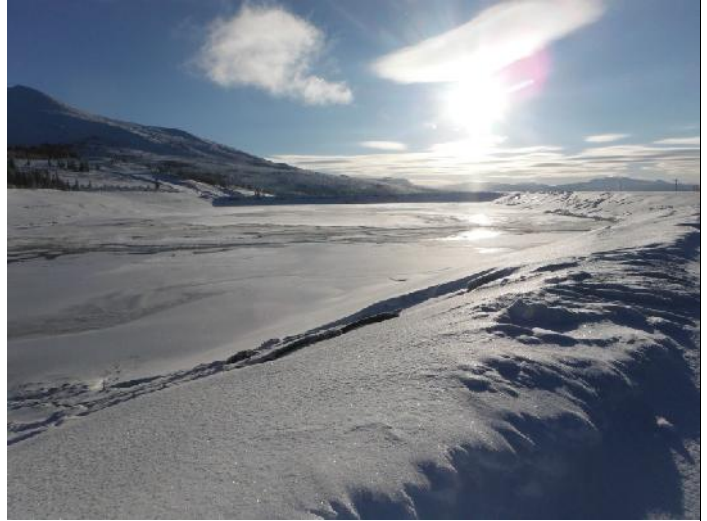
Photo 2: Looking towards barge from North West corner of TSF

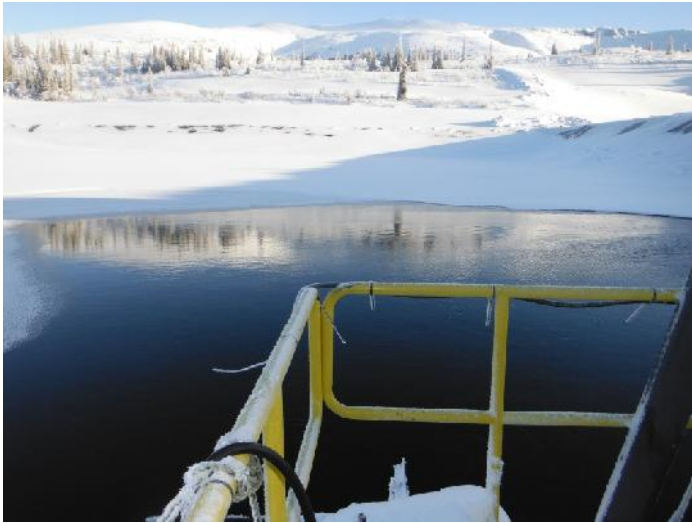
Photo 5: looking at East wall from barge

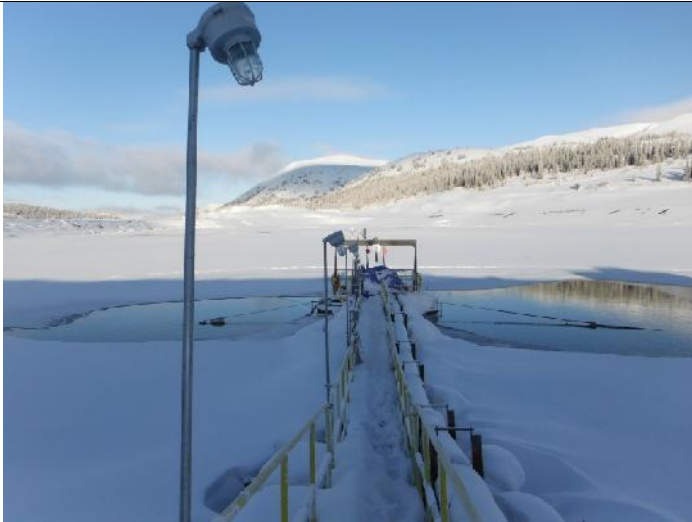
Photo 7: looking north from barge ramp

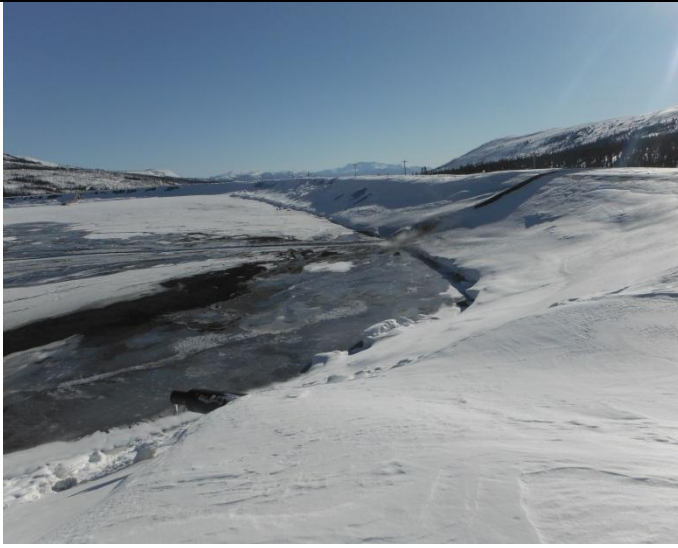
Photo 1: Looking at mill tailings discharge line with pump reclaim water pump house overflow line in foreground

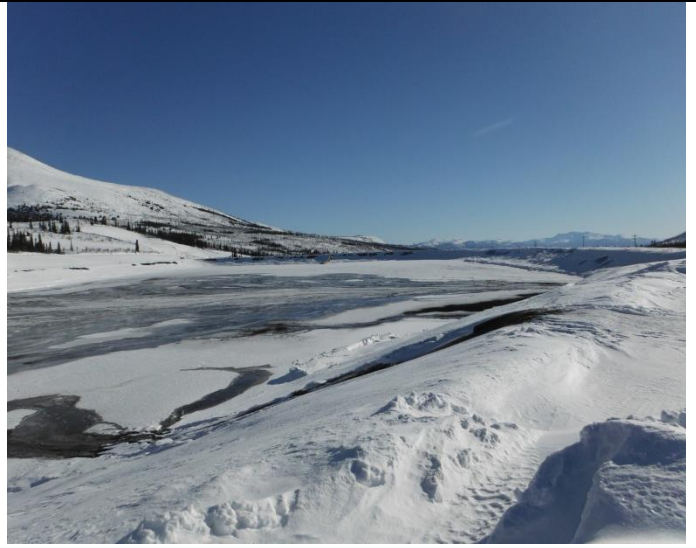
Photo 2: Looking towards barge from North West corner of TSF

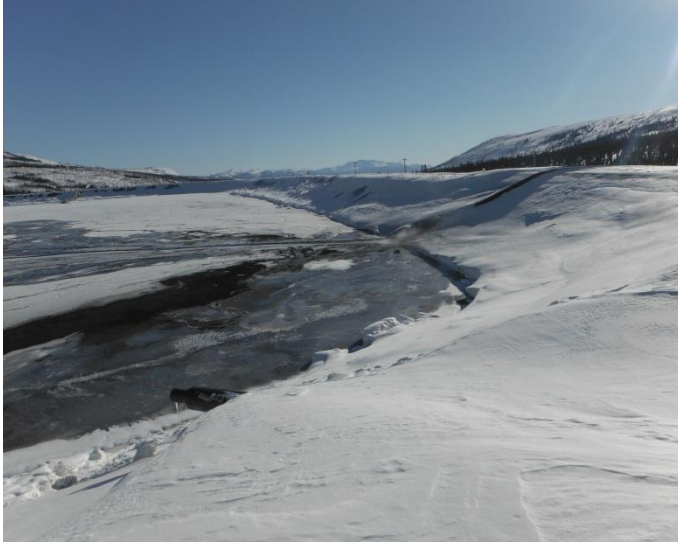
Photo 1: Looking at mill tailings discharge line with pump reclaim water pump house overflow line in foreground

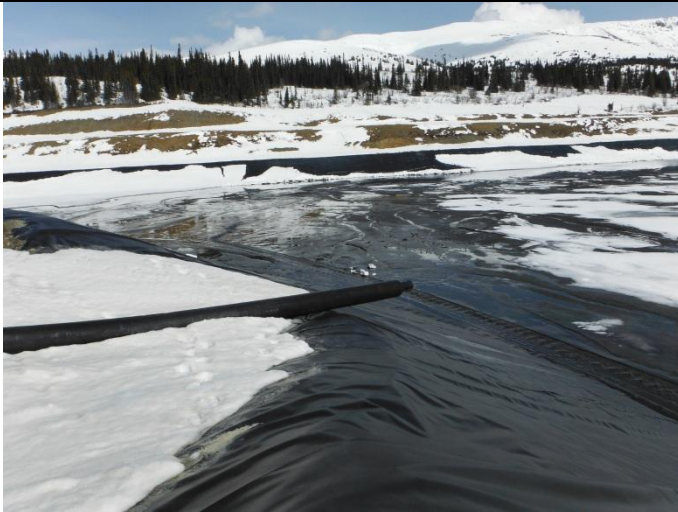
Photo 1: Looking at transfer station over flow line from North West corner of TSF

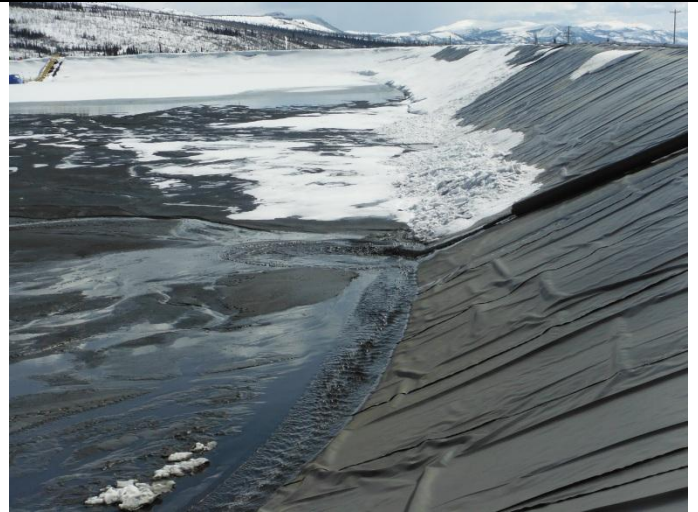
Photo 2: Looking at south wall from North West corner of TSF

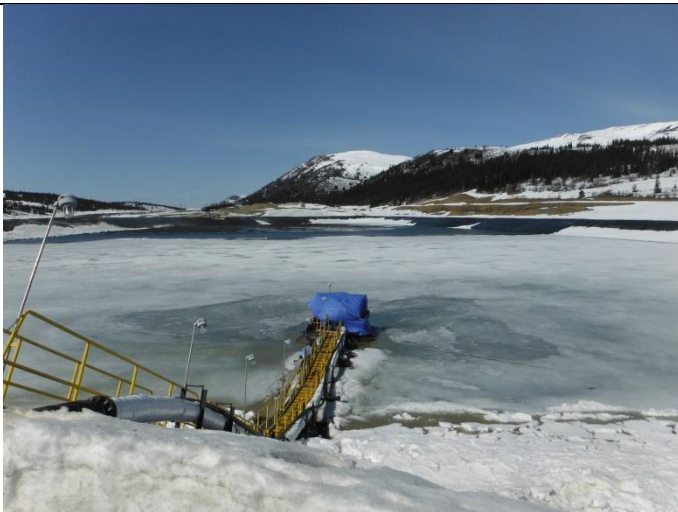
Photo 3: South wall view with walk way to the barge.

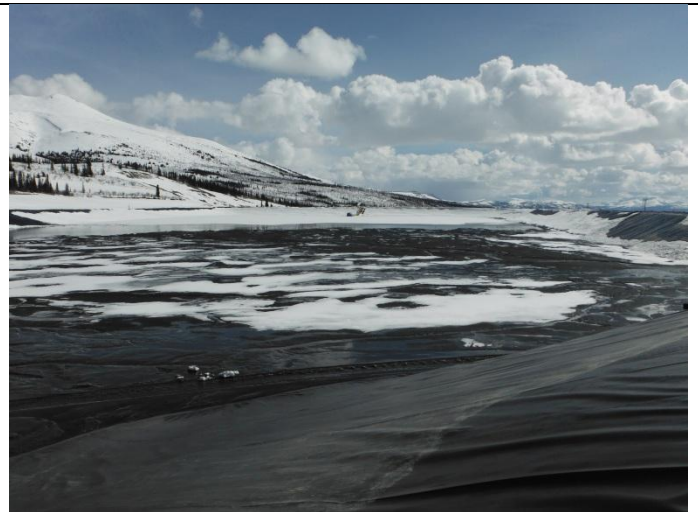
Photo 4: View of South Wall from North Wall

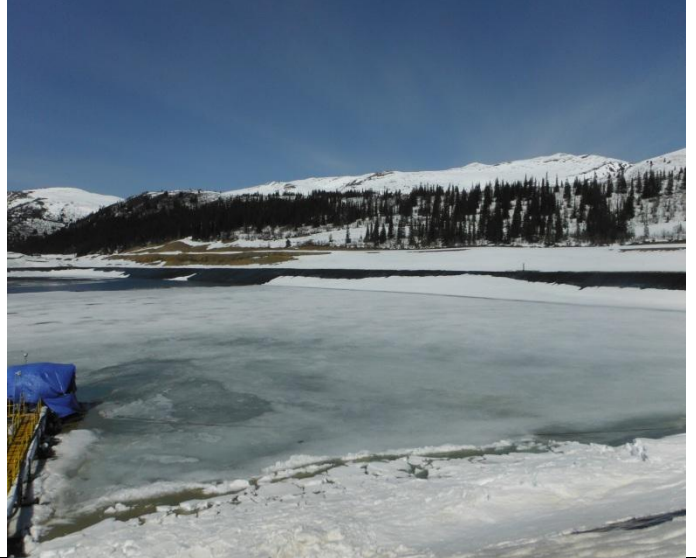
Photo 6: looking at east wall from South wall.

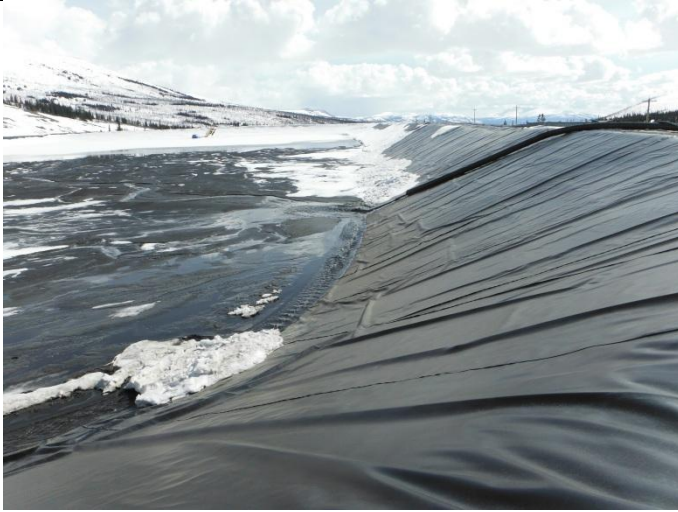
Photo 7: looking at tailings discharge from north west corner of TSF.

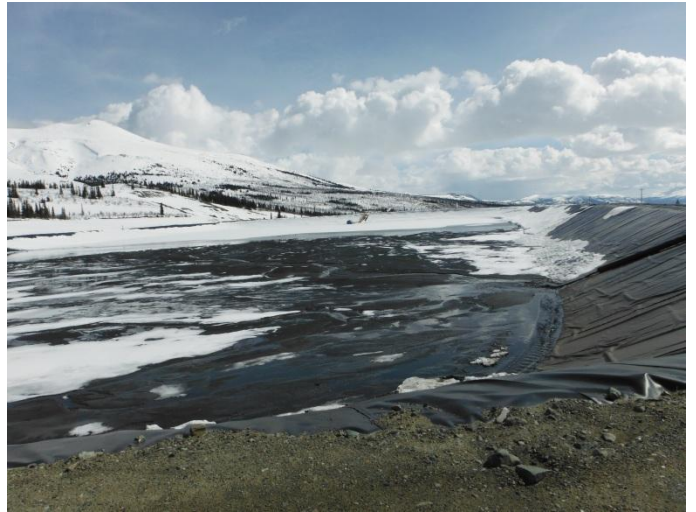
Photo 8: looking south east from transfer station.

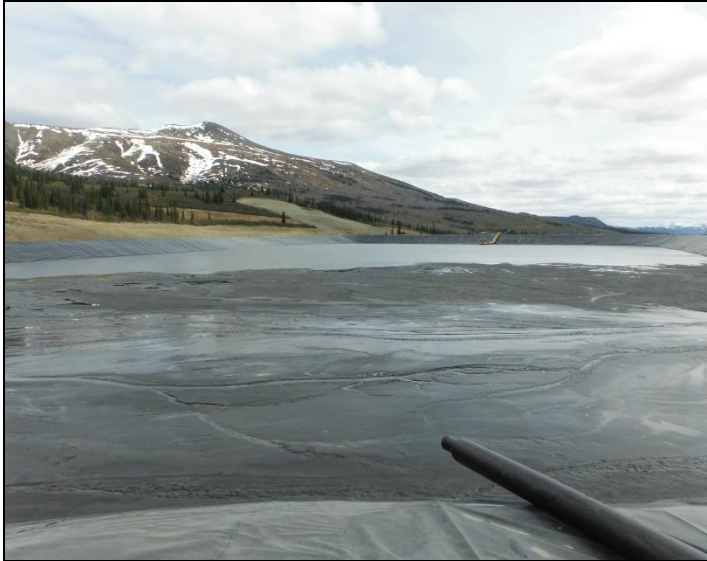
Photo 1: Looking at transfer station over flow line from North West corner of TSF

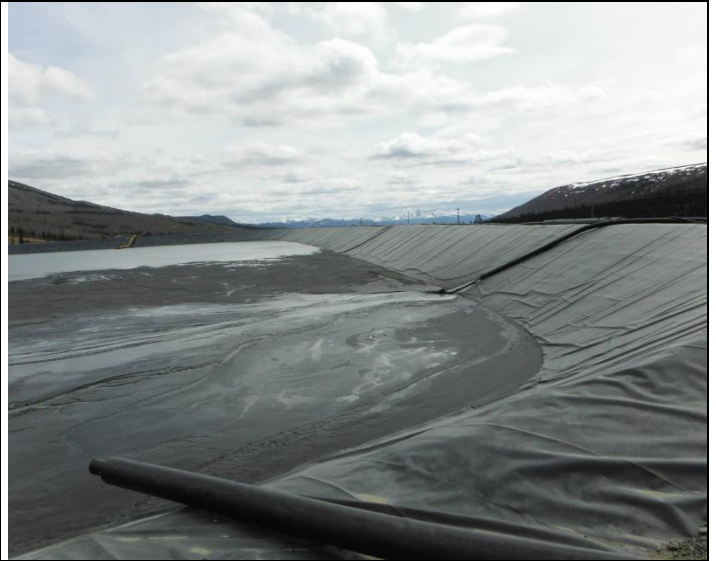
Photo 2: Looking at south wall from North West corner of TSF with Tailing discharge line in foreground.

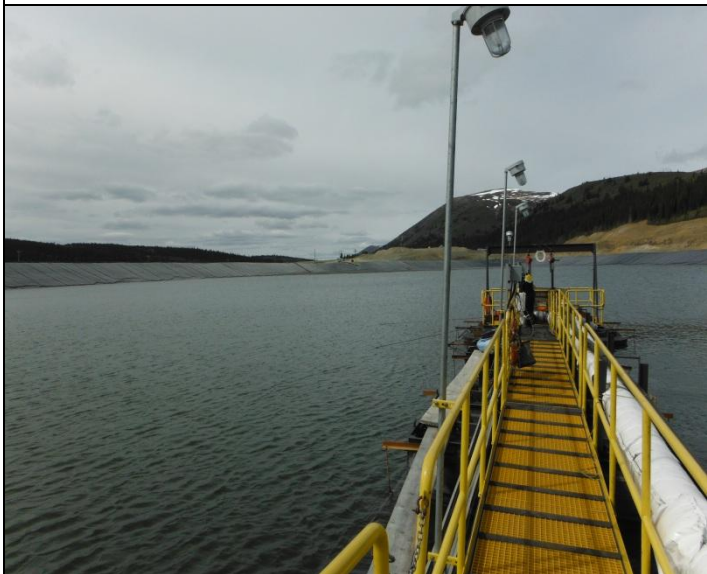
Photo 3: South wall view with walk way to the barge.

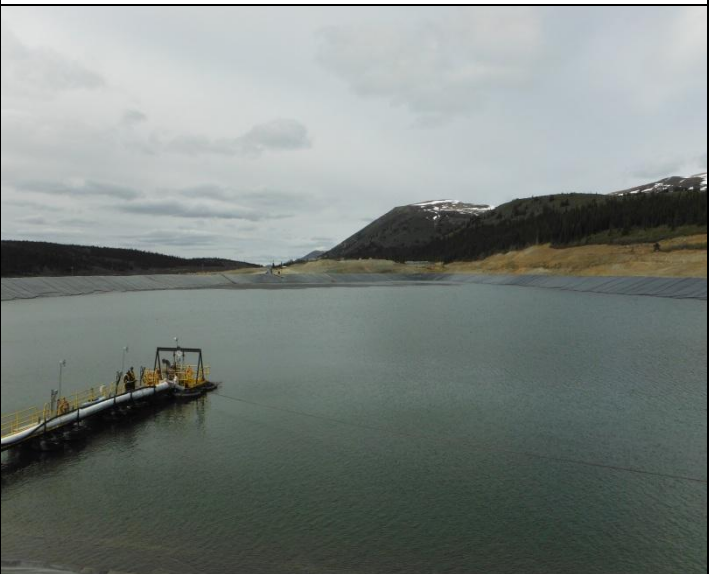
Photo 4: View of South Wall from North Wall

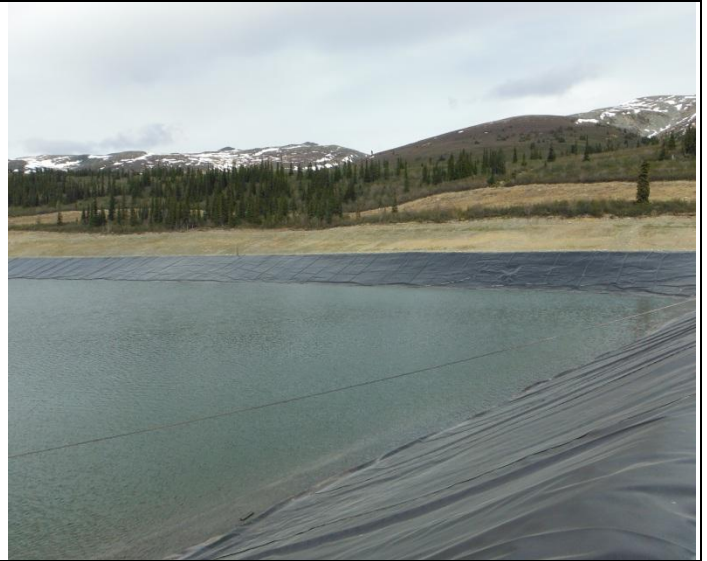
Photo 6: looking at east wall from South wall.

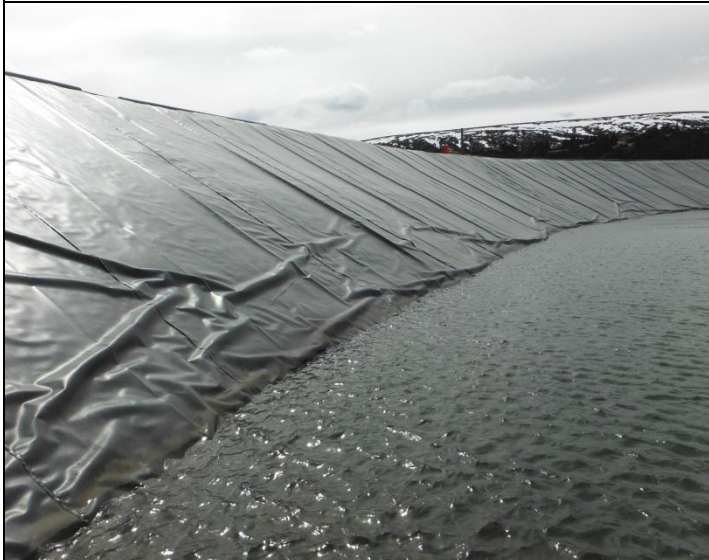
Photo 7: looking at south west corner of TSF.

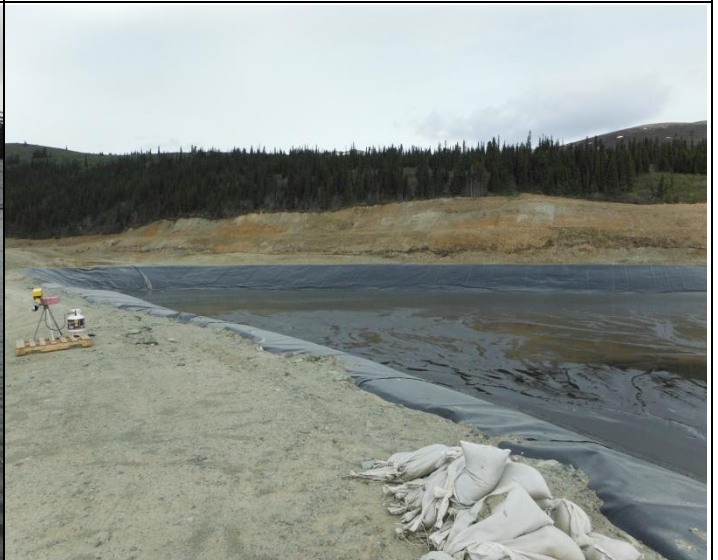
Photo 8: looking east from transfer station.

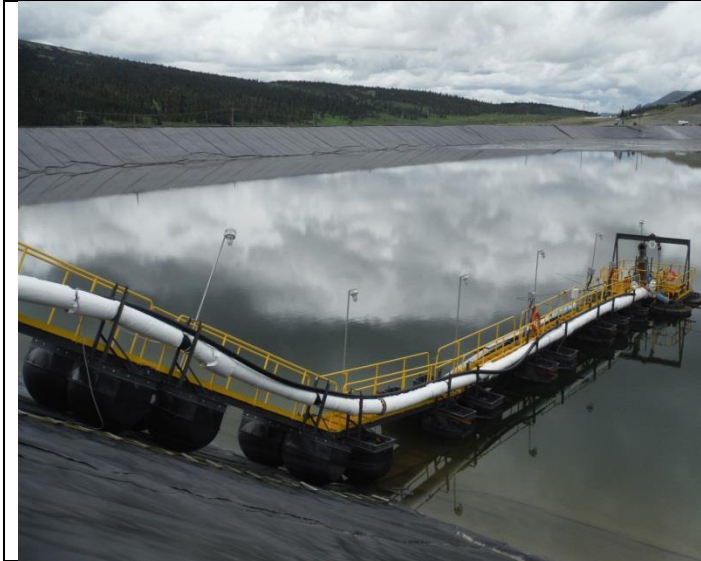
Photo 1: Looking at barge pumping station and discharge line –walk way @East dam & the South wall of TSF

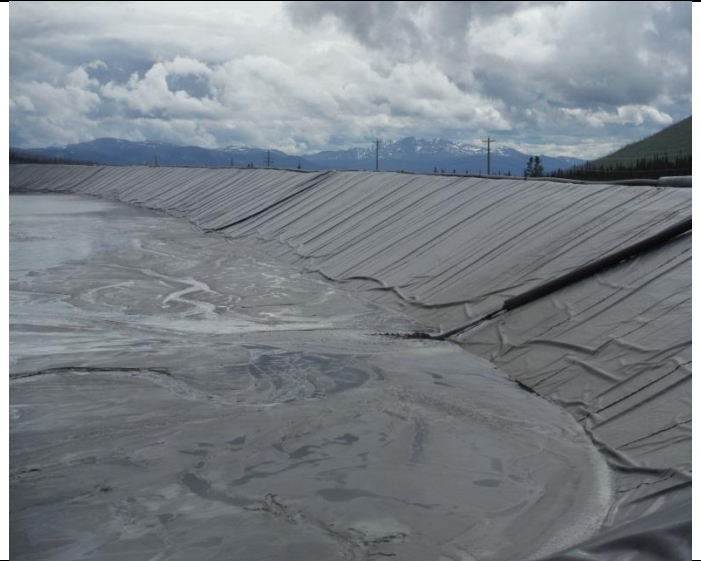
Photo 2: Looking at south wall from North West corner of TSF with Tailing discharge line in foreground.

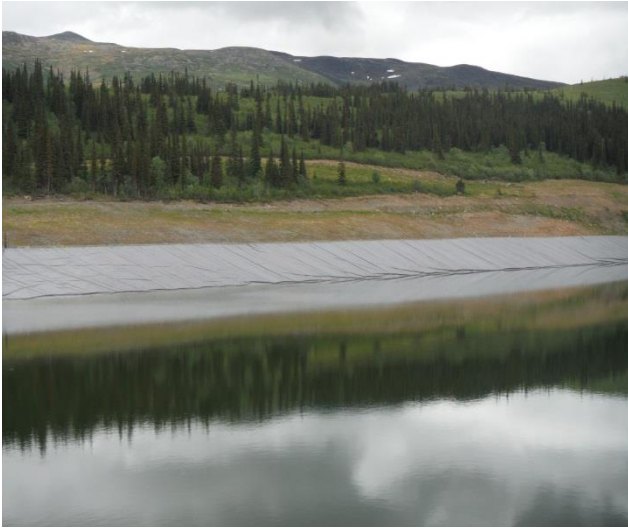
Photo 5: looking at the north wall.

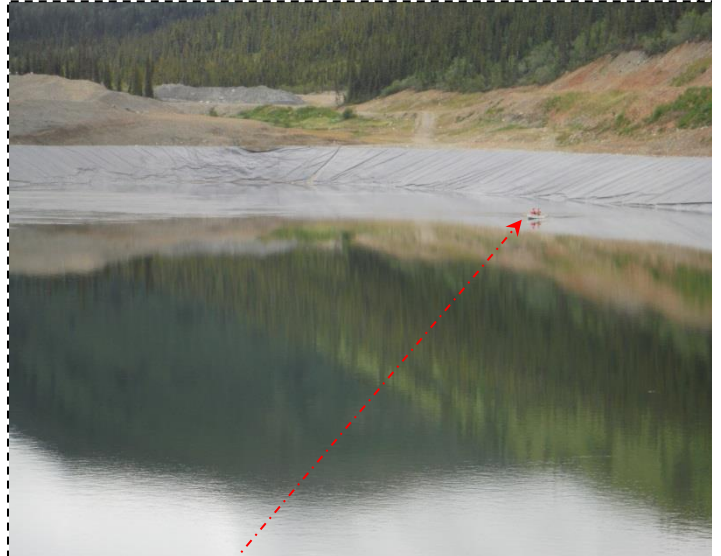
Photo 6: looking at Northwest corner from barge bathometric survey being performed.

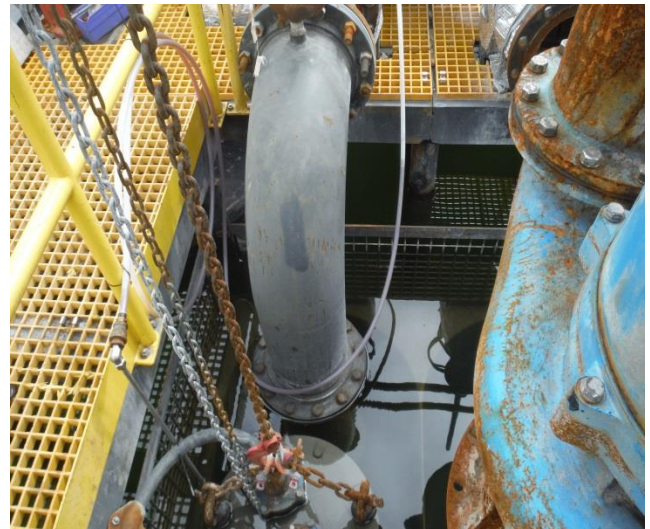
Photo 8: looking barge pump 1 with Winterhib anti-scalent line being added & tested.

2. Brief on any maintenance: No major reported service\repair maintenance on barge or booster pump during the month. Winterhib Anti-scalant application into suction inlet the barge pump #1 continues at dose rate of 30 cc/min. The stainless steel coupon that was installed in reclaim water system in the mill will to be removed on Aug 6th to analyze for scale formation after 60-days of anti-scalent application & will send to Power Chemicals in Vancouver. Maintenance is preparing to work on the barge\pumps de-icing blower & moving the 20' sea-can for de-scalant system & lines winterization.

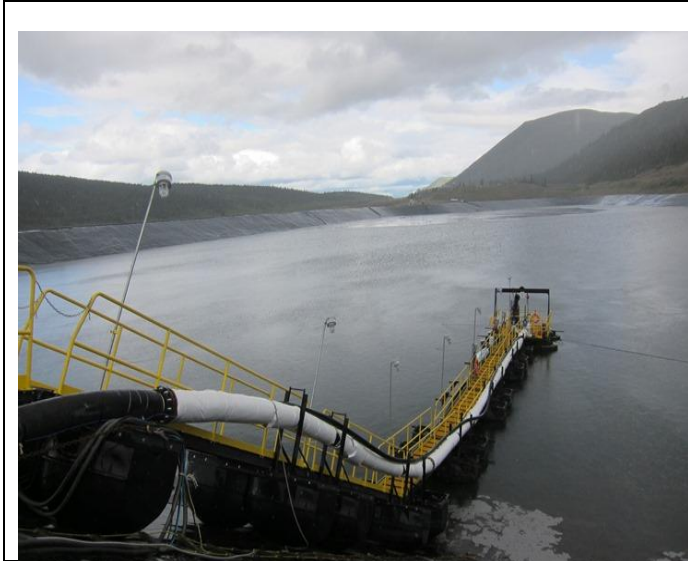
Photo 1: Looking at Barge pump station & its discharge line from East side of TSF

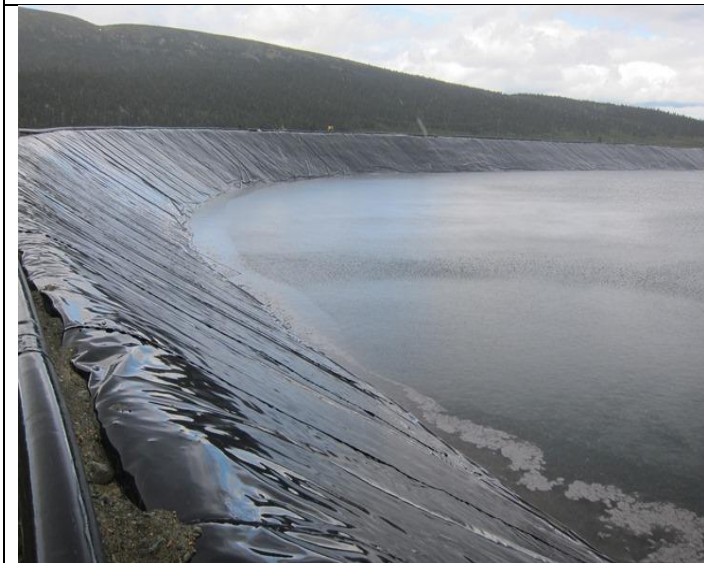
Photo 3: South-east corner view from east side of TSF.

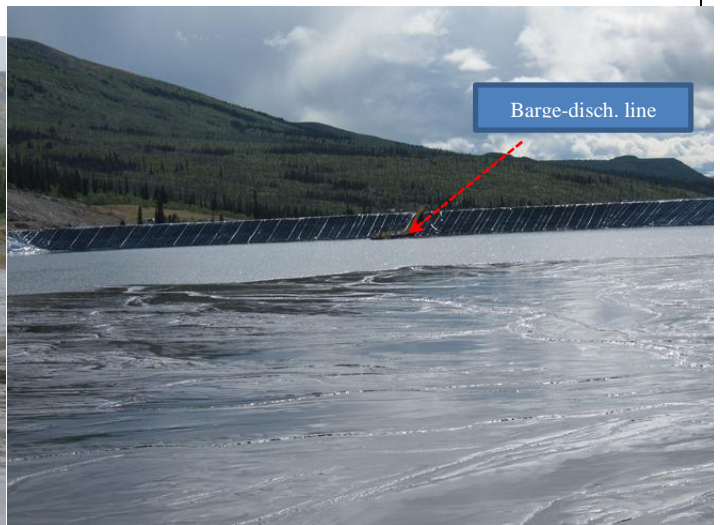
Photo 8: looking east from transfer station.

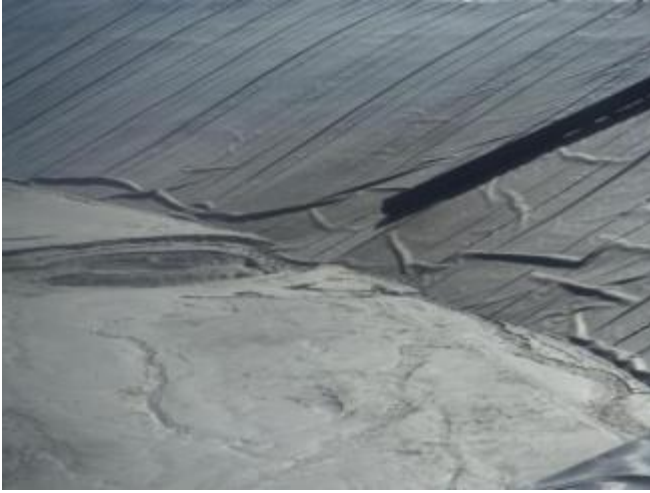
Photo 1: Looking at original discharge location on east side of TSF.

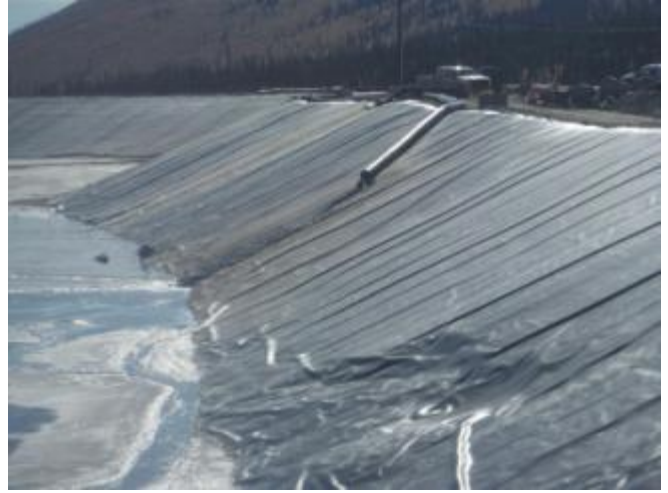
Photo 2: Looking at north-west corner of TSF showing current location of discharge line.

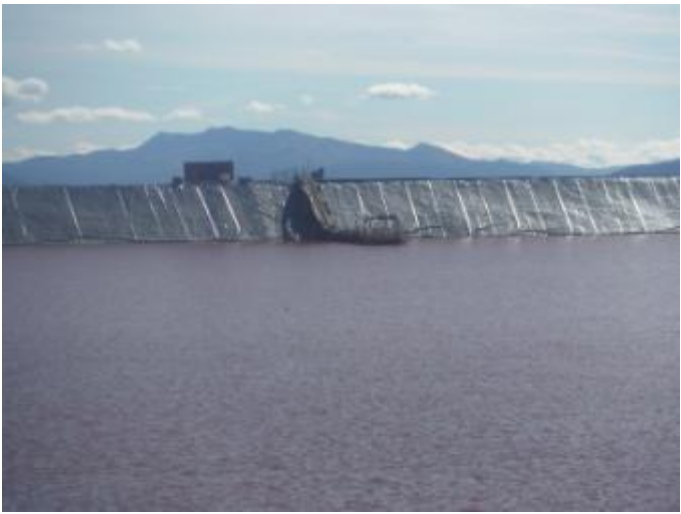
Photo 3: View of Barge for North-east side of TSF.

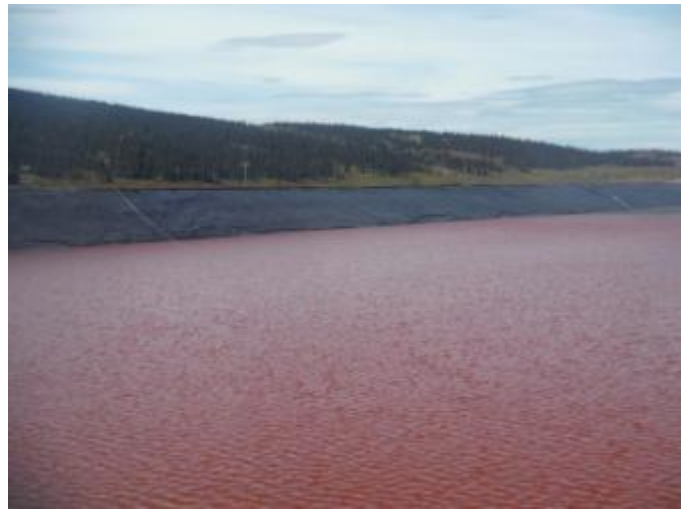
Photo 4: View of South-west wall from the South side of TSF.

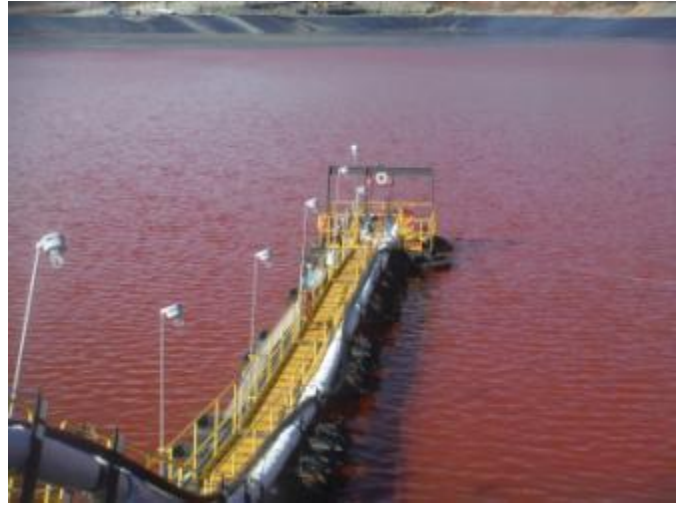
Photo 6: Closer view of barge pump system.

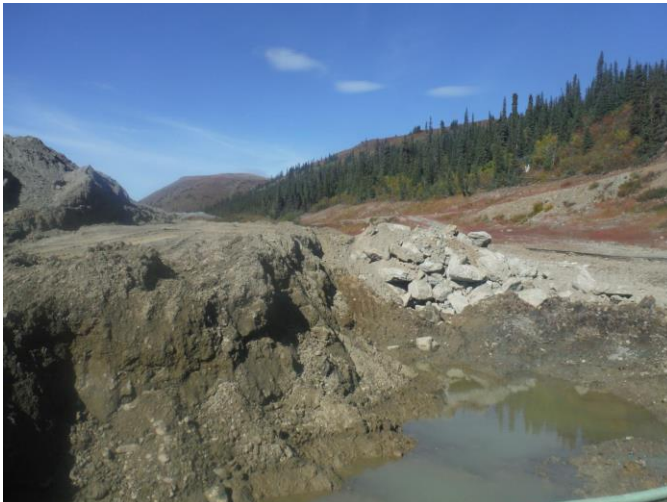
Photo 7: Current construction/rehabilitation of Ditch A on the North end of TSF.

3. Mill time is expected to continue running for September. No plans for maintenance at this point.
4. Rehabilitation of Ditch A and the North slope of the Tailings Pond was started during the month of August, construction of a new sump to divert overland and groundwater springs is currently underway and work will continue into the month of September.
5. Six survey monuments were installed in the Tailings Dam to replace damaged inclinometer casings. These points will require some further adjustment and then they will be monitored monthly by the surveyor.

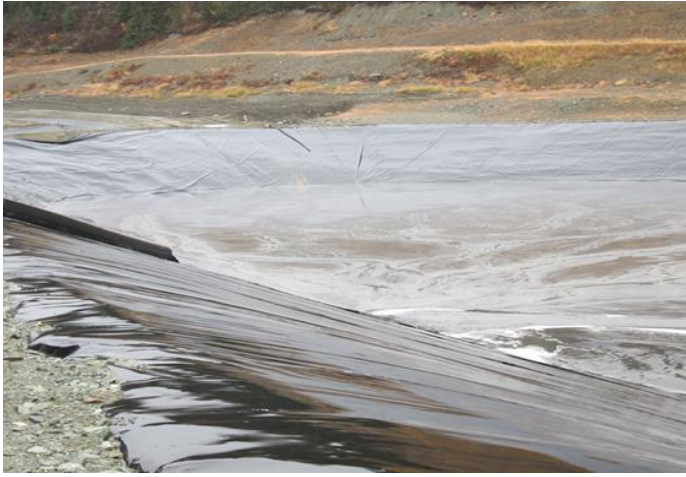
Photo 1: Looking at discharge location at south-west corner side of TFS showing liner movements in the west wall.

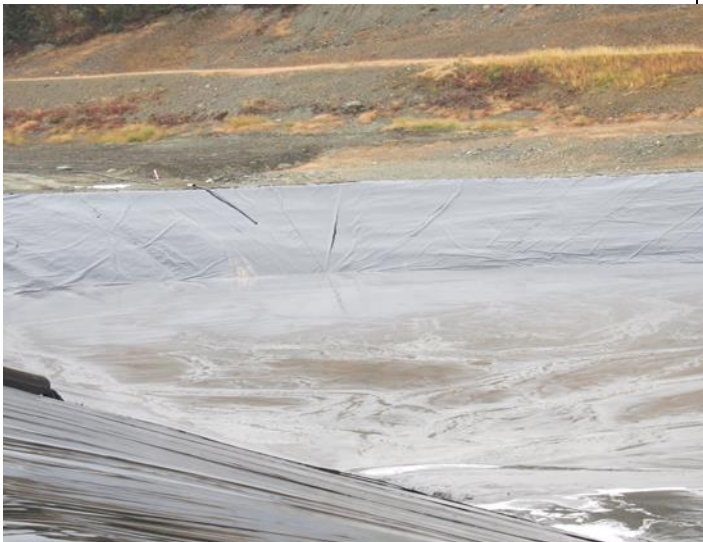
Photo 3: Closer view of discharge pipe location North-west corner of TFS.

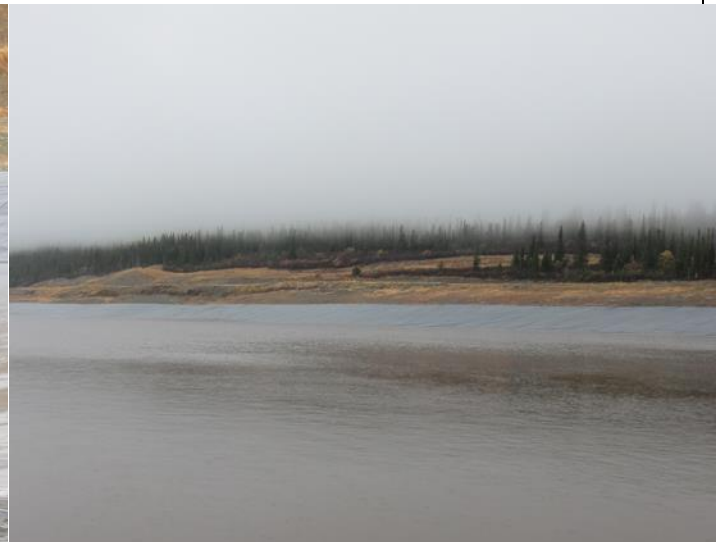
Photo 4: View of North wall of TFS.

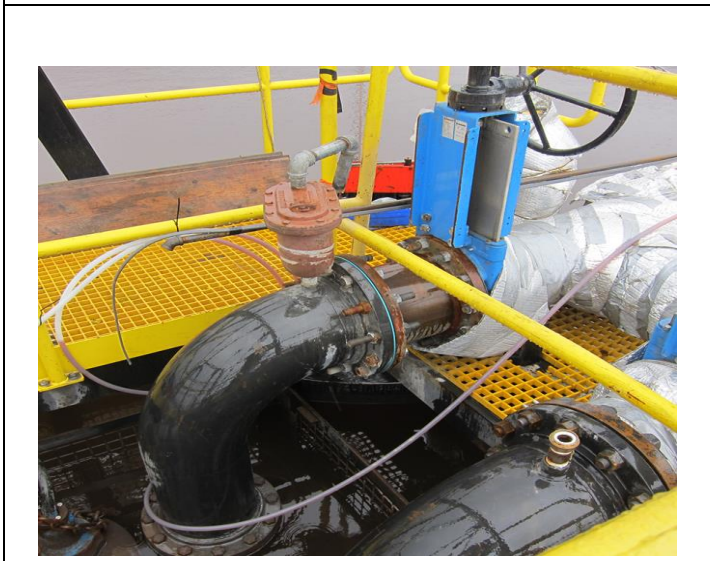
Photo 7: Closer picture of barge pumping station.

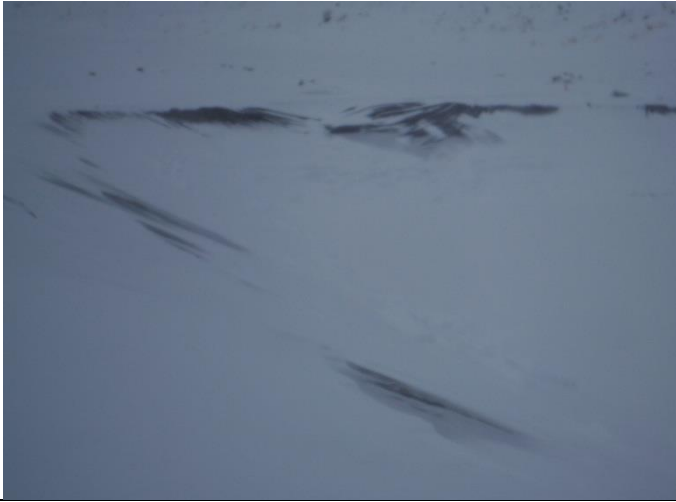
Photo 1: Looking at south-west corner side of TSF showing liner movements in the west wall.

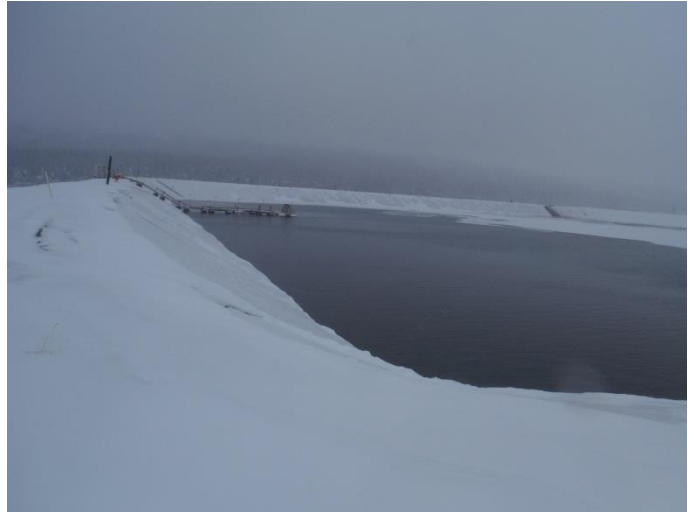
Photo 2: Looking at the south wall of TSF.

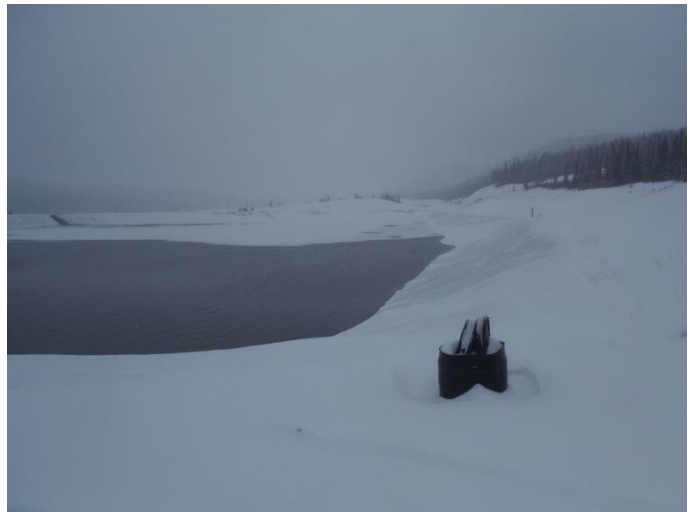
Photo 4: View of North wall of TSF.

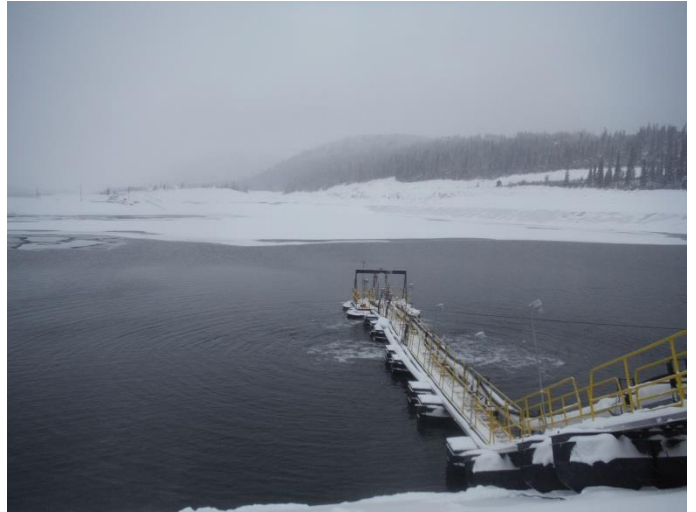
Photo 6: Closer view of barge pump system.

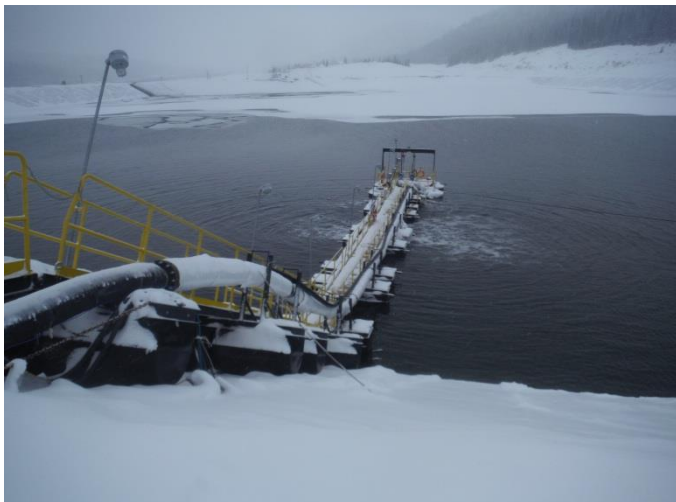
Photo 7: Closer picture of barge pumping station.

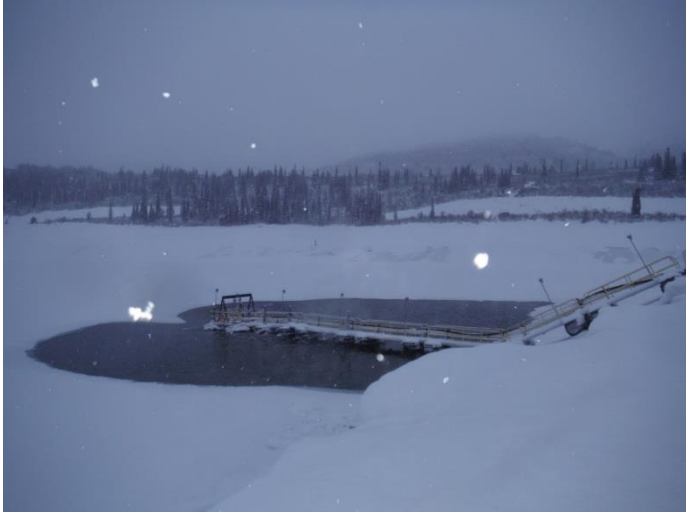
Photo 1: Looking at south east corner side of TSF and barge station.

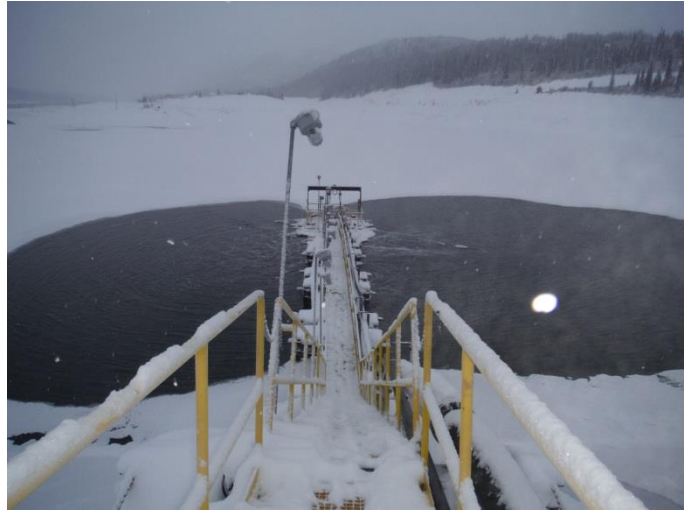
Photo 2: Looking over the barge station towards the north side.

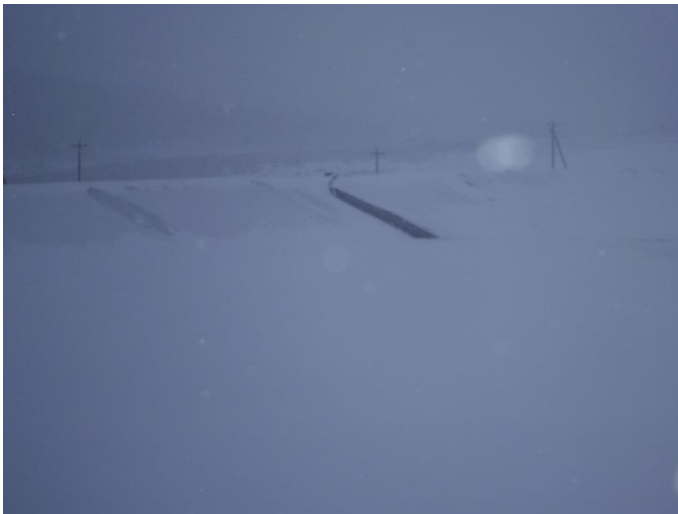
Photo 3: Closer view of discharge pipe location North-west corner of TSF.

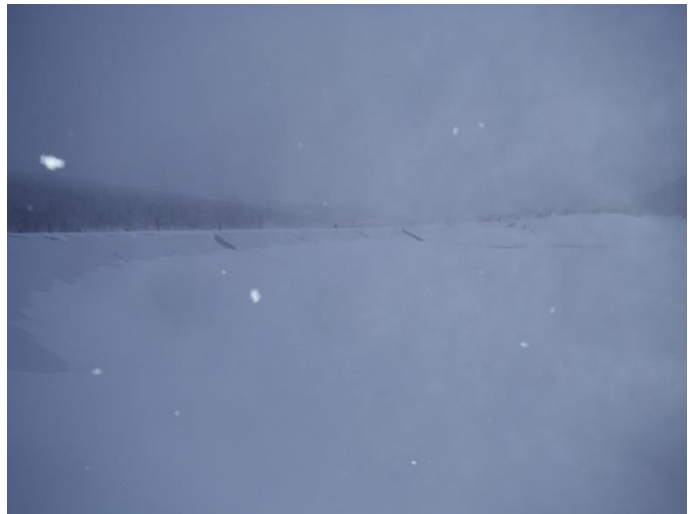
Photo 4: View of north and west walls of TSF.

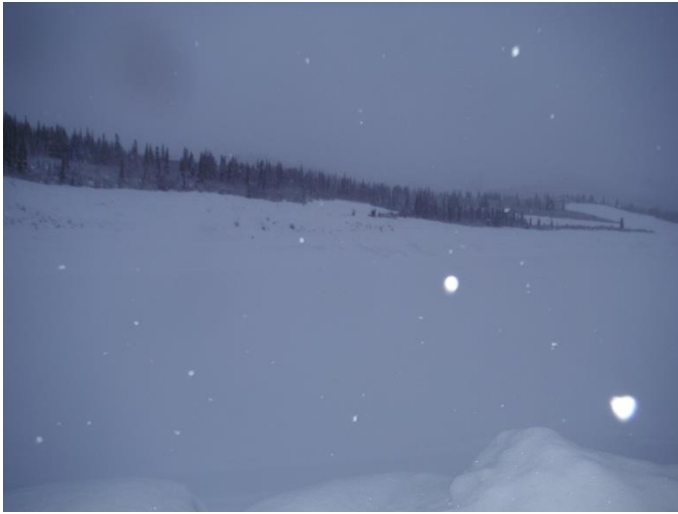
Photo 5: View of east slope from the north side of the TSF.

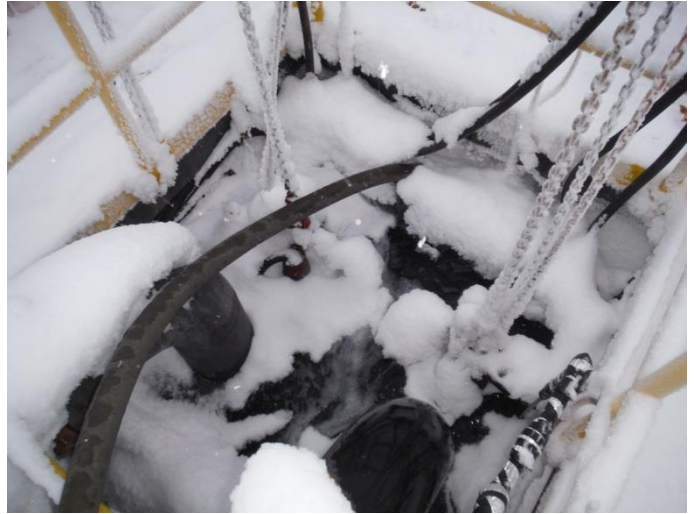
Photo 6: Closer view of barge pumps.

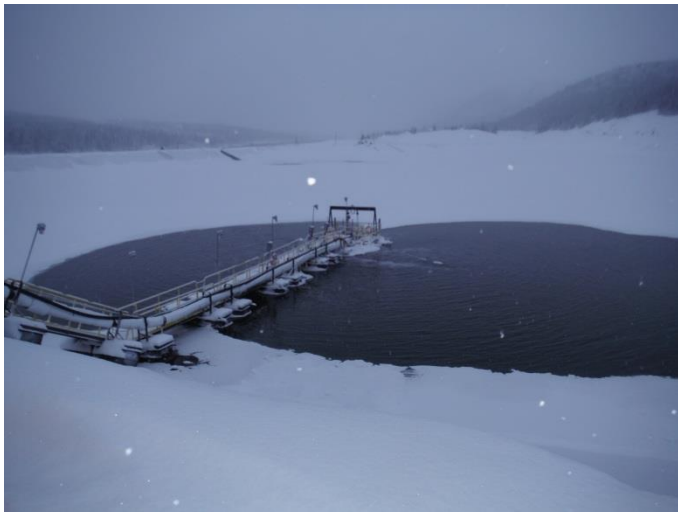
Photo 7: Closer picture of barge pumping station.

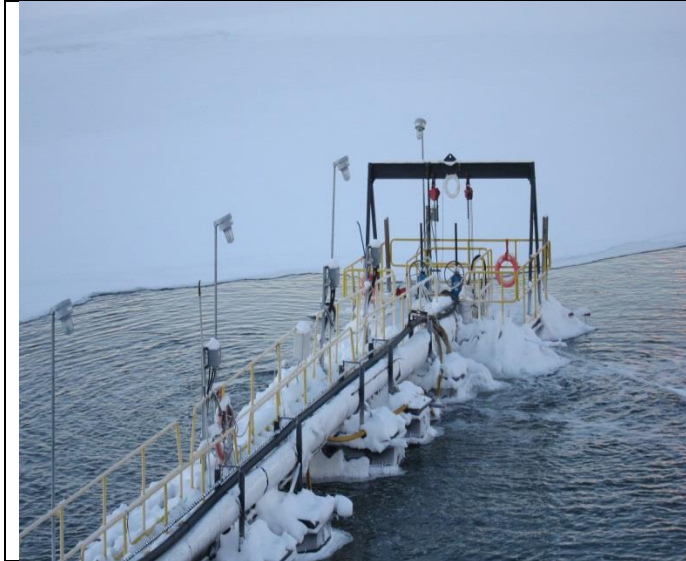
Photo 1: Looking at barge station.

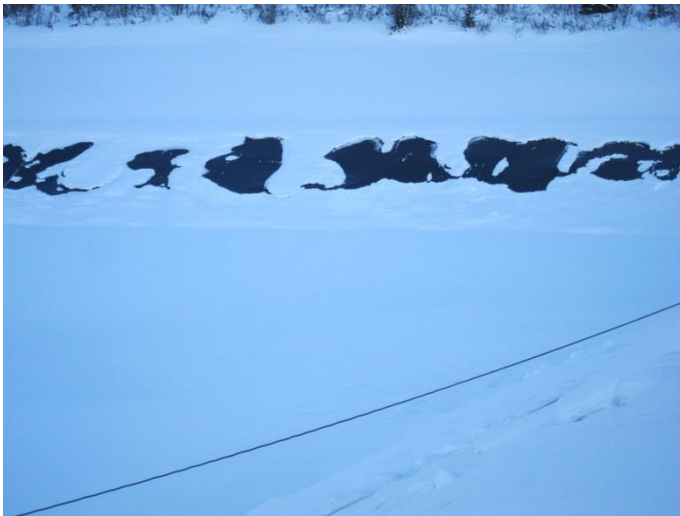
Photo 3: Showing NE view corner from barge pump platform.

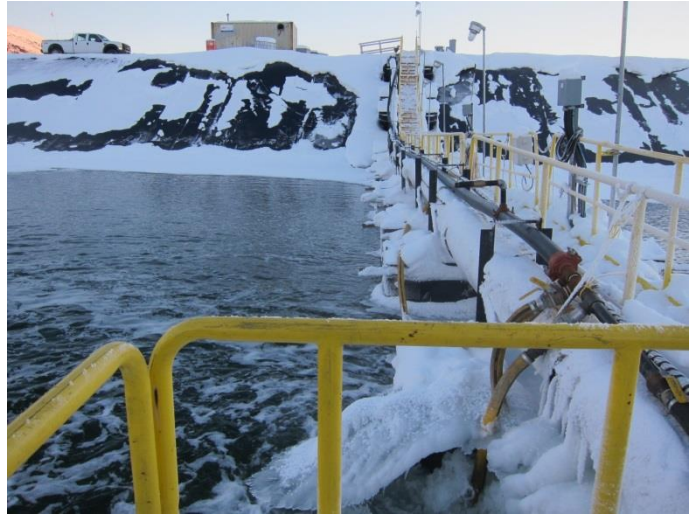
Photo 6: East side of TSF view from barge pumps.

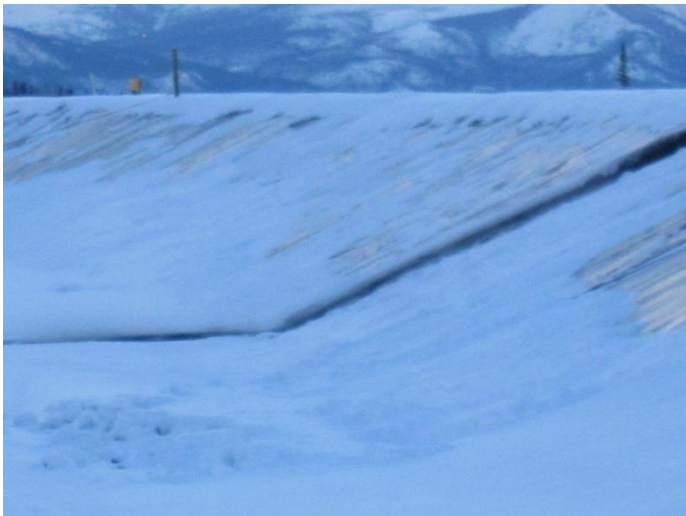
Photo 7: View of tails discharge pipe at center south of TSF.
