**Mayo Lake Generating Station Re-Development**  
**Mollard Memo November 17, 2008**

**Re: Yukon Energy Corporation -- Mayo Lake Generating Station Re-development**

To provide preliminary thoughts on shore erosion changes that may result from lowering the Mayo Lake minimum drawdown level by 1m or raising the maximum full supply level by 1m.

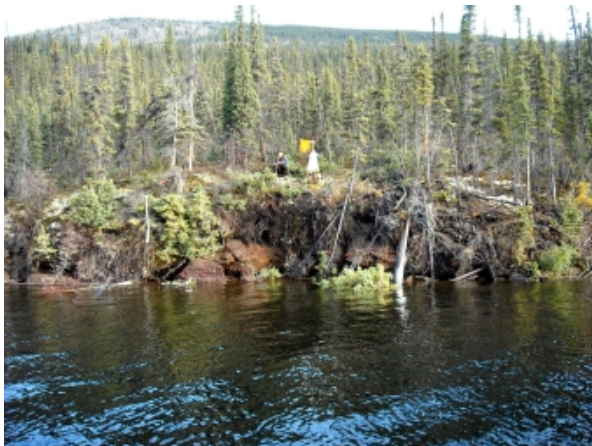
J.D. Mollard and Associates Limited NOVEMBER 2008 **FIGURE 4**

Figure 4 shows an enlarged view of the shore zone profile at cross-section 11, located on the east shore of the southeast arm of Mayo Lake. This cross-section serves as a good example to illustrate the main components of an eroding shore zone profile. The maximum and minimum water levels under the current Mayo Lake operational scheme are shown on the cross-section. The two main geomorphic components of an eroding shore zone are the bluff face and the nearshore slope. As waves approach the shoreline, wave shear stresses are transferred to the lake bottom where water depths are shallower than the wave base depth. If lake bottom sediments are erodible, these shear stresses erode the lake bottom in the nearshore zone (*i.e.*, where water depths are less than the wave base depth). This process is referred to as nearshore downcutting.

The second component of the erosion process is toe-of-bluff erosion which occurs when water levels are sufficiently high so that wave energy is dissipated at the bluff toe. Toe-of-bluff erosion leads to bluff recession as the bluff face is undercut by wave action and the bluff fails due to mass wasting processes.

CROSS-SECTION (XS-11) SHOWING THE MAIN COMPONENTS OF AN ERODING SHORE ZONE PROFILE

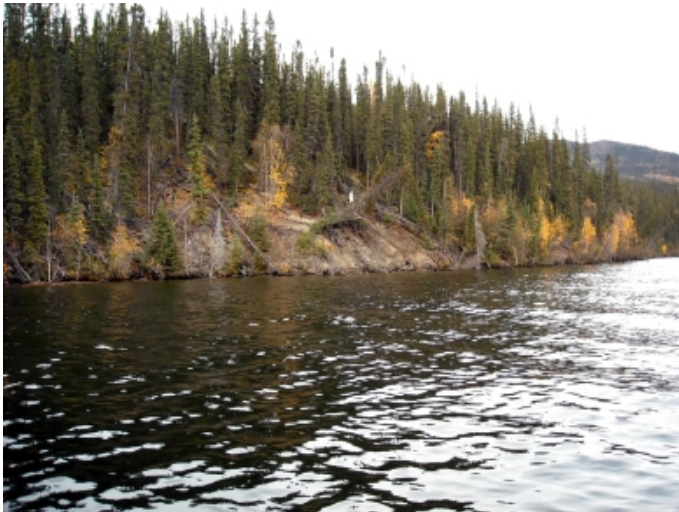
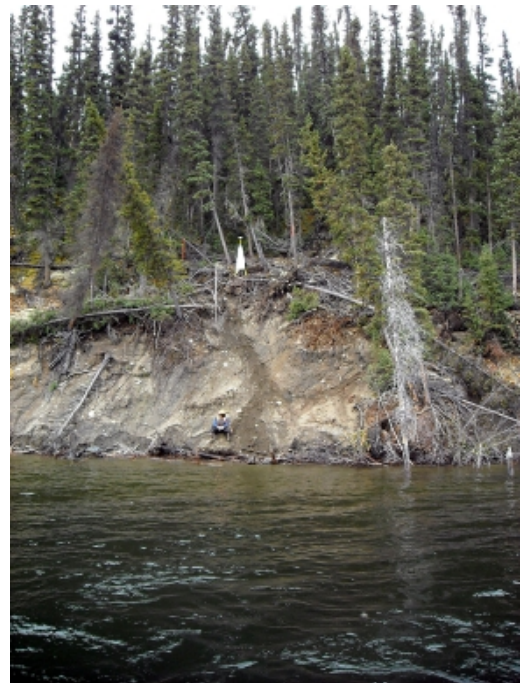
FIGURE 5A

**Cross-section 1 (Figure 5a,b):** This cross-section is located in morainal terrain and experiences low to moderate erosion activity under existing conditions.

Surficial Geology: Moraine  
 Erosion Activity: Low-Moderate  
 Grain Size: coarse sand - fine gravel  
 (re-worked?)

CROSS-SECTION PROFILE AT SITE XS-1, MAYO LAKE

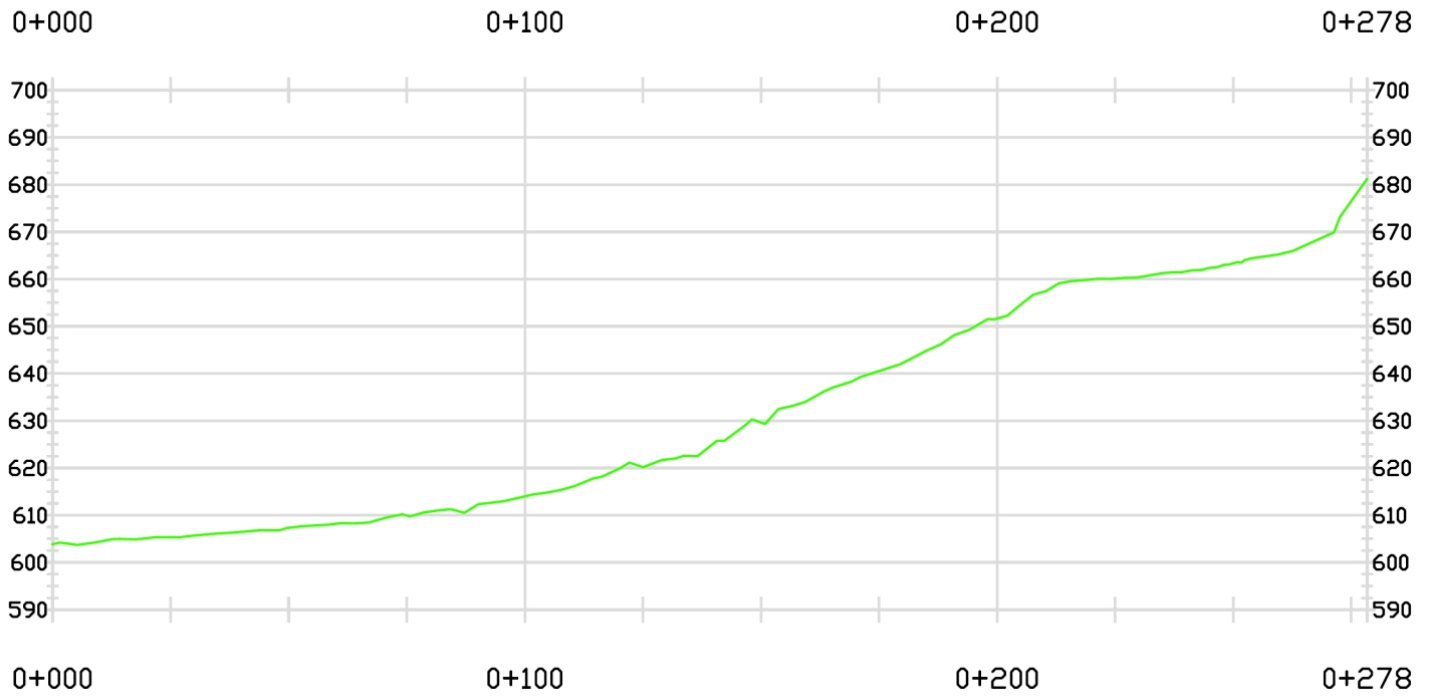
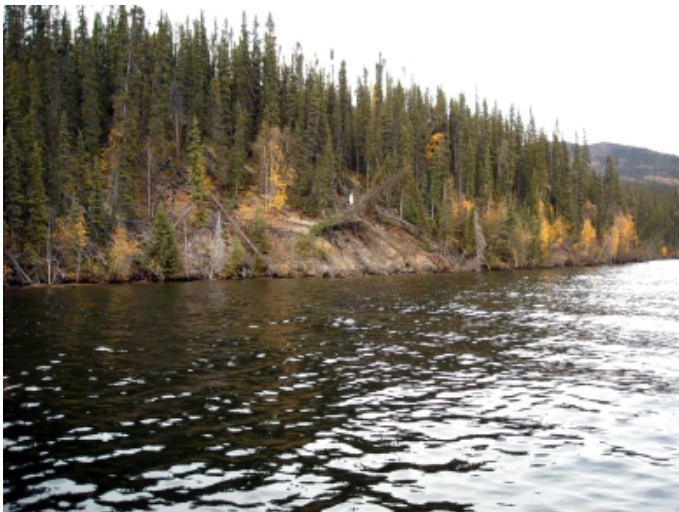
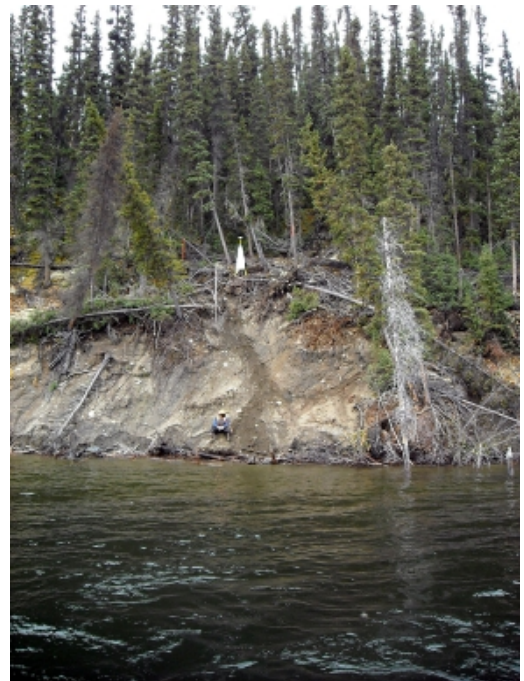
FIGURE A1

Surficial Geology: Moraine  
 Erosion Activity: Low-Moderate  
 Grain Size: coarse sand - fine gravel  
 (re-worked?)

CROSS-SECTION PROFILE AT SITE XS-1, MAYO LAKE

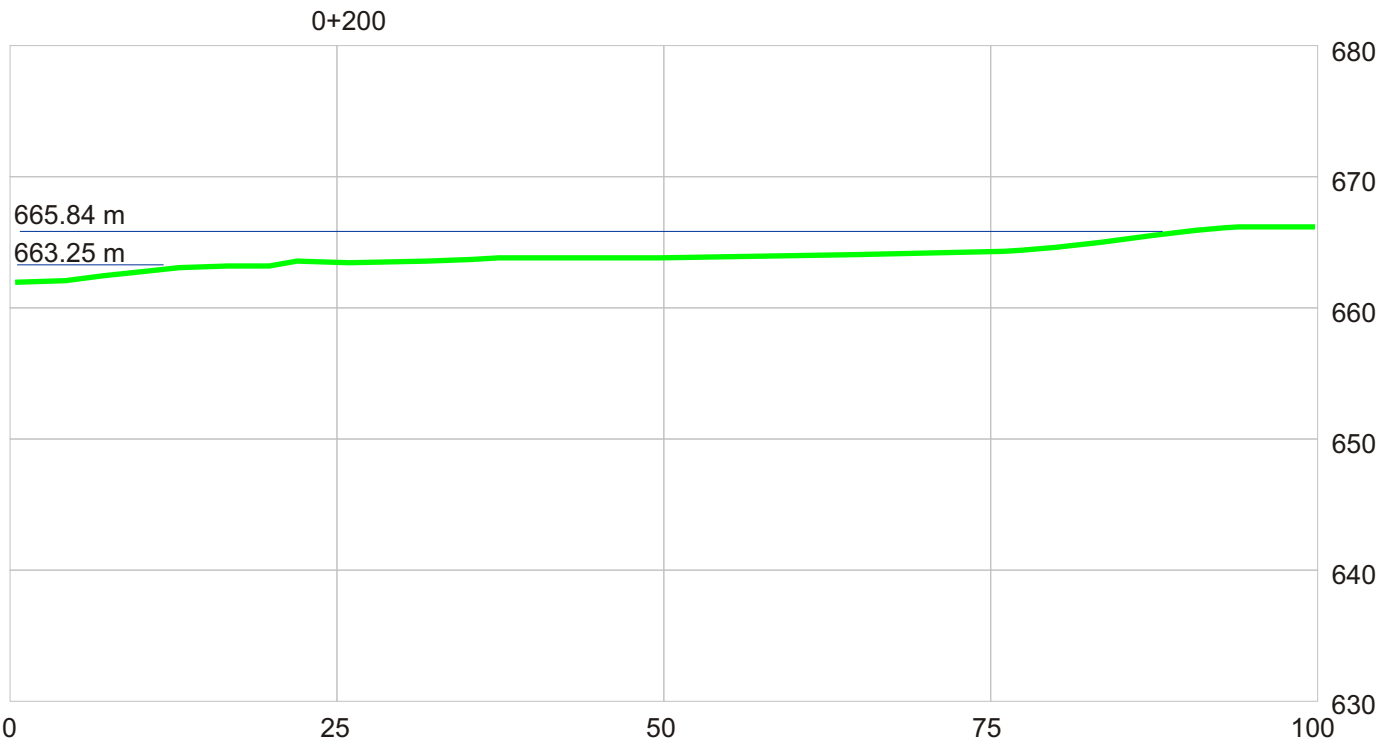
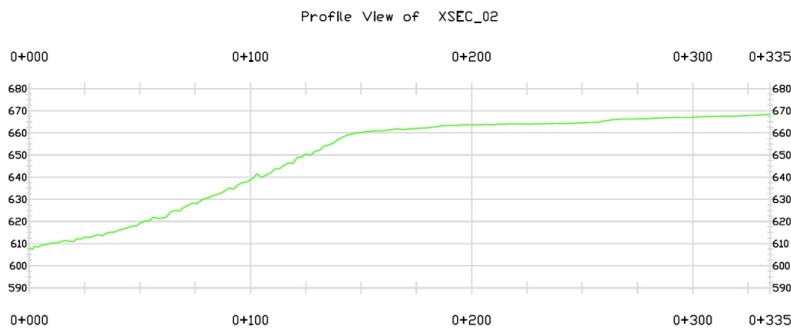
FIGURE A2

Surficial Geology: Alluvial Fan  
 Erosion Activity: Low-Moderate  
 Grain Size: coarse sand, fine gravel  
 (alluvium)

CROSS-SECTION PROFILE AT SITE XS-2, MAYO LAKE

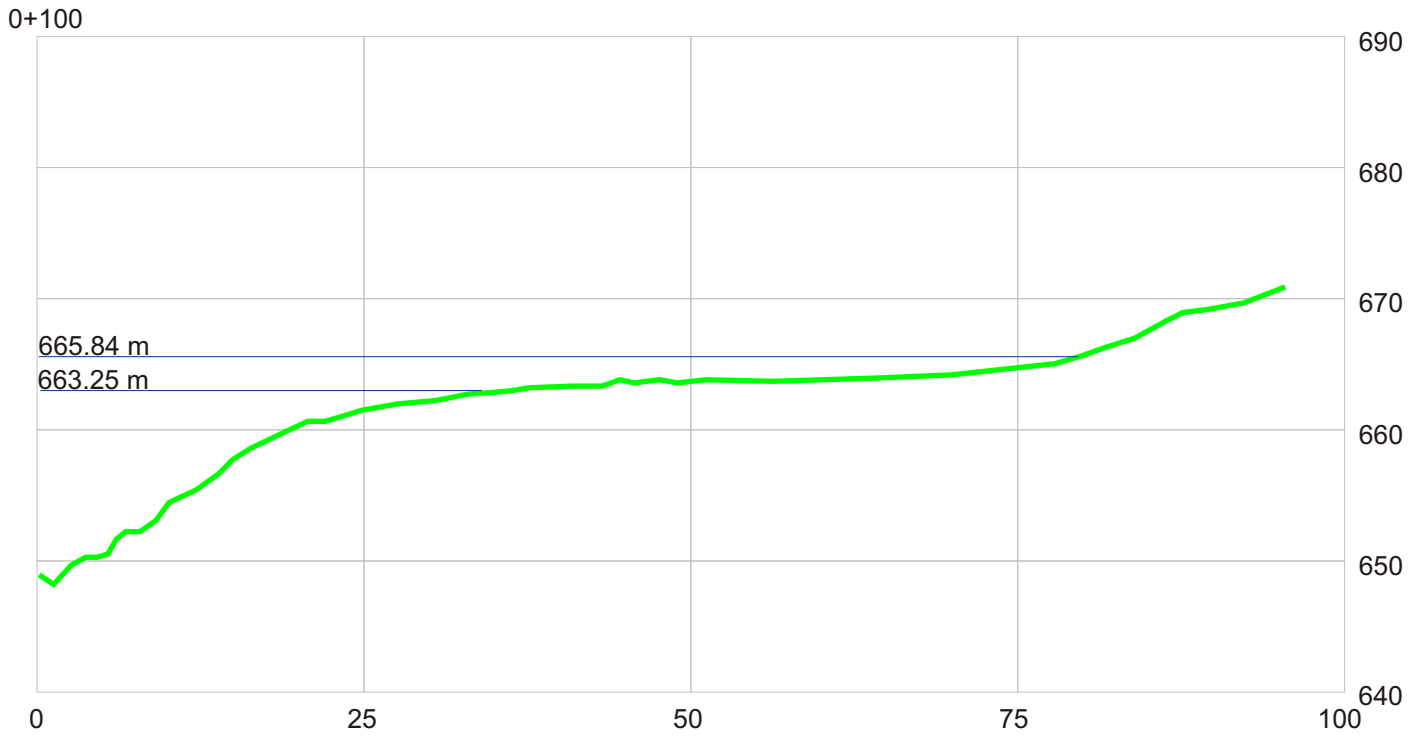
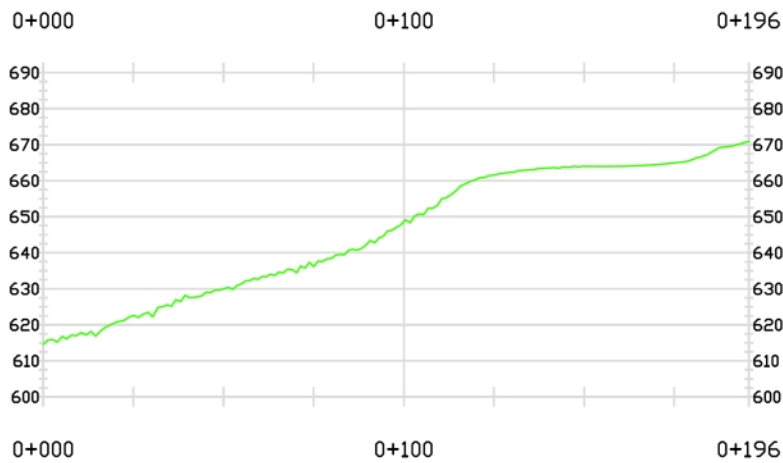
FIGURE A3

Surficial Geology: Moraine  
 Erosion Activity: Low  
 Grain Size: clay, coarse sand, fine gravel  
 (till)

CROSS-SECTION PROFILE AT SITE XS-3, MAYO LAKE

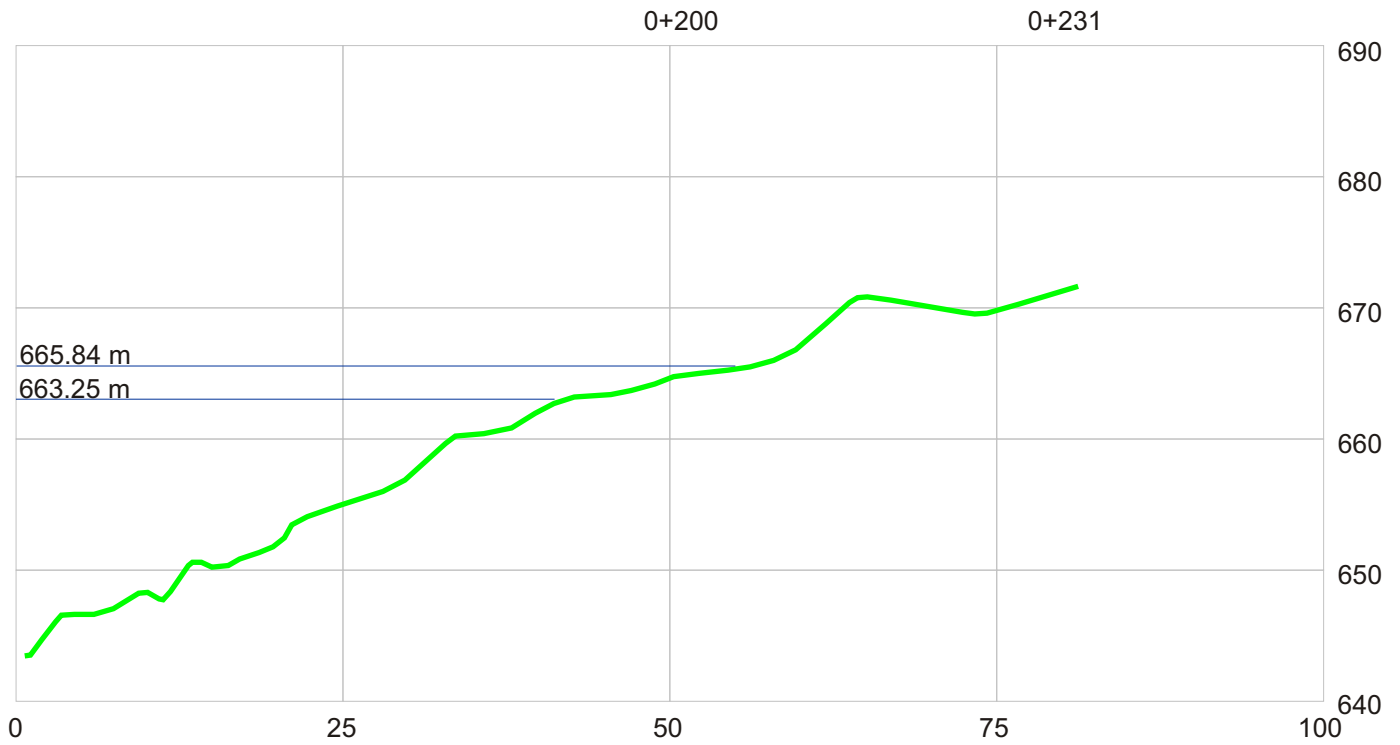
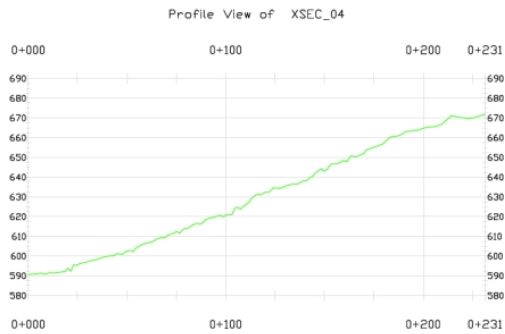
FIGURE A4

Surficial Geology: Moraine  
 Erosion Activity: Low  
 Grain Size: clay, sand, gravel, organics (till?)

CROSS-SECTION PROFILE AT SITE XS-4, MAYO LAKE

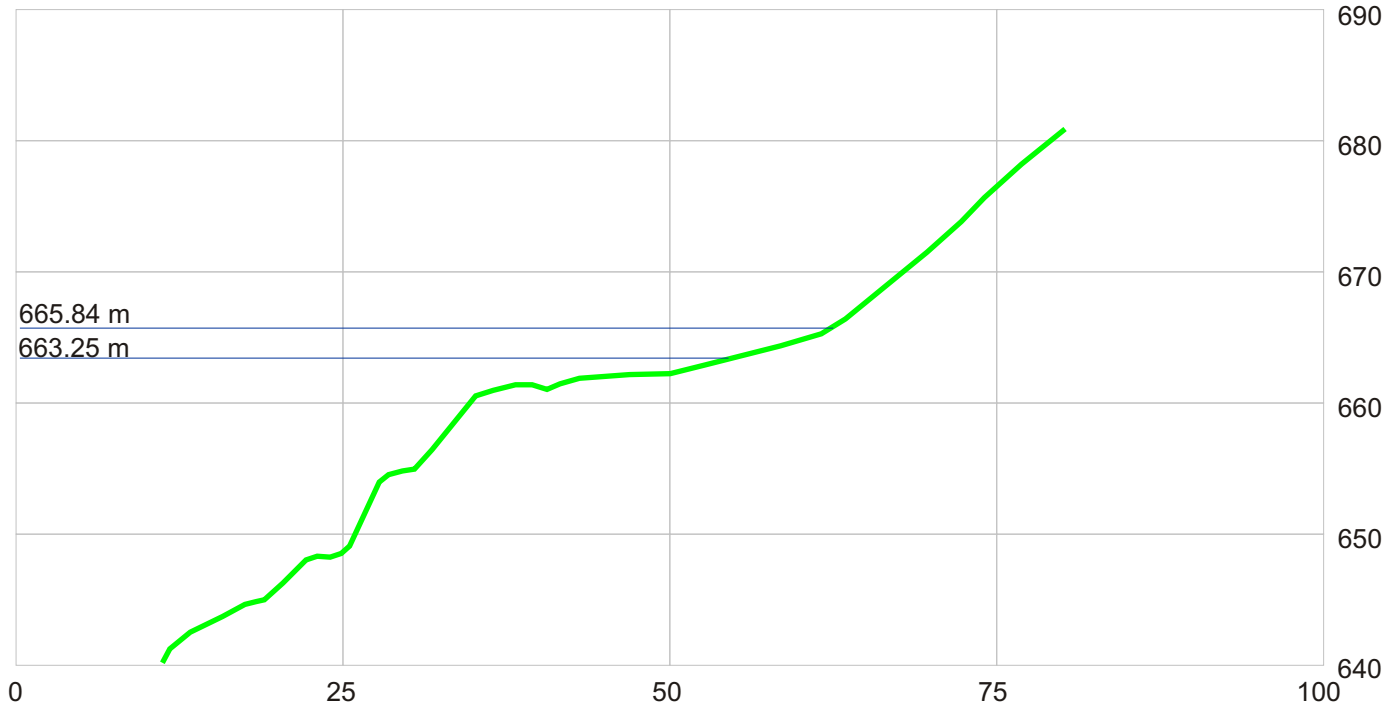
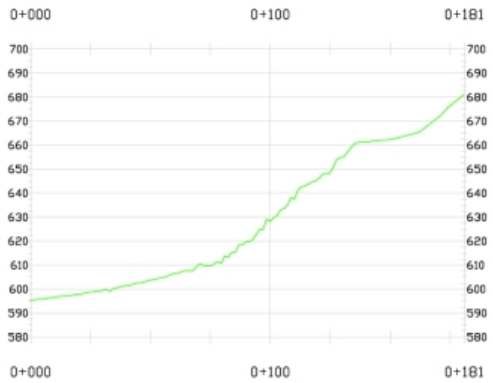
FIGURE A5

Surficial Geology: Moraine  
 Erosion Activity: L  
 Grain Size: clay, silt, sand, gravel (till)

CROSS-SECTION PROFILE AT SITE XS-5, MAYO LAKE

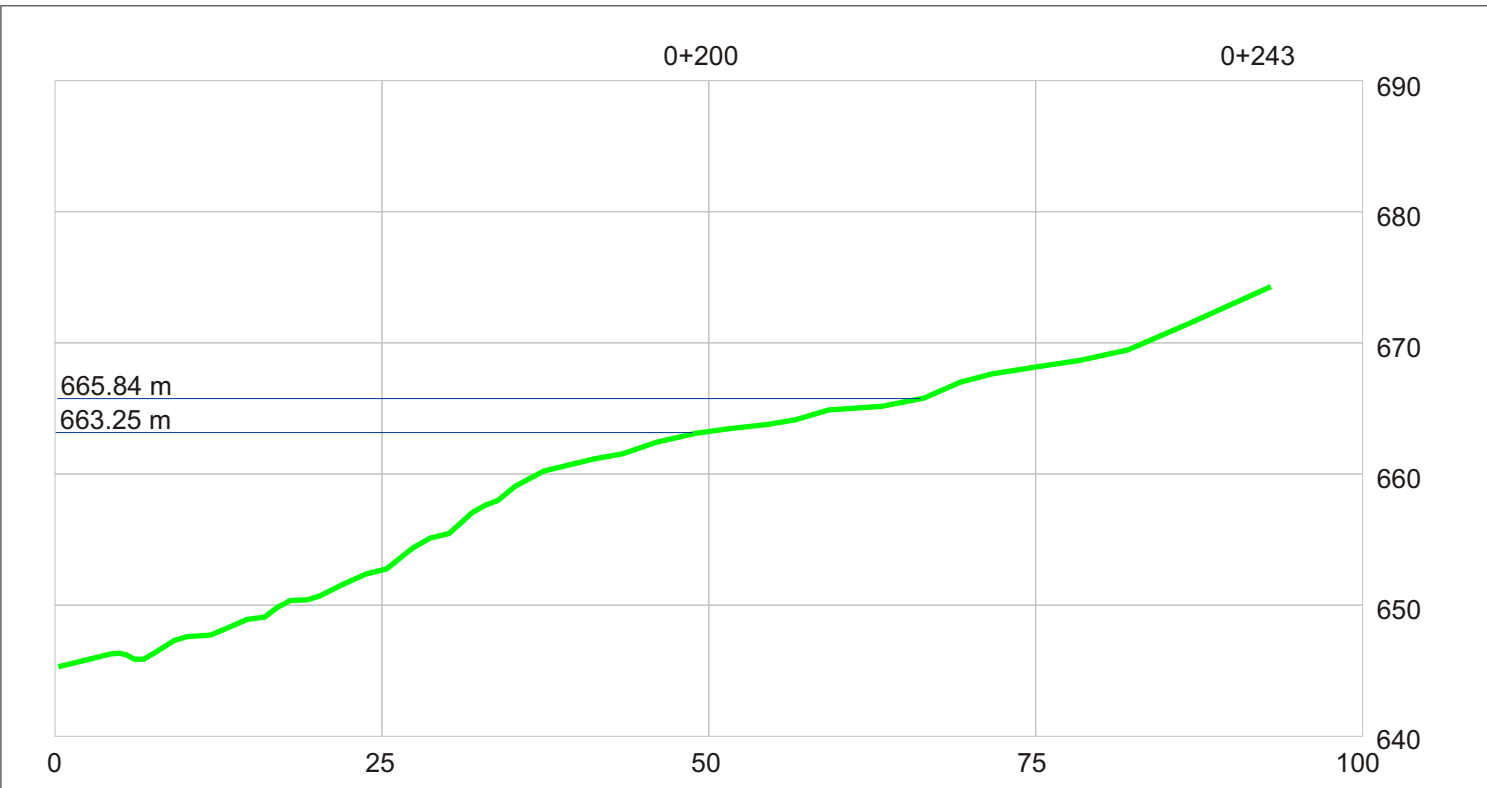
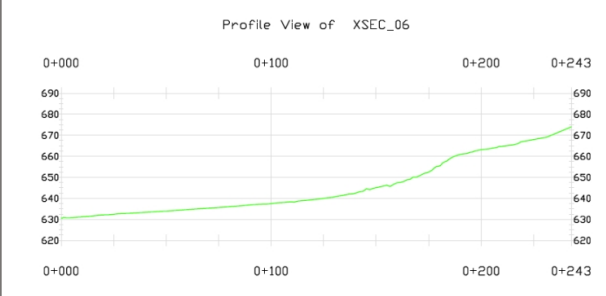
CROSS-SECTION PROFILE AT SITE XS-6, MAYO LAKE		
 	 	NOVEMBER 2008
		<b>FIGURE A6</b>

Surficial Geology: Colluvium/bedrock  
 Erosion Activity: L  
 Grain Size: clay, silt, sand, gravel  
 (till vs colluvium)

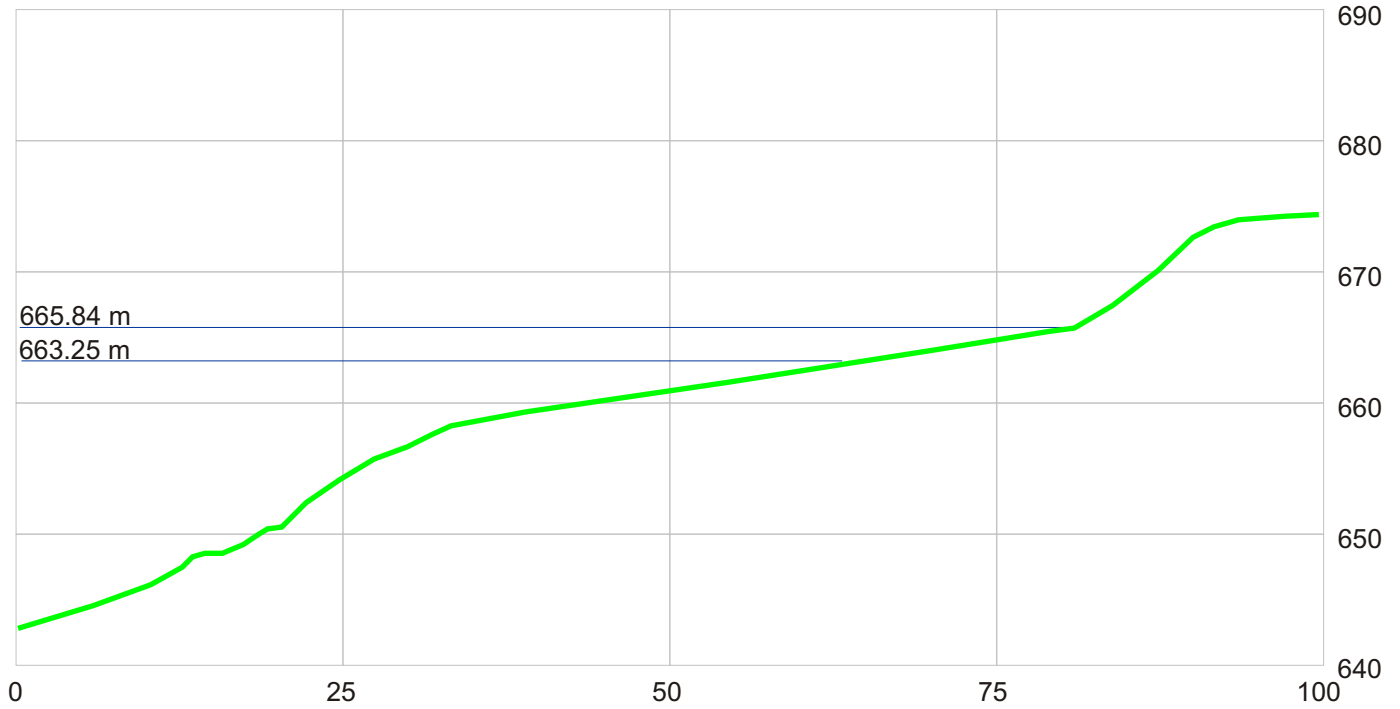
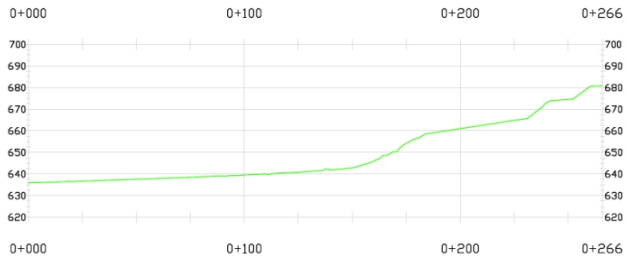
FIGURE A7

Surficial Geology: Glaciofluvial  
 Erosion Activity: Moderate-High  
 Grain Size: sand, gravel (glaciofluvial)

CROSS-SECTION PROFILE AT SITE XS-7, MAYO LAKE

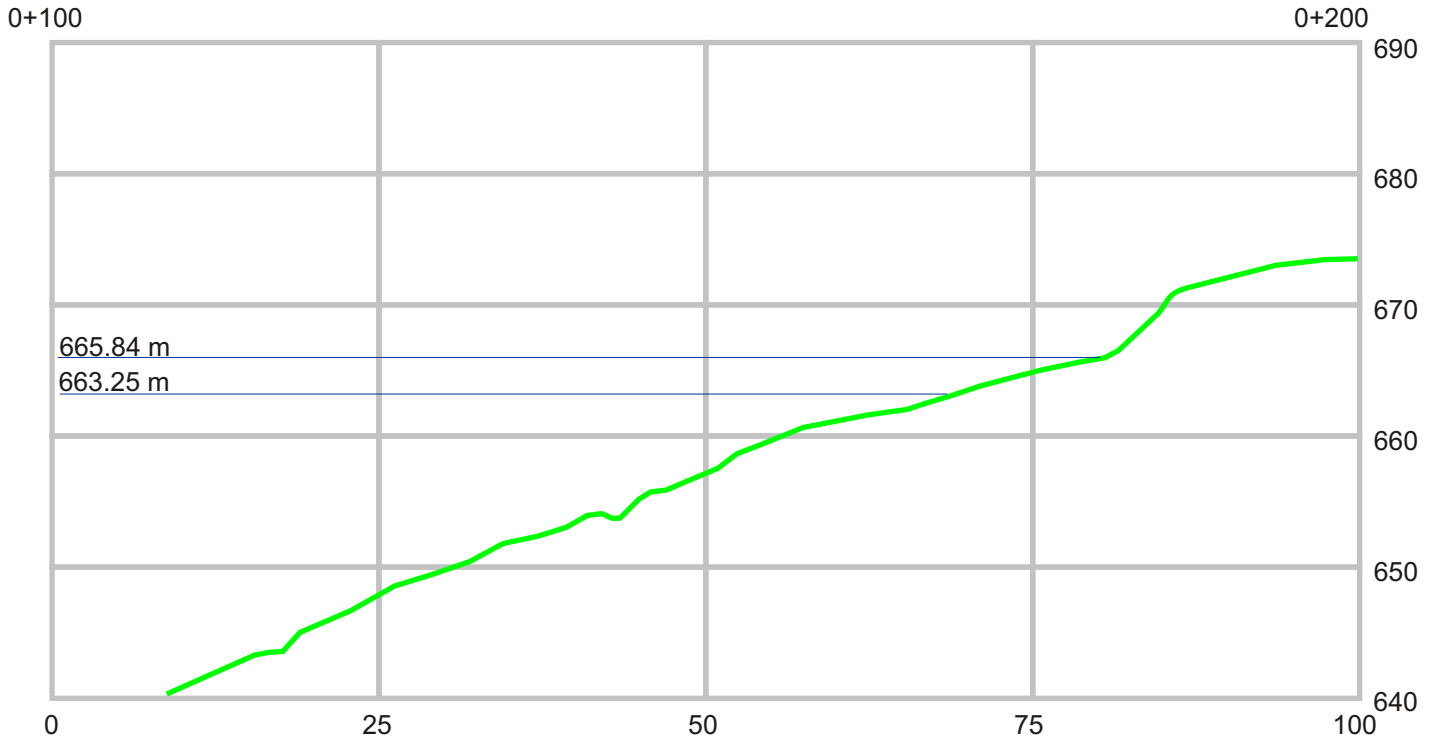
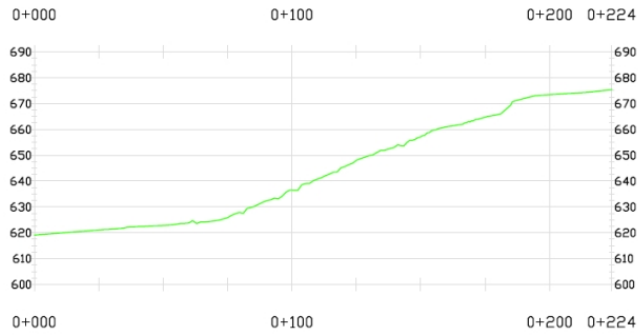
FIGURE A8

Surficial Geology: Moraine  
 Erosion Activity: L-M  
 Grain Size: sand, gravel, clay, silt (till?)

CROSS-SECTION PROFILE AT SITE XS-8, MAYO LAKE

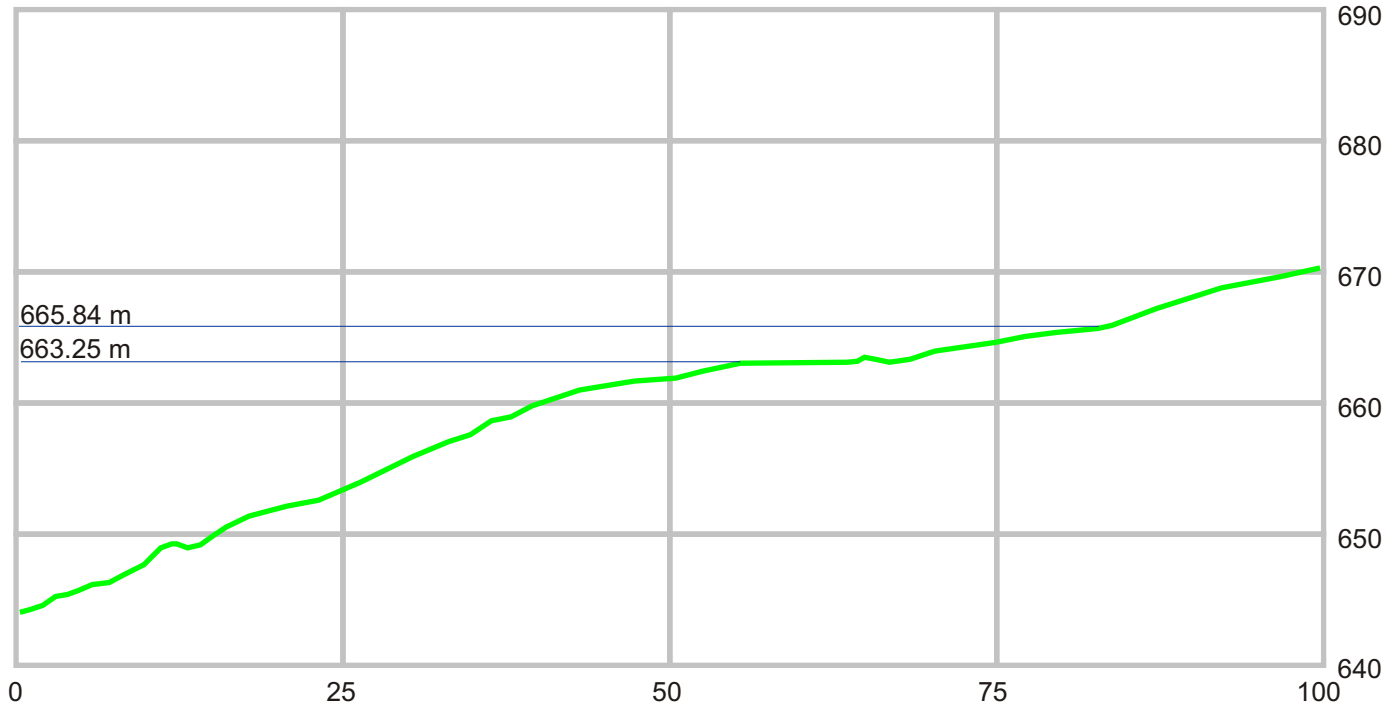
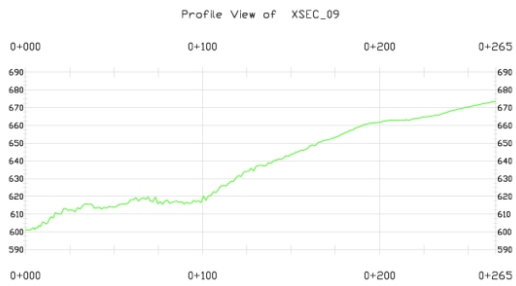
FIGURE A9

Surficial Geology: Colluvium/Bedrock  
 Erosion Activity: L  
 Grain Size: clay, silt, sand, gravel  
 (colluvium vs till)

CROSS-SECTION PROFILE AT SITE XS-9, MAYO LAKE

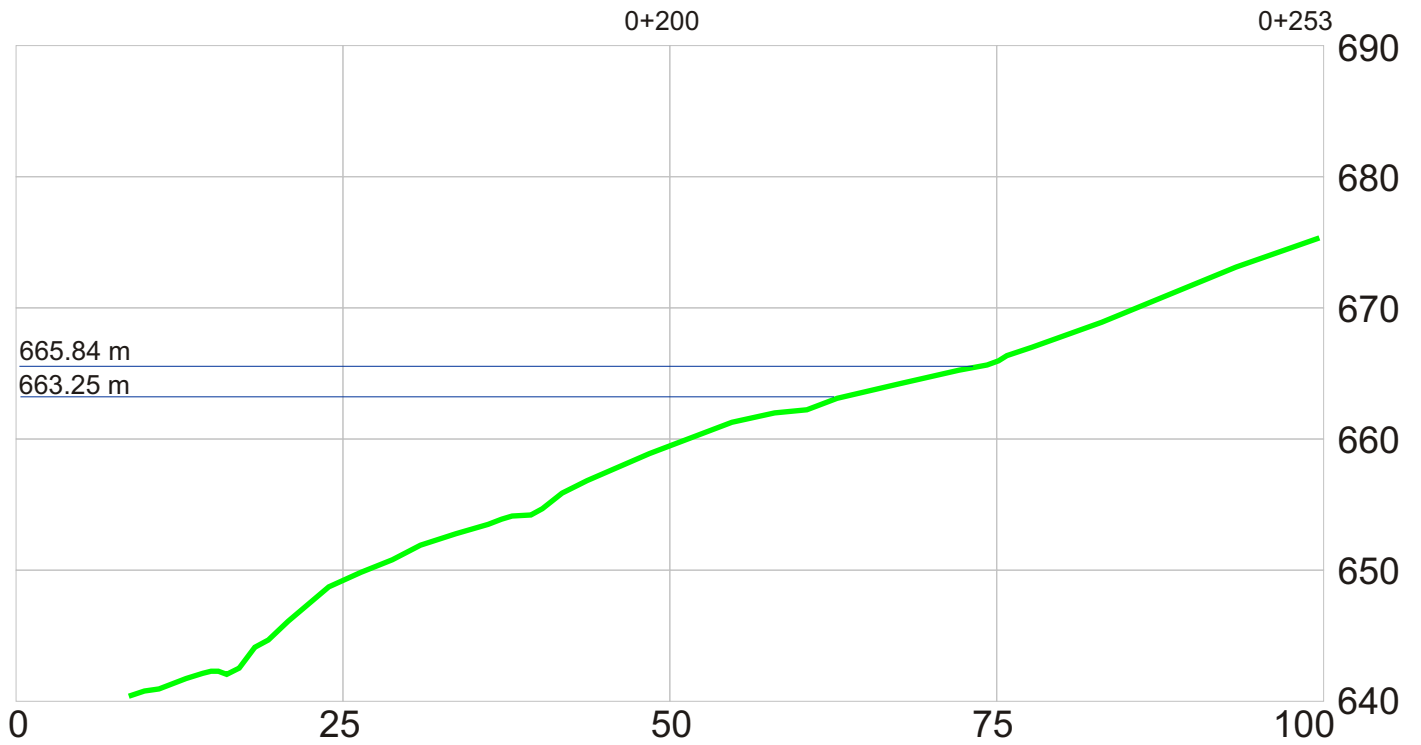
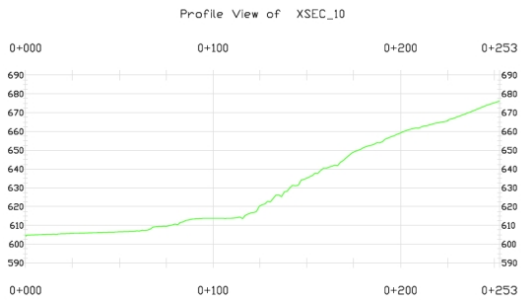
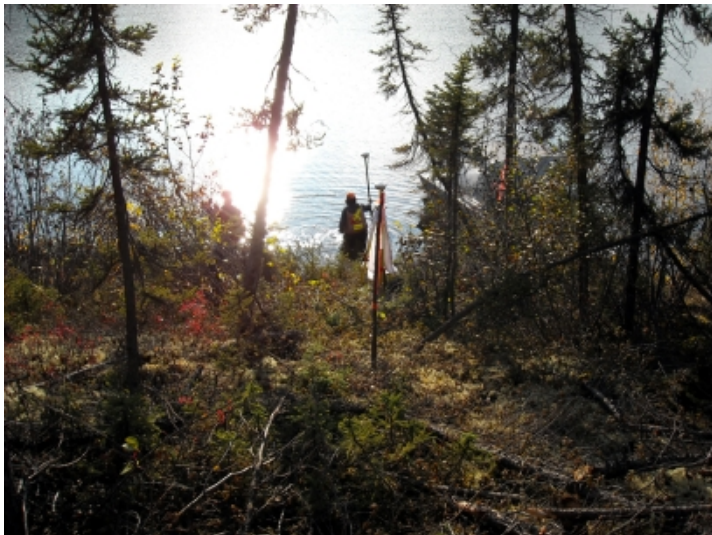
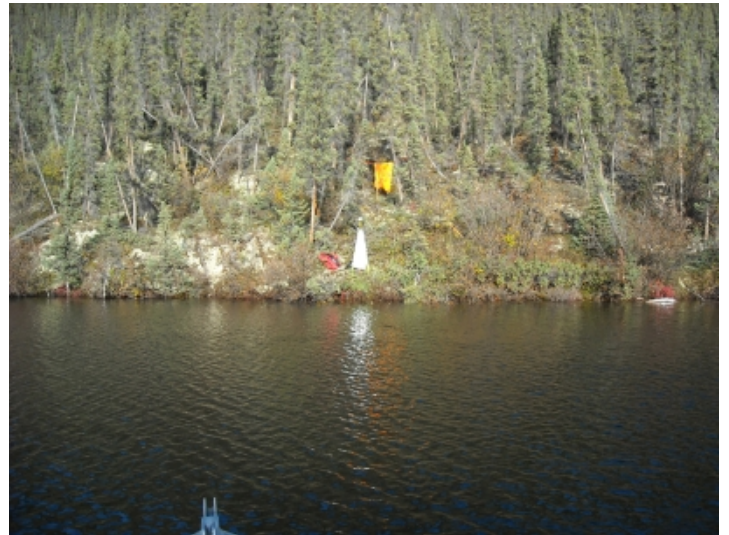
Surficial Geology: Moraine  
Erosion Activity: Low  
Grain Size: 3-4" angular bedrock fragment

CROSS-SECTION PROFILE AT SITE XS-10, MAYO LAKE

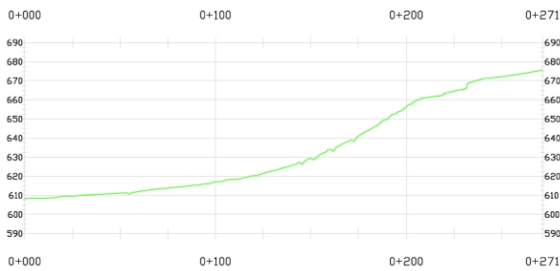
FIGURE A11

Surficial Geology: Colluvium/Bedrock (map) looks like till bluff  
 Erosion Activity: Low-Moderate  
 Grain Size: sand, gravel, clay, till blocks (reworked?)

CROSS-SECTION PROFILE AT SITE XS-11, MAYO LAKE

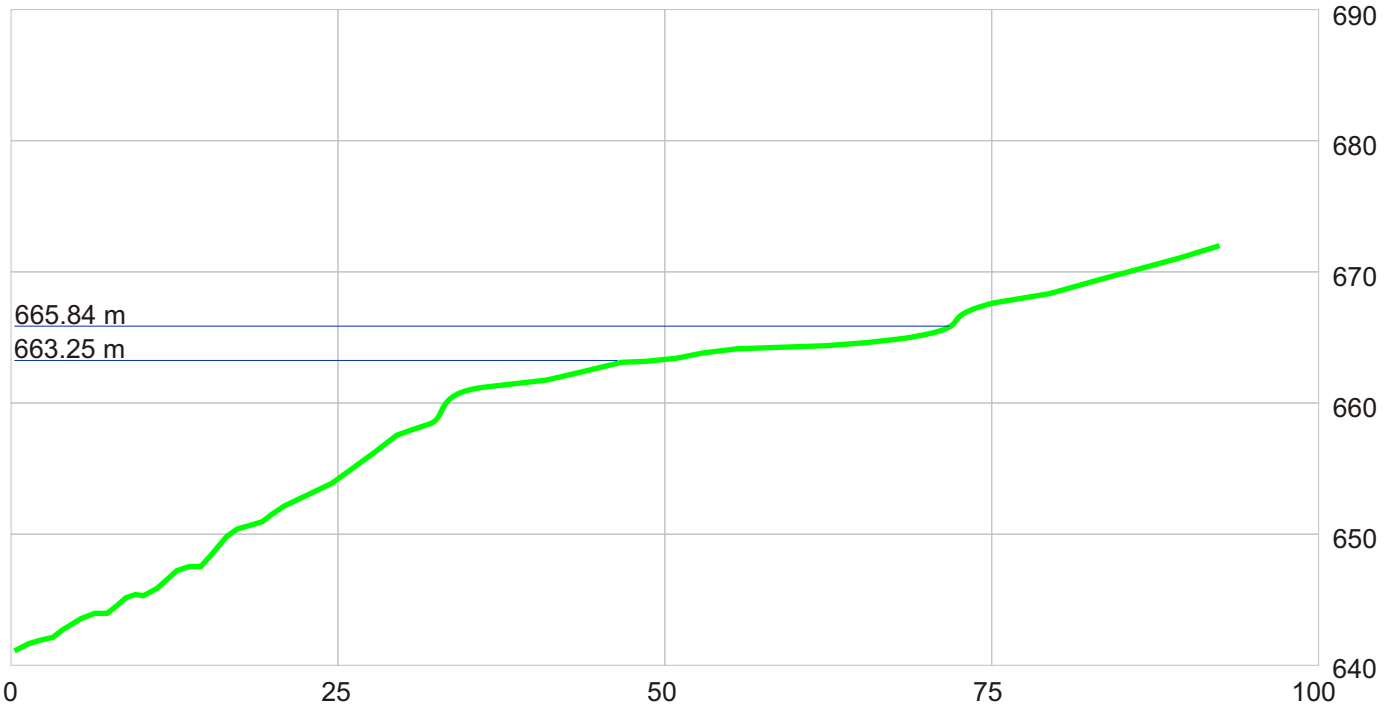
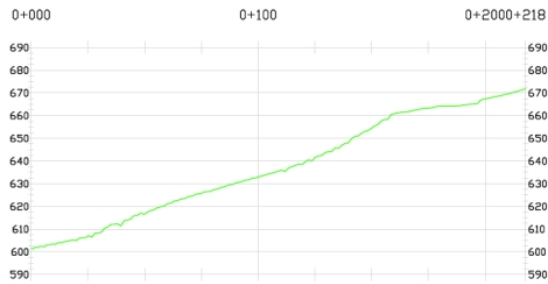
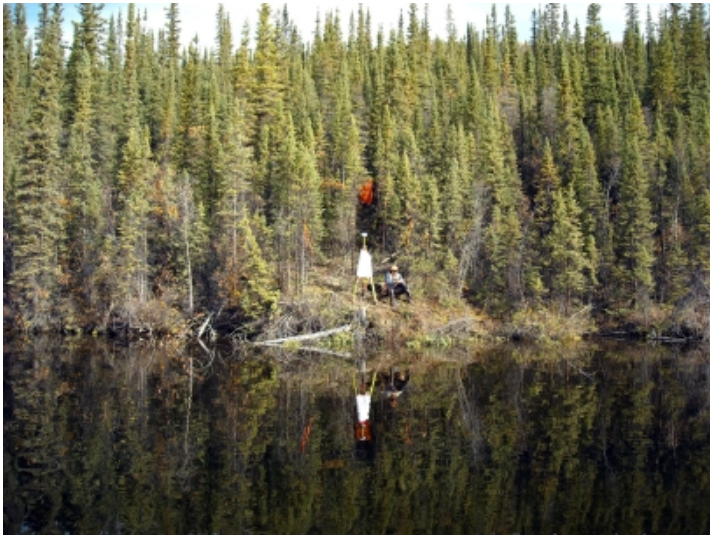
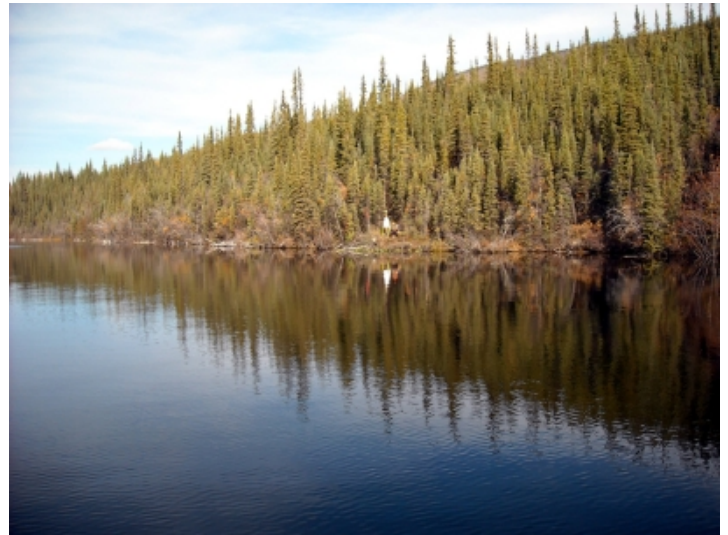
FIGURE A12

Surficial Geology: Moraine  
 Erosion Activity: Low  
 Grain Size: larger flat bedrock fragment organics, clay, coarse sand (wave worked?)

CROSS-SECTION PROFILE AT SITE XS-12, MAYO LAKE

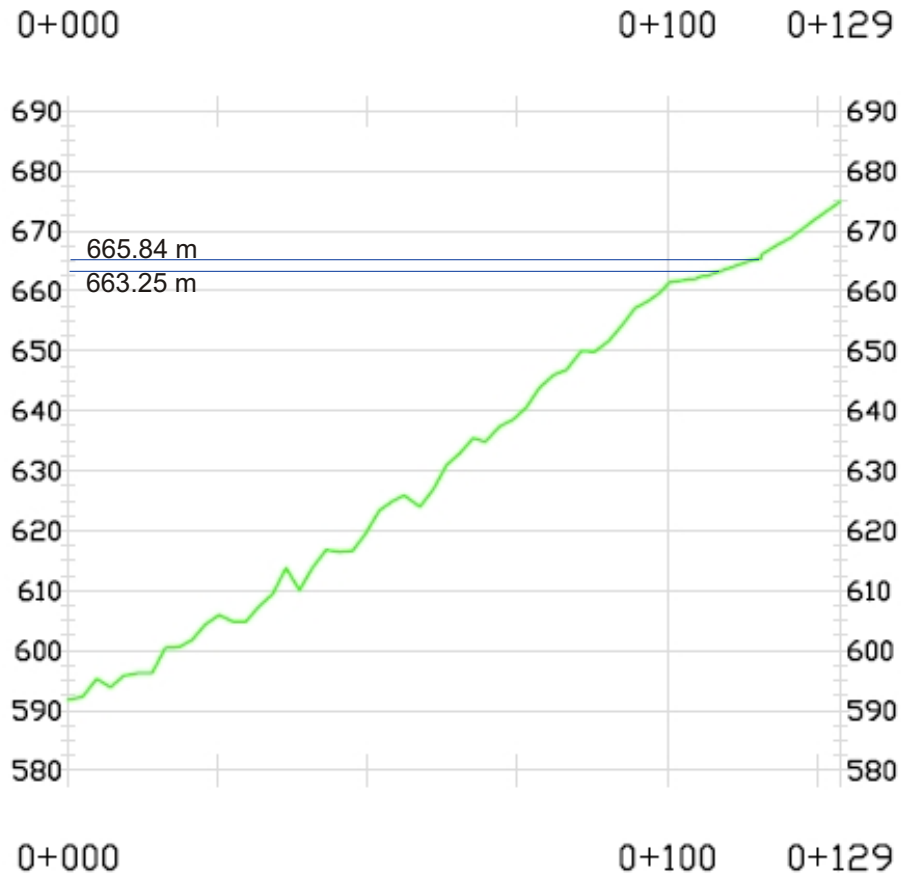
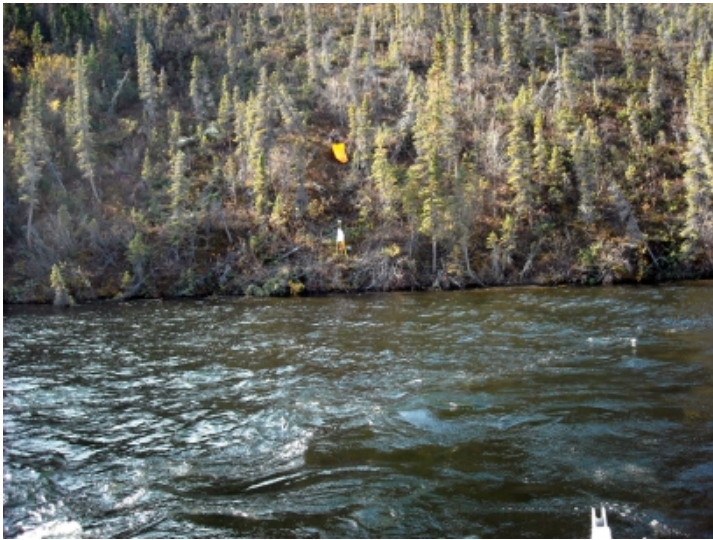
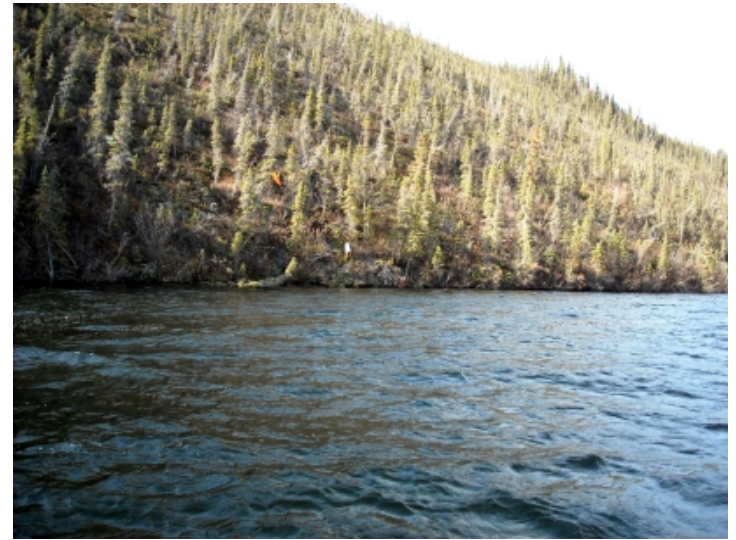
**FIGURE A13**

Surficial Geology: Moraine  
 Erosion Activity: Low  
 Grain Size: clay, organics, rock fragments

CROSS-SECTION PROFILE AT SITE XS-13, MAYO LAKE

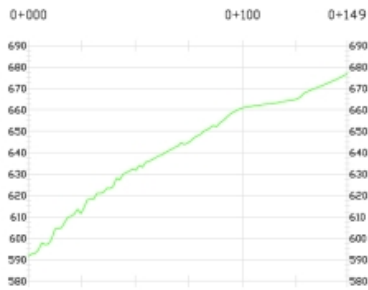
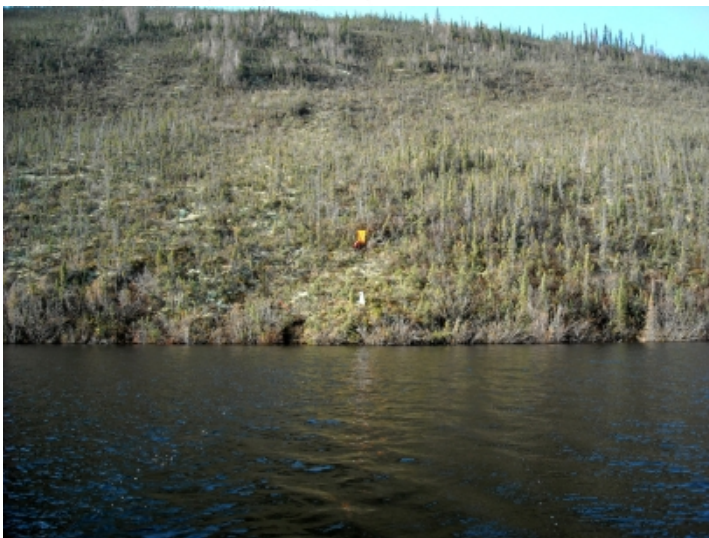
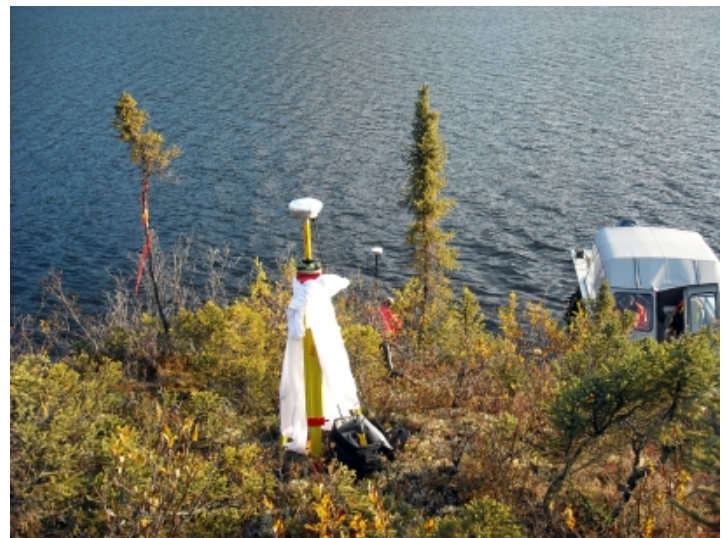
FIGURE A14

Surficial Geology: Alluvium/Colluvium  
 Erosion Activity: Low-Moderate  
 Grain Size: sand, gravel, clay, organics  
 (wave worked colluvium?)

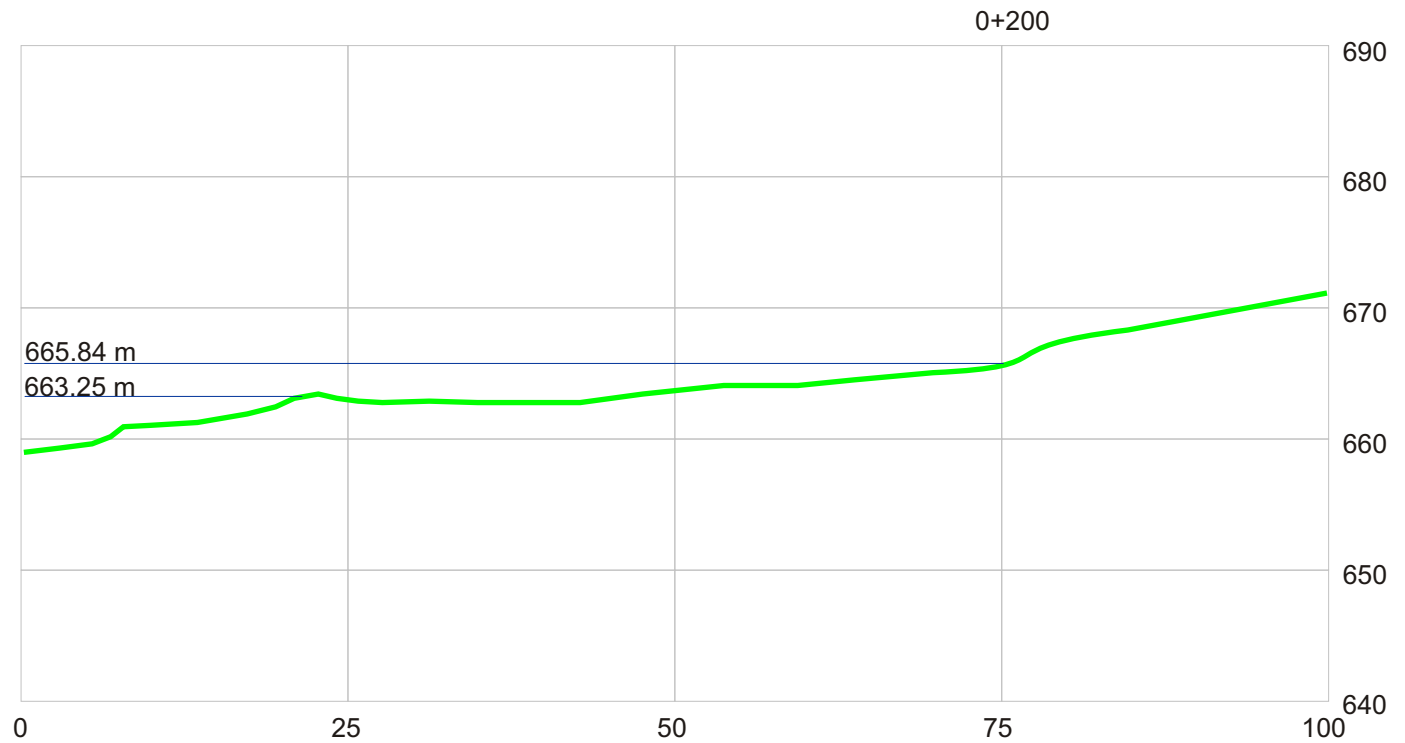
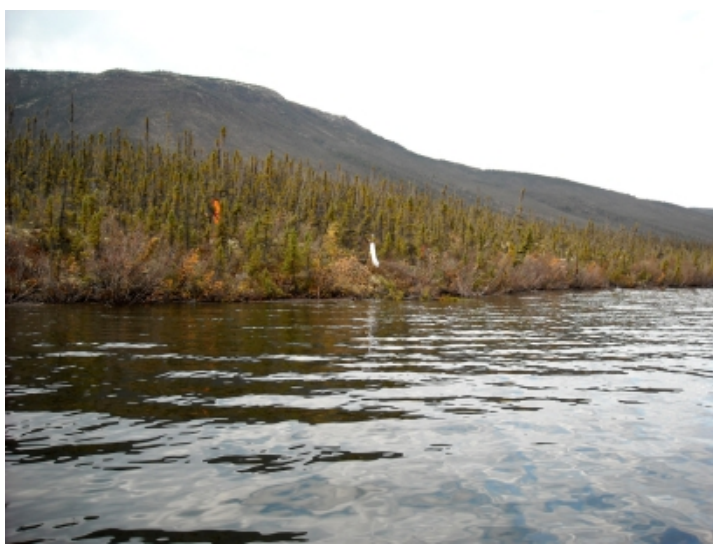
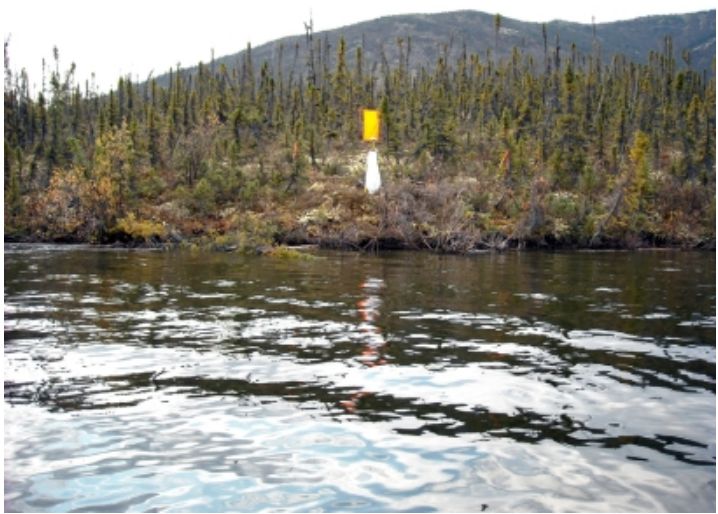
FIGURE A15

Surficial Geology: Moraine  
 Erosion Activity: Low  
 Grain Size: sand, gravel, clay (reworked?)

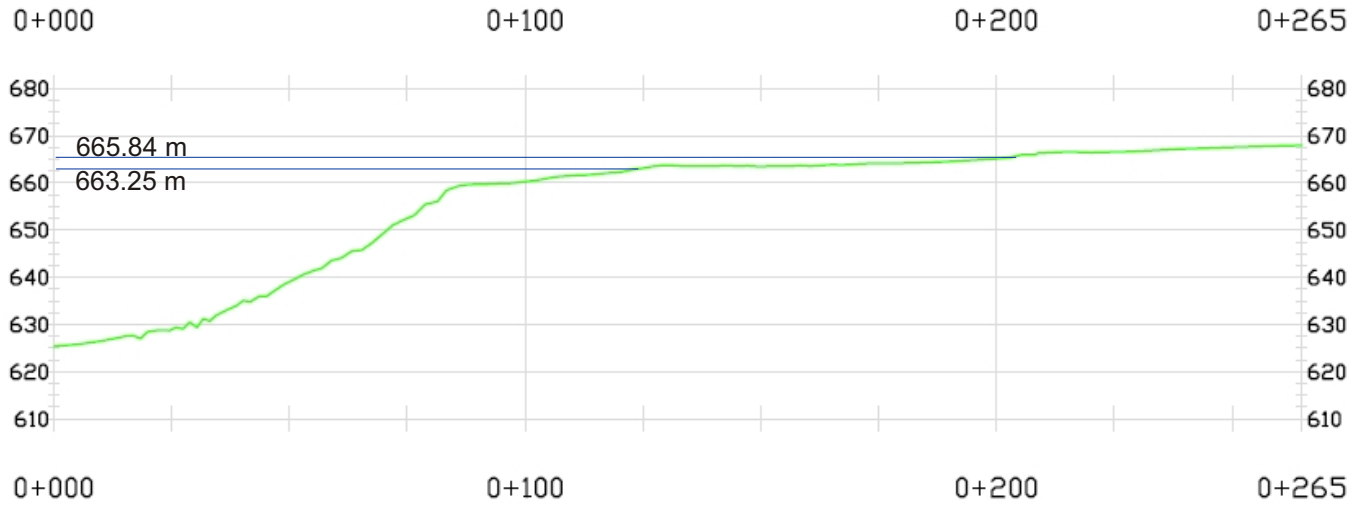
FIGURE A16

**Cross-section 16 (Figure 8a,b):** This cross-section is located on an alluvial fan with low to moderate erosion activity under existing conditions. The cross-section is characterized by low upper and lower bluffs that correspond to the existing maximum and minimum water levels. These low bluffs appear to have formed as a result of nearshore downcutting under these two extreme water level conditions.

Under an increased full supply level additional flooding will occur across the gently sloping alluvial fan and the erosion process will be dominated by nearshore downcutting on the newly created nearshore zone. Downcutting will continue on the lower nearshore slope although downcutting rates may decrease due to increased wave energy dissipation caused by an increased water level fluctuation range.

Under a lower minimum water level increased downcutting is expected to occur on the lower nearshore slope. Nearshore downcutting will continue at high water levels although downcutting rates may decrease due to increased wave energy dissipation caused by an increased water level fluctuation range.

Surficial Geology: Alluvial  
Erosion Activity: Low-Moderate
