**Mayo Lake Generating Station Re-Development**  
**Mollard Memo November 17, 2008**

**Re: Yukon Energy Corporation -- Mayo Lake Generating Station Re-development**

To provide preliminary thoughts on shore erosion changes that may result from lowering the Mayo Lake minimum drawdown level by 1m or raising the maximum full supply level by 1m.

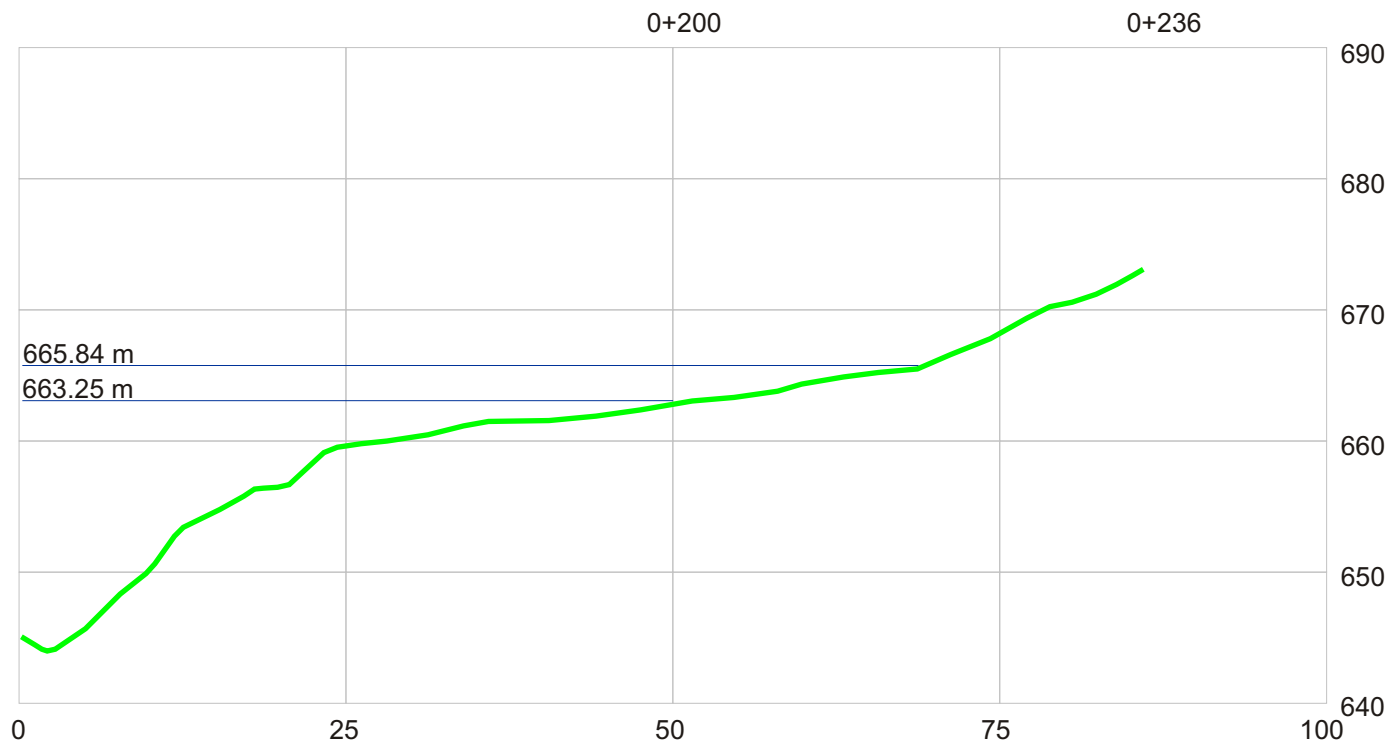
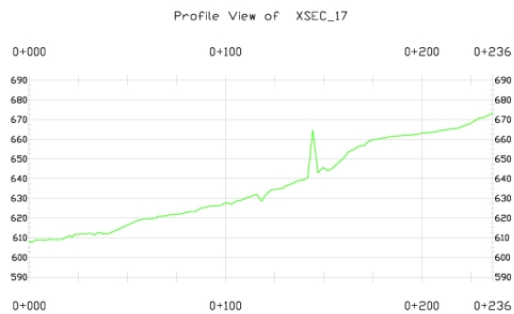
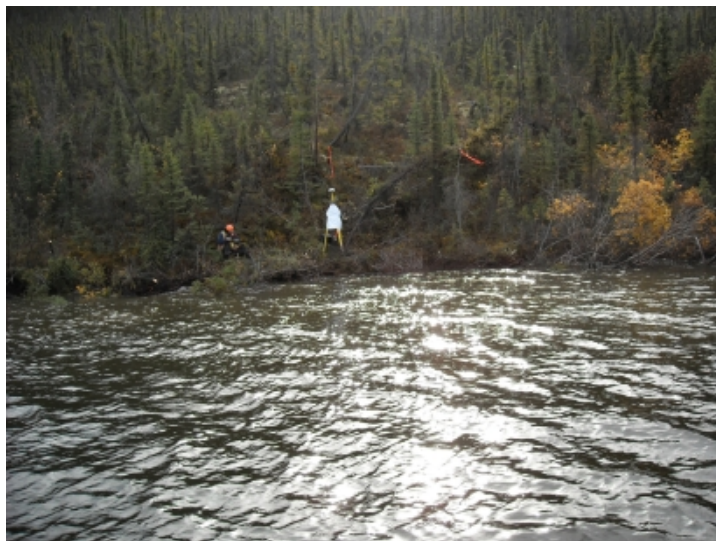
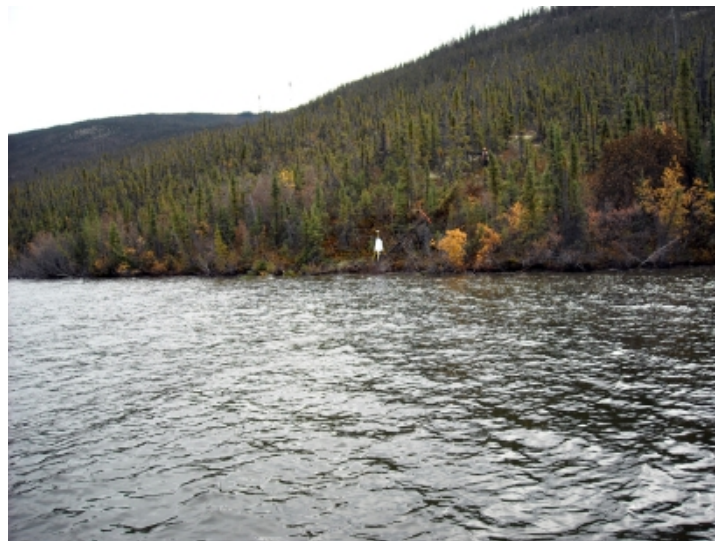
FIGURE A17

Surficial Geology: Moraine  
 Erosion Activity: Low-Moderate  
 Grain Size: sand, gravel, clay (till?)

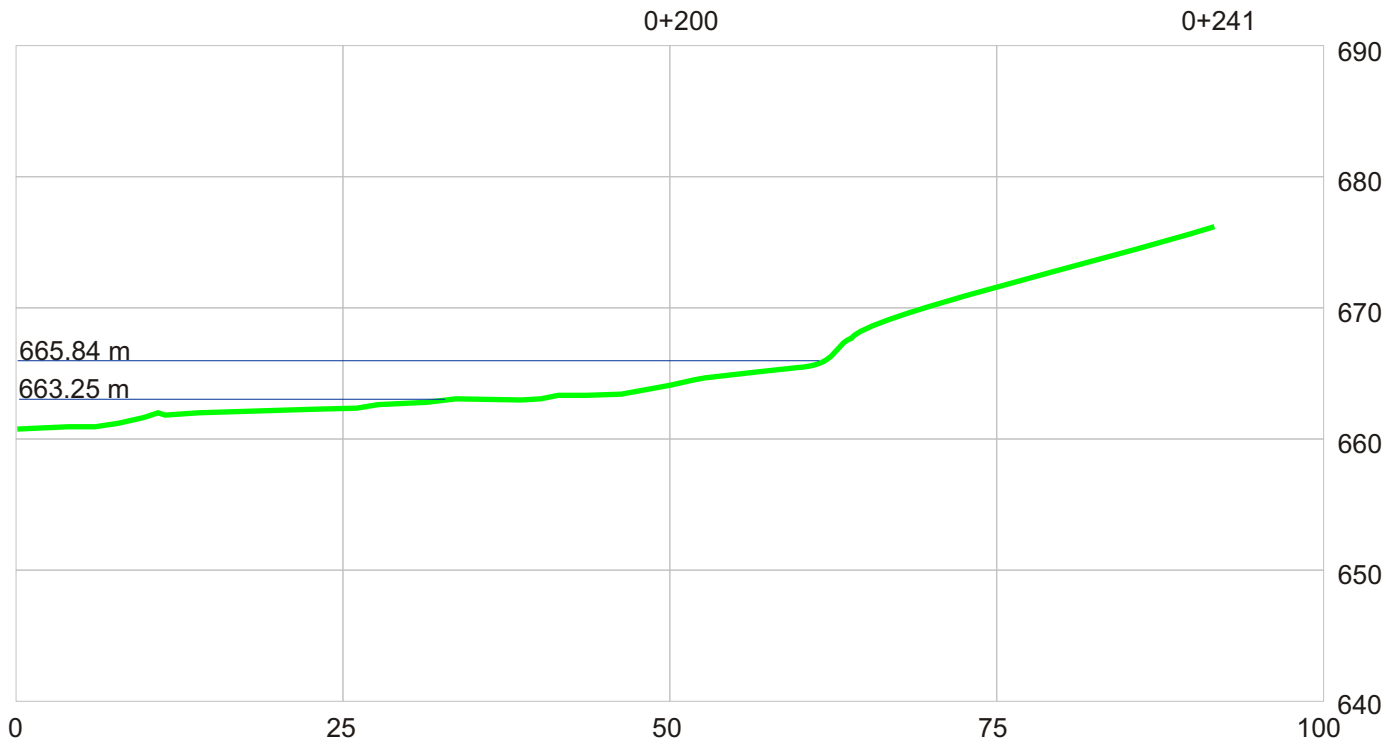
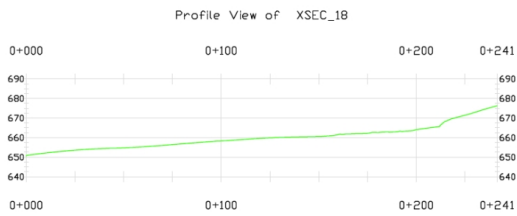
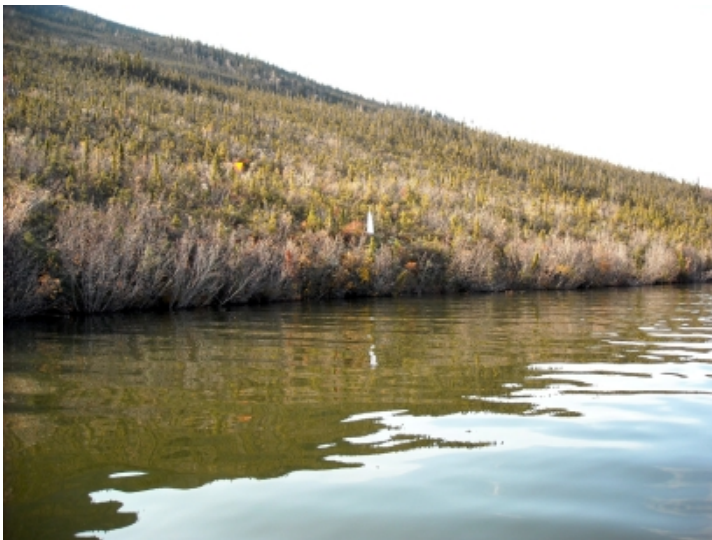
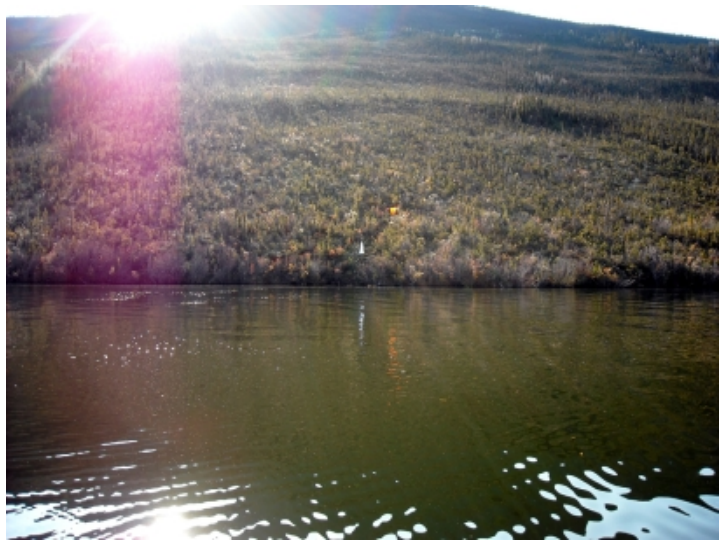
FIGURE A18

Surficial Geology: Moraine  
 Erosion Activity: Low-Moderate  
 Grain Size: angular bedrock (schist?)  
 Clay, sand (re-worked till vs colluvium?)

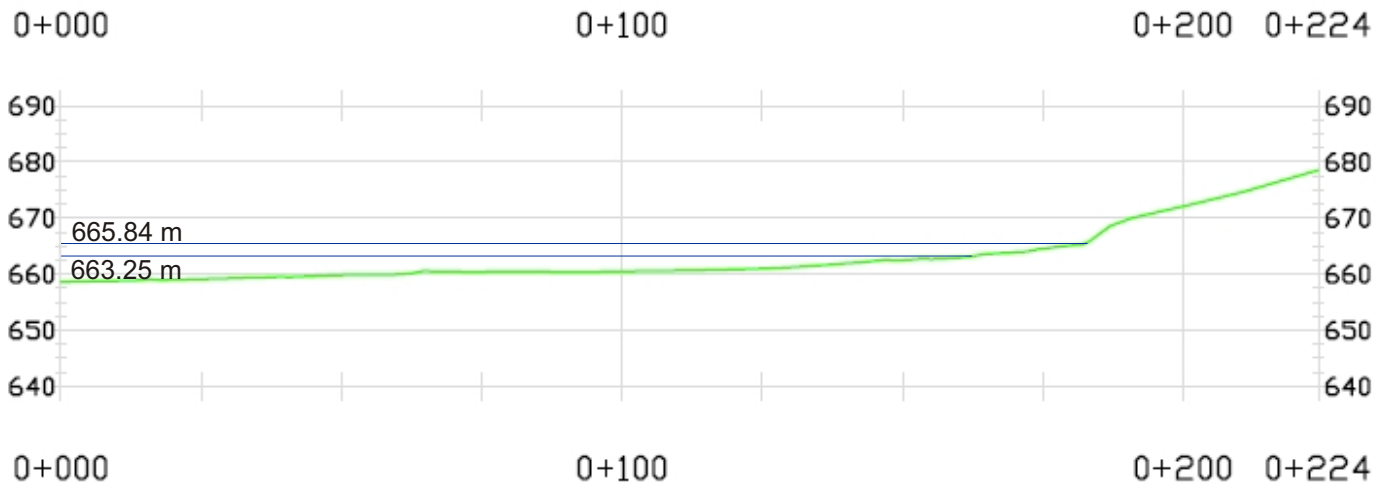
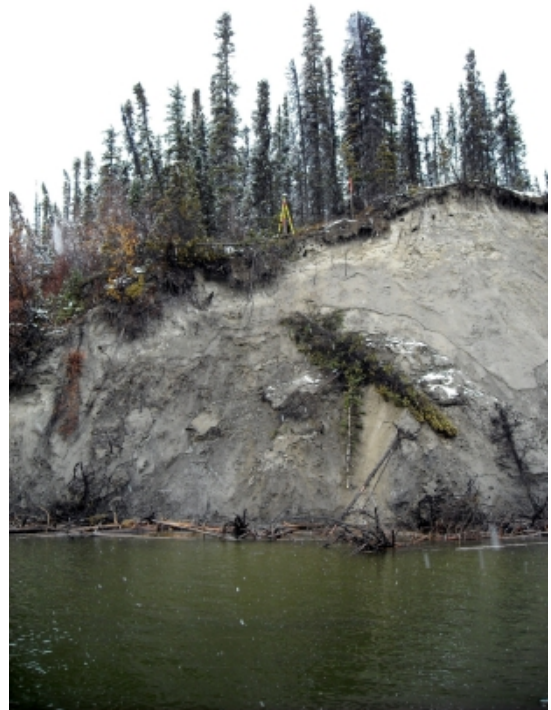
**FIGURE A19**

**Cross-section 19 (Figure 7a,b):** This cross-section is located in glaciolacustrine terrain that experiences moderate to high erosion rates under existing conditions.

Surficial Geology: Glaciolacustrine  
 Erosion Activity: Moderate-High  
 Grain Size: clay, silt, fine sand

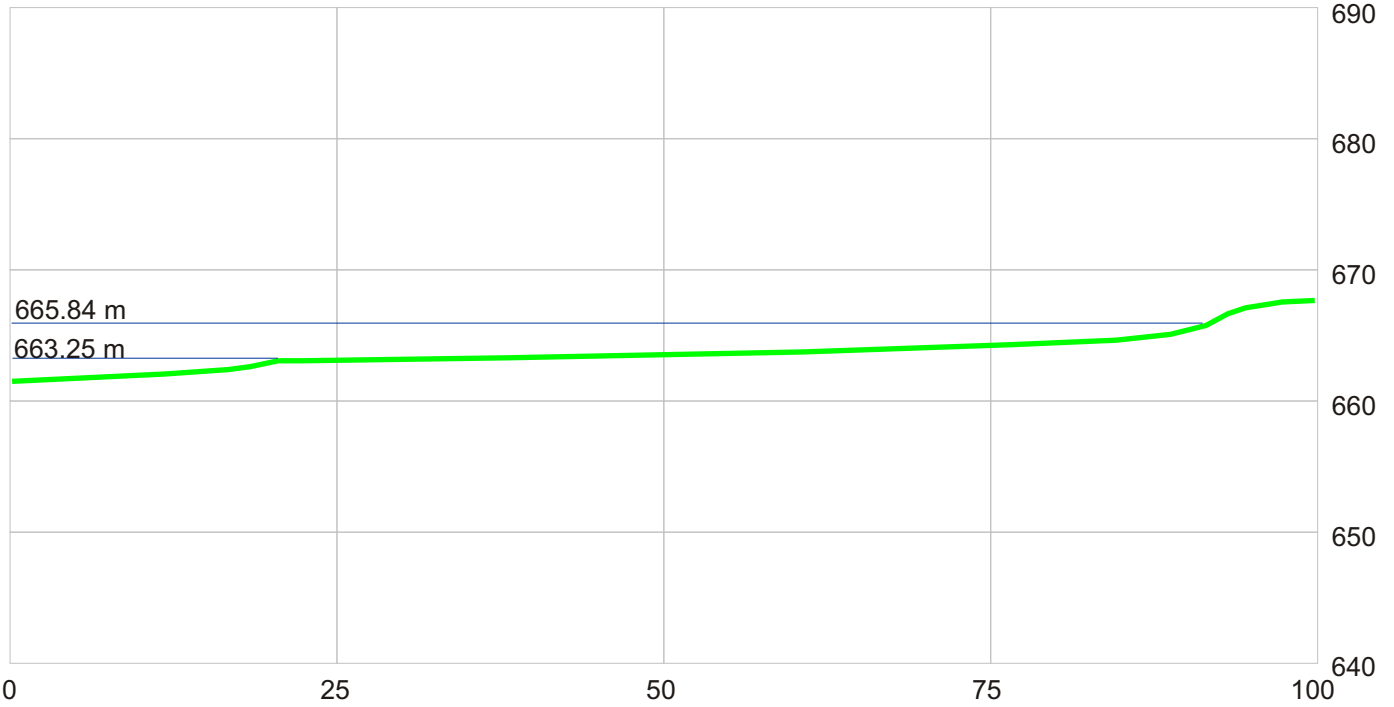
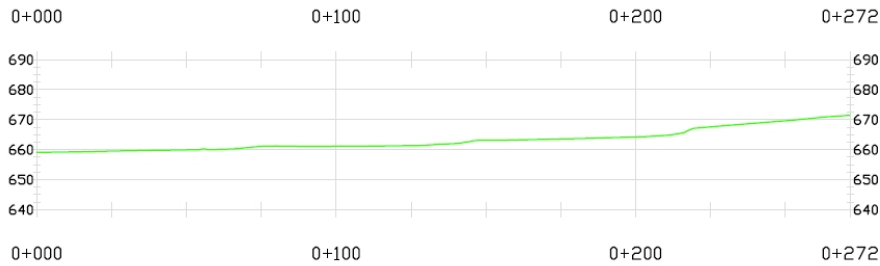
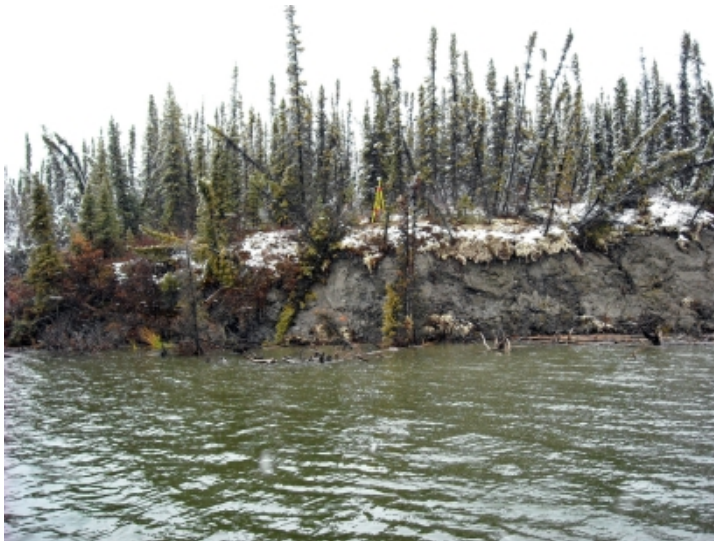
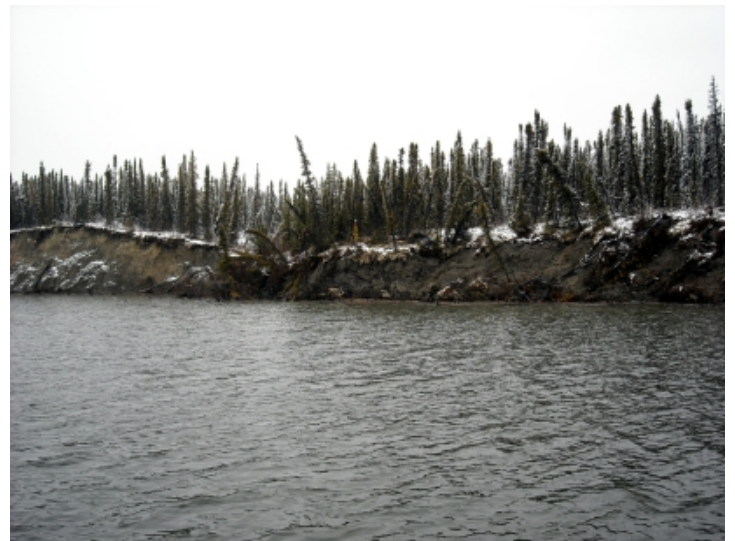
FIGURE A20

Surficial Geology: Glaciolacustrine  
 Erosion Activity: Moderate-High  
 Grain Size: clay, silt (glaciolacustrine)

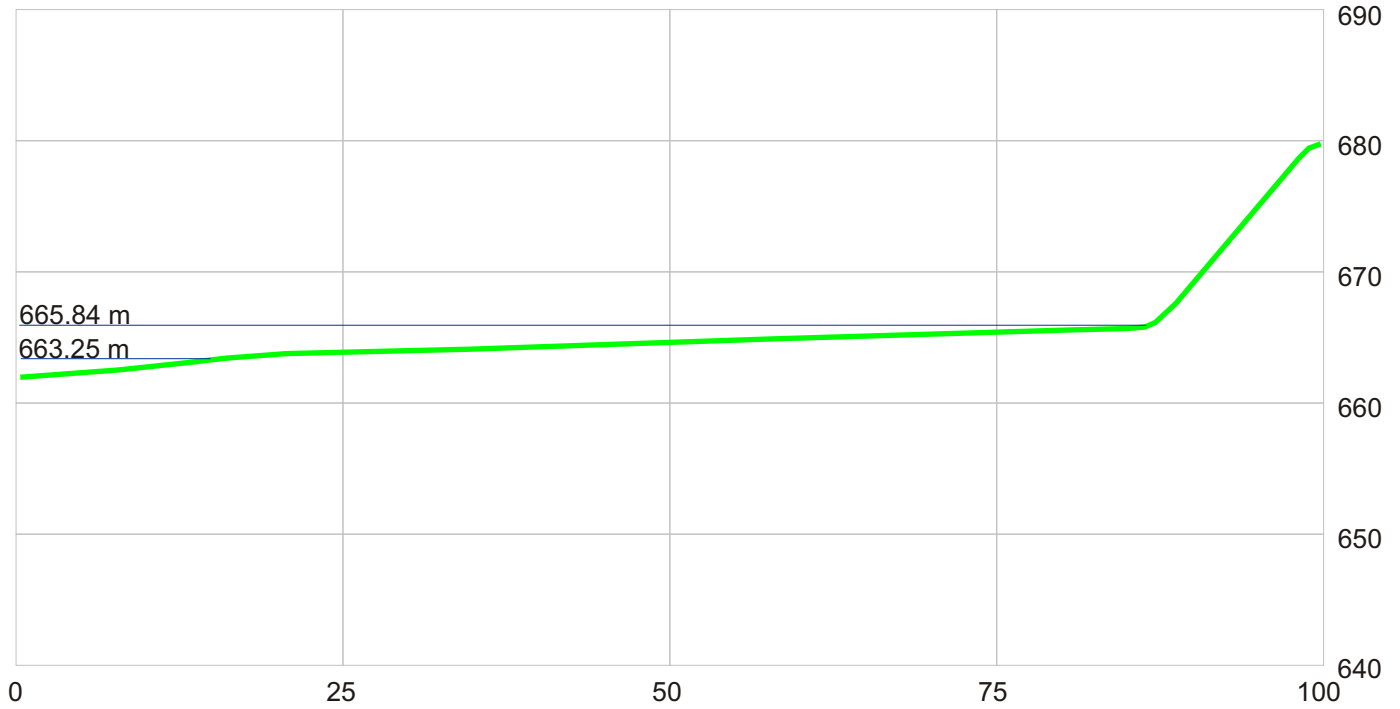
FIGURE A21

Surficial Geology: Glaciolacustrine  
 Erosion Activity: Moderate-High  
 Grain Size: clay, silt (glaciolacustrine)

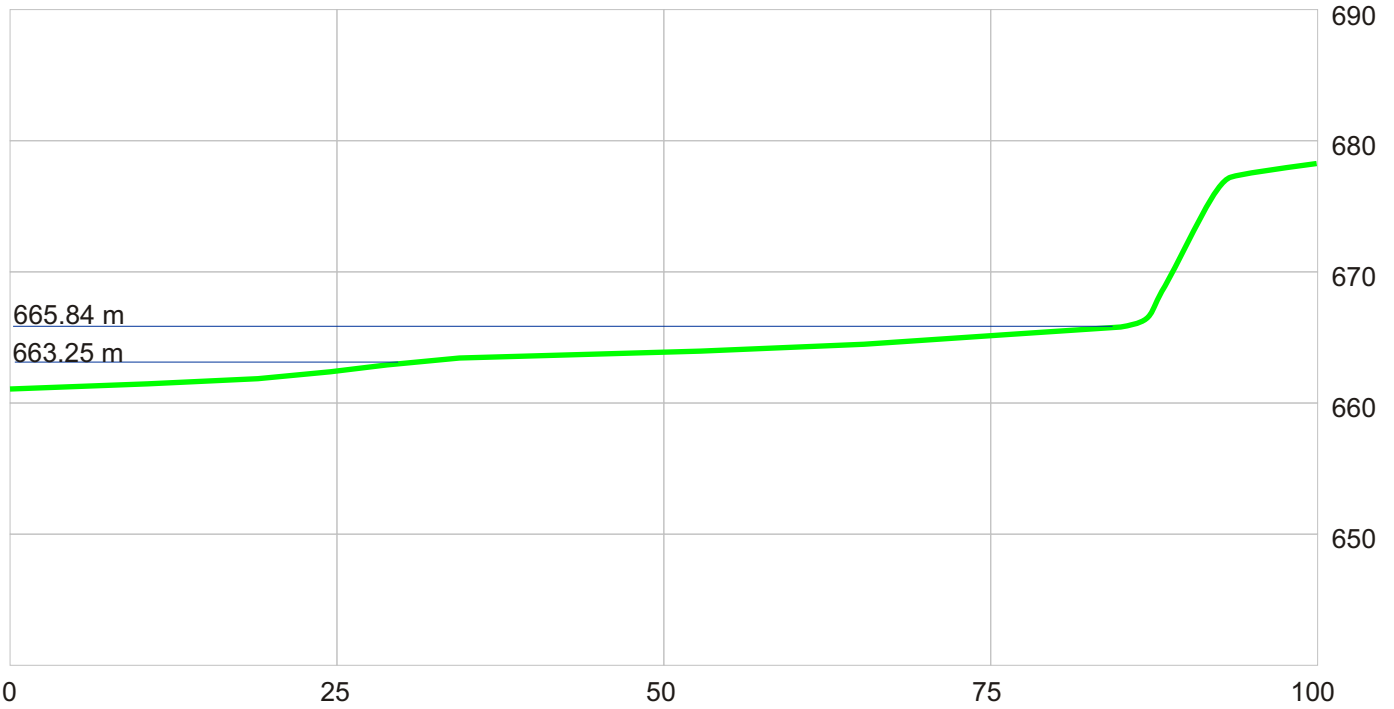
FIGURE A22

Surficial Geology: Glaciolacustrine  
 Erosion Activity: Moderate-High  
 Grain Size: clay, silt  
 (excess water - permafrost?)

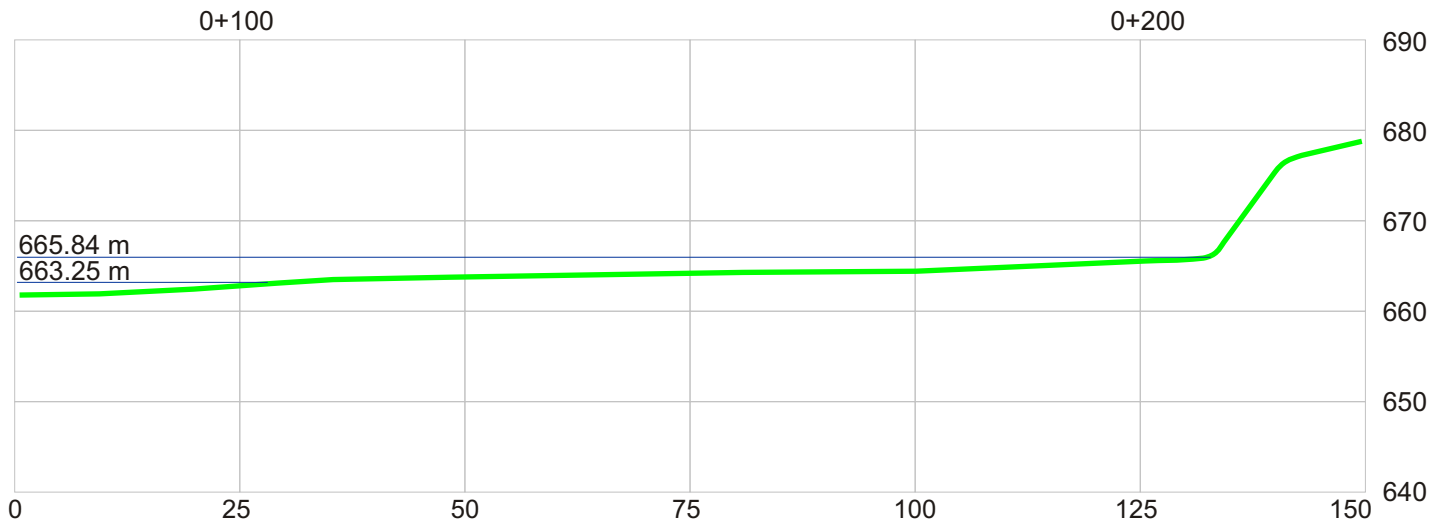
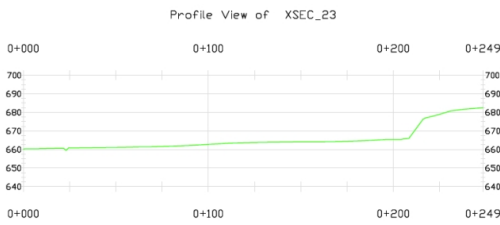
**FIGURE A23**

Surficial Geology: Glaciolacustrine  
 Erosion Activity: Moderate-High  
 Grain Size: uniform fine sand

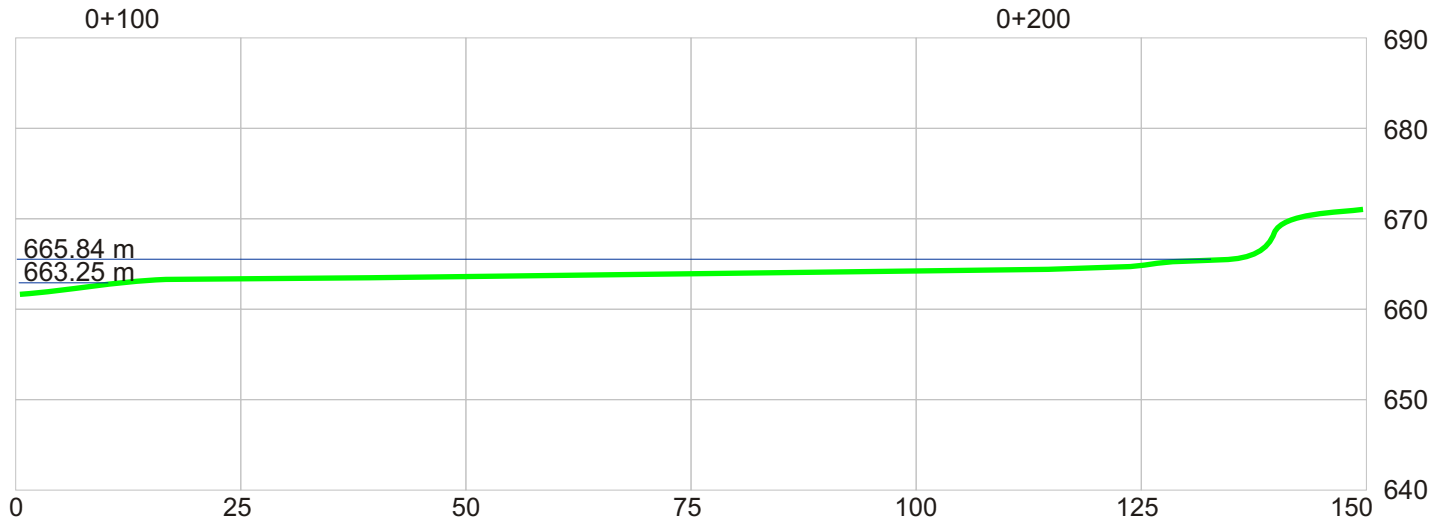
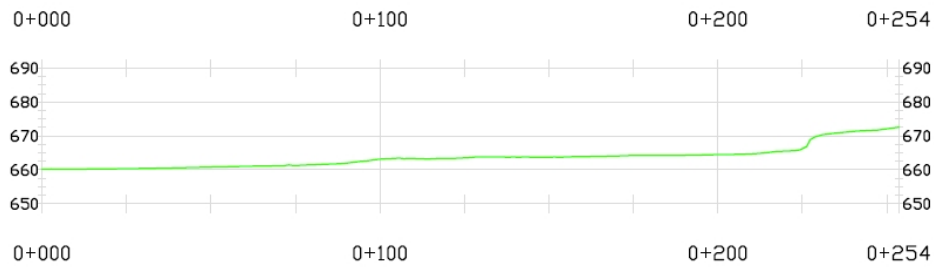
FIGURE A24

Surficial Geology: Glaciolacustrine  
Erosion Activity: Moderate-High  
Grain Size: silt, clay

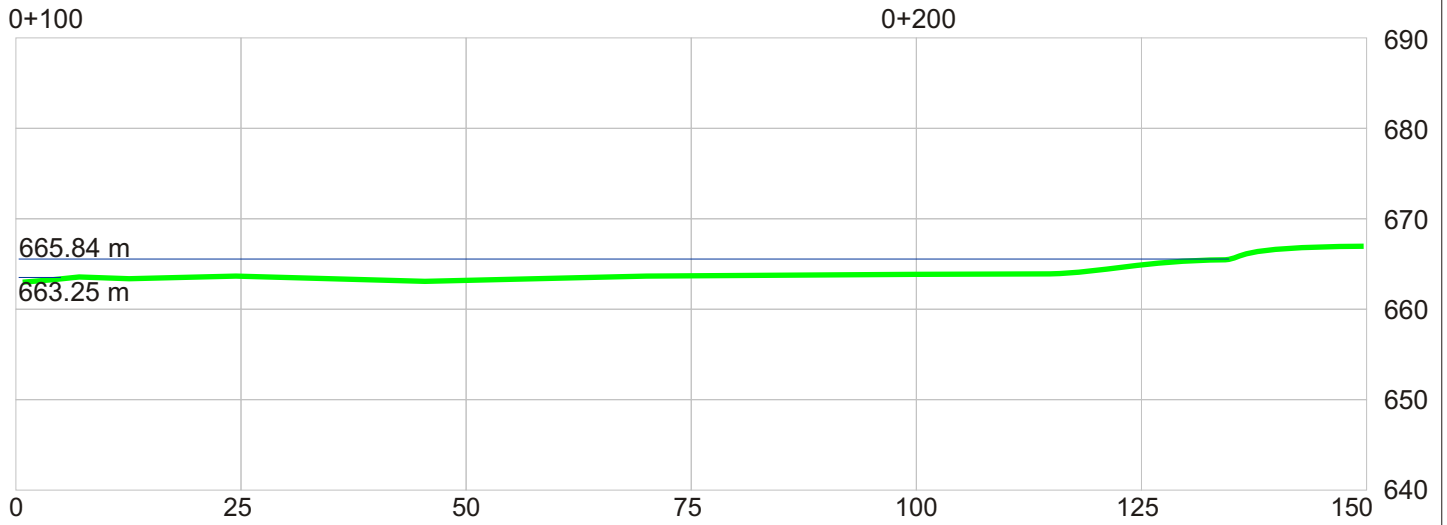
FIGURE A25

Surficial Geology: Alluvium  
 Erosion Activity: Moderate-High  
 Grain Size: clay

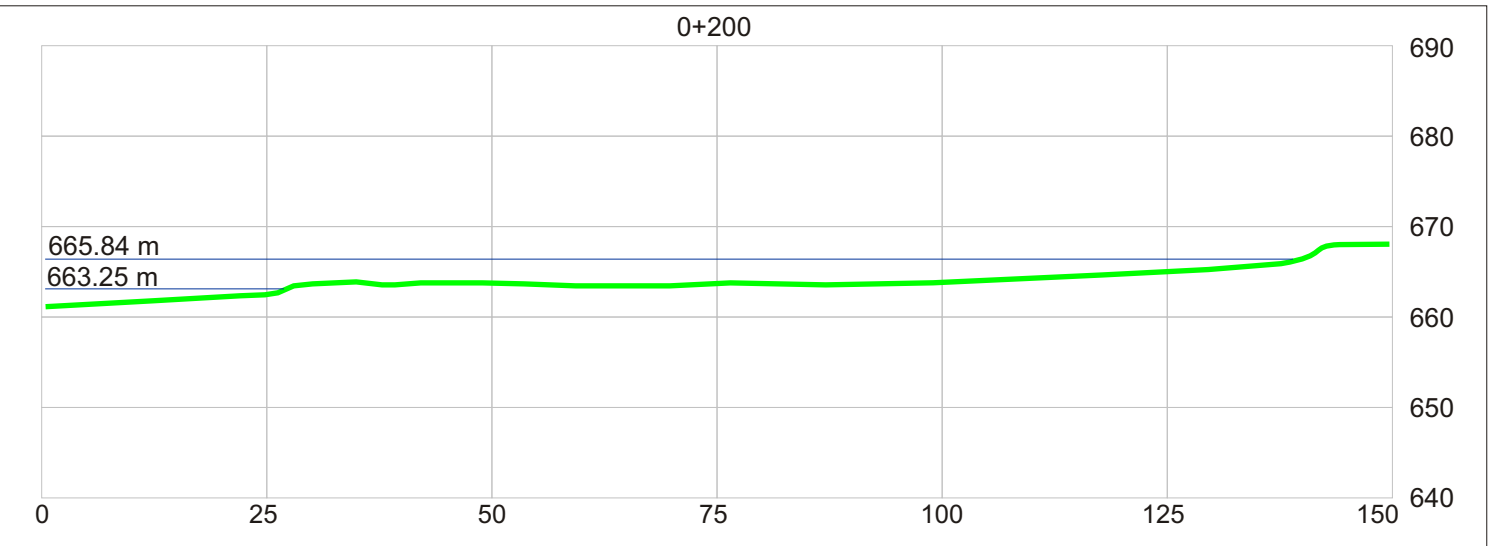
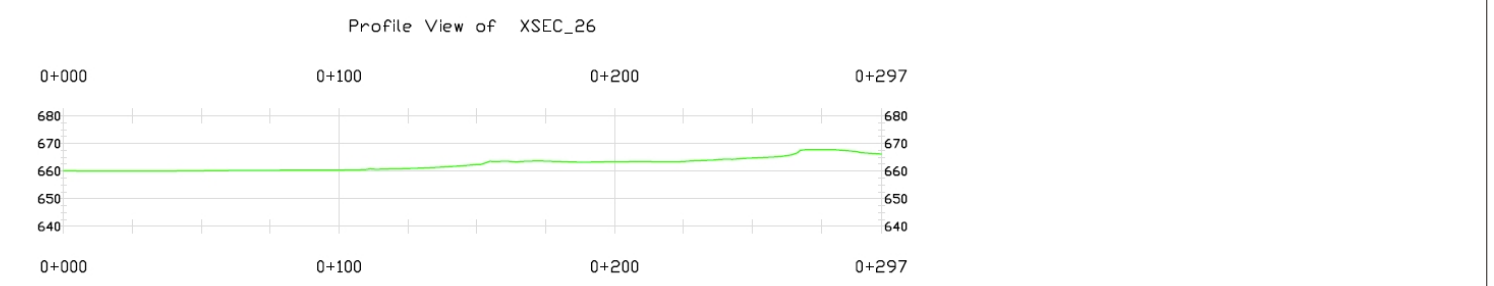
Surficial Geology: Alluvium  
Erosion Activity: Moderate-High  
Grain Size: coarse sand, gravel
