MERG Report 2005-2

Upgrades to the Bioengineering Installations at Noname Creek 2003/2004

**Upgrades to the Bioengineering
Installations at Noname Creek
2003 / 2004**

**Submitted By
LABERGE ENVIRONMENTAL SERVICES
February, 2005**

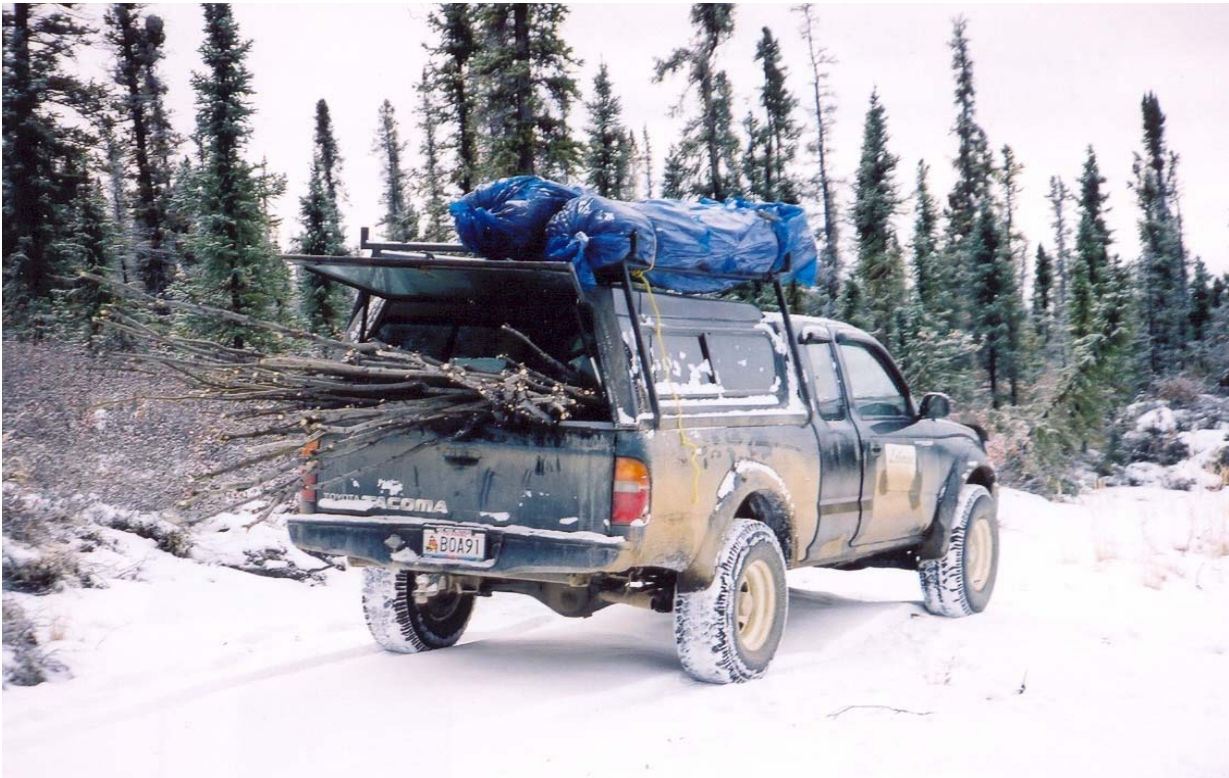
PLATE # 1: Transporting dormant willows and geotextile to access point to Noname repair site, September 23, 2003.

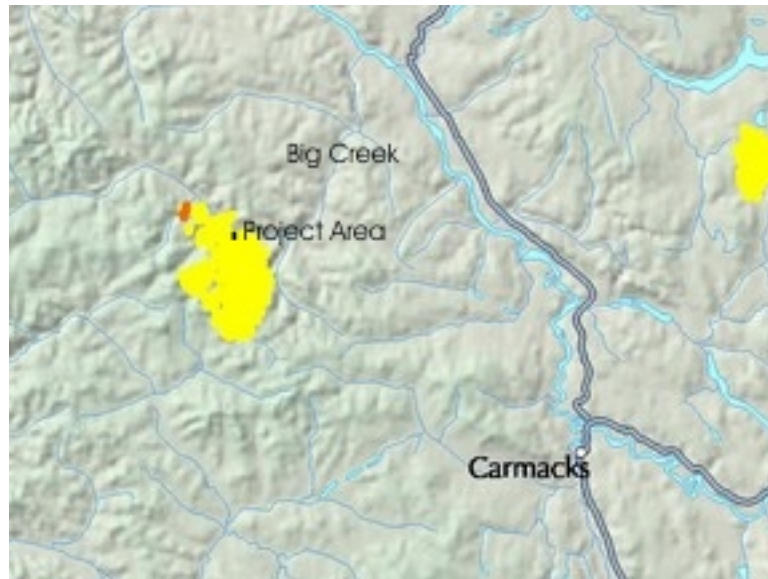
During June and July 2004, several large forest fires were active in the Yukon. One of these was in the Big Creek area (Plate 17). On August 4, 2004, Karen Pellitier, with the Mineral Development Branch, visited the Noname Creek study area. The entire slope had severely burned, including the ground layer. The willow structures in the gully however, appeared relatively untouched and supported green growth (Plates ----).

This fire has likely removed much of the insulation layer, and it is suspected that the underlying permafrost will commence melting in the summer of 2005. Eventually there could be mass movement of this slope. It is recommended that the Noname Creek site be assessed in 2005, as it is probable that flows will now increase in the gully.

PLATE #17: Fire map from a satellite image taken on July 15, 2004. The yellow area indicates burnt land and the orange indicates currently burning.
