MPERG Report 2009-4

**Brewery Creek:
From Assessment and Permitting
Through Production to Post Closure:
A Post Closure Analysis of a
Northern Heap Leach Mine**

Access Consulting Group

2010

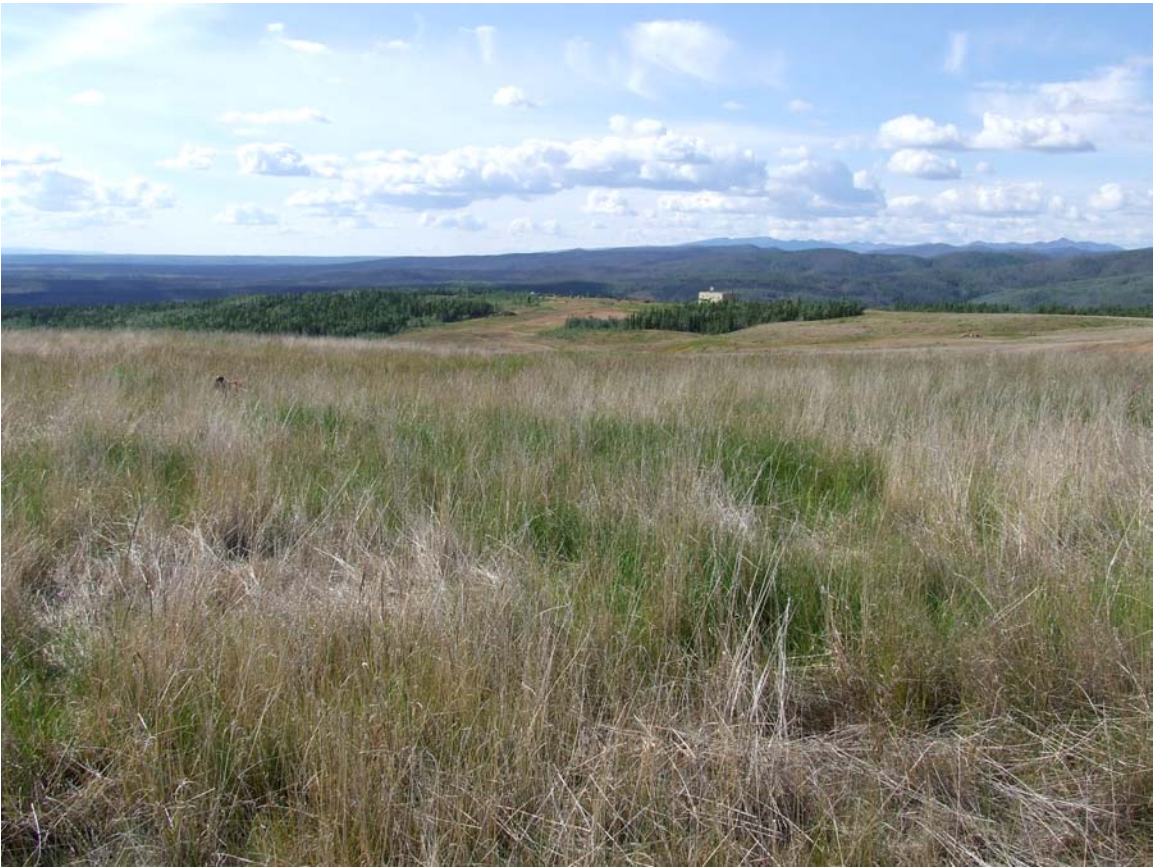
Photo #3: Plot #1 on the top of the Leach Pad.
