Yukon Geological Survey Miscellaneous Report 17

Inventory of mass movement geohazards along the Dempster Highway, Yukon

Robin J. McKillop, Courtenay E. Brown, Daniel J. McParland and David A. Sacco
Palmer Environmental Consulting Group Inc.
and Jim Coates
Kryotek Arctic Innovation Inc.

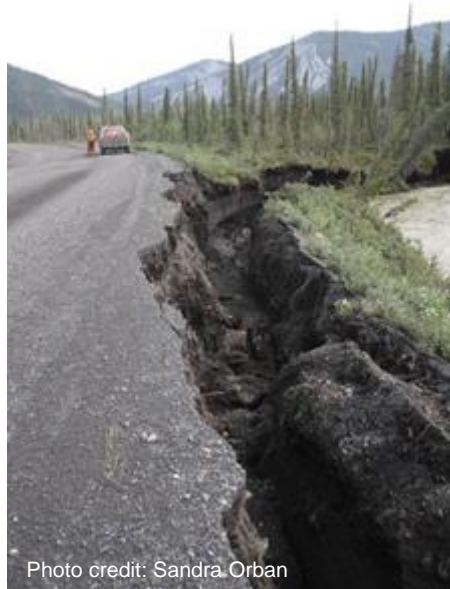
Figure 2-5. Meander-induced Mass Movement of Highway Embankment along Engineer Creek at km 182

3. Mass movement initiated **beneath** the highway, whether from natural or anthropogenic causes, typically occurs as a result of thermokarst and/or piping within underlying materials. This may result in differential subsidence and potentially collapse of the highway, either slowing or blocking traffic and requiring remediation.
4. Mass movement initiated **alongside** the highway (or bridge abutments) commonly occurs due to encroachment of a stream meander. This may result in undermining and collapse (slumping) of the highway embankment, such as occurred at km 182 due to encroachment of Engineer Creek (**Figure 2-5**).

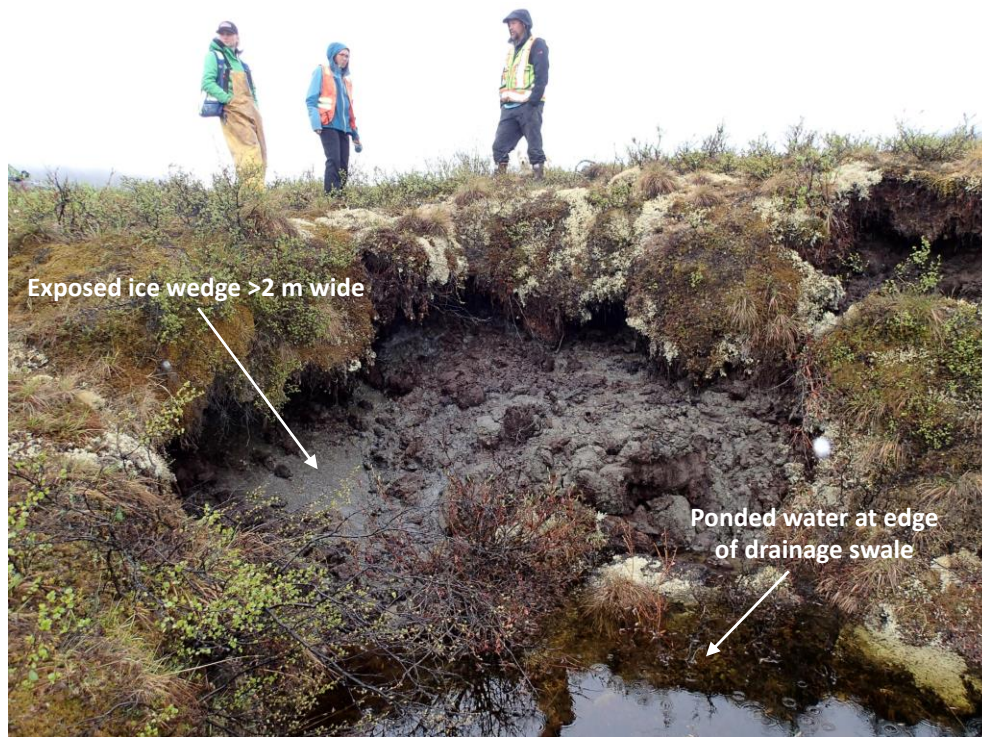
One of the mass movement processes most likely to necessitate localized reconstruction if it reaches the highway is retrogressive thaw slumps. Kryotek’s backpack-portable auger drill was used to assess ground (permafrost) conditions conducive to retrogressive thaw slumps at a relatively small, recently developed retrogressive thaw slump on the west side of the highway at km 93.6 (**Appendices C and D**). The slump had developed in silty to sandy, inactive fluvial deposits on nearly level ground, at the edge of a shallow drainage swale that enters the East Blackstone River shortly after crossing the highway. Field investigations confirmed the desktop-based interpretation of ice-wedge polygons in the area; an ice wedge at least 2 m wide was exposed within the ablating headscarp of the retrogressive thaw slump

(Figure 4-5). Five shallow (<1 m) auger boreholes drilled in undisturbed ground within 10 m of the headscarp intersected ice-rich silt and very fine sand beneath about 15 cm of surface organics. Ground ice was present in pores and segregated seams, in addition to the ice wedges. Meltwater and rainwater ponded at the edge of the drainage swale, at the toe of the retrogressive thaw slump, appears to be contributing to the thawing of the underlying, ice-rich soils.

Figure 4-5. Ice-rich Permafrost in Headscarp of Retrogressive Thaw Slump at km 93.6

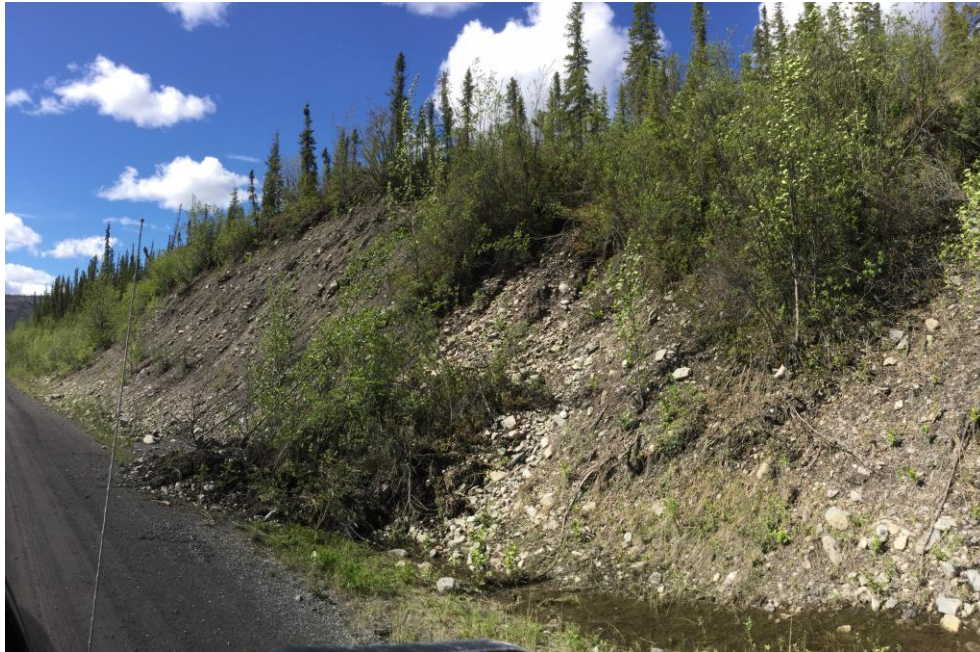
Figure 5-6. Example of a Road-cut Slough Excluded from the Geohazard Inventory

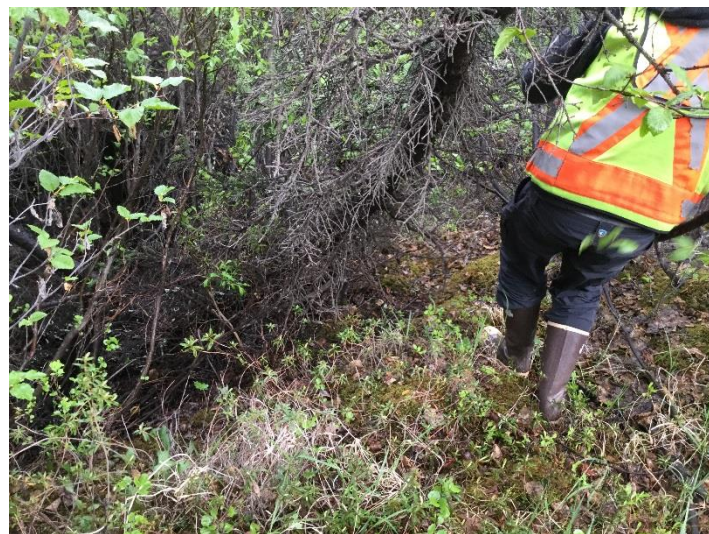
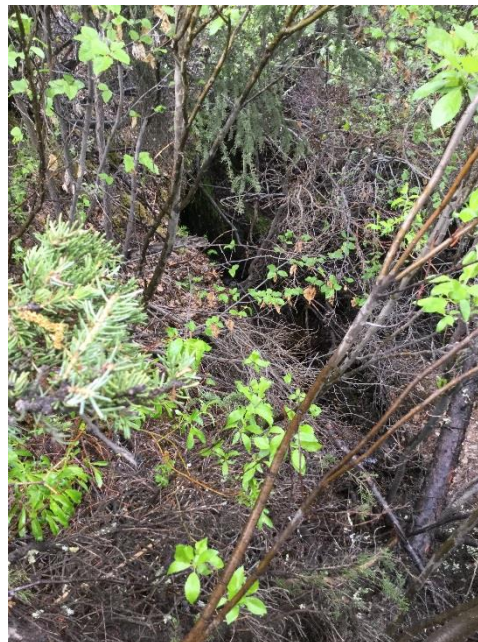
Project: Dempster Geohazard Investigation Project number: 14132 Client: Yukon Government
		KM 60.7

SITE	PROCESS	GEOMETRY	IMPLICATIONS
Section	Type	Elevation (m)	Likelihood
Klondike	thermokarst gully	933	L
Proximity (m)	Position	Length (m)	Consequence
10	below	113	M
Aspect (°)	Causes	Width (m)	Risk
120	concentrated drainage	12	L
Surficial material	Triggers	Depth (m)	Mitigation
szcFa	intense rainfall/snowmelt	3	Management of surface runoff from culvert
Permafrost	Timing	Average slope (°)	Comments
Shallow permafrost, likely locally ice-rich	Ongoing/episodic, likely initiated following highway construction	4

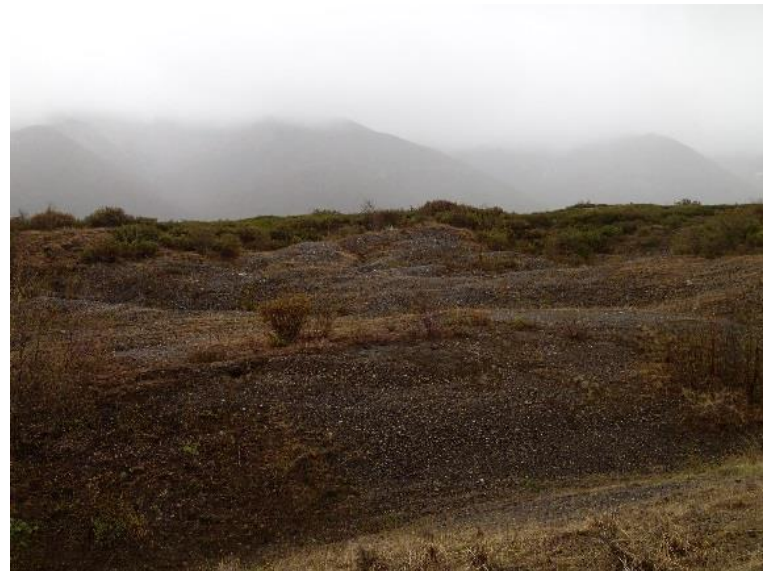
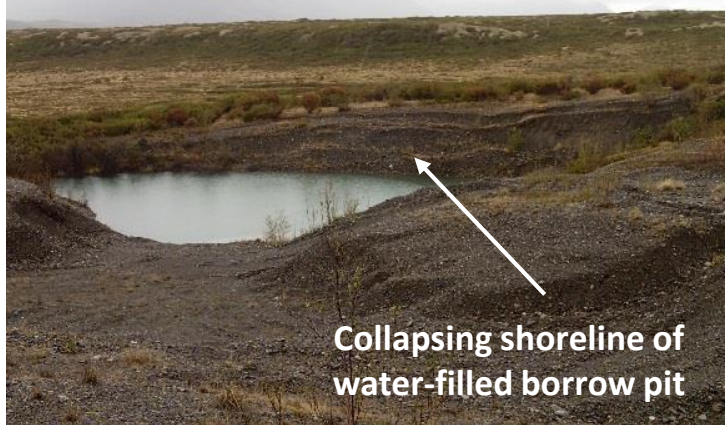
Project: Dempster Geohazard Investigation Project number: 14132 Client: Yukon Government
		KM 85.5

SITE	PROCESS	GEOMETRY	IMPLICATIONS
Section	Type	Elevation (m)	Likelihood
Klondike	thermokarst subsidence	1180	M
Proximity (m)	Position	Length (m)	Consequence
0	beneath	360	L
Aspect (°)	Causes	Width (m)	Risk
240	alteration to surface organic cover, alteration to drainage, permafrost degradation	235	L
Surficial material	Triggers	Depth (m)	Mitigation
dszMu	intense rainfall/snowmelt or heat	<2	Management of ground settlement
Permafrost	Timing	Average slope (°)	Comments
Shallow, ice-rich permafrost in area of degrading ice-wedge polygons	Ongoing/episodic, likely exacerbated by highway construction	3	Differential settlement expected to continue affecting hwy embankments

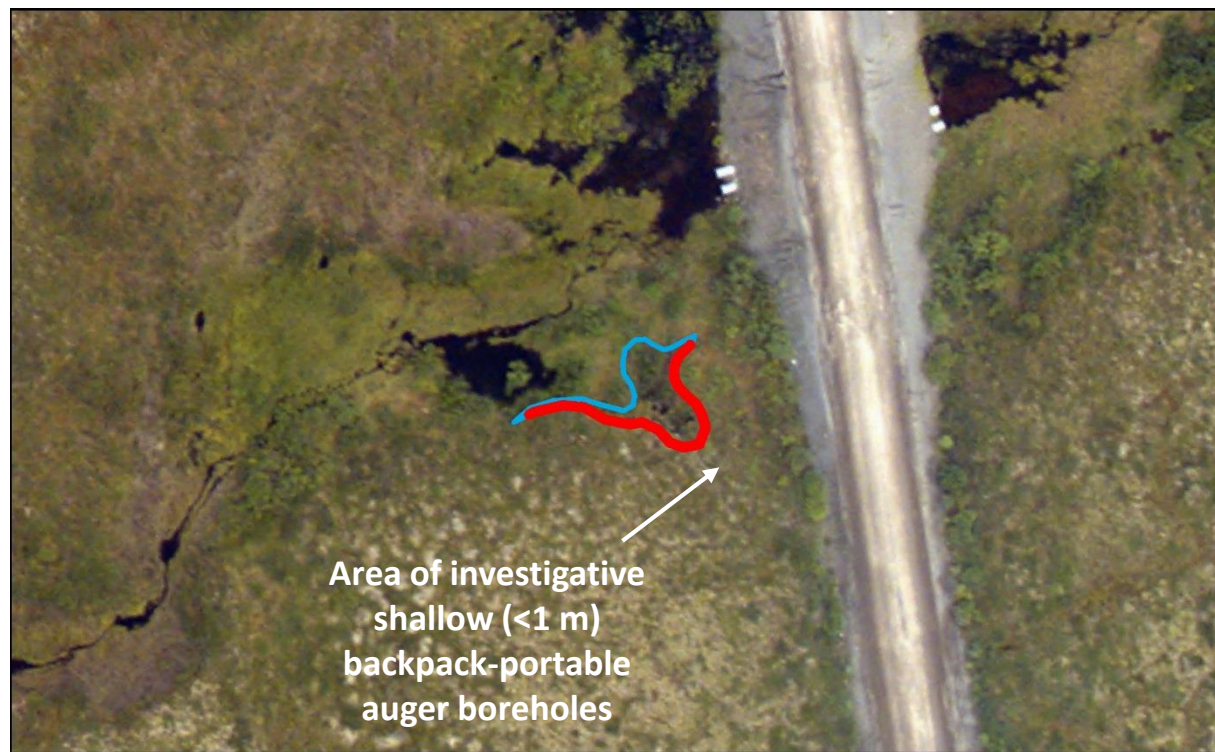
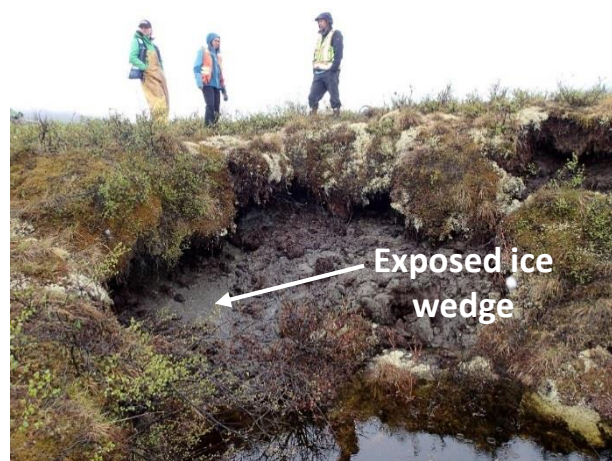
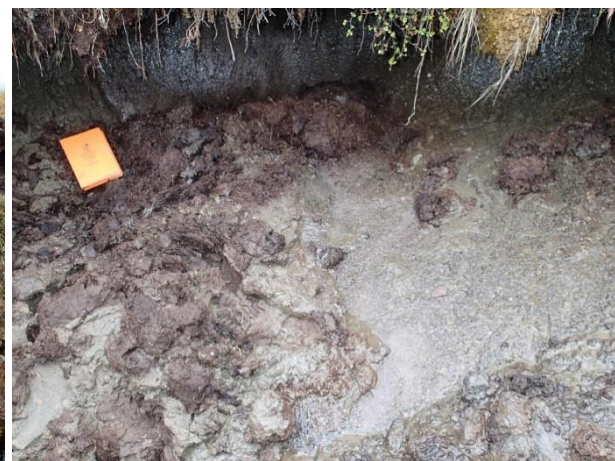
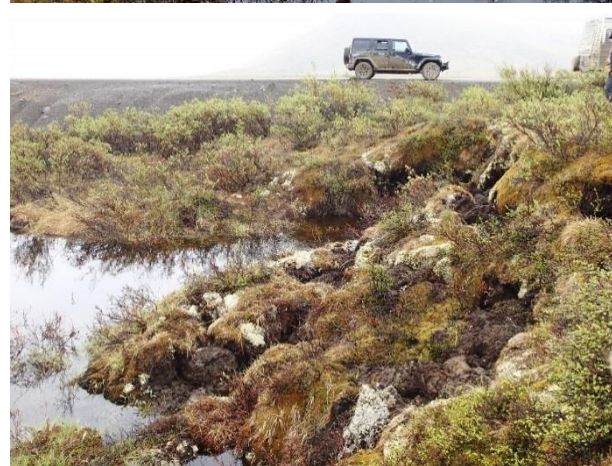
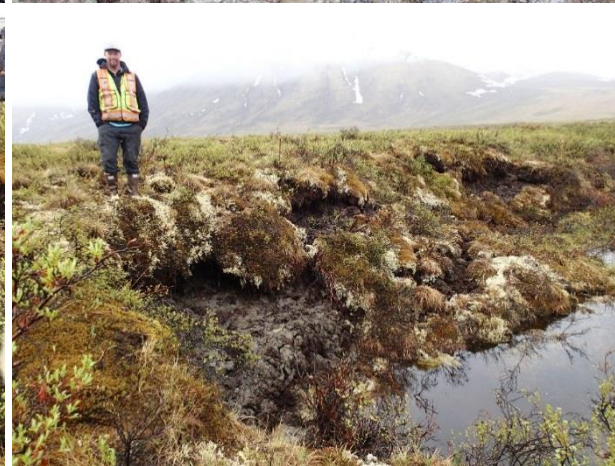
Project: Dempster Geohazard Investigation Project number: 14132 Client: Yukon Government
		<h2>KM 93.6</h2>

SITE	PROCESS	GEOMETRY	IMPLICATIONS
Section	Type	Elevation (m)	Likelihood
Klondike	retrogressive thaw slump	1124	L
Proximity (m)	Position	Initiation slope (°)	Consequence
10	below	11	H
Aspect (°)	Causes	Runout slope (°)	Risk
330	alteration to drainage pattern (unnatural impoundment), permafrost degradation	9	M
Surficial material	Triggers	Average slope (°)	Mitigation
sgzFGt	intense rainfall/snowmelt or heat	11	Management of ground settlement
Permafrost	Timing	Dimensions (L/W/D) (m)	Comments
Shallow, ice-rich permafrost in area of degrading ice-wedge polygons; 2 m of exposed ice wedge plus seams/lenses	Ongoing/episodic, possibly exacerbated by highway construction	13 / 6 / 2	Dominant trajectory of retrogression subparallel to, rather than toward, hwy

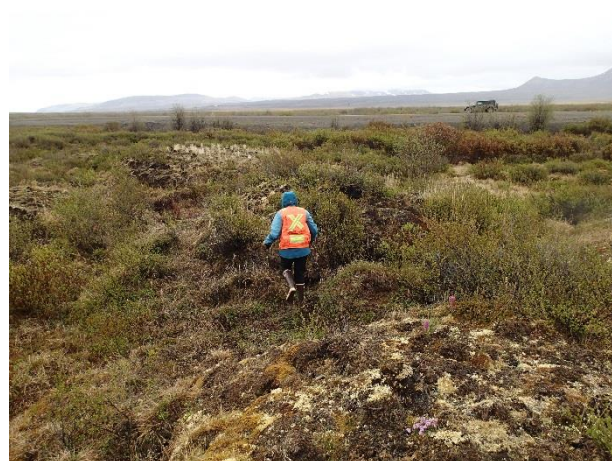
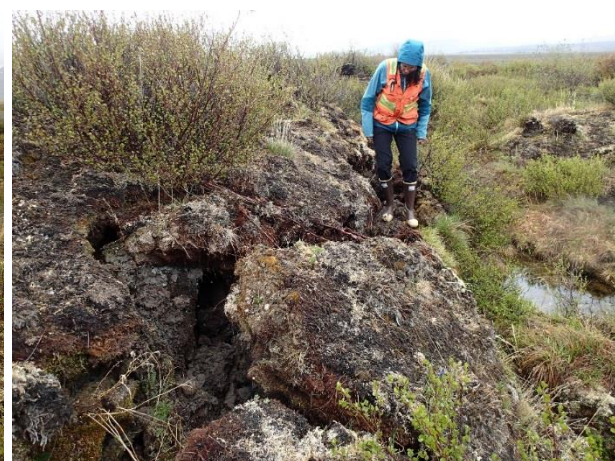
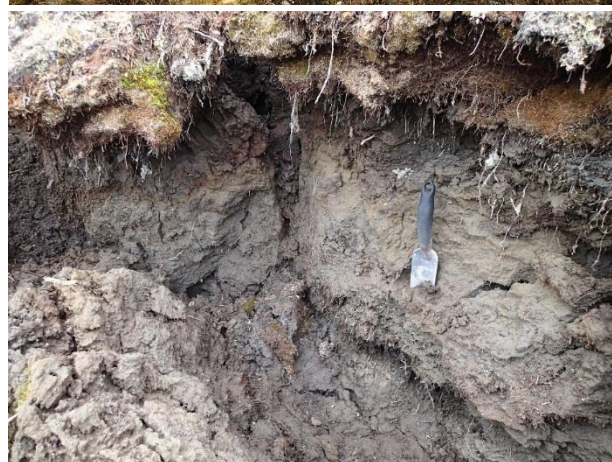
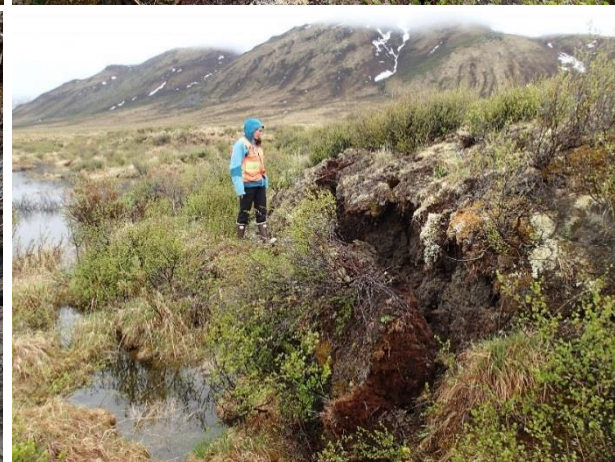
Project: Dempster Geohazard Investigation Project number: 14132 Client: Yukon Government
		KM 96.8

SITE	PROCESS	GEOMETRY	IMPLICATIONS
Section	Type	Elevation (m)	Likelihood
Klondike	thermokarst subsidence	1106	L
Proximity (m)	Position	Length (m)	Consequence
0	beneath	518	M
Aspect (°)	Causes	Width (m)	Risk
55	permafrost degradation	95	L
Surficial material	Triggers	Depth (m)	Mitigation
zsgFf	intense rainfall/snowmelt or heat	2.5	Management of ground settlement
Permafrost	Timing	Average slope (°)	Comments
Shallow, ice-rich permafrost (silt/organics) in area of degrading ice-wedge polygons	Ongoing/episodic, possibly exacerbated by highway construction	1	Area of severest subsidence activity southwest of hwy

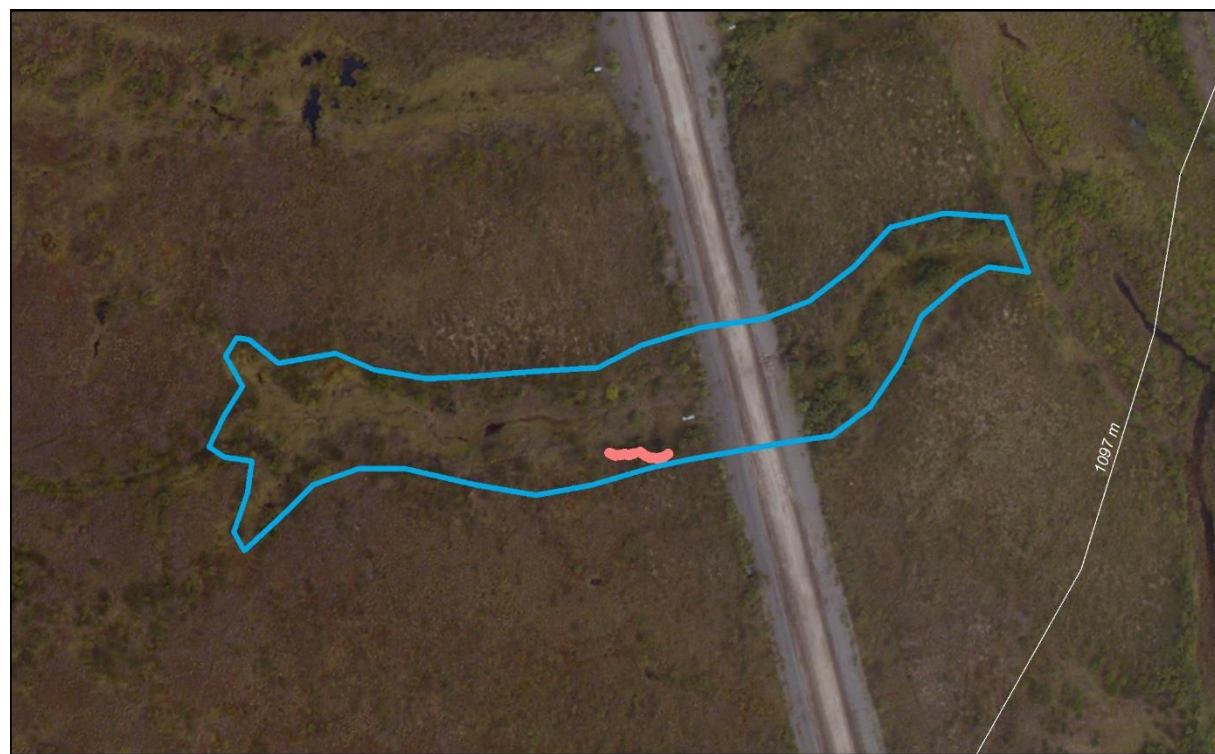
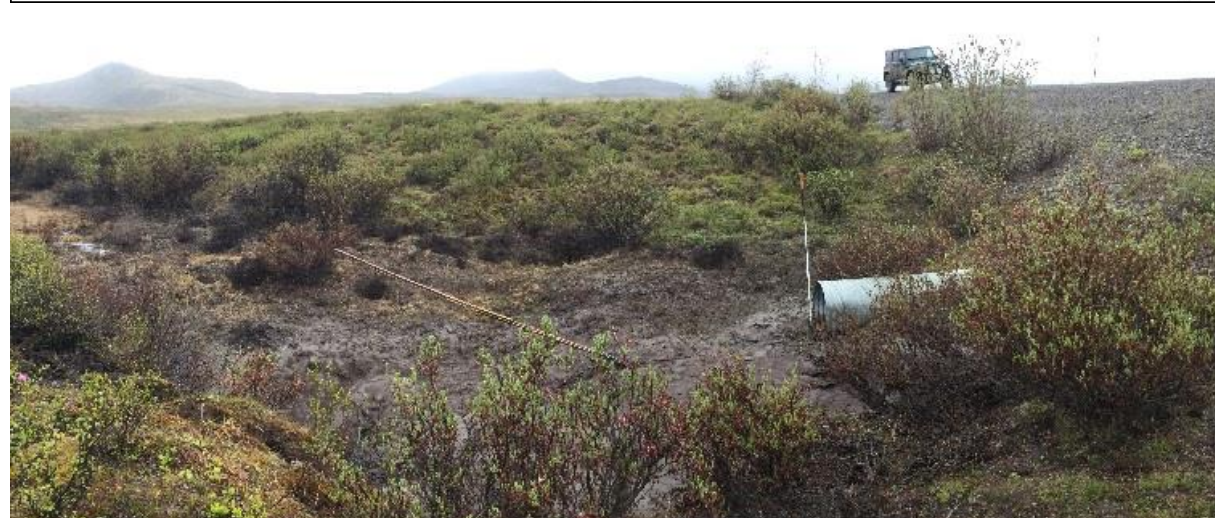
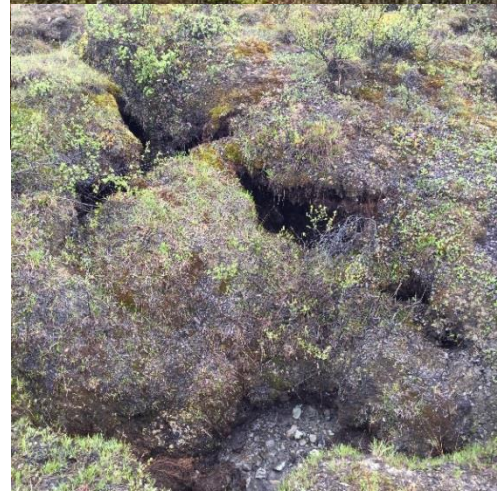
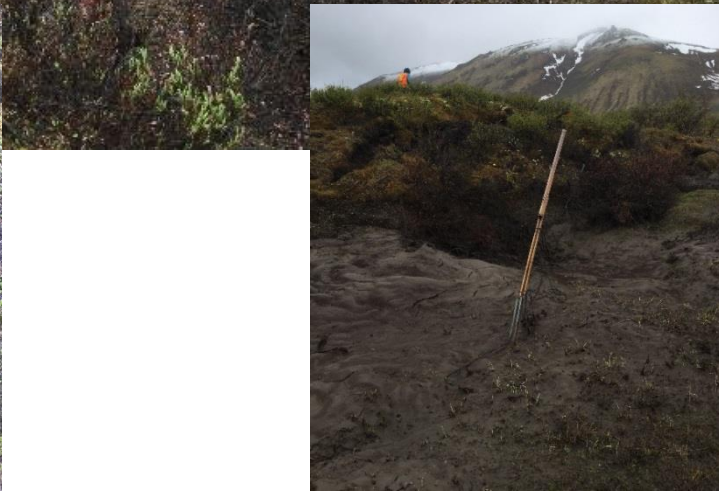
KM 97.1

Section	Type	Elevation (m)	Likelihood
Klondike	thermokarst subsidence	1106	L

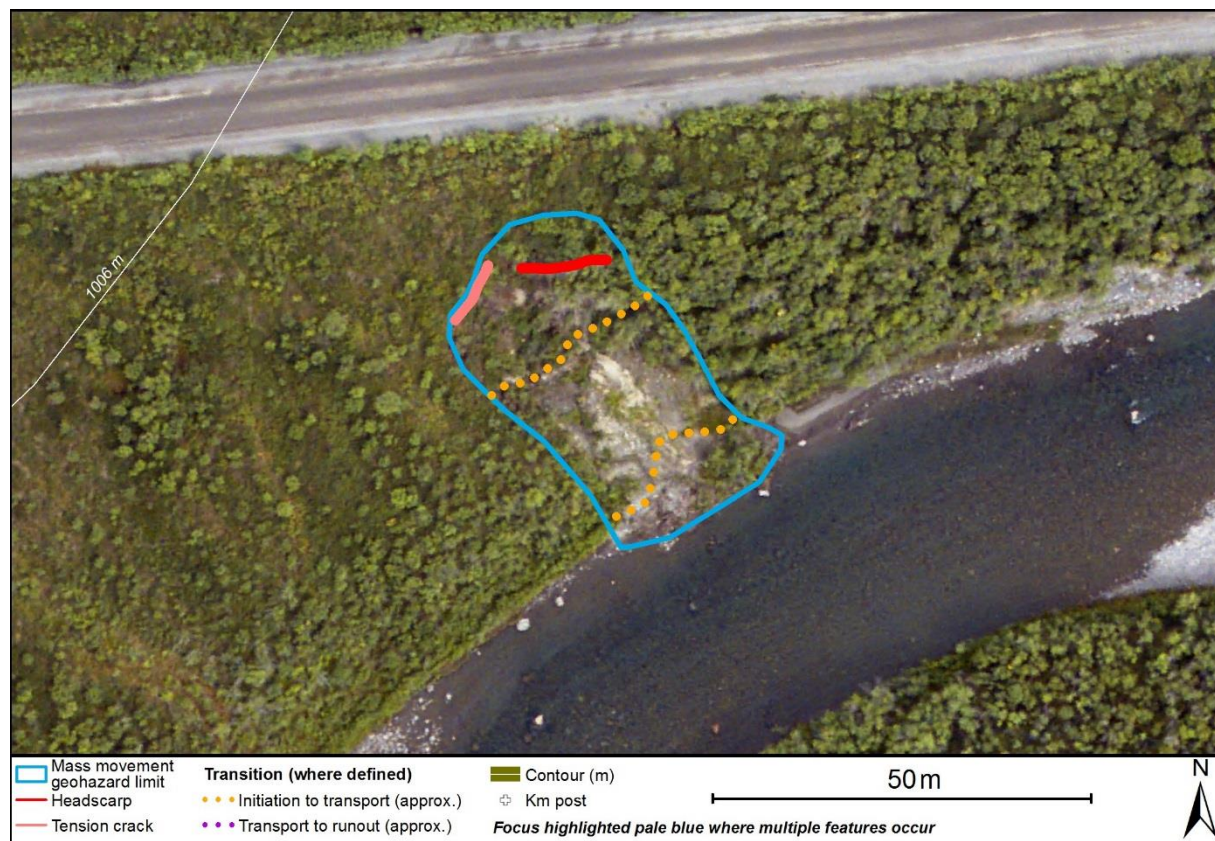
Project: Dempster Geohazard Investigation Project number: 14132 Client: Yukon Government
		KM 115.4

SITE	PROCESS	GEOMETRY	IMPLICATIONS
Section	Type	Elevation (m)	Likelihood
Klondike	debris slide (active layer detachment)	988	M
Proximity (m)	Position	Initiation slope (°)	Consequence
10	below	36	M
Aspect (°)	Causes	Runout slope (°)	Risk
140	incremental undercutting of slope toe by river, permafrost degradation	10	M
Surficial material	Triggers	Average slope (°)	Mitigation
szdMa	intense rainfall/snowmelt or heat	24	Management of ground settlement if/when feature retrogresses toward hwy
Permafrost	Timing	Dimensions (L/W/D) (m)	Comments
Shallow, ice-rich permafrost on river-cut scarp adjacent to degrading ice-wedge polygons	Single event (2007-2013) with potential to initiate retrogressive thaw slump	48 / 26 / 2.5	Potential for feature to evolve into retrogressive thaw slump

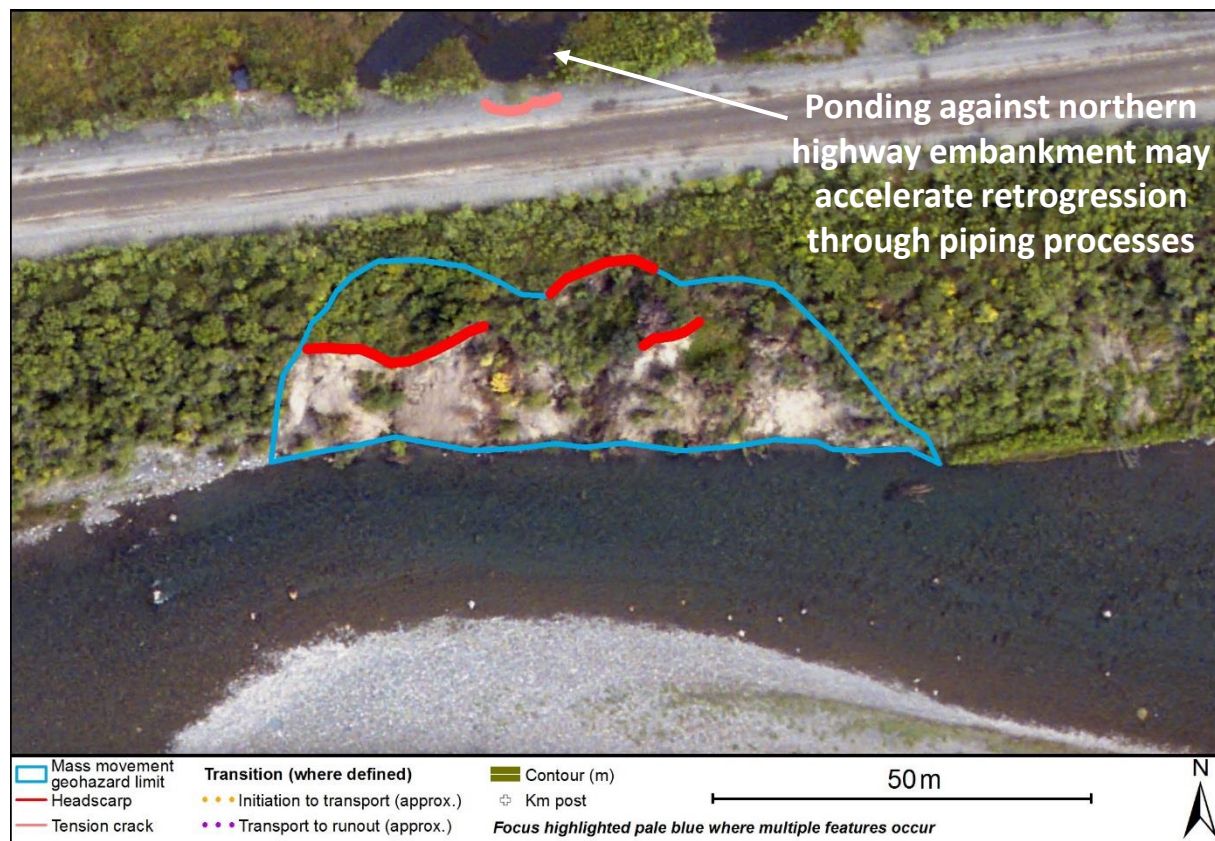
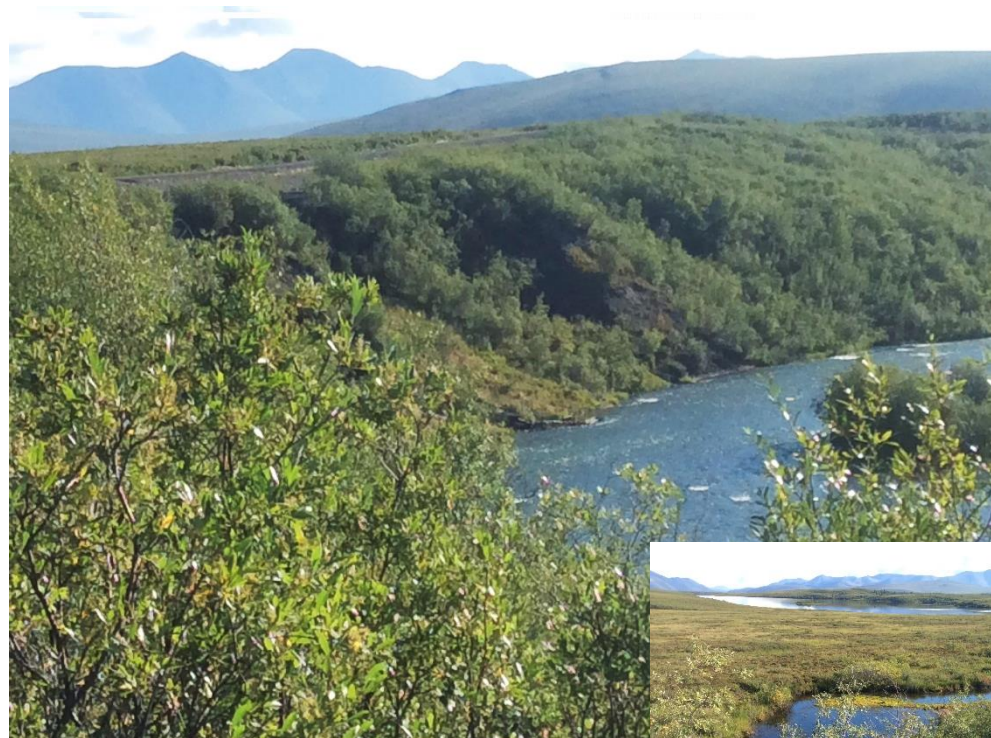
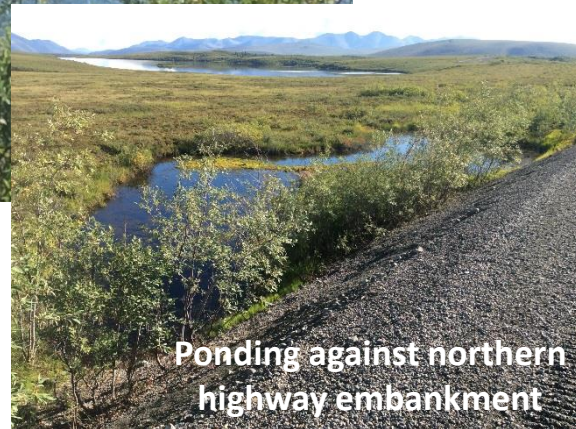
Project: Dempster Geohazard Investigation Project number: 14132 Client: Yukon Government
		<h2>KM 115.6</h2>

SITE	PROCESS	GEOMETRY	IMPLICATIONS
Section	Type	Elevation (m)	Likelihood
Klondike	retrogressive thaw slump	989	M
Proximity (m)	Position	Initiation slope (°)	Consequence
3.5	below	29	H
Aspect (°)	Causes	Runout slope (°)	Risk
155	disturbance to surface organic cover, alteration of drainage pattern, permafrost degradation	0	H
Surficial material	Triggers	Average slope (°)	Mitigation
gszFt/szdMa	intense rainfall/snowmelt or heat	35	Management of ponding adjacent to hwy and ground settlement if/when feature retrogresses toward hwy
Permafrost	Timing	Dimensions (L/W/D) (m)	Comments
Shallow, ice-rich permafrost on river-cut scarp adjacent to degrading ice-wedge polygons	Ongoing/episodic, possibly exacerbated by highway construction	23 / 60 / 2.4	Ponding north of hwy may exacerbate failure to south

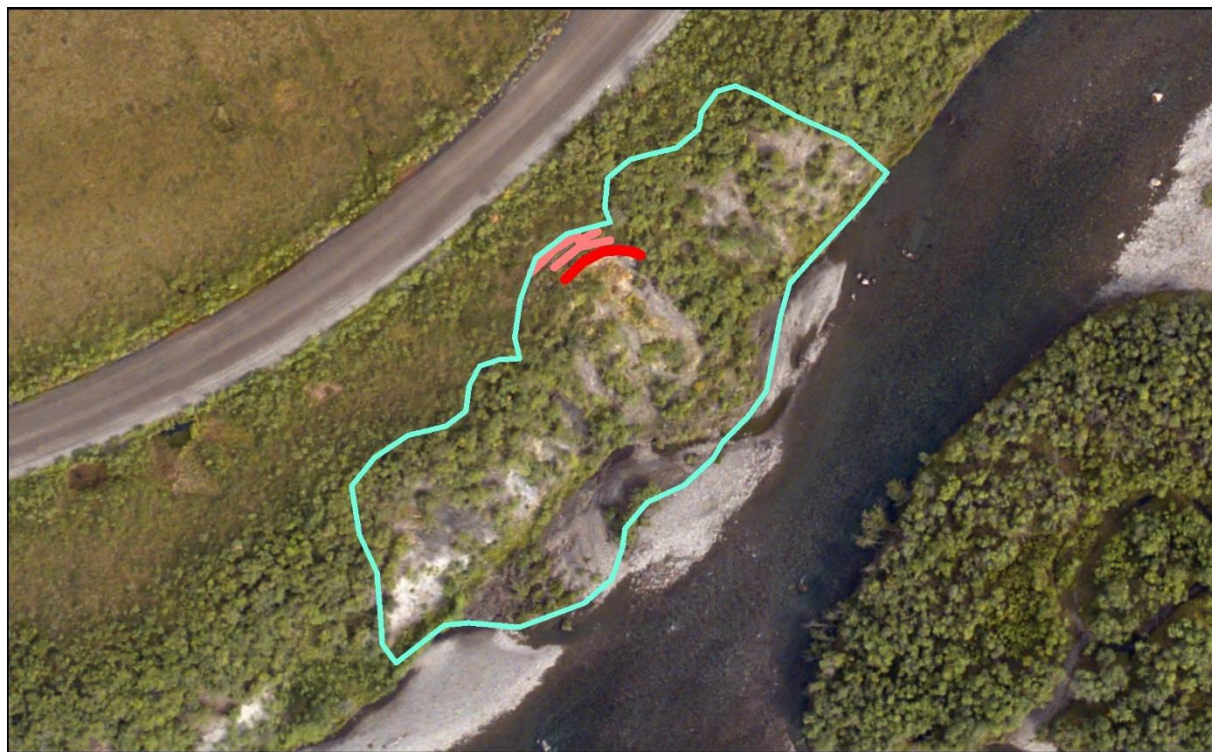
Project: Dempster Geohazard Investigation Project number: 14132 Client: Yukon Government
		<h2>KM 115.9</h2>

SITE	PROCESS	GEOMETRY	IMPLICATIONS
Section Klondike	Type retrogressive thaw slump	Elevation (m) 986	Likelihood M
Proximity (m) 5	Position below	Initiation slope (°) 29	Consequence H
Aspect (°) 135	Causes alteration of drainage pattern, permafrost degradation	Runout slope (°) 11	Risk H
Surficial material gszFt\szdMa	Triggers intense rainfall/snowmelt or heat	Average slope (°) 24	Mitigation Management of ground settlement and slope failures if/when feature retrogresses toward hwy
Permafrost Shallow, ice-rich permafrost on river-cut scarp adjacent to degrading ice-wedge polygons	Timing Ongoing/episodic, possibly exacerbated by highway construction	Dimensions (L/W/D) (m) 45 / 90 / 4.5	Comments

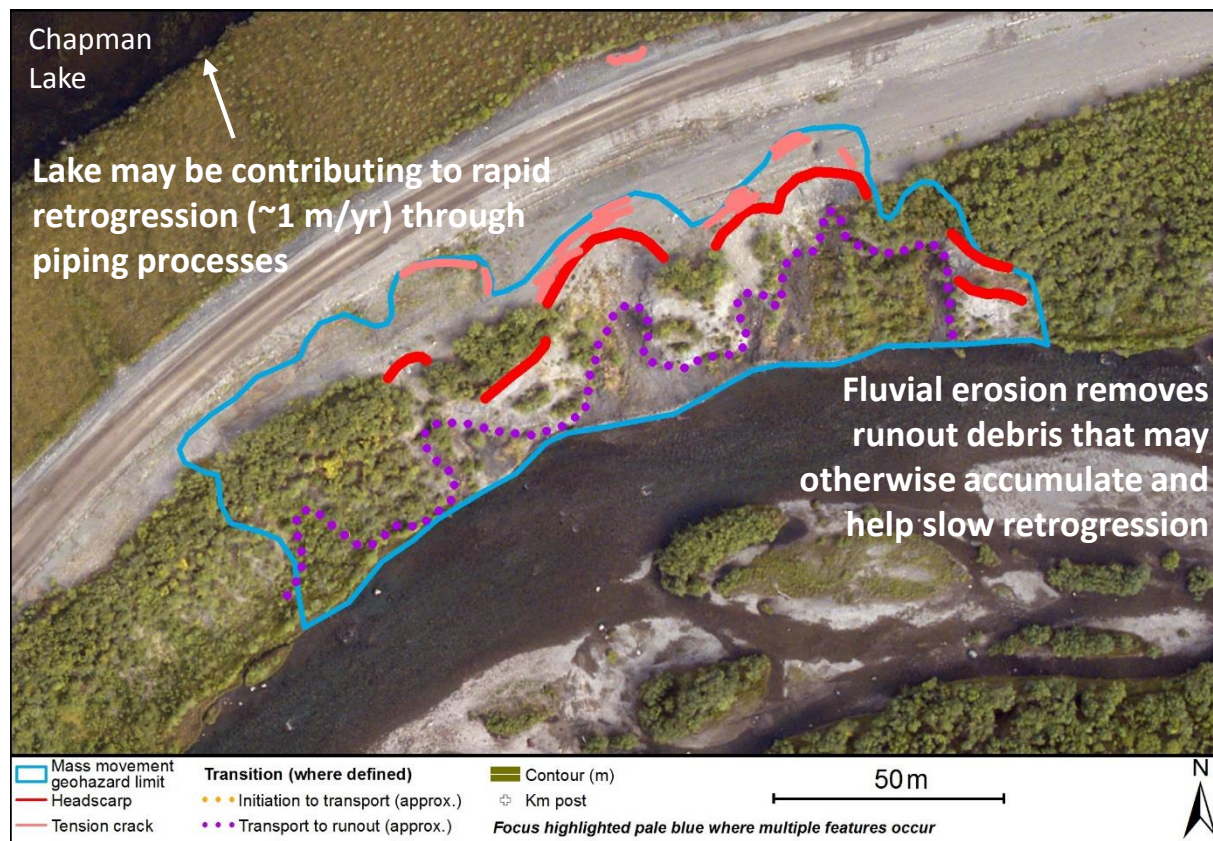
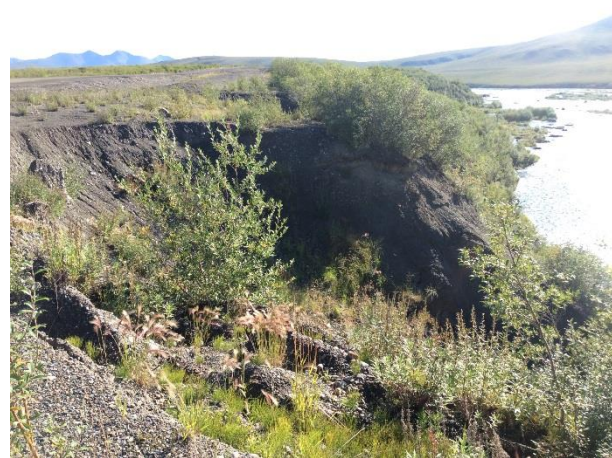
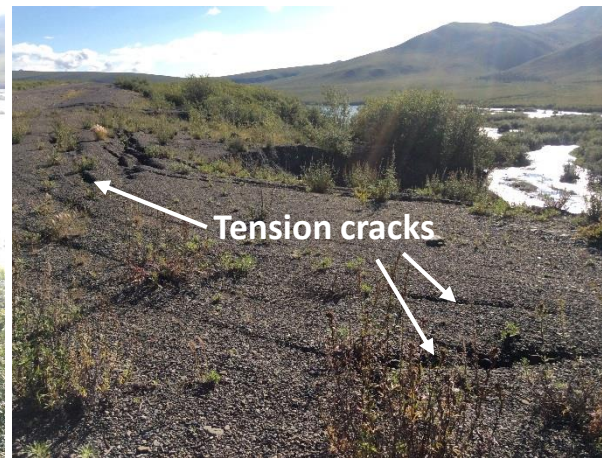
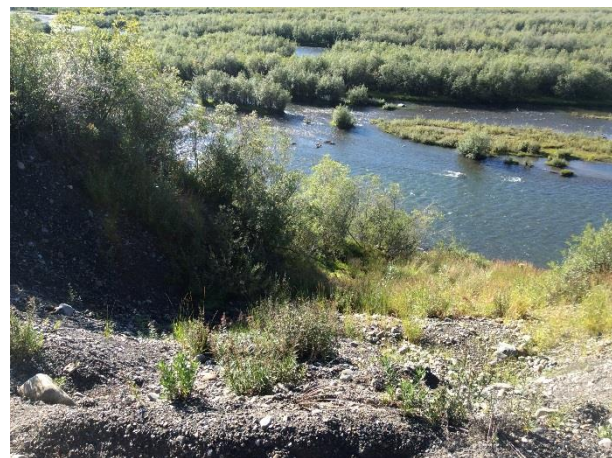
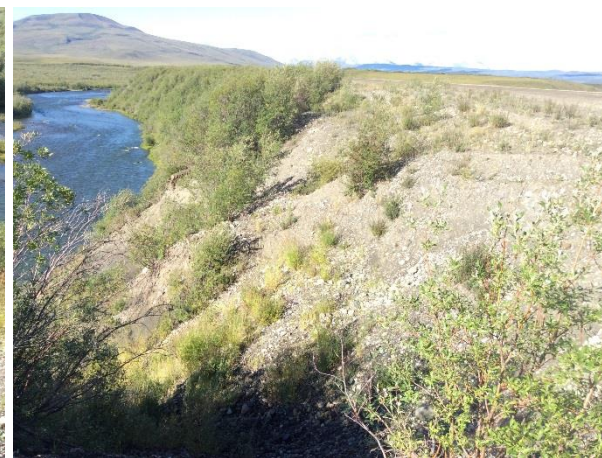
KM 116.2

SITE	PROCESS	GEOMETRY	IMPLICATIONS
Section Klondike	Type retrogressive thaw slump	Elevation (m) 989	Likelihood H
Proximity (m) 0	Position below	Initiation slope (°) 4	Consequence H
Aspect (°) 135	Causes disturbance to surface organic cover, alteration of drainage pattern, permafrost degradation	Runout slope (°) 20	Risk VH
Surficial material gszFt/szdMa	Triggers intense rainfall/snowmelt or heat	Average slope (°) 20	Mitigation Management of ground settlement and slope failures if/when feature retrogresses toward hwy
Permafrost Shallow, ice-rich permafrost on river-cut scarp adjacent to degrading ice-wedge polygons with lake on opposite, upslope side of highway	Timing Ongoing/episodic, possibly exacerbated by highway construction; rapid retrogression 2007-2013 (~1 m/yr)	Dimensions (L/W/D) (m) 50 / 155 / 3	Comments Significant risk to hwy, especially given lake to north and relatively rapid retrogression (up to ~1 m/year); potential for future lake drainage

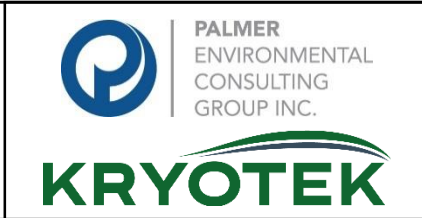
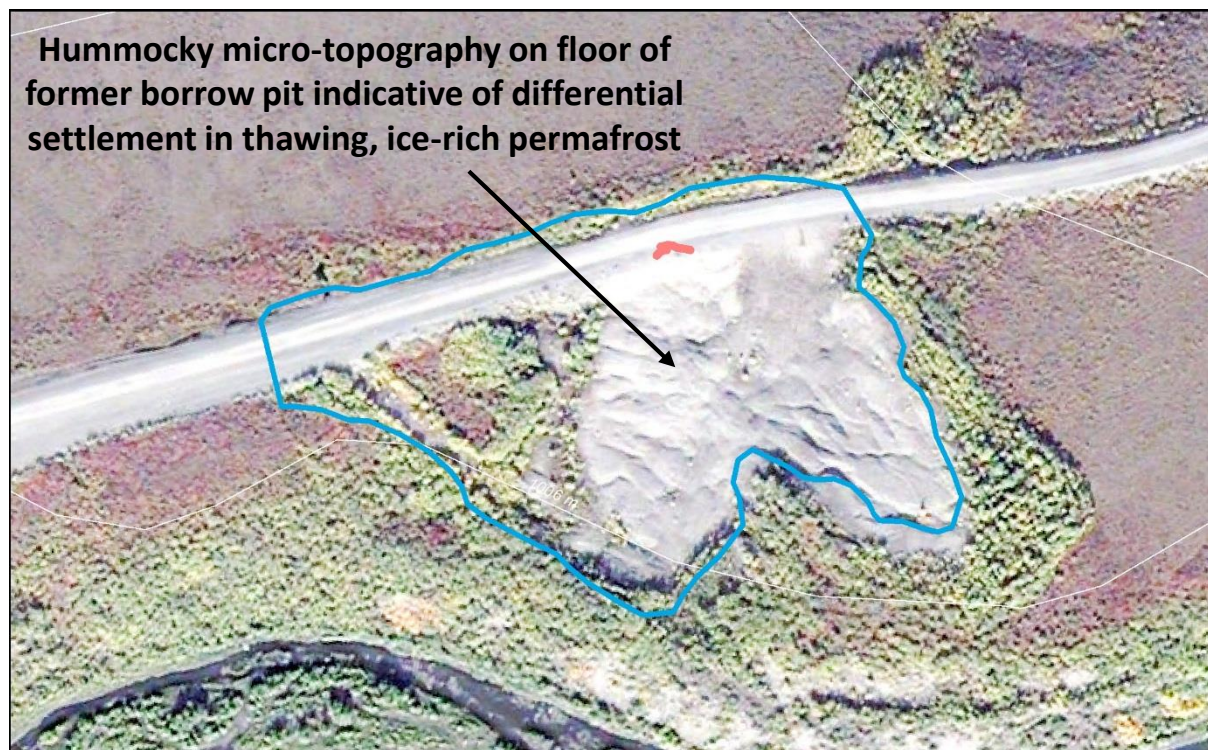
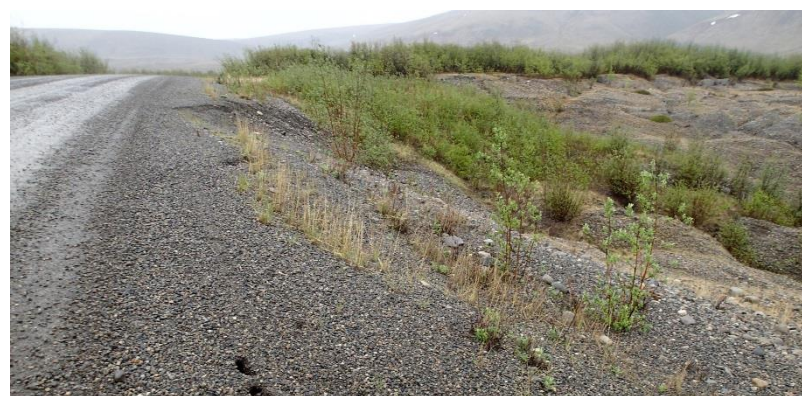
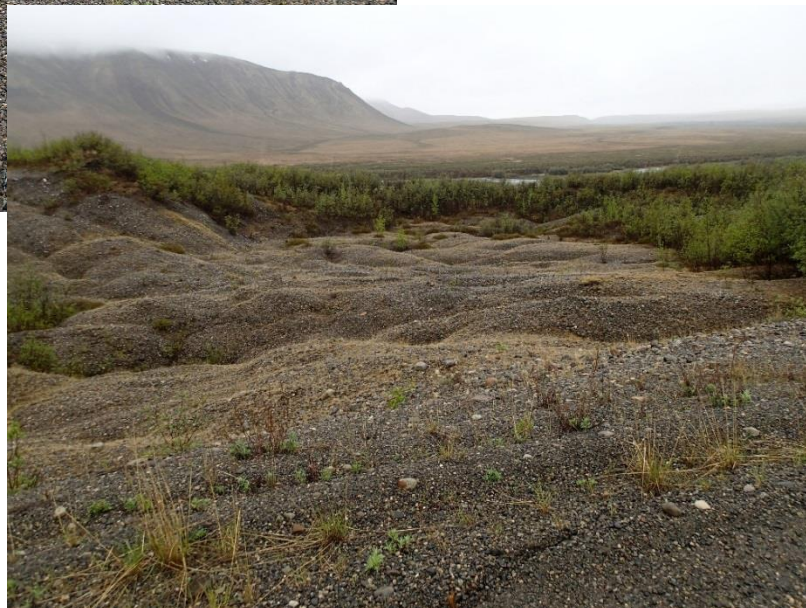
Project: Dempster Geohazard Investigation Project number: 14132 Client: Yukon Government
		<h2>KM 116.7</h2>

Hummocky micro-topography on floor of former borrow pit indicative of differential settlement in thawing, ice-rich permafrost

SITE	PROCESS	GEOMETRY	IMPLICATIONS
Section Klondike	Type thermokarst subsidence	Elevation (m) 998	Likelihood M
Proximity (m) 0	Position beneath	Length (m) 147	Consequence M
Aspect (°) 160	Causes disturbance to surface organic cover, alteration of drainage pattern, permafrost degradation	Width (m) 200	Risk M
Surficial material gszFt	Triggers intense rainfall/snowmelt or heat	Depth (m) 1.5	Mitigation Management of ground settlement
Permafrost Shallow, ice-rich permafrost in area of ice-wedge polygons	Timing Ongoing/episodic, likely initiated by clearing for borrow pit	Average slope (°) 5	Comments Differential settlement expected to continue affecting hwy embankments

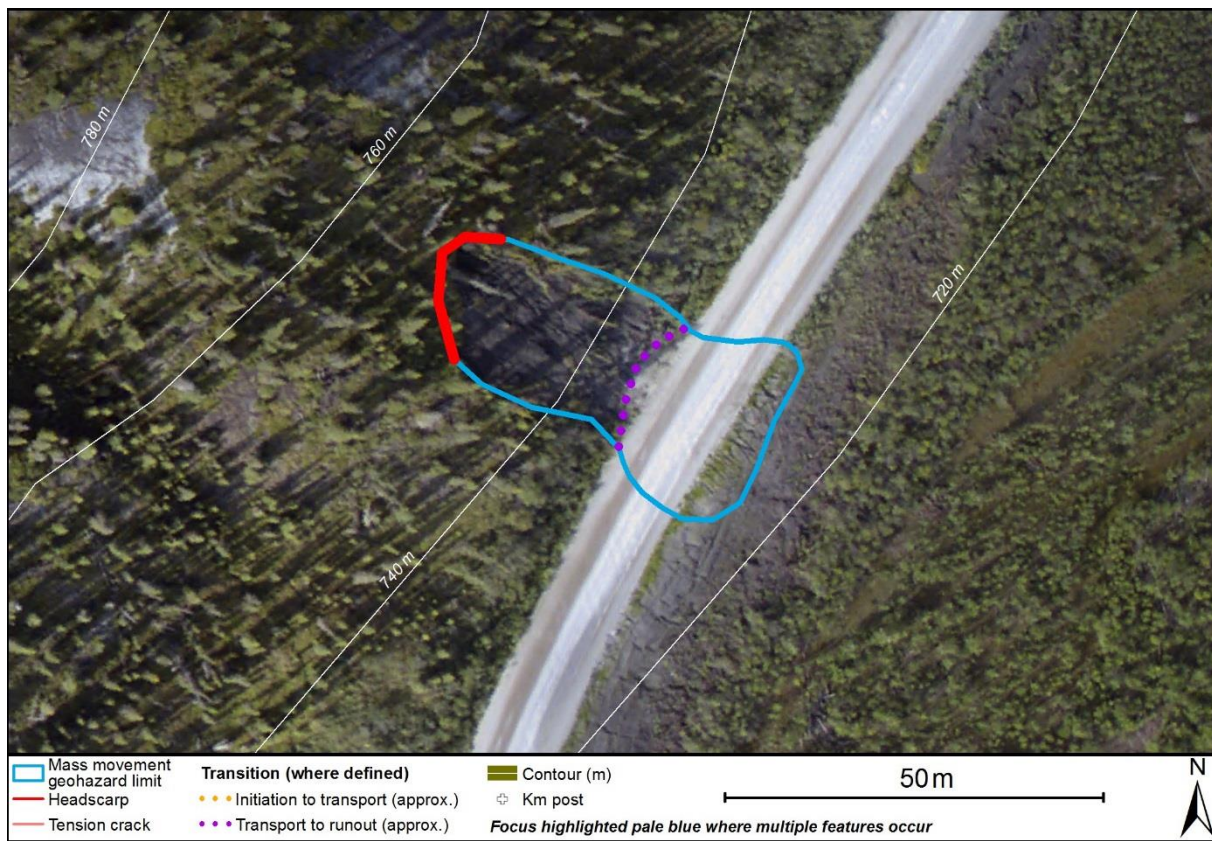
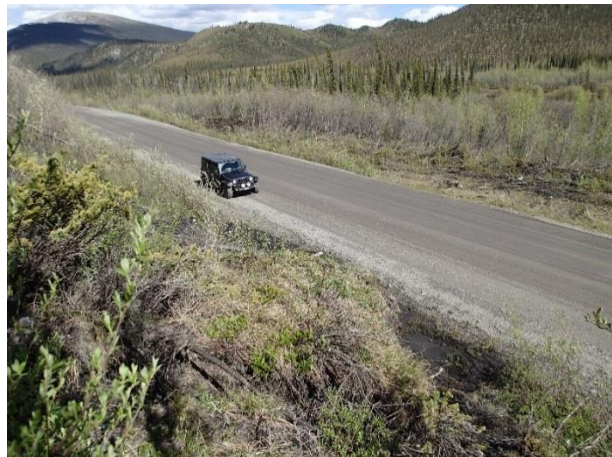
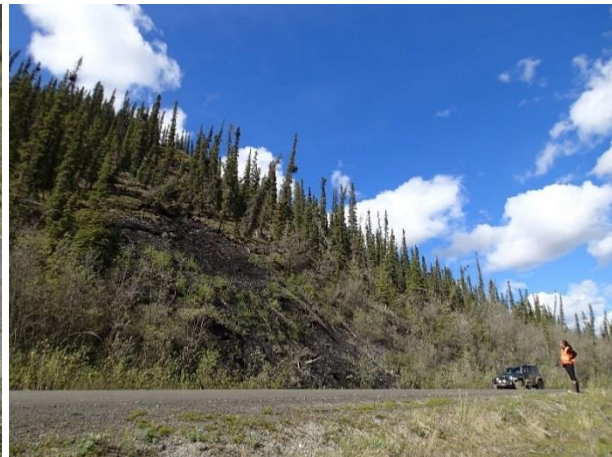
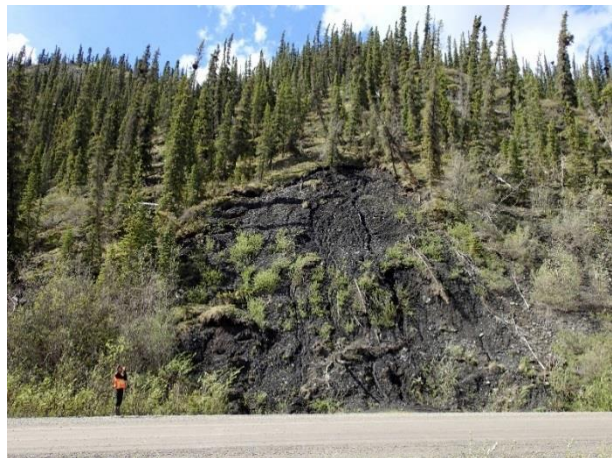
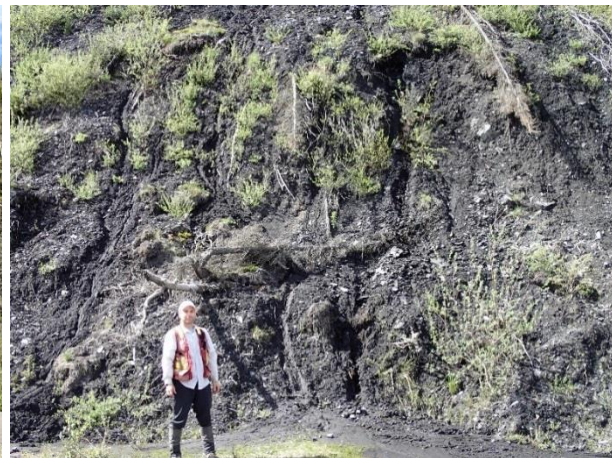
SITE	PROCESS	GEOMETRY	IMPLICATIONS
Section	Type	Elevation (m)	Likelihood
Ogilvie	debris slide (active layer detachment)	724	M
Proximity (m)	Position	Initiation slope (°)	Consequence
0	above	32	L
Aspect (°)	Causes	Runout slope (°)	Risk
110	oversteepened slope toe, permafrost degradation	4	L
Surficial material	Triggers	Average slope (°)	Mitigation
sziCv	intense rainfall/snowmelt or heat	26	Management of debris accumulation in ditch
Permafrost	Timing	Dimensions (L/W/D) (m)	Comments
Shallow permafrost	Single event (2007-2013) with potential for post-failure sloughs/flows	54 / 27 / 0.9	Runout limits approximate due to clearing of former debris accumulation
