Yukon Geological Survey Miscellaneous Report 17

Inventory of mass movement geohazards along the Dempster Highway, Yukon

Robin J. McKillop, Courtenay E. Brown, Daniel J. McParland and David A. Sacco
Palmer Environmental Consulting Group Inc.
and Jim Coates
Kryotek Arctic Innovation Inc.

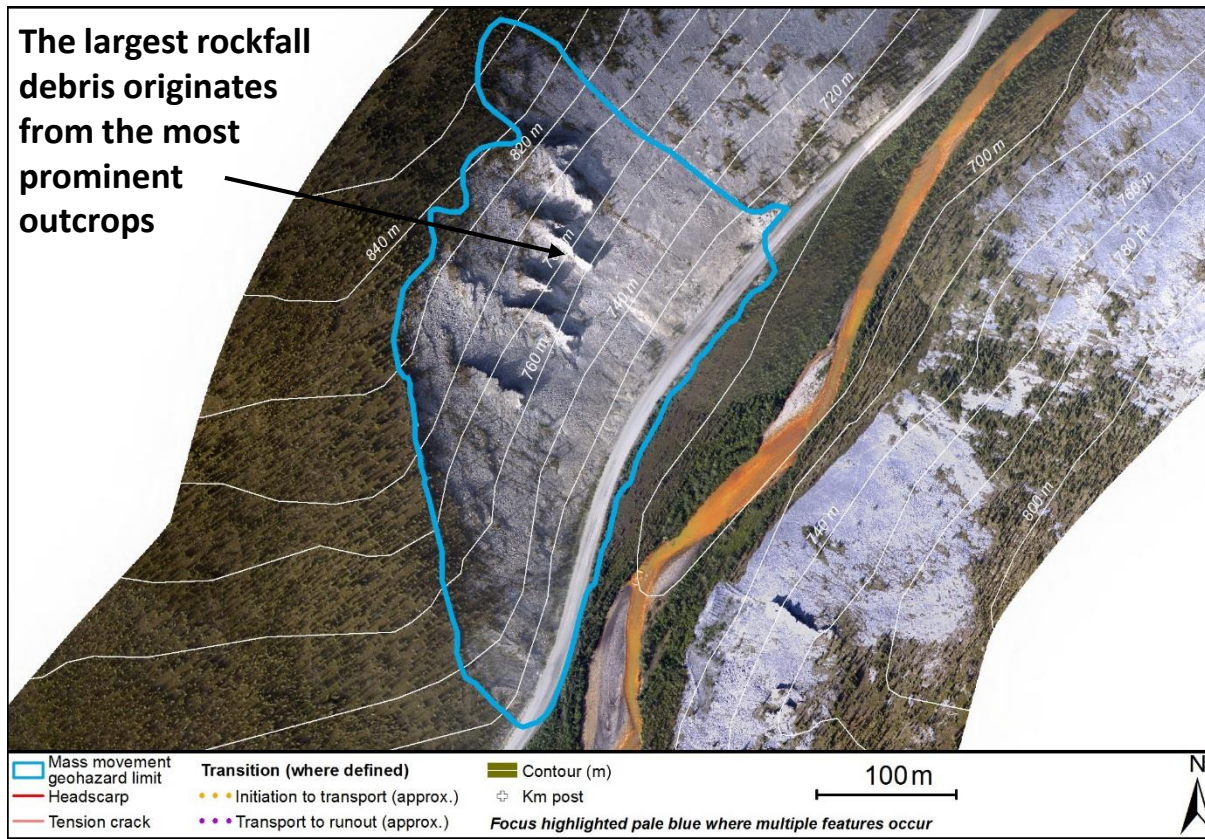
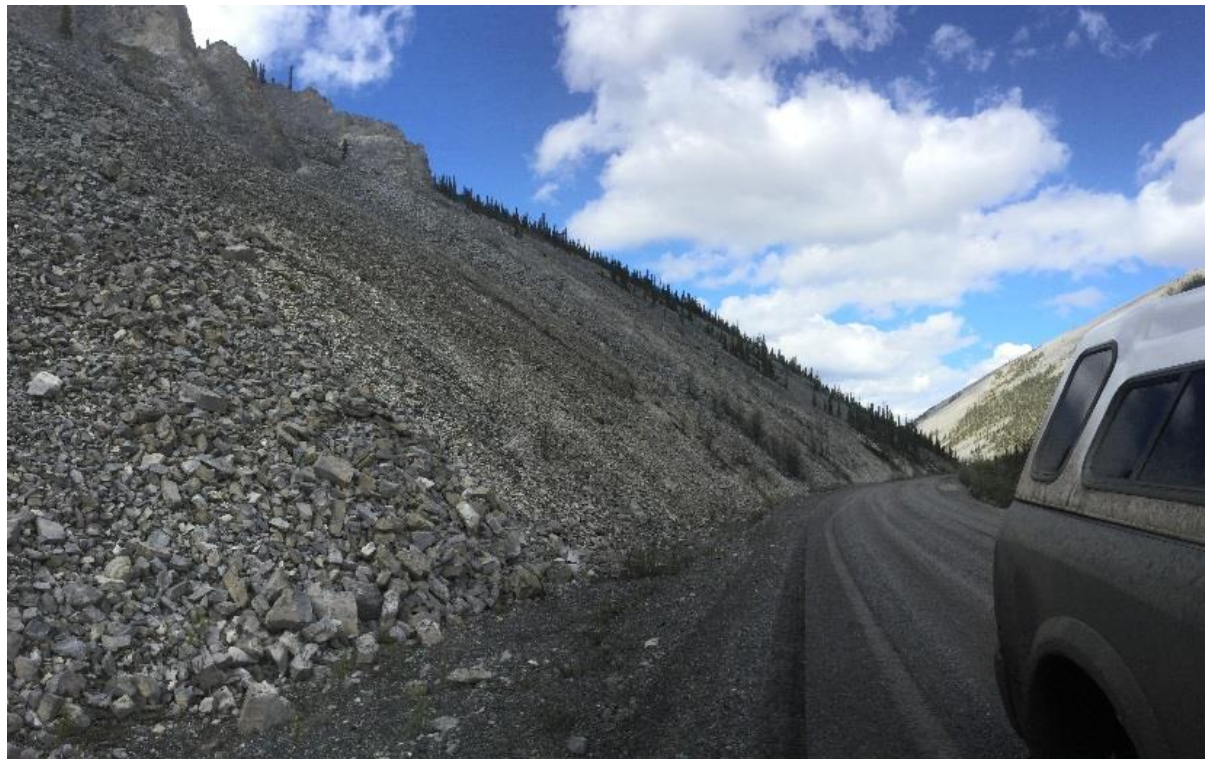
Project: Dempster Geohazard Investigation Project number: 14132 Client: Yukon Government
		KM 173.7

The largest rockfall debris originates from the most prominent outcrops

SITE	PROCESS	GEOMETRY	IMPLICATIONS
Section Ogilvie	Type rockfall	Elevation (m) 752	Likelihood H
Proximity (m) 0	Position above	Initiation slope (°) 44	Consequence M
Aspect (°) 120	Causes steep rock bluffs	Runout slope (°) 17	Risk H
Surficial material R	Triggers freeze/thaw, intense rainfall/snowmelt	Average slope (°) 34	Mitigation Management of rockfall debris in ditch and on hwy
Permafrost Permafrost, likely ice-poor, deep within weathered bedrock	Timing Recurrent (likely annual)	Dimensions (L/W/D) (m) 231 / 420 / n/a	Comments Runout limits approximate due to clearing of former debris accumulation; risk greatest downslope of prominent rock bluffs

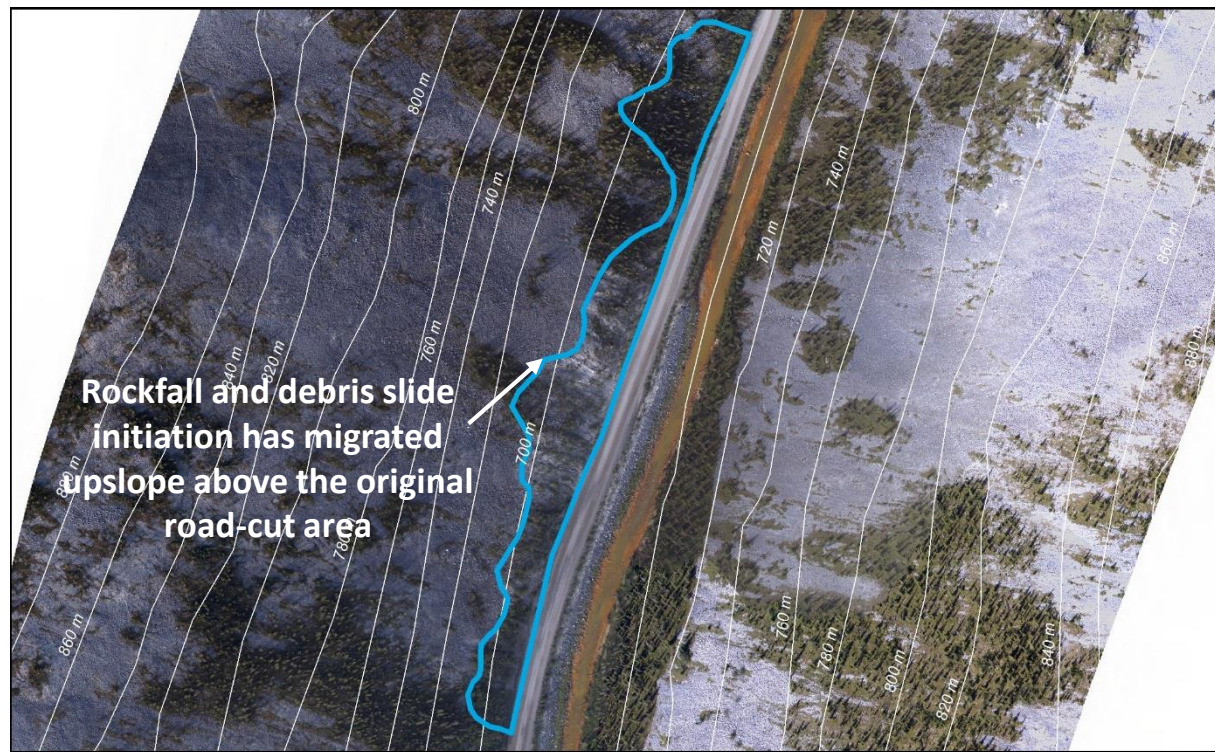
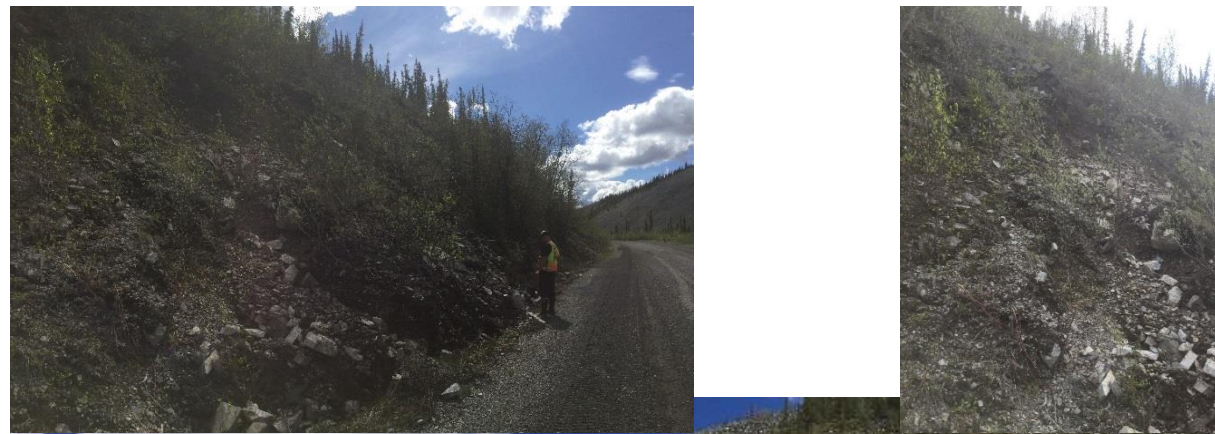
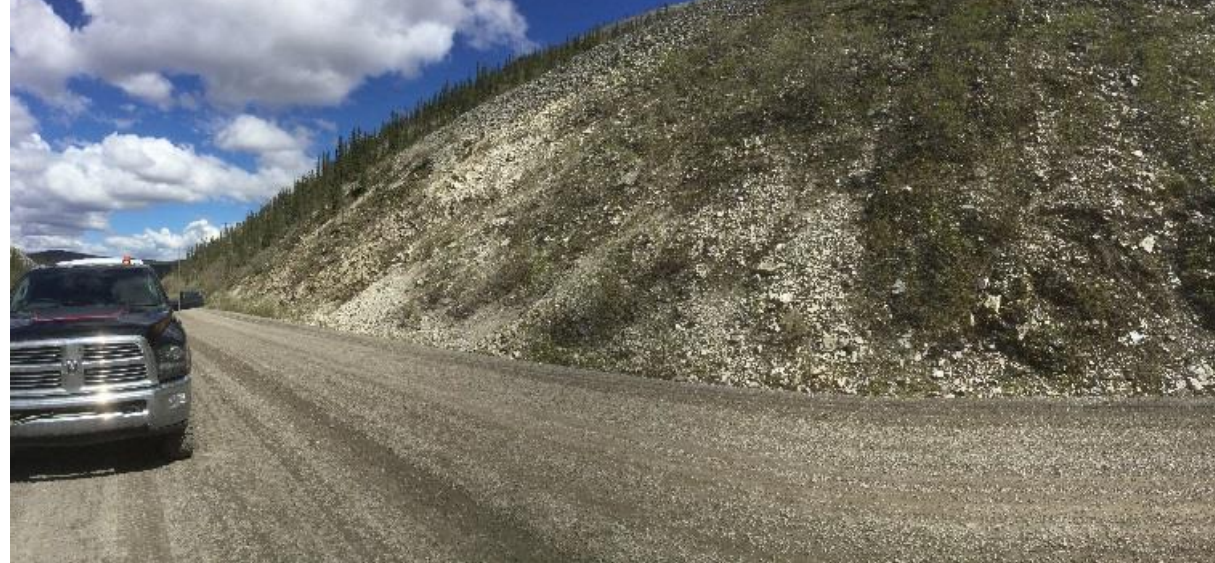
Project: Dempster Geohazard Investigation Project number: 14132 Client: Yukon Government
		<h2>KM 176.5</h2>

Rockfall and debris slide initiation has migrated upslope above the original road-cut area

SITE	PROCESS	GEOMETRY	IMPLICATIONS
Section	Type	Elevation (m)	Likelihood
Ogilvie	rockfall & debris slide	708	H
Proximity (m)	Position	Initiation slope (°)	Consequence
0	above	50	L
Aspect (°)	Causes	Runout slope (°)	Risk
107	oversteepened slope toe	20	M
Surficial material	Triggers	Average slope (°)	Mitigation
rszCv	freeze/thaw, intense rainfall/snowmelt	45	Management of rockfall debris in ditch and on hwy
Permafrost	Timing	Dimensions (L/W/D) (m)	Comments
Permafrost, likely ice-poor, relatively deep within colluvial rubble or weathered bedrock	Recurrent (likely annual)	41 / 406 / n/a	Runout limits approximate due to clearing of former debris accumulation

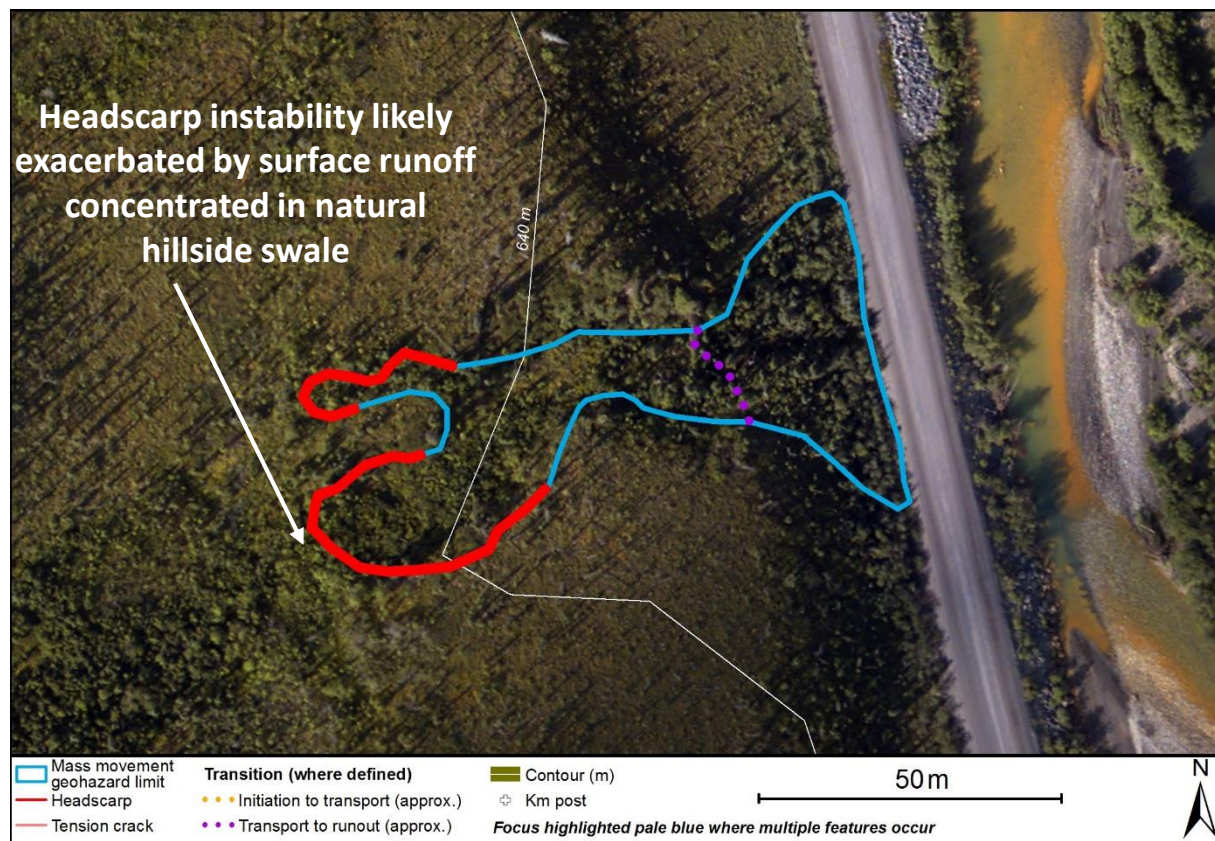
Project: Dempster Geohazard Investigation Project number: 14132 Client: Yukon Government
		<h2>KM 177.6</h2>

Aspect (°)	Causes	Runout slope (°)	Risk
70	permafrost degradation	13	L

Surficial material	Triggers	Average slope (°)	Mitigation
zsgFt	intense rainfall/snowmelt or heat	11	Management of debris accumulation in ditch

Permafrost	Timing	Dimensions (L/W/D) (m)	Comments
Shallow, likely ice-rich permafrost above terrace scarp beside highway	Ongoing/episodic, possibly exacerbated by old winter trail upslope of highway	100 / 53 / 4.3

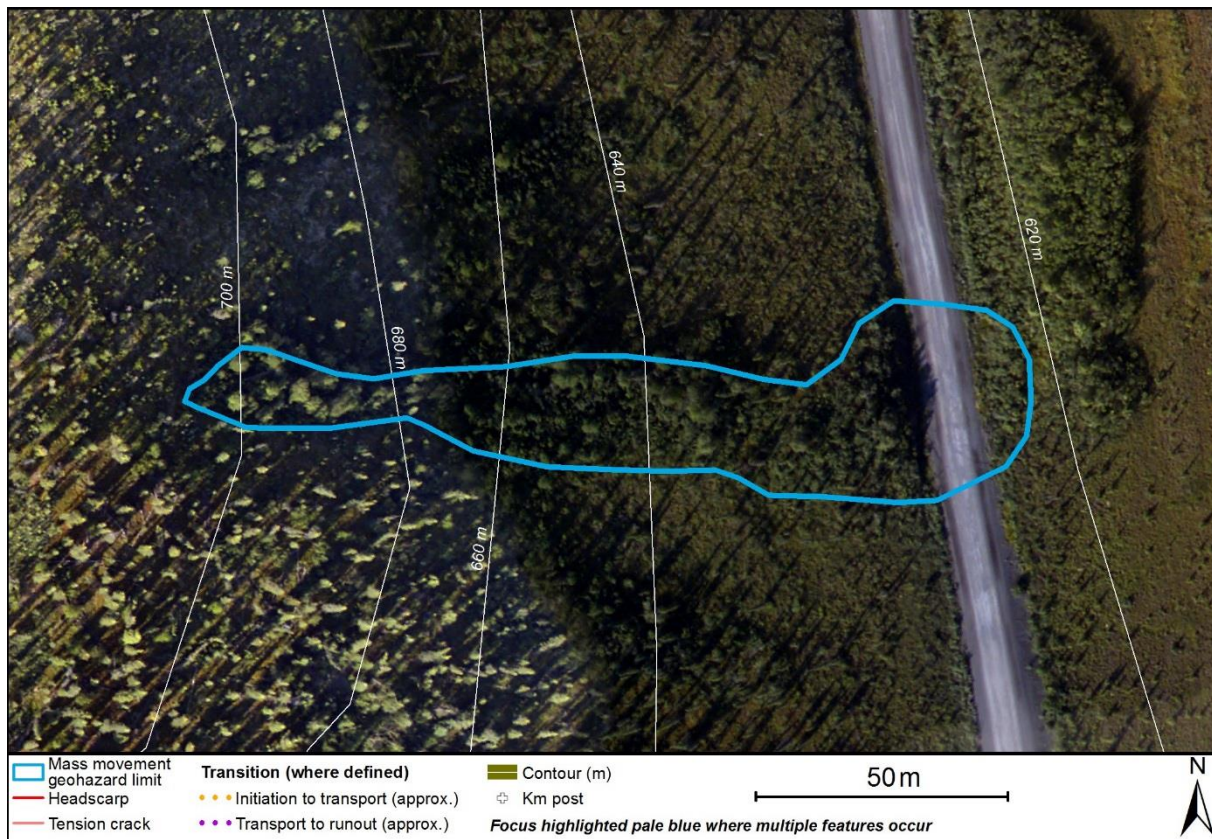
SITE	PROCESS	GEOMETRY	IMPLICATIONS
Section	Type	Elevation (m)	Likelihood
Ogilvie	debris slide (active layer detachment)	635	L
Proximity (m)	Position	Initiation slope (°)	Consequence
0	above	39	L
Aspect (°)	Causes	Runout slope (°)	Risk
85	permafrost degradation	15	VL
Surficial material	Triggers	Average slope (°)	Mitigation
szrCv	intense rainfall/snowmelt	26	None expected to be required
Permafrost	Timing	Dimensions (L/W/D) (m)	Comments
Shallow permafrost	Single event (likely slightly pre-dates highway construction) with minimal remaining potential for post-failure sloughs/flows	168 / 40 / 2.2	Mostly stabilized through natural revegetation

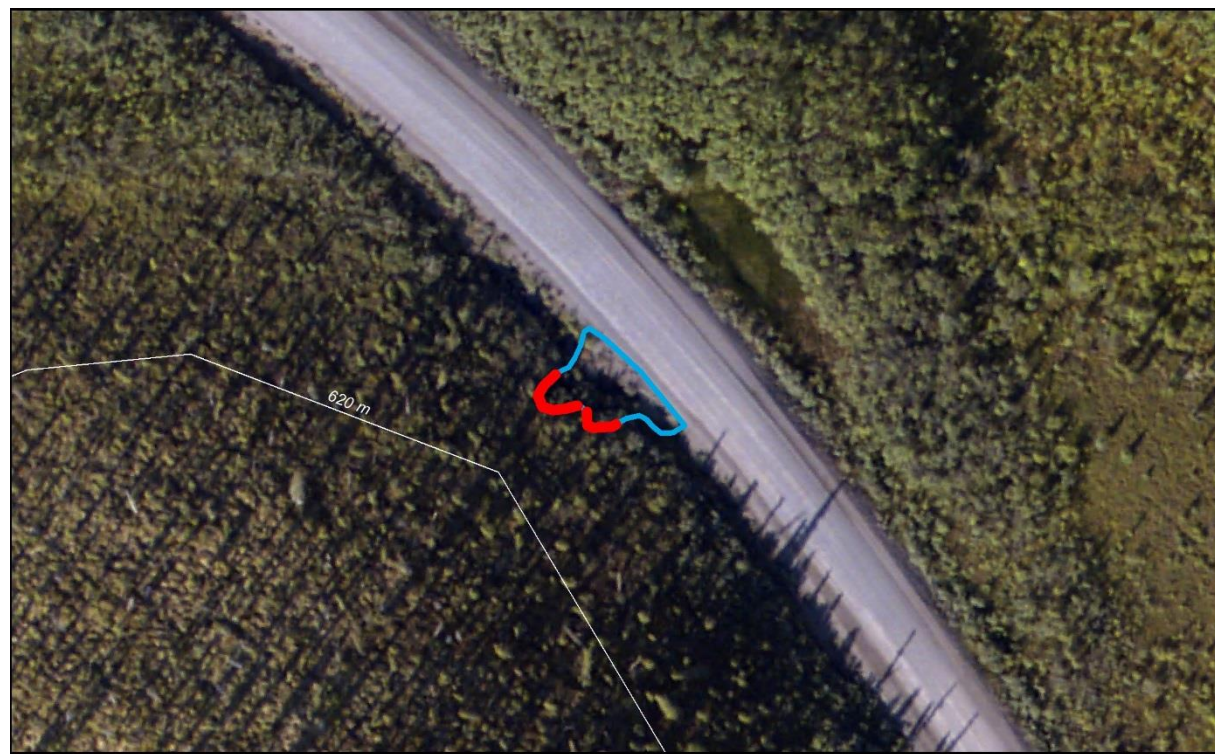
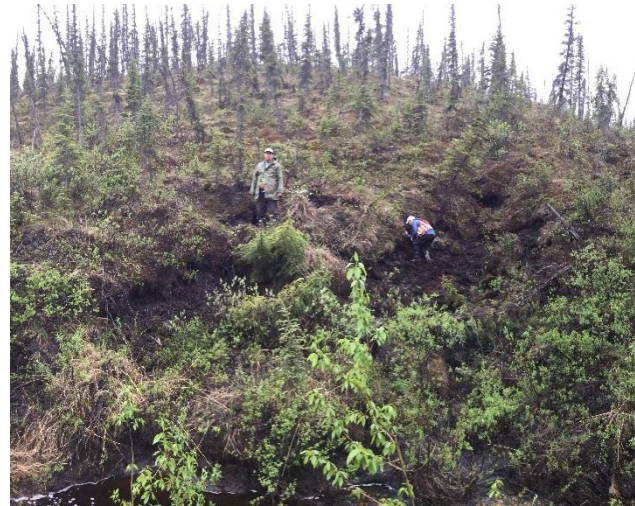
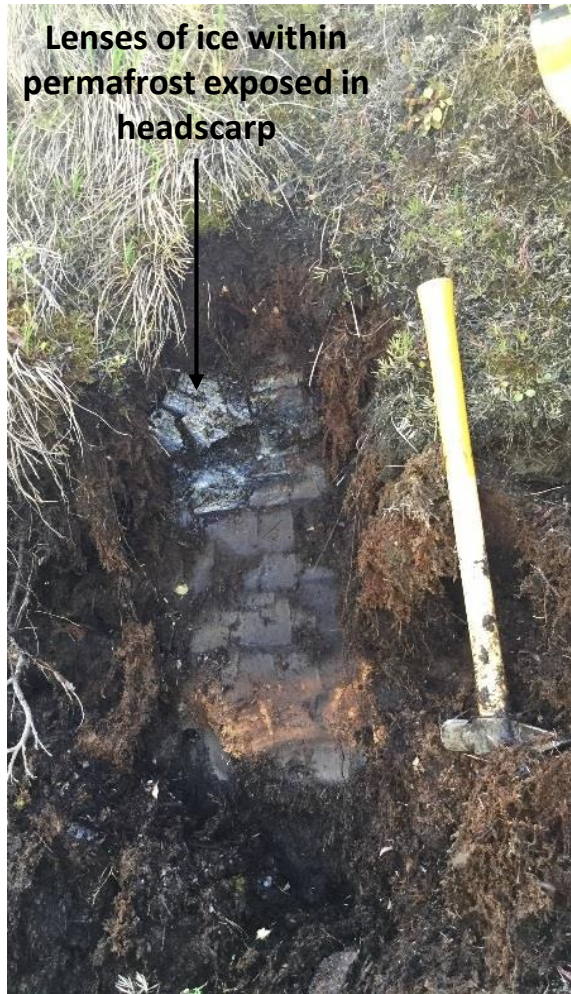
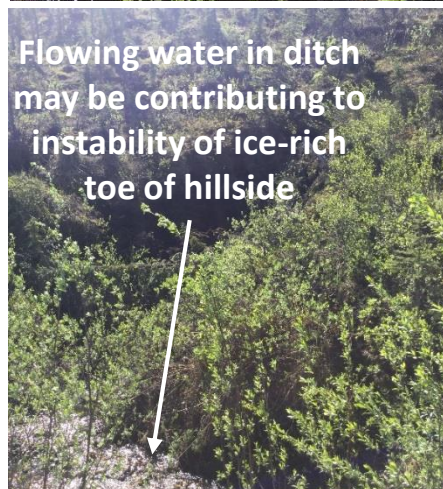
Project: Dempster Geohazard Investigation Project number: 14132 Client: Yukon Government
		KM 191.6

SITE	PROCESS	GEOMETRY	IMPLICATIONS
Section	Type	Elevation (m)	Likelihood
Ogilvie	retrogressive thaw slump	605	M
Proximity (m)	Position	Initiation slope (°)	Consequence
0	above	28	L
Aspect (°)	Causes	Runout slope (°)	Risk
60	fluvio-thermal erosion of slope toe, permafrost degradation	15	L
Surficial material	Triggers	Average slope (°)	Mitigation
zsrCa	intense rainfall/snowmelt or heat	28	Management of surface runoff and debris accumulation in ditch
Permafrost	Timing	Dimensions (L/W/D) (m)	Comments
Shallow permafrost with segregated ice (lenses/seams)	Ongoing/episodic, likely exacerbated by concentrated drainage along ditch at slope toe	8 / 15 / 1.5

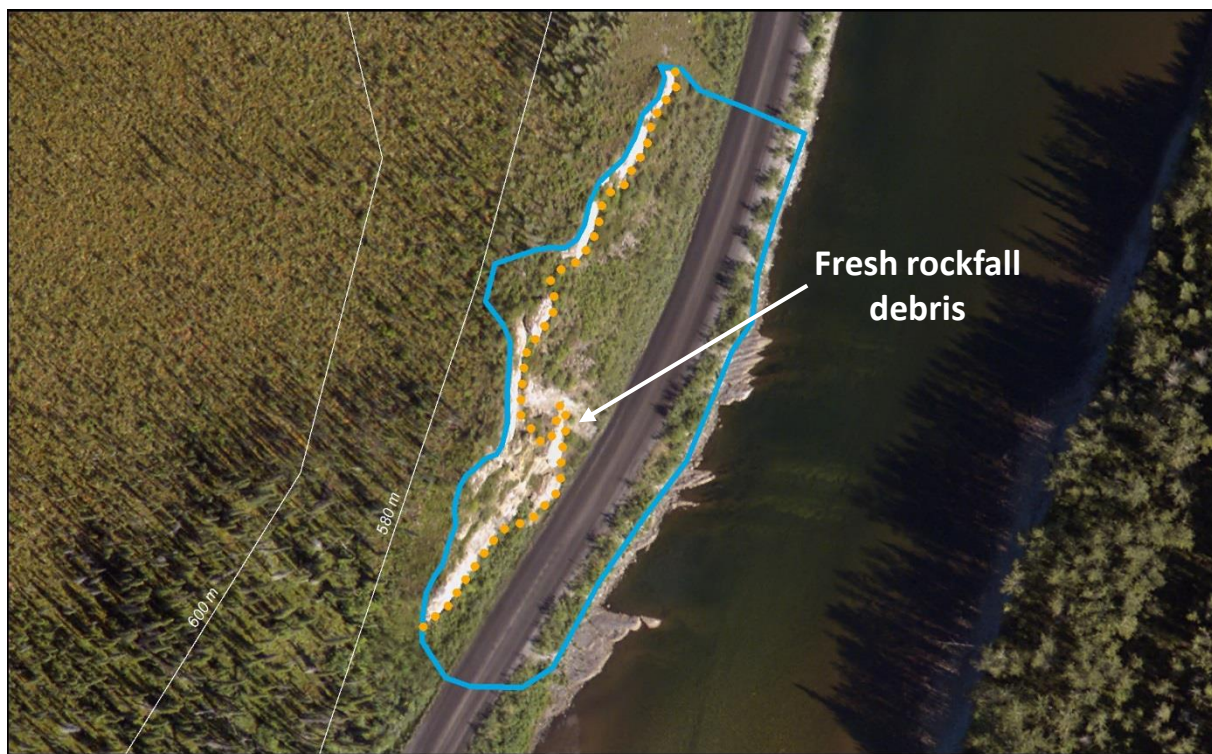
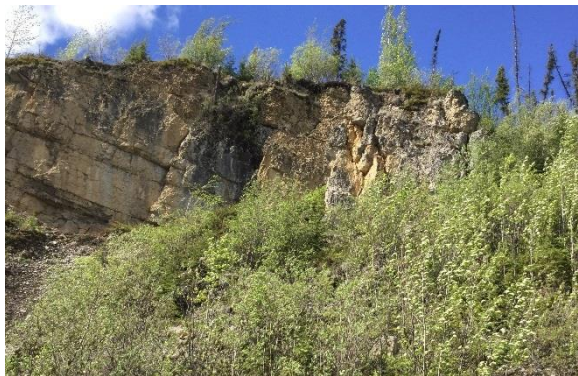
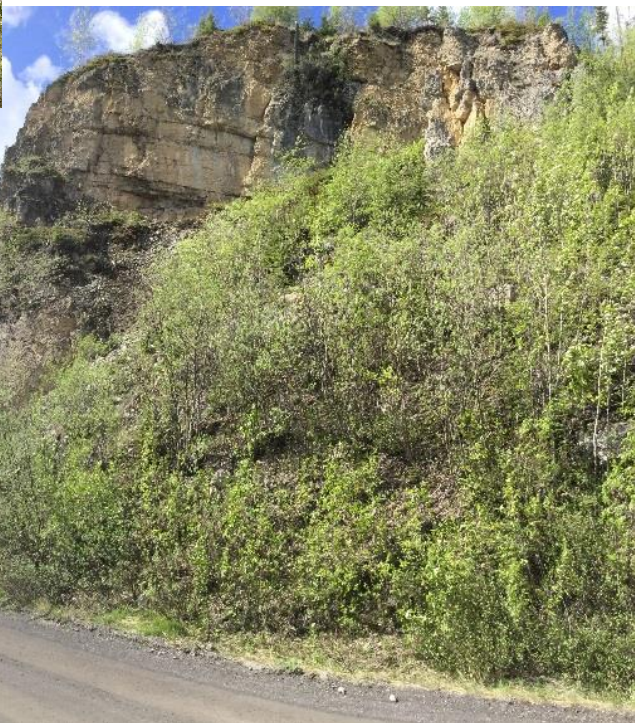
KM 193

SITE	PROCESS	GEOMETRY	IMPLICATIONS
Section	Type	Elevation (m)	Likelihood
Ogilvie	rockfall	581	M
Proximity (m)	Position	Initiation slope (°)	Consequence
0	above	27	L
Aspect (°)	Causes	Runout slope (°)	Risk
115	steep rock bluff	15	L
Surficial material	Triggers	Average slope (°)	Mitigation
R	freeze/thaw, intense rainfall/snowmelt	34	Management of rockfall debris in ditch and on hwy
Permafrost	Timing	Dimensions (L/W/D) (m)	Comments
Permafrost, likely ice-poor, relatively deep within colluvial rubble or weathered bedrock	Recurrent (likely annual)	44 / 132 / n/a	Runout limits approximate due to clearing of former debris accumulation

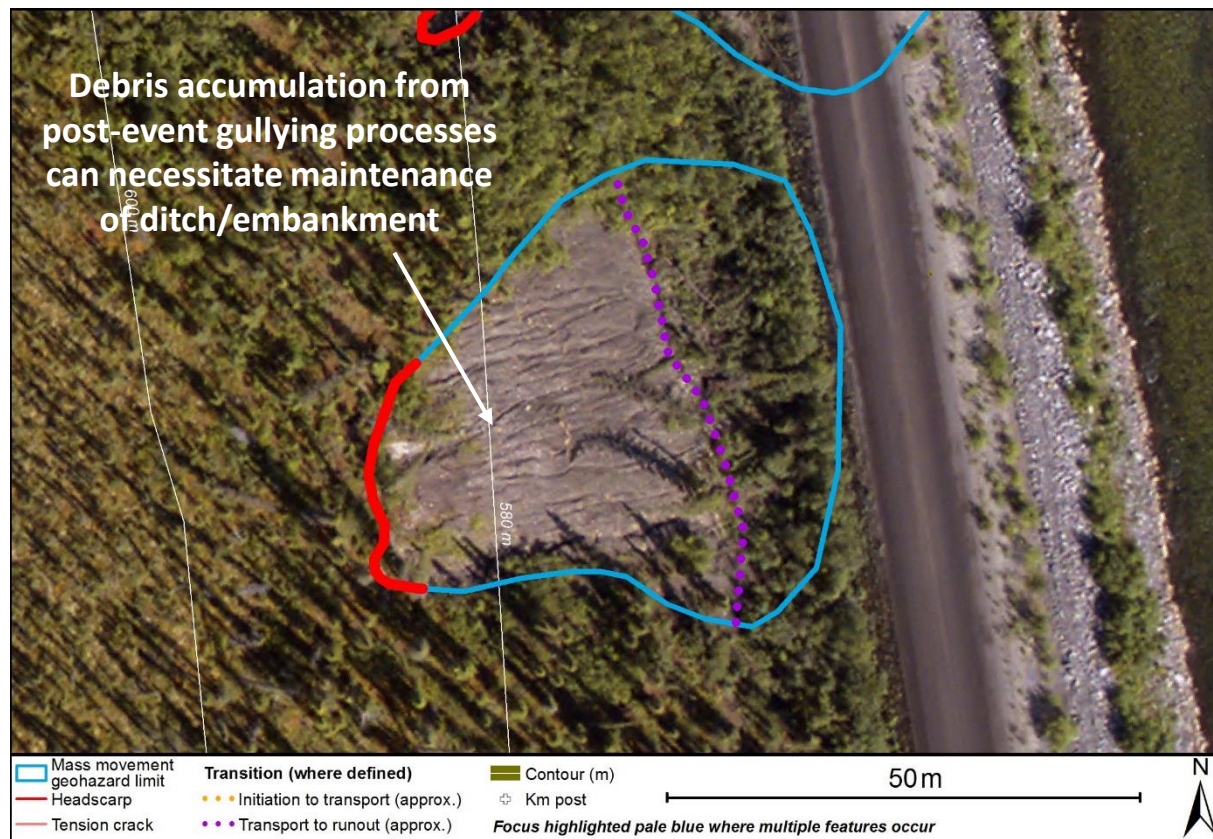
KM 205

SITE	PROCESS	GEOMETRY	IMPLICATIONS
Section	Type	Elevation (m)	Likelihood
Ogilvie	debris slide (active layer detachment)	578	M
Proximity (m)	Position	Initiation slope (°)	Consequence
0	above	29	M
Aspect (°)	Causes	Runout slope (°)	Risk
70	disturbance and possible over-steepening of slope toe, permafrost degradation	24	M
Surficial material	Triggers	Average slope (°)	Mitigation
dszCv	intense rainfall/snowmelt or heat	35	Management of runout debris
Permafrost	Timing	Dimensions (L/W/D) (m)	Comments
Shallow permafrost	Single event (2007-2013) with potential for post-failure sloughs/flows	52 / 52 / 1	Runout limits approximate due to clearing of former debris accumulation

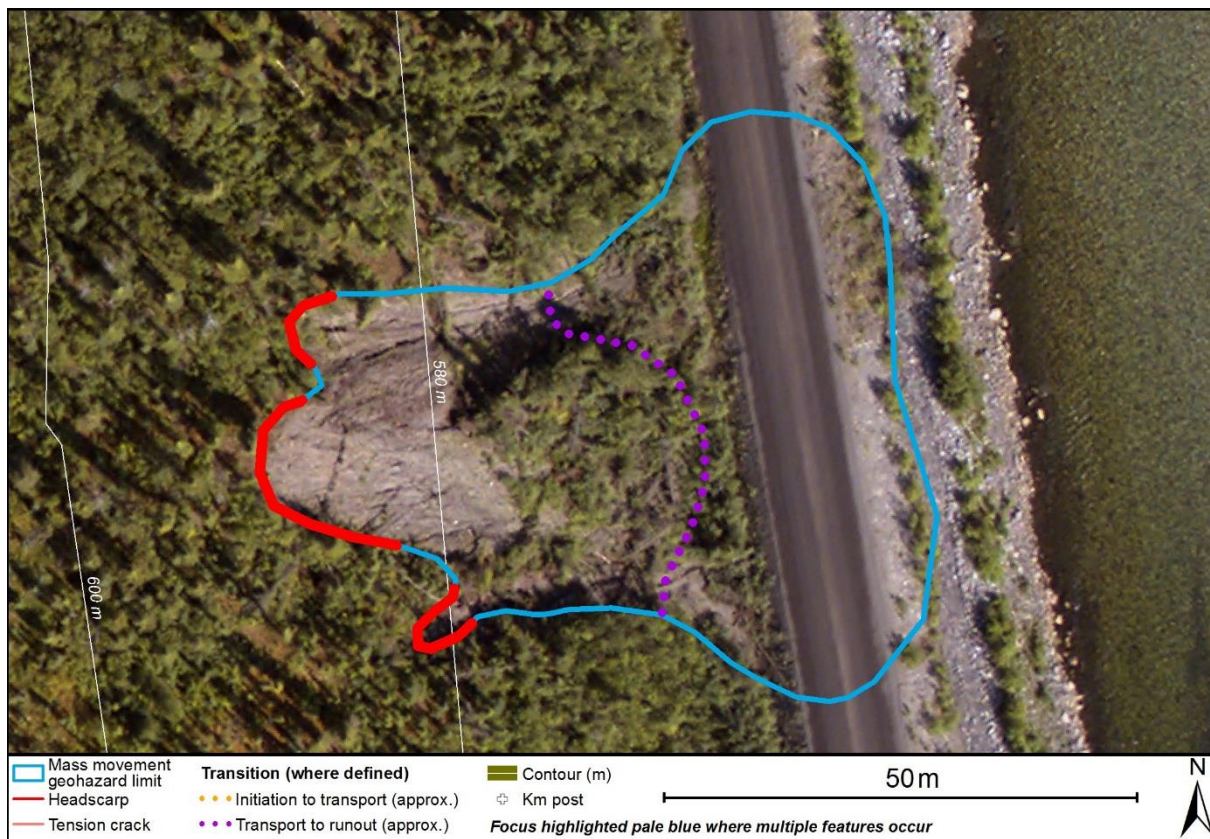
Project: Dempster Geohazard Investigation Project number: 14132 Client: Yukon Government
		<h2>KM 209.5</h2>

SITE	PROCESS	GEOMETRY	IMPLICATIONS
Section	Type	Elevation (m)	Likelihood
Ogilvie	debris slide (active layer detachment)	569	M
Proximity (m)	Position	Initiation slope (°)	Consequence
0	above	42	M
Aspect (°)	Causes	Runout slope (°)	Risk
80	disturbance and possible over-steepening of slope toe, permafrost degradation	17	M
Surficial material	Triggers	Average slope (°)	Mitigation
dszCv	intense rainfall/snowmelt or heat	28	Management of runout debris
Permafrost	Timing	Dimensions (L/W/D) (m)	Comments
Shallow permafrost	Single event (2007-2013) with potential for post-failure sloughs/flows	67 / 63 / <1	Runout limits approximate due to clearing of former debris accumulation

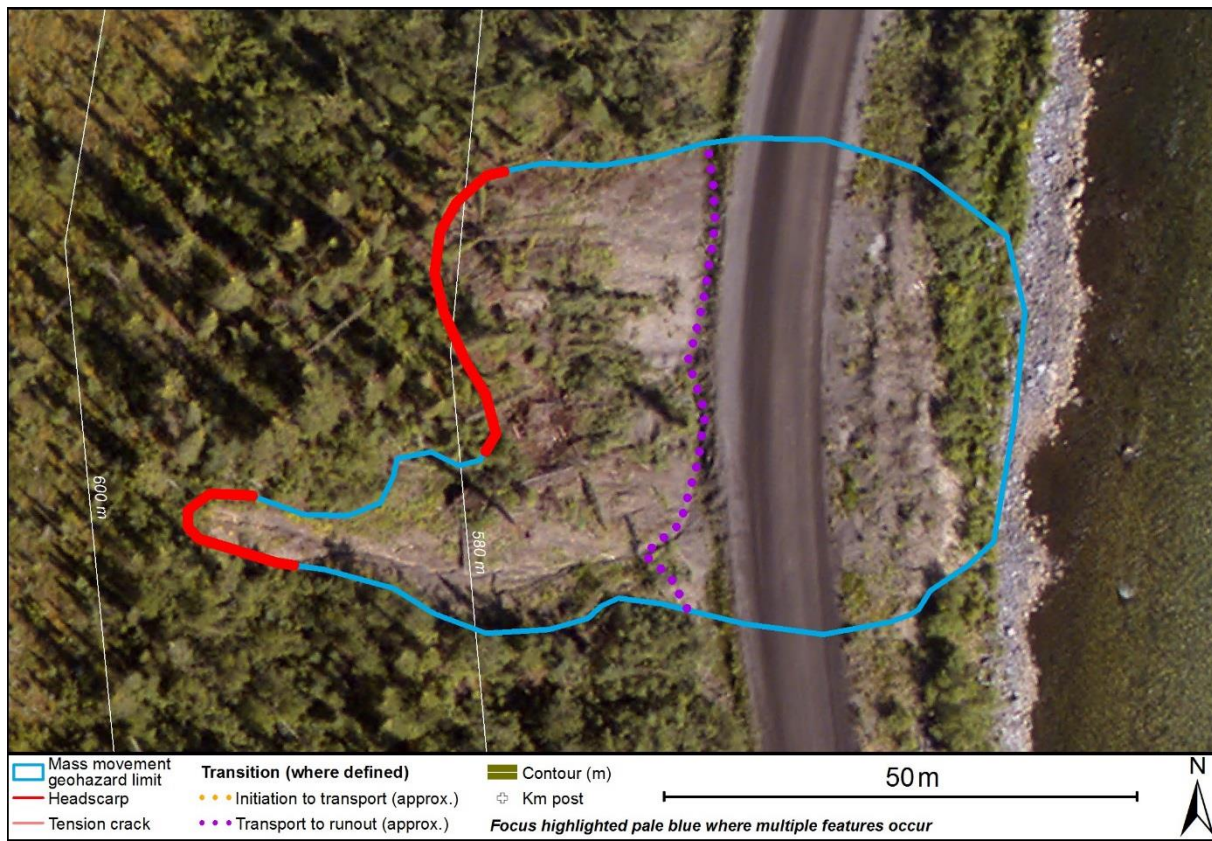
Project: Dempster Geohazard Investigation Project number: 14132 Client: Yukon Government
		<h2>KM 209.6</h2>

SITE	PROCESS	GEOMETRY	IMPLICATIONS
Section	Type	Elevation (m)	Likelihood
Ogilvie	debris slide (active layer detachment)	566	M
Proximity (m)	Position	Initiation slope (°)	Consequence
0	above	50	M
Aspect (°)	Causes	Runout slope (°)	Risk
85	disturbance and possible over-steepening of slope toe, permafrost degradation	14	M
Surficial material	Triggers	Average slope (°)	Mitigation
dszCv	intense rainfall/snowmelt or heat	37	Management of runout debris
Permafrost	Timing	Dimensions (L/W/D) (m)	Comments
Shallow permafrost	Single event (2007-2013) with potential for post-failure sloughs/flows	66 / 54 / <1	Runout limits approximate due to clearing of former debris accumulation

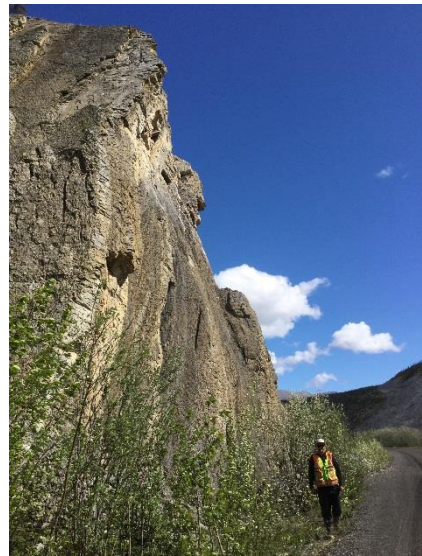
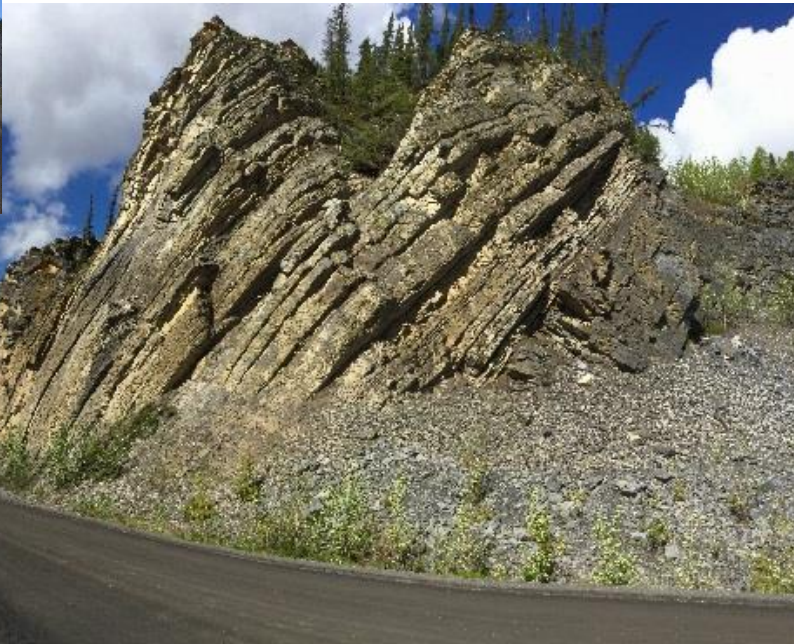
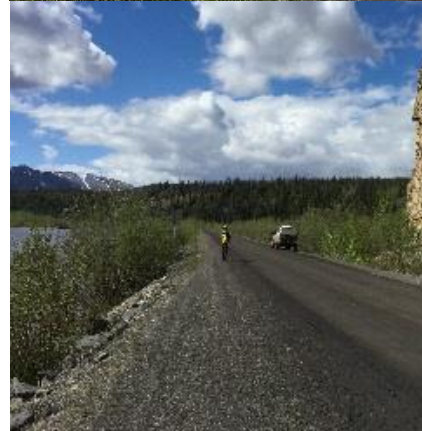
Project: Dempster Geohazard Investigation Project number: 14132 Client: Yukon Government
		<h2>KM 209.7</h2>

SITE	PROCESS	GEOMETRY	IMPLICATIONS
Section	Type	Elevation (m)	Likelihood
Ogilvie	rockfall	590	H
Proximity (m)	Position	Initiation slope (°)	Consequence
0	above	46	L
Aspect (°)	Causes	Runout slope (°)	Risk
165	steep rock bluff	17	M
Surficial material	Triggers	Average slope (°)	Mitigation
R	freeze/thaw	42	Management of rockfall initiation and/or debris in ditch and on hwy
Permafrost	Timing	Dimensions (L/W/D) (m)	Comments
Permafrost, likely ice-poor, deep within bedrock	Recurrent (likely annual)	45 / 41 / n/a	Runout limits approximate due to clearing of former debris accumulation

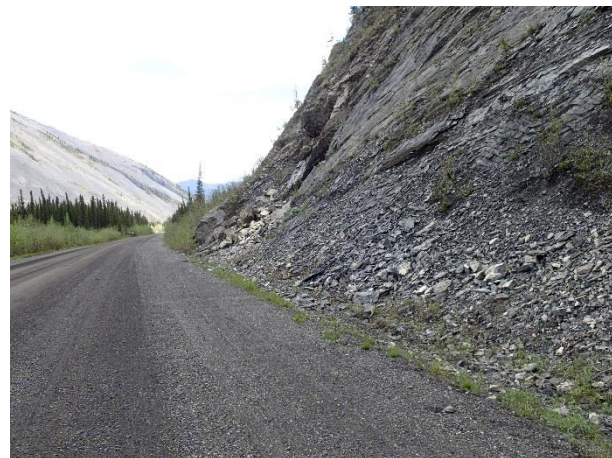
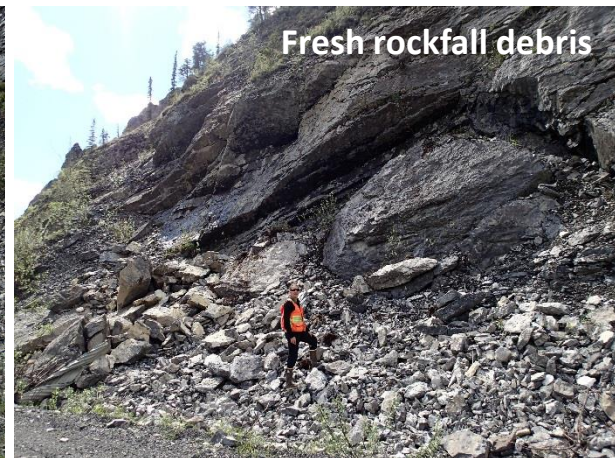
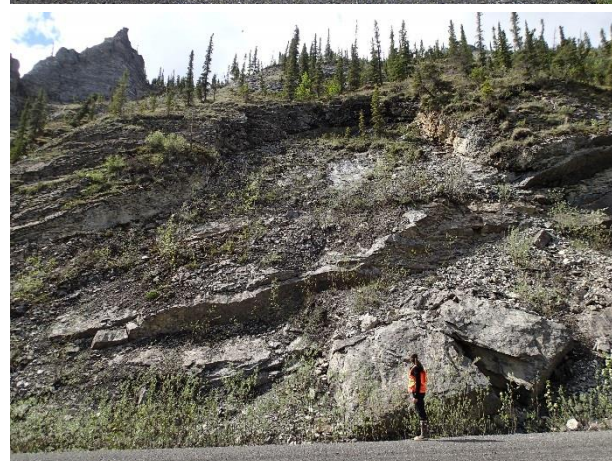
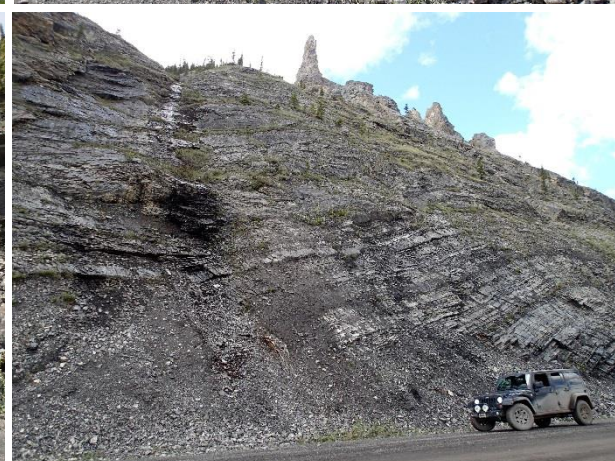
Project: Dempster Geohazard Investigation Project number: 14132 Client: Yukon Government
		<h2>KM 210.9</h2>

SITE	PROCESS	GEOMETRY	IMPLICATIONS
Section	Type	Elevation (m)	Likelihood
Ogilvie	rockfall & debris slide	622	H
Proximity (m)	Position	Initiation slope (°)	Consequence
0	above	35	M
Aspect (°)	Causes	Runout slope (°)	Risk
70	steep rock bluffs	27	H
Surficial material	Triggers	Average slope (°)	Mitigation
R	freeze/thaw, intense rainfall/snowmelt	42	Management of rockfall/debris slide debris in ditch and on hwy
Permafrost	Timing	Dimensions (L/W/D) (m)	Comments
Permafrost, likely ice-poor, relatively deep within colluvial rubble or weathered bedrock	Recurrent (likely annual)	208 / 453 / n/a	Runout limits approximate due to clearing of former debris accumulation; risk greatest downslope of prominent rock bluffs; small debris slides

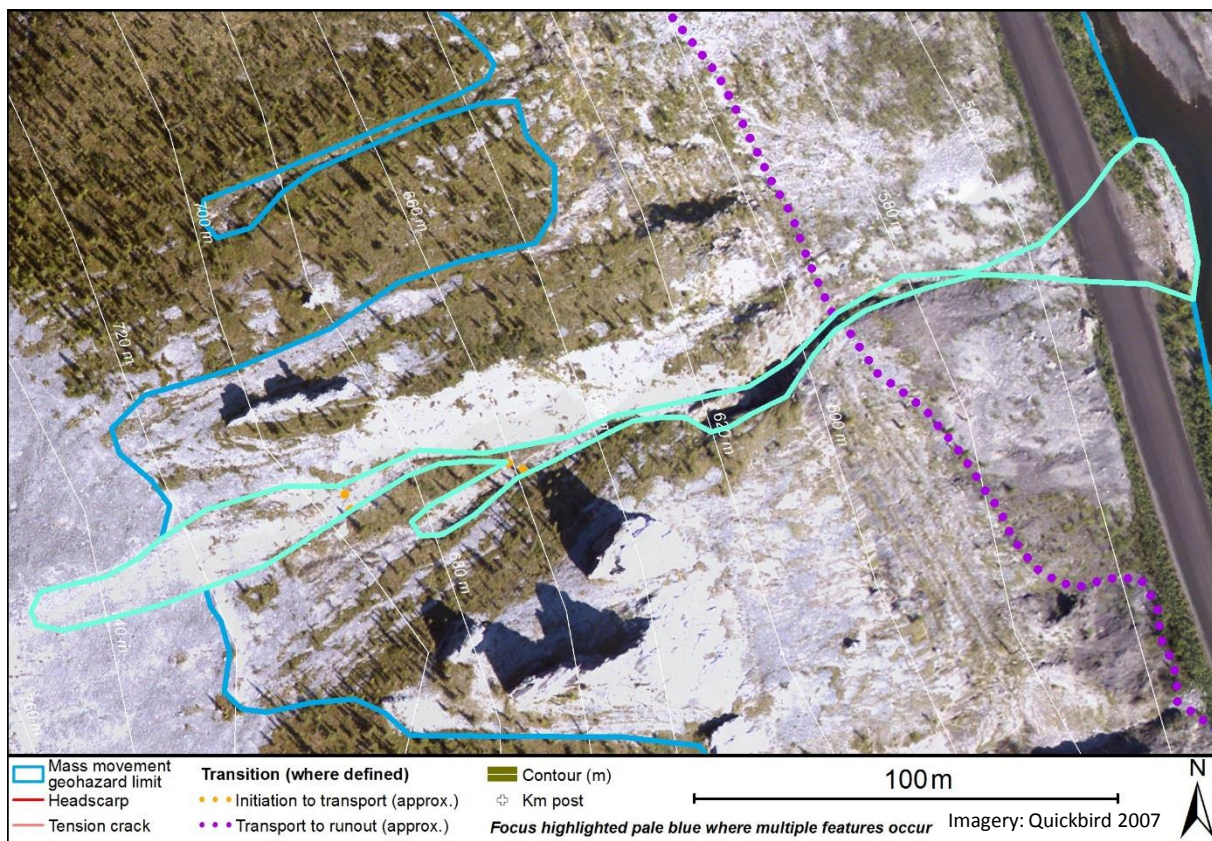
Project: Dempster Geohazard Investigation Project number: 14132 Client: Yukon Government
		<h1>KM 212.5</h1>

SITE	PROCESS	GEOMETRY	IMPLICATIONS
Section Ogilvie	Type debris flow	Elevation (m) 652	Likelihood L
Proximity (m) 0	Position above	Initiation slope (°) 32	Consequence H
Aspect (°) 70	Causes saturation of colluvial debris in headwater basin, gully channelization	Runout slope (°) 19	Risk M
Surficial material rszCv	Triggers intense rainfall/snowmelt	Average slope (°) 34	Mitigation Management of runout debris
Permafrost Permafrost, likely ice-poor, relatively deep within colluvial rubble or weathered bedrock	Timing Recurrent (likely decadal)	Dimensions (L/W/D) (m) 294 / 38 / n/a	Comments

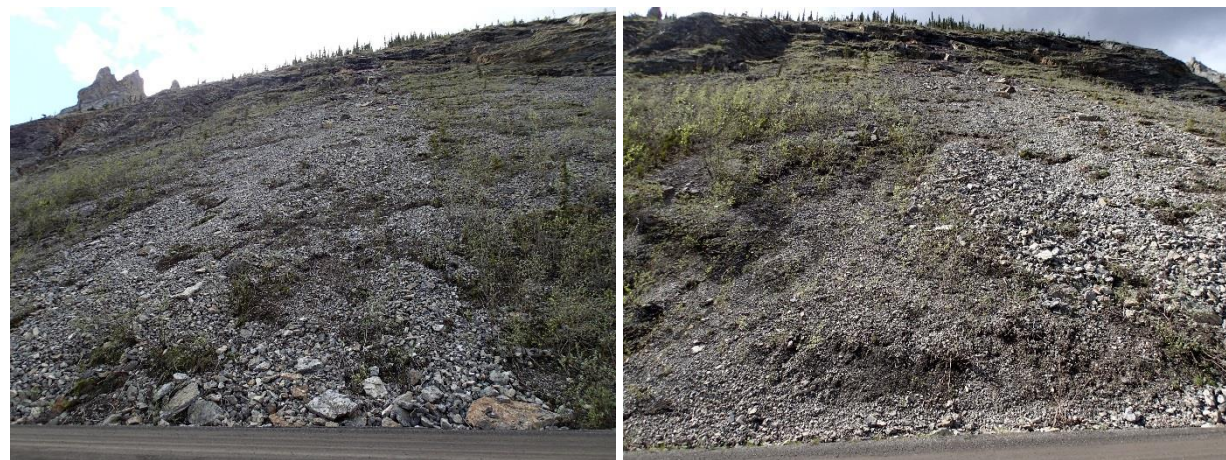
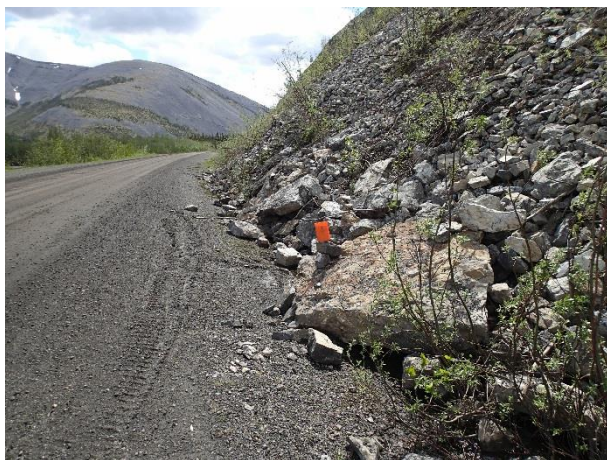
KM 212.7

SITE	PROCESS	GEOMETRY	IMPLICATIONS
Section	Type	Elevation (m)	Likelihood
Ogilvie	rockfall & debris slide	615	H
Proximity (m)	Position	Initiation slope (°)	Consequence
0	above	36	M
Aspect (°)	Causes	Runout slope (°)	Risk
65	steep rock bluffs	31	H
Surficial material	Triggers	Average slope (°)	Mitigation
R/rszCb	freeze/thaw, intense rainfall/snowmelt	40	Management of rockfall/debris slide debris in ditch and on hwy
Permafrost	Timing	Dimensions (L/W/D) (m)	Comments
Permafrost, likely ice-poor, relatively deep within colluvial rubble or weathered bedrock	Recurrent (likely annual)	220 / 165 / n/a	Runout limits approximate due to clearing of former debris accumulation; small debris slides

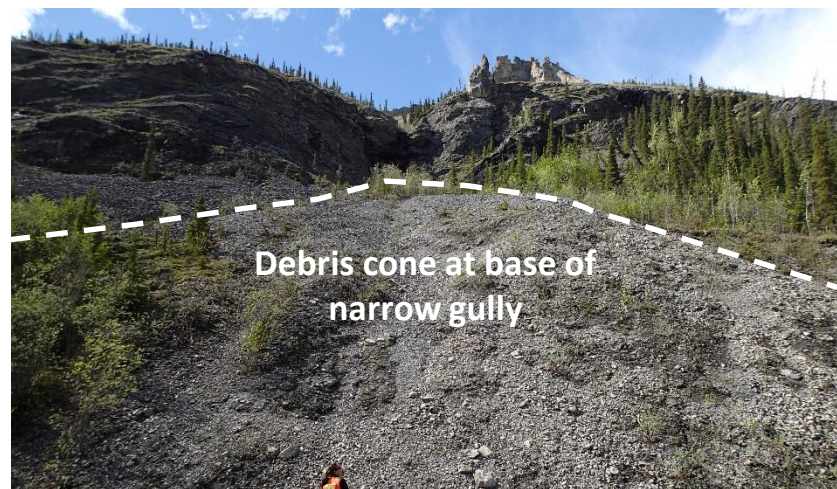
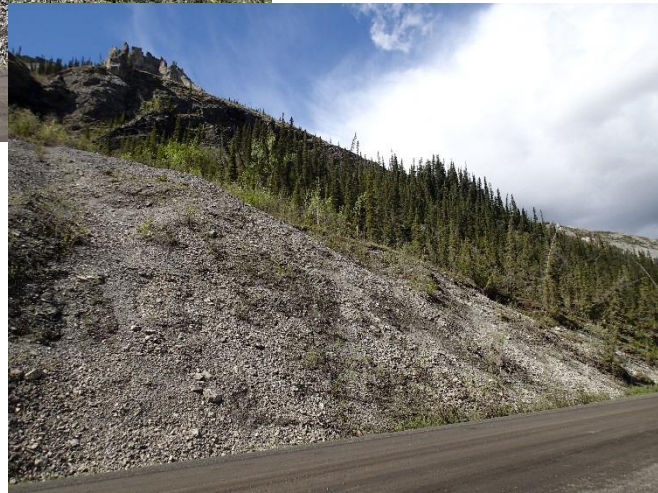
Project: Dempster Geohazard Investigation Project number: 14132 Client: Yukon Government
		<h2>KM 212.8</h2>

SITE	PROCESS	GEOMETRY	IMPLICATIONS
Section	Type	Elevation (m)	Likelihood
Ogilvie	debris flow & rockfall	805	L
Proximity (m)	Position	Initiation slope (°)	Consequence
0	above	36	H
Aspect (°)	Causes	Runout slope (°)	Risk
60	saturation of colluvial debris in headwater basin, gully channelization	30	M
Surficial material	Triggers	Average slope (°)	Mitigation
rszCv	intense rainfall/snowmelt, freeze/thaw	33	Management of runout debris
Permafrost	Timing	Dimensions (L/W/D) (m)	Comments
Permafrost, likely ice-poor, relatively deep within colluvial rubble or weathered bedrock	Recurrent (likely decadal)	666 / 105 / n/a

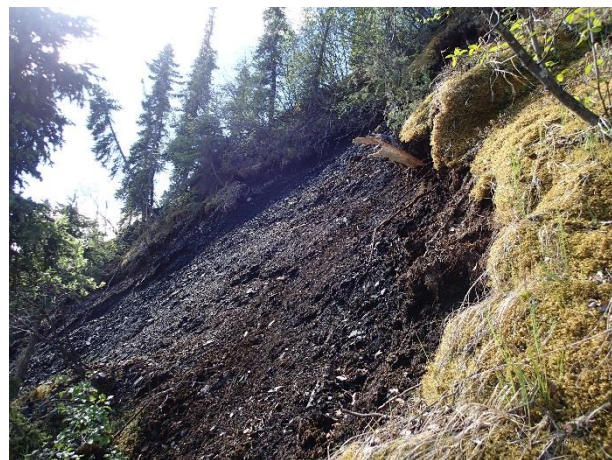
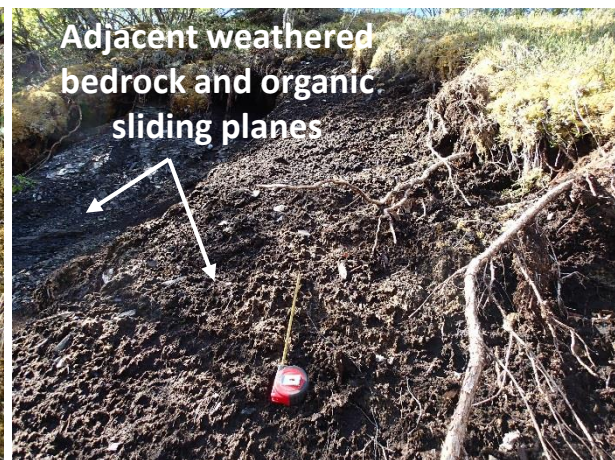
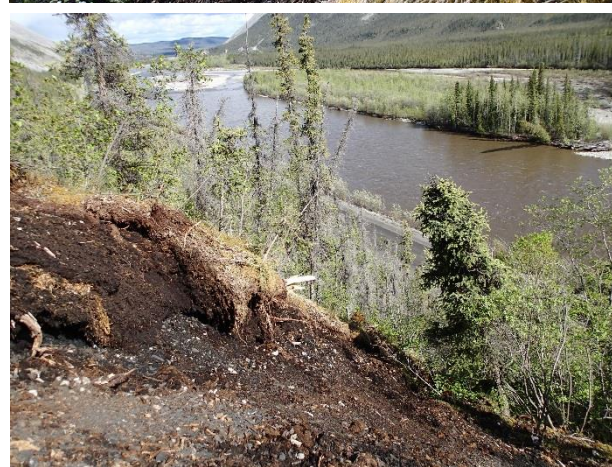
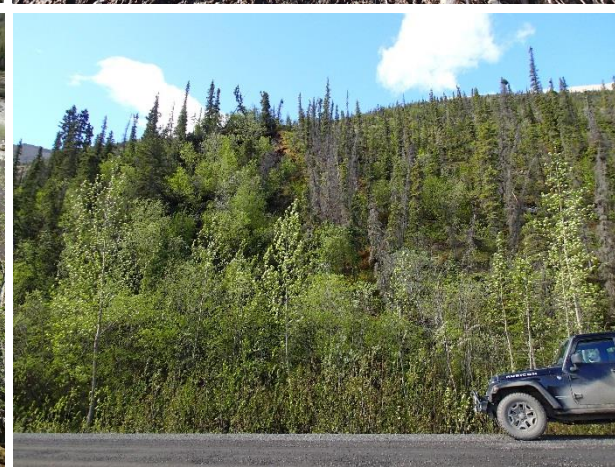
Project: Dempster Geohazard Investigation Project number: 14132 Client: Yukon Government
		KM 213

SITE	PROCESS	GEOMETRY	IMPLICATIONS
Section	Type	Elevation (m)	Likelihood
Ogilvie	debris slide (active layer detachment)	573	M
Proximity (m)	Position	Initiation slope (°)	Consequence
10	above	48	L
Aspect (°)	Causes	Runout slope (°)	Risk
55	permafrost degradation	33	L
Surficial material	Triggers	Average slope (°)	Mitigation
rszCv	intense rainfall/snowmelt or heat	37	Management of debris accumulation in ditch
Permafrost	Timing	Dimensions (L/W/D) (m)	Comments
Shallow permafrost	Single event (2007-2013) with potential for post-failure sloughs/flows	64 / 28 / <1
