Yukon Geological Survey Miscellaneous Report 17

Inventory of mass movement geohazards along the Dempster Highway, Yukon

Robin J. McKillop, Courtenay E. Brown, Daniel J. McParland and David A. Sacco
Palmer Environmental Consulting Group Inc.
and Jim Coates
Kryotek Arctic Innovation Inc.

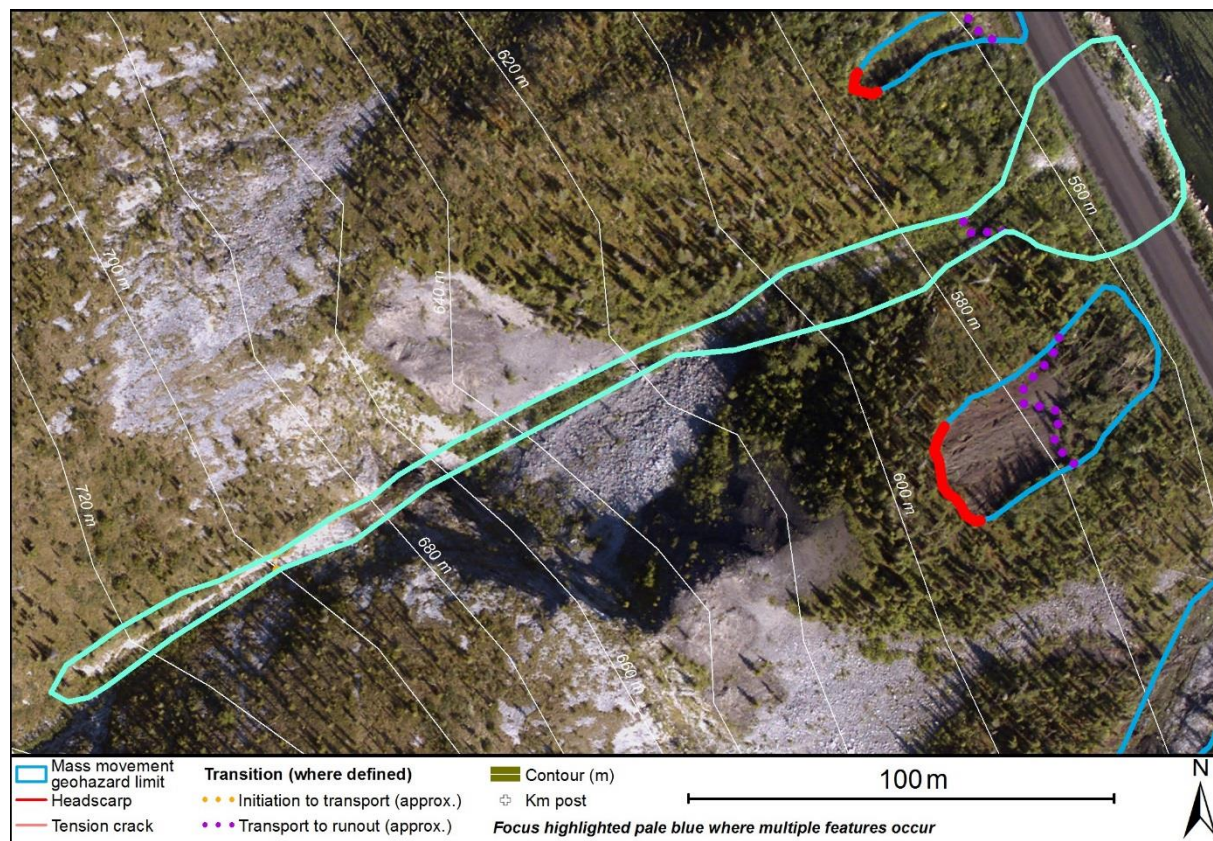
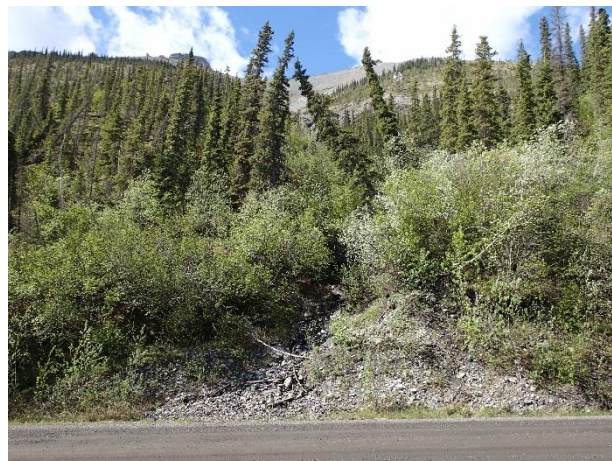
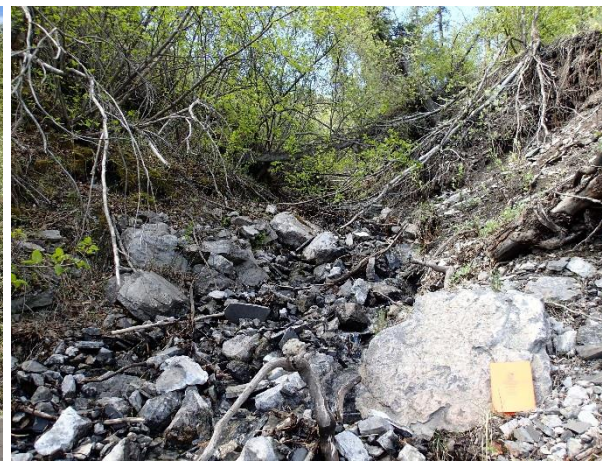
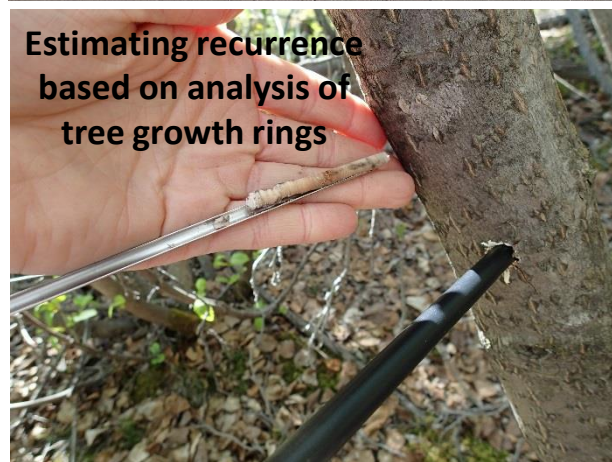
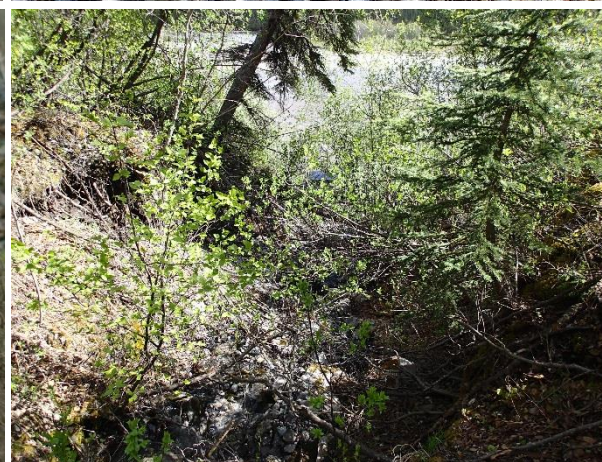
KM 213.05

Estimating recurrence based on analysis of tree growth rings

SITE	PROCESS	GEOMETRY	IMPLICATIONS
Section	Type	Elevation (m)	Likelihood
Ogilvie	debris flow	594	L
Proximity (m)	Position	Initiation slope (°)	Consequence
0	above	31	H
Aspect (°)	Causes	Runout slope (°)	Risk
60	saturation of colluvial debris in headwater basin, gully channelization	23	M
Surficial material	Triggers	Average slope (°)	Mitigation
rszCv	intense rainfall/snowmelt	31	Management of runout debris
Permafrost	Timing	Dimensions (L/W/D) (m)	Comments
Permafrost, likely ice-poor, relatively deep within colluvial rubble or weathered bedrock	Recurrent (likely decadal)	295 / 44 / n/a

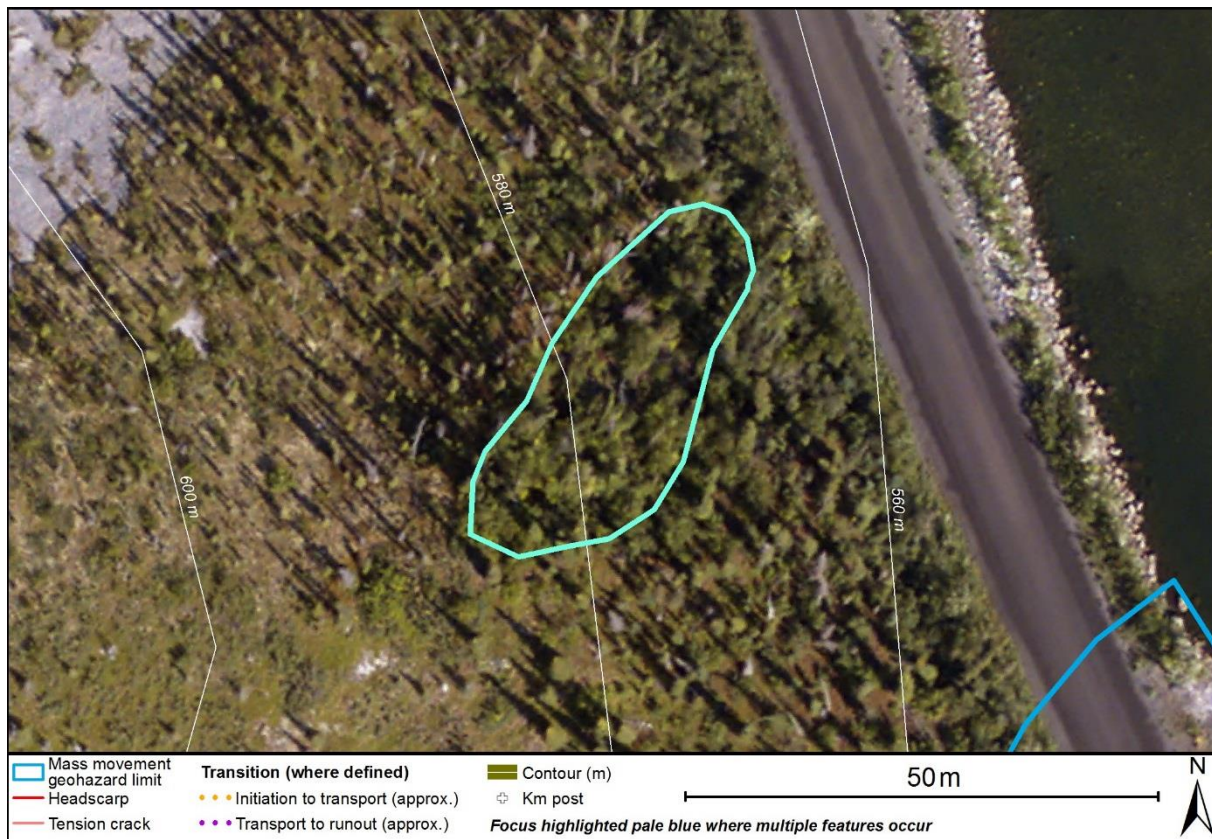
Project: Dempster Geohazard Investigation Project number: 14132 Client: Yukon Government
		<h2>KM 213.35</h2>

SITE	PROCESS	GEOMETRY	IMPLICATIONS
Section	Type	Elevation (m)	Likelihood
Ogilvie	debris slide (active layer detachment)	576	M
Proximity (m)	Position	Initiation slope (°)	Consequence
10	above	41	L
Aspect (°)	Causes	Runout slope (°)	Risk
30	permafrost degradation	36	L
Surficial material	Triggers	Average slope (°)	Mitigation
rszCv	intense rainfall/snowmelt or heat	42	Management of debris accumulation in ditch
Permafrost	Timing	Dimensions (L/W/D) (m)	Comments
Shallow permafrost	Single event (2013-2016) with potential for post-failure sloughs/flows	43 / 9 / 0.6

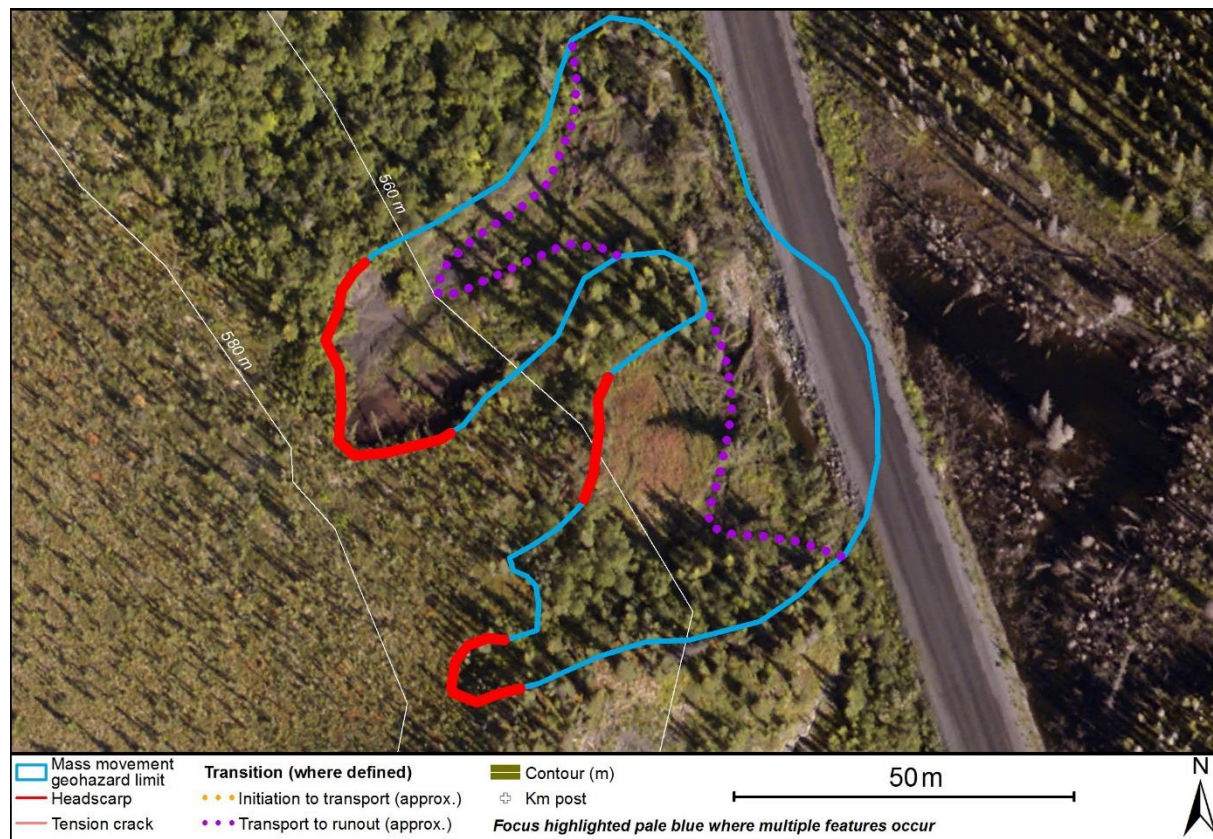
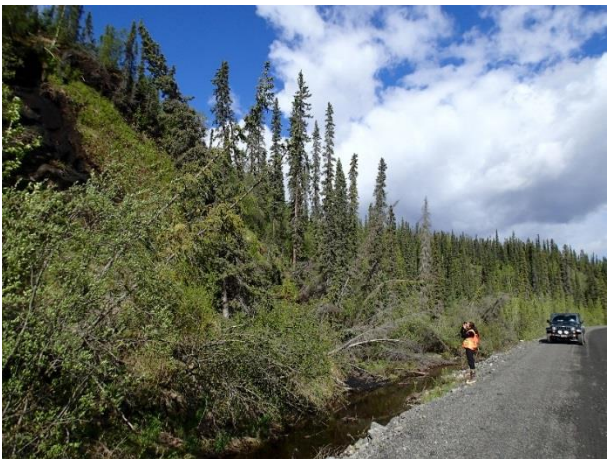
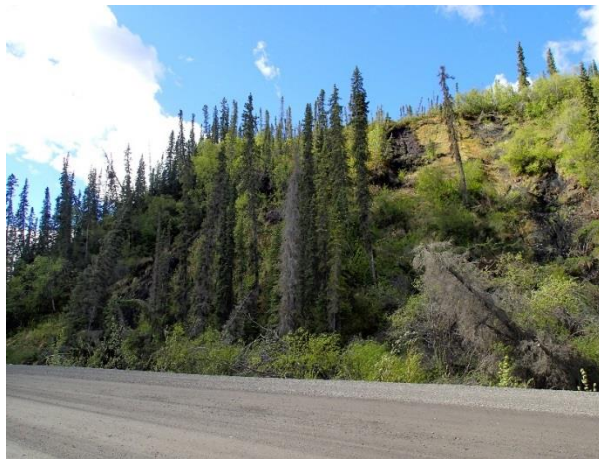
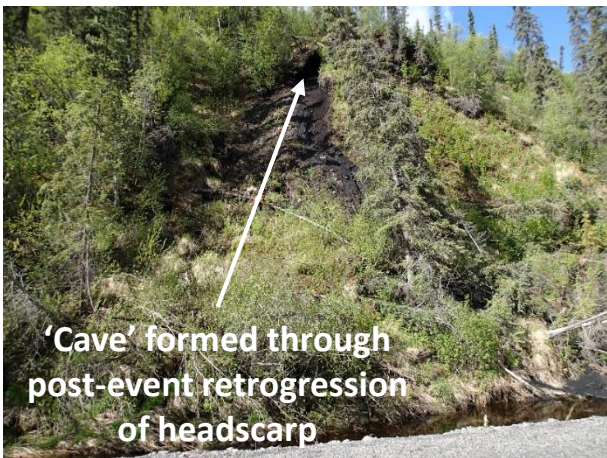
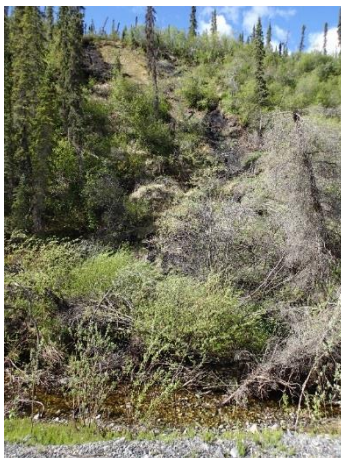
Project: Dempster Geohazard Investigation Project number: 14132 Client: Yukon Government
		KM 213.4

SITE	PROCESS	GEOMETRY	IMPLICATIONS
Section	Type	Elevation (m)	Likelihood
Ogilvie	debris slide (active layer detachment)	553	M
Proximity (m)	Position	Initiation slope (°)	Consequence
0	above	40	L
Aspect (°)	Causes	Runout slope (°)	Risk
45	permafrost degradation	25	L
Surficial material	Triggers	Average slope (°)	Mitigation
rszCv	intense rainfall/snowmelt or heat	32	Management of debris accumulation in ditch
Permafrost	Timing	Dimensions (L/W/D) (m)	Comments
Shallow permafrost	Single event (2007-2013) with potential for post-failure sloughs/flows	73 / 86 / <1	Runout limits approximate due to clearing of former debris accumulation

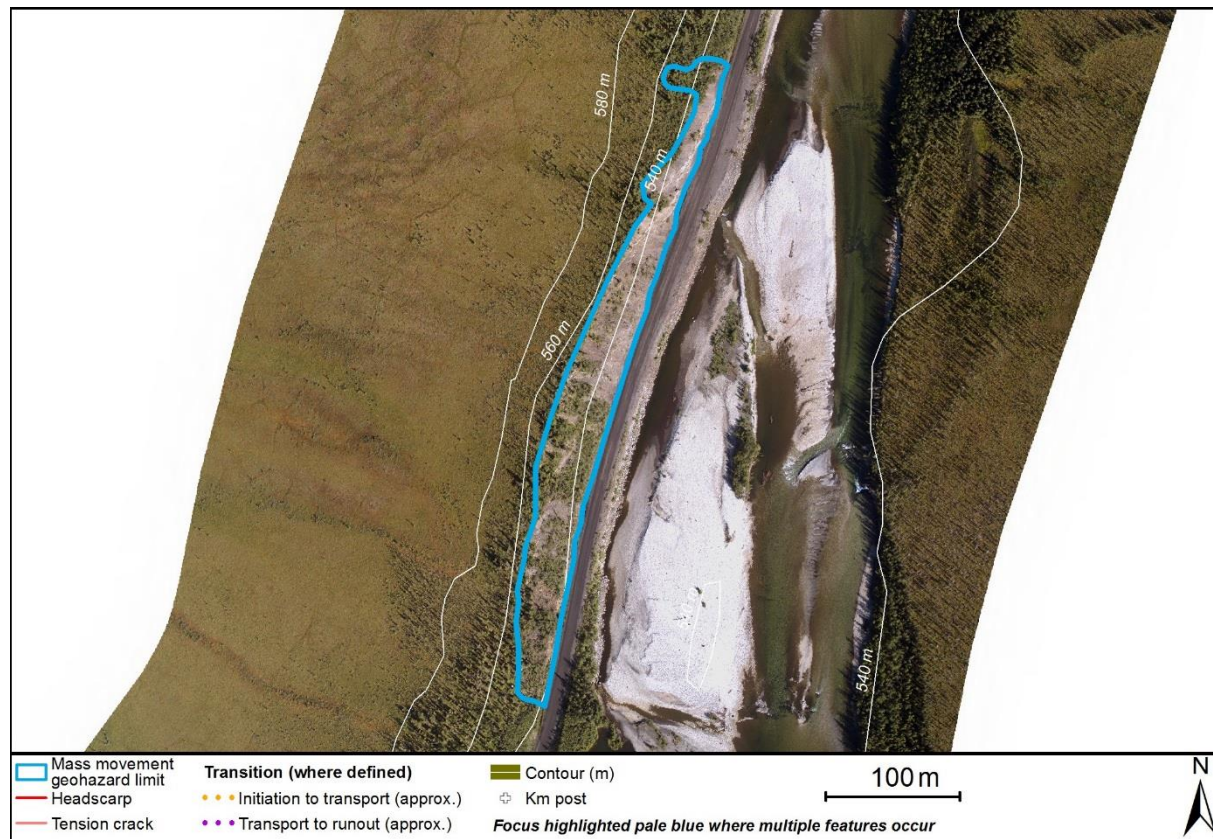
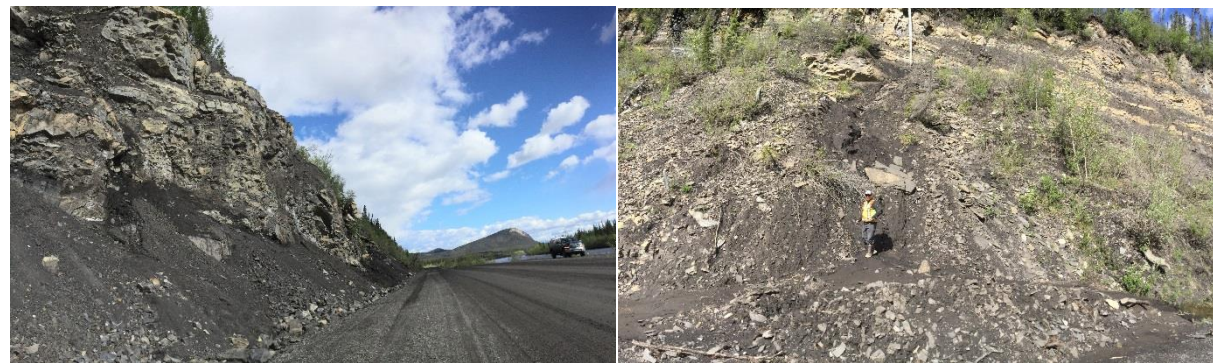
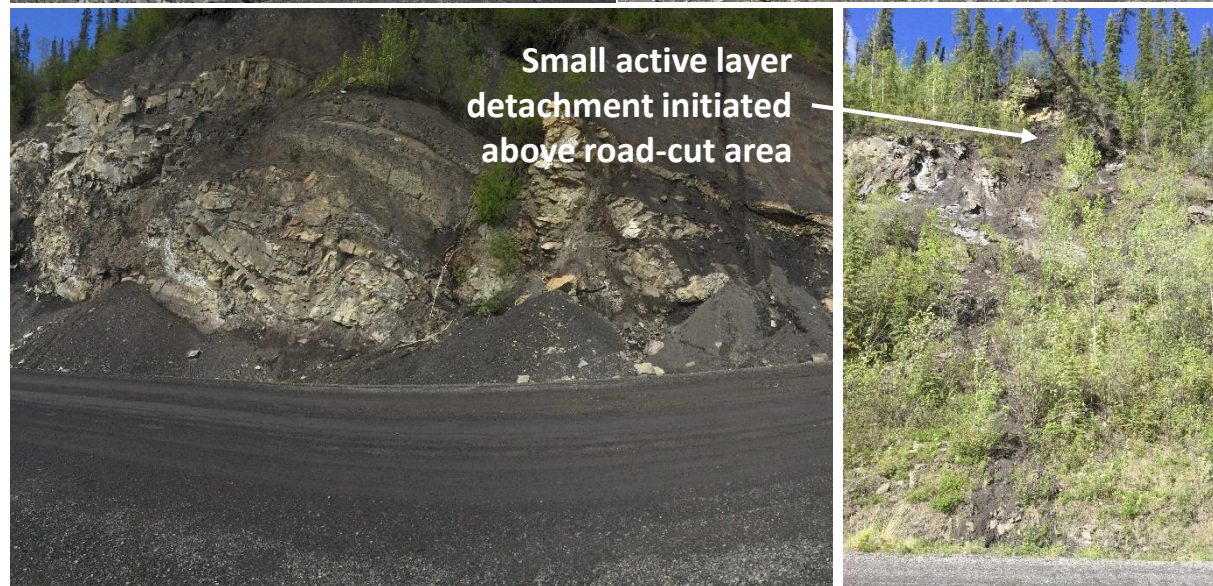
KM 218.1

SITE	PROCESS	GEOMETRY	IMPLICATIONS
Section	Type	Elevation (m)	Likelihood
Ogilvie	rockfall & debris slide (active layer detachment)	550	H
Proximity (m)	Position	Initiation slope (°)	Consequence
0	above	47	L
Aspect (°)	Causes	Runout slope (°)	Risk
105	oversteepened slope toe, steep rock bluffs	13	M
Surficial material	Triggers	Average slope (°)	Mitigation
rszCv/R	freeze/thaw, intense rainfall/snowmelt	50	Management of debris accumulation in ditch
Permafrost	Timing	Dimensions (L/W/D) (m)	Comments
Permafrost, likely ice-poor, relatively deep within colluvial rubble or weathered bedrock	Recurrent (likely annual)	32 / 500 / n/a	Runout limits approximate due to clearing of former debris accumulation

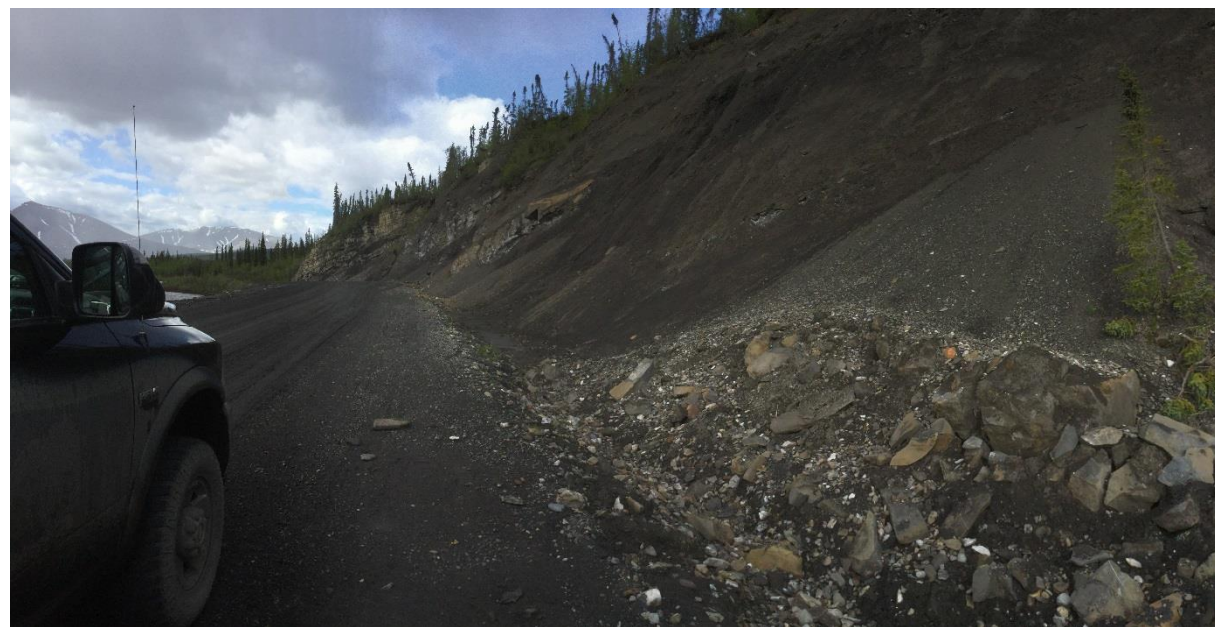
Project: Dempster Geohazard Investigation Project number: 14132 Client: Yukon Government
		<h2>KM 219.3</h2>

SITE	PROCESS	GEOMETRY	IMPLICATIONS
Section	Type	Elevation (m)	Likelihood
Ogilvie	rockfall	544	H
Proximity (m)	Position	Initiation slope (°)	Consequence
0	above	55	L
Aspect (°)	Causes	Runout slope (°)	Risk
120	steep rock bluff	14	M
Surficial material	Triggers	Average slope (°)	Mitigation
R	freeze/thaw, intense rainfall/snowmelt	51	Management of debris accumulation in ditch
Permafrost	Timing	Dimensions (L/W/D) (m)	Comments
Permafrost, likely ice-poor, relatively deep within colluvial rubble or weathered bedrock	Recurrent (likely annual)	17 / 86 / n/a	Runout limits approximate due to clearing of former debris accumulation

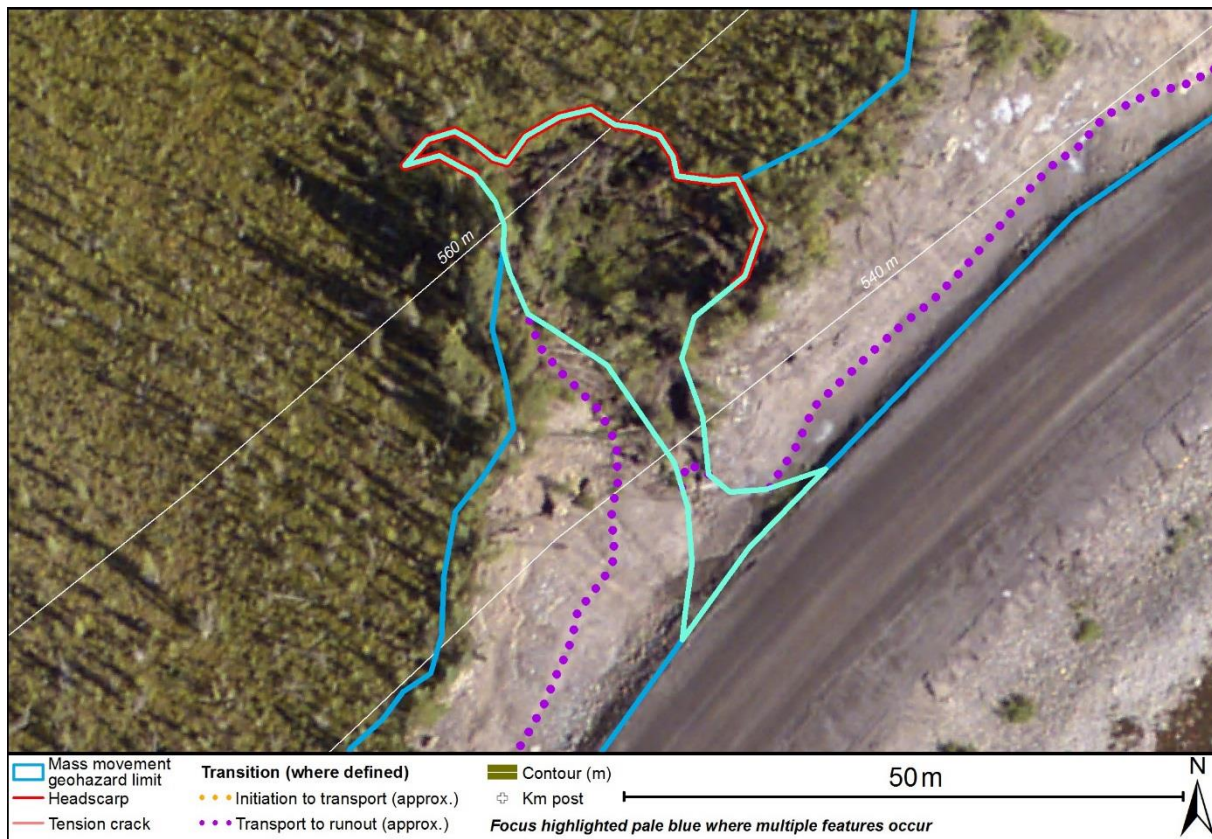
Project: Dempster Geohazard Investigation Project number: 14132 Client: Yukon Government
		<h2>KM 221.5</h2>

SITE	PROCESS	GEOMETRY	IMPLICATIONS
Section Ogilvie	Type retrogressive thaw slump	Elevation (m) 555	Likelihood M
Proximity (m) 0	Position above	Initiation slope (°) 34	Consequence L
Aspect (°) 145	Causes disturbance and possible over-steepening of slope toe, permafrost degradation	Runout slope (°) 11	Risk L
Surficial material dszCv	Triggers intense rainfall/snowmelt or heat	Average slope (°) 26	Mitigation Management of debris accumulation in ditch
Permafrost Shallow, likely ice-rich permafrost above slope-toe scarp beside highway	Timing Ongoing/episodic, possibly exacerbated by highway construction	Dimensions (L/W/D) (m) 49 / 15 / 3	Comments

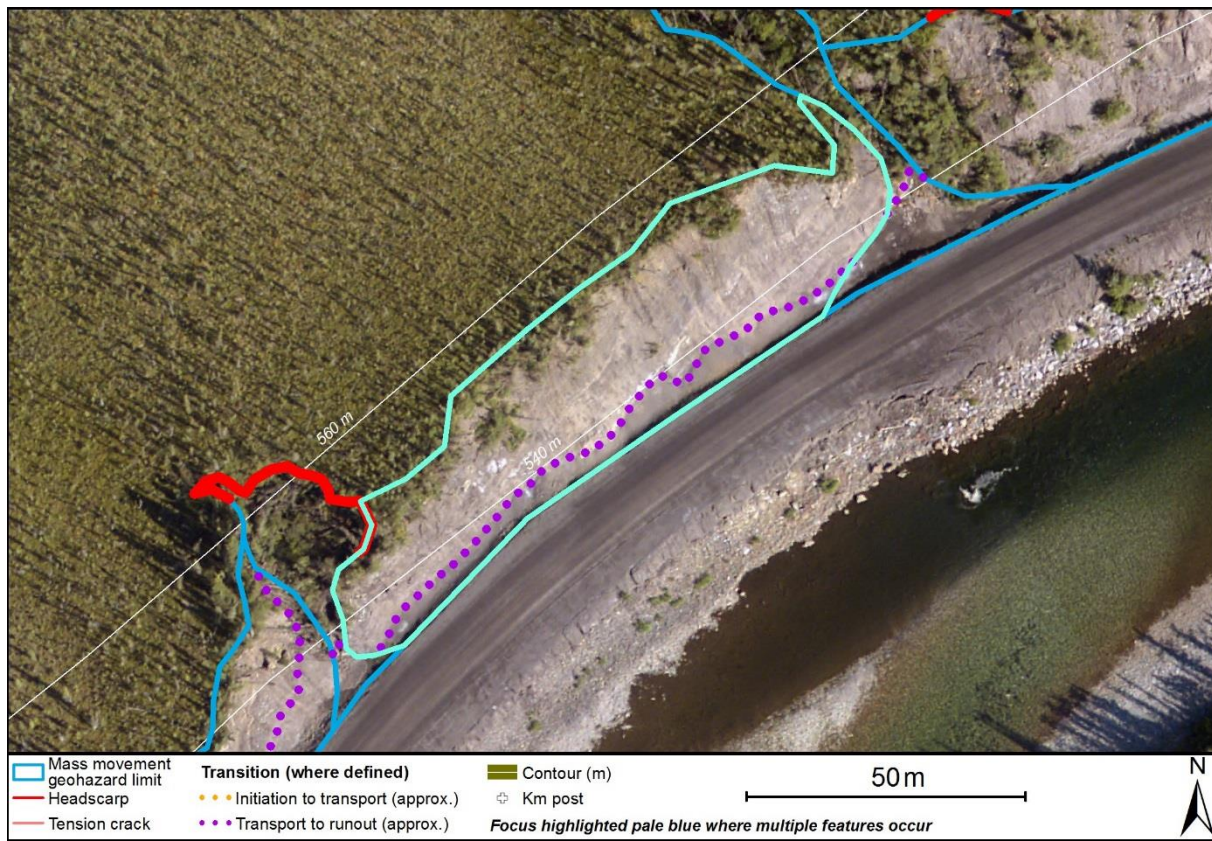
Project: Dempster Geohazard Investigation Project number: 14132 Client: Yukon Government
		KM 221.6

SITE	PROCESS	GEOMETRY	IMPLICATIONS
Section	Type	Elevation (m)	Likelihood
Ogilvie	rockfall	551	H
Proximity (m)	Position	Initiation slope (°)	Consequence
0	above	18	L
Aspect (°)	Causes	Runout slope (°)	Risk
130	steep rock bluff	32	M
Surficial material	Triggers	Average slope (°)	Mitigation
R	freeze/thaw, intense rainfall/snowmelt	46	Management of debris accumulation in ditch
Permafrost	Timing	Dimensions (L/W/D) (m)	Comments
Permafrost, likely ice-poor, relatively deep within colluvial rubble or weathered bedrock	Recurrent (likely annual)	30 / 130 / n/a	Runout limits approximate due to clearing of former debris accumulation

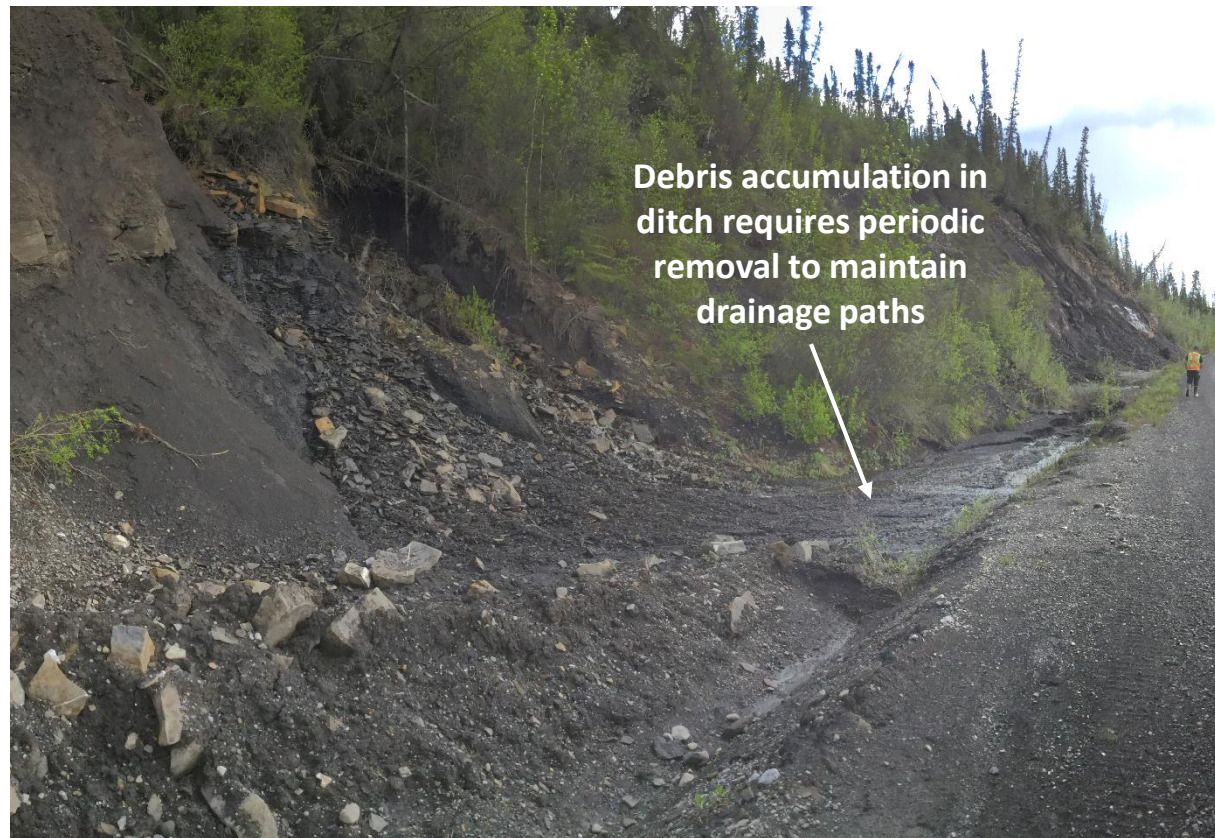
Project: Dempster Geohazard Investigation Project number: 14132 Client: Yukon Government
		KM 221.7

SITE	PROCESS	GEOMETRY	IMPLICATIONS
Section	Type	Elevation (m)	Likelihood
Ogilvie	retrogressive thaw slump	563	M
Proximity (m)	Position	Initiation slope (°)	Consequence
0	above	31	L
Aspect (°)	Causes	Runout slope (°)	Risk
110	natural concentration of runoff, permafrost degradation	12	L
Surficial material	Triggers	Average slope (°)	Mitigation
dszCv	intense rainfall/snowmelt or heat	18	Management of debris accumulation in ditch
Permafrost	Timing	Dimensions (L/W/D) (m)	Comments
Shallow, likely ice-rich permafrost above slope-toe scarp beside highway	Ongoing/episodic, possibly exacerbated by highway construction	99 / 45 / 3

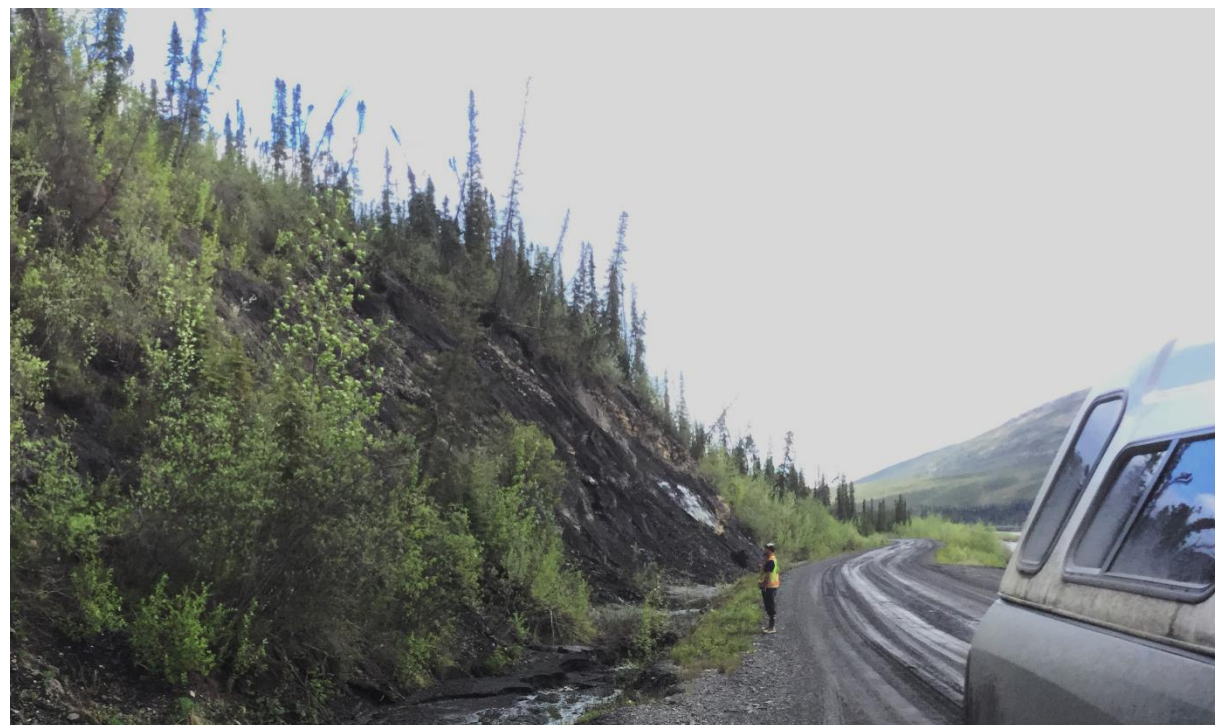
Project: Dempster Geohazard Investigation Project number: 14132 Client: Yukon Government
		KM 221.8

SITE	PROCESS	GEOMETRY	IMPLICATIONS
Section	Type	Elevation (m)	Likelihood
Ogilvie	debris slide & rockfall	549	H
Proximity (m)	Position	Initiation slope (°)	Consequence
0	above	33	L
Aspect (°)	Causes	Runout slope (°)	Risk
145	disturbance and possible over-steepening of slope toe, steep rock bluffs	10	M
Surficial material	Triggers	Average slope (°)	Mitigation
dszCv/R	freeze/thaw, intense rainfall/snowmelt	40	Management of debris accumulation in ditch
Permafrost	Timing	Dimensions (L/W/D) (m)	Comments
Shallow permafrost areas remaining within slope otherwise underlain by permafrost relatively deep within colluvium or weathered bedrock	Recurrent (likely annual)	30 / 130 / <1	Runout limits approximate due to clearing of former debris accumulation

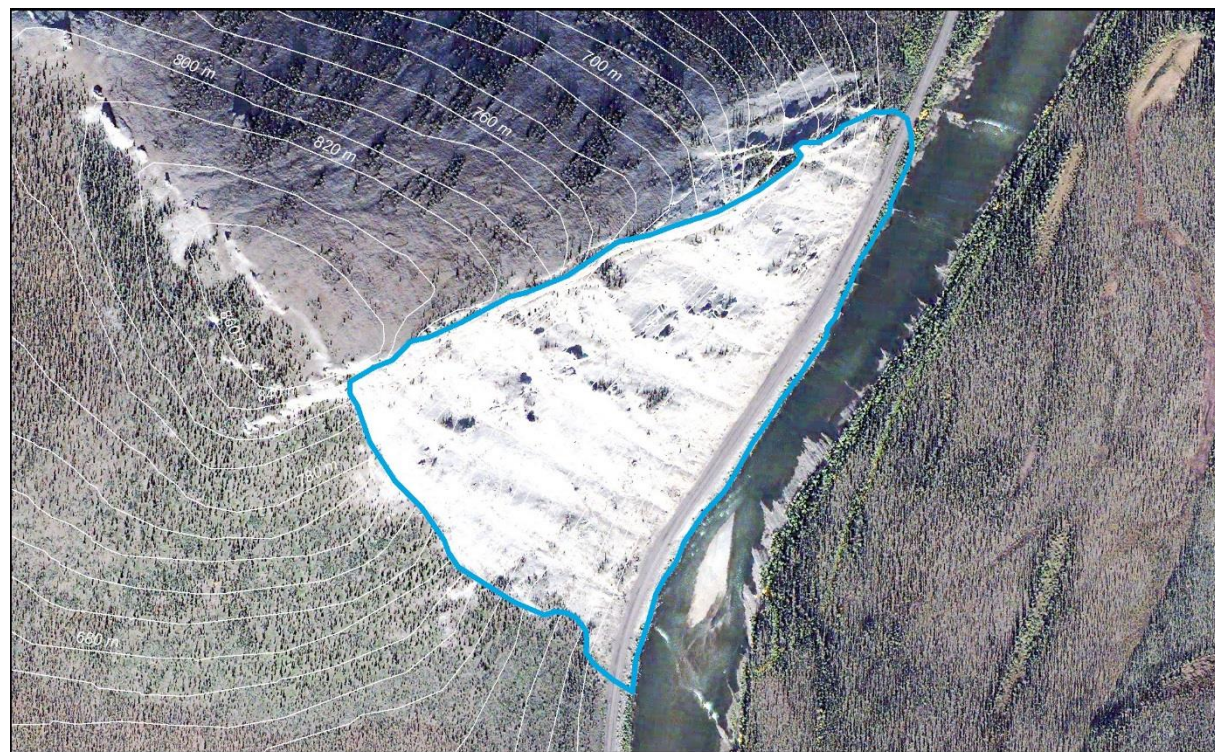
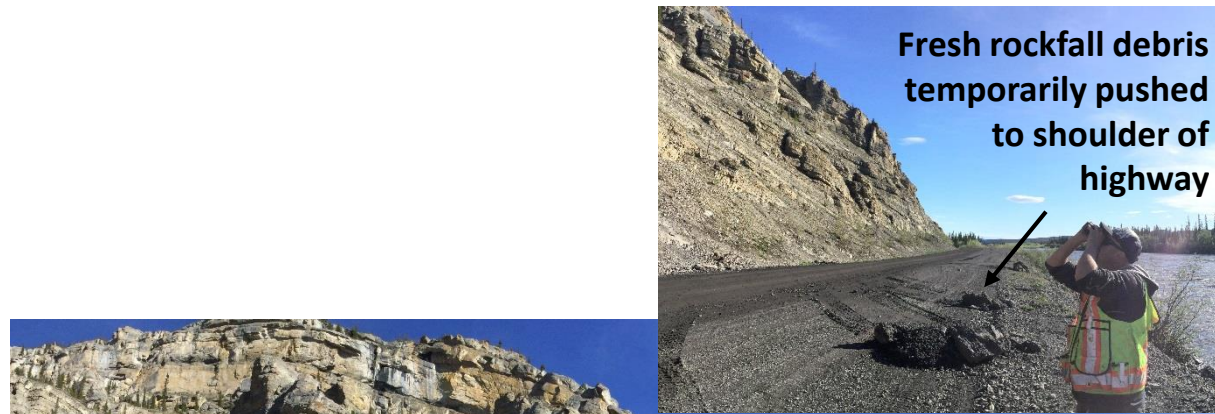
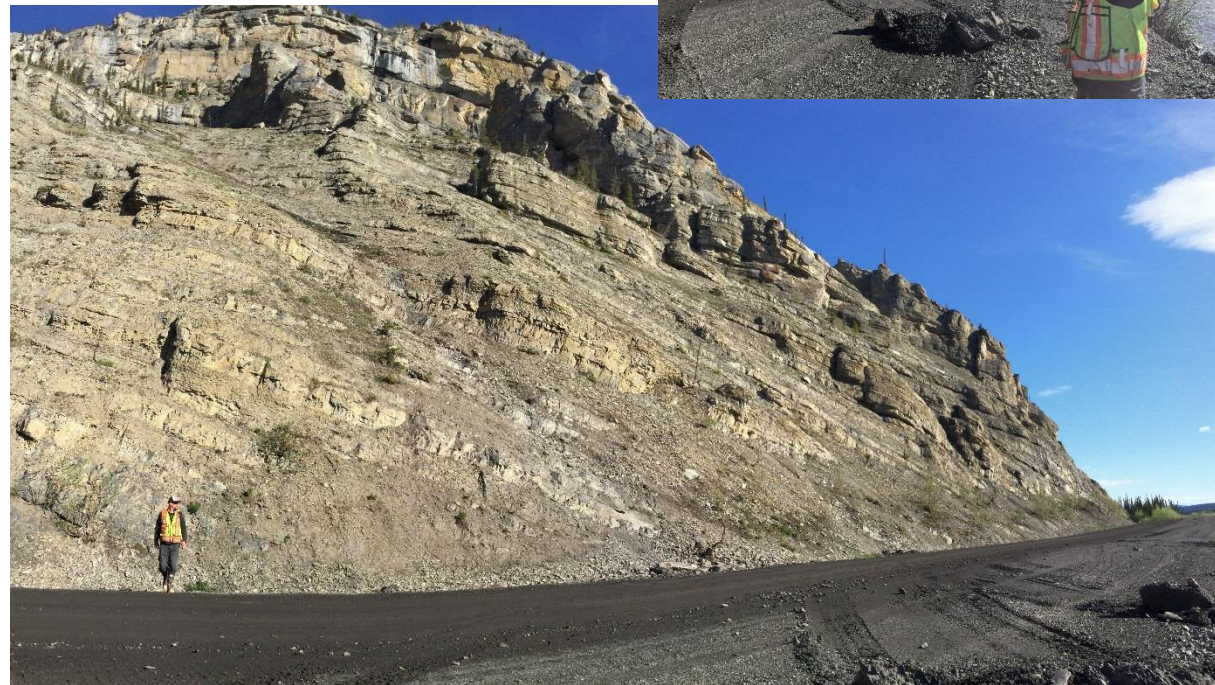
Project: Dempster Geohazard Investigation Project number: 14132 Client: Yukon Government
		<h2>KM 221.9</h2>

SITE	PROCESS	GEOMETRY	IMPLICATIONS
Section	Type	Elevation (m)	Likelihood
Ogilvie	rockfall	635	H
Proximity (m)	Position	Initiation slope (°)	Consequence
0	above	55	M
Aspect (°)	Causes	Runout slope (°)	Risk
150	steep rock bluffs	16	H
Surficial material	Triggers	Average slope (°)	Mitigation
R	freeze/thaw, intense rainfall/snowmelt	49	Management of rockfall debris in ditch and on hwy
Permafrost	Timing	Dimensions (L/W/D) (m)	Comments
Permafrost, likely ice-poor, relatively deep within colluvial rubble or weathered bedrock	Recurrent (likely annual)	270 / 695 / n/a	Runout limits approximate due to clearing of former debris accumulation; risk greatest downslope of prominent rock bluffs

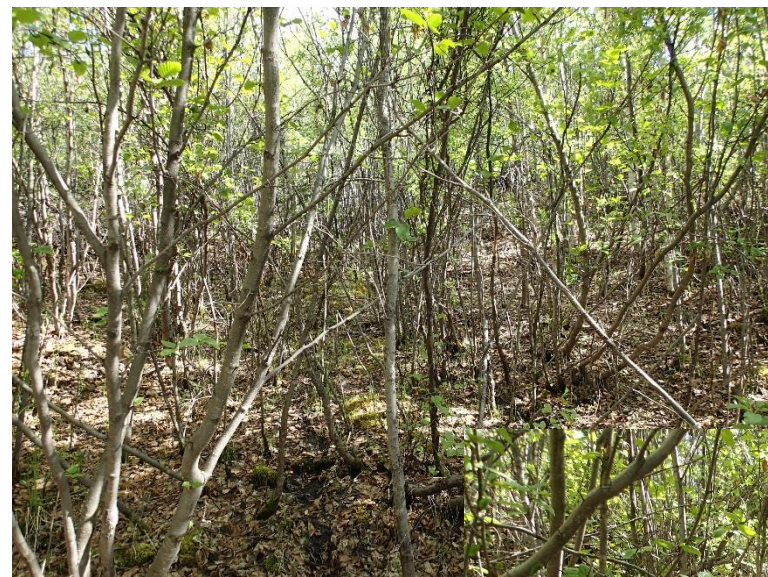
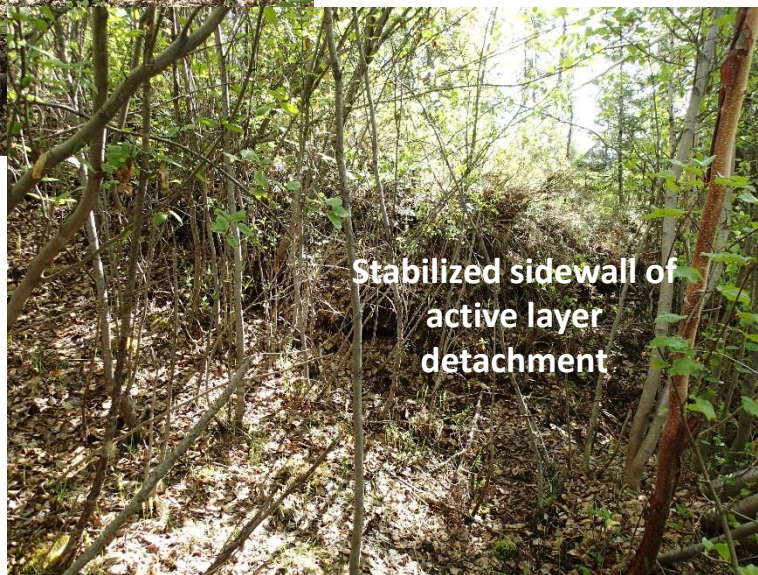
Project: Dempster Geohazard Investigation Project number: 14132 Client: Yukon Government
		KM 241.9

Stabilized sidewall of active layer detachment

SITE	PROCESS	GEOMETRY	IMPLICATIONS
Section	Type	Elevation (m)	Likelihood
Ogilvie	debris slide (active layer detachment)	534	L
Proximity (m)	Position	Initiation slope (°)	Consequence
0	above	29	L
Aspect (°)	Causes	Runout slope (°)	Risk
170	permafrost degradation, possible fire	14	VL
Surficial material	Triggers	Average slope (°)	Mitigation
szrCb	intense rainfall/snowmelt or heat	19	None expected to be required
Permafrost	Timing	Dimensions (L/W/D) (m)	Comments
Shallow permafrost	Single event (1977-2007) with minimal remaining potential for post-failure sloughs/flows	338 / 28 / 1	Mostly stabilized through natural revegetation

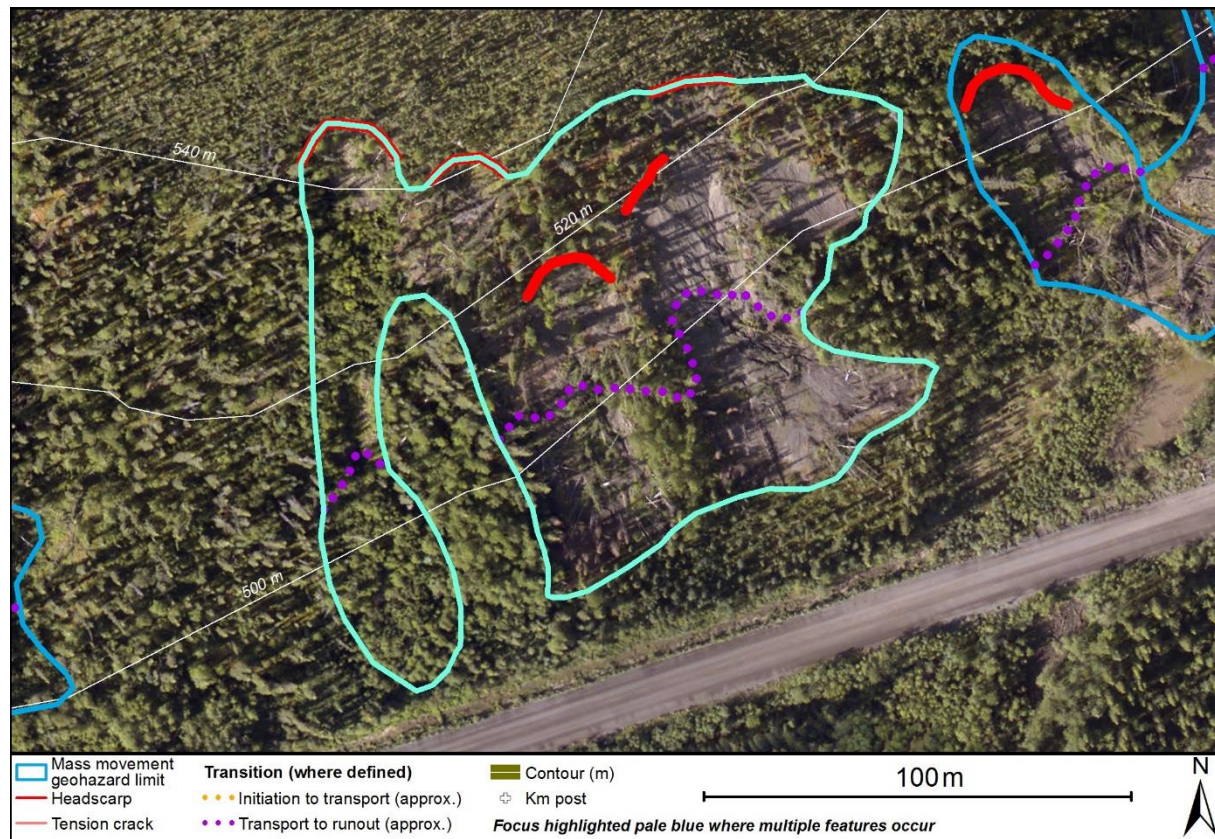
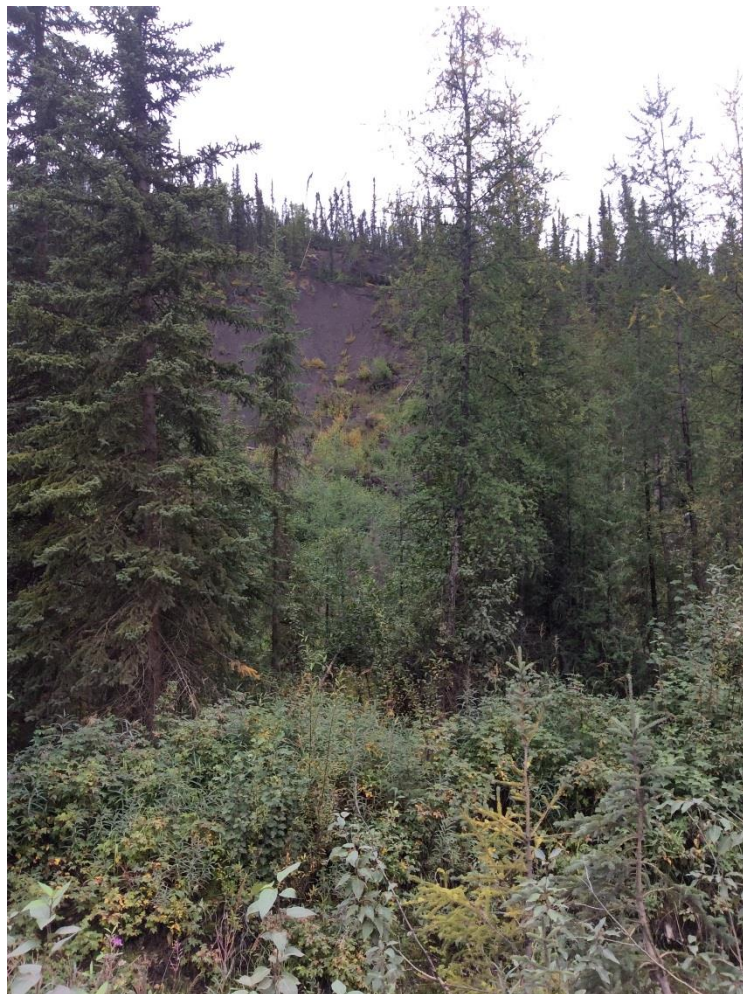
Project: Dempster Geohazard Investigation Project number: 14132 Client: Yukon Government
		KM 244

Aspect (°)	Causes	Runout slope (°)	Risk
145	permafrost degradation	16	L

Permafrost	Timing	Dimensions (L/W/D) (m)	Comments
Shallow permafrost	Single event with potential for post-failure sloughs/flows	115 / 150 / <1

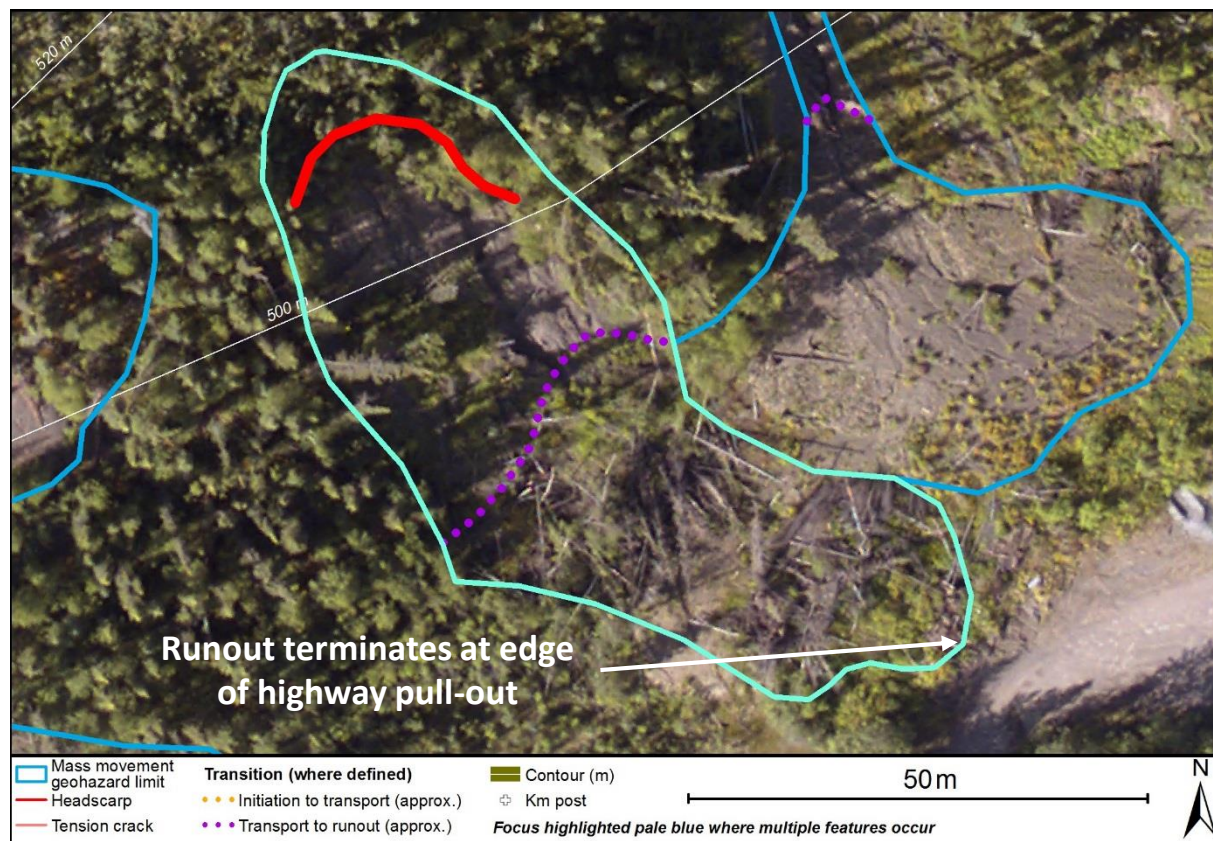
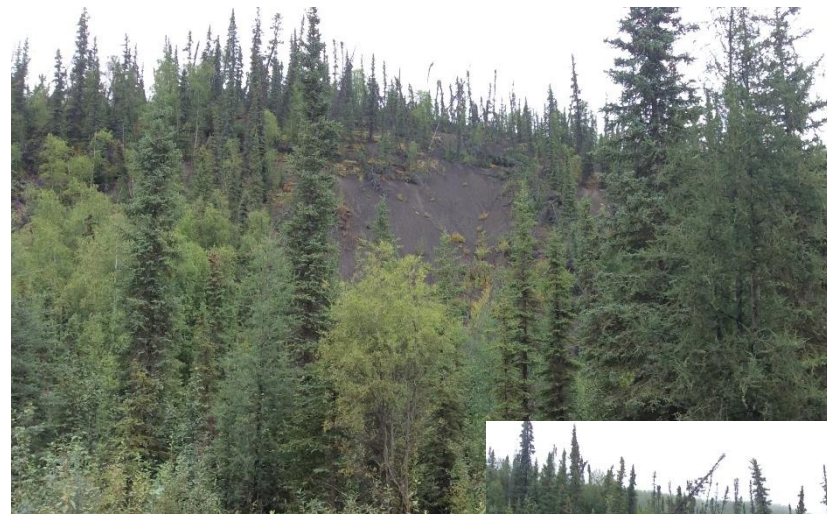
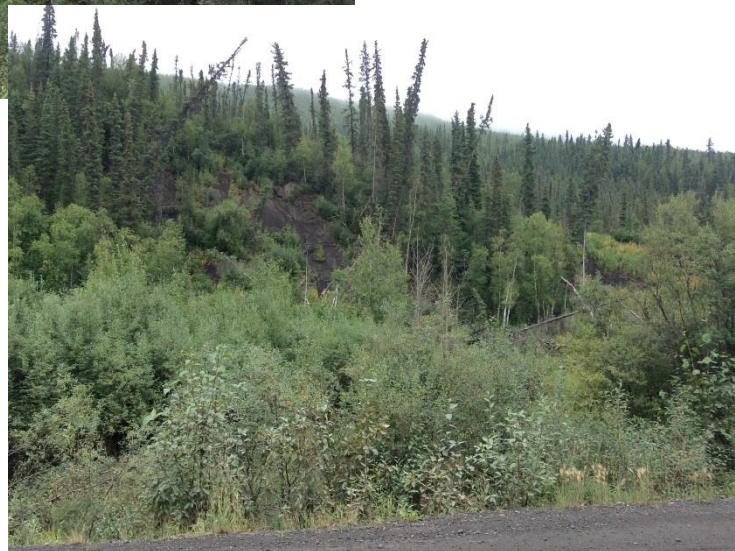
KM 244.1

SITE	PROCESS	GEOMETRY	IMPLICATIONS
Section	Type	Elevation (m)	Likelihood
Ogilvie	debris slide (active layer detachment)	488	L
Proximity (m)	Position	Initiation slope (°)	Consequence
30	above	36	L
Aspect (°)	Causes	Runout slope (°)	Risk
120	permafrost degradation	5	VL
Surficial material	Triggers	Average slope (°)	Mitigation
sZRcV	intense rainfall/snowmelt or heat	18	Management of debris accumulation in ditch of staging area
Permafrost	Timing	Dimensions (L/W/D) (m)	Comments
Shallow permafrost	Single event (2007-2013) with potential for post-failure sloughs/flows	100 / 26 / <1
