Yukon Geological Survey Miscellaneous Report 17

Inventory of mass movement geohazards along the Dempster Highway, Yukon

Robin J. McKillop, Courtenay E. Brown, Daniel J. McParland and David A. Sacco
Palmer Environmental Consulting Group Inc.
and Jim Coates
Kryotek Arctic Innovation Inc.

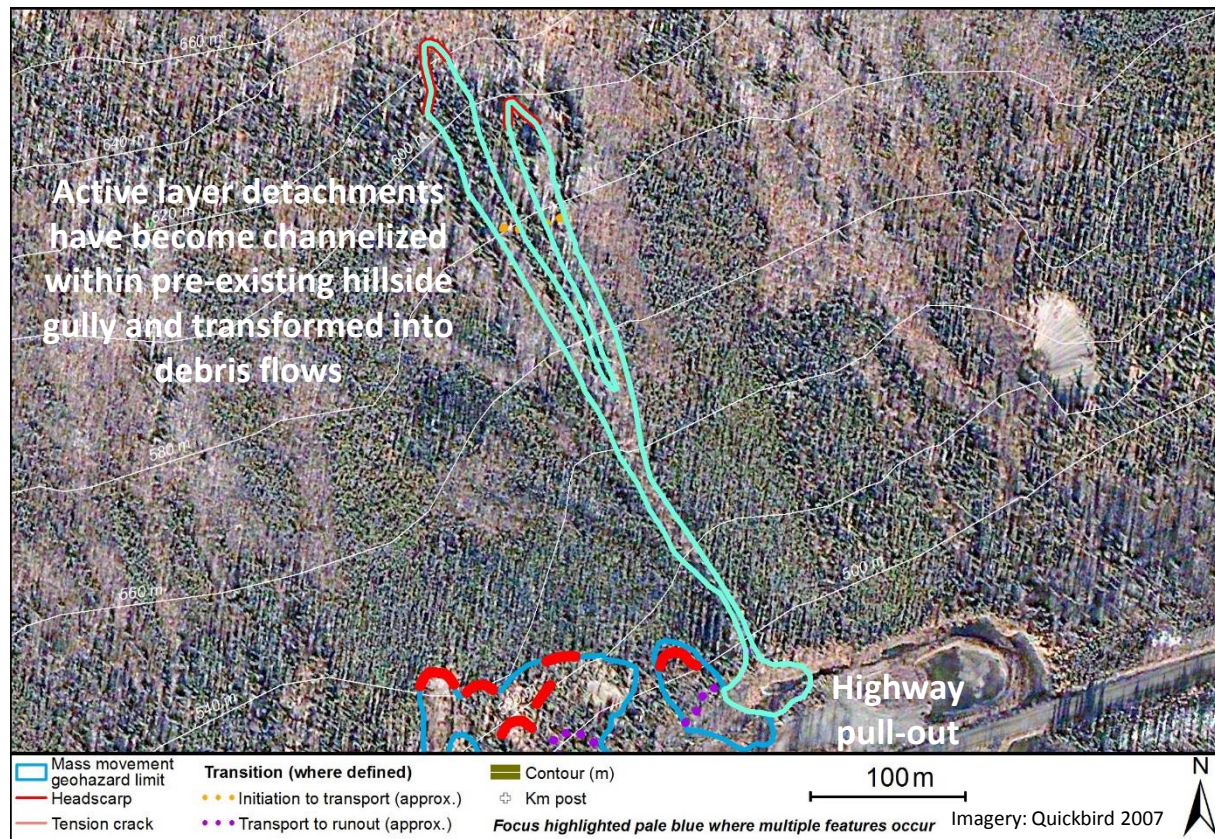
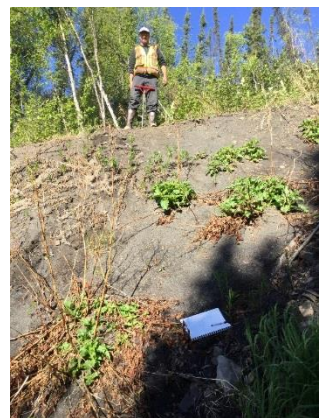
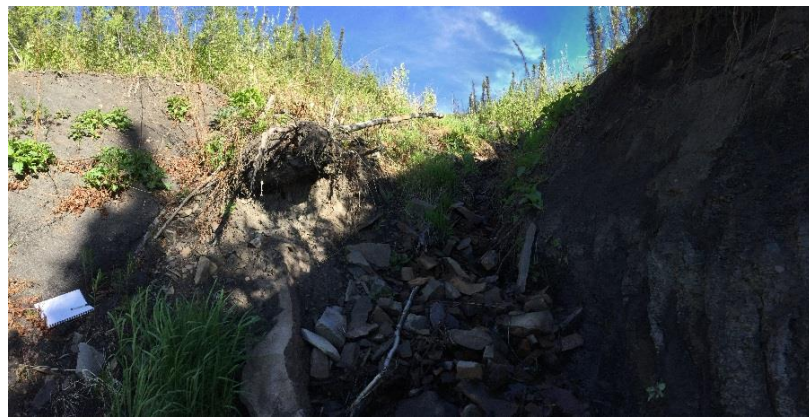
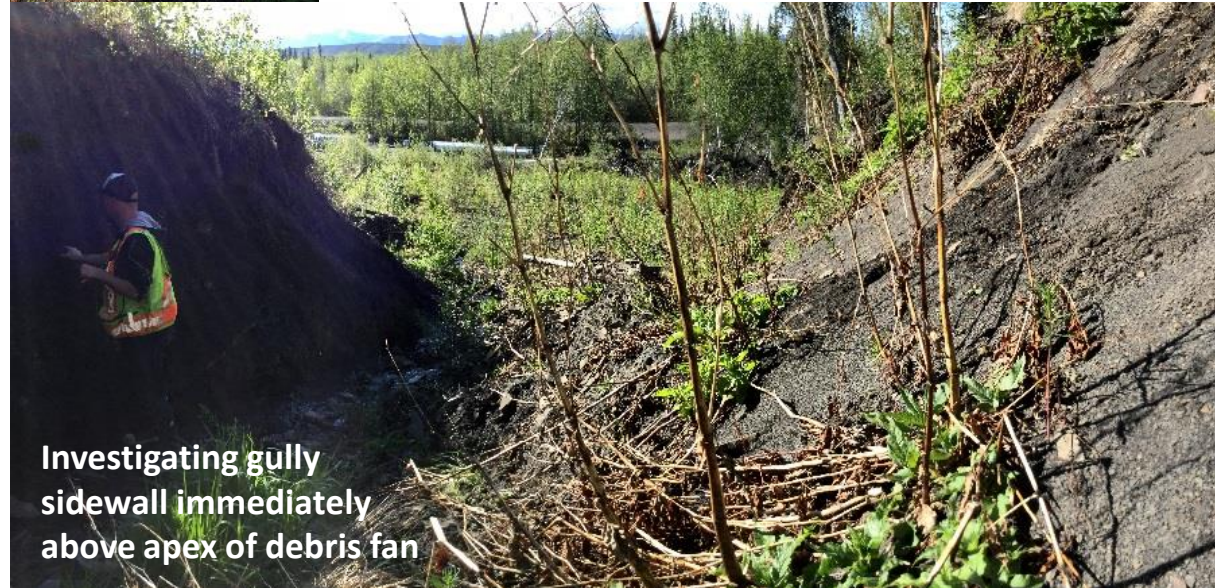
KM 244.25

Investigating gully sidewall immediately above apex of debris fan

SITE	PROCESS	GEOMETRY	IMPLICATIONS
Section	Type	Elevation (m)	Likelihood
Ogilvie	debris flow & debris slide (active layer detachment)	560	L
Proximity (m)	Position	Initiation slope (°)	Consequence
46.6	above	29	L
Aspect (°)	Causes	Runout slope (°)	Risk
135	permafrost degradation, possible fire	8	VL
Surficial material	Triggers	Average slope (°)	Mitigation
szrCv	intense rainfall/snowmelt or heat	16	Management of debris accumulation in ditch or staging area
Permafrost	Timing	Dimensions (L/W/D) (m)	Comments
Shallow permafrost	Single event (2007-2013) with potential for post-failure sloughs/flows	493 / 57 / n/a	Special case of recurrent runout of debris from multiple active layer detachment sources

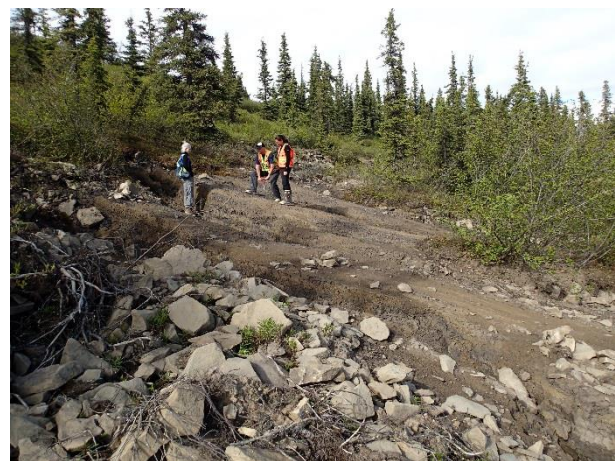
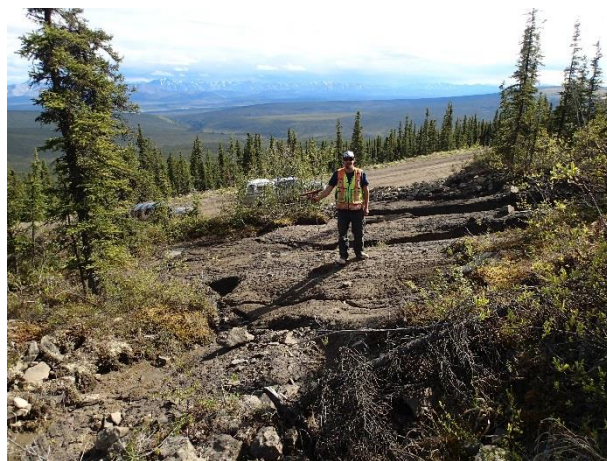
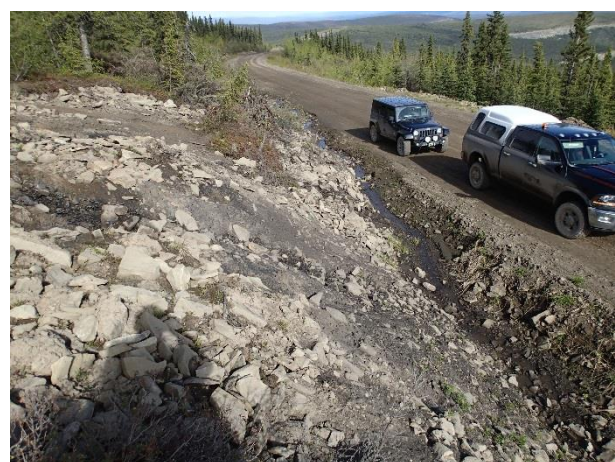
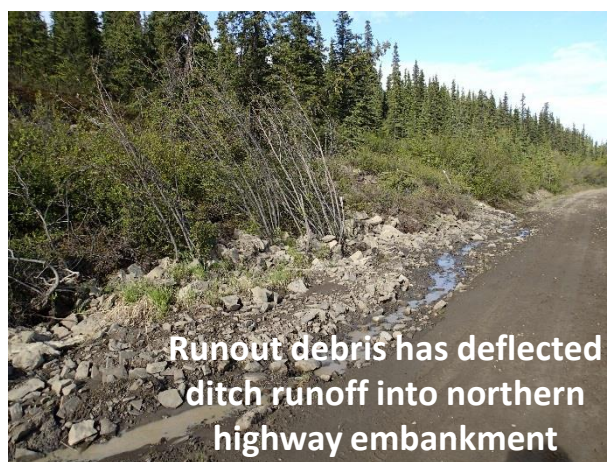
KM 244.3

SITE	PROCESS	GEOMETRY	IMPLICATIONS
Section	Type	Elevation (m)	Likelihood
Ogilvie	debris slide (active layer detachment)	854	M
Proximity (m)	Position	Initiation slope (°)	Consequence
0	above	17	M
Aspect (°)	Causes	Runout slope (°)	Risk
150	oversteepened slope toe, permafrost degradation	17	M
Surficial material	Triggers	Average slope (°)	Mitigation
rszCv	intense rainfall/snowmelt or heat	16	Management of runout debris
Permafrost	Timing	Dimensions (L/W/D) (m)	Comments
Shallow permafrost	Single event (2007-2013) with potential for post-failure sloughs/flows	33 / 49 / 0.3	Reactivation possible

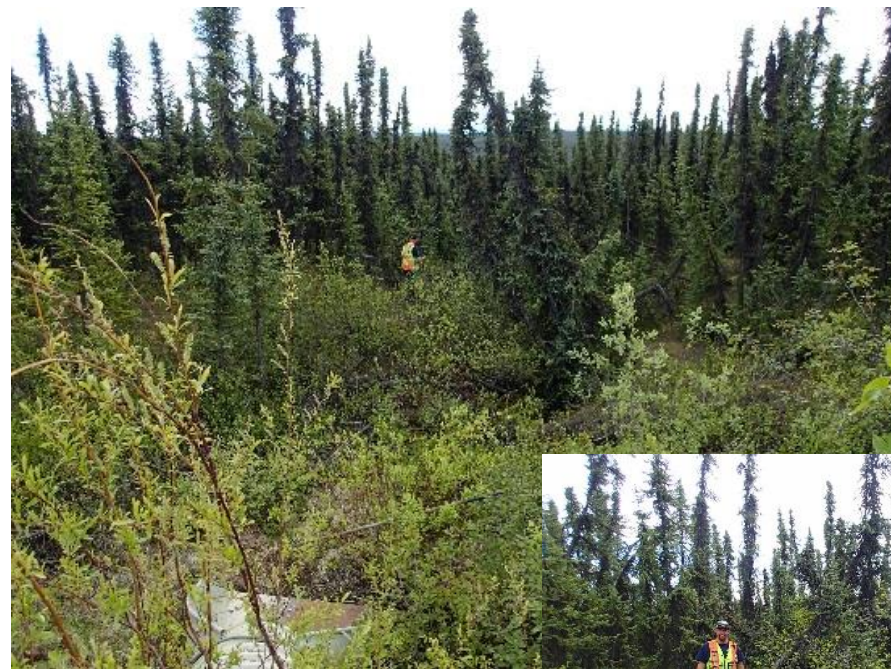
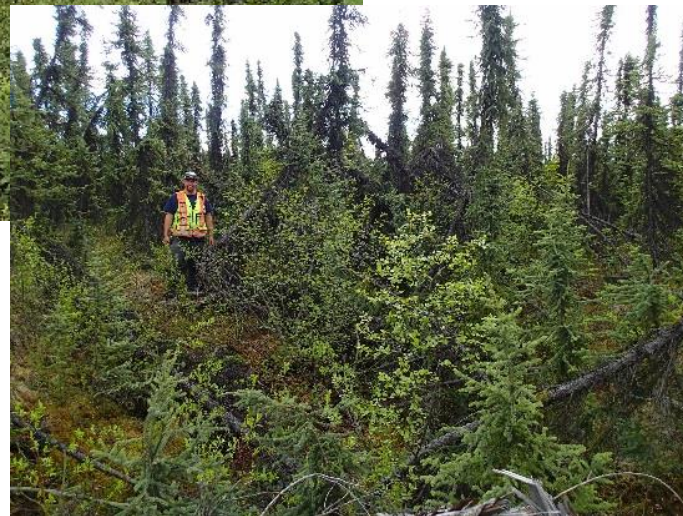
Project: Dempster Geohazard Investigation Project number: 14132 Client: Yukon Government
		<h2>KM 273.1</h2>

SITE	PROCESS	GEOMETRY	IMPLICATIONS
Section	Type	Elevation (m)	Likelihood
Eagle Plains	thermokarst gully	607	L
Proximity (m)	Position	Length (m)	Consequence
0	below	86	L
Aspect (°)	Causes	Width (m)	Risk
175	concentrated drainage	5	VL
Surficial material	Triggers	Depth (m)	Mitigation
rszCb	intense rainfall/snowmelt	1	Management of surface runoff from culvert
Permafrost	Timing	Dimensions (L/W/D) (m)	Comments
Shallow permafrost	Ongoing/episodic, likely initiated following highway construction	5

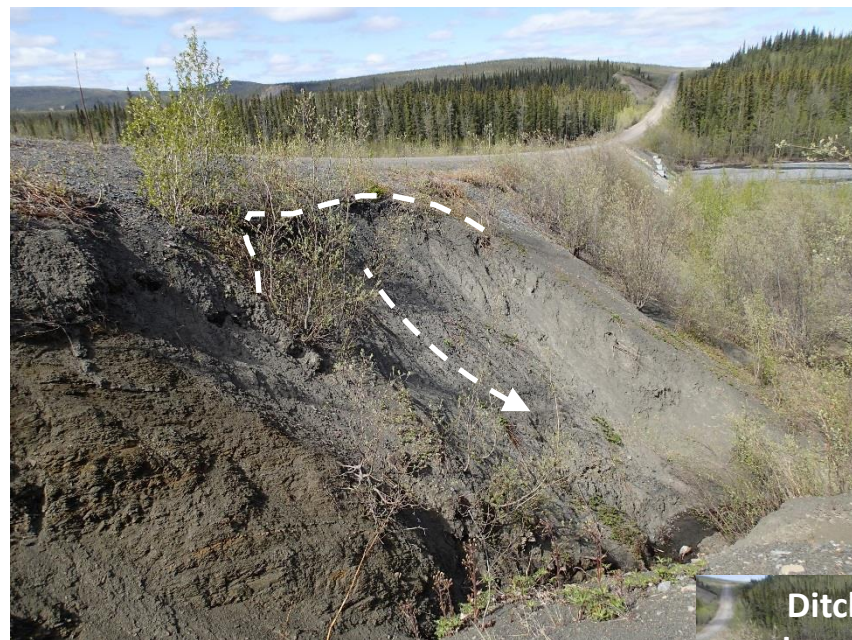
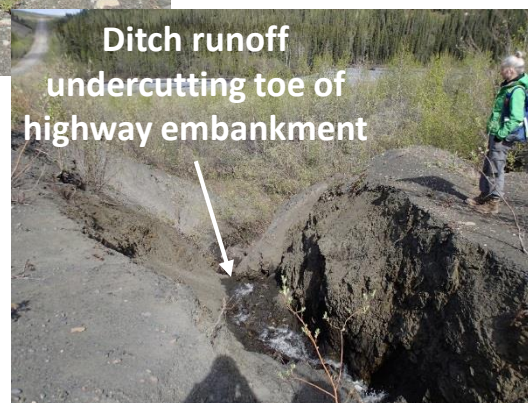
Project: Dempster Geohazard Investigation Project number: 14132 Client: Yukon Government
		KM 378.8

SITE	PROCESS	GEOMETRY	IMPLICATIONS
Section	Type	Elevation (m)	Likelihood
Eagle Plains	debris slide	549	M
Proximity (m)	Position	Initiation slope (°)	Consequence
0	below	30	M
Aspect (°)	Causes	Runout slope (°)	Risk
45	concentrated drainage in hwy ditch undercutting embankment	20	M
Surficial material	Triggers	Average slope (°)	Mitigation
A	intense rainfall/snowmelt	25	Management of runoff in hwy ditch
Permafrost	Timing	Dimensions (L/W/D) (m)	Comments
Permafrost likely relatively deep within highway embankment or underlying weathered bedrock	Single event with potential for post-failure sloughs and gradual retrogression	25 / 10 / 0.5

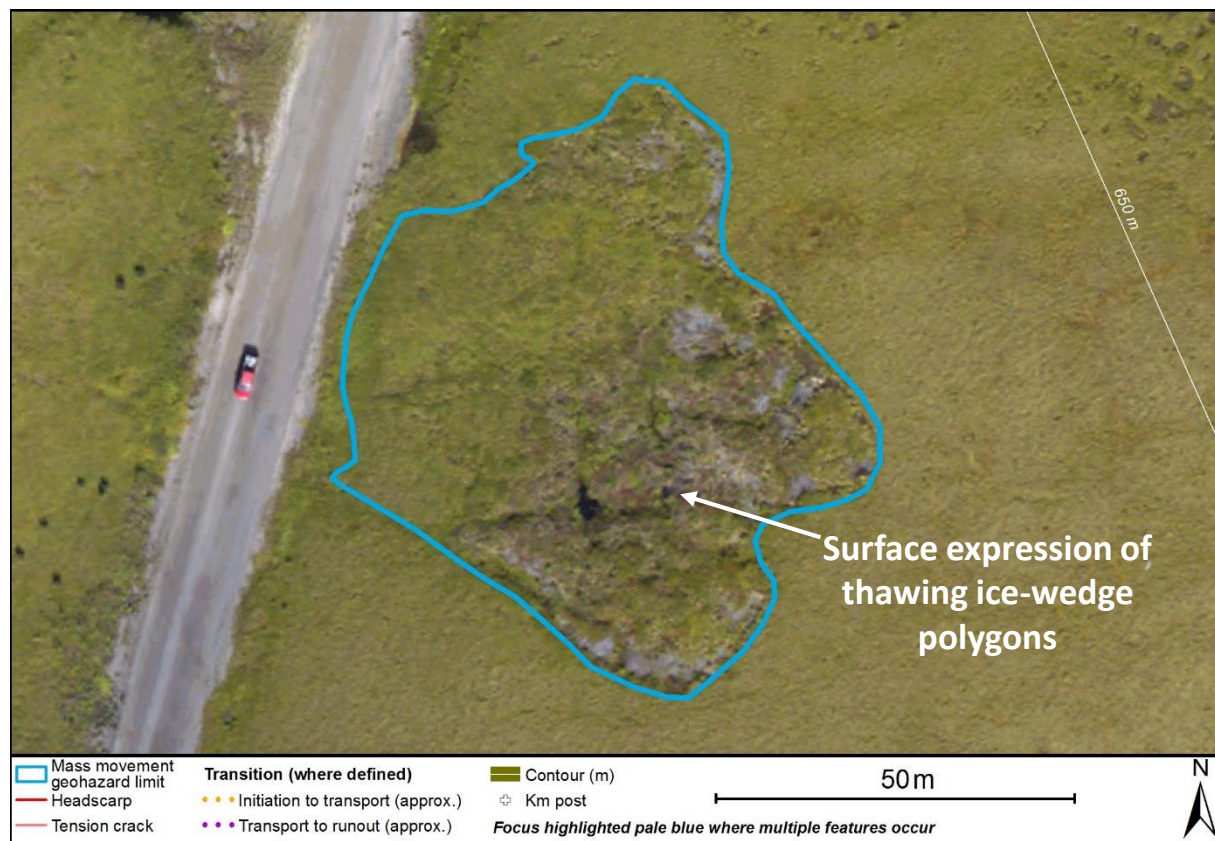
Project: Dempster Geohazard Investigation Project number: 14132 Client: Yukon Government
		<h2>KM 432.7</h2>

SITE	PROCESS	GEOMETRY	IMPLICATIONS
Section	Type	Elevation (m)	Likelihood
Eagle Plains	thermokarst subsidence	653	L
Proximity (m)	Position	Length (m)	Consequence
3	above	78	M
Aspect (°)	Causes	Width (m)	Risk
285	possible disturbance to surface organic cover, permafrost degradation	70	L
Surficial material	Triggers	Depth (m)	Mitigation
szxCb	intense rainfall/snowmelt or heat	<1	Management of ground settlement
Permafrost	Timing	Average slope (°)	Comments
Shallow, ice-rich permafrost in area of degrading ice-wedge polygons	Ongoing/episodic, possibly exacerbated by highway construction	2	Potential for feature to evolve into retrogressive thaw slump

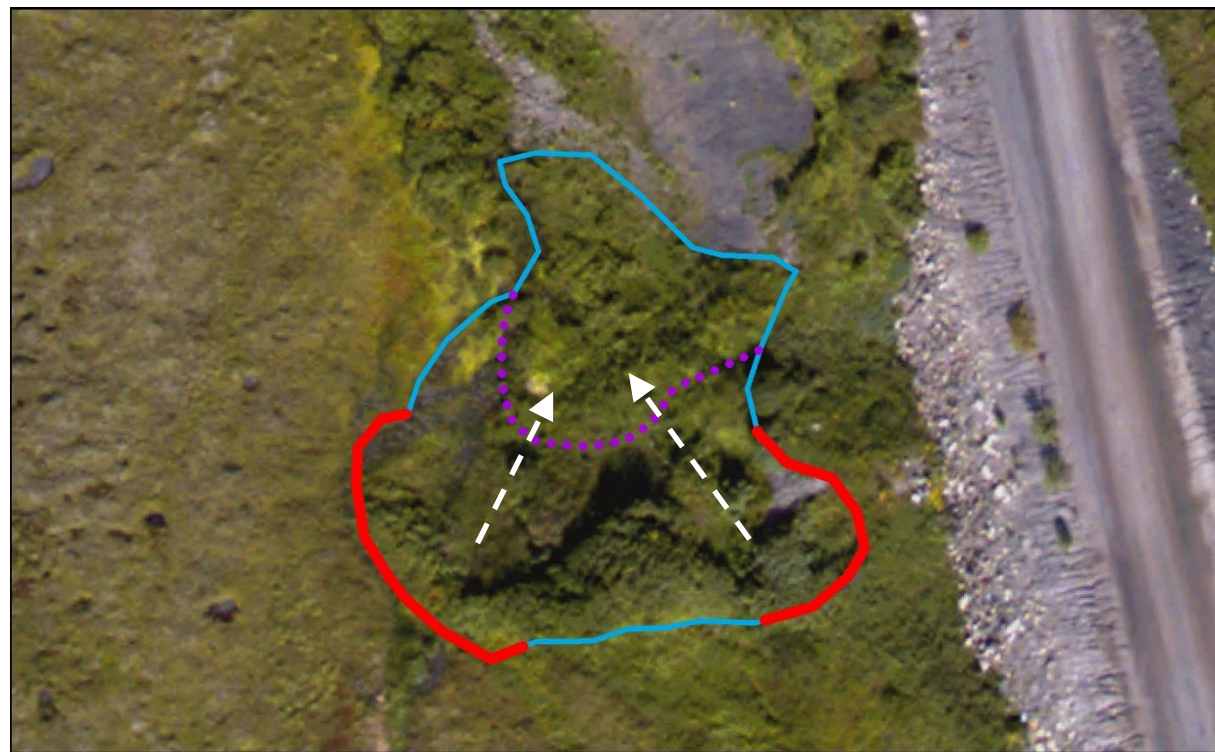
Project: Dempster Geohazard Investigation Project number: 14132 Client: Yukon Government
		KM 453.9

Aspect (°)	Causes	Runout slope (°)	Risk
20	alteration of drainage pattern, permafrost degradation	5	M

Permafrost	Timing	Dimensions (L/W/D) (m)	Comments
Shallow, likely ice-rich permafrost	Ongoing/episodic, possibly exacerbated by highway construction	47 / 13 / 2	Dominant trajectory of retrogression parallel to, rather than toward, hwy

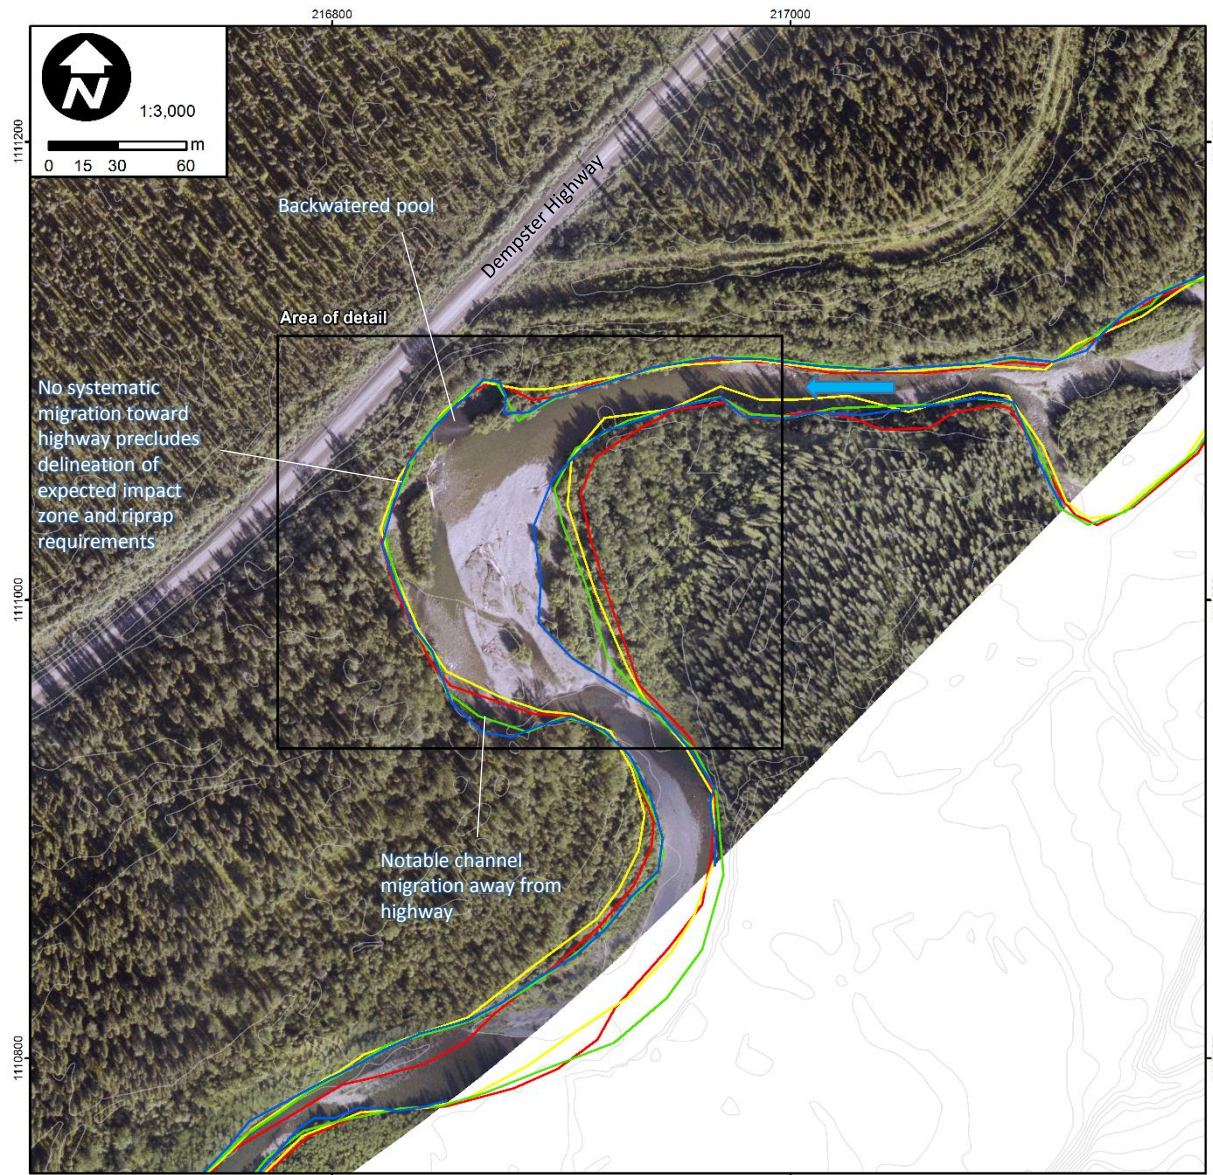
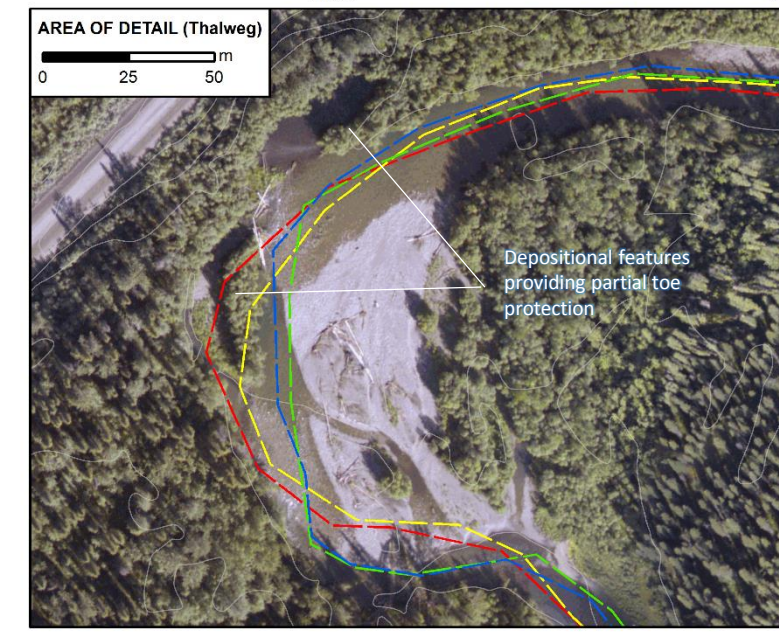
Project: Dempster Meander Migration Hazards Project number: 14132 Client: Yukon Government
		KM 52.3

SITE	CHANNEL	MEANDER	RIPRAP REQUIREMENTS
Section Klondike	Setting Fluvial plain	1^o migration rate (m/yr) -	Timeframe until impact (yr) -
Watercourse North Klondike R.	Permafrost Deep, ice-moderate	1^o trajectory NA	Lateral extent (m) -
Riprap history No riprap	Bank height (m) 1.3	2^o migration rate (m/yr) -	Slope length (m) -
Hwy-watercourse proximity (m) 19	Low-flow width (m) 20	2^o trajectory -	Thickness (m) -
Position in meander belt Edge	Bankfull width (m) 65	Confinement Unconfined	Volume (m³) -

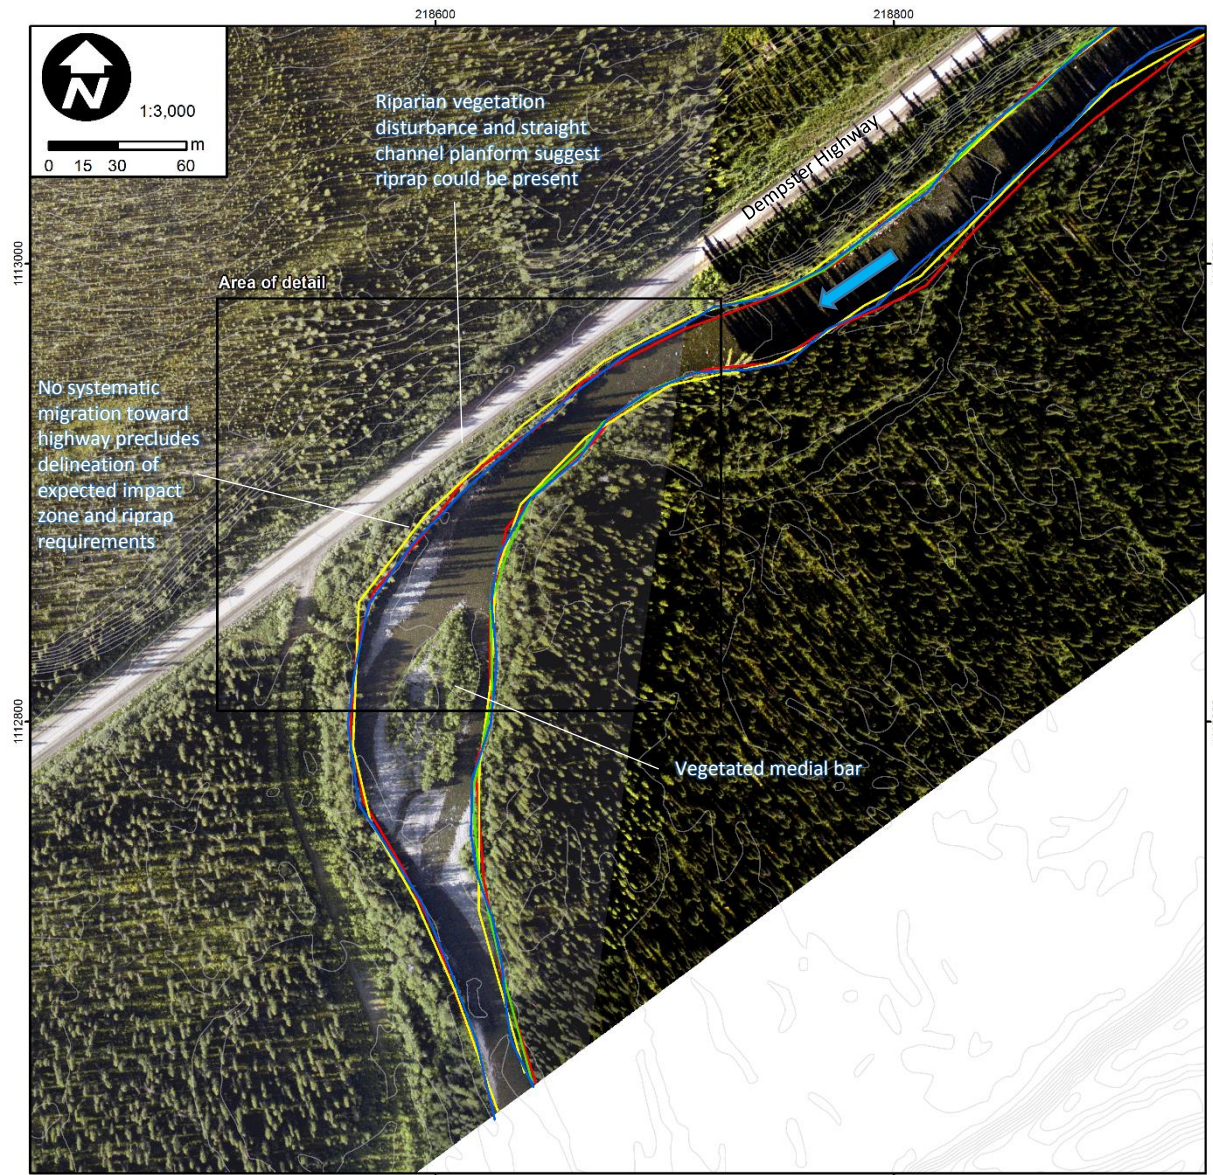
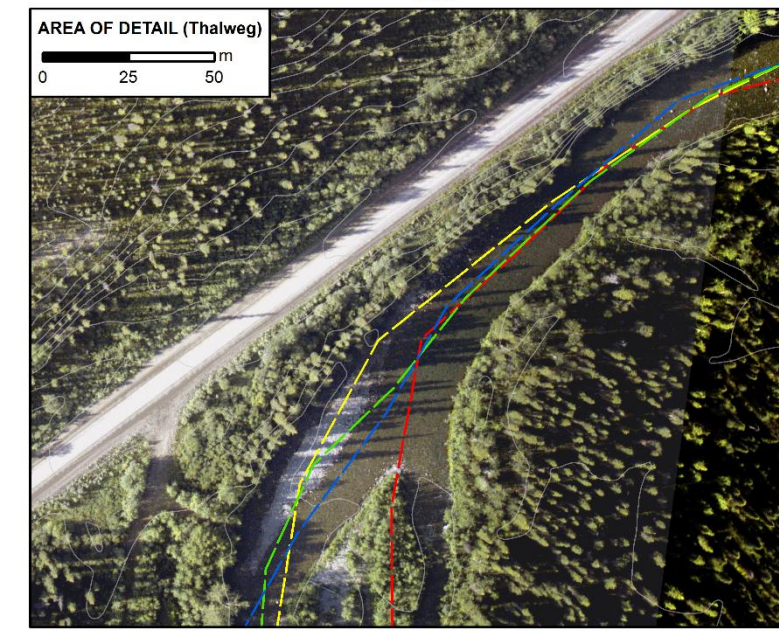
Project: Dempster Meander Migration Hazards Project number: 14132 Client: Yukon Government
		KM 54.9

SITE	CHANNEL	MEANDER	RIPRAP REQUIREMENTS
Section Klondike	Setting Hwy edge fluvial plain	1^o migration rate (m/yr) -	Timeframe until impact (yr) -
Watercourse North Klondike R.	Permafrost Deep, ice-moderate	1^o trajectory -	Lateral extent (m) -
Riprap history No riprap	Bank height (m) 5.9	2^o migration rate (m/yr) -	Slope length (m) -
Hwy-watercourse proximity (m) 7	Low-flow width (m) 22	2^o trajectory -	Thickness (m) -
Position in meander belt Edge	Bankfull width (m) 25	Confinement Confined by highway	Volume (m³) -

Riprap application, if required in the future, could cause longitudinal channel migration, potentially exposing the highway embankment and side road immediately downstream to erosion if not extended far enough downstream.

The bank slumping observed during 2016 field reconnaissance near the downstream end of the encroachment site should be monitored to ensure the highway embankment does not become undercut if slumping continues.

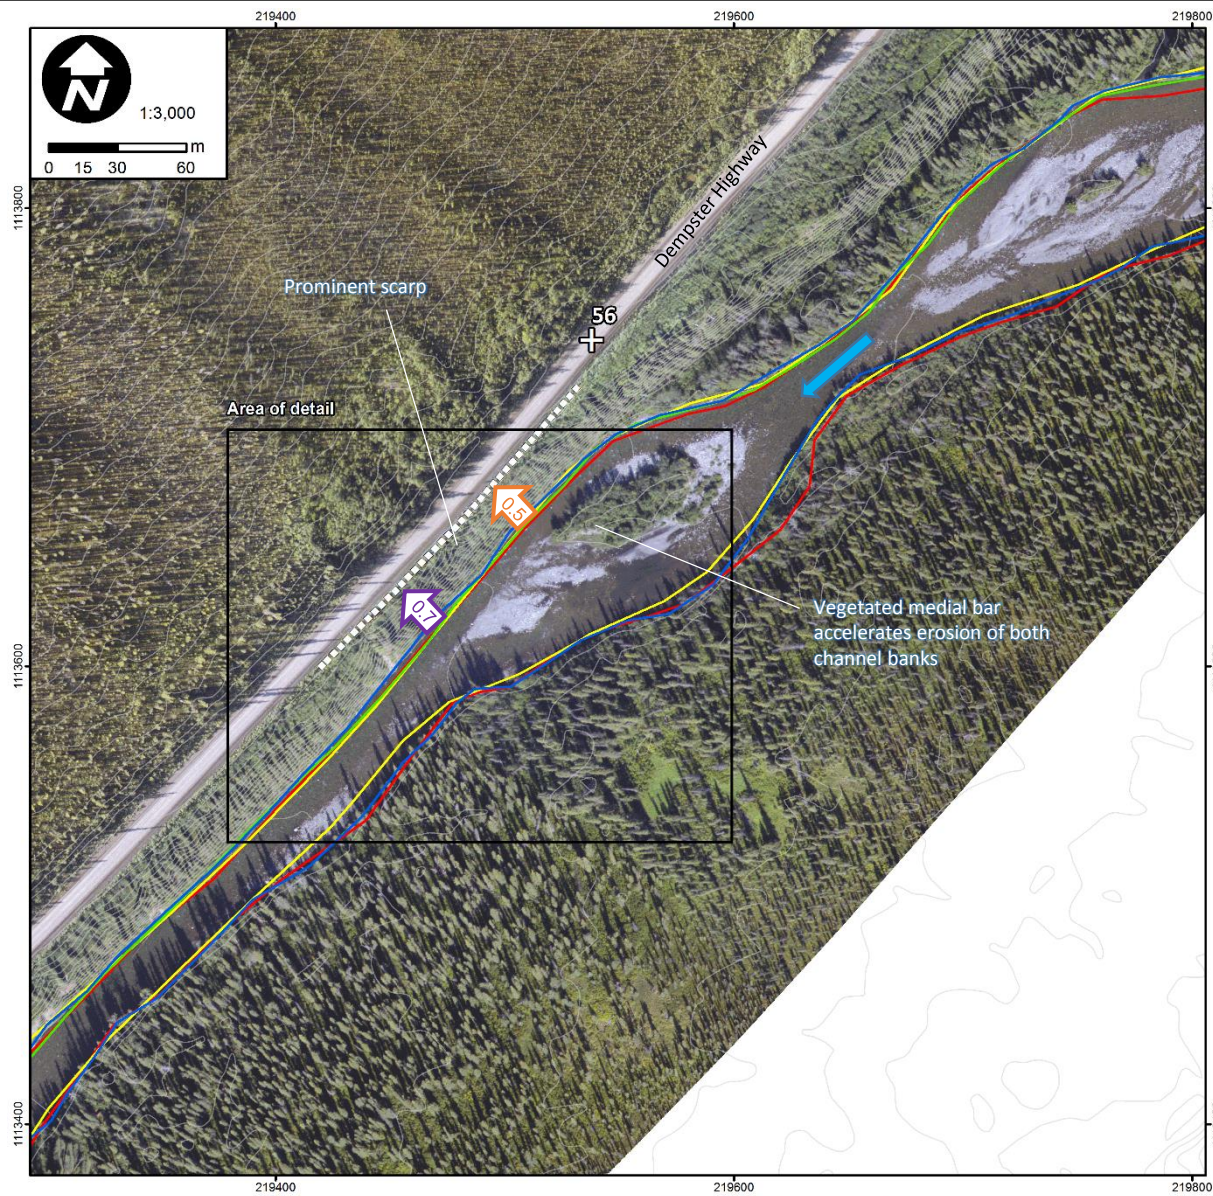
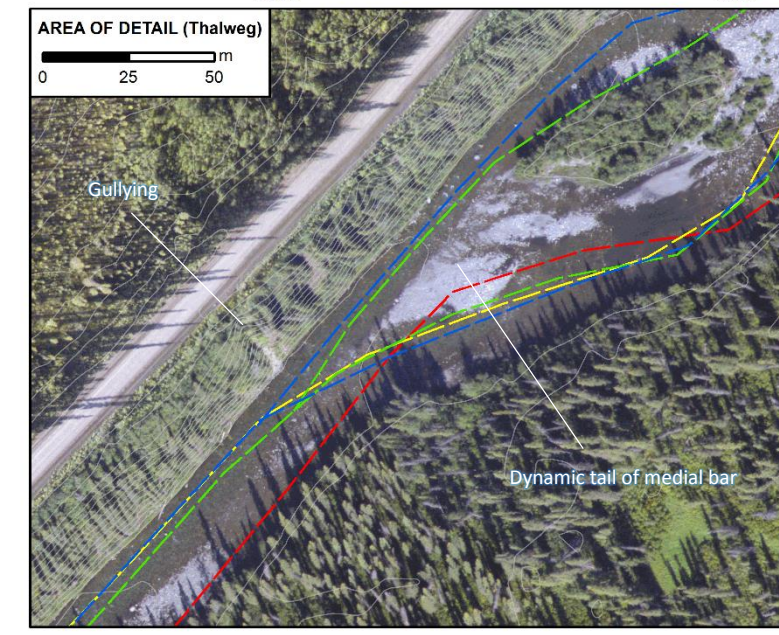
Project: Dempster Meander Migration Hazards Project number: 14132 Client: Yukon Government
		KM 55.9

SITE	CHANNEL	MEANDER	RIPRAP REQUIREMENTS
Section Klondike	Setting Colluvial toe slope	1st migration rate (m/yr) 0.7	Timeframe until impact (yr) >25
Watercourse North Klondike R.	Permafrost Deep, ice-moderate	1st trajectory NW	Lateral extent (m) 170
Riprap history No riprap	Bank height (m) 11.9	2nd migration rate (m/yr) 0.5	Slope length (m) 31.7
Hwy-watercourse proximity (m) 20	Low-flow width (m) 53	2nd trajectory NW	Thickness (m) 1
Position in meander belt Edge	Bankfull width (m) 57	Confinement Naturally confined	Volume (m³) 5,391

This encroachment site is located within a partly confined, irregularly meandering reach of North Klondike River. Migration rates throughout the reach, including in the vicinity of the encroachment site, have been low over the period of record. The encroachment site itself is at the edge of the meander belt, which limits lateral migration potential. Furthermore, the highway is perched atop a natural, ~10 m-high slope-toe scarp, which confines the channel. Small, shallow slope failures and gullying have occurred along this scarp below the highway embankment. A large, vegetated medial bar bifurcates flow immediately adjacent to the encroachment site. The bar has been reworked over the period of record. No intervention is recommended at this encroachment site due to the relative stability documented over the past several decades.

Estimates of the timeframe of impact are less reliable in confined settings, such as this, due to potential interactions between fluvial and hillslope processes. No significant slope failures were observed during 2016 field reconnaissance.

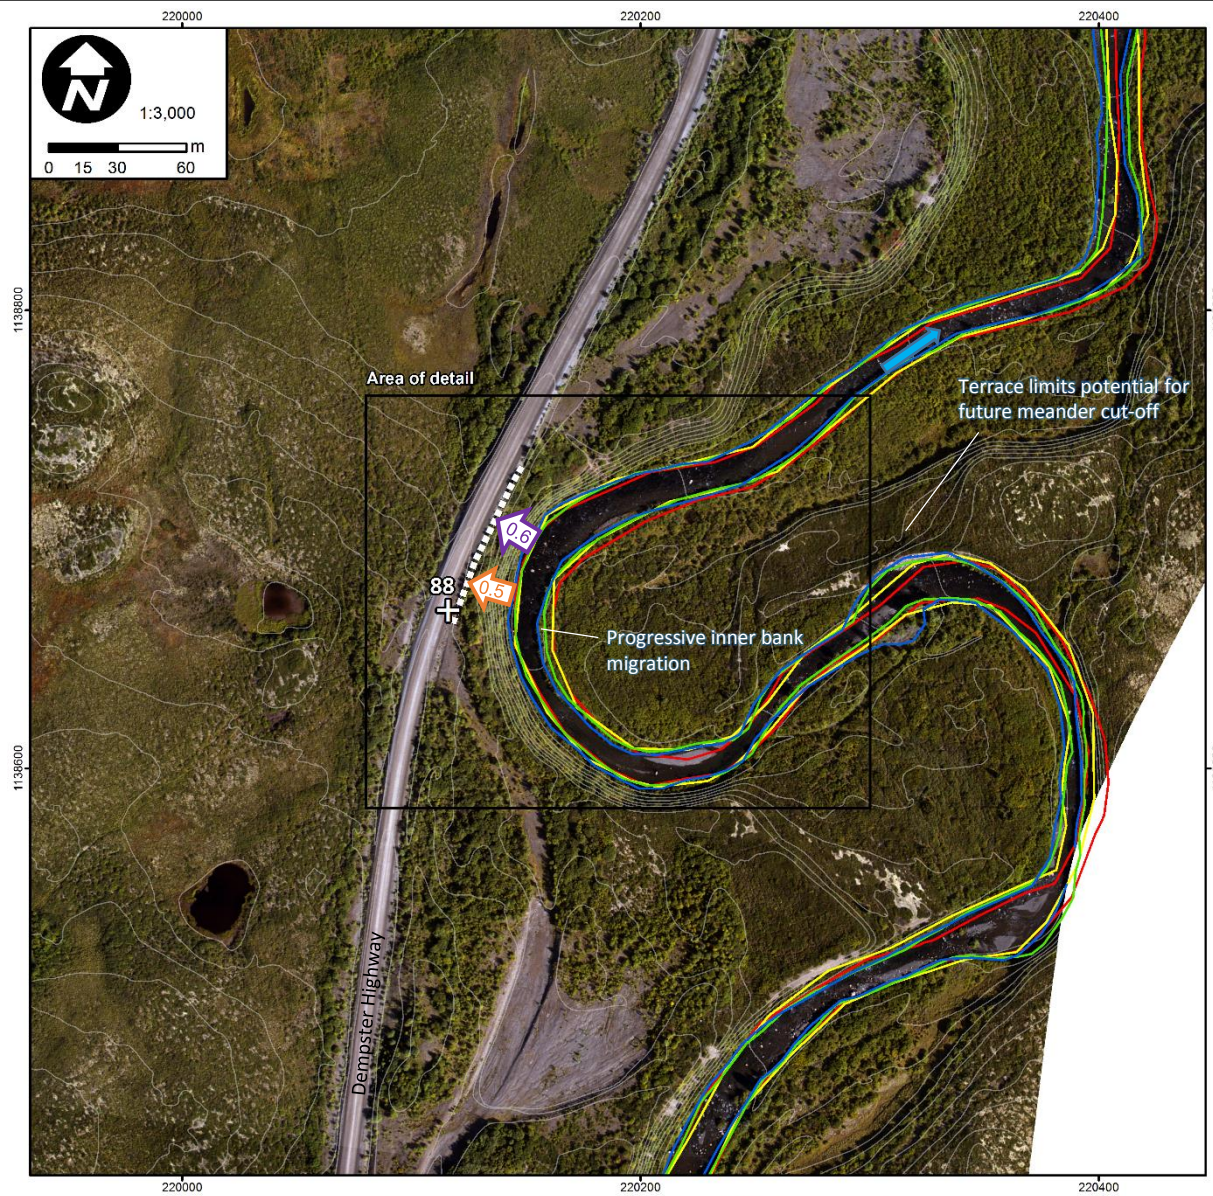
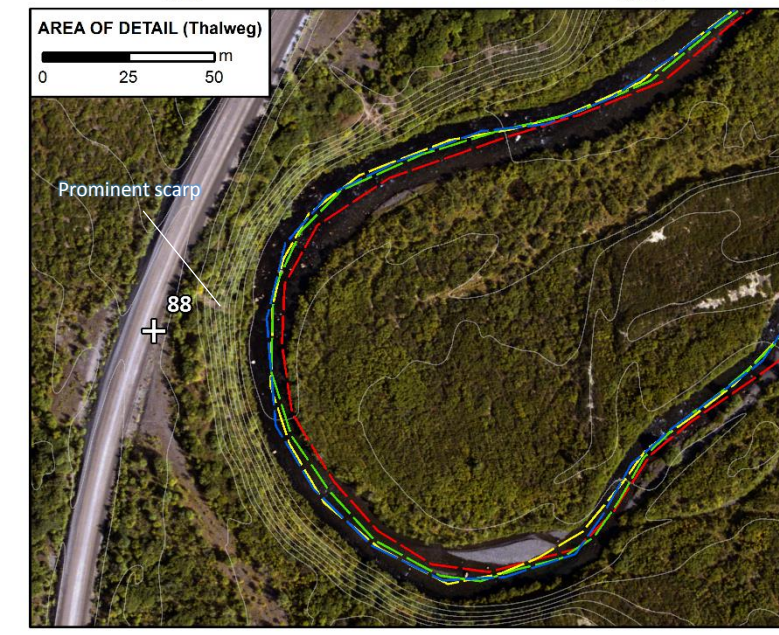
Project: Dempster Meander Migration Hazards Project number: 14132 Client: Yukon Government
		KM 88.0

SITE	CHANNEL	MEANDER	RIPRAP REQUIREMENTS
Section Klondike	Setting Morainal scarp	1st migration rate (m/yr) 0.6	Timeframe until impact (yr) 21-25
Watercourse East Blackstone R.	Permafrost Deep, ice-poor	1st trajectory WNW	Lateral extent (m) 75
Riprap history No riprap	Bank height (m) 7.5	2nd migration rate (m/yr) 0.5	Slope length (m) 22.1
Hwy-watercourse proximity (m) 15	Low-flow width (m) 19	2nd trajectory W	Thickness (m) 1
Position in meander belt Edge	Bankfull width (m) 22	Confinement Naturally confined	Volume (m³) 1,658

This encroachment site is located along a partly confined, irregularly meandering tributary of East Blackstone River. Migration rates throughout the reach, including in the vicinity of the encroachment site, have been low over the period of record. The encroachment site itself is at the edge of the meander belt, which limits lateral migration potential. Furthermore, the highway is perched atop a natural, ~8 m-high scarp, which confines the channel. No intervention is recommended at this encroachment site due to the low lateral migration and planform stability documented over the past several decades.

Estimates of the timeframe of impact are less reliable in confined settings, such as this, due to potential interactions between fluvial and hillslope processes. No significant slope failures were observed during 2016 field reconnaissance.

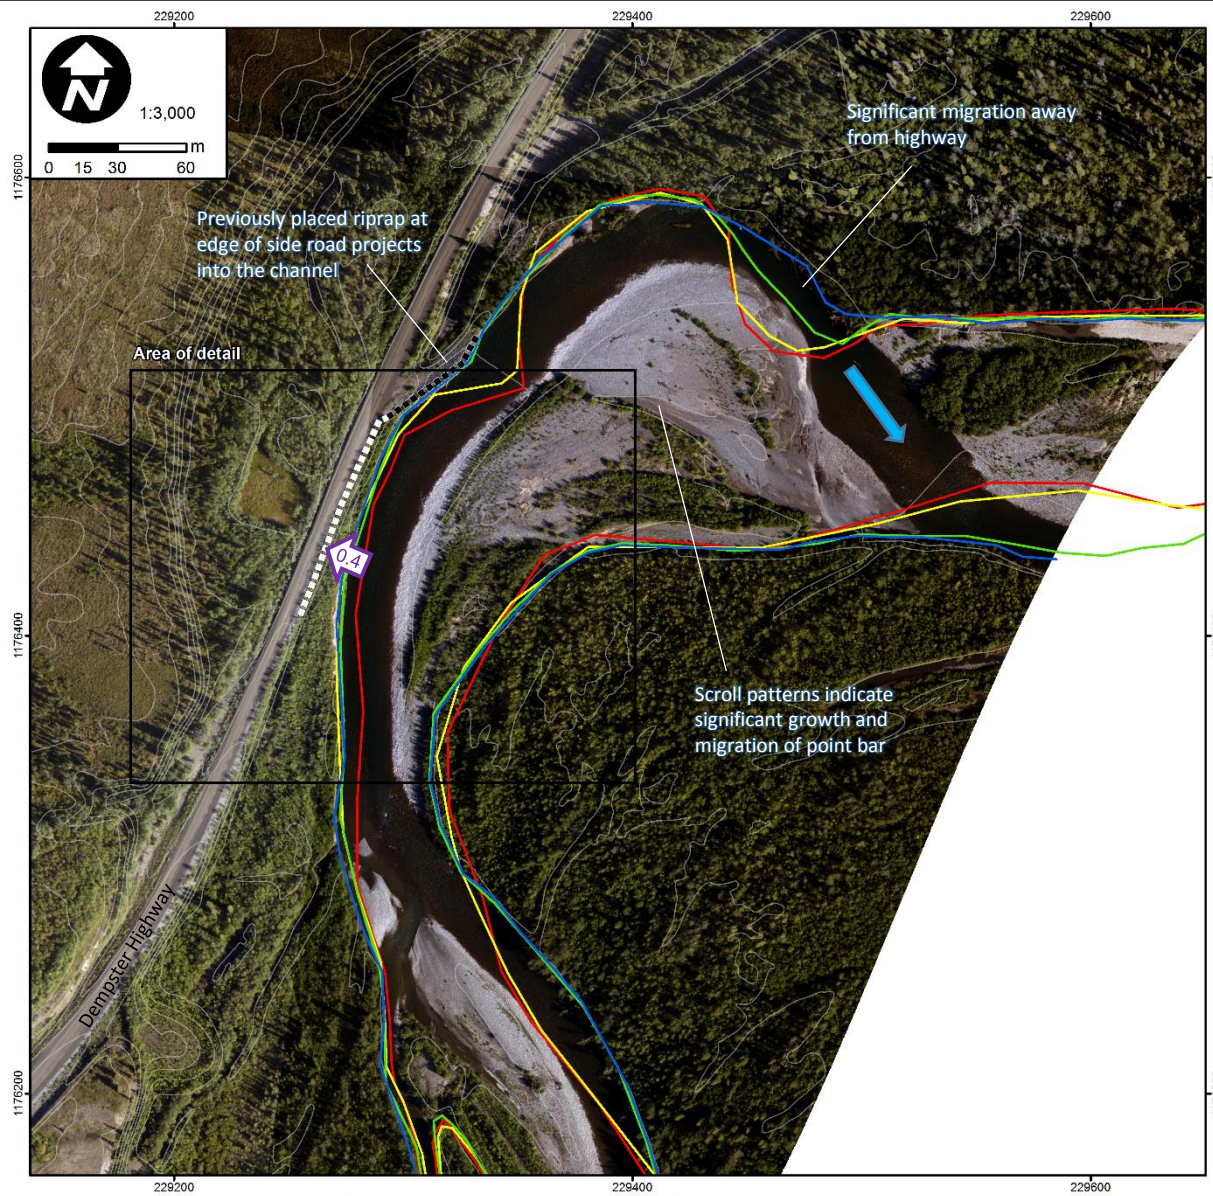
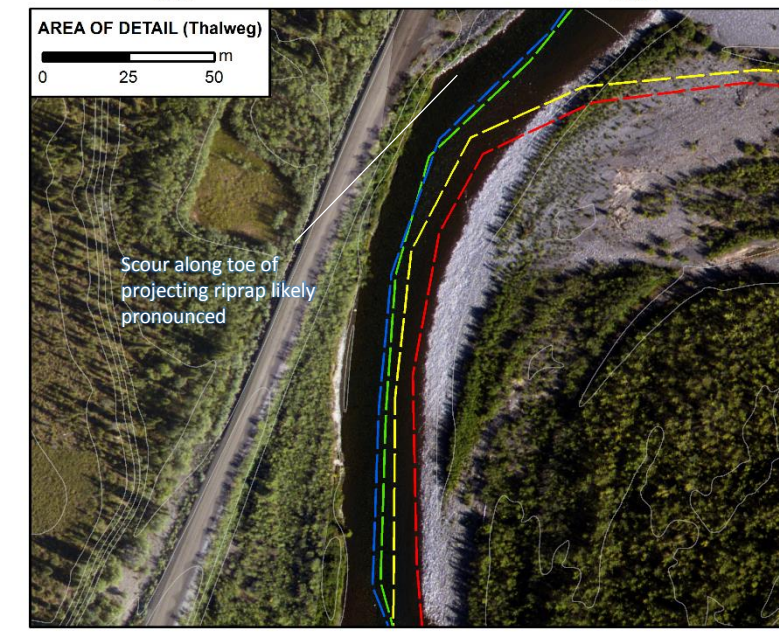
KM 131.4

SITE	CHANNEL	MEANDER	RIPRAP REQUIREMENTS
Section Klondike/Ogilvie	Setting Hwy edge fluvial plain	1 migration rate (m/yr) 0.4	Timeframe until impact (yr) 21-25
Watercourse Blackstone River	Permafrost Deep, ice-moderate	1 trajectory W	Lateral extent (m) 100
Riprap history 2004	Bank height (m) 1.1	2 migration rate (m/yr) -	Slope length (m) 6.5
Hwy-watercourse proximity (m) 6	Low-flow width (m) 24	2 trajectory -	Thickness (m) 1
Position in meander belt Within	Bankfull width (m) 75	Confinement Confined by highway	Volume (m³) 648

Scour may be pronounced along the toe of the isolated projection of riprap. No significant evidence of riprap instability was observed during 2016 field reconnaissance.

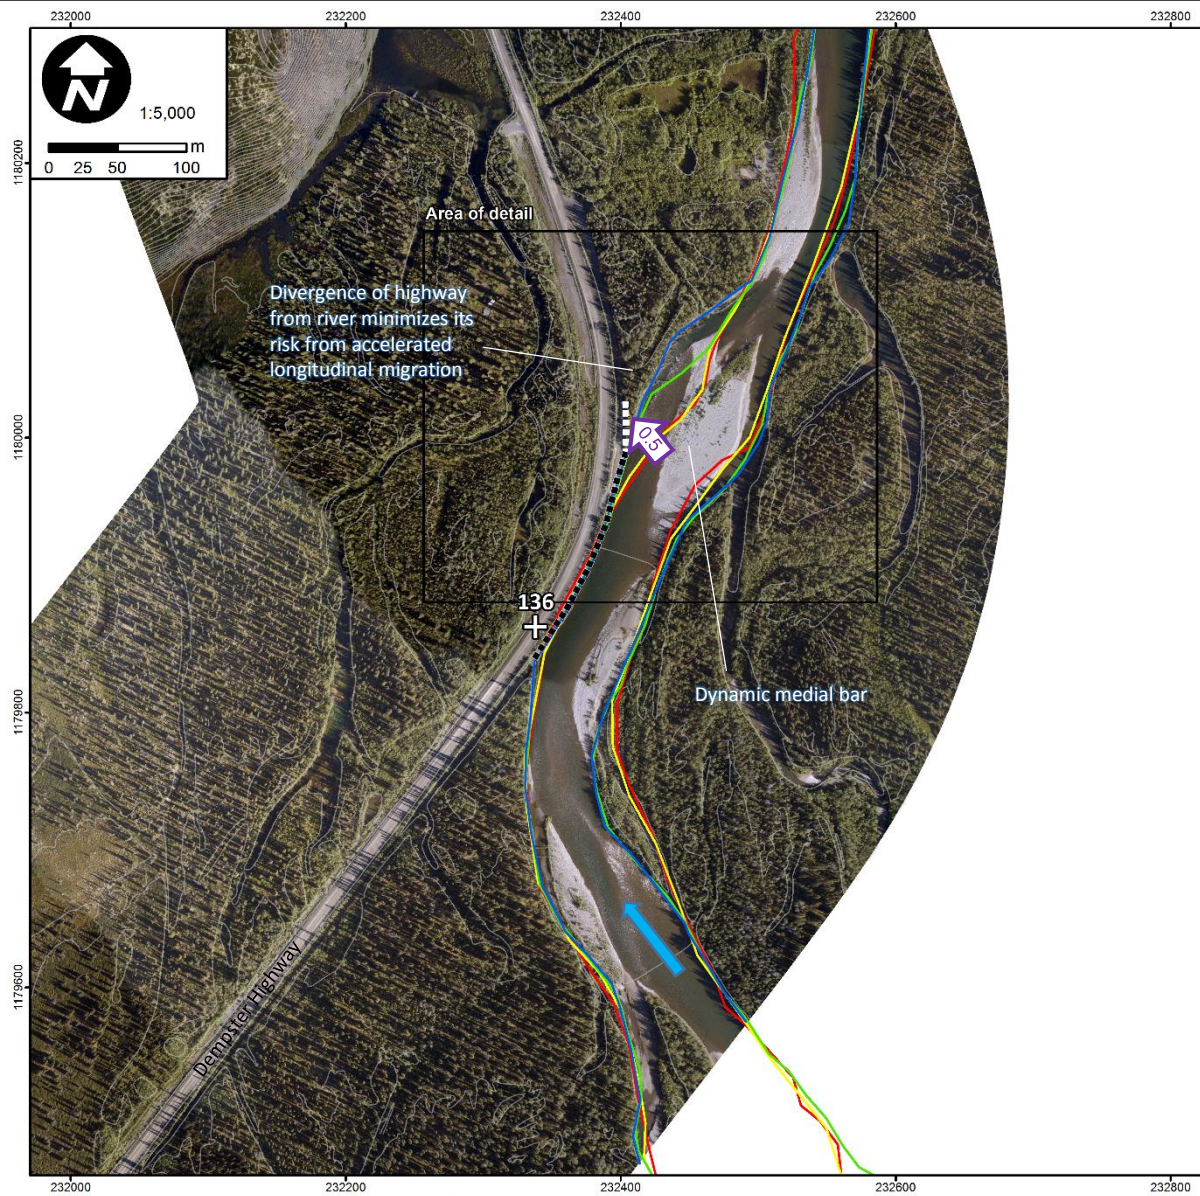
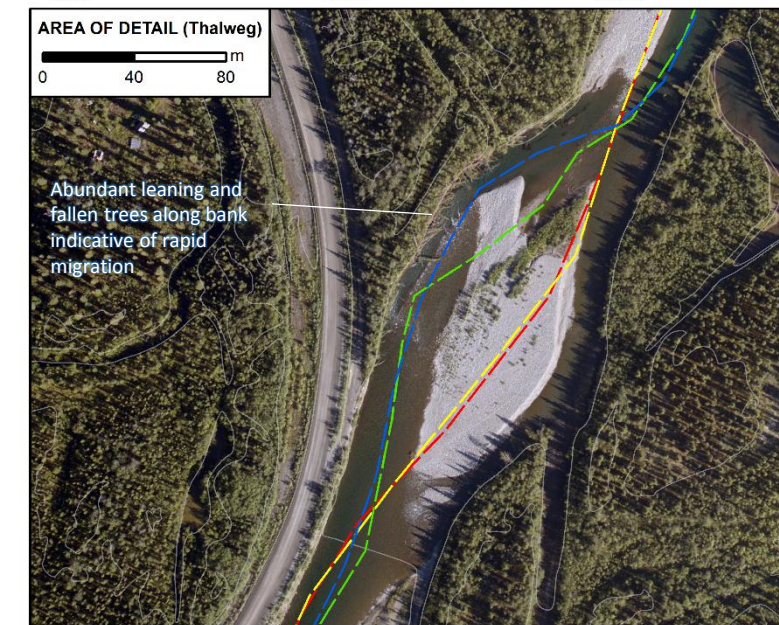
Project: Dempster Meander Migration Hazards Project number: 14132 Client: Yukon Government
		KM 136.1

SITE	CHANNEL	MEANDER	RIPRAP REQUIREMENTS
Section Klondike/Ogilvie	Setting Fluvial plain	1st migration rate (m/yr) 0.5	Timeframe until impact (yr) 11-15
Watercourse Blackstone River	Permafrost Shallow, ice-moderate	1st trajectory NW	Lateral extent (m) 40
Riprap history Unknown	Bank height (m) 0.1	2nd migration rate (m/yr) -	Slope length (m) 2.5
Hwy-watercourse proximity (m) 4	Low-flow width (m) 27	2nd trajectory -	Thickness (m) 1
Position in meander belt Within	Bankfull width (m) 94	Confinement Confined by highway	Volume (m³) 98

This encroachment site is located within a partly confined, wandering gravel-bed reach of Blackstone River. Riprap has been placed alongside the highway embankment, which has limited lateral migration and caused significant longitudinal migration (70 m between 1989 and 2007). The encroachment site is within the meander belt, which suggests the channel would migrate farther west if not confined by the riprapped embankment. A large, unvegetated medial bar bifurcates flow at the downstream end of the encroachment site. The bar is a transient feature and could influence the future position of the thalweg. Without intervention, longitudinal channel migration immediately downstream of the existing riprap will likely impact the highway in 11 to 15 years.

Due to the longitudinal nature of the observed bank migration, it is possible that the embankment immediately downstream of the previously placed riprapped could be impacted prior to the timeframe estimated along the main trajectory of erosion. The low bank height and anecdotal evidence of previous highway overtopping during a flood indicate future potential for a breach in the highway.
