Yukon Geological Survey Miscellaneous Report 17

Inventory of mass movement geohazards along the Dempster Highway, Yukon

Robin J. McKillop, Courtenay E. Brown, Daniel J. McParland and David A. Sacco
Palmer Environmental Consulting Group Inc.
and Jim Coates
Kryotek Arctic Innovation Inc.

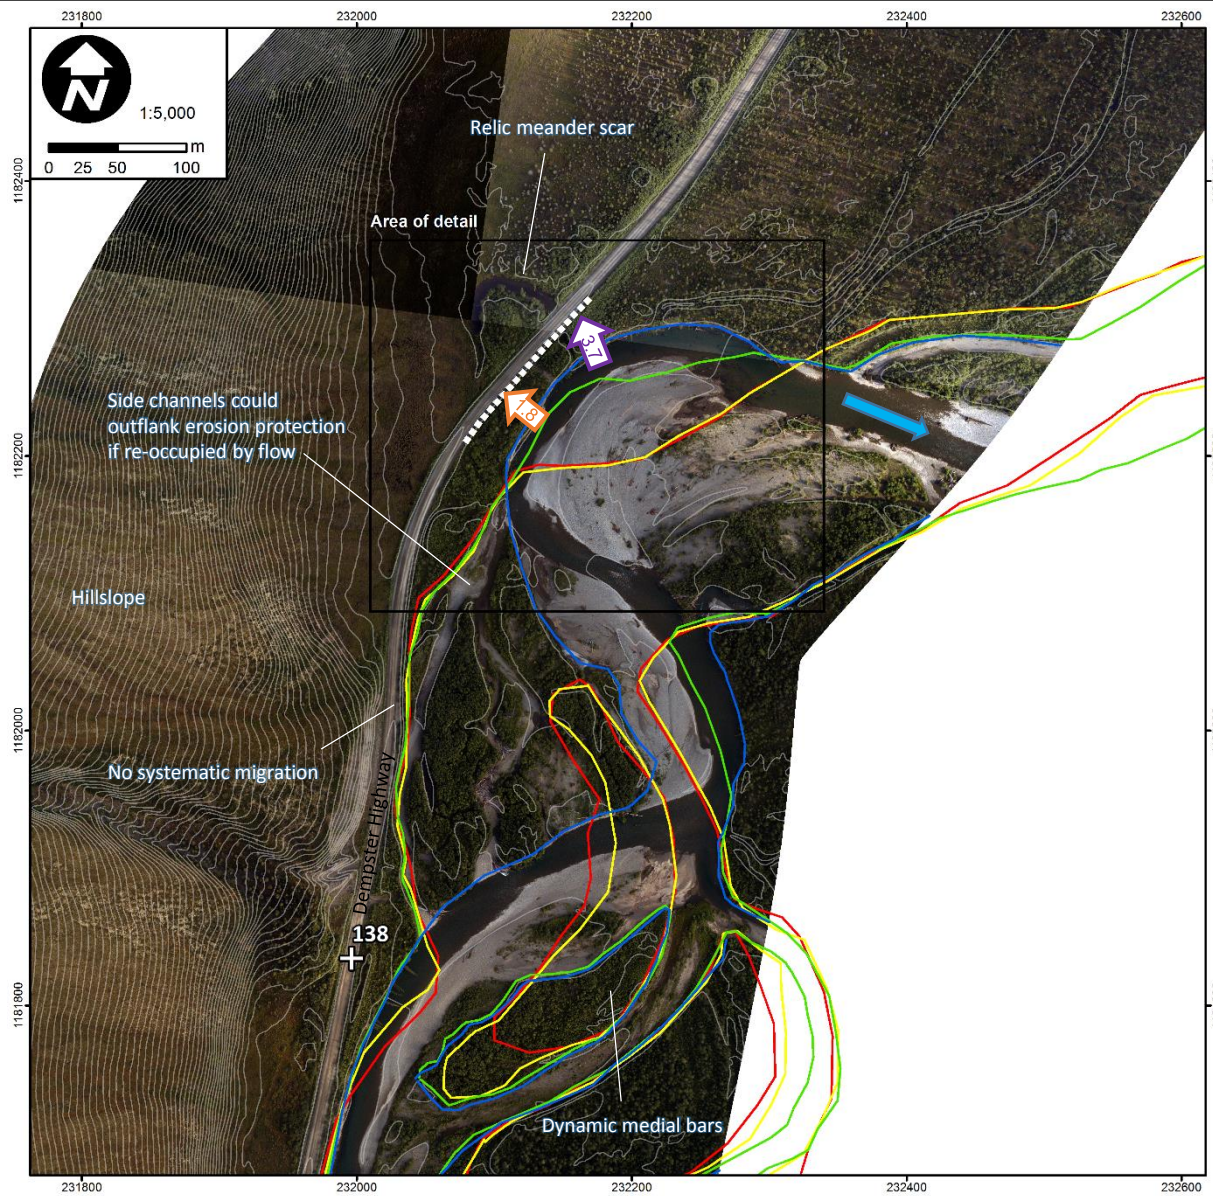
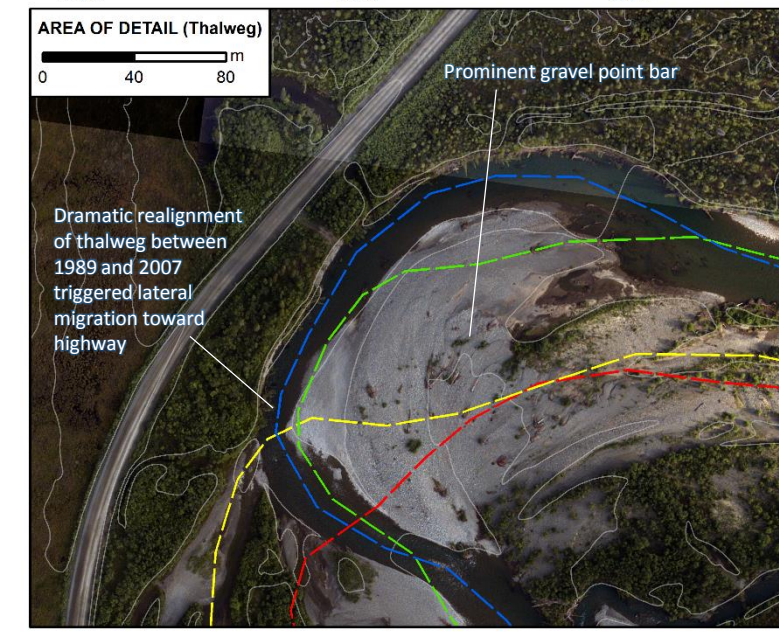
Project: Dempster Meander Migration Hazards Project number: 14132 Client: Yukon Government
		KM 138.5

SITE	CHANNEL	MEANDER	RIPRAP REQUIREMENTS
Section Klondike/Ogilvie	Setting Fluvial plain	1^o migration rate (m/yr) 3.7	Timeframe until impact (yr) 6-10
Watercourse Blackstone River	Permafrost Deep, ice-moderate	1^o trajectory NNW	Lateral extent (m) 140
Riprap history No riprap	Bank height (m) 2.1	2^o migration rate (m/yr) 1.8	Slope length (m) 7.6
Hwy-watercourse proximity (m) 21	Low-flow width (m) 20	2^o trajectory WNW	Thickness (m) 1
Position in meander belt Within	Bankfull width (m) 140	Confinement Unconfined	Volume (m³) 1,063

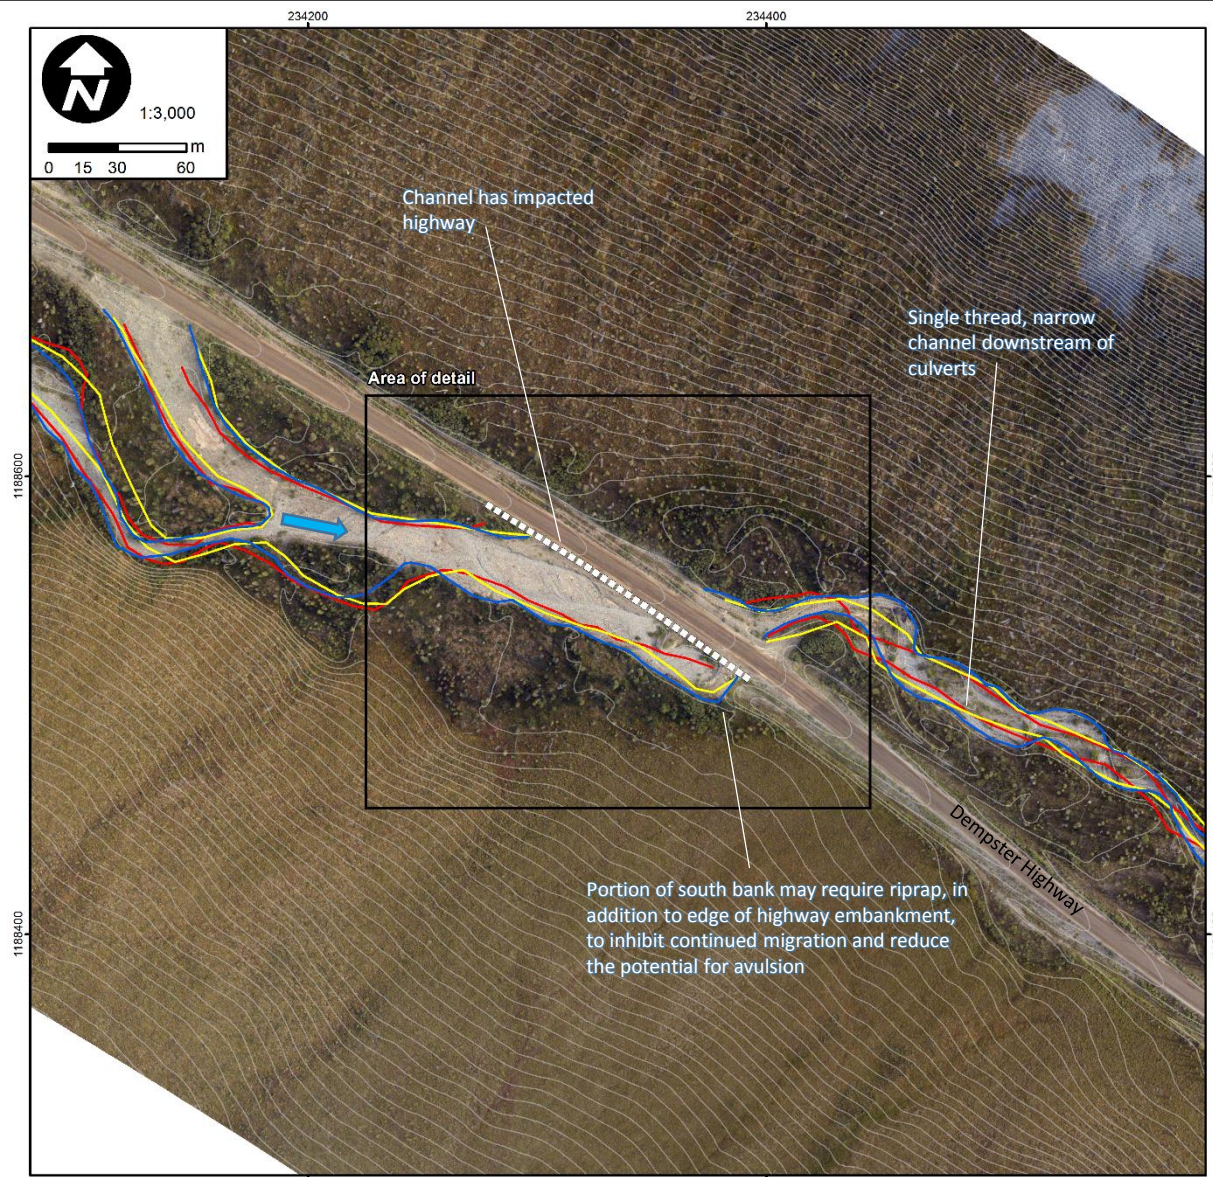
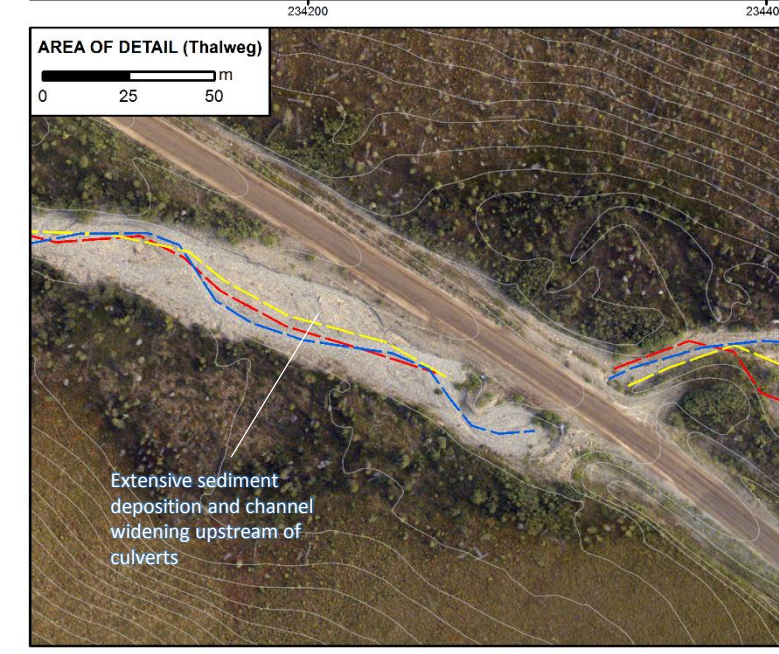
This encroachment site is located within a relatively steep, confined, ephemeral tributary of Blackstone River. The channel likely flows during the spring freshet and significant summer and fall rain events. Large accumulations of coarse gravel throughout the reach suggest bedload transport is high during flow events, potentially briefly occurring as a debris flood. There is an anomalously wide deposit of sediment immediately upstream of the Dempster Highway crossing/encroachment site, likely caused by the upstream convergence of two branches of the creek and by undersized or temporarily obstructed culverts beneath the highway. The active channel appears to be in contact with the highway over the period of record, although recent anthropogenic alteration of this encroachment observed during 2016 field reconnaissance has erased most field evidence of local channel morphology and behaviour. A large flow event could cause significant damage to the highway or lead to a channel avulsion.

The twin culverts beneath the highway appear to be impounding high flows and potentially becoming at least partly obstructed by sediment, which has resulted in deposition and channel widening upstream. Annual dredging of sediment at culvert inlets may be required. If highway impacts or maintenance are recurrent and significant, consideration should be given to replacing the culverts with a larger structure (e.g. box culvert or bridge) with improved capacity to convey storm flows and bedload.

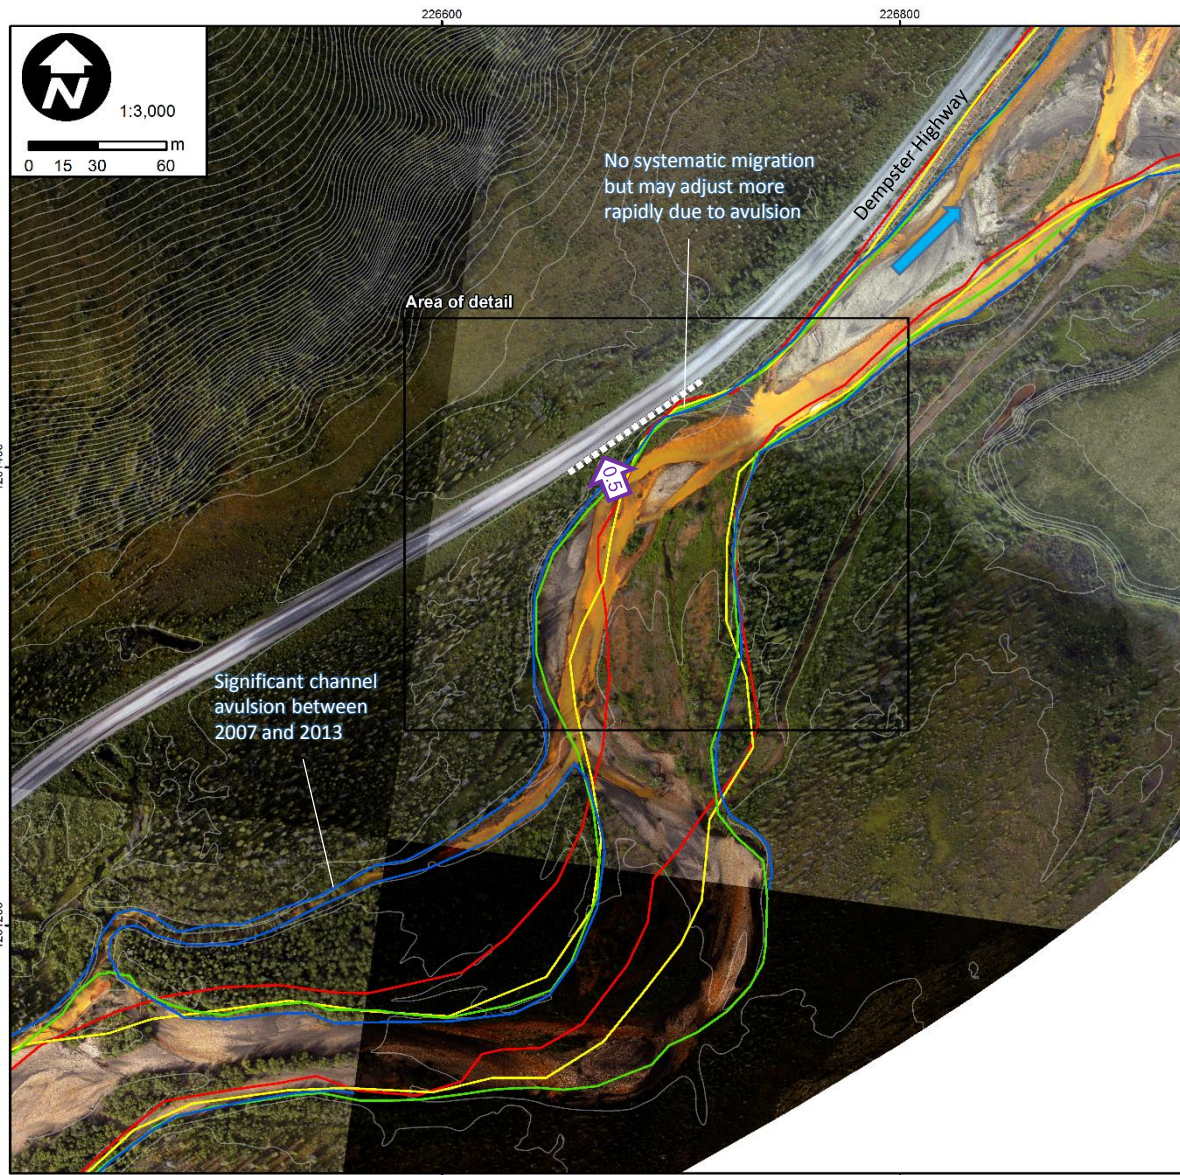
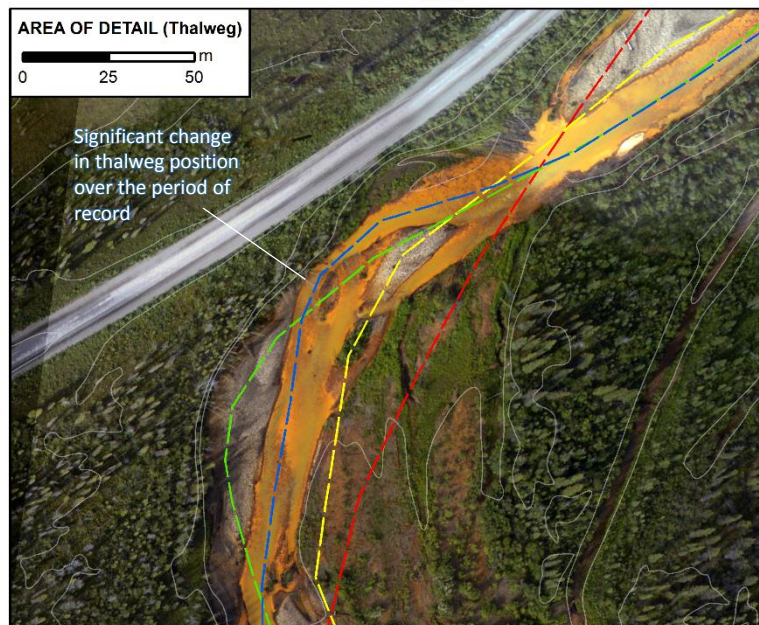
Project: Dempster Meander Migration Hazards Project number: 14132 Client: Yukon Government
		KM 147.6

SPECIAL CONSIDERATIONS
 It is not clear how channel morphology and dynamics in the vicinity of the encroachment site are going to respond to the channel avulsion that occurred upstream of the encroachment site between 2007 and 2013. Monitoring is recommended at this site, in particular, given the potential for the recent avulsion to affect local channel stability and bank erosion patterns.

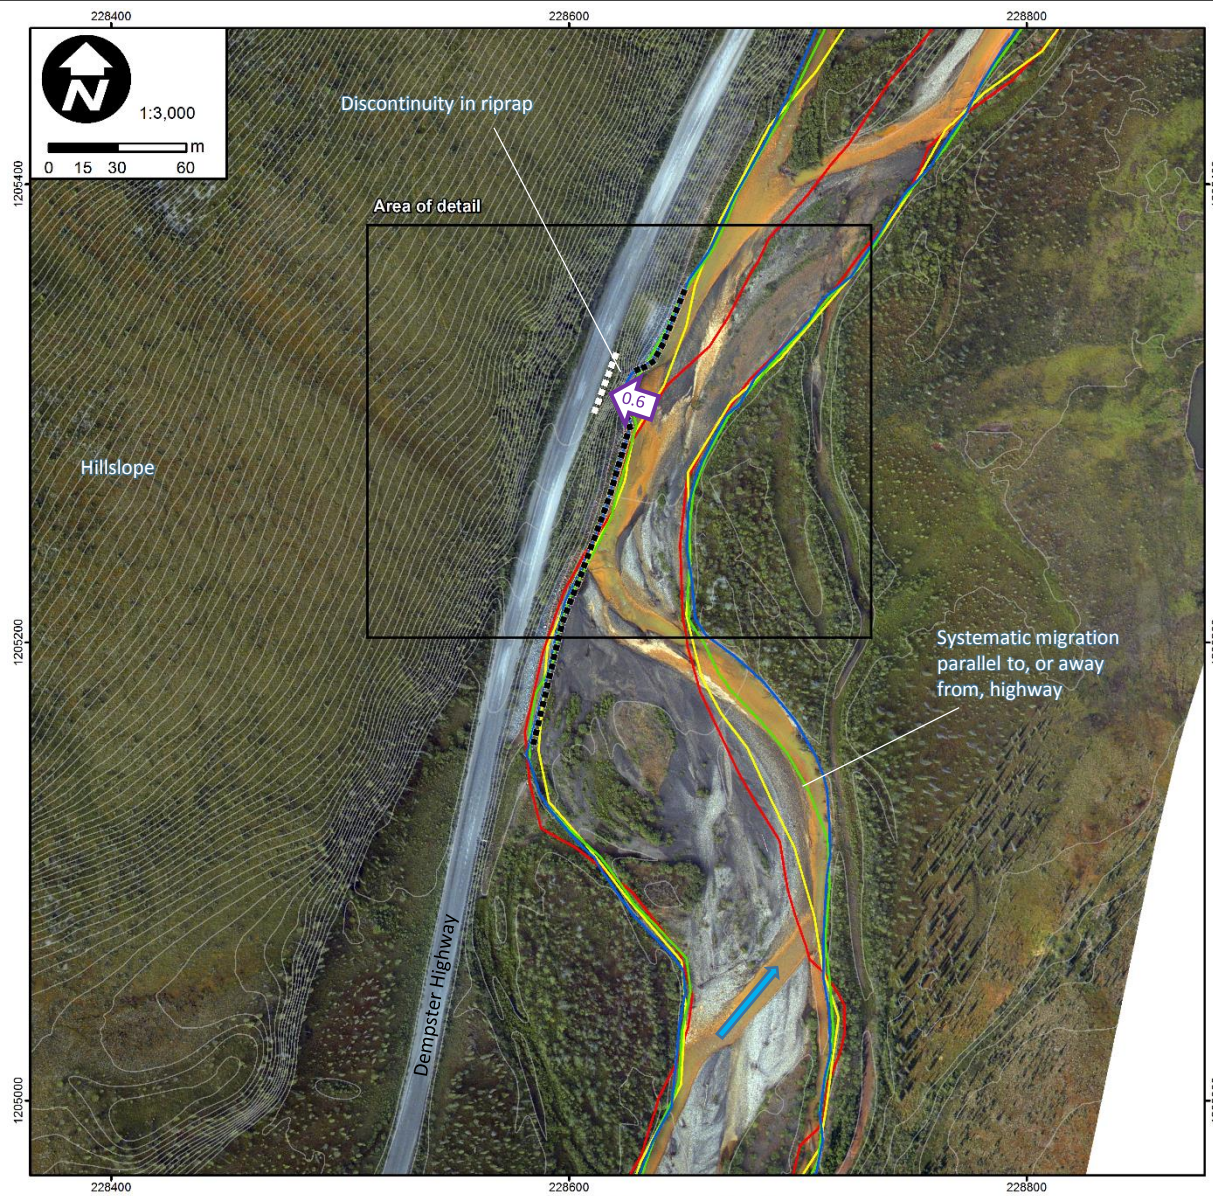
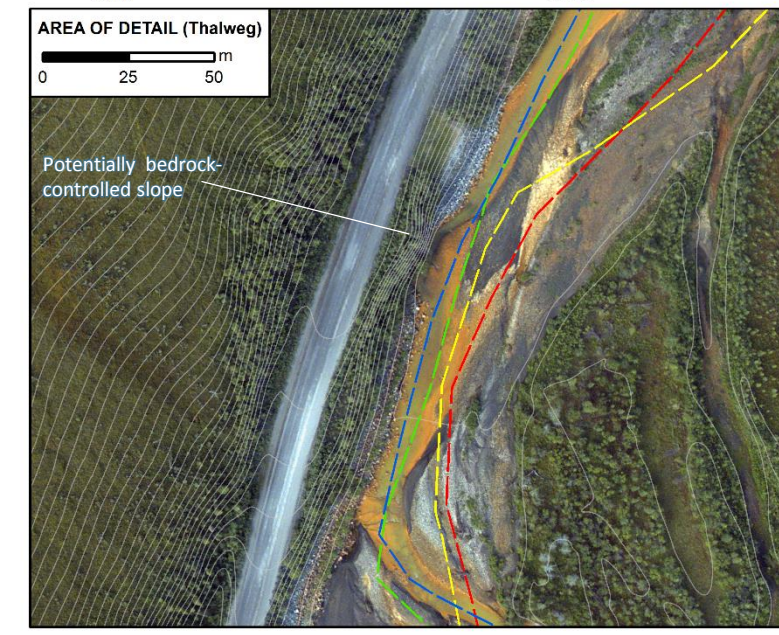
Project: Dempster Meander Migration Hazards Project number: 14132 Client: Yukon Government
		KM 172.9

SPECIAL CONSIDERATIONS
 Estimates of the timeframe of impact are less reliable in confined settings, such as this, due to potential interactions between fluvial and hillslope processes. No significant slope failures were observed during 2016 field reconnaissance.

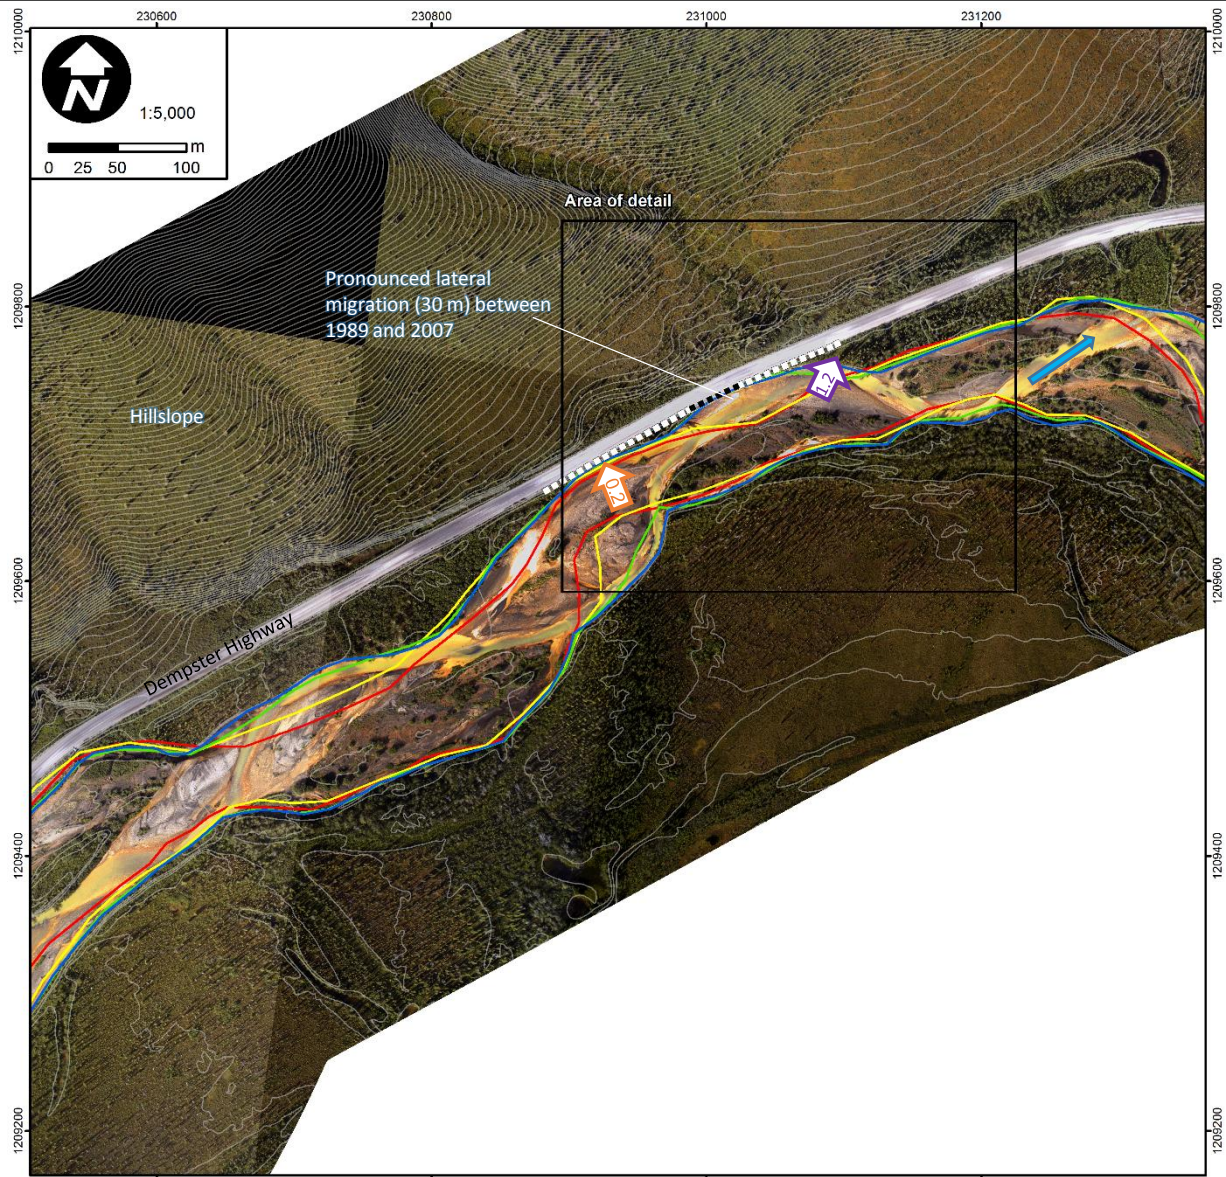
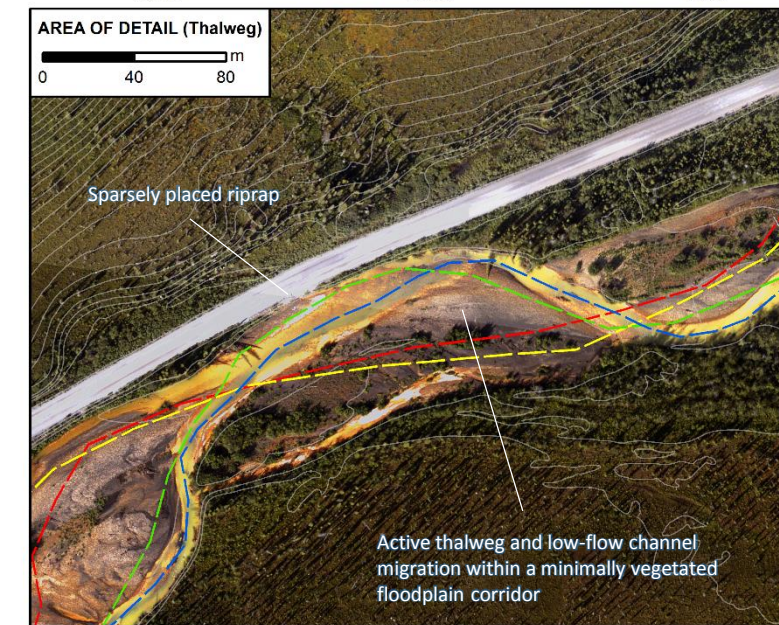
Project: Dempster Meander Migration Hazards Project number: 14132 Client: Yukon Government
		KM 175.2

Due to the longitudinal nature of the observed bank migration, it is possible that the embankment immediately downstream of the previously placed riprapped could be impacted prior to the estimated timeframe.

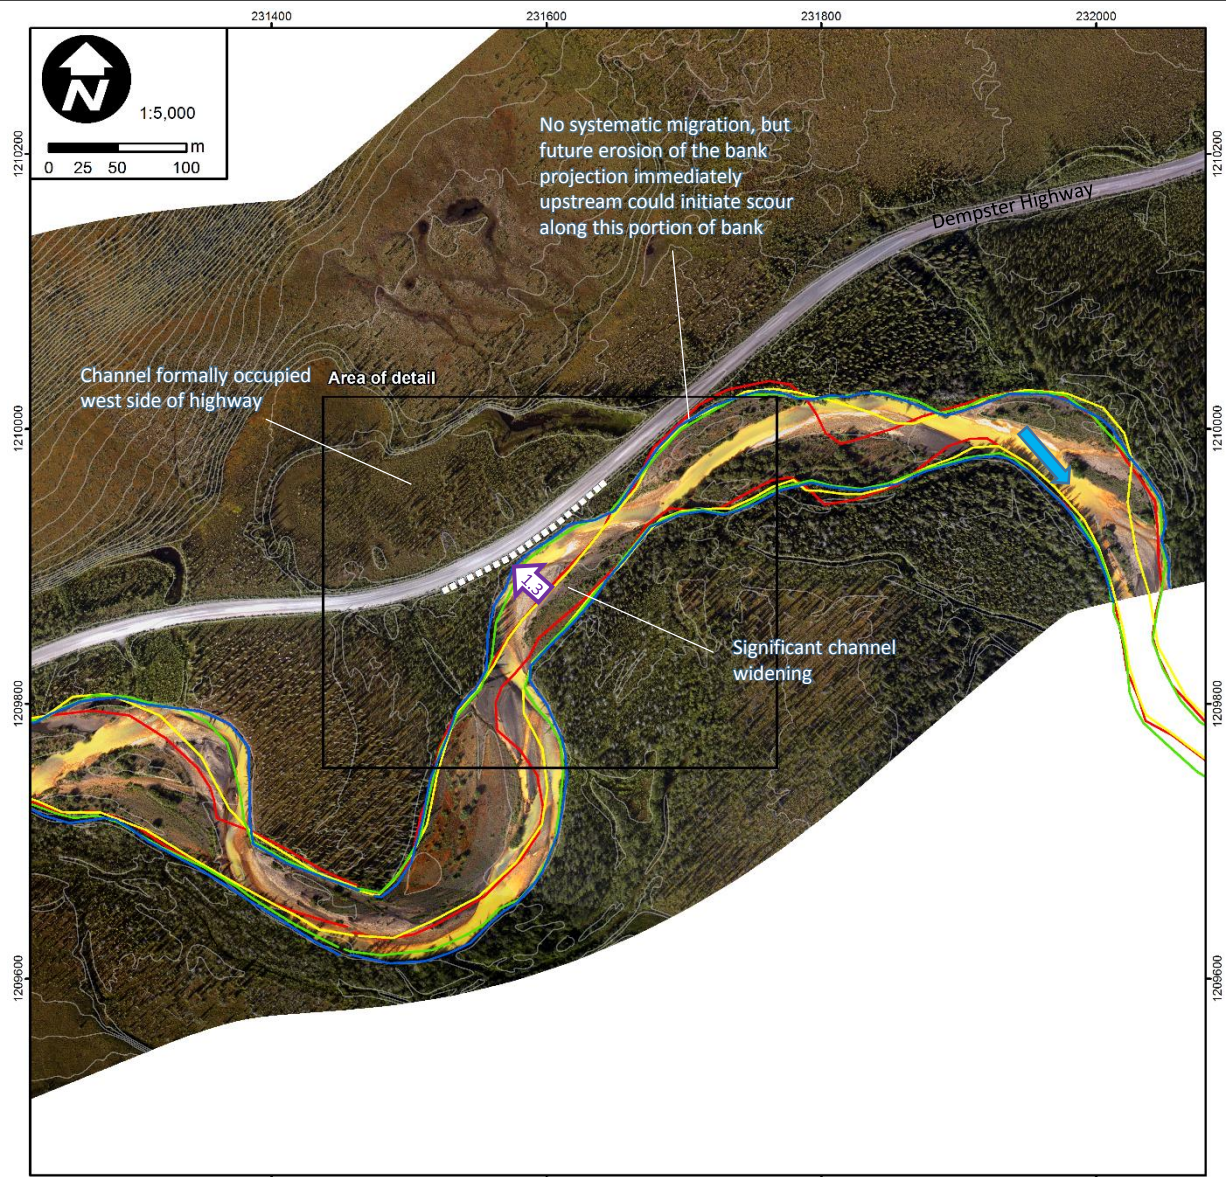
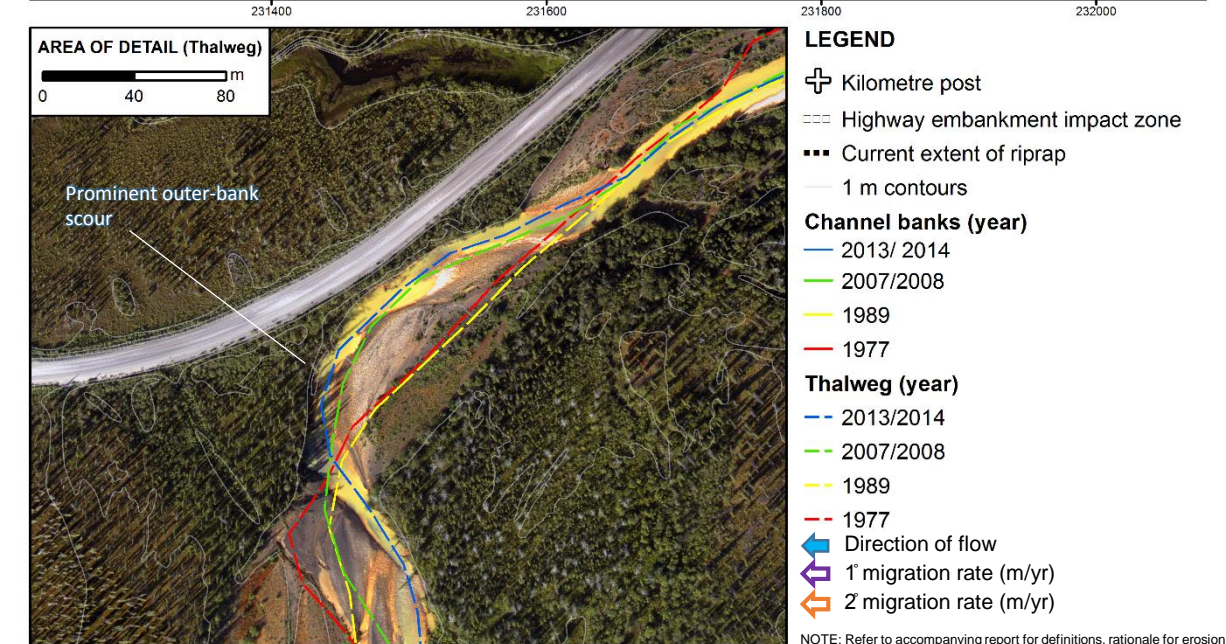
Project: Dempster Meander Migration Hazards Project number: 14132 Client: Yukon Government
		KM 180.7

IMPLICATIONS OF RIPRAP APPLICATION
 Riprap application could cause longitudinal channel migration, potentially exposing the highway embankment immediately downstream to erosion if not extended far enough downstream.

SPECIAL CONSIDERATIONS
 Riprap placement is required to protect the existing highway embankment toe. Future erosion of the projection of bank near the downstream end of the encroachment site may increase the exposure of highway embankment to erosion along the downstream bend of the compound meander, which currently only conveys flows during flood conditions.

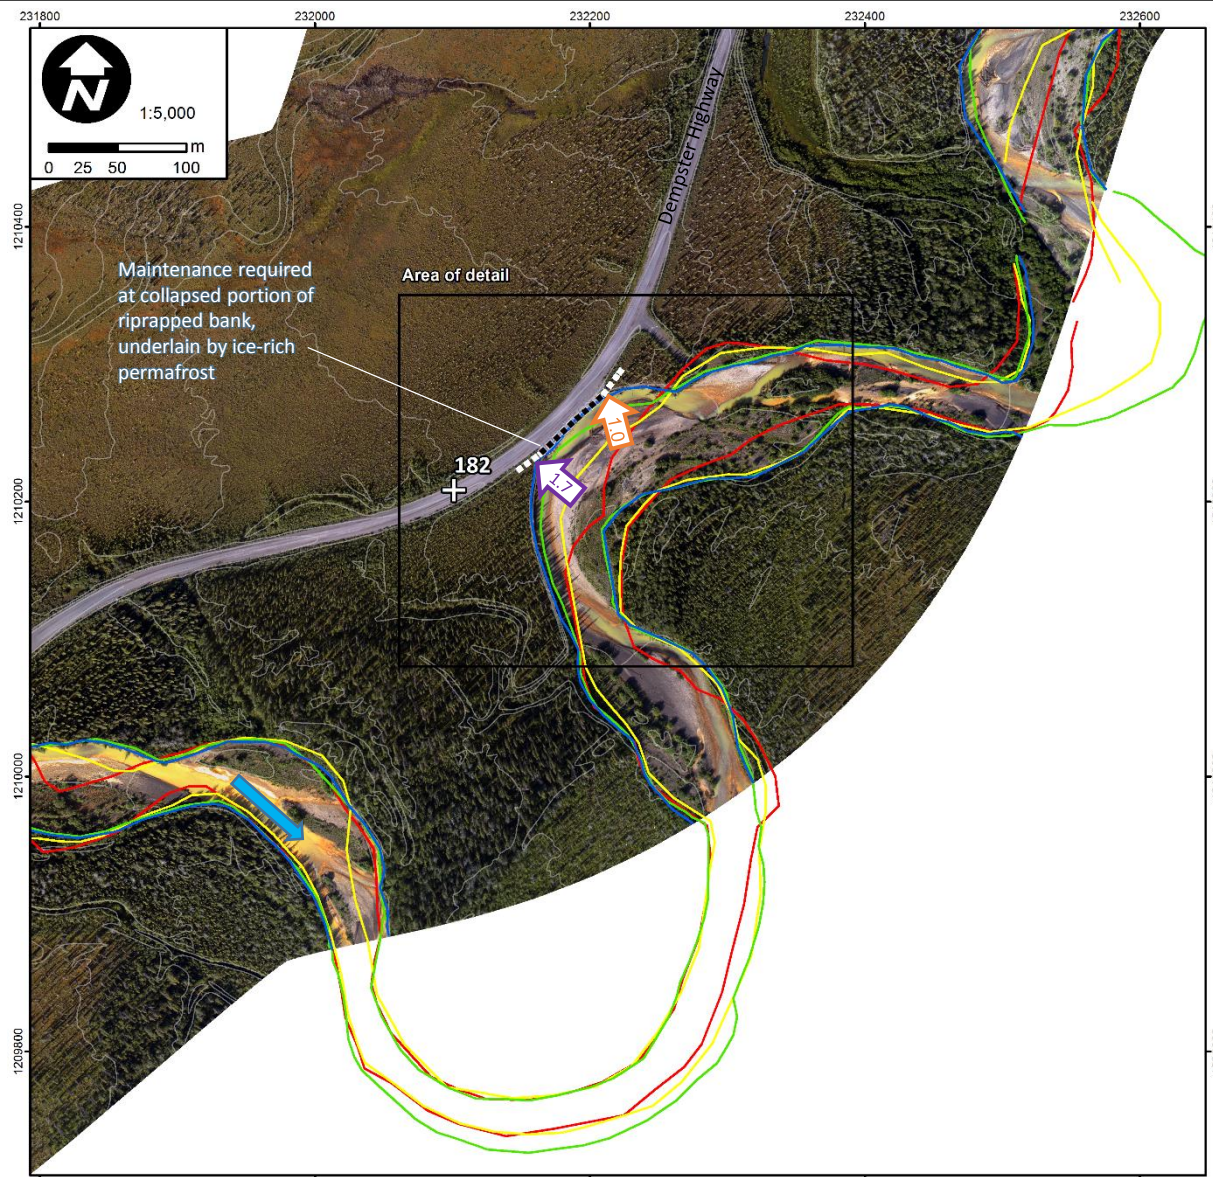
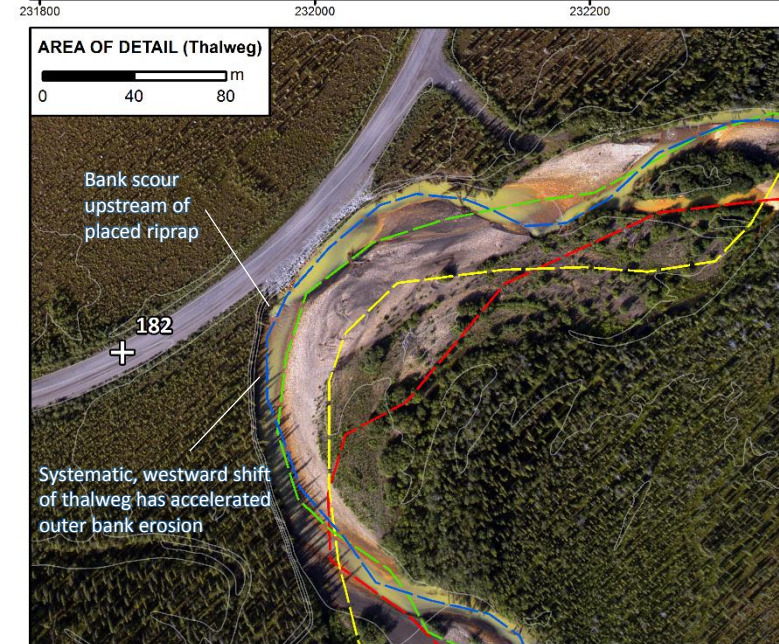
Project: Dempster Meander Migration Hazards Project number: 14132 Client: Yukon Government
		KM 181.5

This encroachment site is located within a partly confined, wandering gravel-bed reach of Engineer Creek. Lateral migration rates throughout the reach are relatively high, gravel bars are extensive and dynamic, and channel avulsions are frequent. Locally, there has been significant lateral migration (60 m) towards the highway over the period of record. Near-surface, ice-rich permafrost is present at this site and can lead to irregular and episodic bank erosion and collapse. Riprap has been placed along the highway embankment, which has slowed lateral migration and accelerated longitudinal migration. A conspicuous, scallop-shaped form visible in the most recent imagery (2013) at the upstream end of riprap is the headscarp of a bank slump, likely triggered by undercutting and thawing of ice-rich permafrost beneath the riprap. This upstream riprap limit is also at risk of being outflanked by continued migration. There is notable bank failure at the downstream limit of riprap; a 5 m-wide block has collapsed into the channel following fluvio-thermal erosion of permafrost in the lower bank. Without intervention, continued bank scour and slumping, as well as longitudinal migration, will likely impact the highway embankment within 2 years.

Based on the 2013 aerial imagery and 2016 field reconnaissance, the previously placed riprap is failing and likely requires maintenance. Over-excavation and placement of thick filter material may be required in advance of riprap placement in an effort to reduce embankment failure due to thawing permafrost.

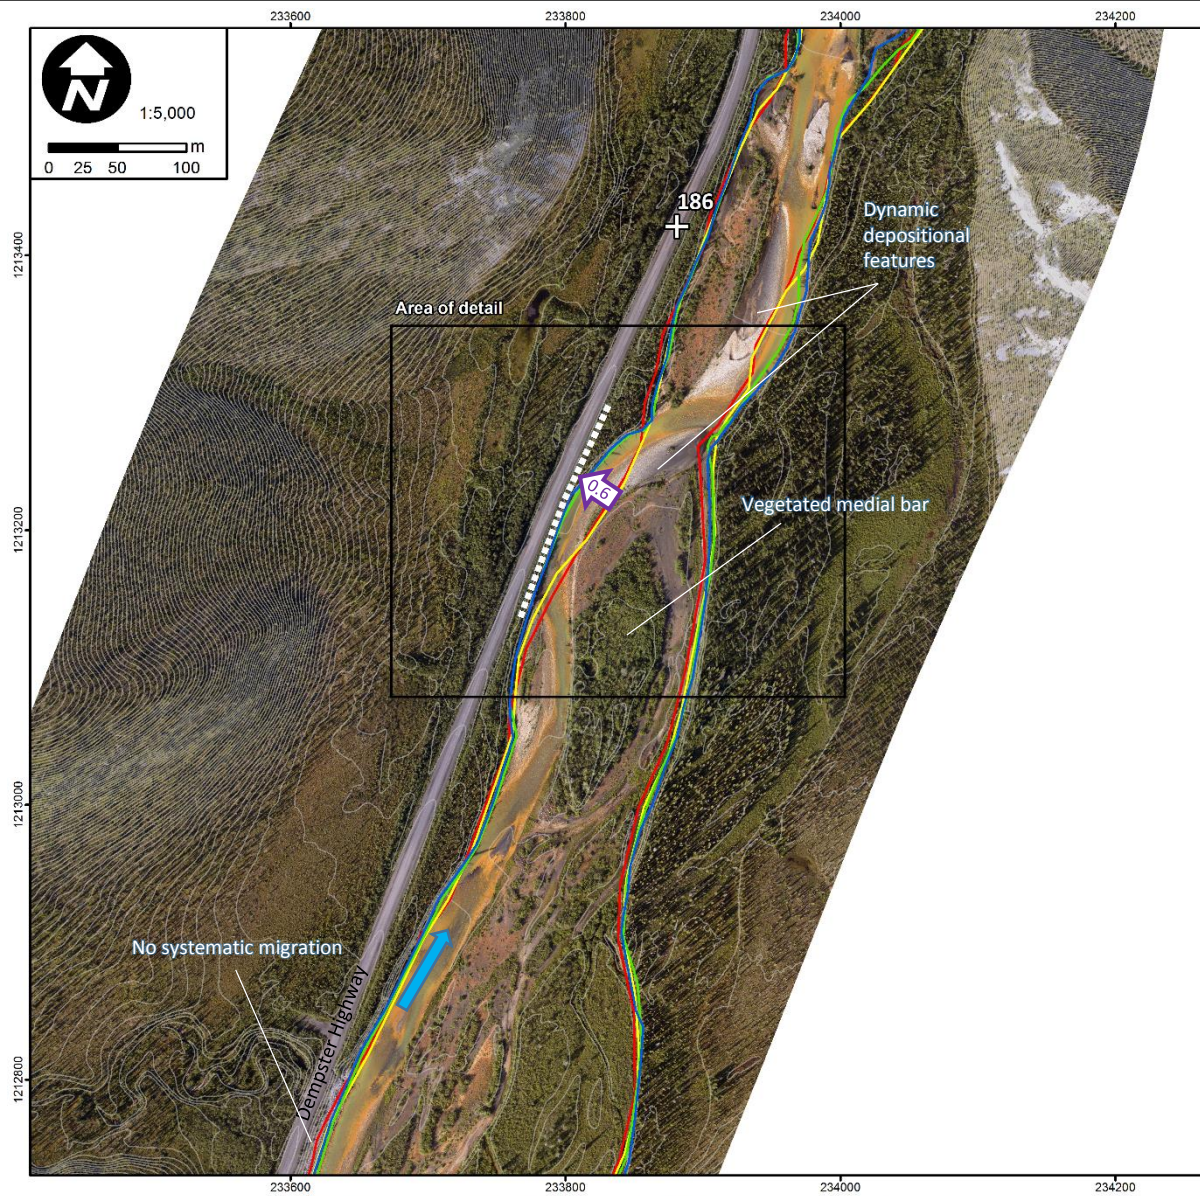
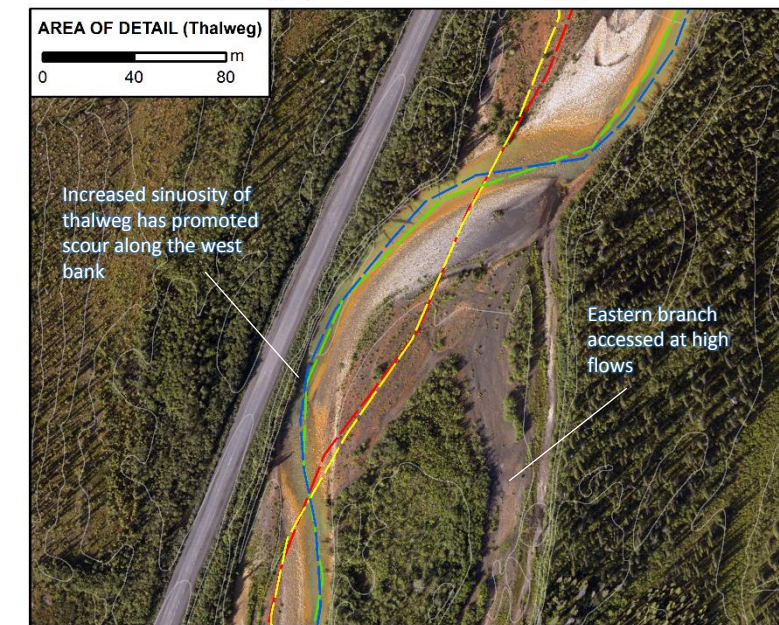
Project: Dempster Meander Migration Hazards Project number: 14132 Client: Yukon Government
		KM 183.3

Riprap application could cause longitudinal channel migration, potentially exposing the highway embankment immediately downstream to erosion if not extended far enough.

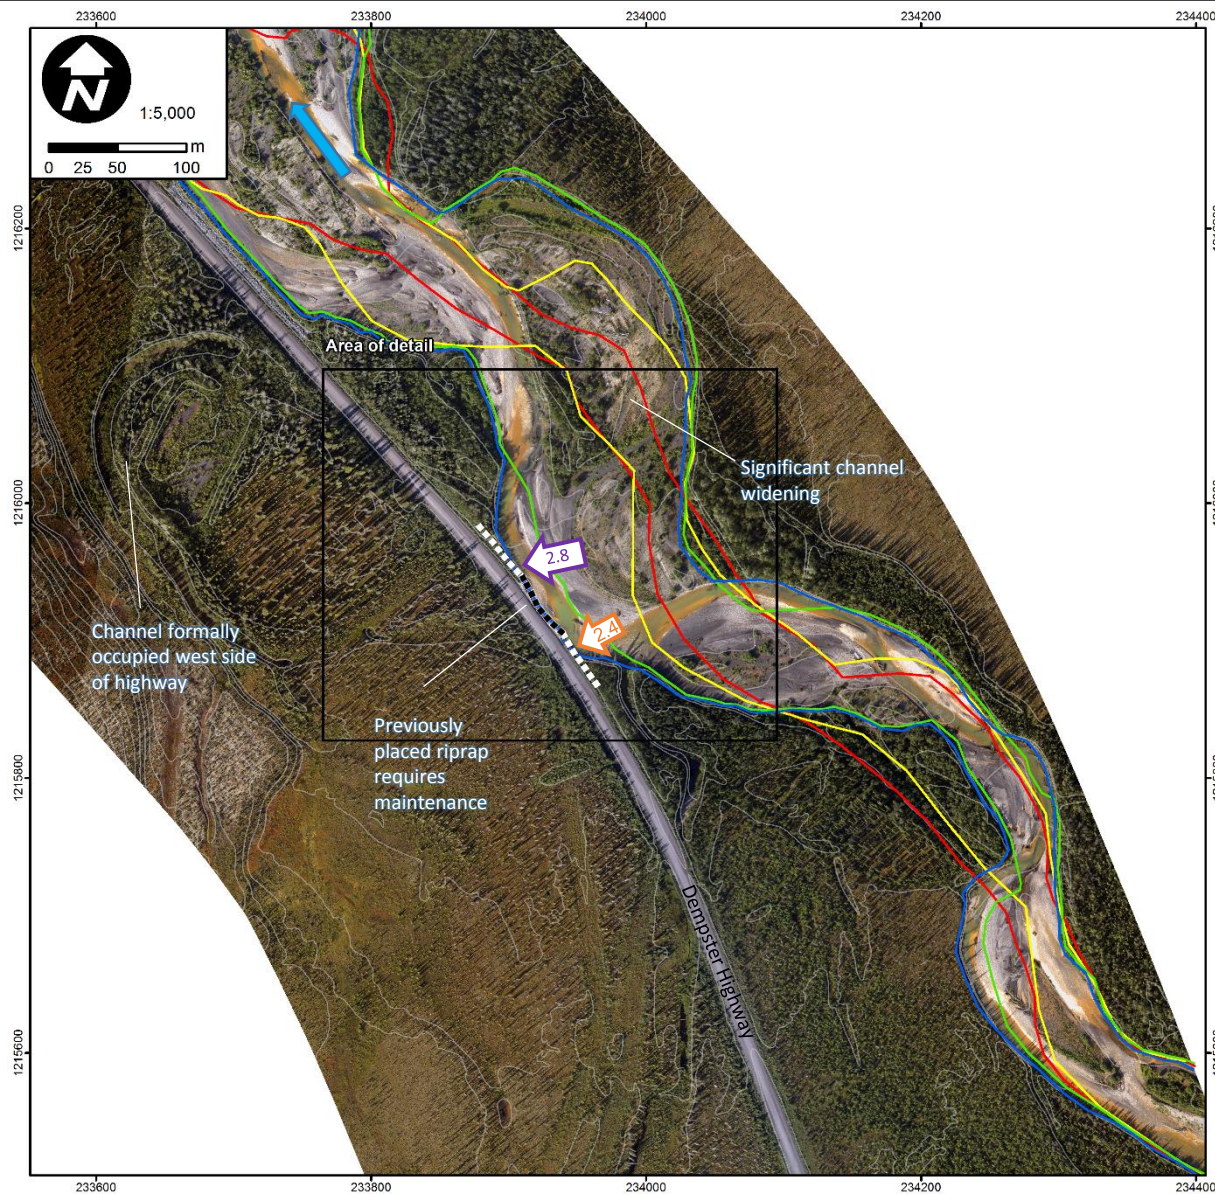
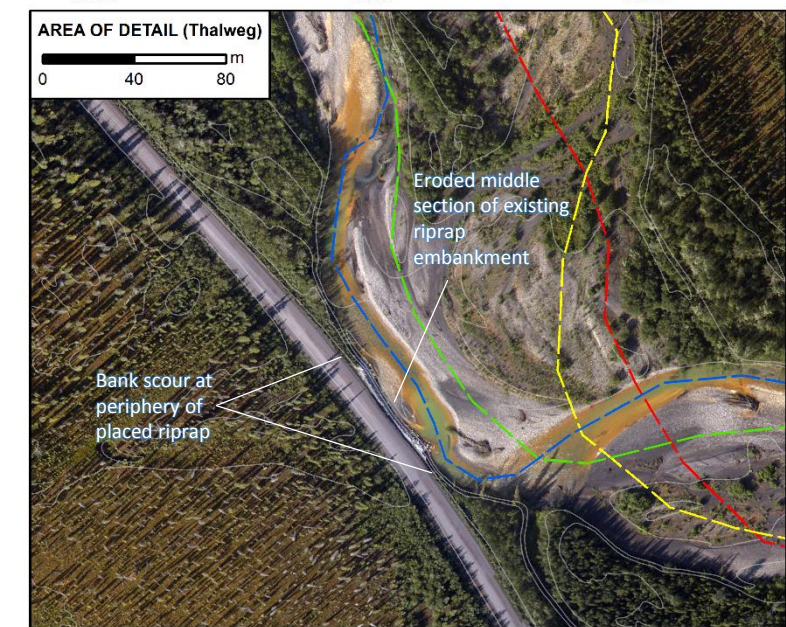
Project: Dempster Meander Migration Hazards Project number: 14132 Client: Yukon Government
		KM 185.8

This encroachment site is located within a partly confined, wandering gravel-bed reach of Engineer Creek. Lateral migration rates throughout the reach are relatively high, gravel bars are extensive and dynamic, and channel avulsions are frequent. Locally, there has been significant lateral migration (up to 105 m) toward the highway over the period of record. Furthermore, the encroachment site is within the meander belt and the channel formally occupied the west (i.e. opposite) side of the Dempster Highway prior to the earliest aerial photography (1977). Shallow, ice-rich permafrost may persist in portions of this disturbed site, which can lead to irregular and episodic bank erosion and collapse. Riprap has been previously placed along the highway embankment in an effort to slow lateral migration. Scour of the embankment is visible upstream and downstream of previously placed riprap in the most recent imagery (2013). Without intervention, continued lateral migration upstream and downstream of the existing riprap will likely impact the highway embankment within 2 years.

The central portion of the existing riprap embankment appears thinner than adjacent areas, suggesting possible scour and entrainment of rocks by high flows and/or rafted ice. Maintenance may be required to reconstruct the failed portion of embankment, ideally with larger-diameter riprap and deeper embedment to inhibit undermining. There is noticeable scour immediately upstream and downstream of the current limits of riprap, which can accelerate failure by exposing underlying ice-rich permafrost. More riprap is likely required to protect the highway embankment, and careful site preparation may be required if ice-rich permafrost is indeed contributing to failure.

Based on the 2013 aerial imagery and 2016 field reconnaissance, the previously placed riprap is locally failing due to pronounced toe scour and episodic thalweg adjustments and likely requires maintenance.

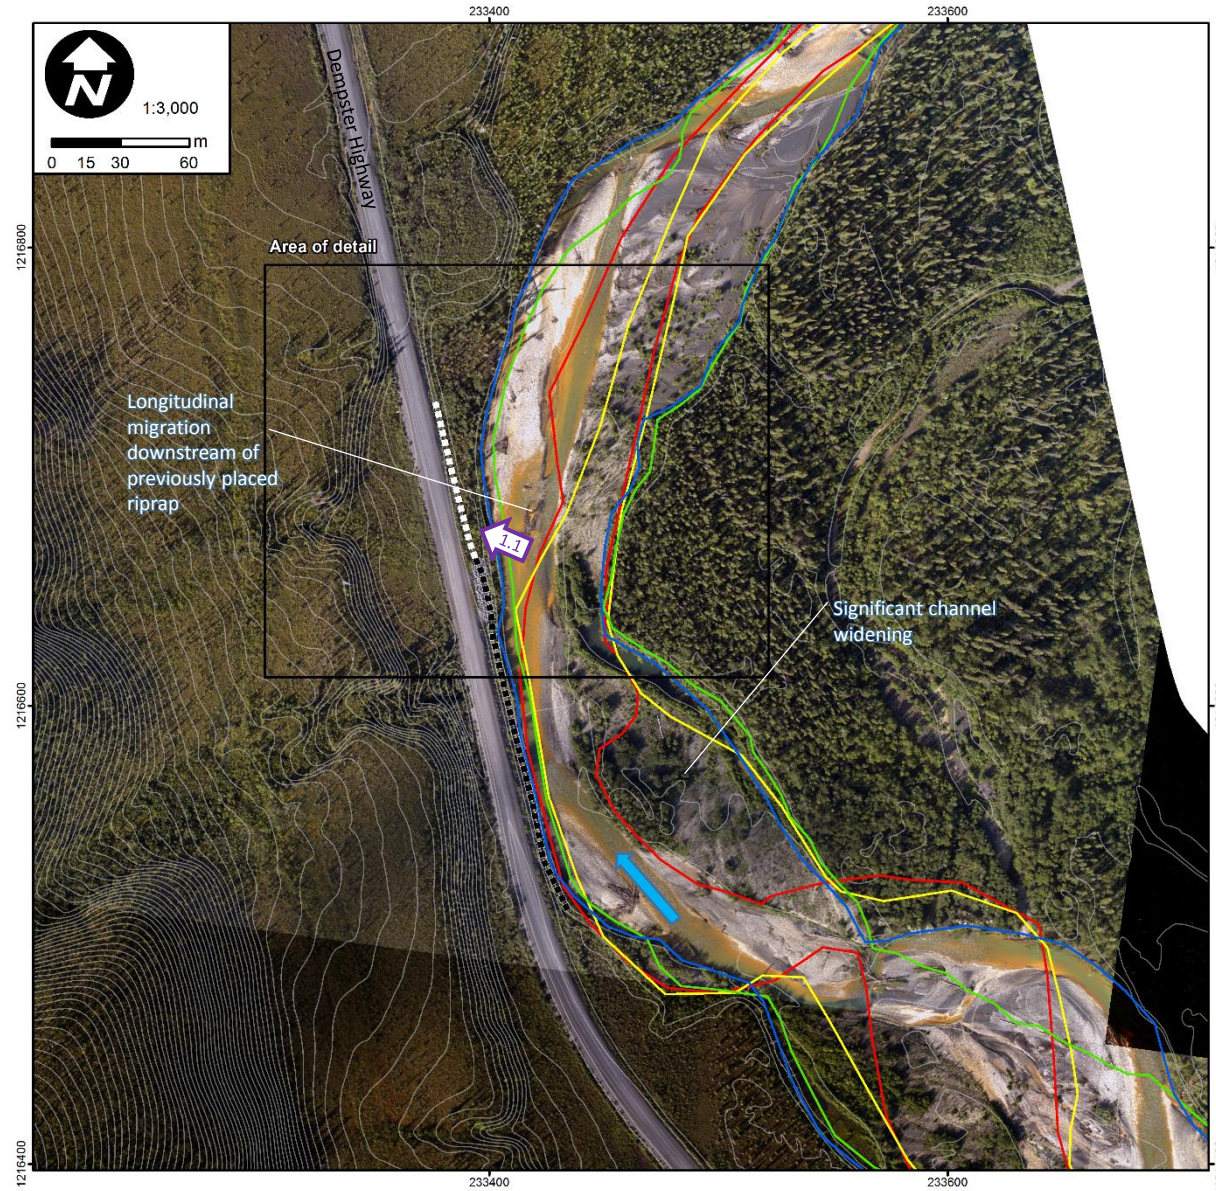
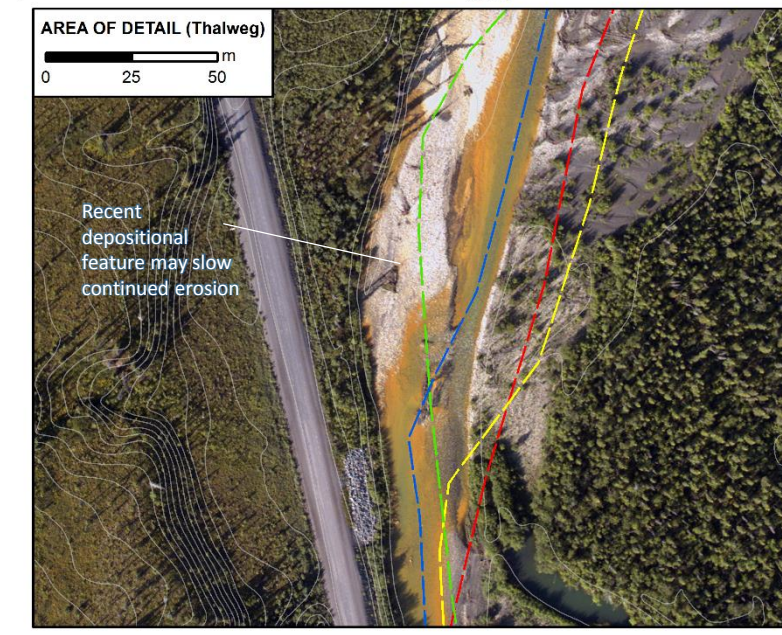
Project: Dempster Meander Migration Hazards Project number: 14132 Client: Yukon Government
		KM 188.6

This encroachment site is located within a partly confined, wandering gravel-bed reach of Engineer Creek. Lateral migration rates throughout the reach are relatively high, gravel bars are extensive and dynamic, and channel avulsions are frequent. The encroachment site is situated at a natural narrowing within the reach, which concentrates flow and erosive energy. The channel is also confined along its west bank by the riprapped highway embankment. This lateral confinement has led to longitudinal migration over the period of record. Shallow, ice-rich permafrost may persist in portions of this disturbed site, which can lead to irregular and episodic bank erosion and collapse. Without intervention, continued longitudinal migration will likely impact the highway embankment in 16 to 20 years.
