Yukon Geological Survey Miscellaneous Report 17

Inventory of mass movement geohazards along the Dempster Highway, Yukon

Robin J. McKillop, Courtenay E. Brown, Daniel J. McParland and David A. Sacco
Palmer Environmental Consulting Group Inc.
and Jim Coates
Kryotek Arctic Innovation Inc.

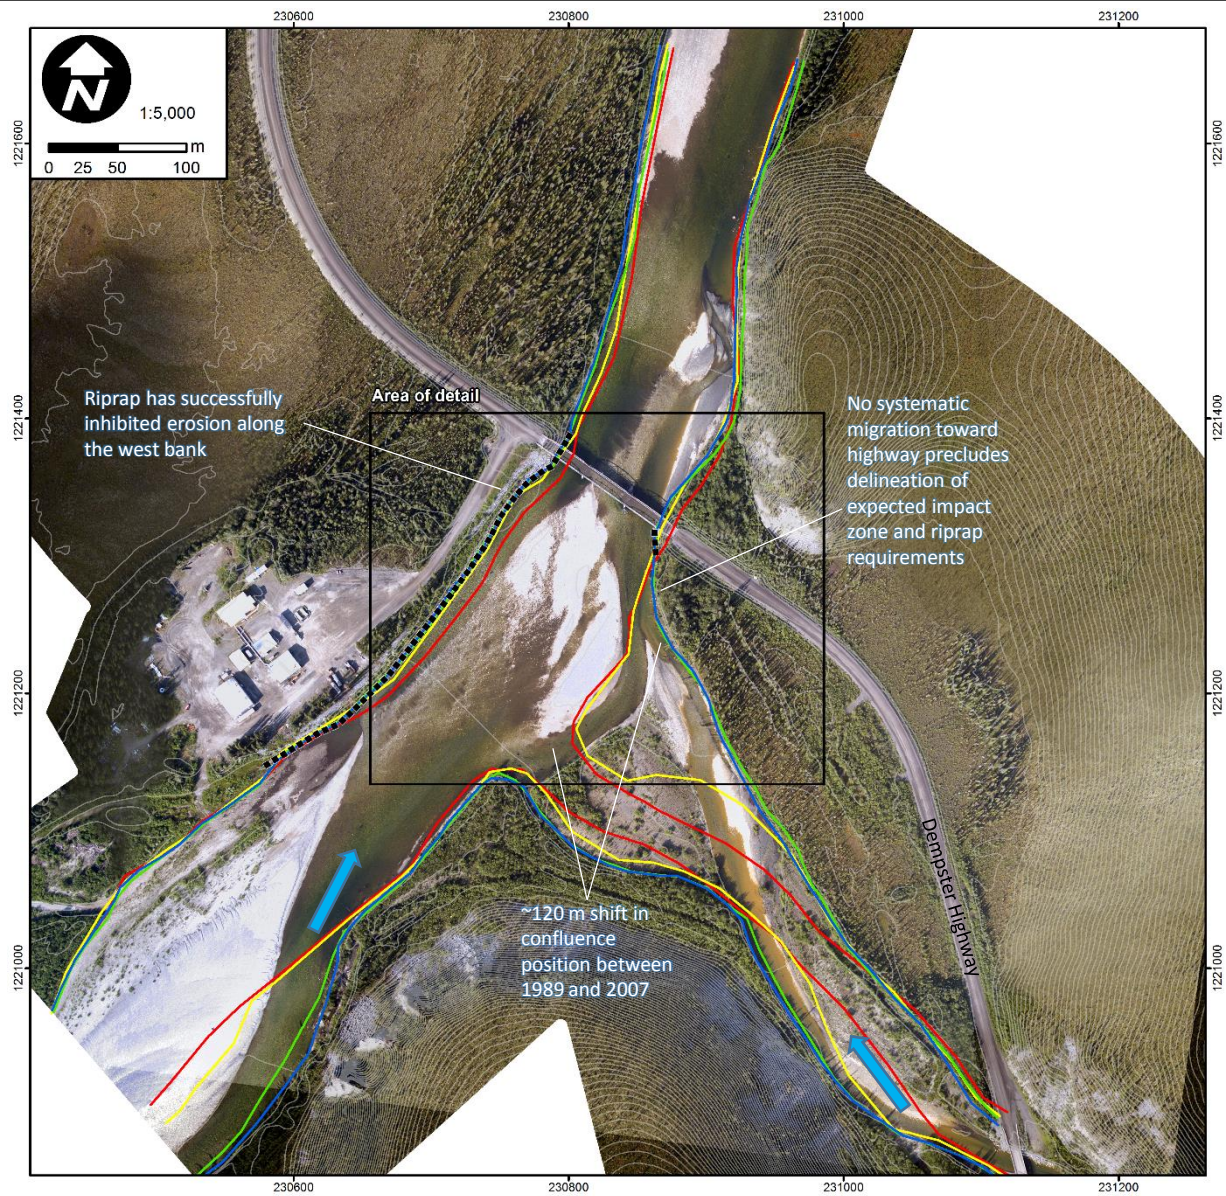
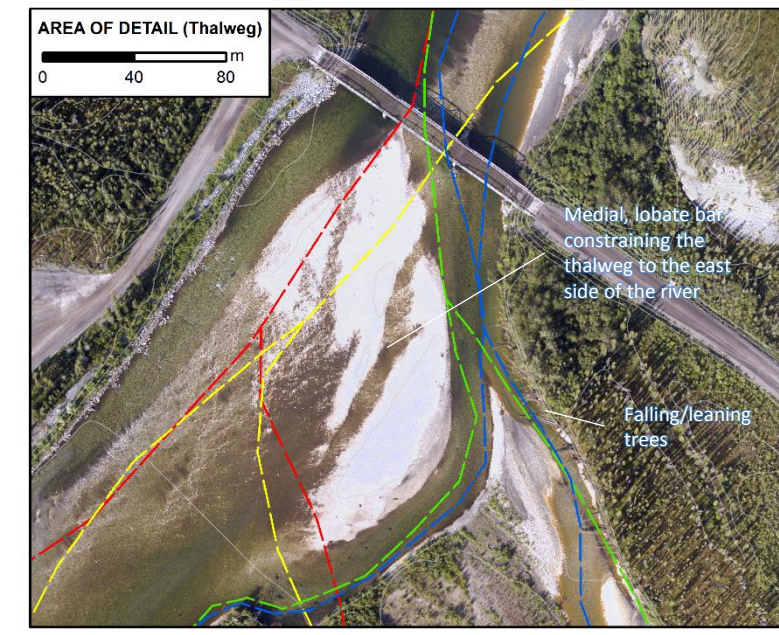
KM 189.4

Channel confluences are often dynamic and unstable geomorphic features. Local confluence dynamics, the extent and condition of riprap, and bank stability should be monitored regularly given the importance of bridge abutment stability.

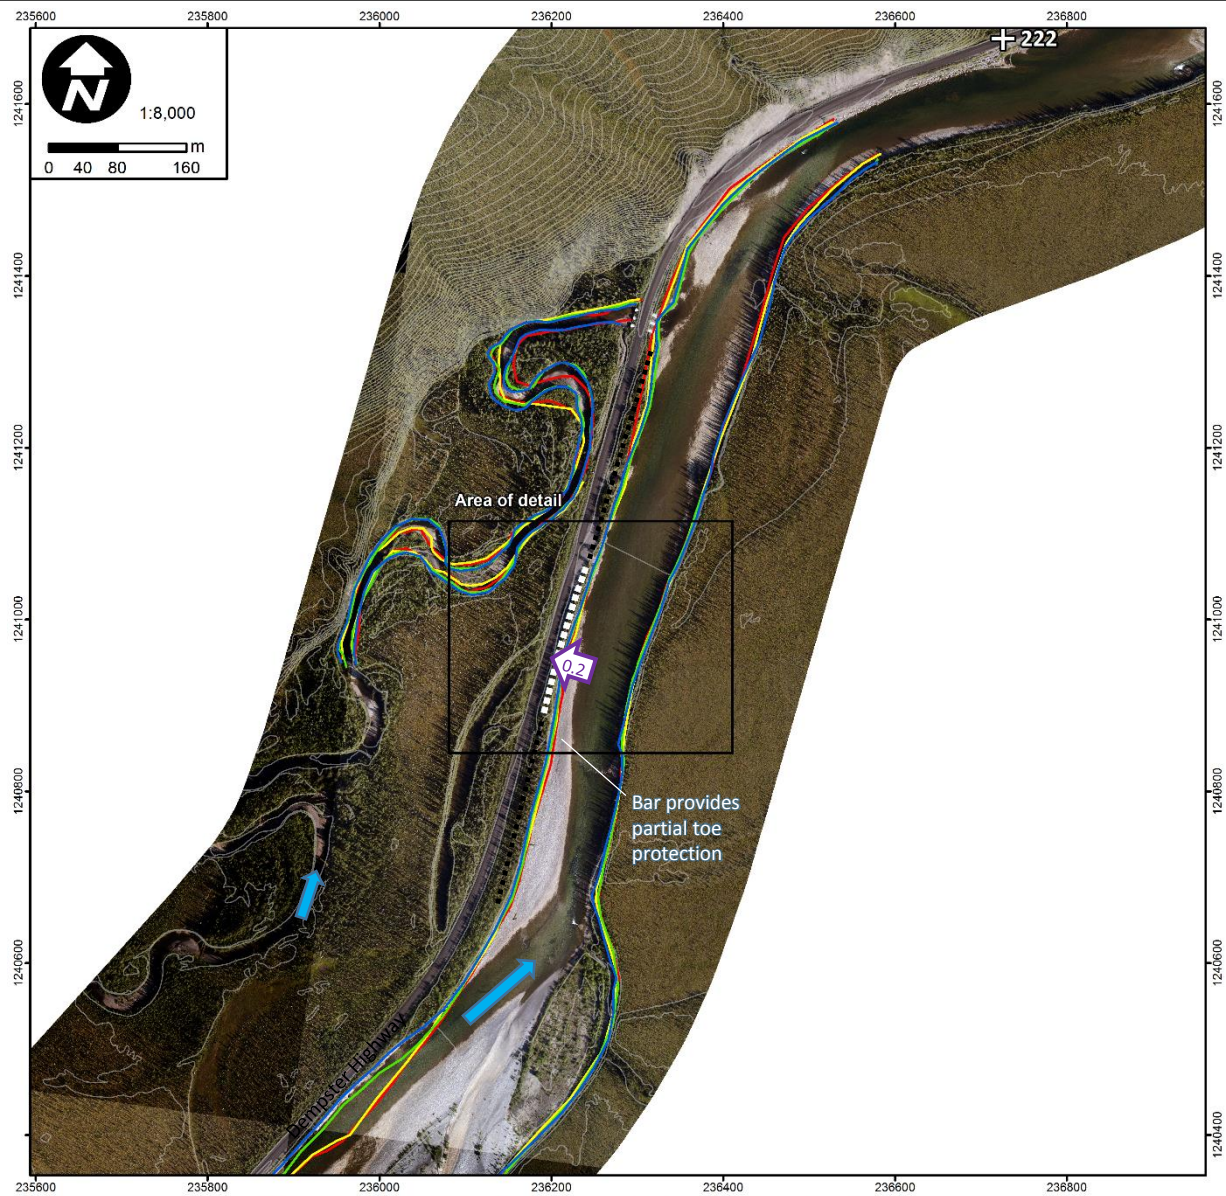
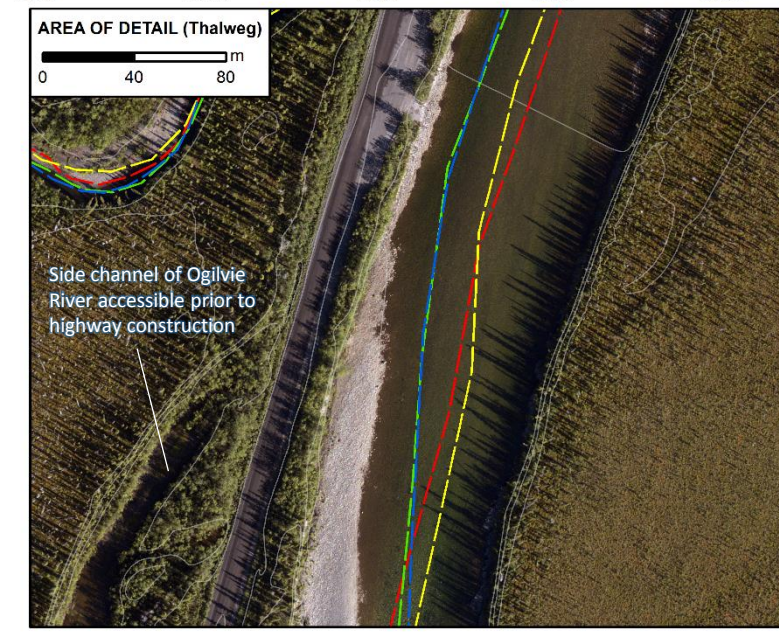
Project: Dempster Meander Migration Hazards Project number: 14132 Client: Yukon Government
		KM 202.5

This encroachment site is located within a partly confined, wandering gravel-bed reach of Ogilvie River. The reach contains prominent point, lateral and medial gravel bars, which influence the position of the thalweg. The west bank of the reach was extensively riprapped during highway construction. As such, bank migration rates throughout the reach, including within the vicinity of the encroachment site, have been very low over the period of record. Slow lateral migration was observed in a small section (~50 m in length) of the west bank that was not previously riprapped. However, it is unlikely that channel migration will impact the highway embankment within the next 25 years.

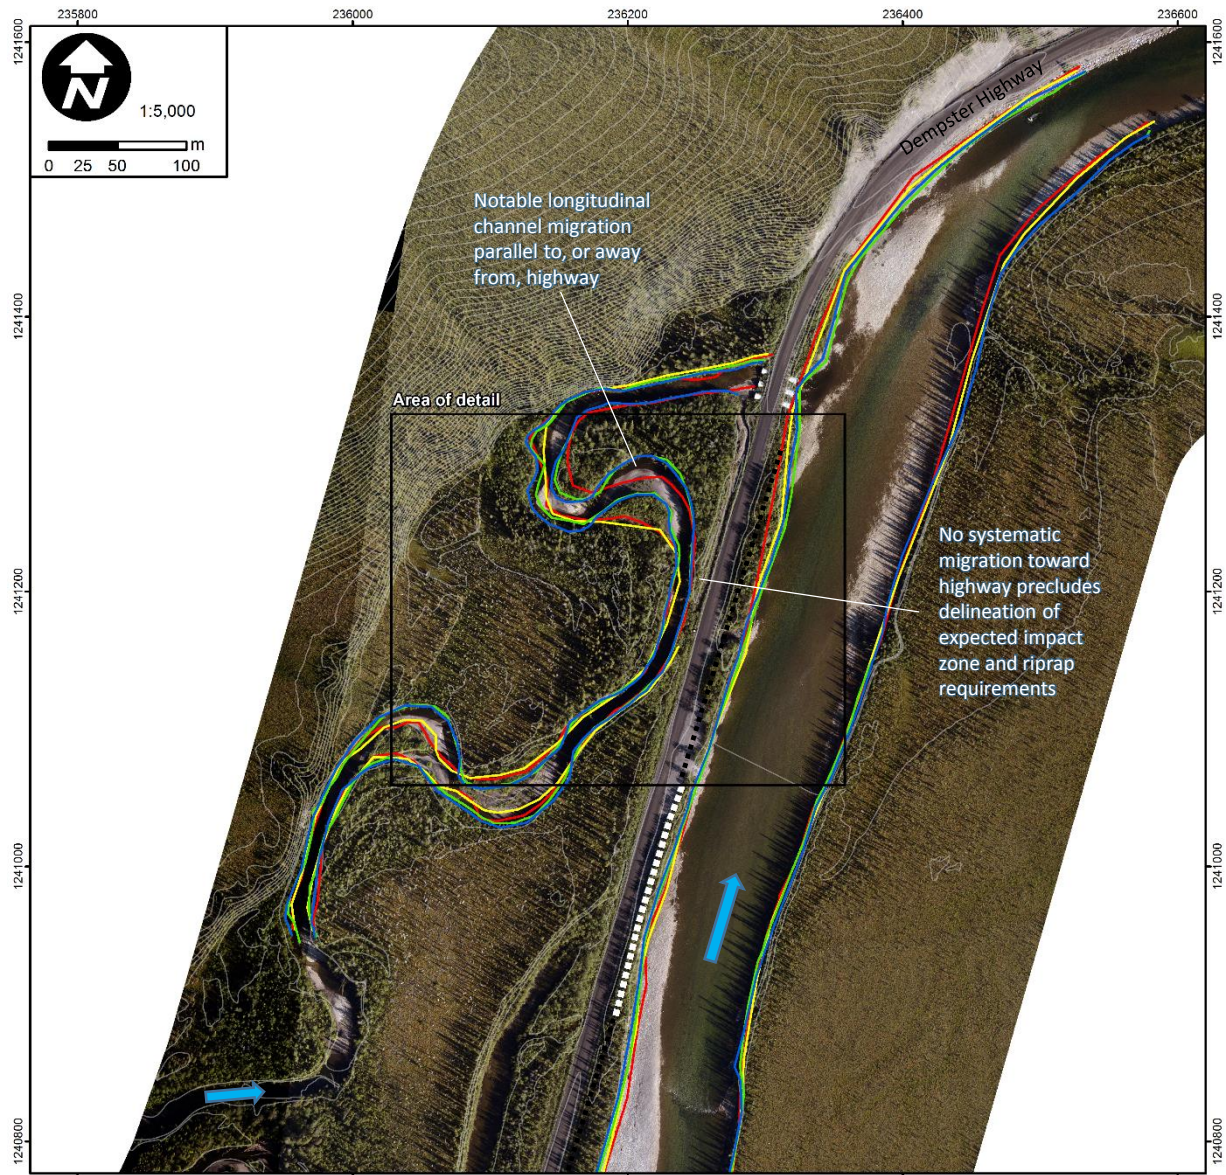
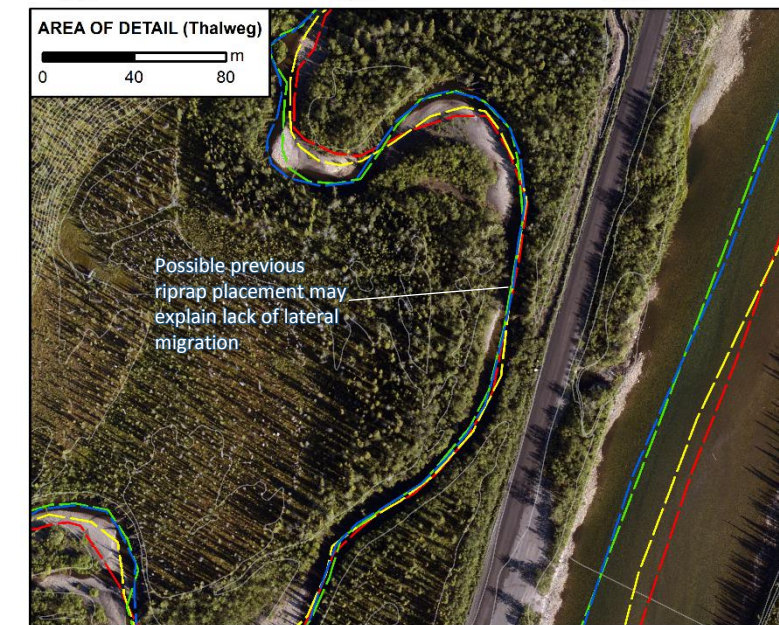
Project: Dempster Meander Migration Hazards Project number: 14132 Client: Yukon Government
		KM 221.1

IMPLICATIONS OF RIPRAP APPLICATION
 Riprap application would likely cause longitudinal channel migration, which in turn could initiate formation of a meander cut-off channel and destabilize this section of channel immediately adjacent to the highway.

SPECIAL CONSIDERATIONS
 The meanders in the vicinity of the encroachment site should be monitored annually to assess the risk erosion processes pose to the highway embankment and the downstream crossing structure.

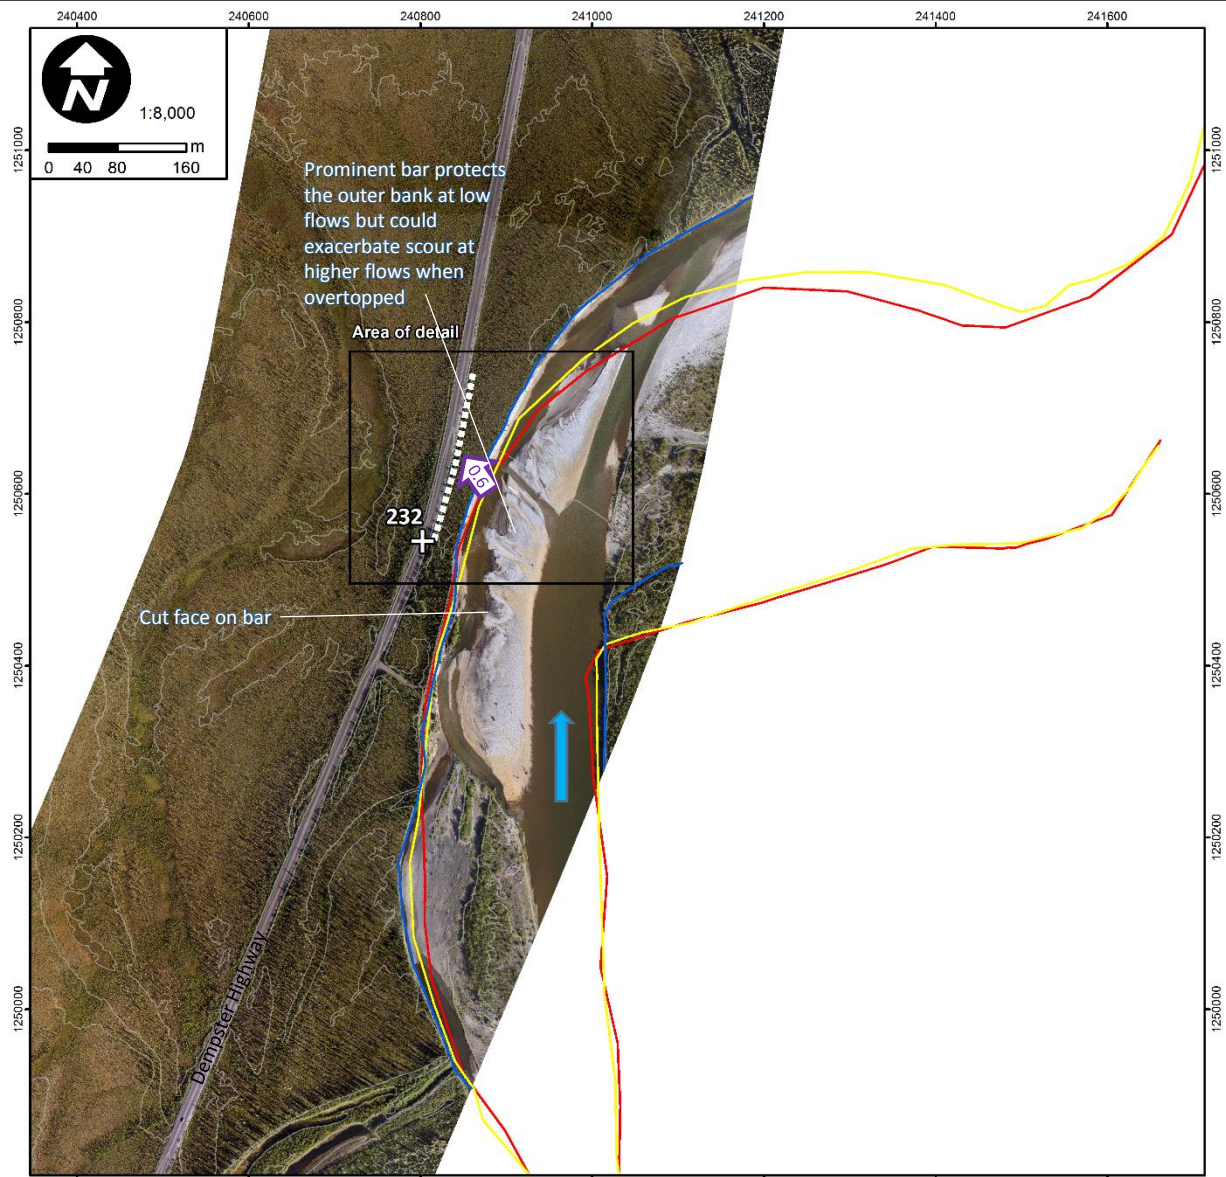
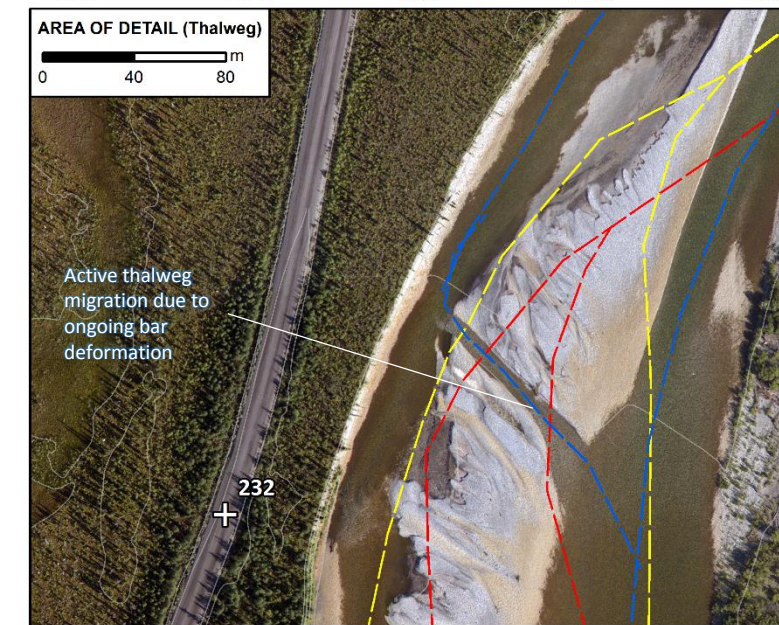
Project: Dempster Meander Migration Hazards Project number: 14132 Client: Yukon Government
		KM 221.3

The prominent bar that parallels the encroachment site has been significantly reworked over the period of record. Continued adjustments during flood conditions could trigger rapid bank erosion and dramatically reduce the separation from the highway embankment, invalidating predicted timeframes of impact based on migration within the past several decades. Monitoring is recommended at this site.

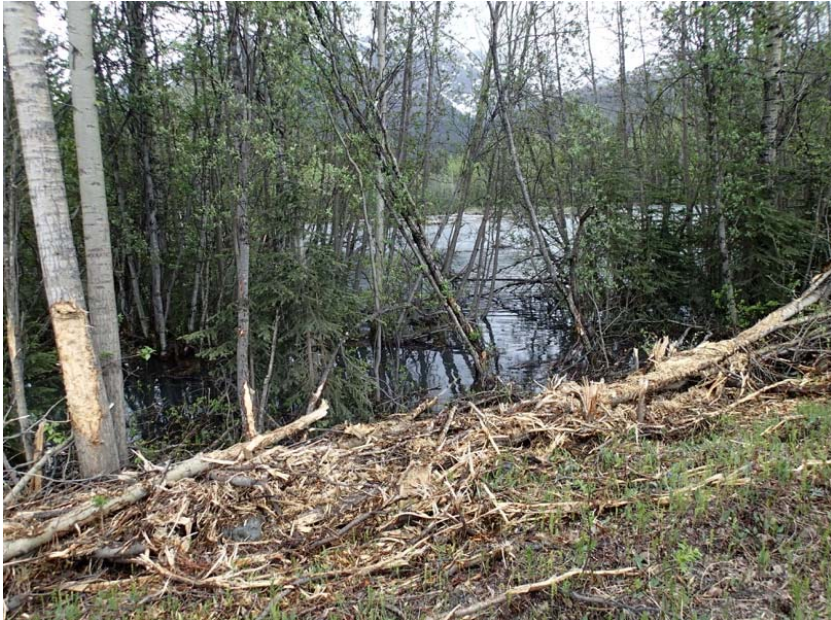
KM 52.3 (Photo 1). Backwatered pool at upstream end of meander

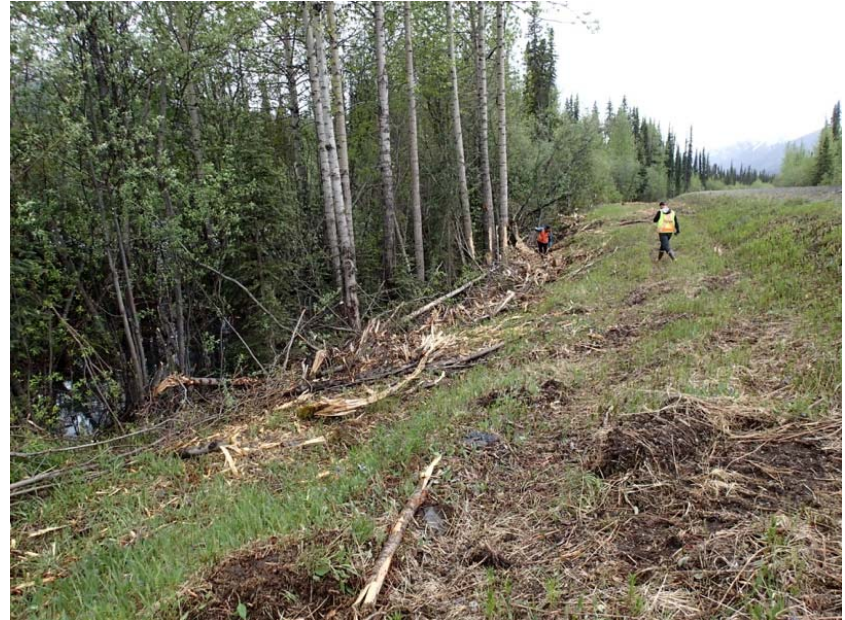
KM 52.3 (Photo 2). Riparian buffer between watercourse and highway

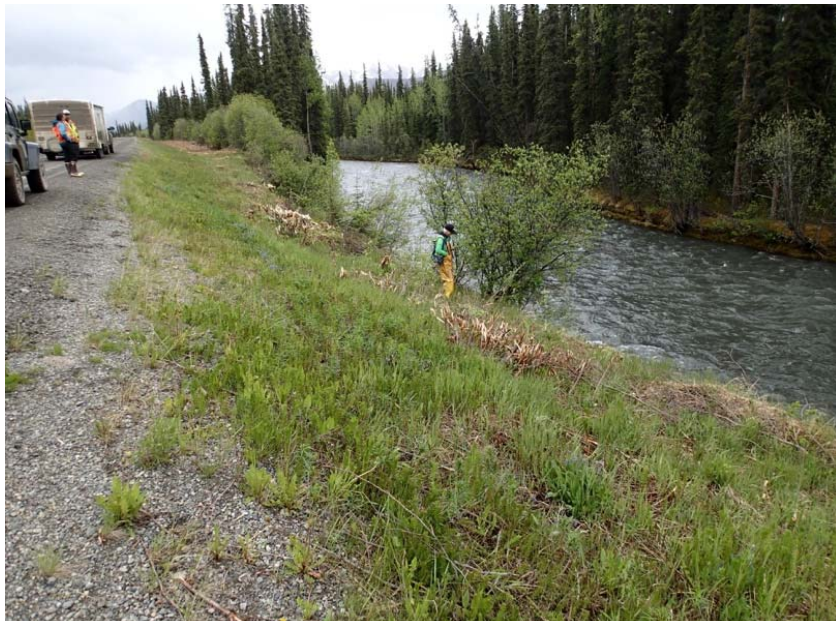
KM 54.9 (Photo 1). Lack of woody vegetation between watercourse and highway

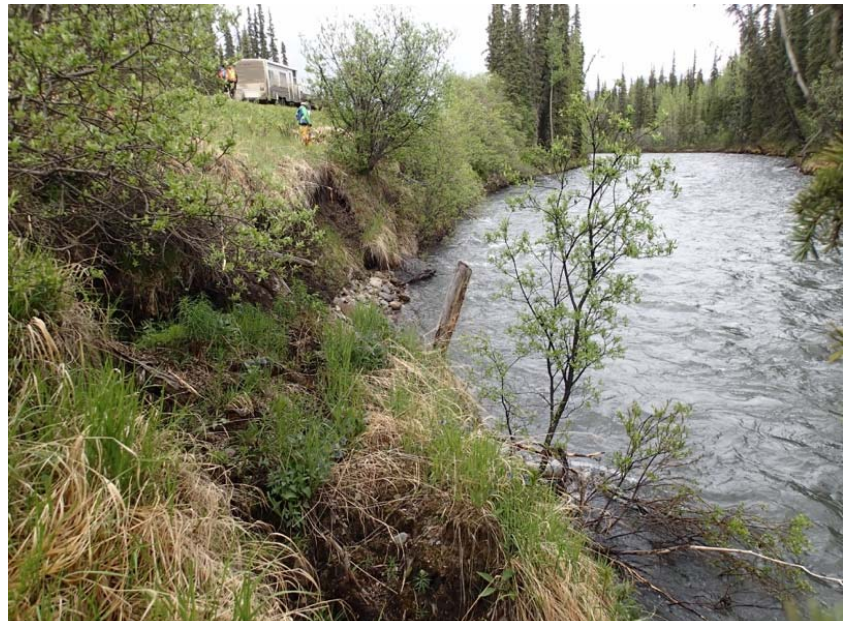
KM 54.9 (Photo 2). Bank slumping at downstream end of encroachment site

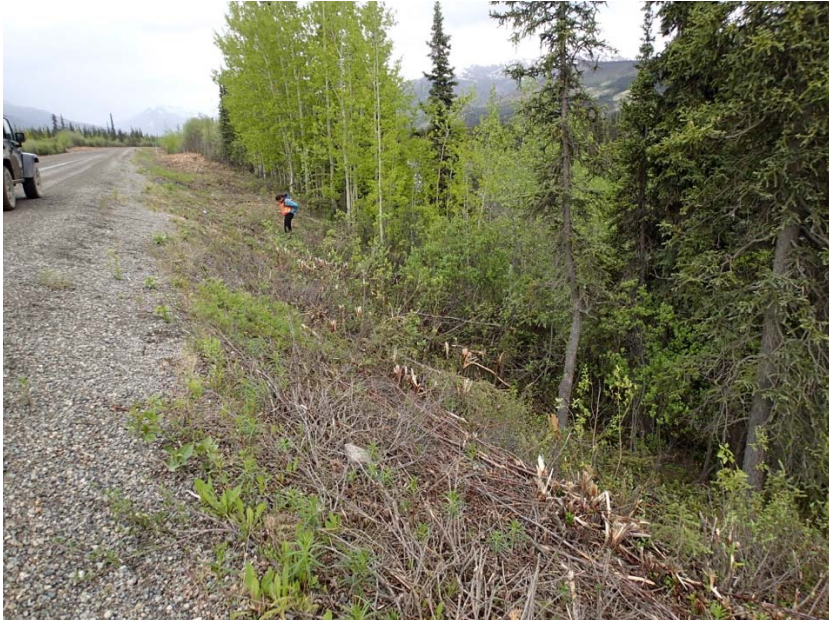
KM 55.9 (Photo 1). Dense riparian buffer between watercourse and highway

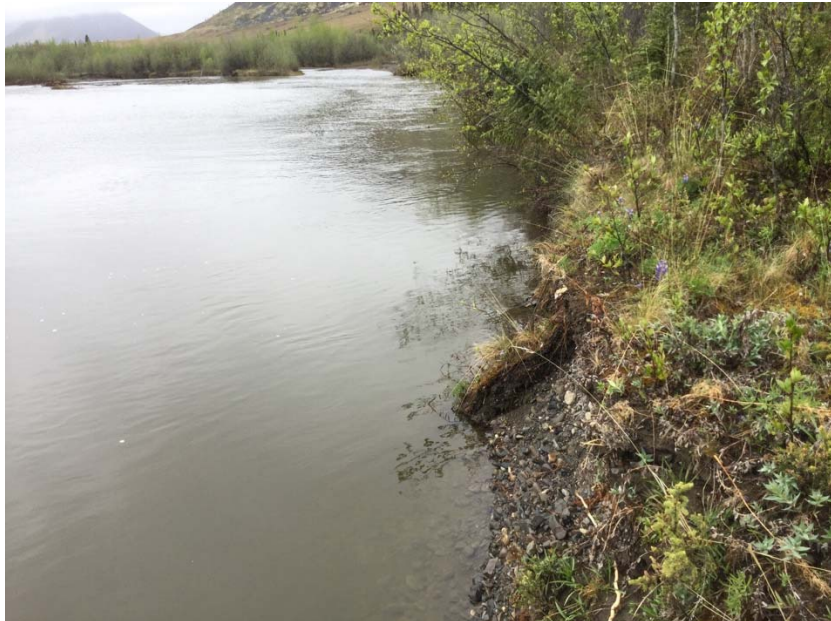
KM 138.5 (Photo 1). Leaning trees and exposed bank at the upstream end of the encroachment site

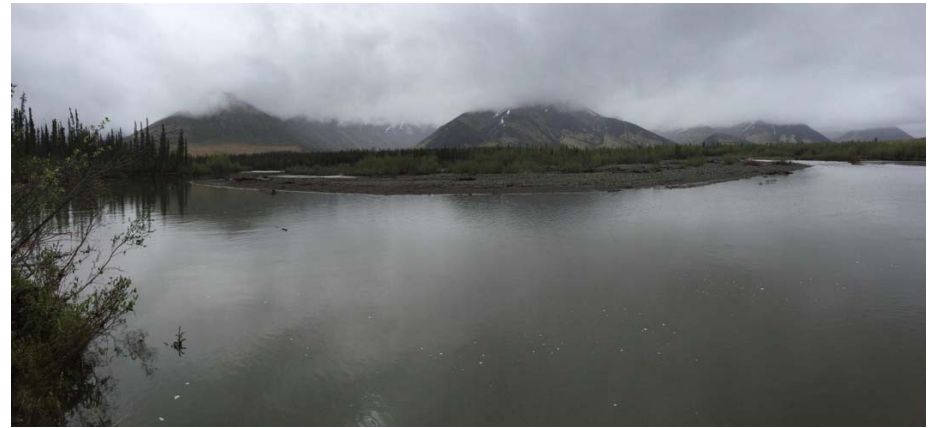
KM 138.5 (Photo 2). Prominent point bar across from the encroachment site

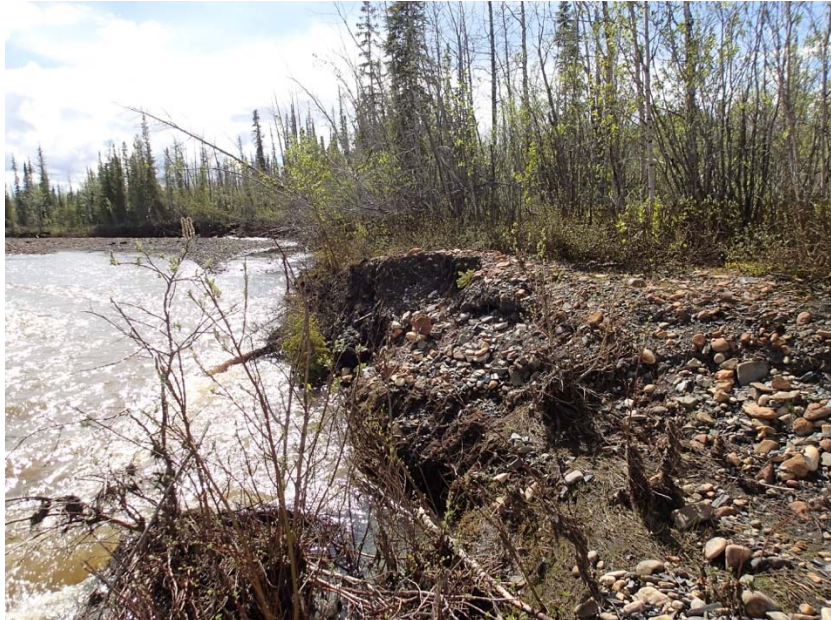
KM 170.9 (Photo 1). Active erosion at upstream end of encroachment site

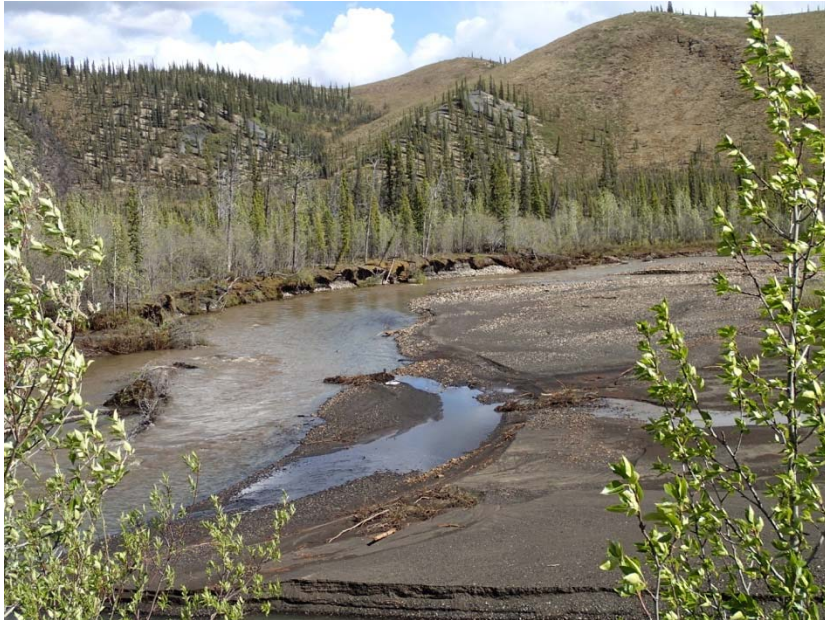
KM 175.2 (Photo 1). Actively migrating channel upstream of the encroachment site

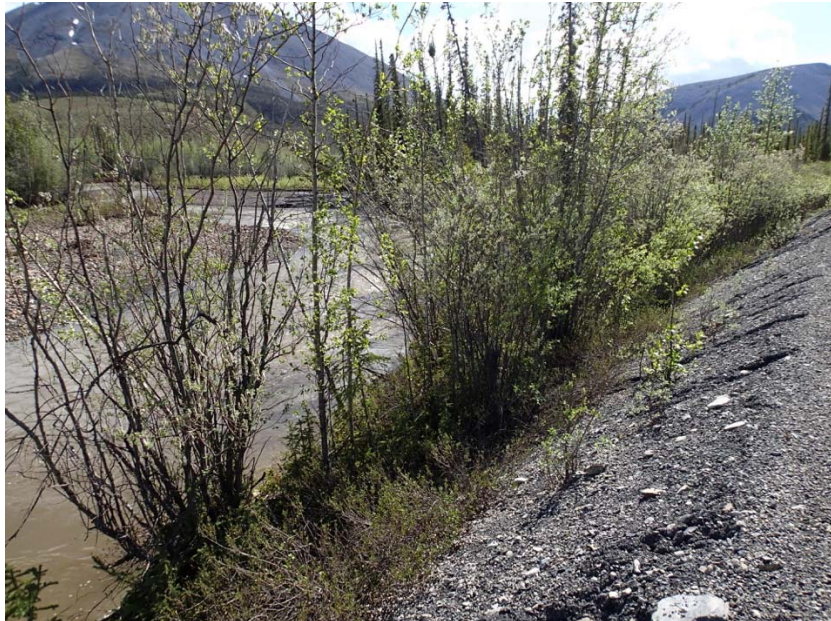
KM 181.5 (Photo 1). Thin riparian buffer between watercourse and highway

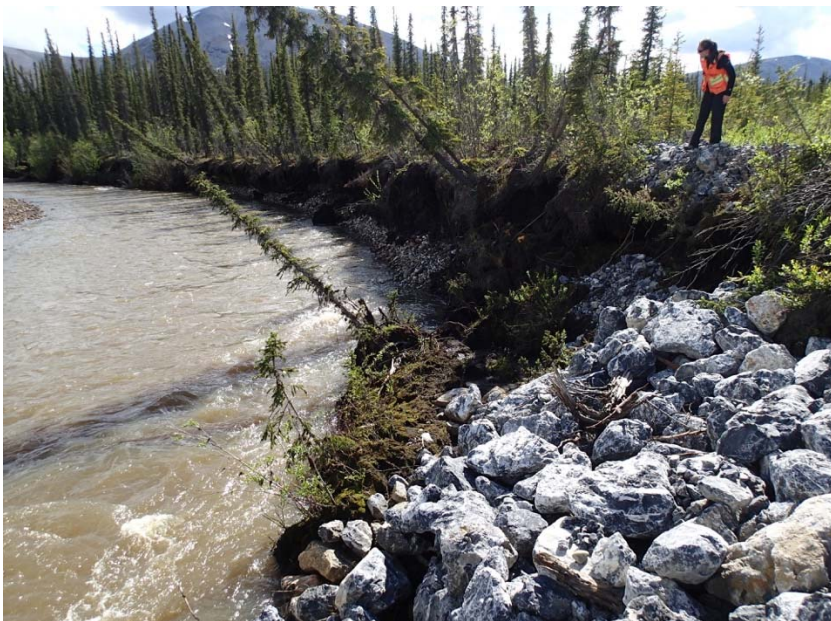
KM 182.1 (Photo 1). Active scour and permafrost degradation beneath previously placed riprap

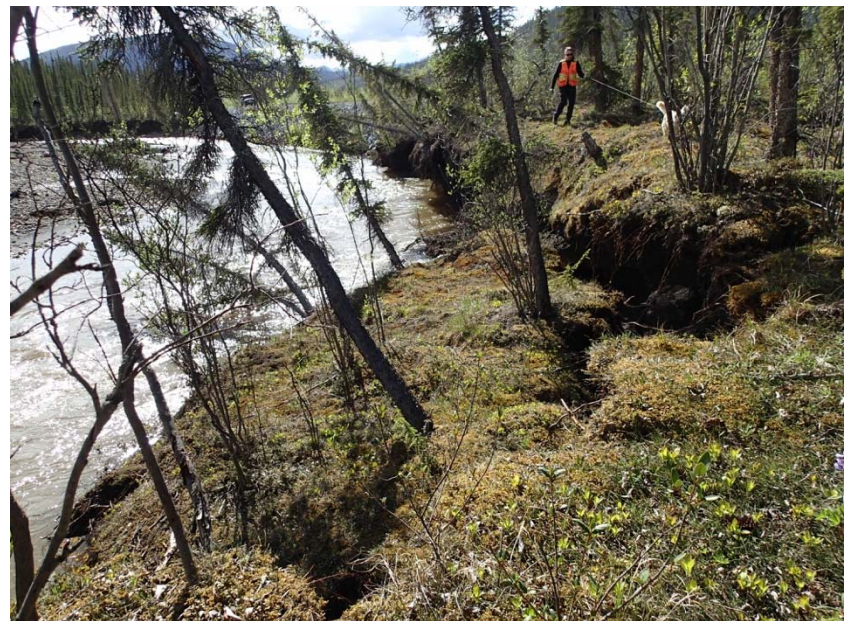
KM 182.1 (Photo 2). Significant bank collapse in permafrost downstream of previously placed riprap

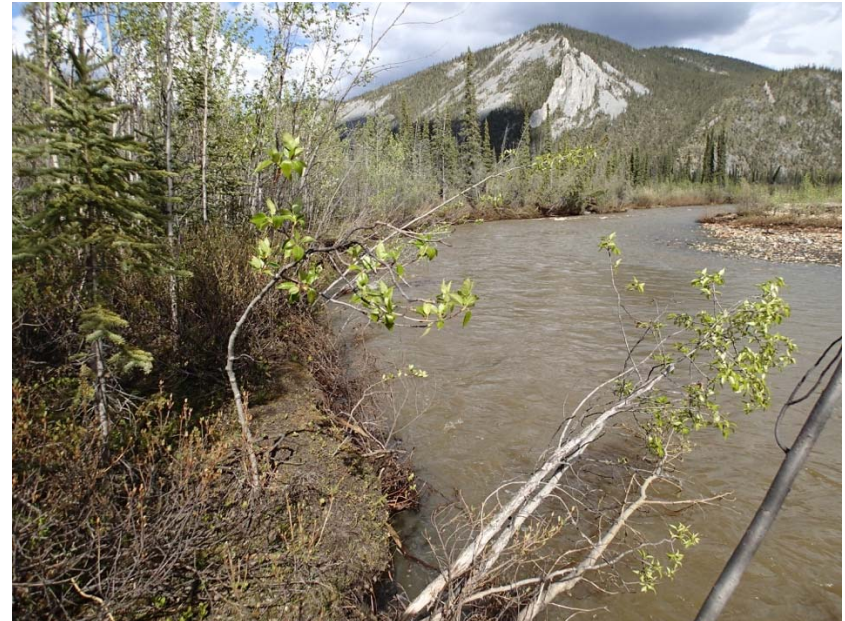
KM 183.3 (Photo 2). Leaning trees and bank scour

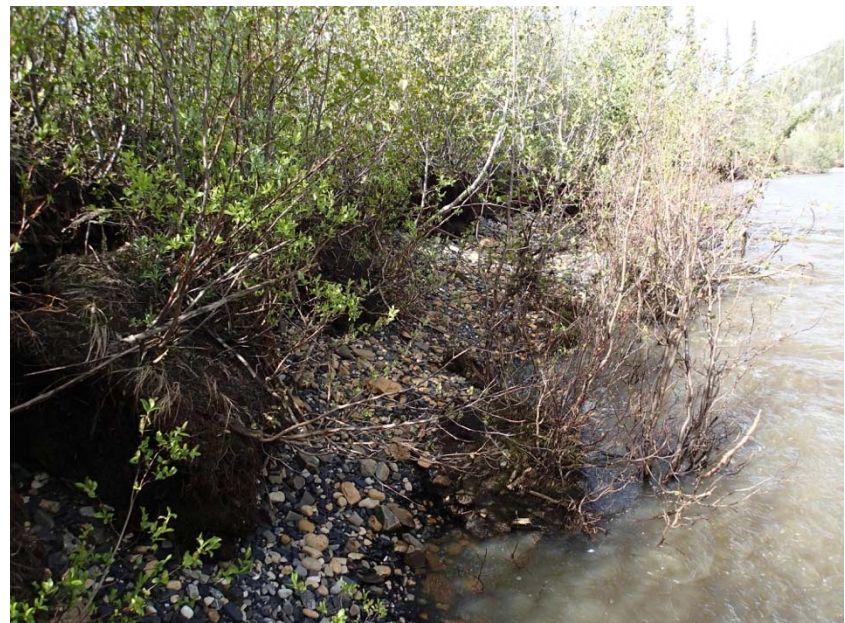
KM 185.8 (Photo 2). Slumping/exposed banks

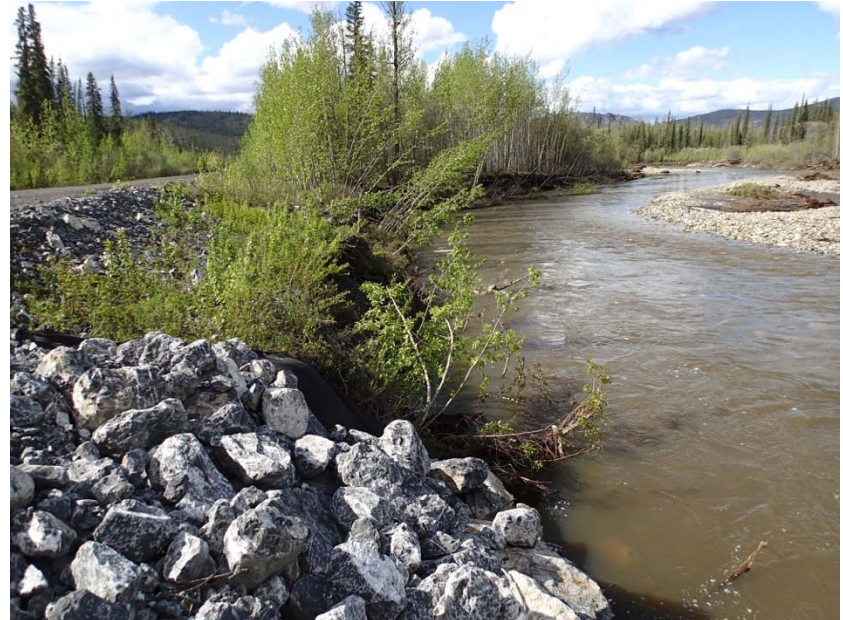
KM 188.6 (Photo 2). Leaning trees and bank scour downstream of recently placed riprap

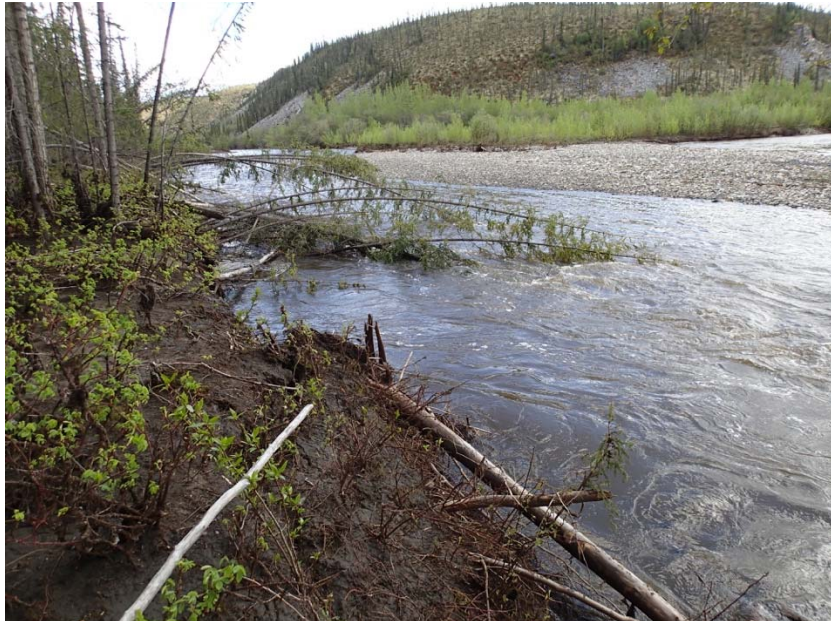
KM 195.1 (Photo 1). Fallen/leaning trees along the outer (northeast) bank of Engineer Creek

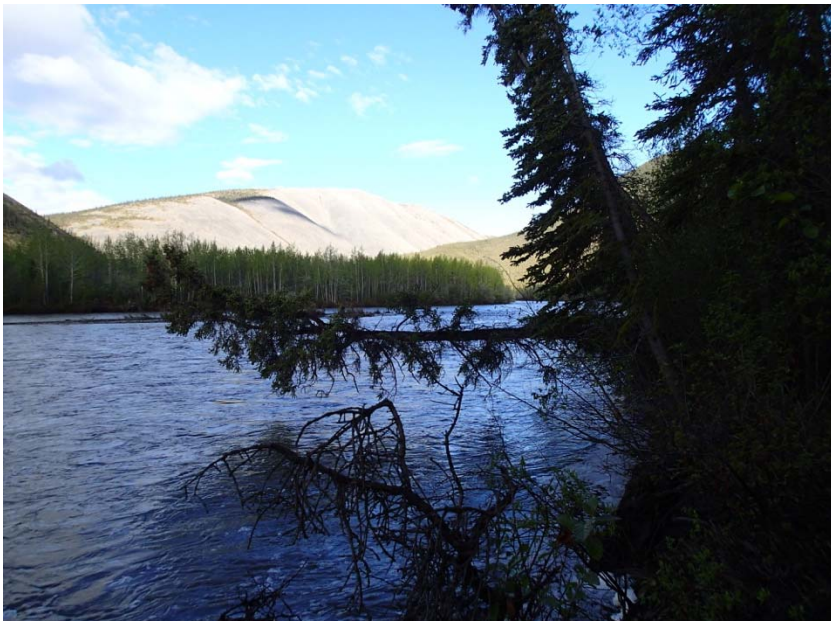
KM 202.5 (Photo 1). Looking upstream at fallen/leaning trees

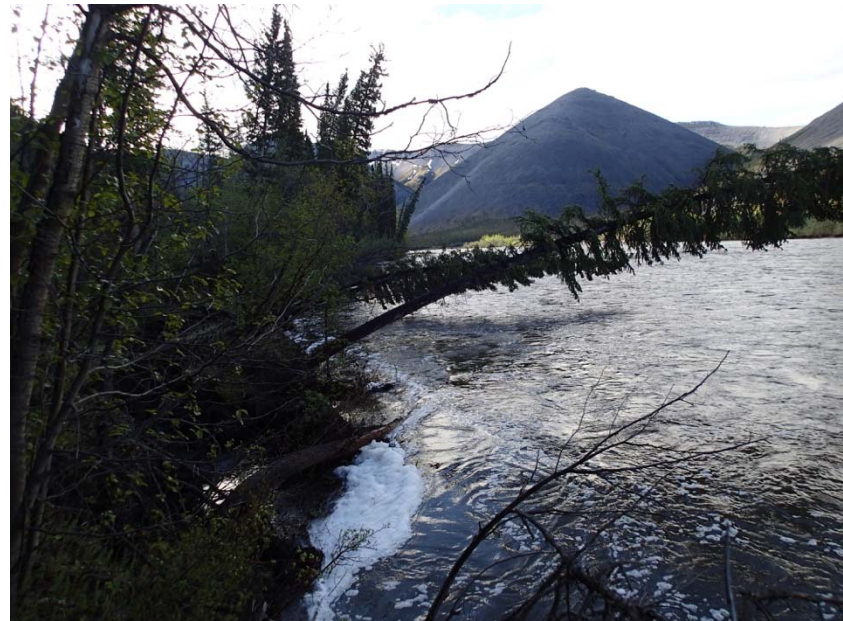
KM 202.5 (Photo 2). Looking downstream at fallen/leaning trees

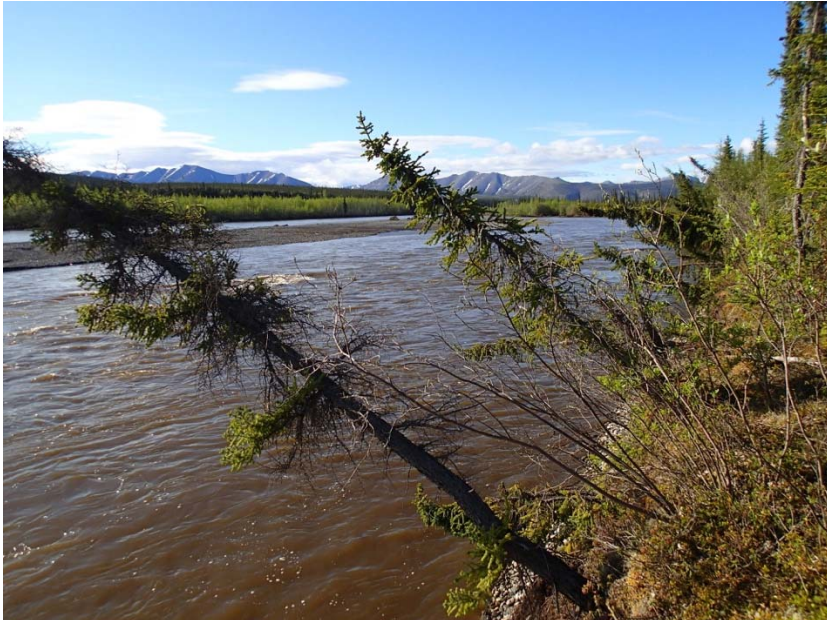
KM 232.0 (Photo 1). Looking upstream at fallen/leaning trees

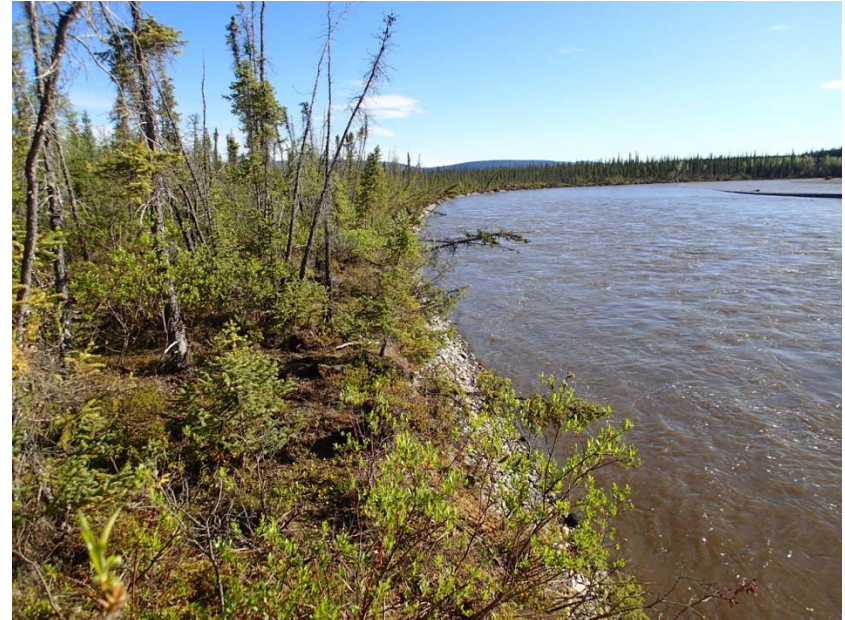
KM 232.0 (Photo 2). Looking downstream from encroachment site; note low banks in permafrost

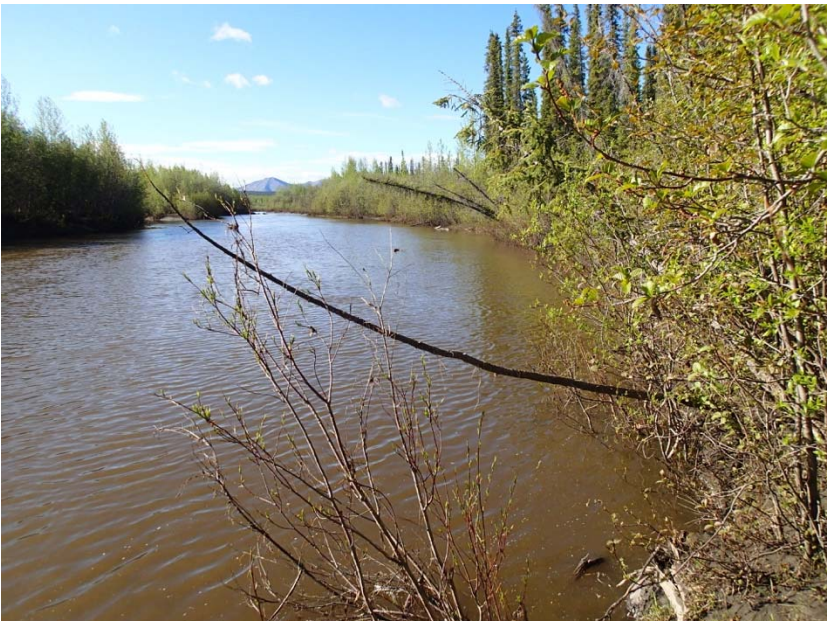
KM 236.3 (Photo 1). Looking upstream at leaning trees

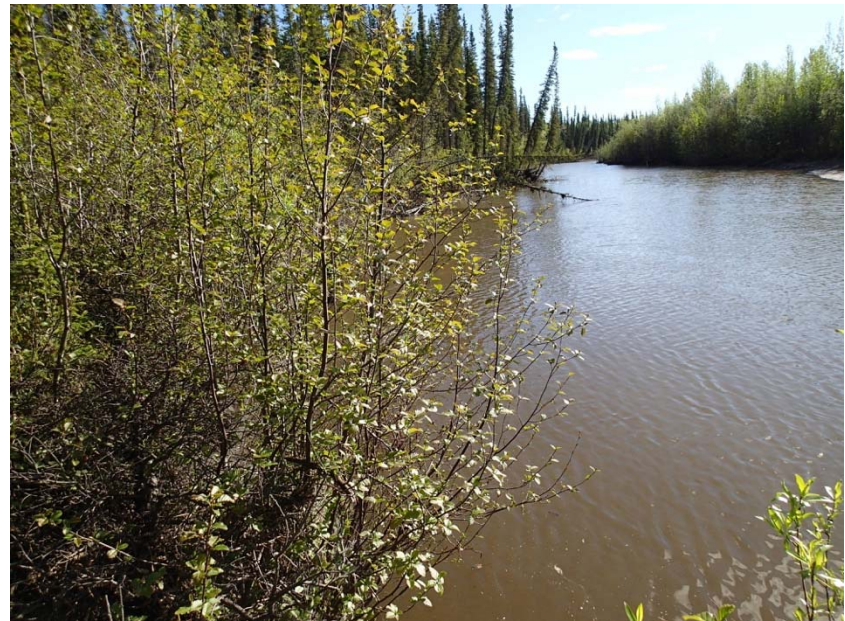
This encroachment site is located within an unconfined, wandering gravel-bed reach of Ogilvie River. Lateral migration rates throughout the reach are relatively high, gravel bars are extensive and dynamic, and channel avulsions are frequent. Shallow, ice-rich permafrost is present at this site, which can lead to irregular and episodic bank erosion and collapse. Locally, the formally occupied the west (i.e. opposite) side of the Dempster Highway prior to the earliest aerial photography (1977). The meander exhibits a subdued compound form with two minor bends superimposed on its overall meander form. There has been significant lateral migration towards the highway over the period of record along two distinct trajectories (69 m and 58 m). However, there is a large buffer (24 m) between the position of the 2013 outer bank and the highway. Without intervention, continued lateral migration will likely impact the highway embankment in 16 to 20 years.

KM 236.3 (Photo 2). Looking downstream from encroachment site

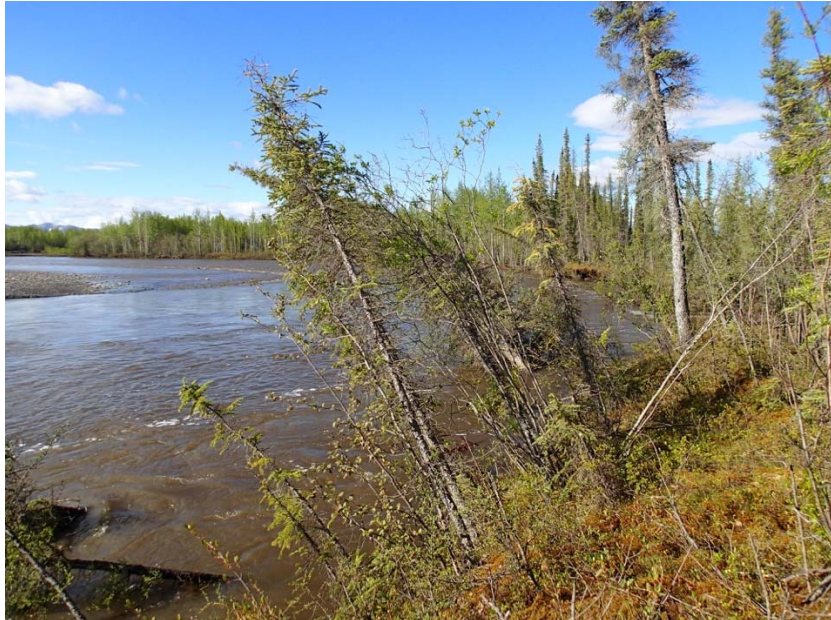
KM 239.5 (Photo 1). Looking upstream at leaning trees

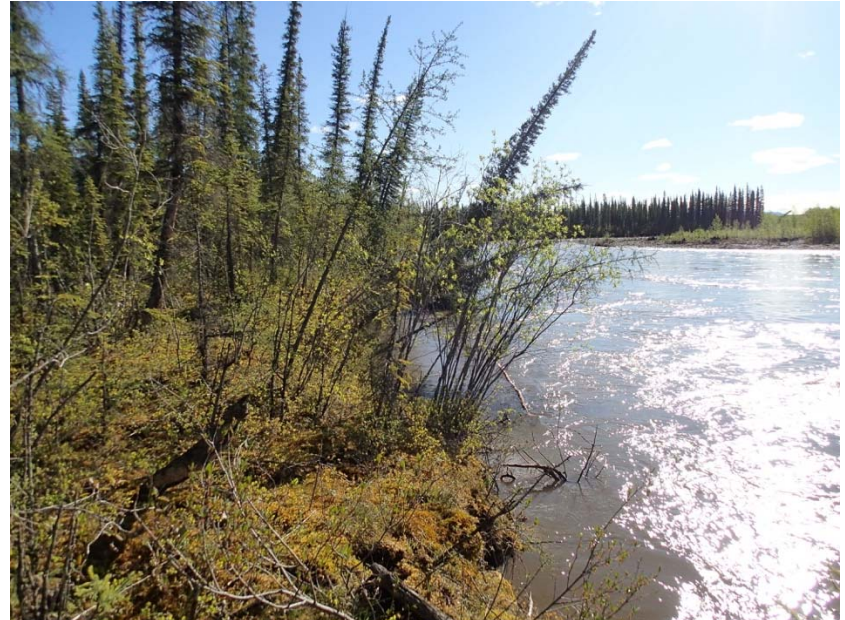
KM 239.5 (Photo 2). Looking downstream at fallen/leaning trees

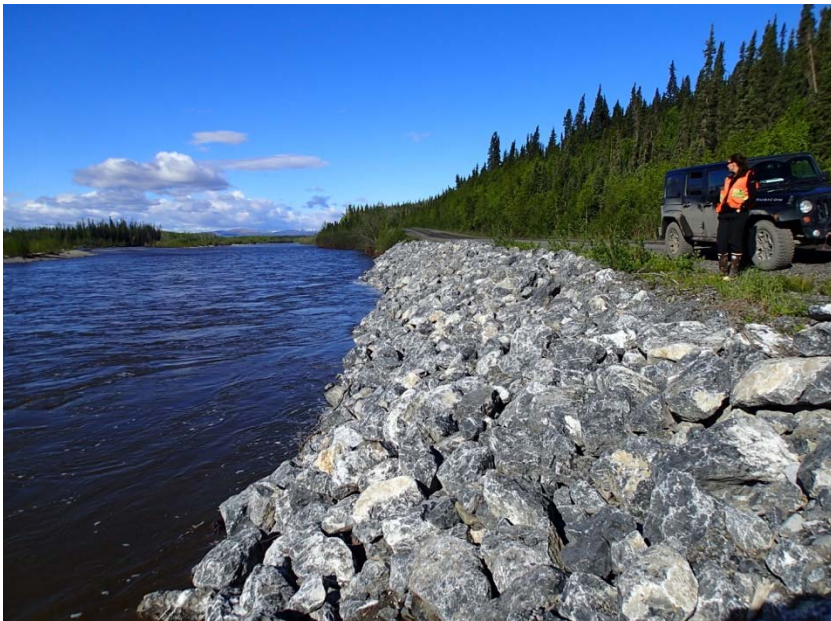
KM 243.8 (Photo 1). Looking upstream from recently placed riprap

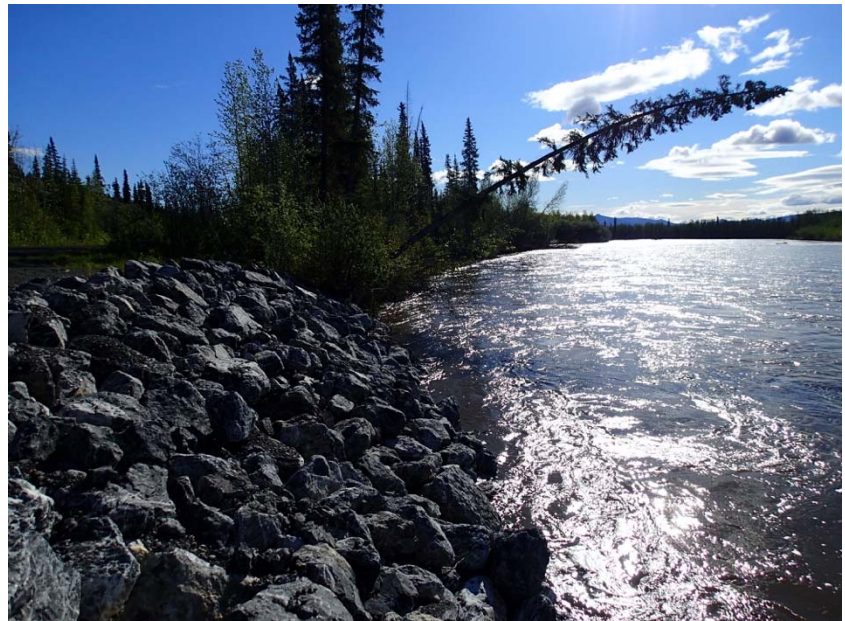
KM 243.8 (Photo 2). Leaning trees downstream of recently placed riprap
