2005 Village of Mayo Well Rehabilitation and Resource Assessment on PW1 and PW2

Prepared for
Energy Solutions Centre

Submitted by
Gartner Lee Limited

January 2006

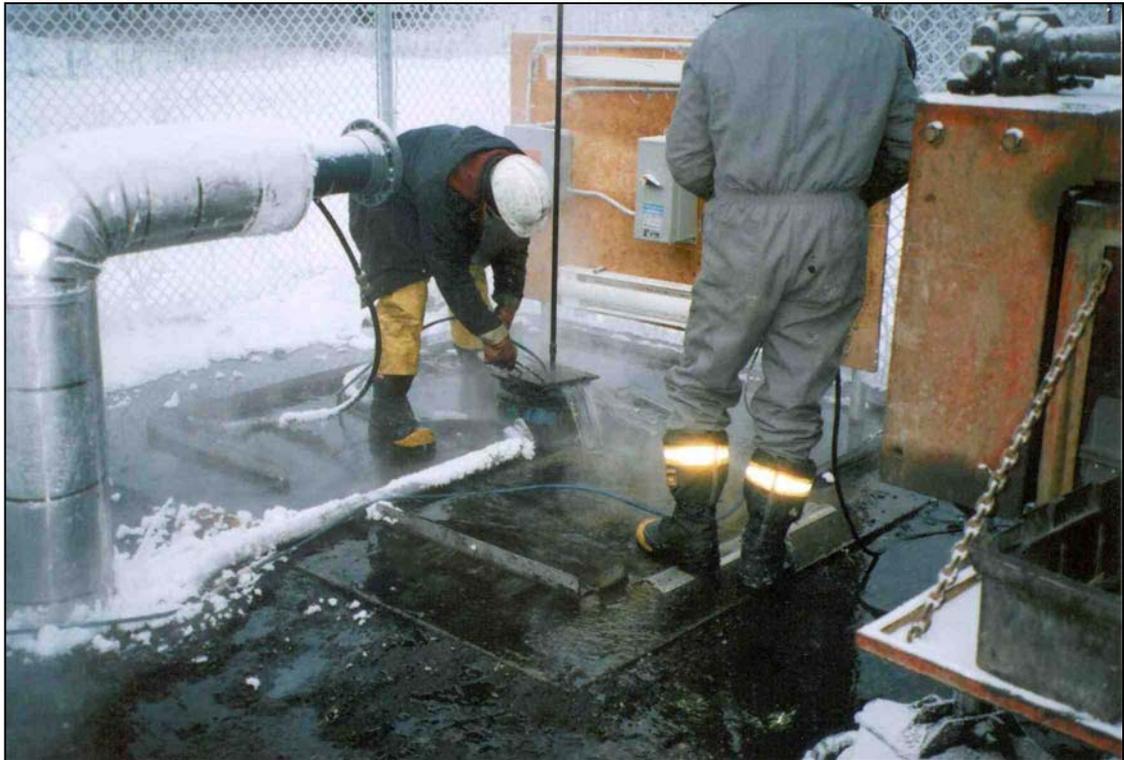
Photograph 1: Following the initial step test and prior to well cleaning, the riser pipe and pump were removed from the well to provide access with the rehabilitation tools and well cleaning chemicals.

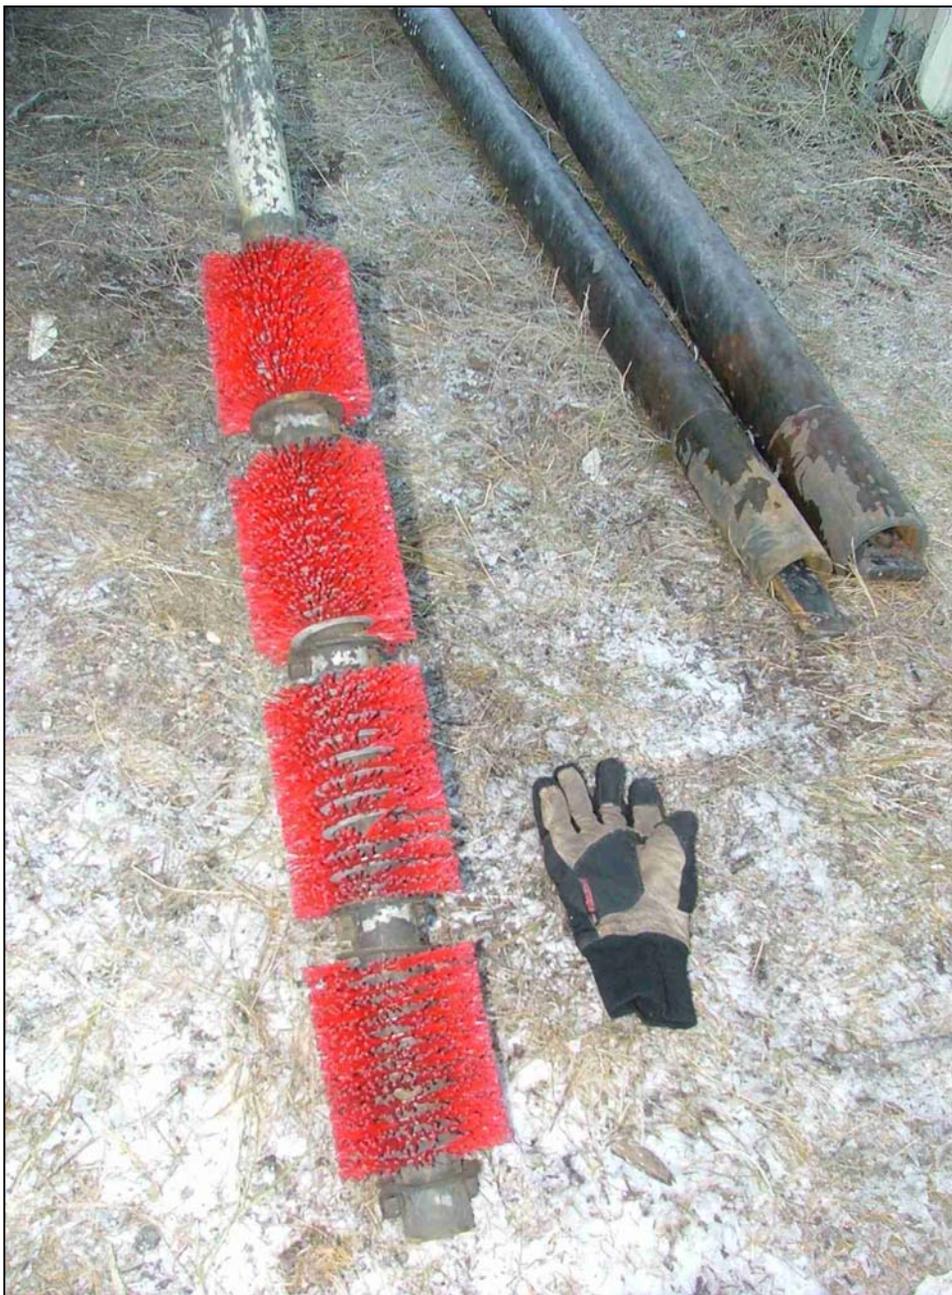
Photograph 4: Well brushing tool used to swab the side walls of the casing and screen. Various sizes were on-site to accommodate different casing diameters.

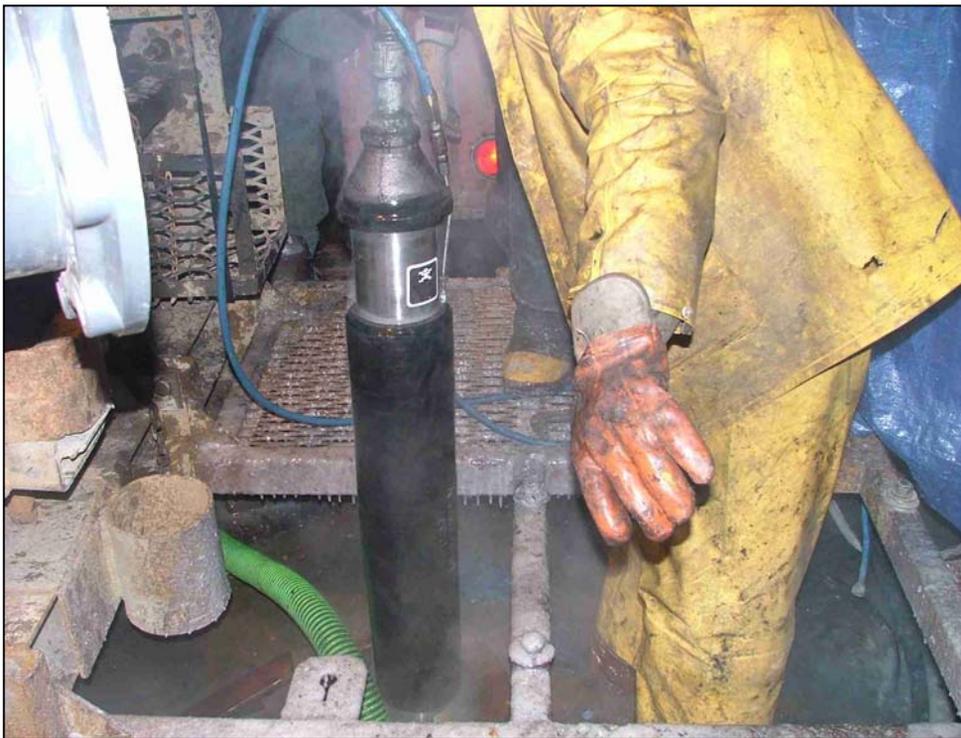
Photograph 5: Air inflatable (blue line) packer used to isolate the bottom portion of the well. Once the lower portion of the well was “packed off” (I.e. no flow condition was established), the well cleaning chemicals were injected from surface down the metal riser pipe (shown above), into the screen interval.

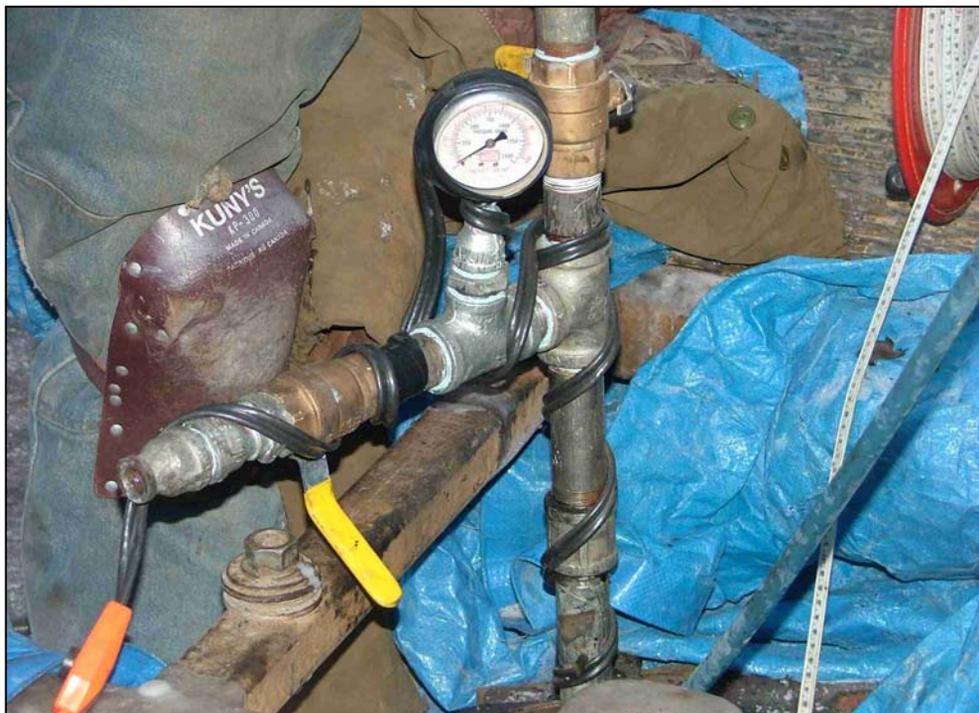
Photograph 6: Metal riser pipe attached to top off packer. The pipe / valve on the left was used to inject the well cleaning chemicals. Once pumped into the well this valve was closed and a pressure gauge was used to monitor “off gas” pressure build up. The valve shown at top was used to periodically vent the system. A hose was attached to this pipe (not shown in photo) to ensure that any vented gas or liquid was discharged in an appropriate area.

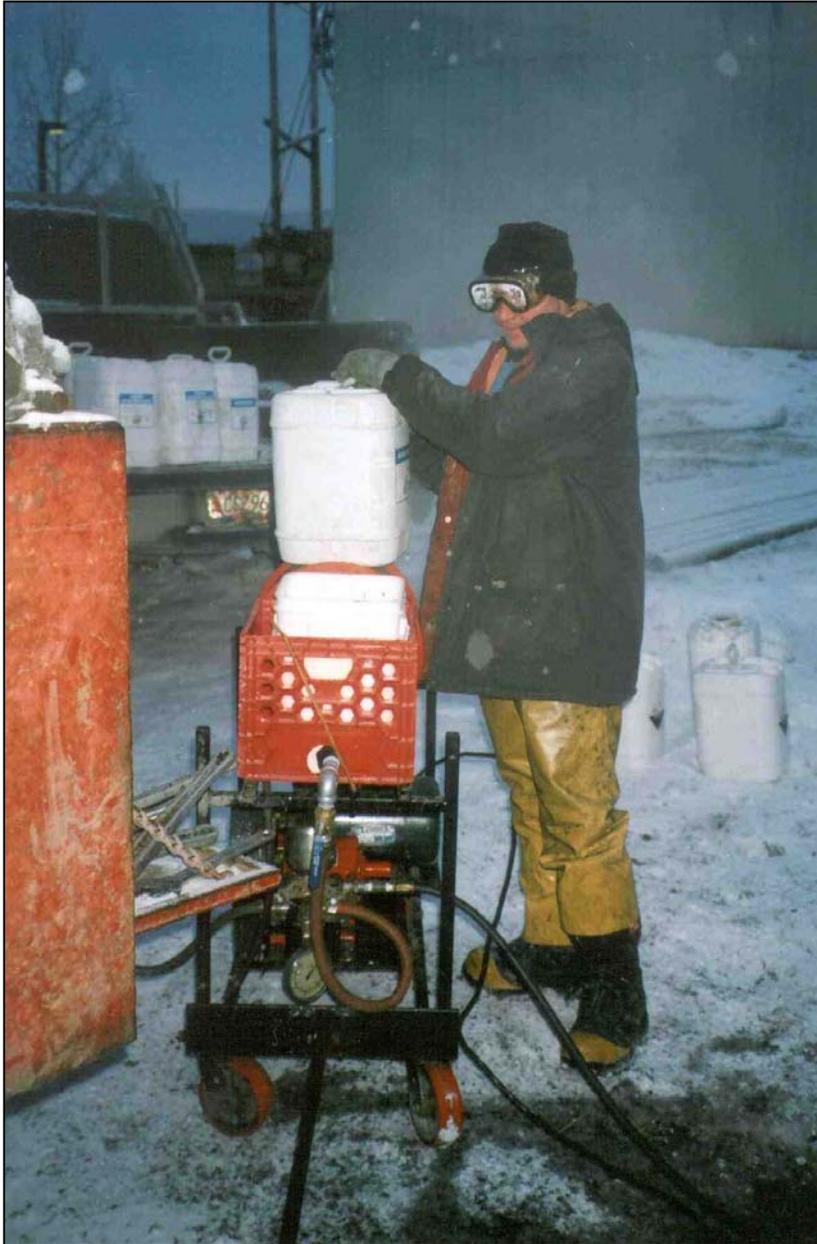
Photograph 7: A pump used to inject the well cleaning chemicals below the packer into the screen interval. An artesian pressure of approximately 9 psi had to be overcome in order to pump the chemicals into the system.
