**REPORT ON RECLAMATION
AT
NORANDA EXPLORATION LTD.
McMILLAN PROPERTY NTS 95 D/12
AND AT
NORANDA EXPLORATION LTD.
ANKY CLAIMS NTS 105 J/2**

by Gordon MacKay P. Geo.

MACKAY FALKINER AND ASSOCIATES

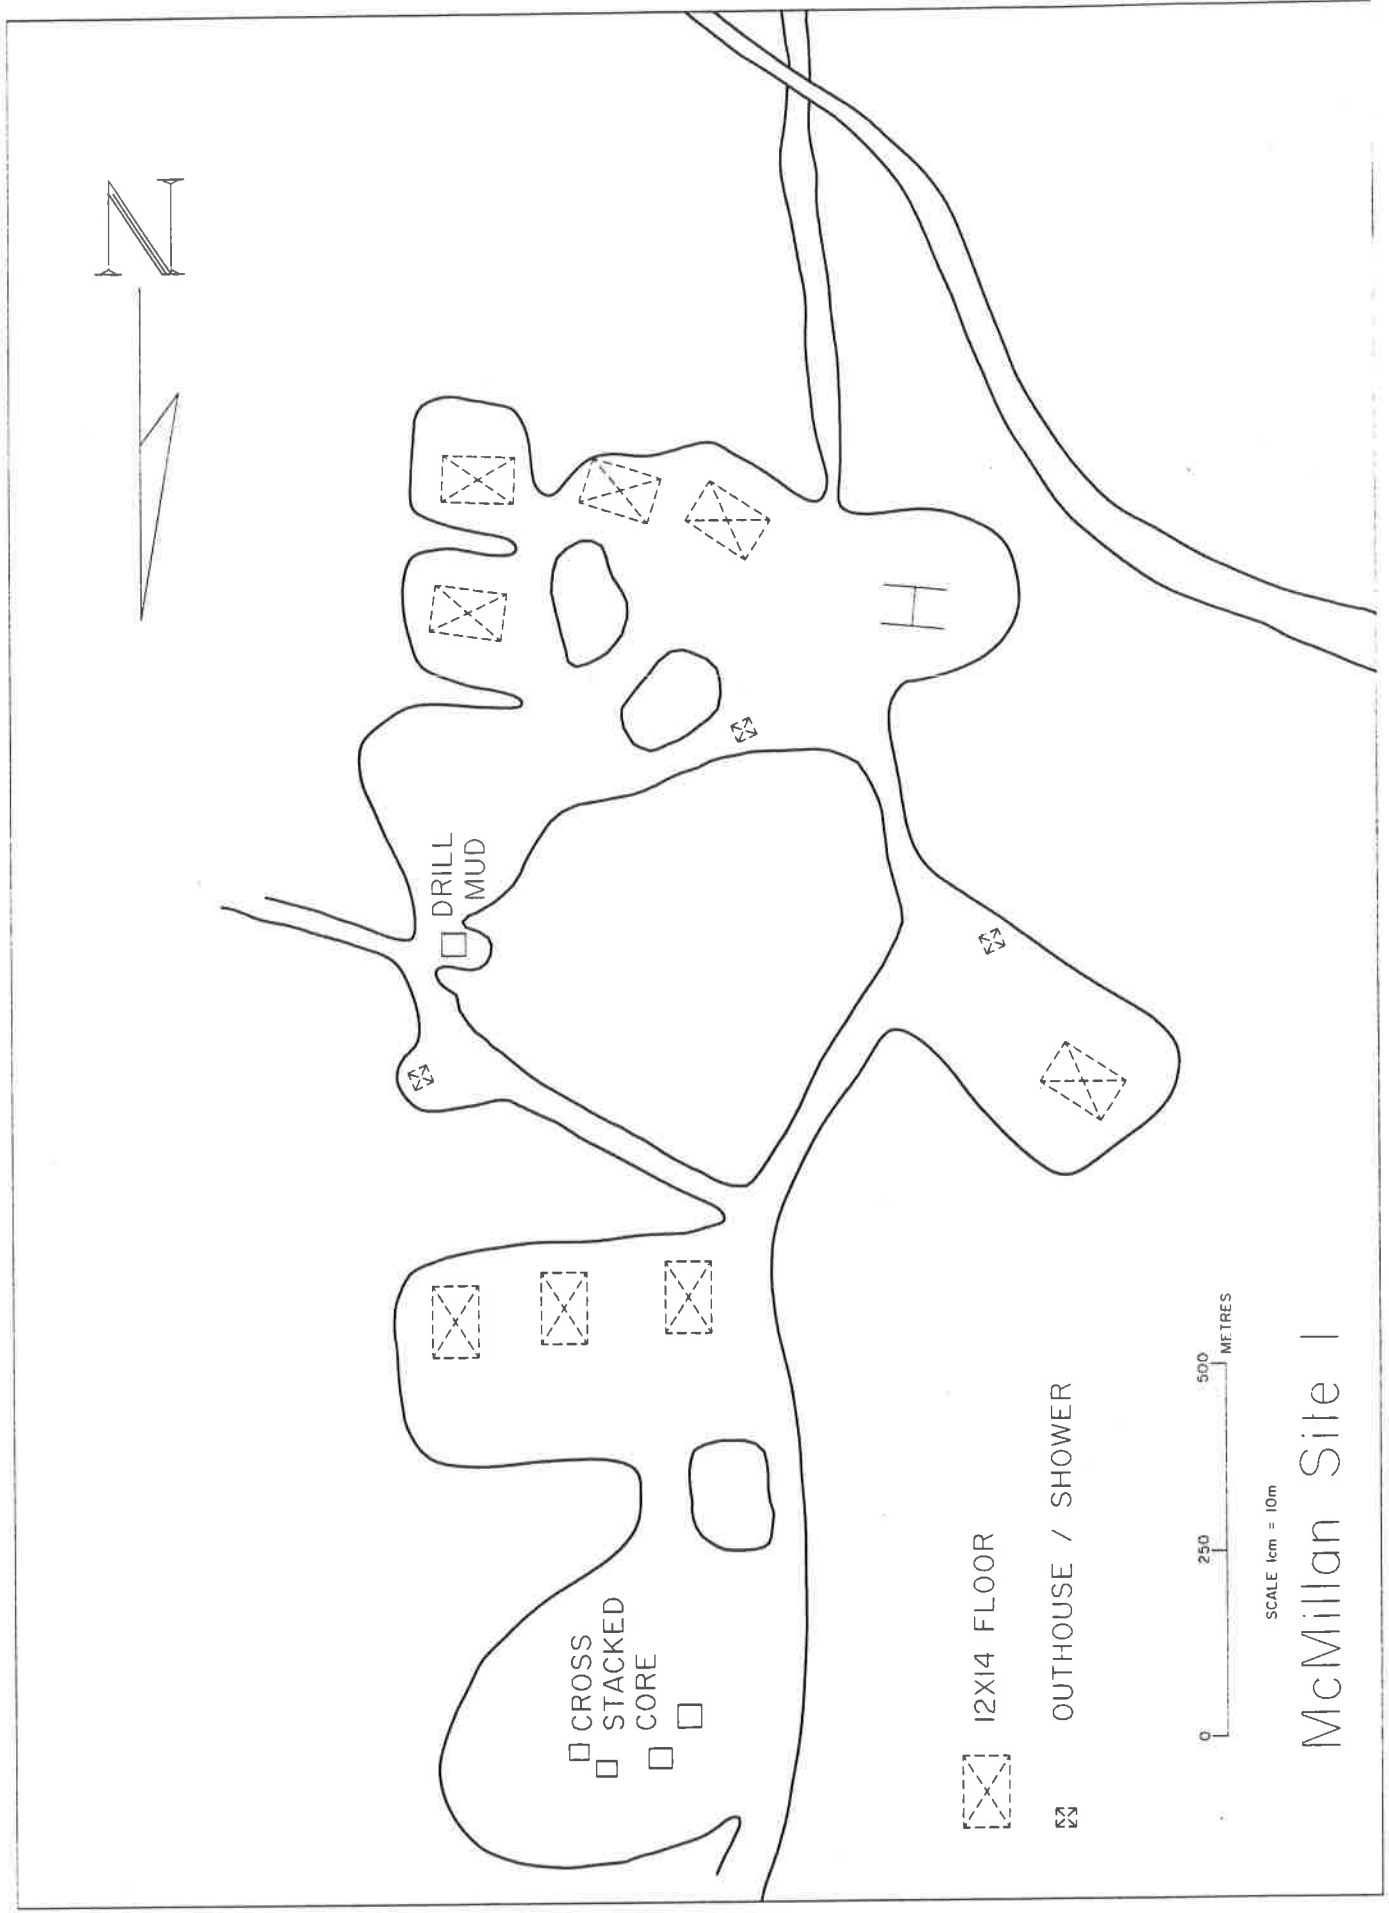
McMillan Site I

DRILL MUD

□ CROSS
 □ STACKED
 □ CORE

12X14 FLOOR

OUTHOUSE / SHOWER

- four piles of boxed drill core, labelled and cross stacked (see photo 4).
- pile of decomposed drill mud (see photo 5).

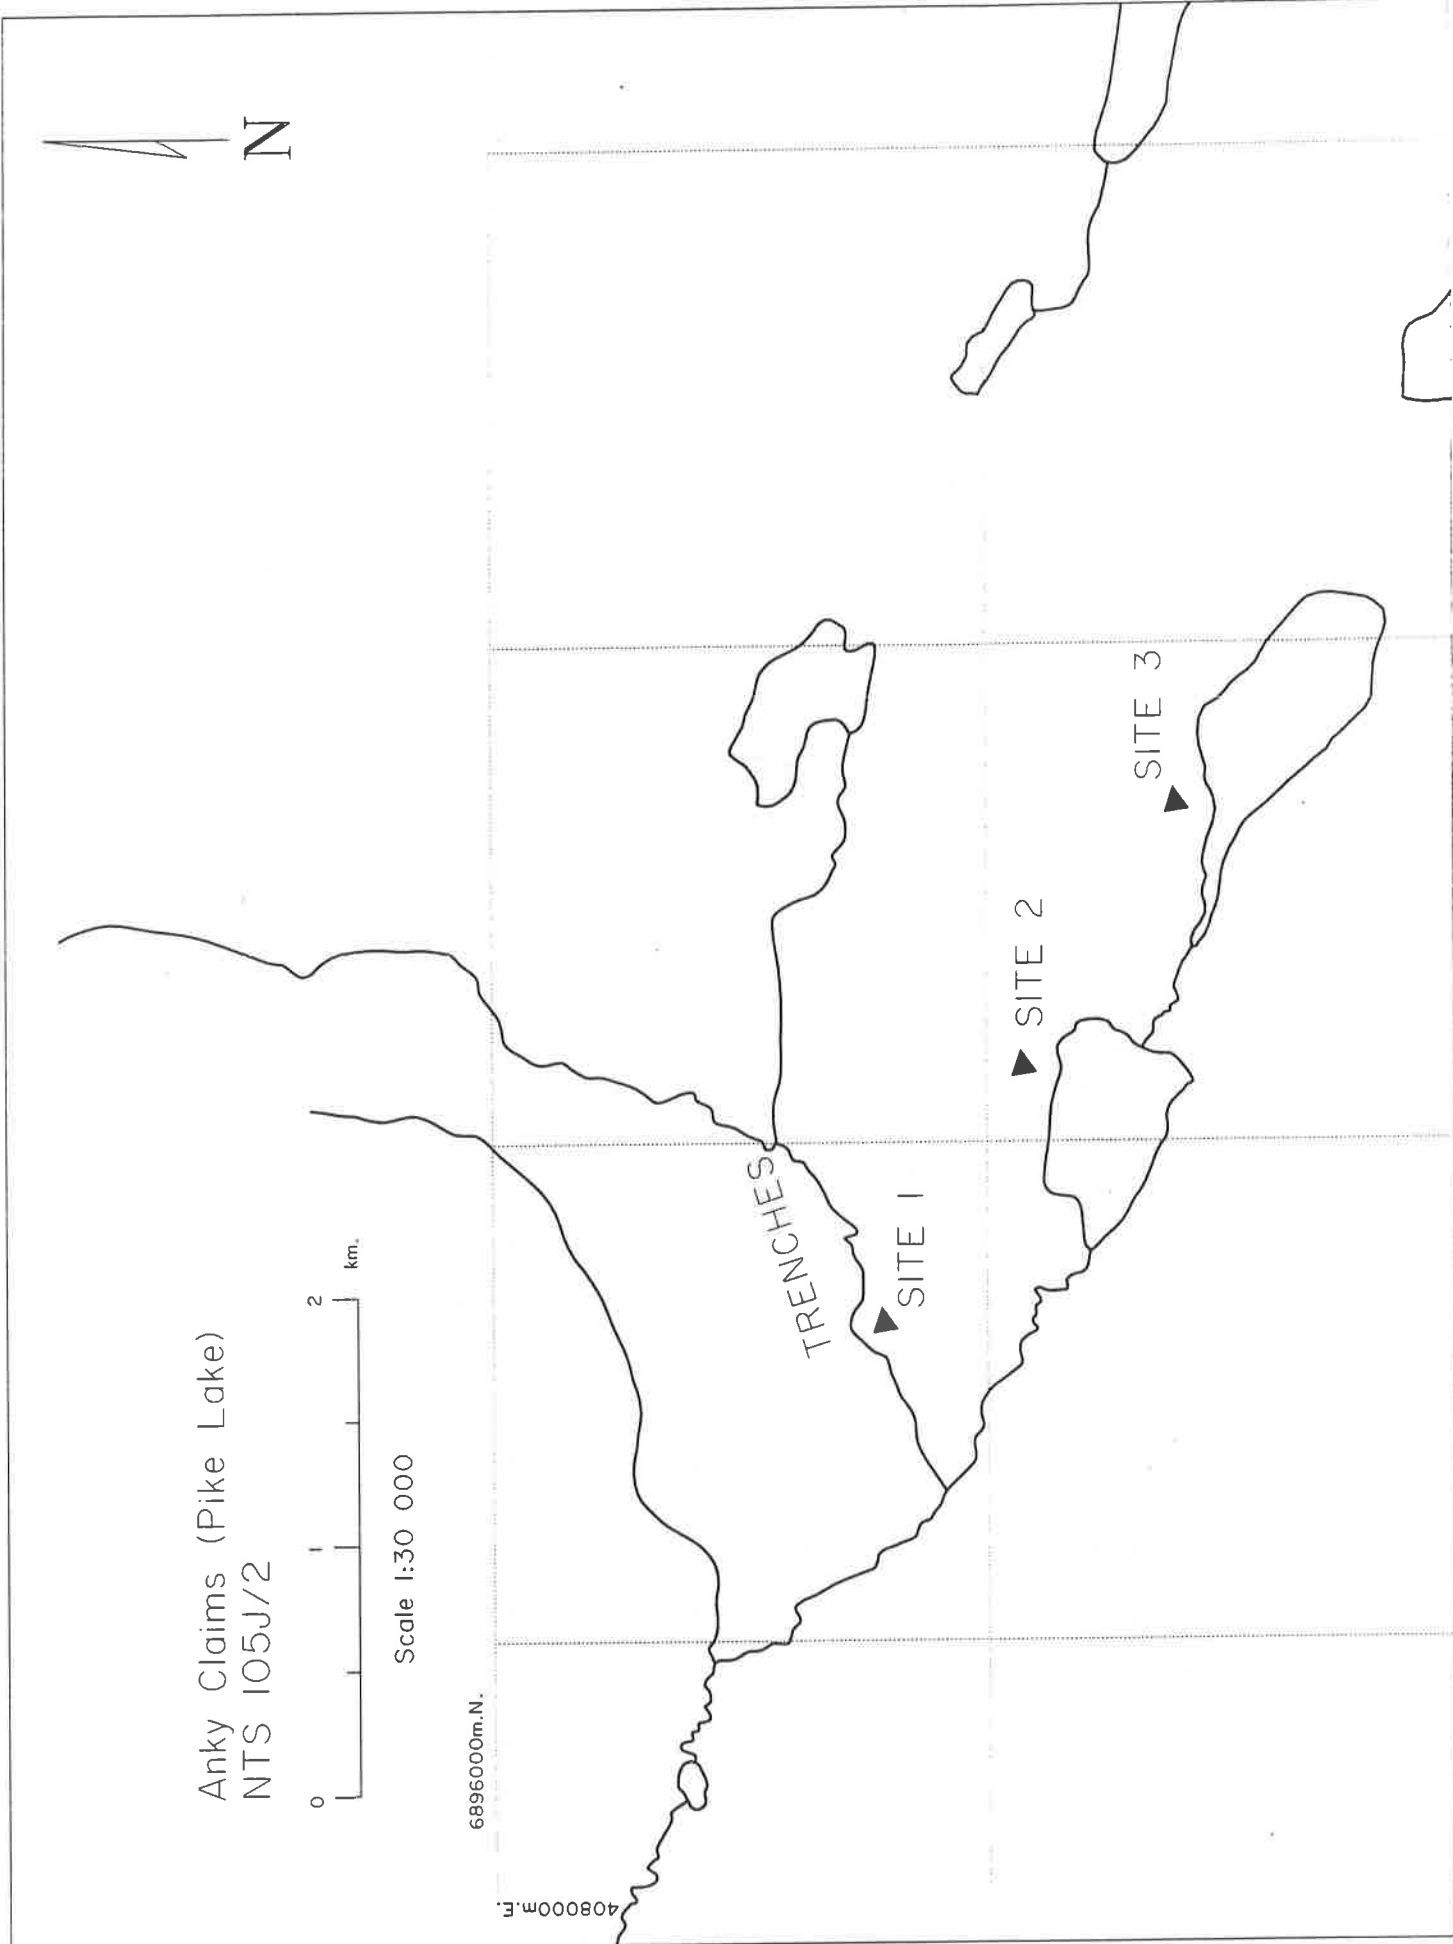
Photo 9: Site 1 - trenches in the main showing kill zone.

Trenches at this site are being reclaimed by natural revegetation (see photo 9).
