GEOLOGICAL SURVEY OF CANADA TOPICAL REPORT NO. 103

MACKENZIE RIVER DRAINAGE BASIN DAM SITE INVESTIGATION

UPPER CANYON DAM SITE (Frances River)

(MAP AND PRELIMINARY REPORT)

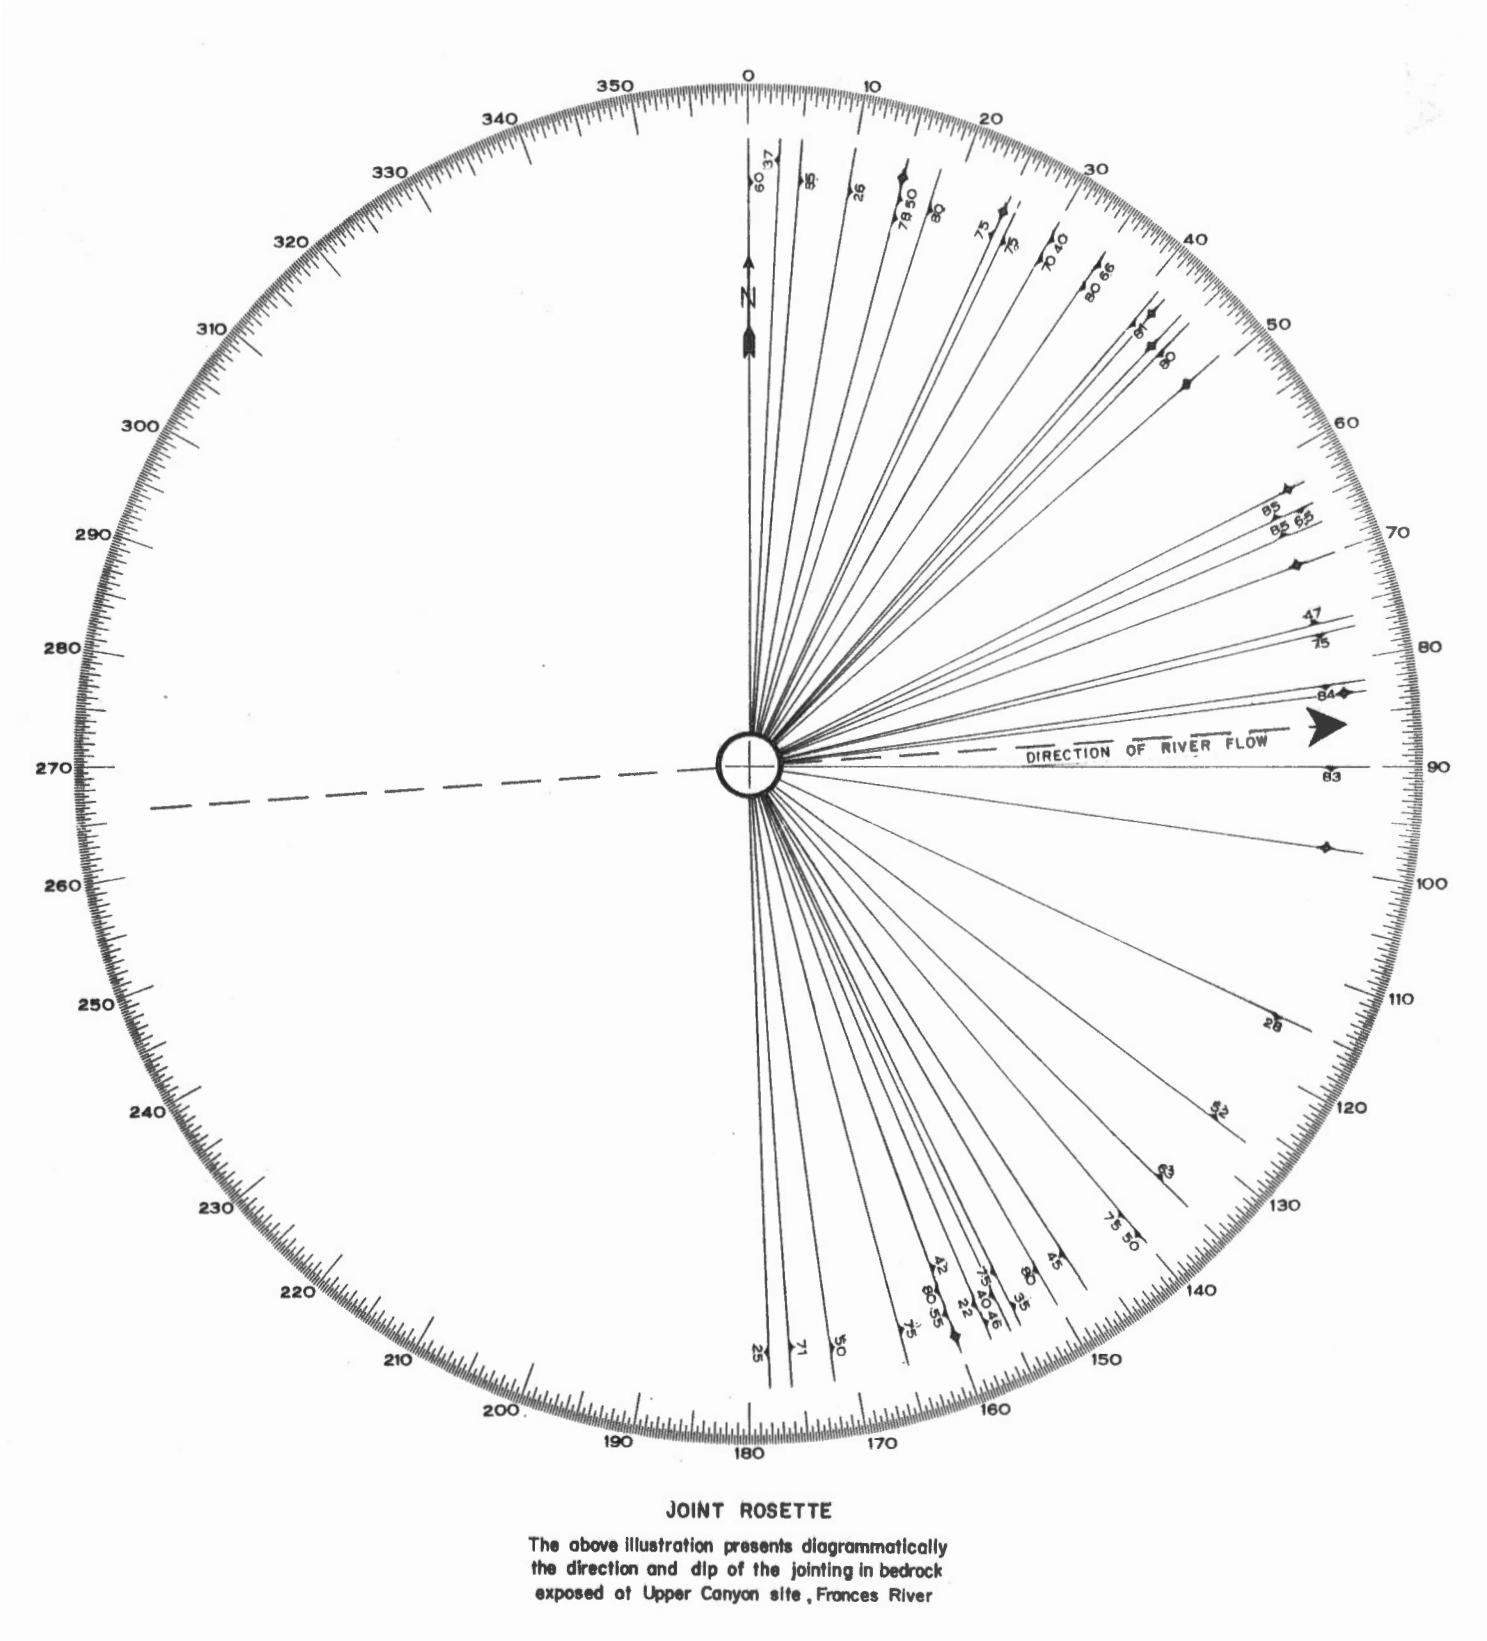
The above illustration presents diagrammatically the direction and dip of the bedding in bedrock exposed at Upper Canyon site, Frances River

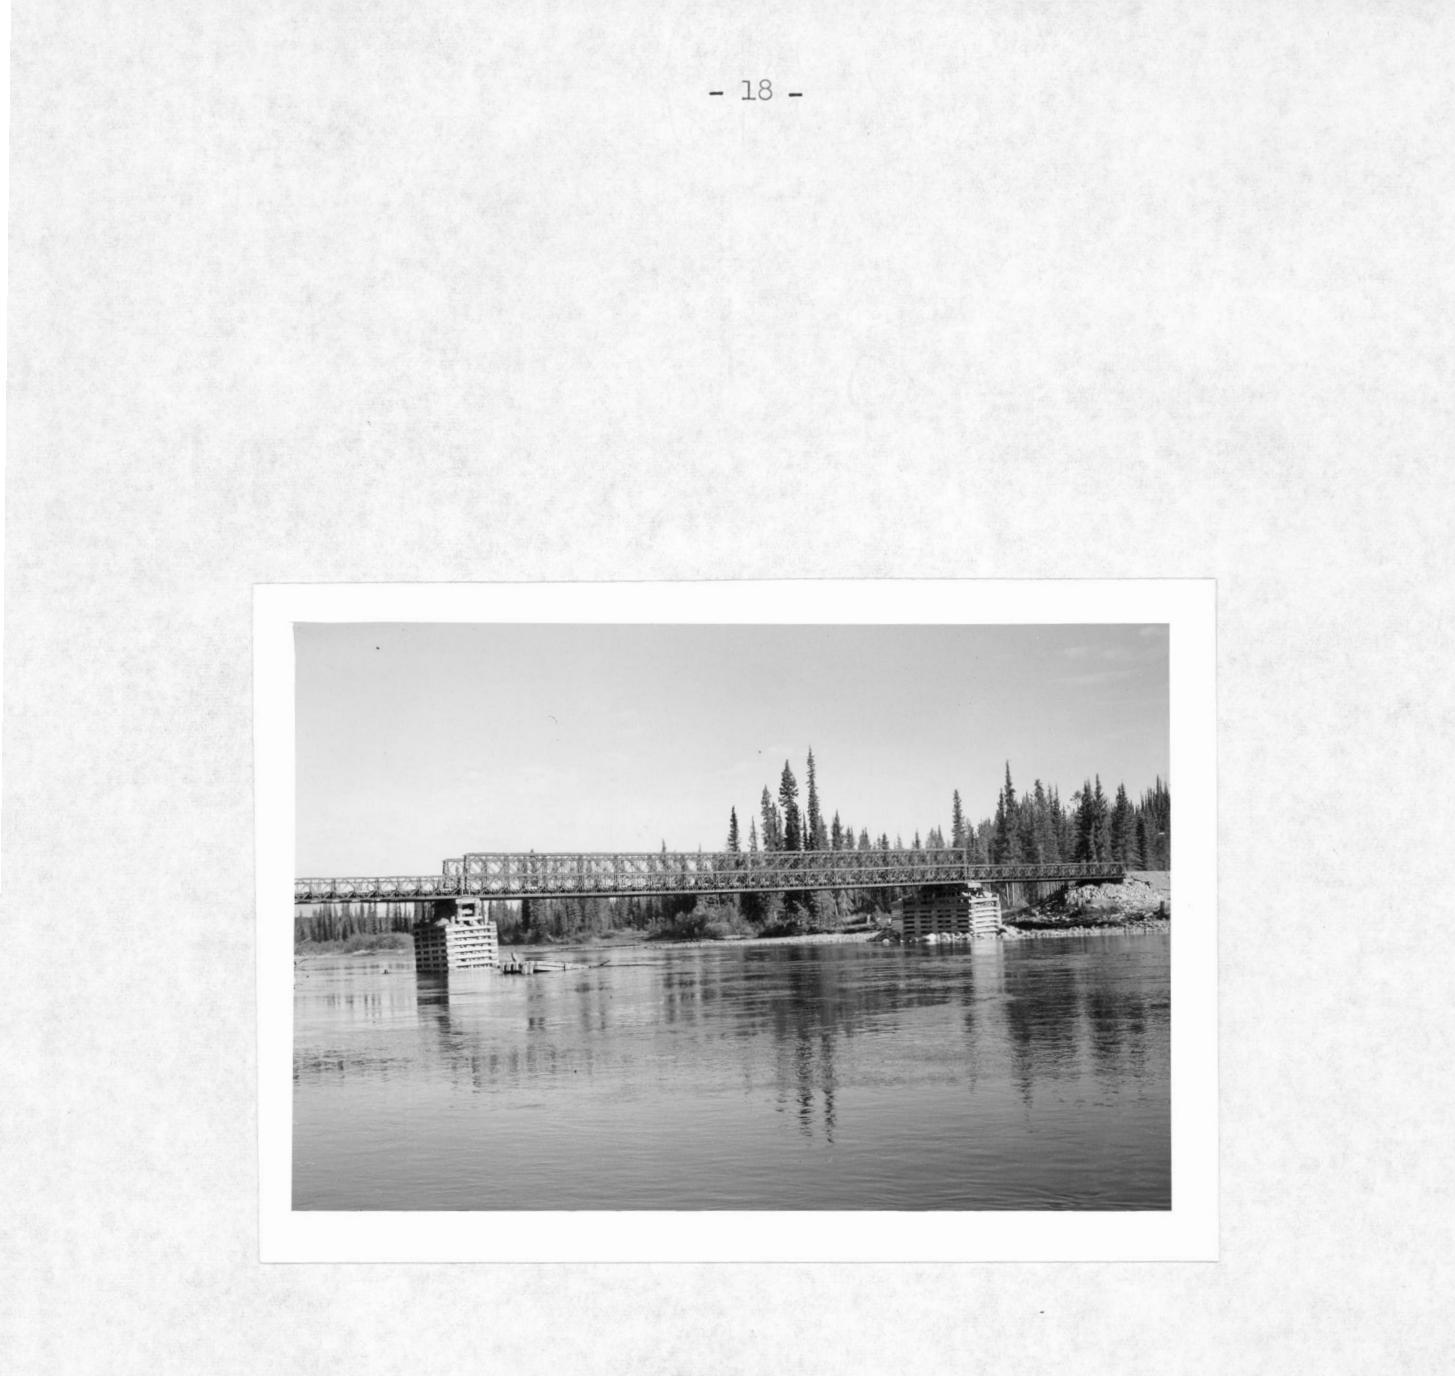
G.S.C. 9-8-63

Bridge over Frances River on Canada Tungsten Mines Road about one mile downstream from Upper Canyon dam site.

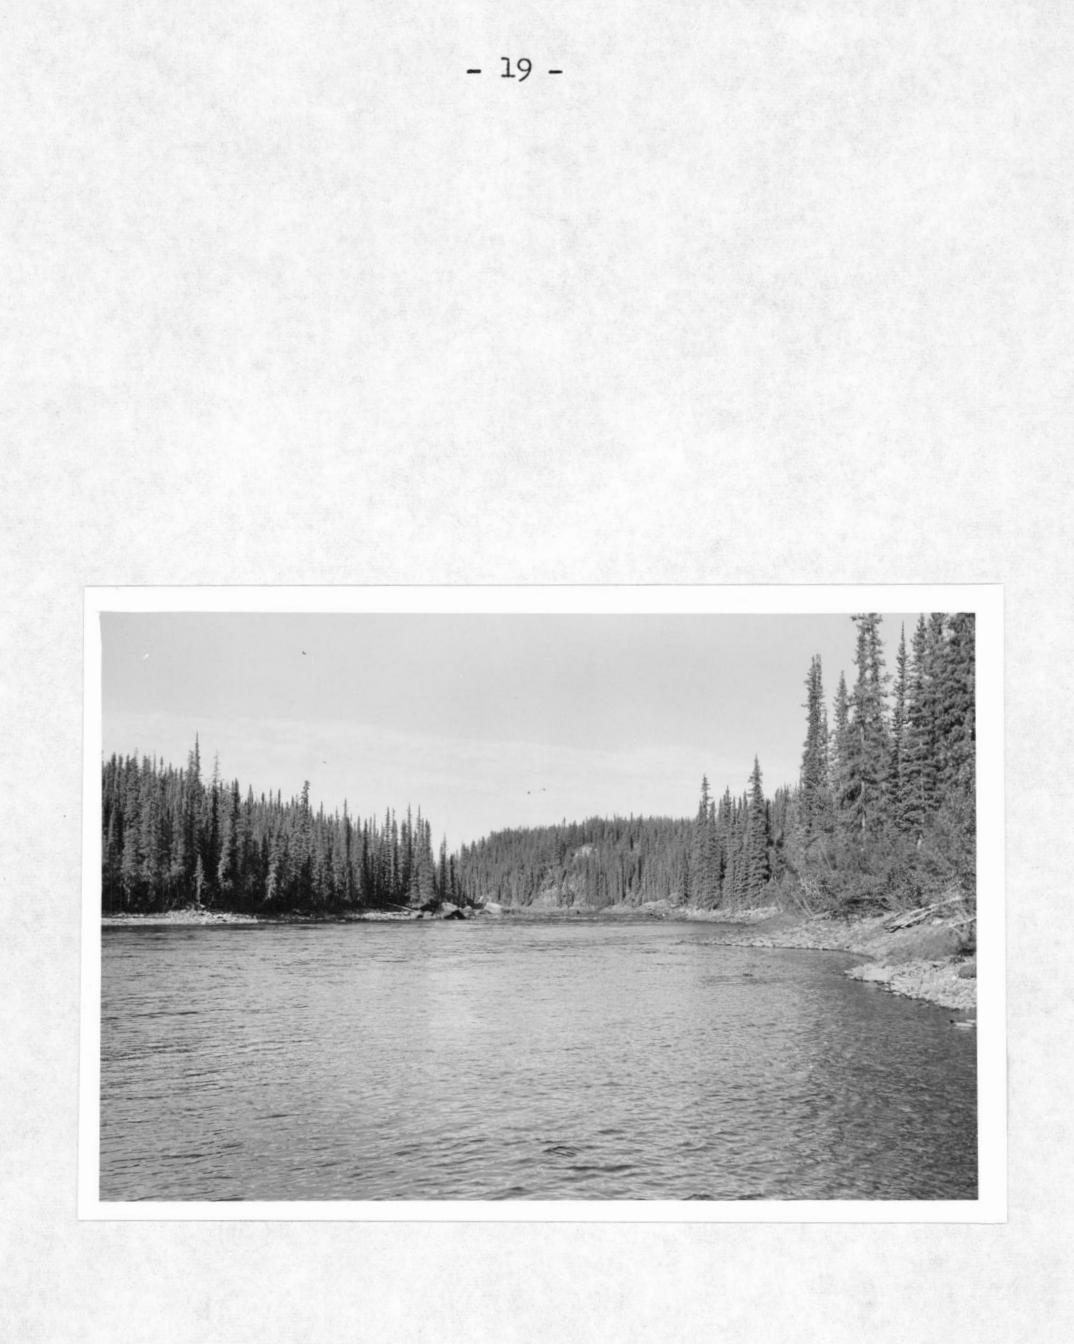
G.S.C. 10-1-63

View looking upstream toward lower end of Upper Canyon, Frances River.

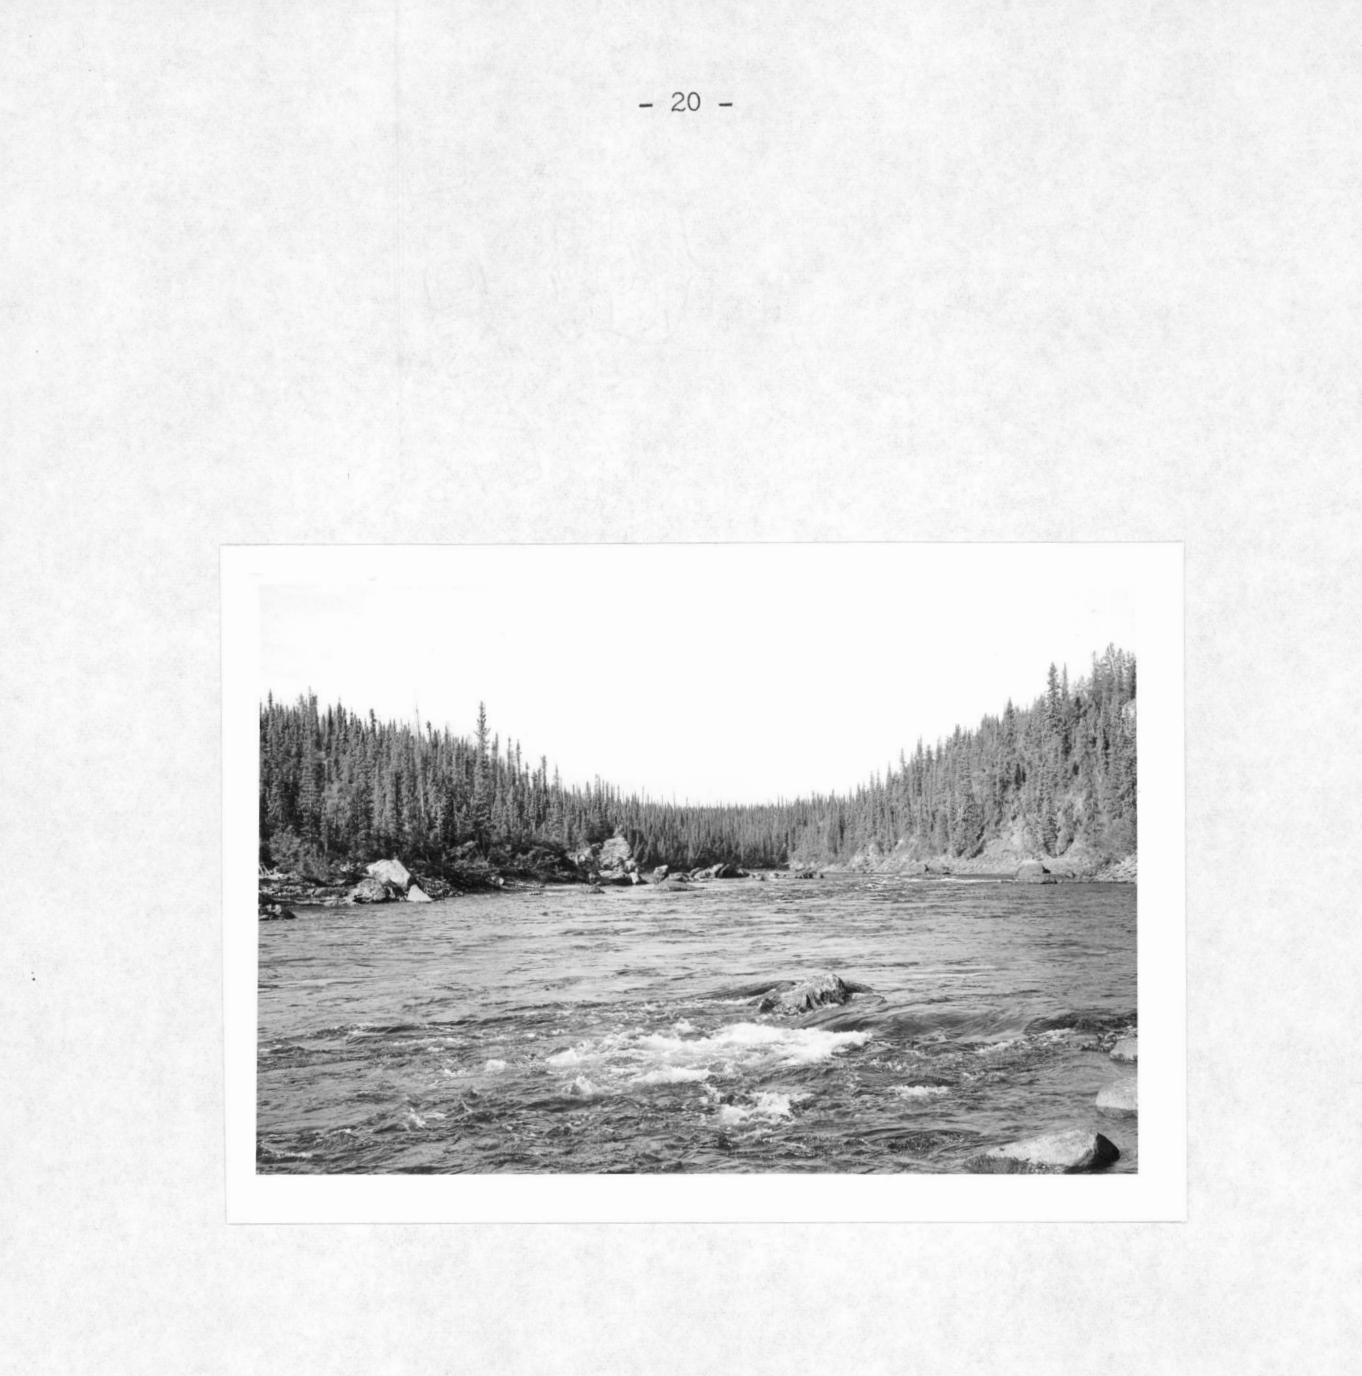
G.S.C. 10-2-63

View looking upstream into Upper Canyon from its lower end.
