GEOLOGICAL SURVEY OF CANADA  
TOPICAL REPORT NO. 105

YUKON RIVER DRAINAGE BASIN  
DAM SITE INVESTIGATION

SITE No. 27

**HOOLE CANYON DAM SITE**  
(Map and Preliminary Report)

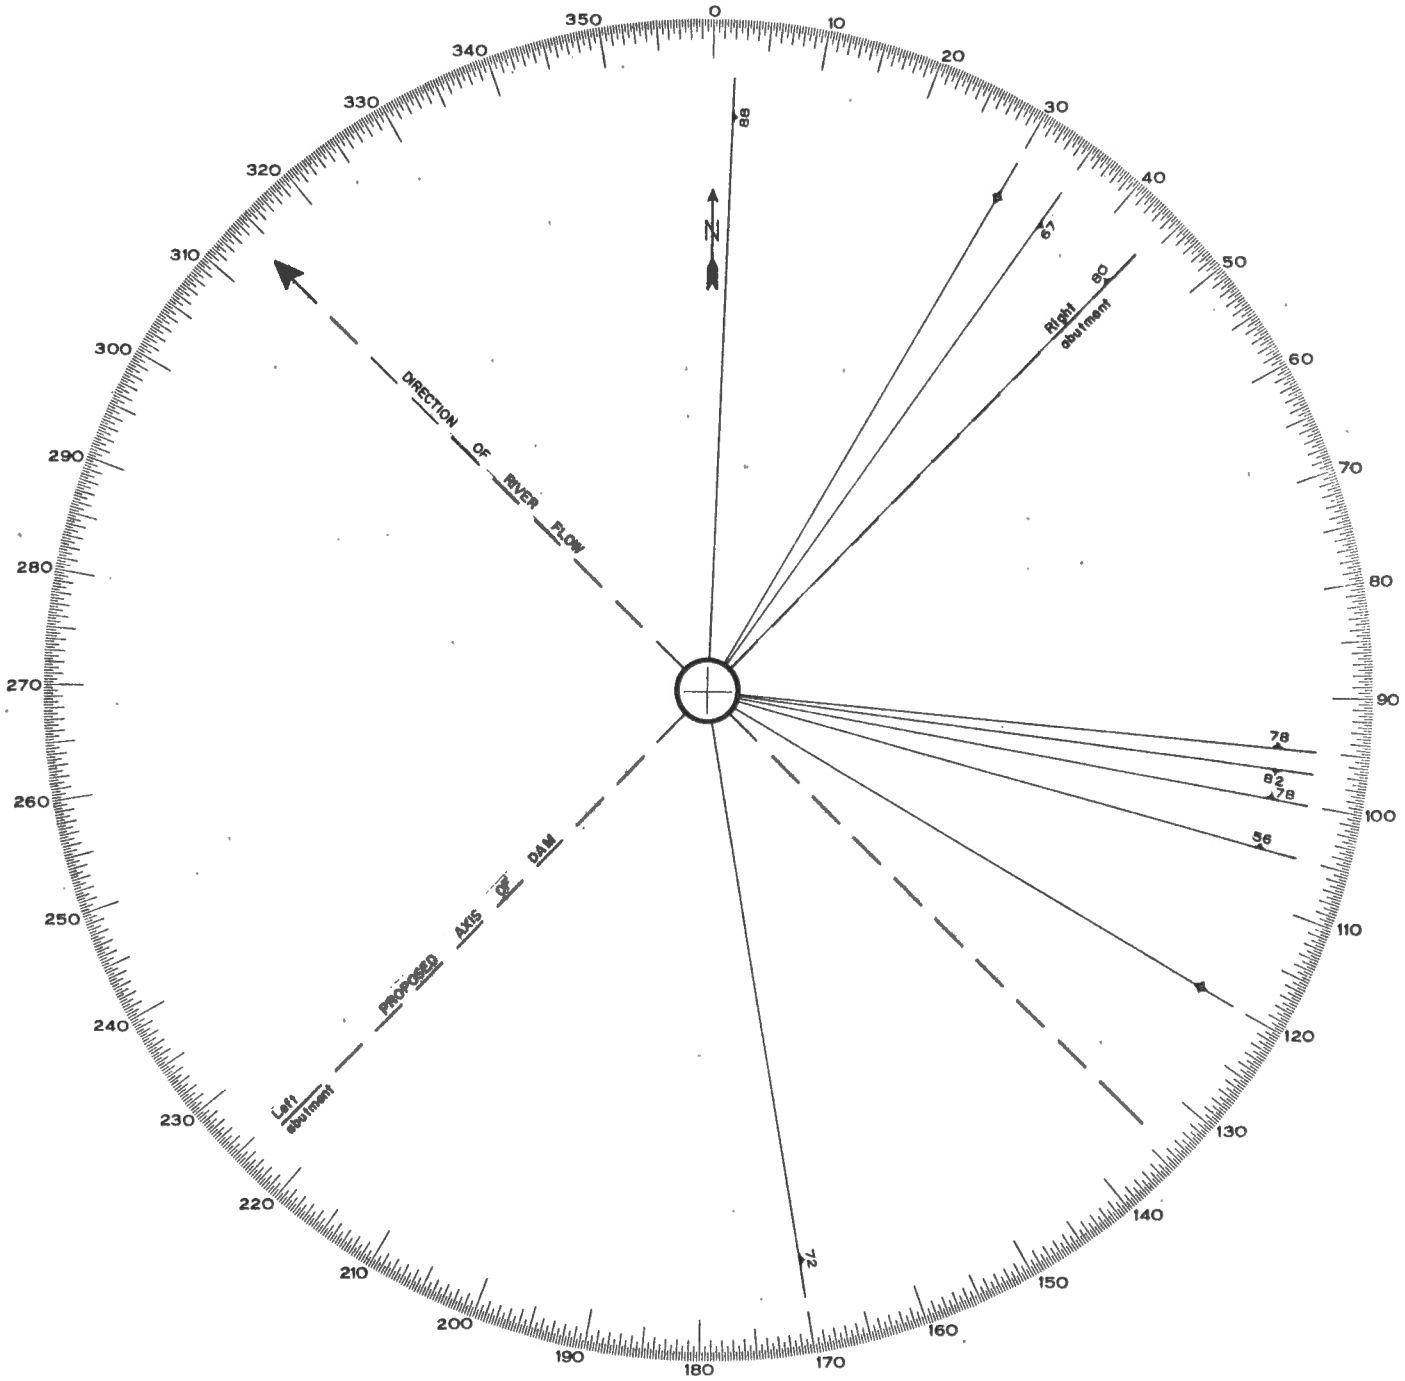
**BEDDING ROSETTE**

The above illustration presents diagrammatically the direction and dip of bedding in limestone exposed at Hoole Canyon dam site.

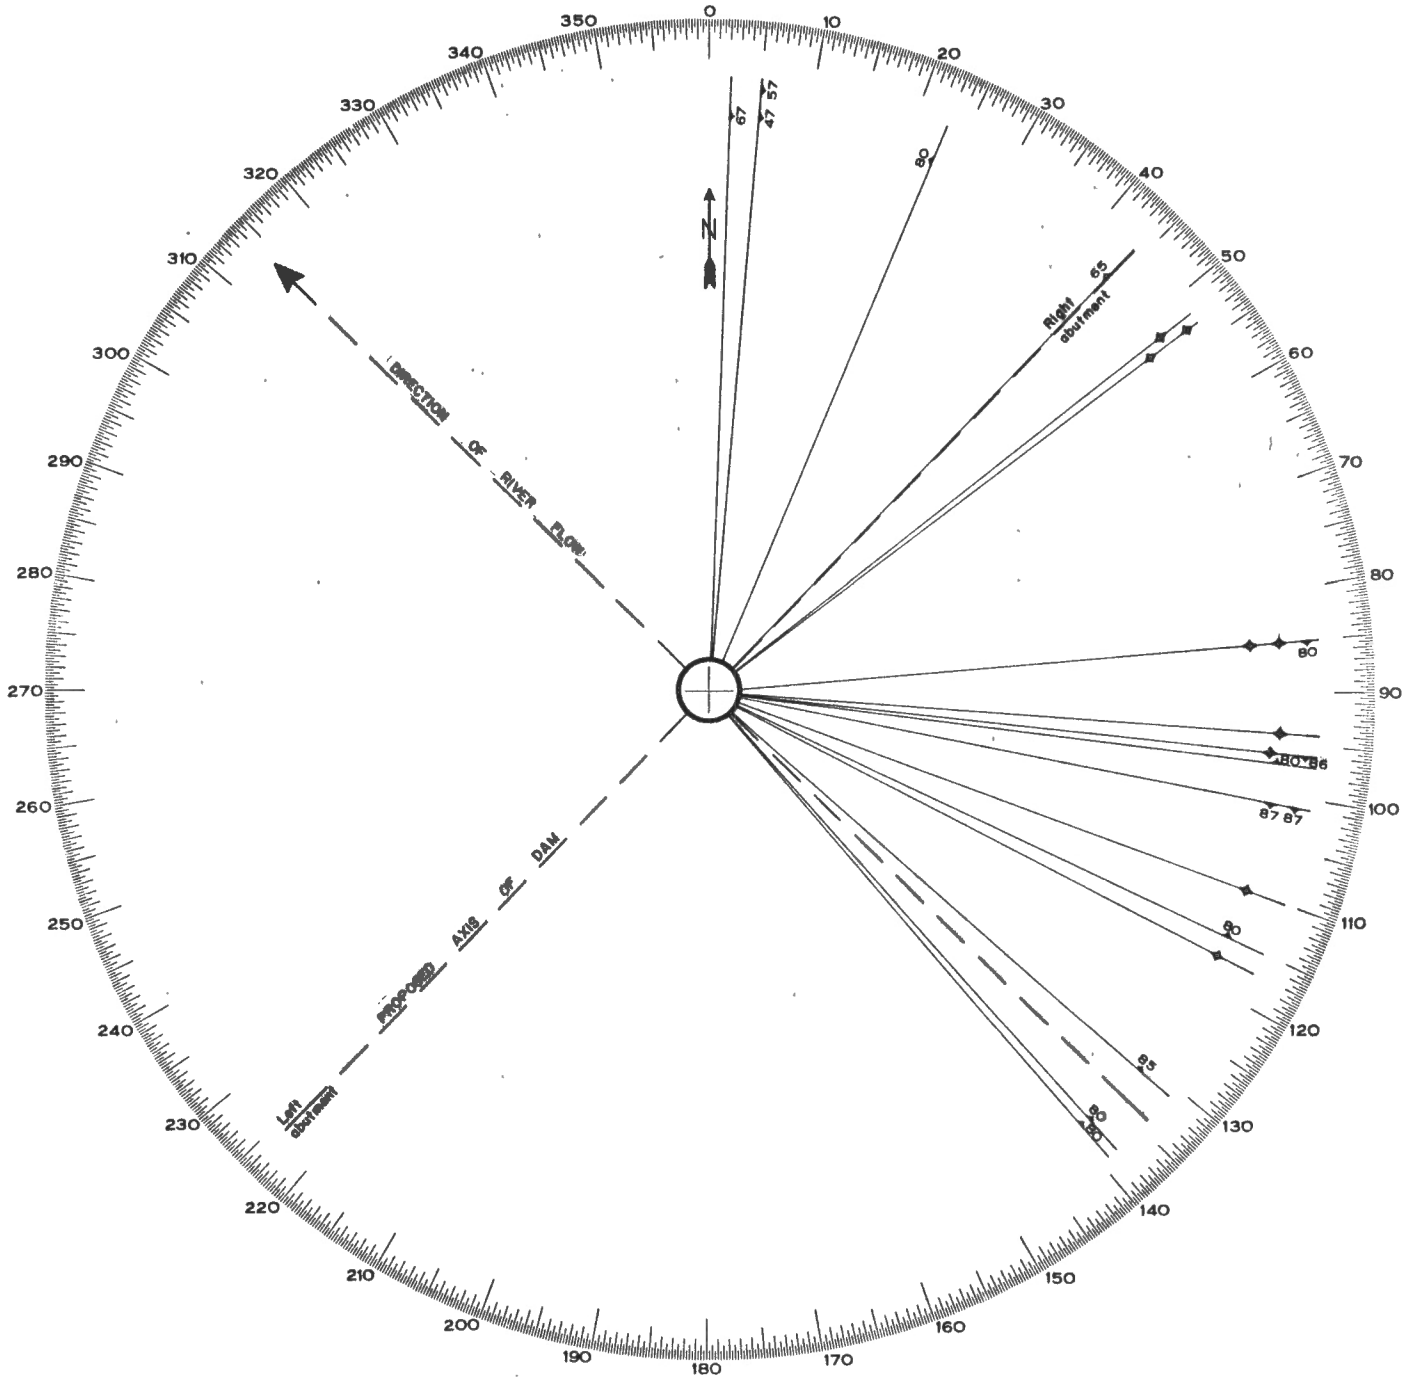
BEDDING ROSETTE

The above illustration presents diagrammatically the direction and dip of bedding in quartzite exposed at Hoole Canyon dam site.

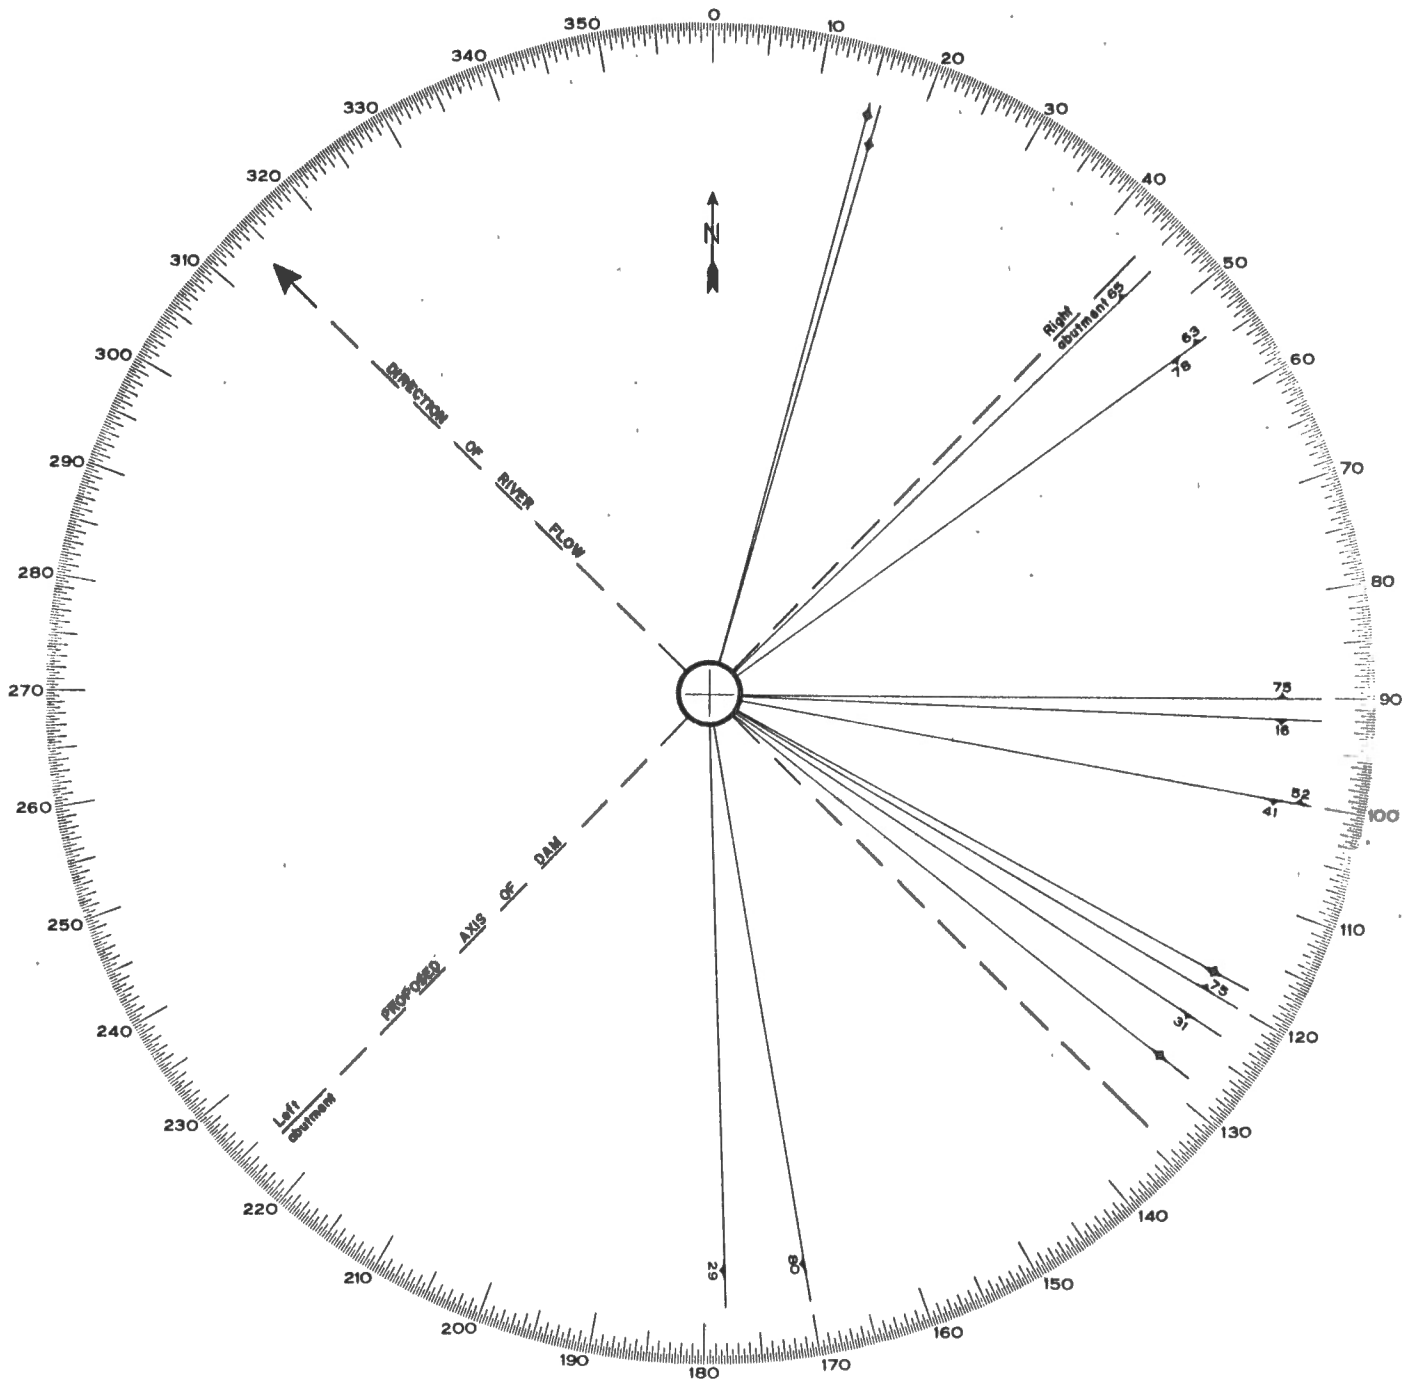
JOINT ROSETTE

The above illustration presents diagrammatically the direction and dip of jointing in limestone exposed at Hoole Canyon dam site

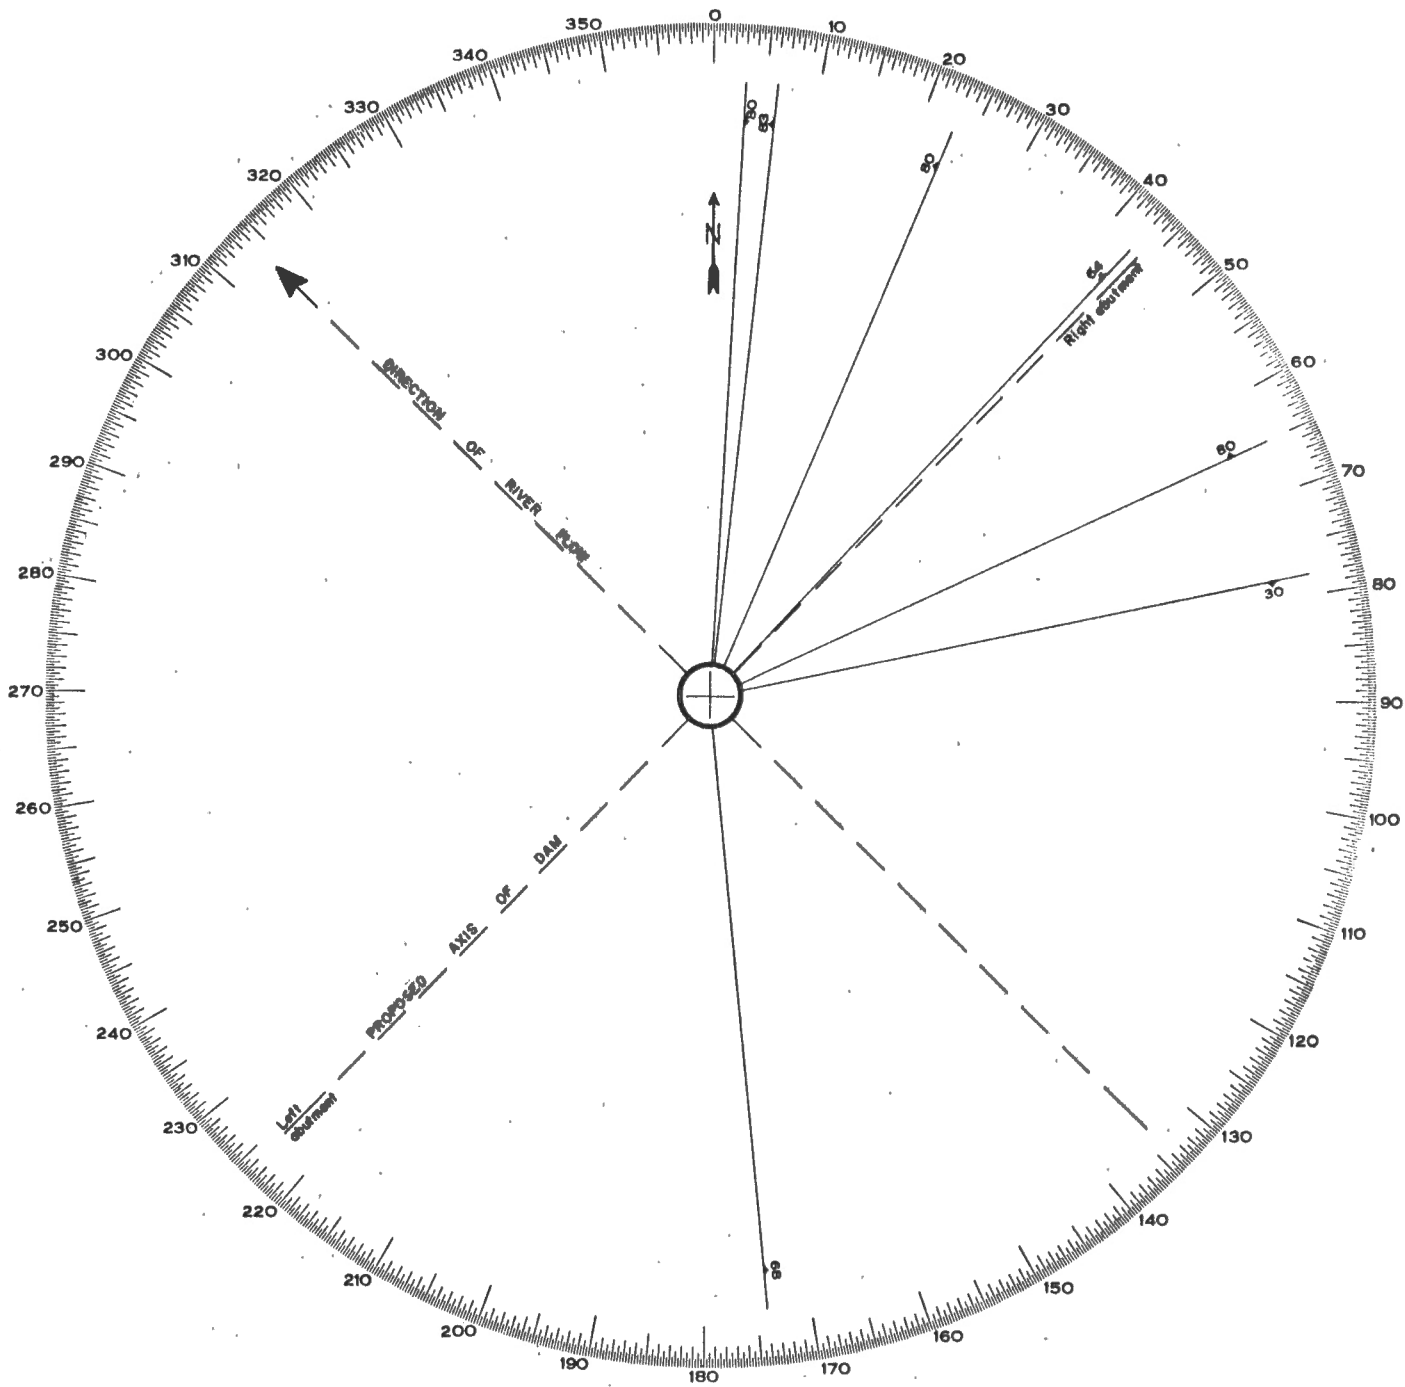
**JOINT ROSETTE**

The above illustration presents diagrammatically the direction and dip of jointing in quartzite exposed at Hoole Canyon dam site.
