YUKON RIVER DRAINAGE BASIN
DAM SITE INVESTIGATION

SITE No. 18

DETOUR DAM SITE
(MAP AND PRELIMINARY REPORT)

BY
E. B. OWEN

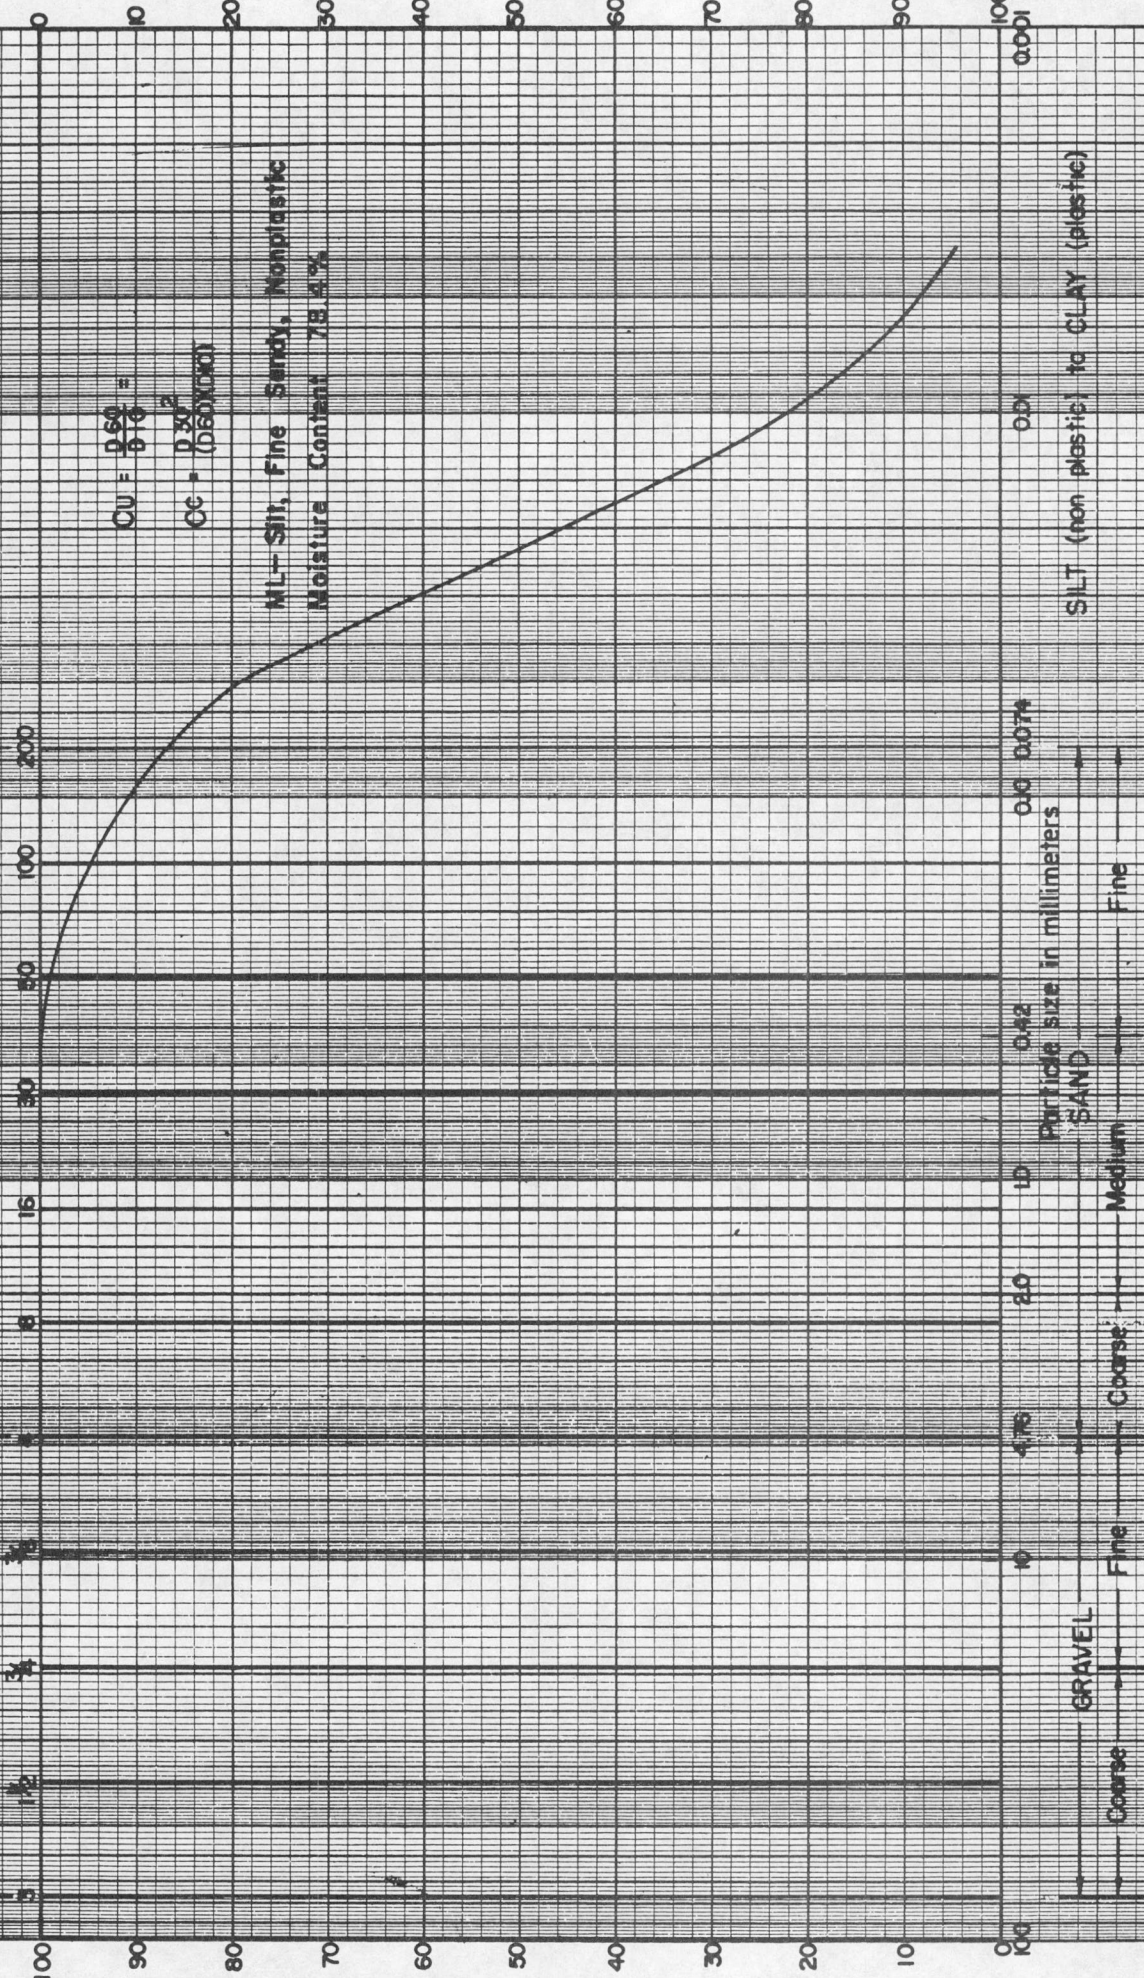
$CU = \frac{D_{60}}{D_{10}} = \frac{0.25}{0.075} = 3.33$
 $CC = \frac{D_{30}^2}{(D_{60} \times D_{10})} = \frac{0.15^2}{(0.25 \times 0.075)} = 1.2$

ML-Silt, Fine Sandy, Nonplastic
 Moisture Content 78.4%

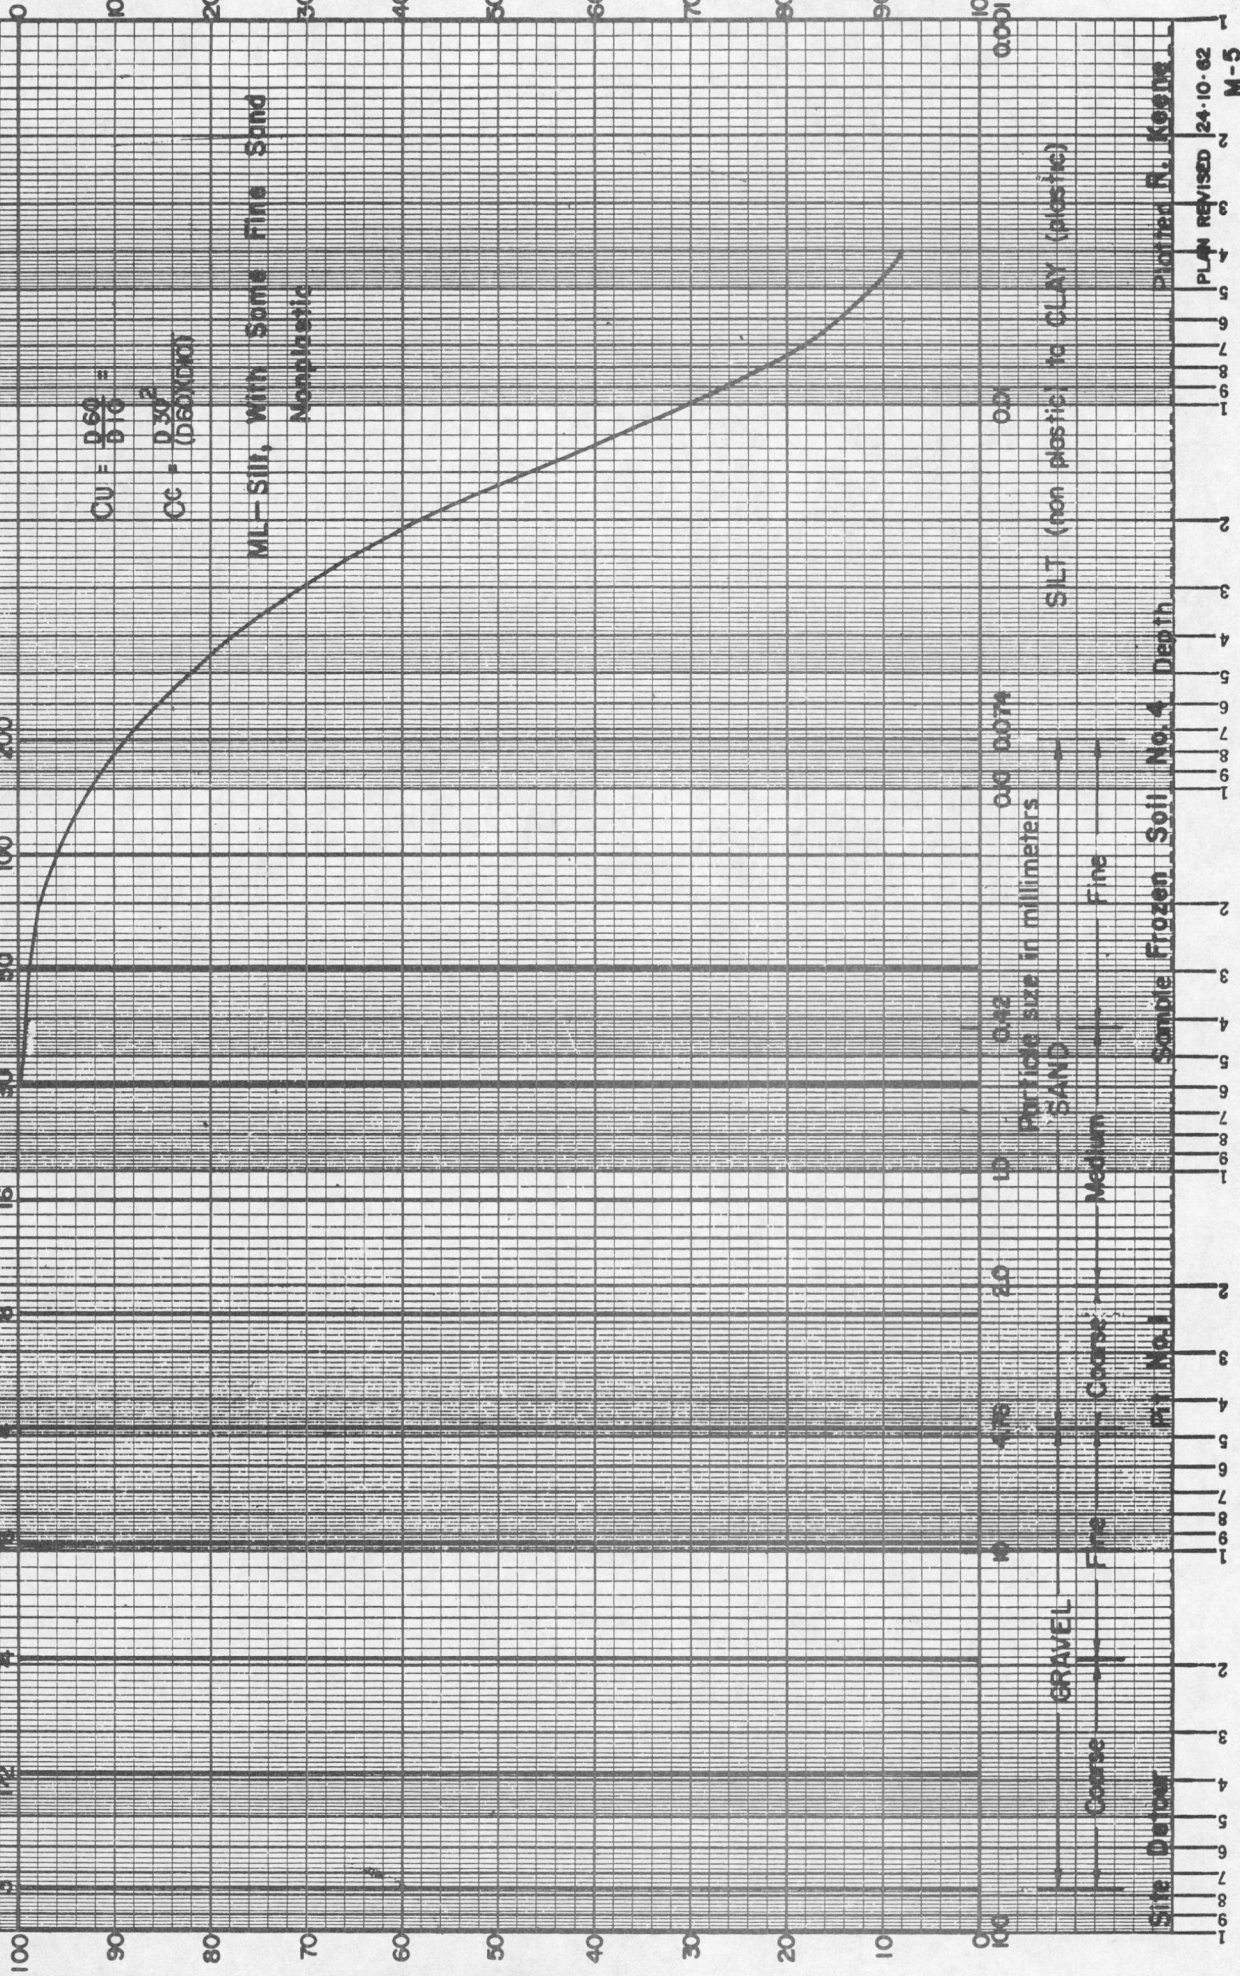
$U.C.U. = \frac{D_{60}}{D_{10}} = 0.60$
 $C.C. = \frac{D_{30}^2}{D_{10} D_{60}} = 0.30$

ML-Silt, With Some Fine Sand
Nonplastic

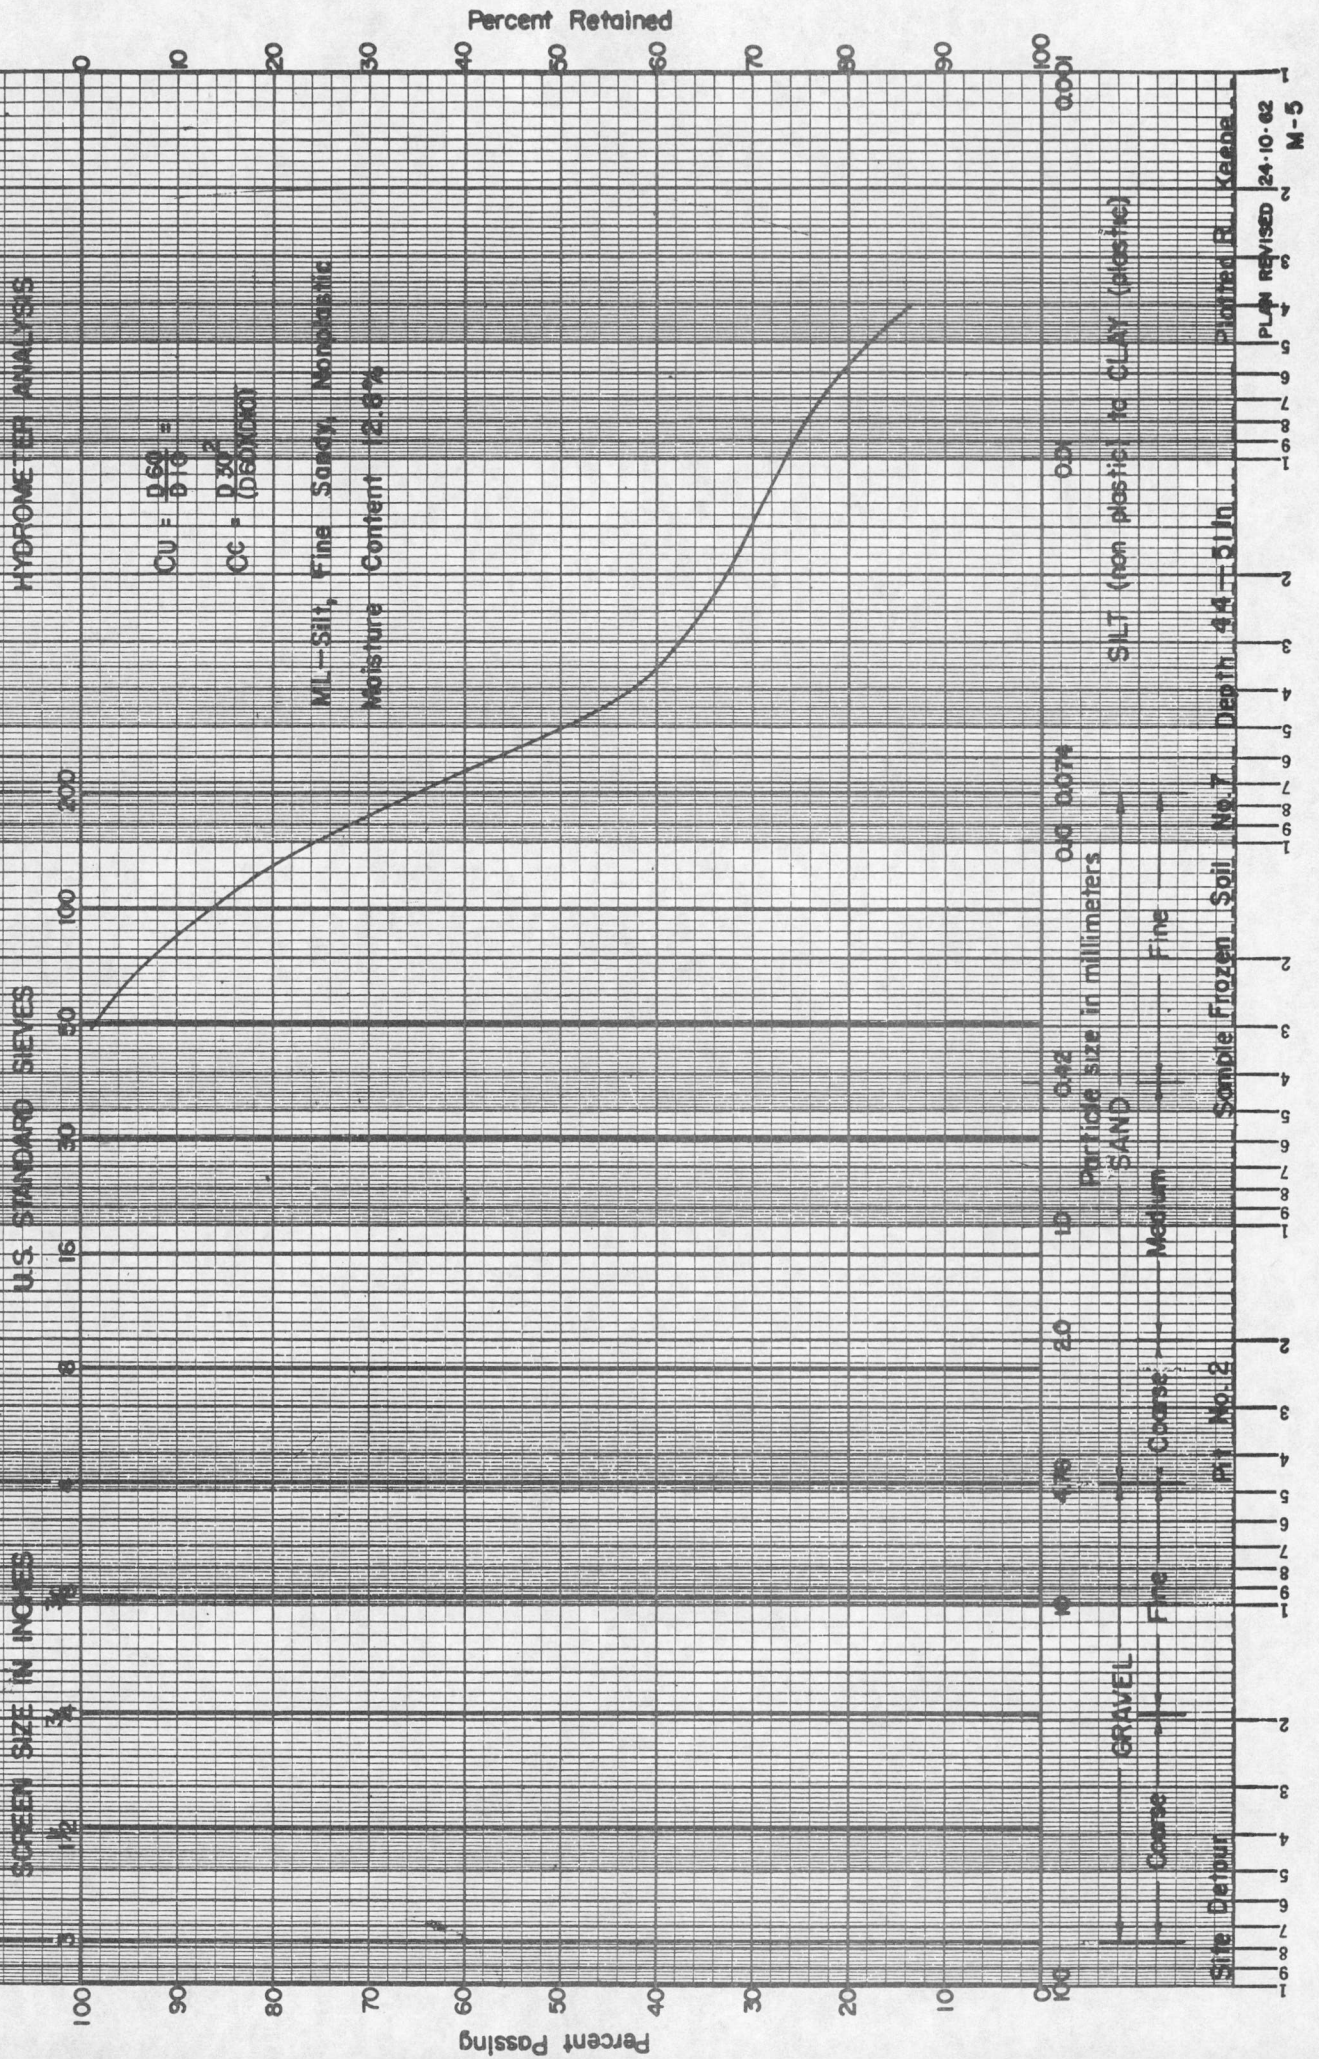
$CU = \frac{D_{60}}{D_{10}} =$
 $CC = \frac{D_{20}^2}{(D_{10}D_{60})}$

ML-Silt, Fine Sandy, Nonplastic
Moisture Content 12.8%
