GEOLOGICAL SURVEY OF CANADA
TOPICAL REPORT NO. 41

MACKENZIE RIVER DRAINAGE BASIN
DAM SITE INVESTIGATION

SITE NO. 3

LOWER CANYON DAM SITE
(MAP AND PRELIMINARY REPORT)

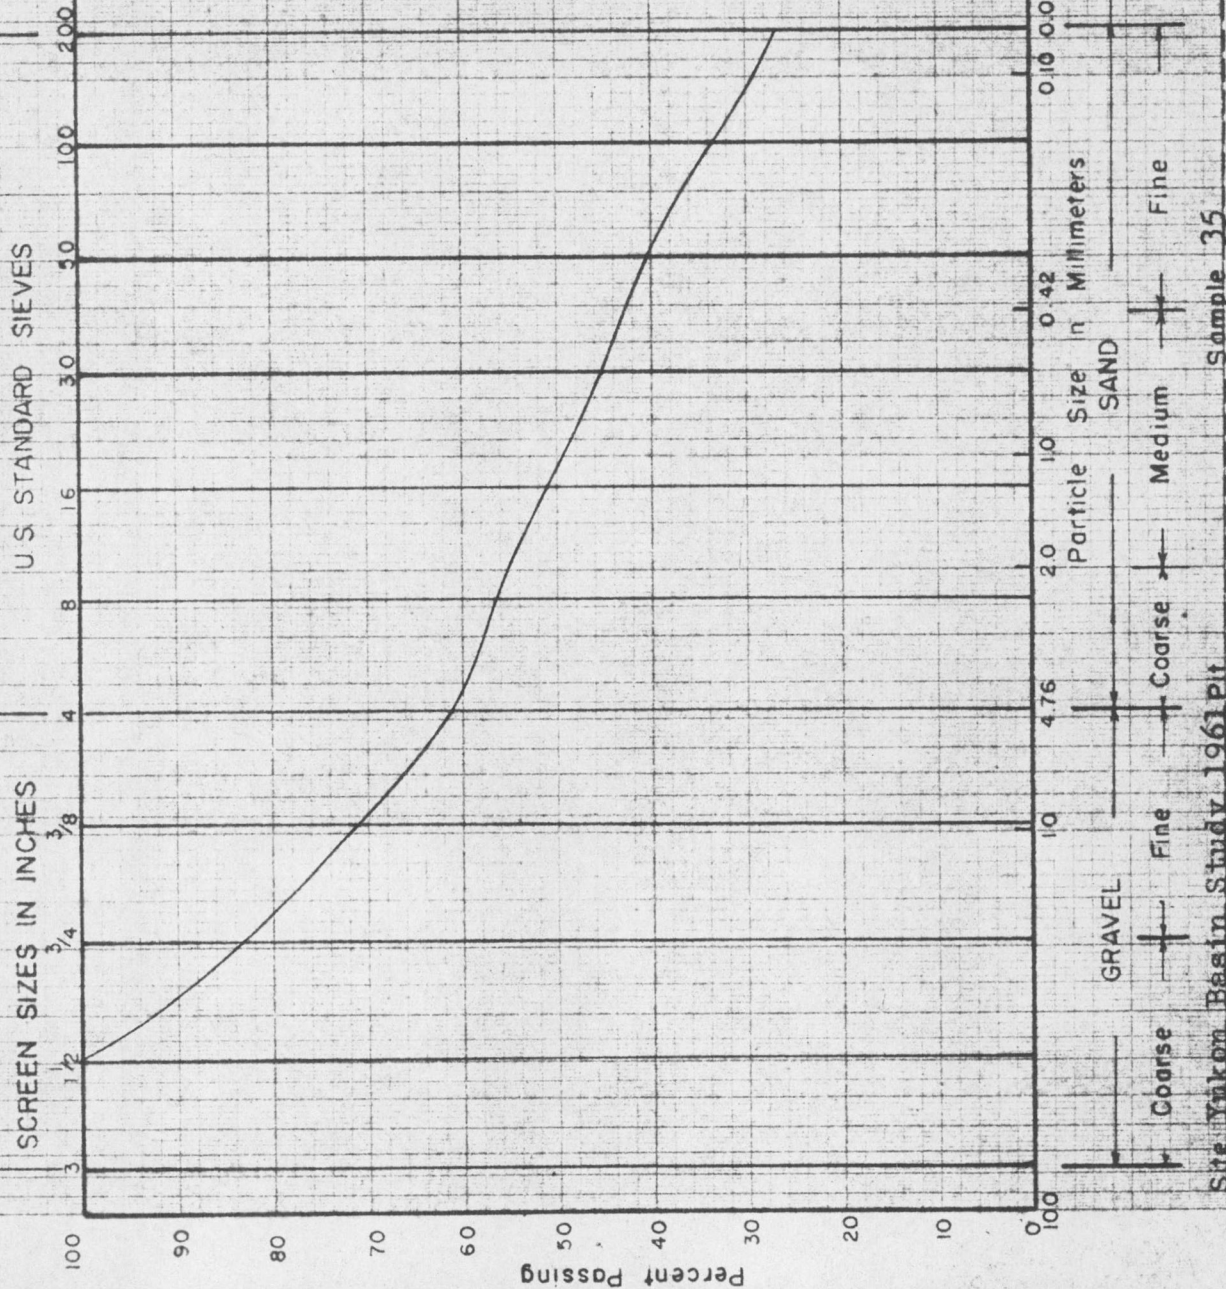
DEPARTMENT OF NORTHERN AFFAIRS & NATIONAL RESOURCES

Liquid limit 35.8
 Plastic limit 19.9
 Classification CL
