GEOLOGICAL SURVEY OF CANADA  
TOPICAL REPORT NO. 86

86  
YUKON RIVER DRAINAGE BASIN  
DAM SITE INVESTIGATION

SITES Nos. 34 AND 35

UPPER AND LOWER PORCUPINE CANYON DAM SITES  
(MAPS AND PRELIMINARY REPORT)

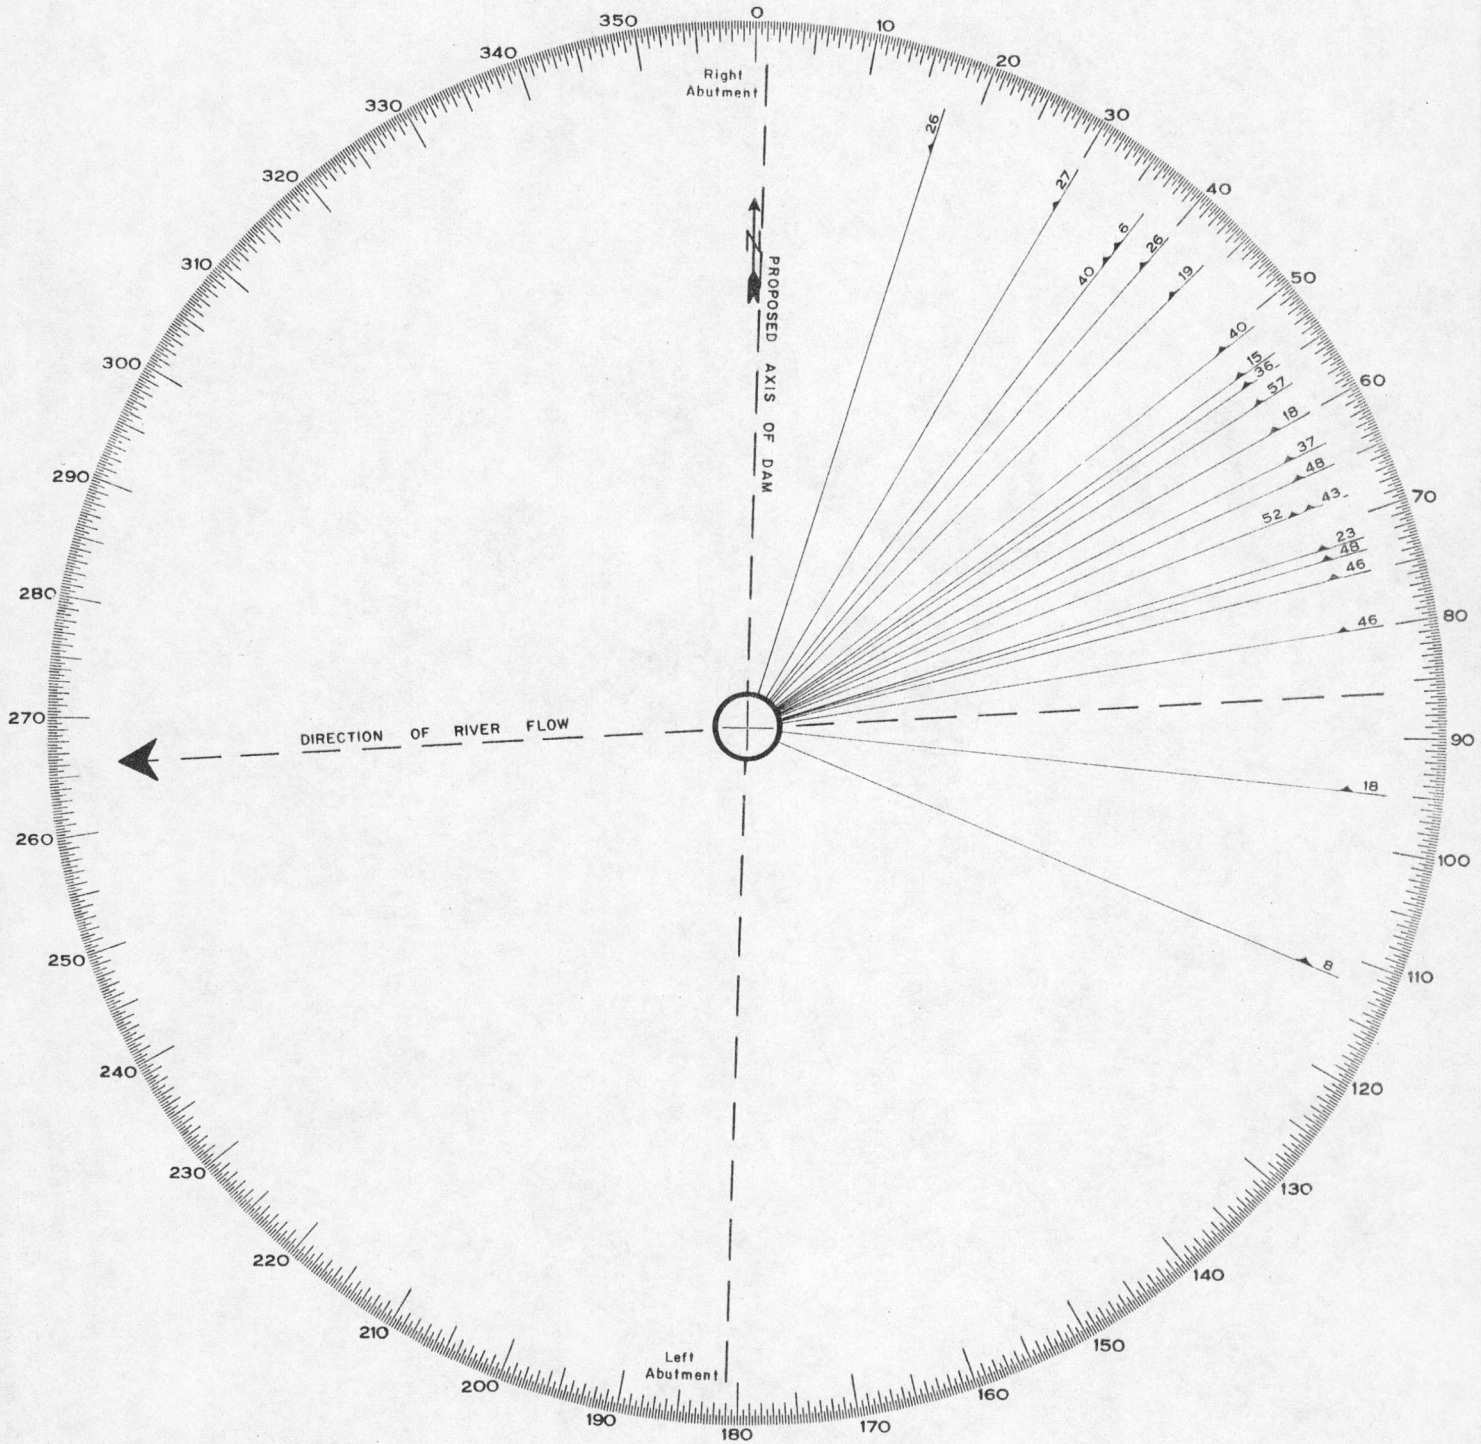
# BEDDING ROSETTE

The above illustration presents diagrammatically the direction and dip of bedding in bedrock exposed at Porcupine Canyon site (Upper)

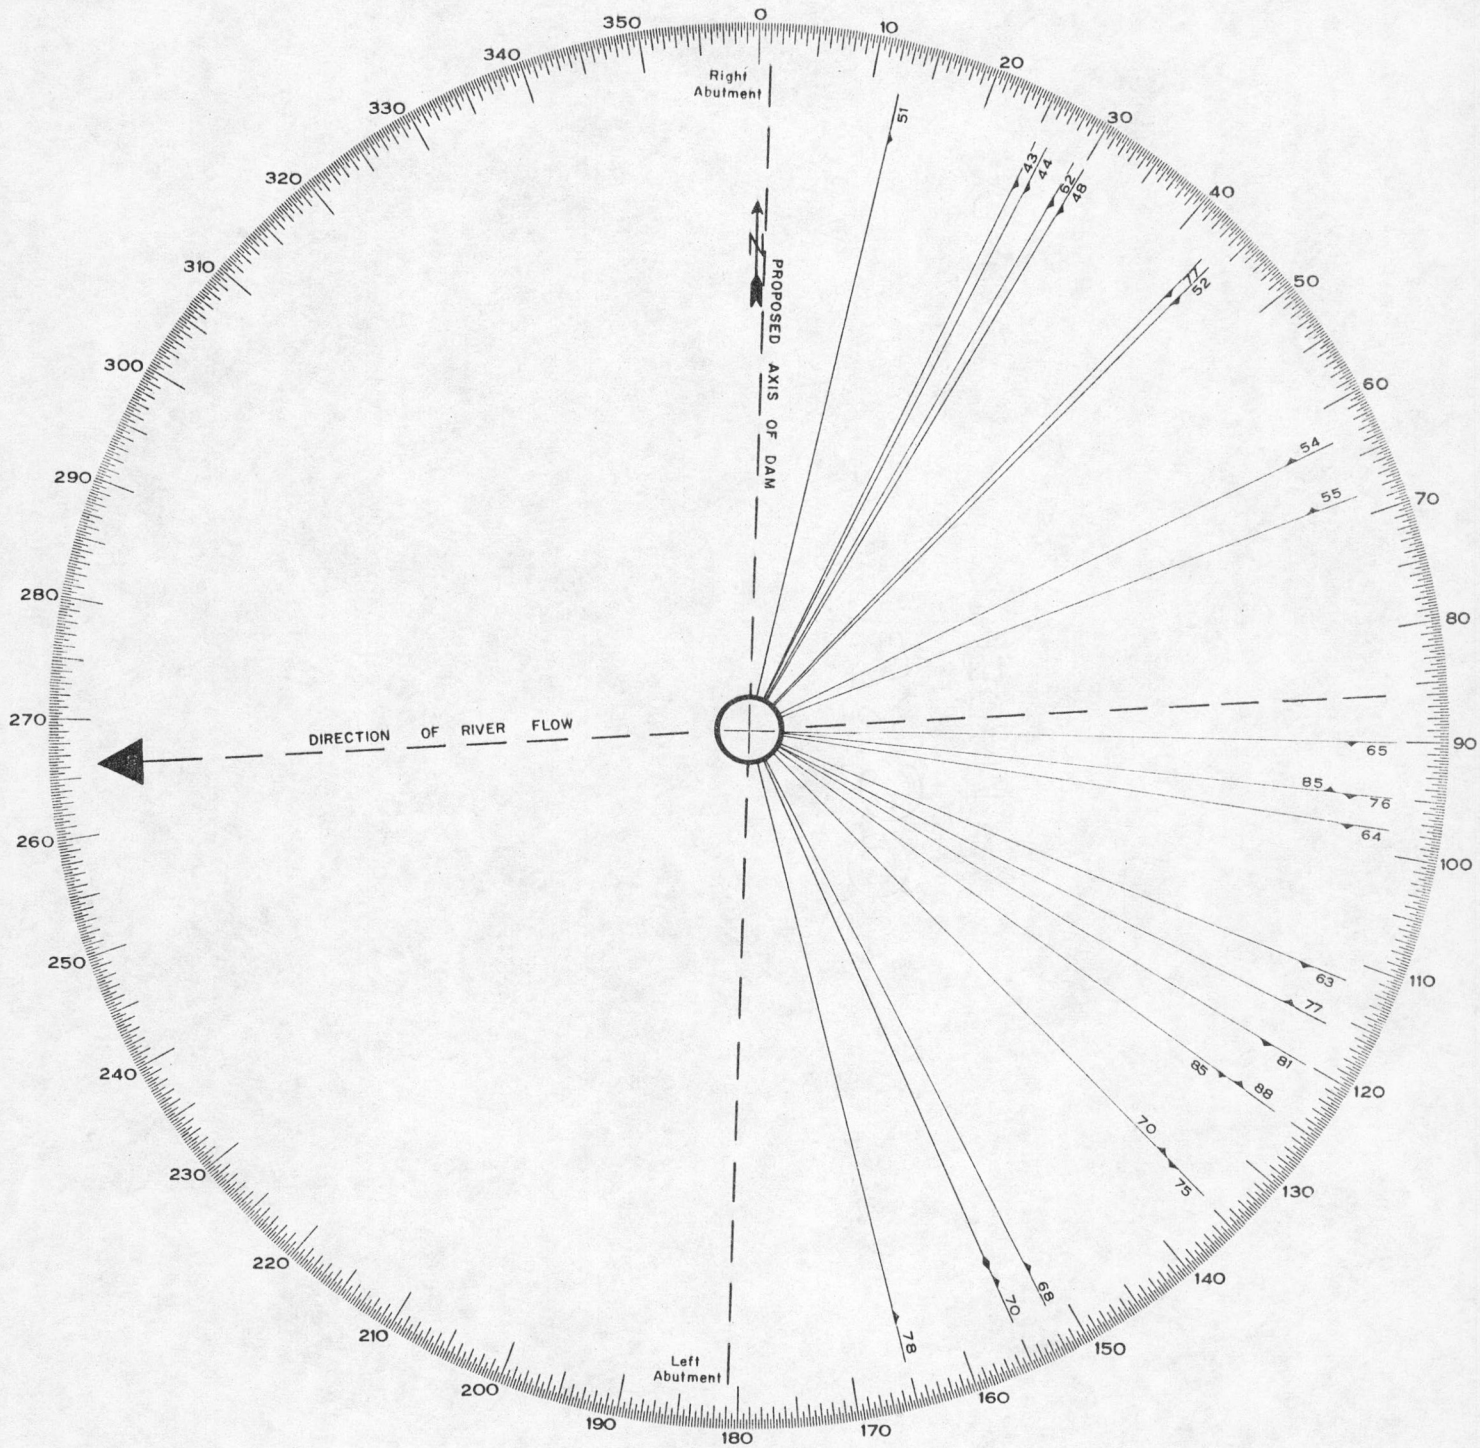
#### JOINT ROSETTE

The above illustration presents diagrammatically the direction and dip of jointing in bedrock exposed at Porcupine Canyon site (Upper)

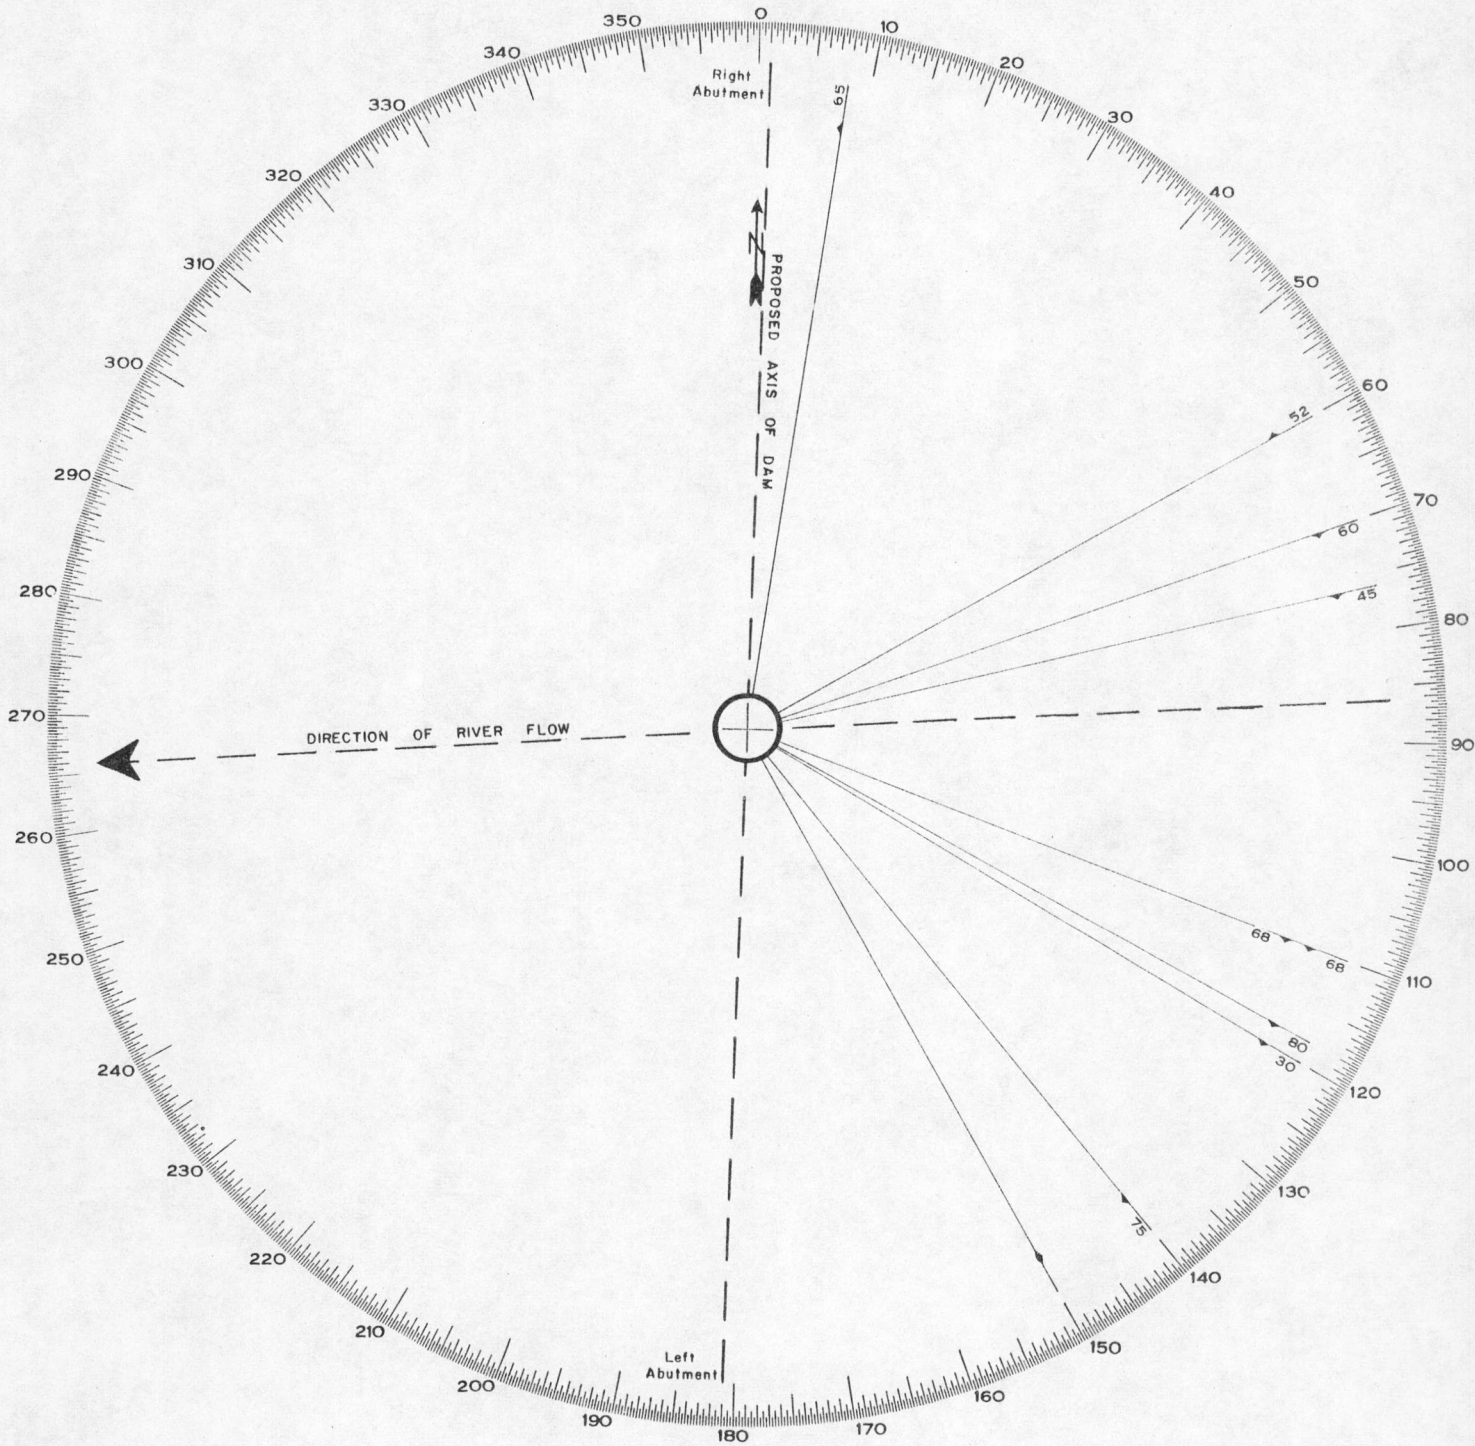
#### FAULT ROSETTE

The above illustration presents diagrammatically the direction and dip of faulting in bedrock exposed at Porcupine Canyon site (Upper)

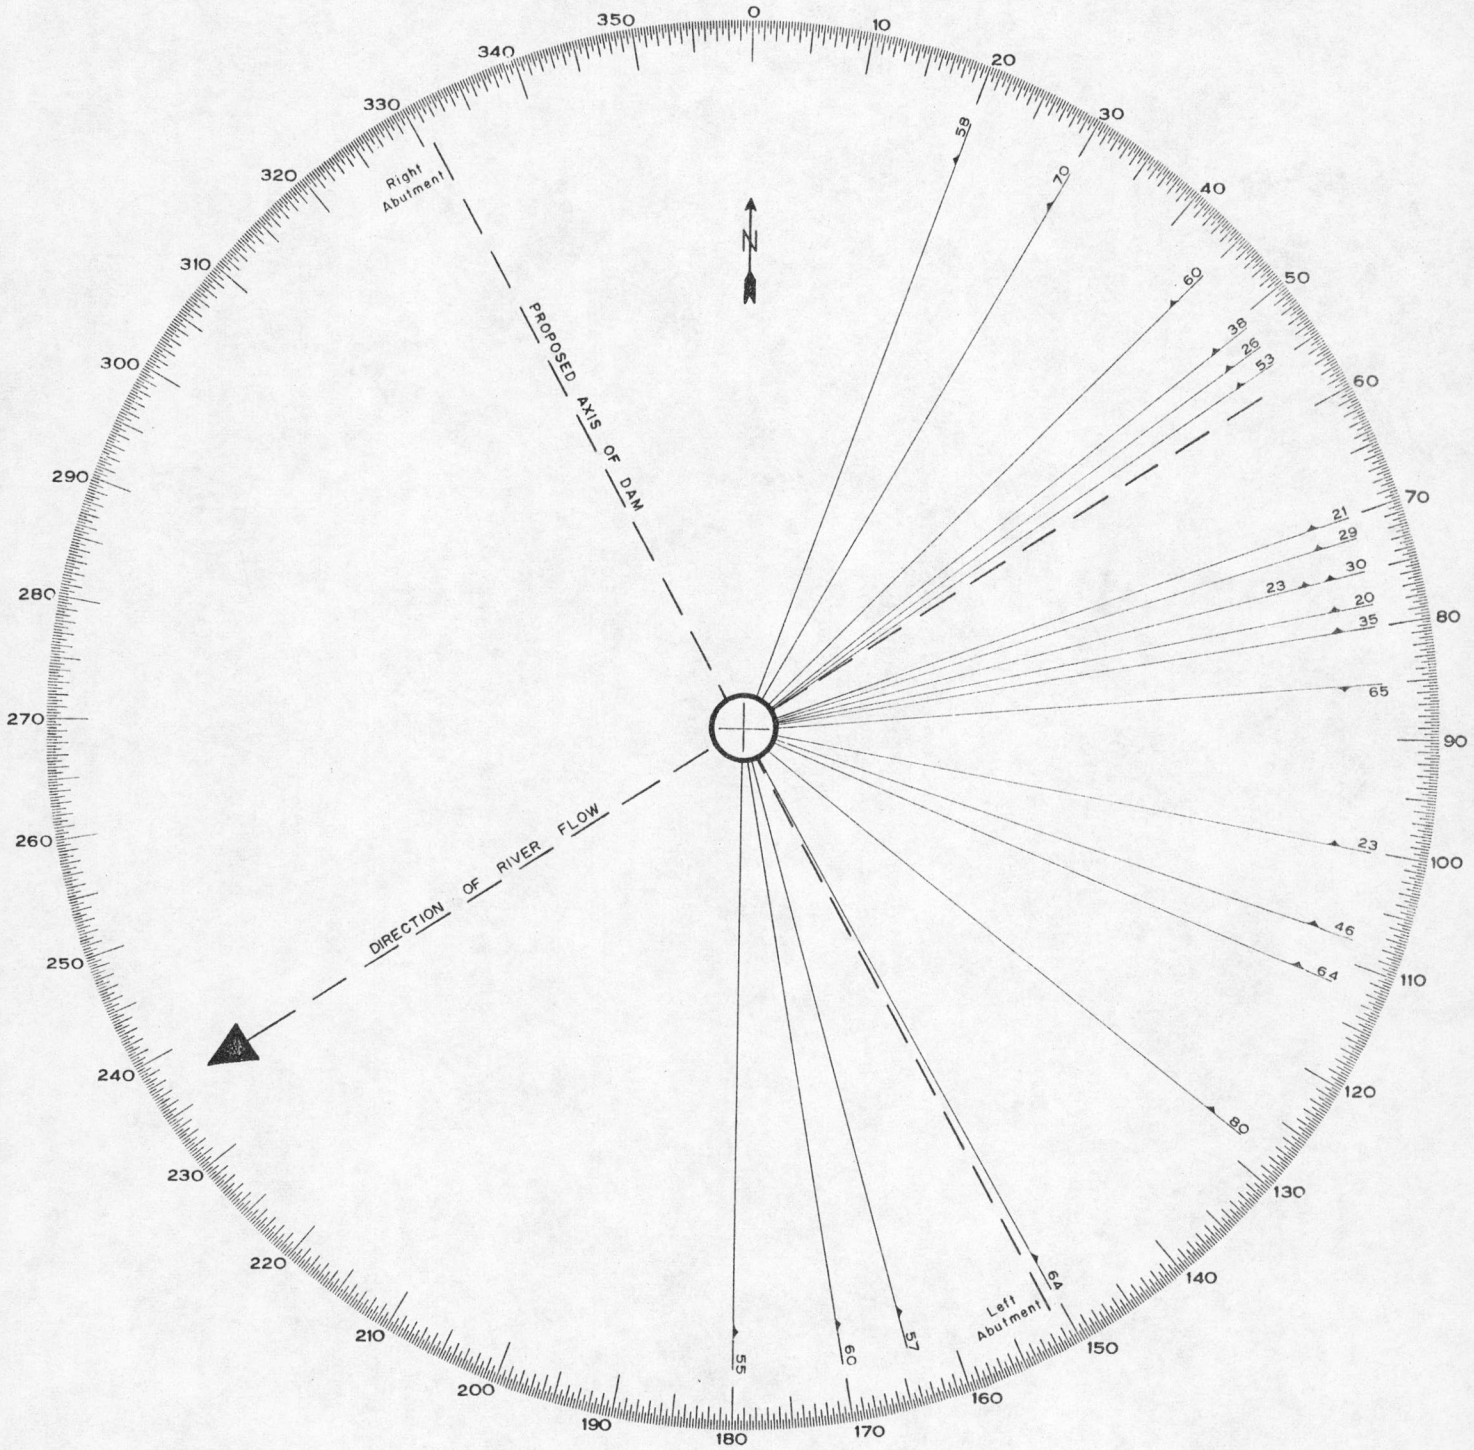
#### BEDDING ROSETTE

The above illustration presents diagrammatically the direction and dip of bedding in bedrock exposed at Porcupine Canyon site (Lower)

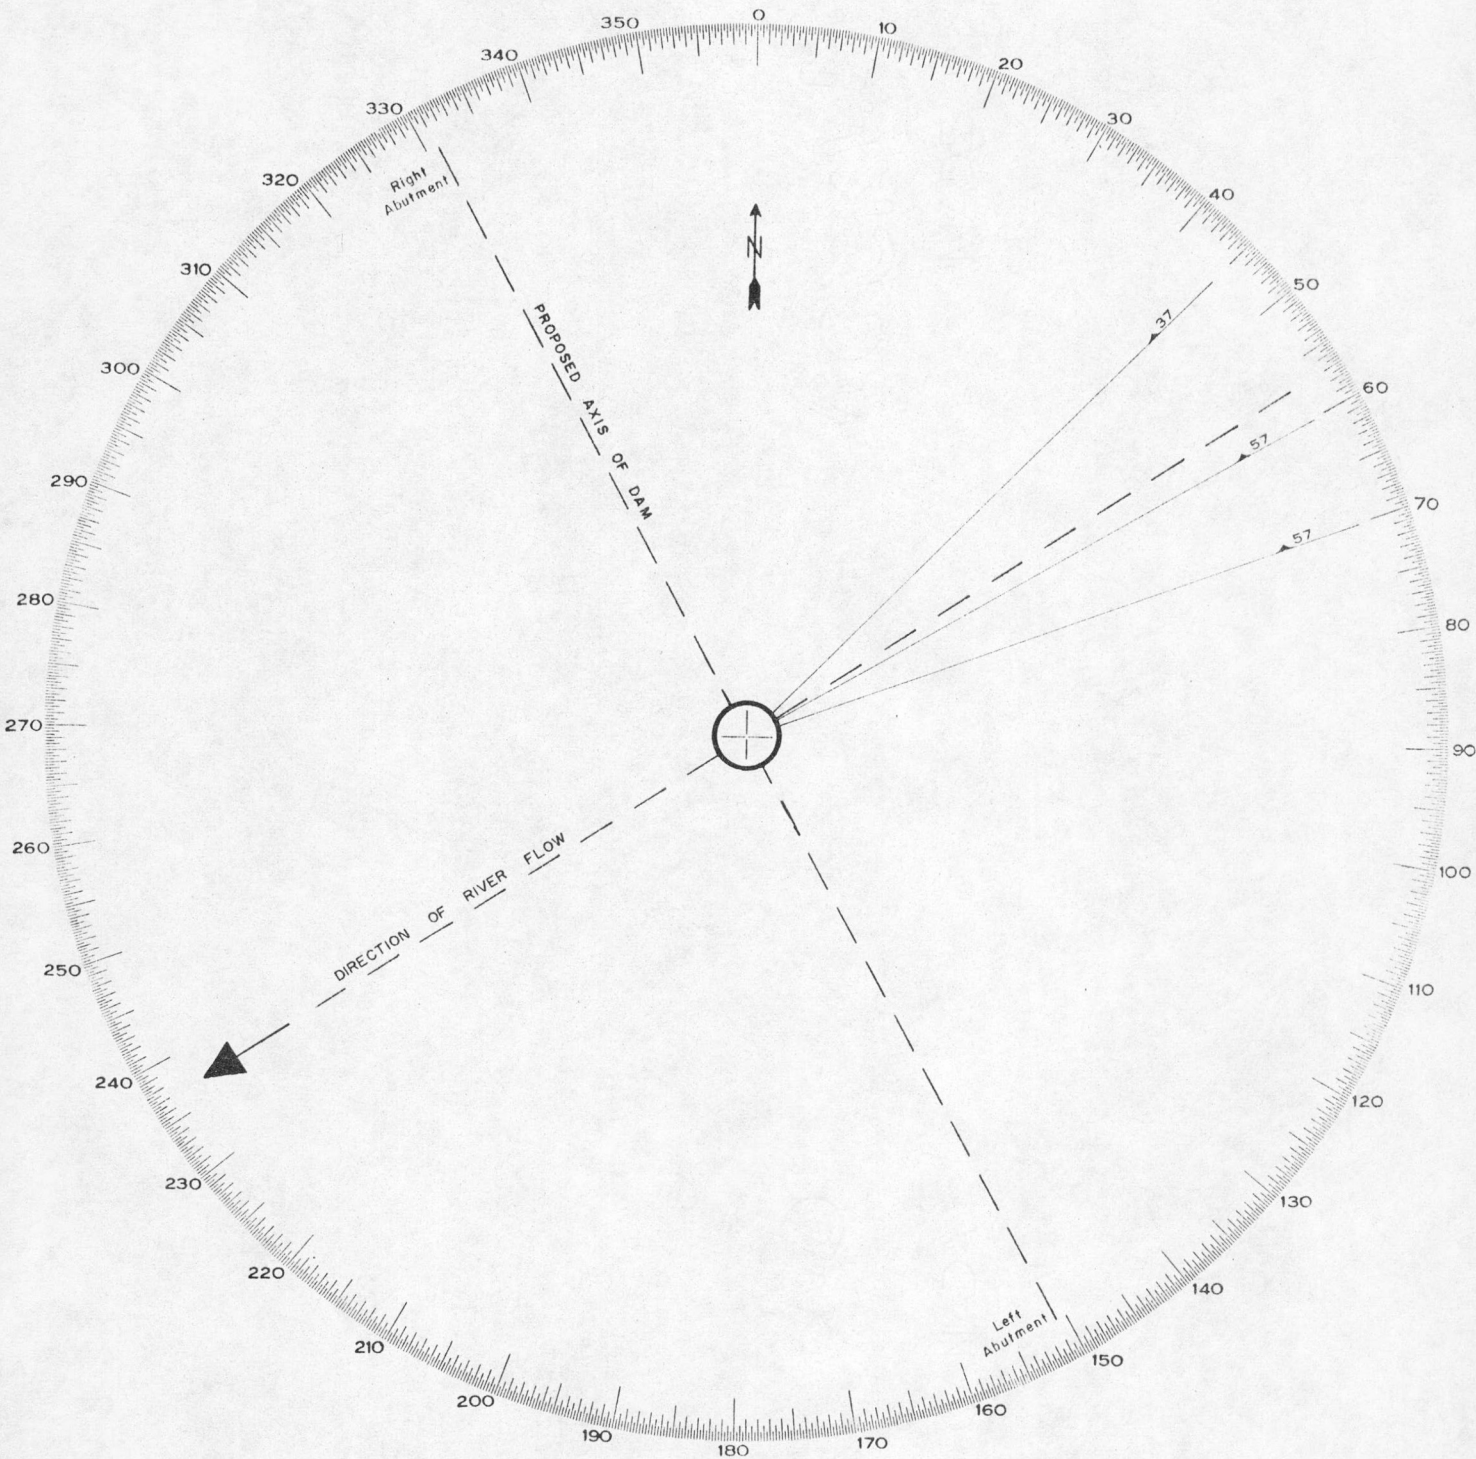
FAULT ROSETTE

The above illustration presents diagrammatically the direction and dip of faulting in bedrock exposed at Porcupine Canyon site (Lower)
