GEOLOGICAL SURVEY OF CANADA  
TOPICAL REPORT NO. 98

YUKON RIVER DRAINAGE BASIN  
DAM SITE INVESTIGATION

SITE No. 23

**FRASER FALLS DAM SITE**  
(MAP AND PRELIMINARY REPORT)

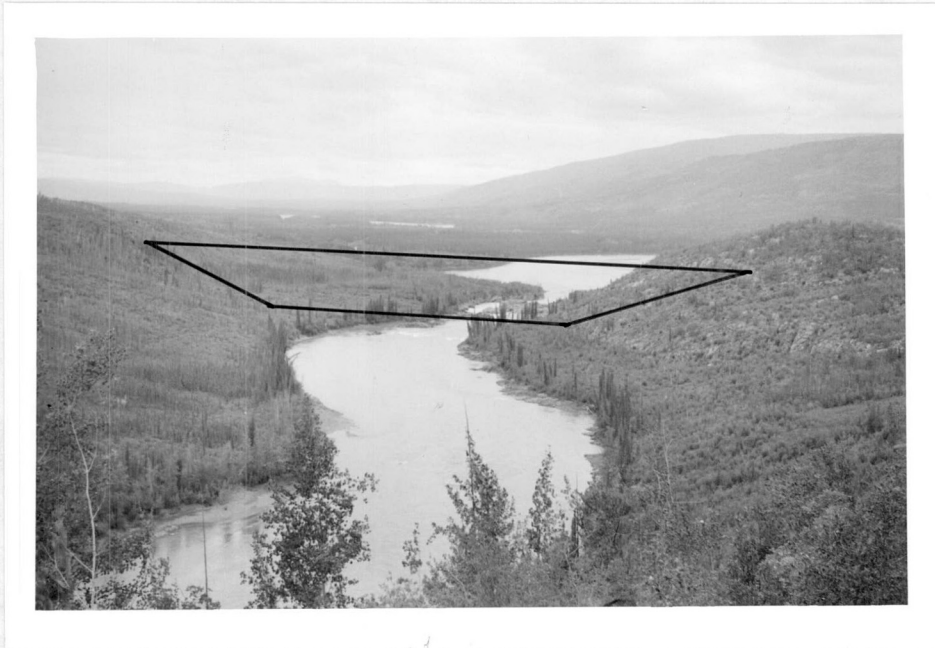
Plate 1

View looking downstream through Fraser Falls dam site area,  
approximate location of dam indicated by black lines.

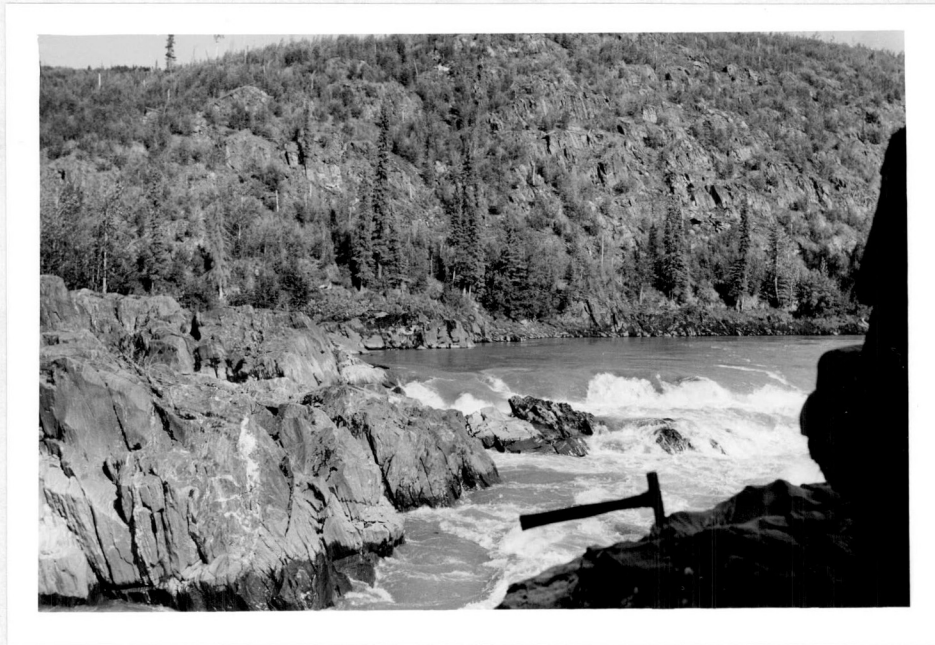
Plate 4

In the foreground the upstream end of the gorge at Fraser Falls dam site; in the background the rocky right abutment.

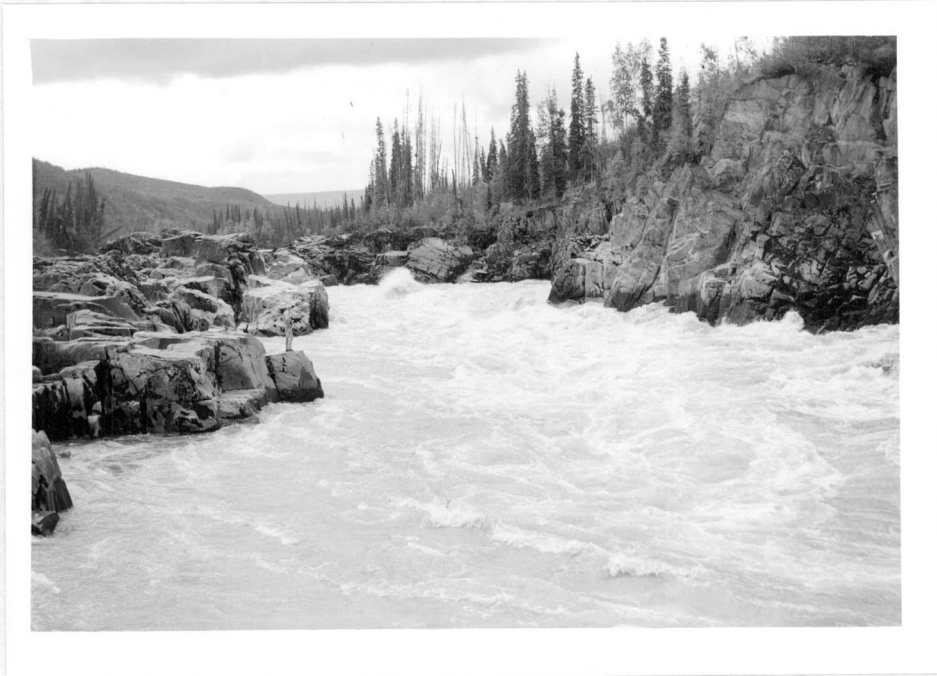
Plate 5

View upstream through gorge, Fraser Falls dam site.

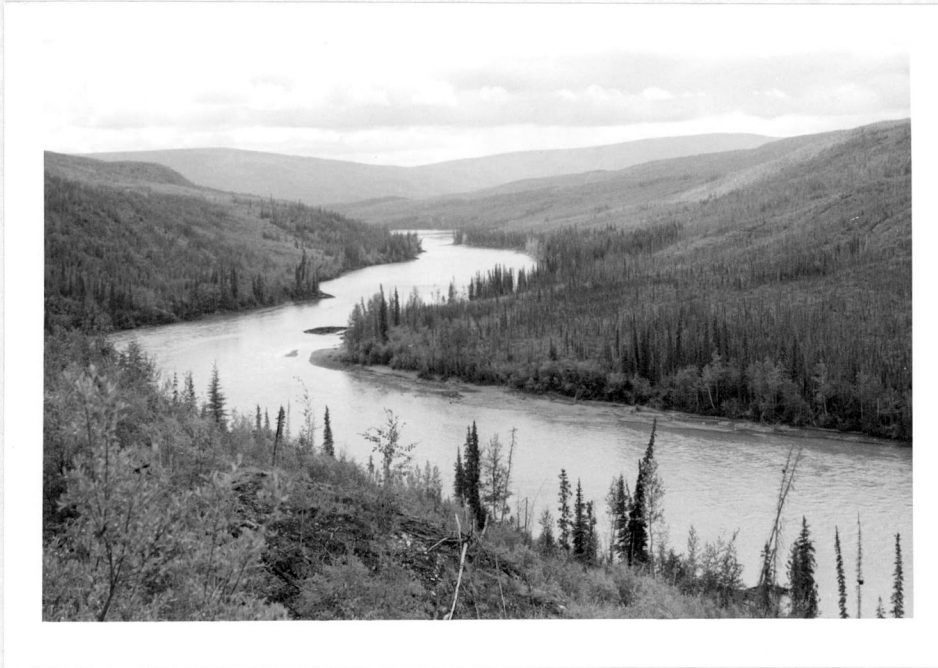
Plate 6

View of reservoir area immediately upstream from site, photograph taken from right abutment.
