| SMALL PUBLIC WATER SYSTEMS ASSESSMENT WESTERN REGION | GOVERNMENT OF YUKON HIGHWAYS & PUBLIC WORKS |
| BEAVER CREEK VISITOR RECEPTION CENTRE BUILDING # 3121 SITE LOCATION DIAGRAM WELL ID: 3121 | REVISION ISSUE 0 |

SMALL PUBLIC WATER SYSTEM ASSESSMENT

PART A: EBA Site Inspection

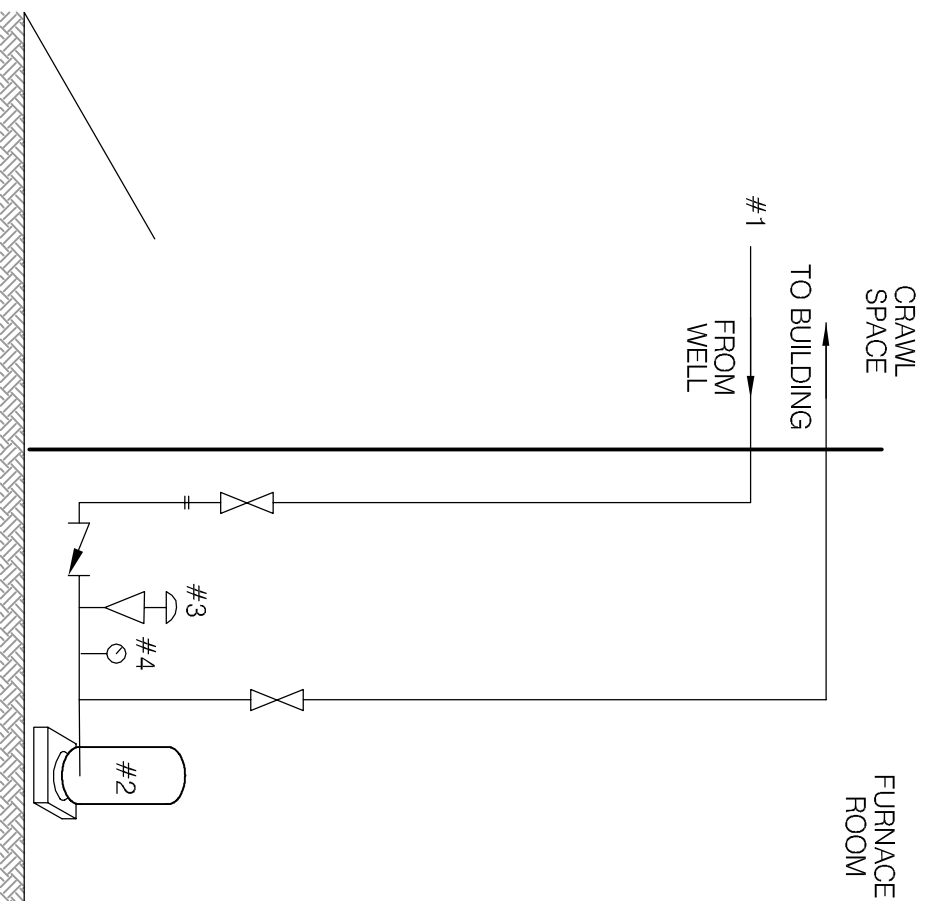
FIGURE 3121-B

SCHEMATIC PRODUCED BY BERT ALBISSER OF AQUA TECH SUPPLIES AND SERVICES LTD.

REPIPE THE PUMP CONTROLS WITH MATERIAL
THAT MEETS THE PLUMBING CODE. REPLACE
THE PRESSURE SWITCH - IT DATES BACK TO 1970.
INSTALL TREATMENT IF REQUIRED TO SUIT UV
INSTALLATION. INSTALL UV (NSF55 CERTIFIED)
STERILIZER.
INSTITUTE B. ANNUAL WELL MAINTENANCE PROGRAM
SERVICE UV SYSTEM REGULARLY.
