Western Region – Swimming Pool
Building # 3122

SMALL PUBLIC WATER SYSTEM ASSESSMENT

PART A: EBA Site Inspection

WELL ID #	Owner	Location Description
<u>3122</u>	<u>YTG</u>	<u>Beaver Creek Swimming Pool</u>

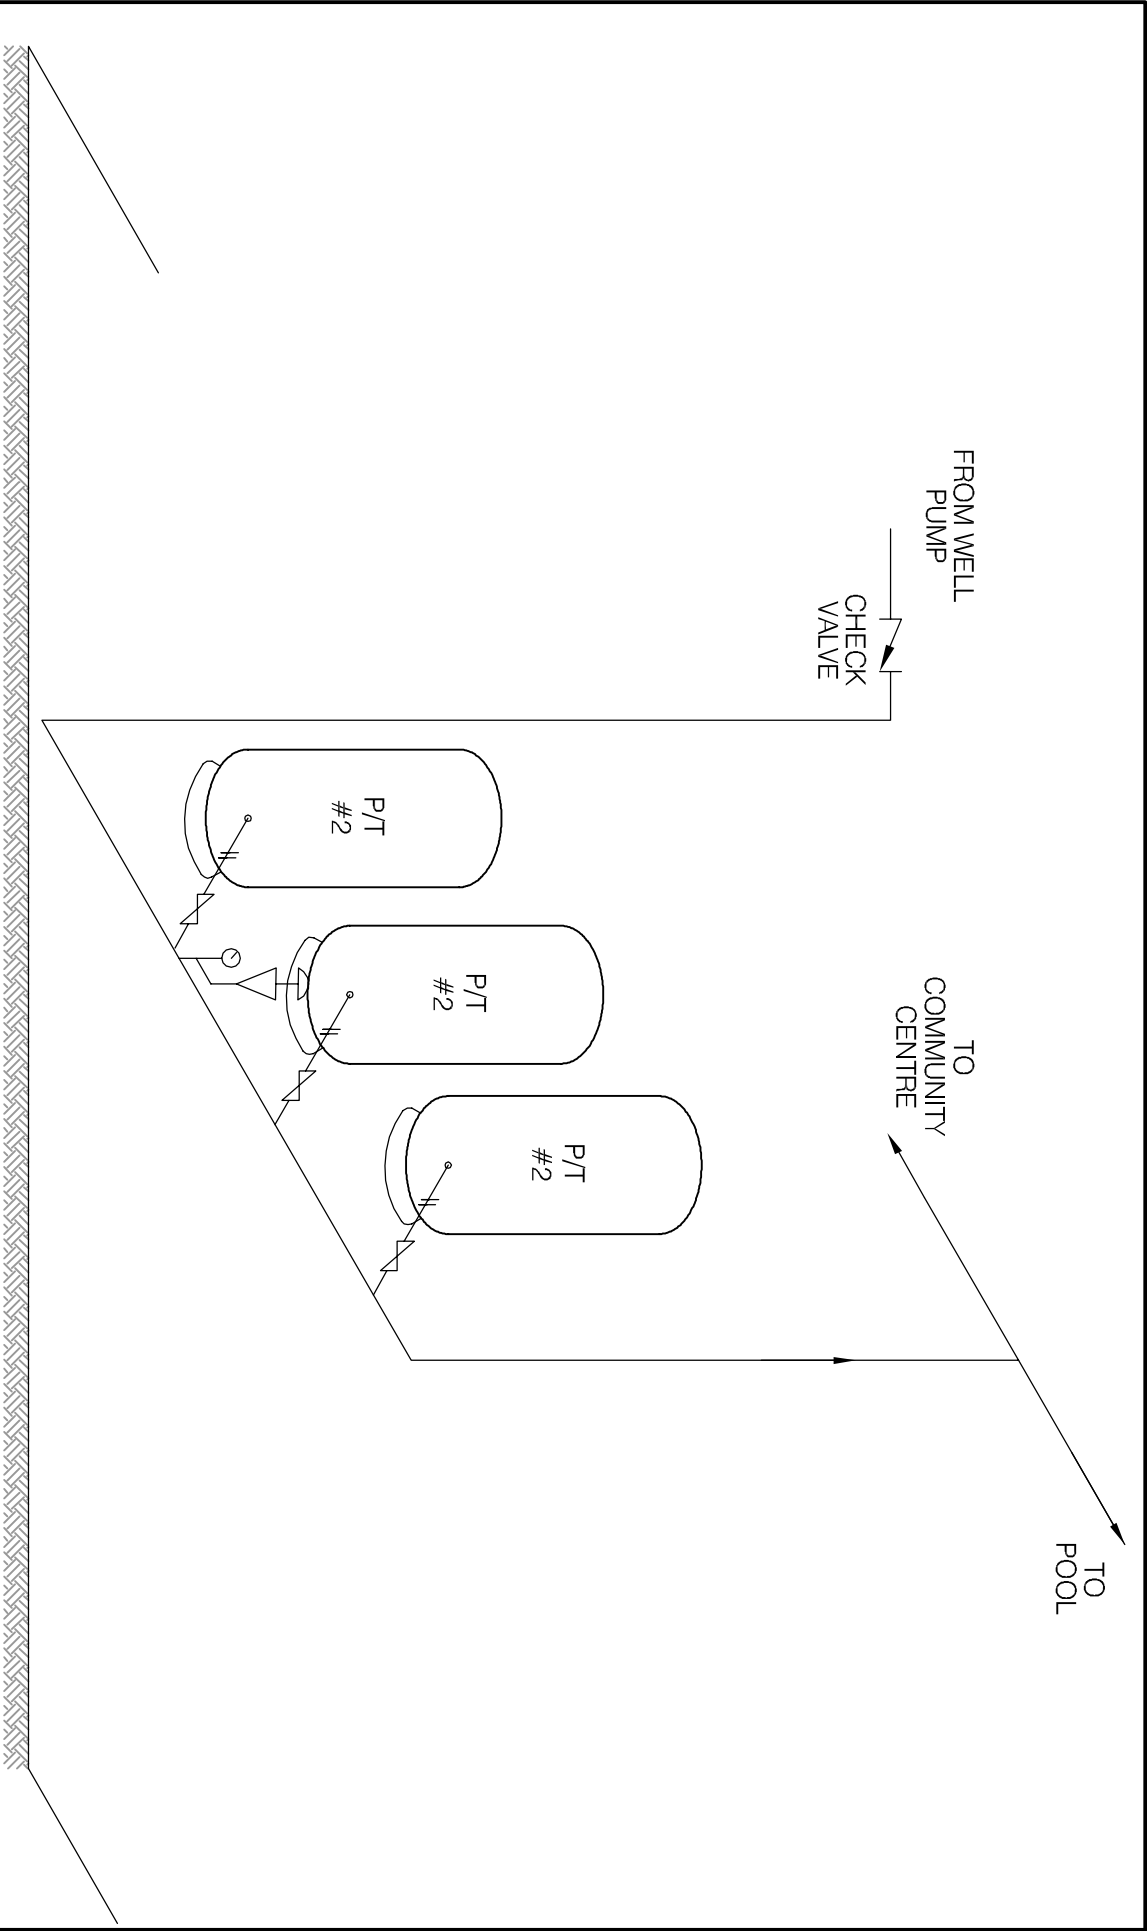
Yukon Highways and Public Works Property Management Branch</div>			TITLE WATER SYSTEM DISTRIBUTION/TREATMENT SCHEMATIC SYSTEM ID.: 3122 BEAVER CREEK SWIMMING POOL		
DATE SEPT. 2005	DWN. JSB	CHKD.	FMN	FILE NO. 1260002.003	DWG.: FIGURE 3122-B

THIS IS A PROFESSIONAL BUT OLD INSTALLATIONS. 2 OF THE TANKS HAVE SLIGHT LEAKS. THE PUMP IS VERY NOISY AND RUNS FOR A LONG TIME. IT IS WORTH NOTING THAT THIS SYSTEM HAD EARLIER BEEN SERVED BY A 2 HP SUB. PUMP. IT NOW HAS ONLY A 3/4 HP PUMP.

REPAIR THE LEAKS. BRING INSTALLATION BACK UP TO CODE IE INSULATE THE COPPER LINES AS THEY ARE SWEATING ~~HEAVY~~ HEAVY AT THIS POINT. INSTALL TREATMENT AS DETERMINED BY THE WATER ANALYSIS TO SUIT UV TREATMENT. INSTALL APPROPRIATE UV FOR FLOW REQUIREMENT. INSTITUTE AN ANNUAL WELL MAINTENANCE PROGRAM.
