SMALL PUBLIC WATER SYSTEMS ASSESSMENT WESTERN REGION	GOVERNMENT OF YUKON HIGHWAYS & PUBLIC WORKS
DESTRUCTION BAY GRADER STATION BUILDING # 3186 SITE LOCATION DIAGRAM WELL ID: 3186-C	REVISION ISSUE 0
	FIGURE No. FIGURE 1

Western Region – Destruction Bay Grader Station  
Building # 3186

## SMALL PUBLIC WATER SYSTEM ASSESSMENT

WELL ID #	Owner	Location Description
3186	YTG	Destruction Bay Grader Station

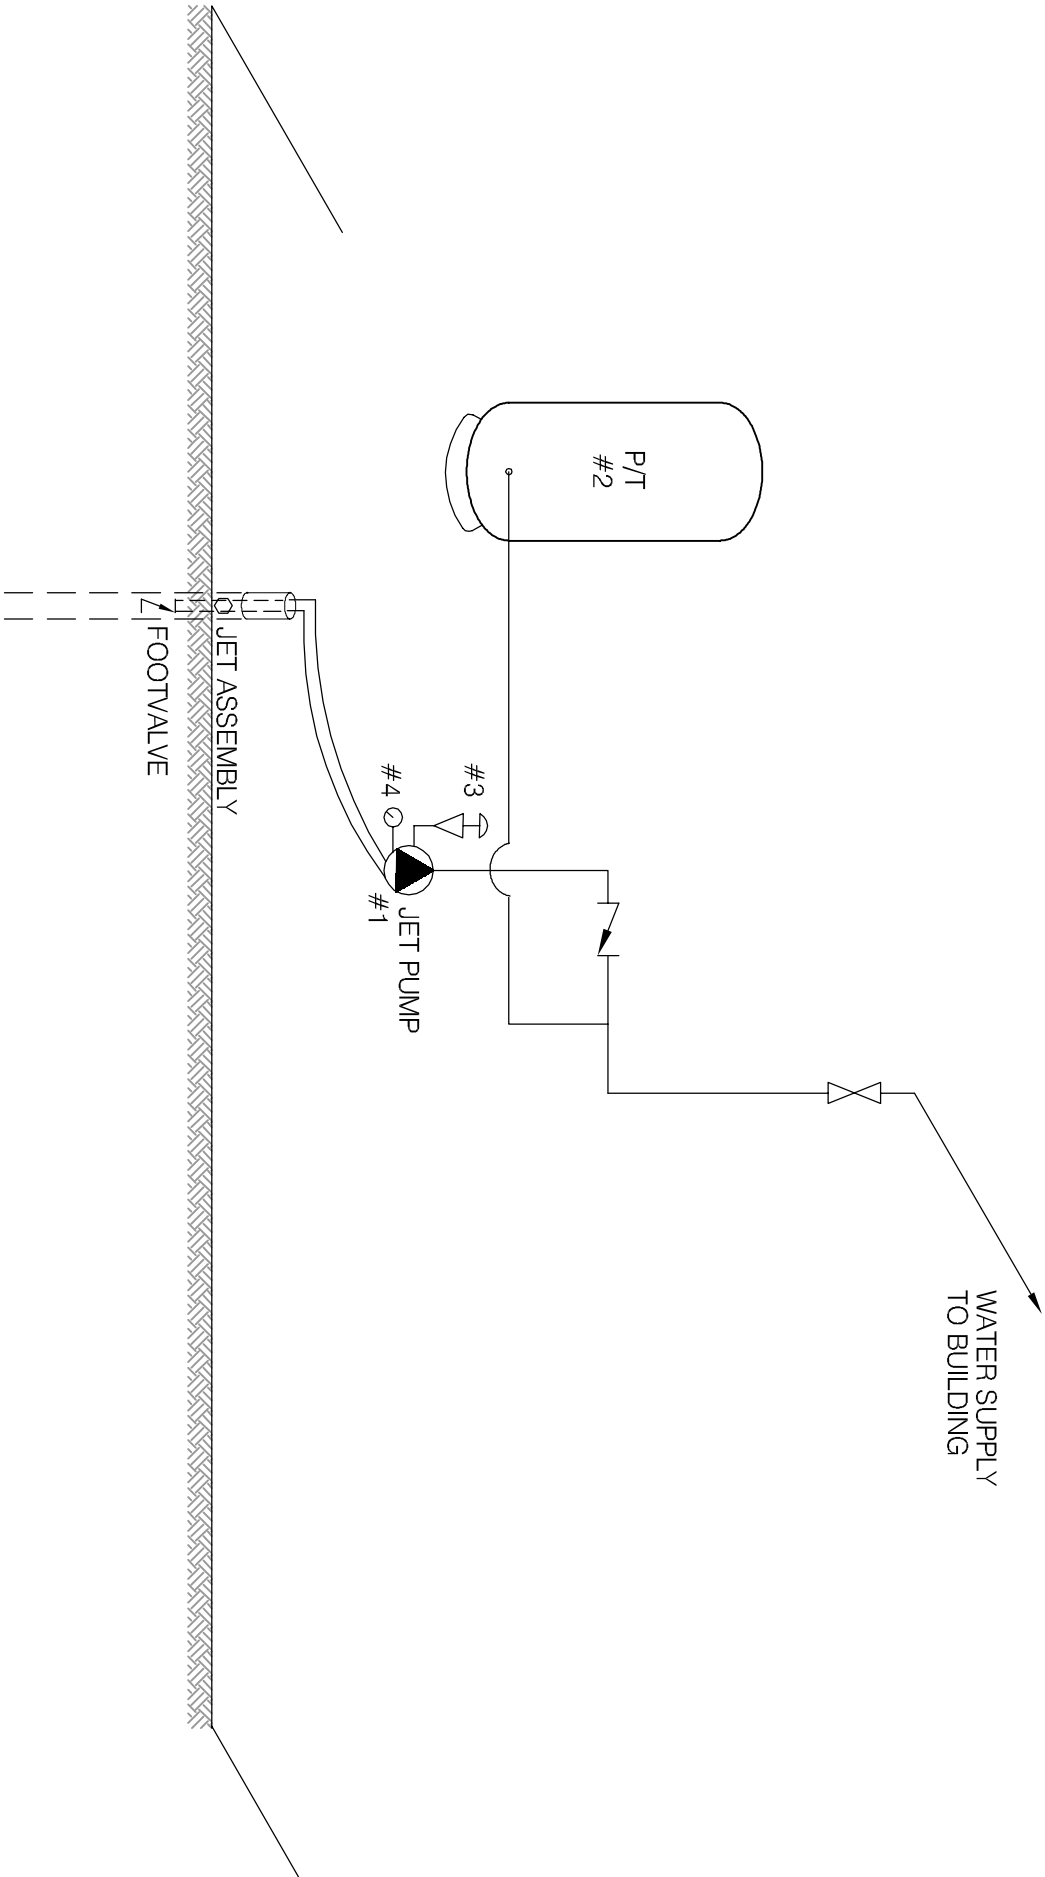
Item	Description	Manufacturer	Model	Part No.	Serial No.	Size
1	Jet Pump	Monarch	MJC-50		2004	1/2 HP
2	PRESSURE TANK	CHALLENGER	PC-144		070494	
3	PRESSURE SWITCH	SQUARE D	FSG-2			2HP 1/4" NPT
4	PRESSURE GAGE	MARSA	2"-(0-100 PSI)			1/4" NPT
5						
6						
7						
8						
9						
10
