SMALL PUBLIC WATER SYSTEMS ASSESSMENT
WESTERN REGION

BEAVER CREEK RCMP
RESIDENCE BUILDING # M0133
SITE LOCATION DIAGRAM
WELL ID: M0133

SMALL PUBLIC WATER SYSTEM ASSESSMENT

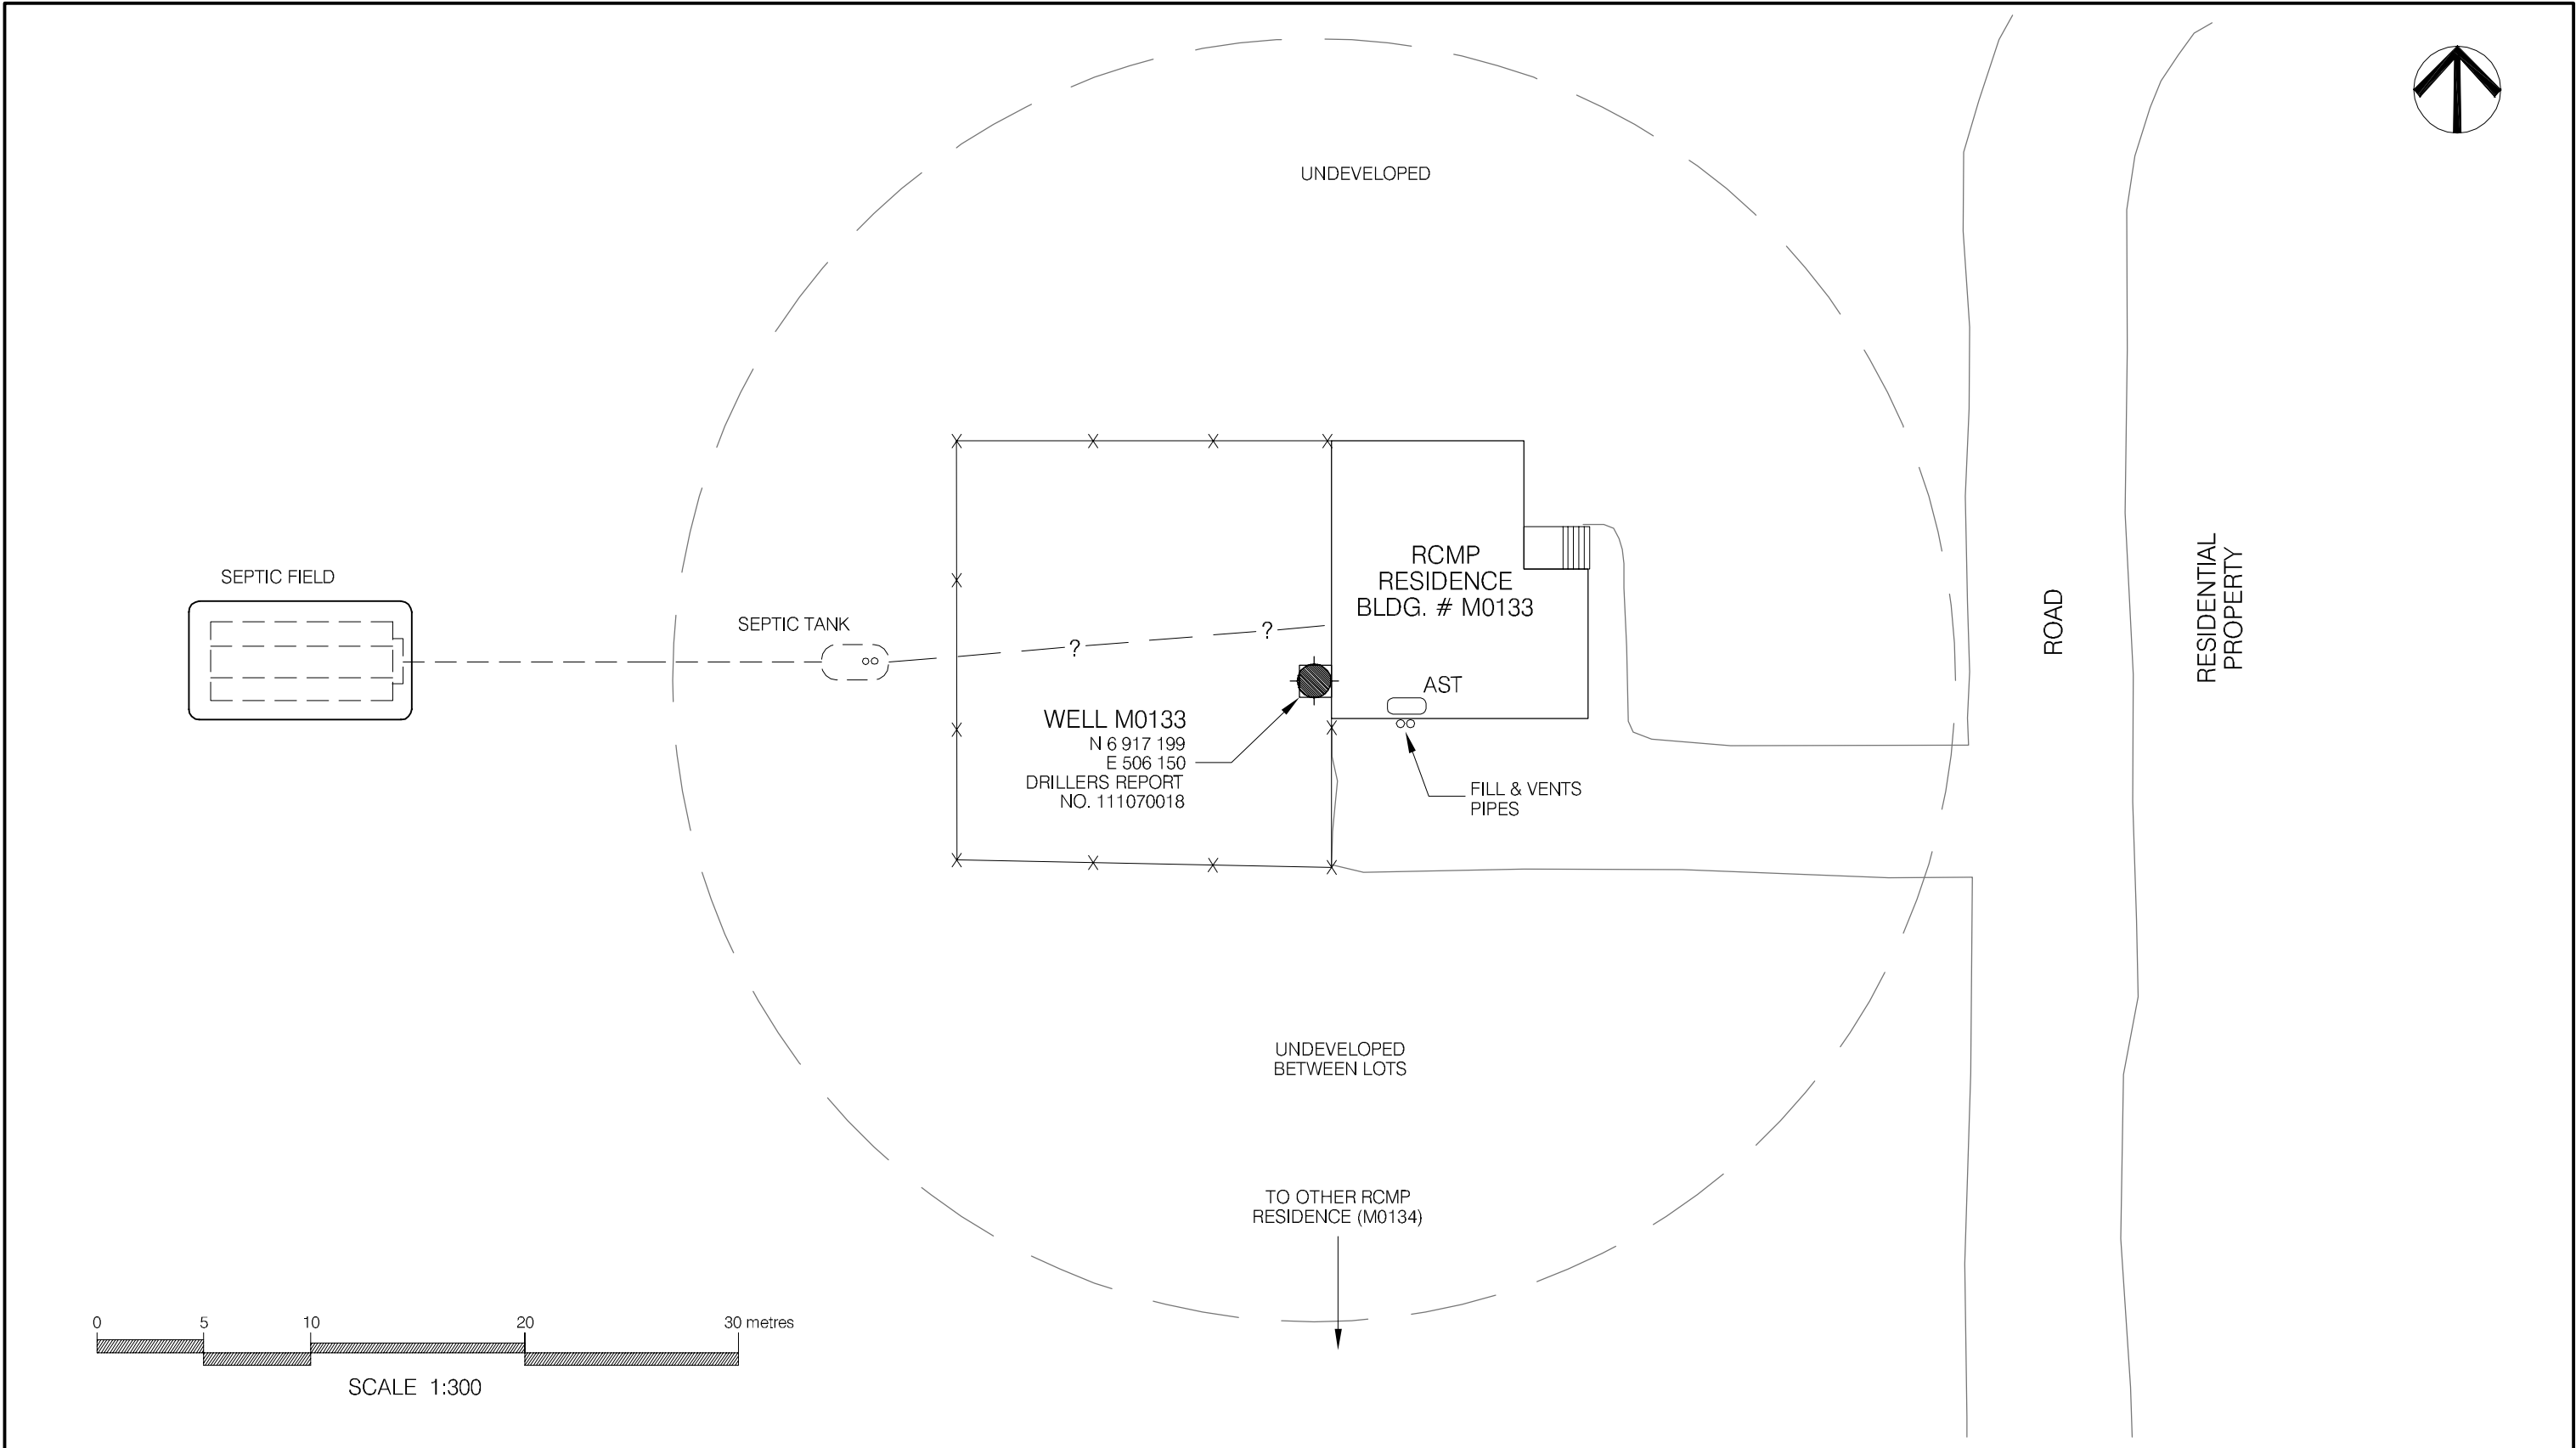
REVISION	ISSUE
	0
FIGURE No.	FIGURE M0133-A

30 m RADIUS FROM WATER WELL FOR CONSIDERATION OF PROXIMITY TO POTENTIAL CONTAMINANT SOURCES.
