August 28, 2014

Reference No. 1314270077-227-L-Rev0-7000

**ANNUAL INSPECTION, JULY 17, 2014
CARMACKS COPPER PROJECT, CARMACKS, YUKON**

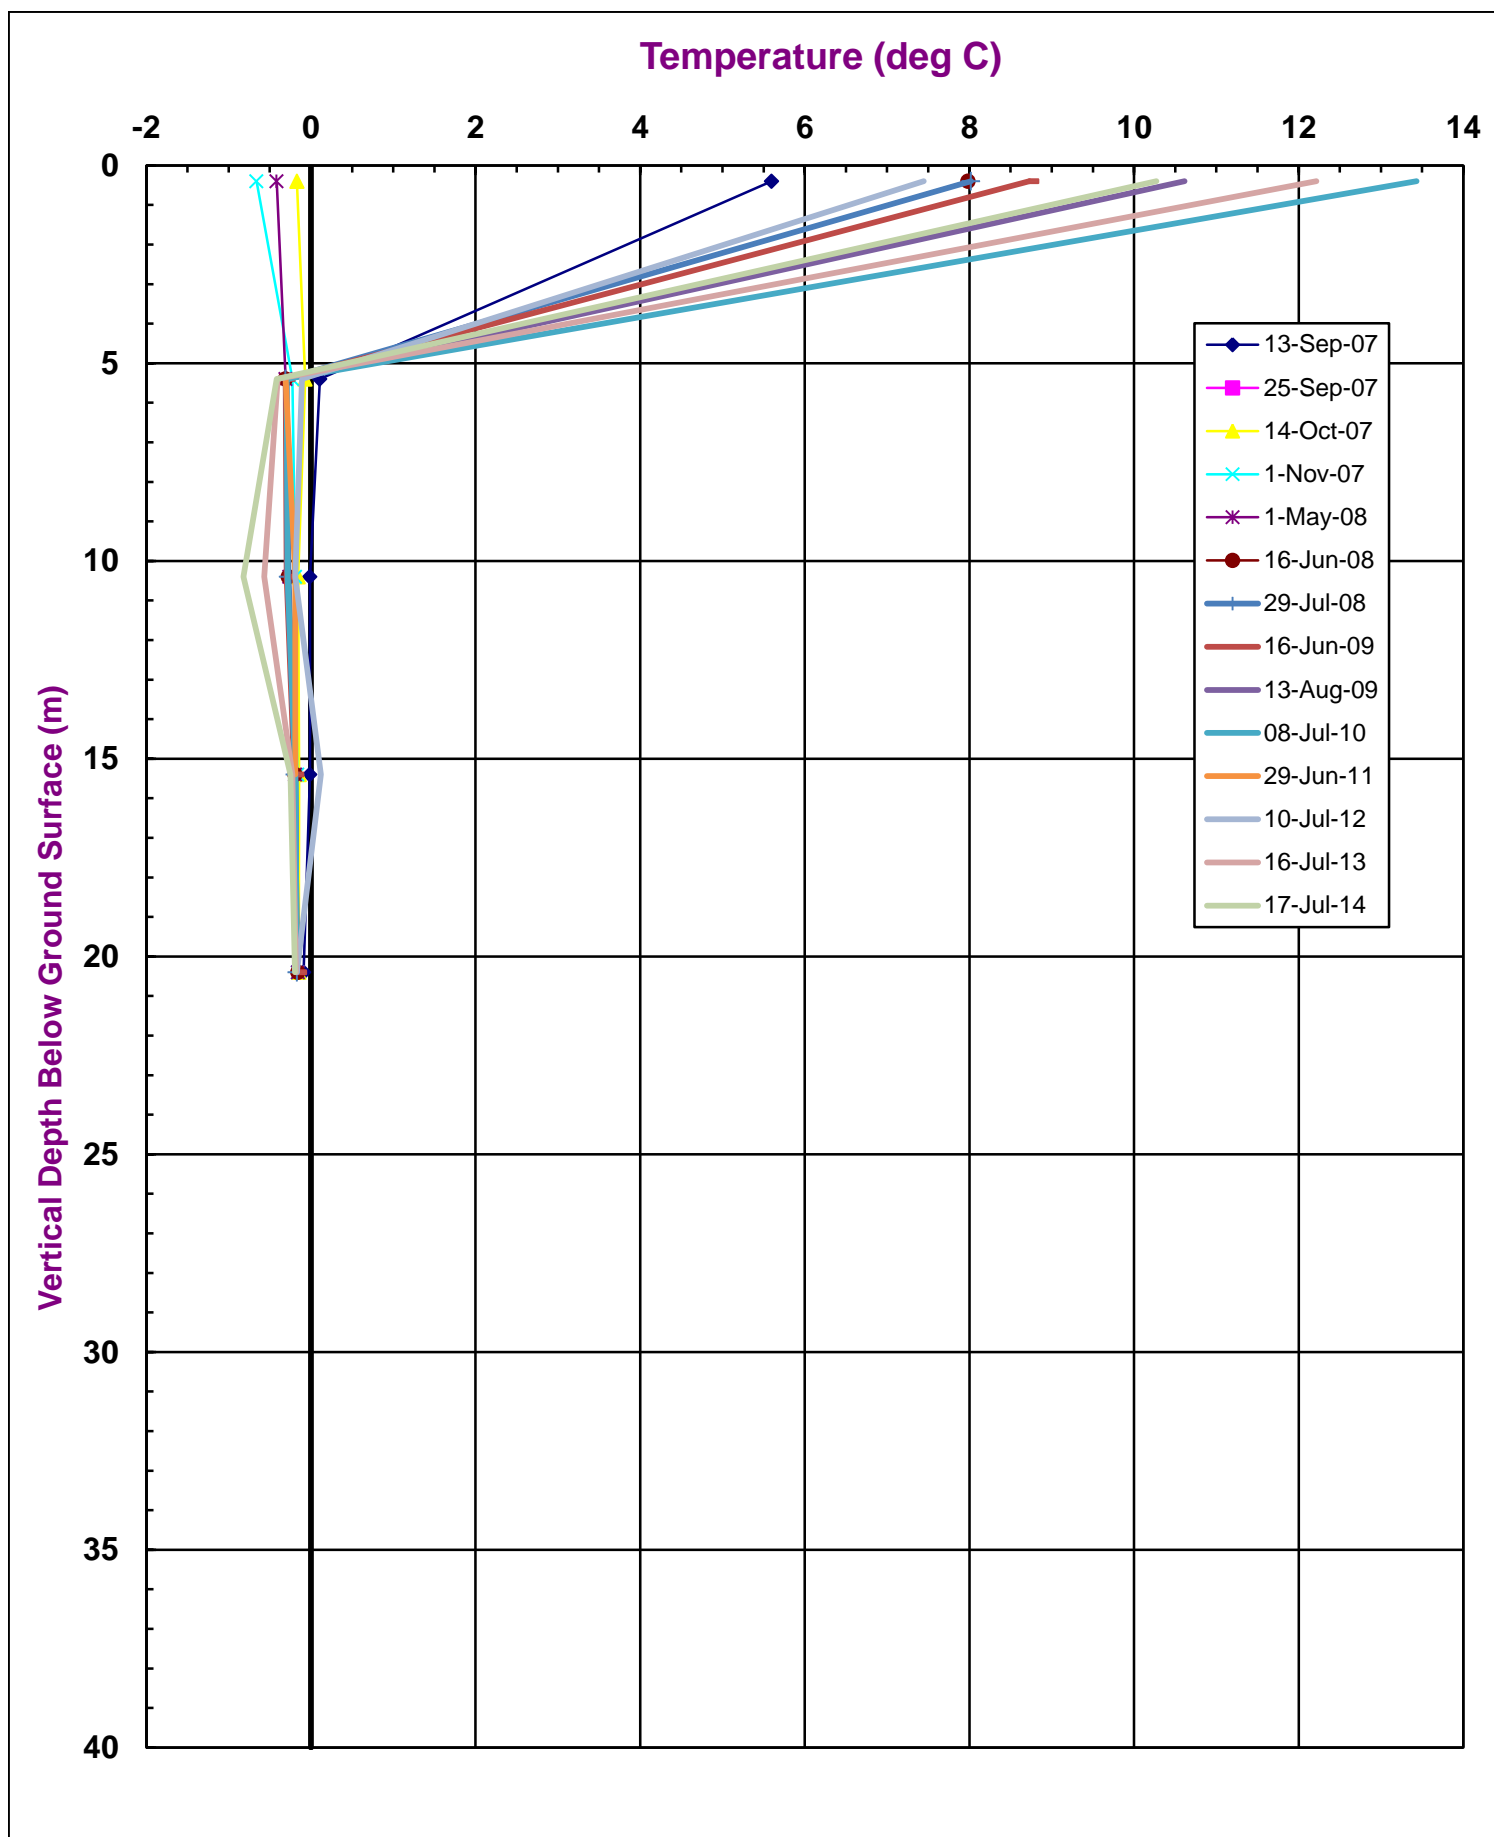
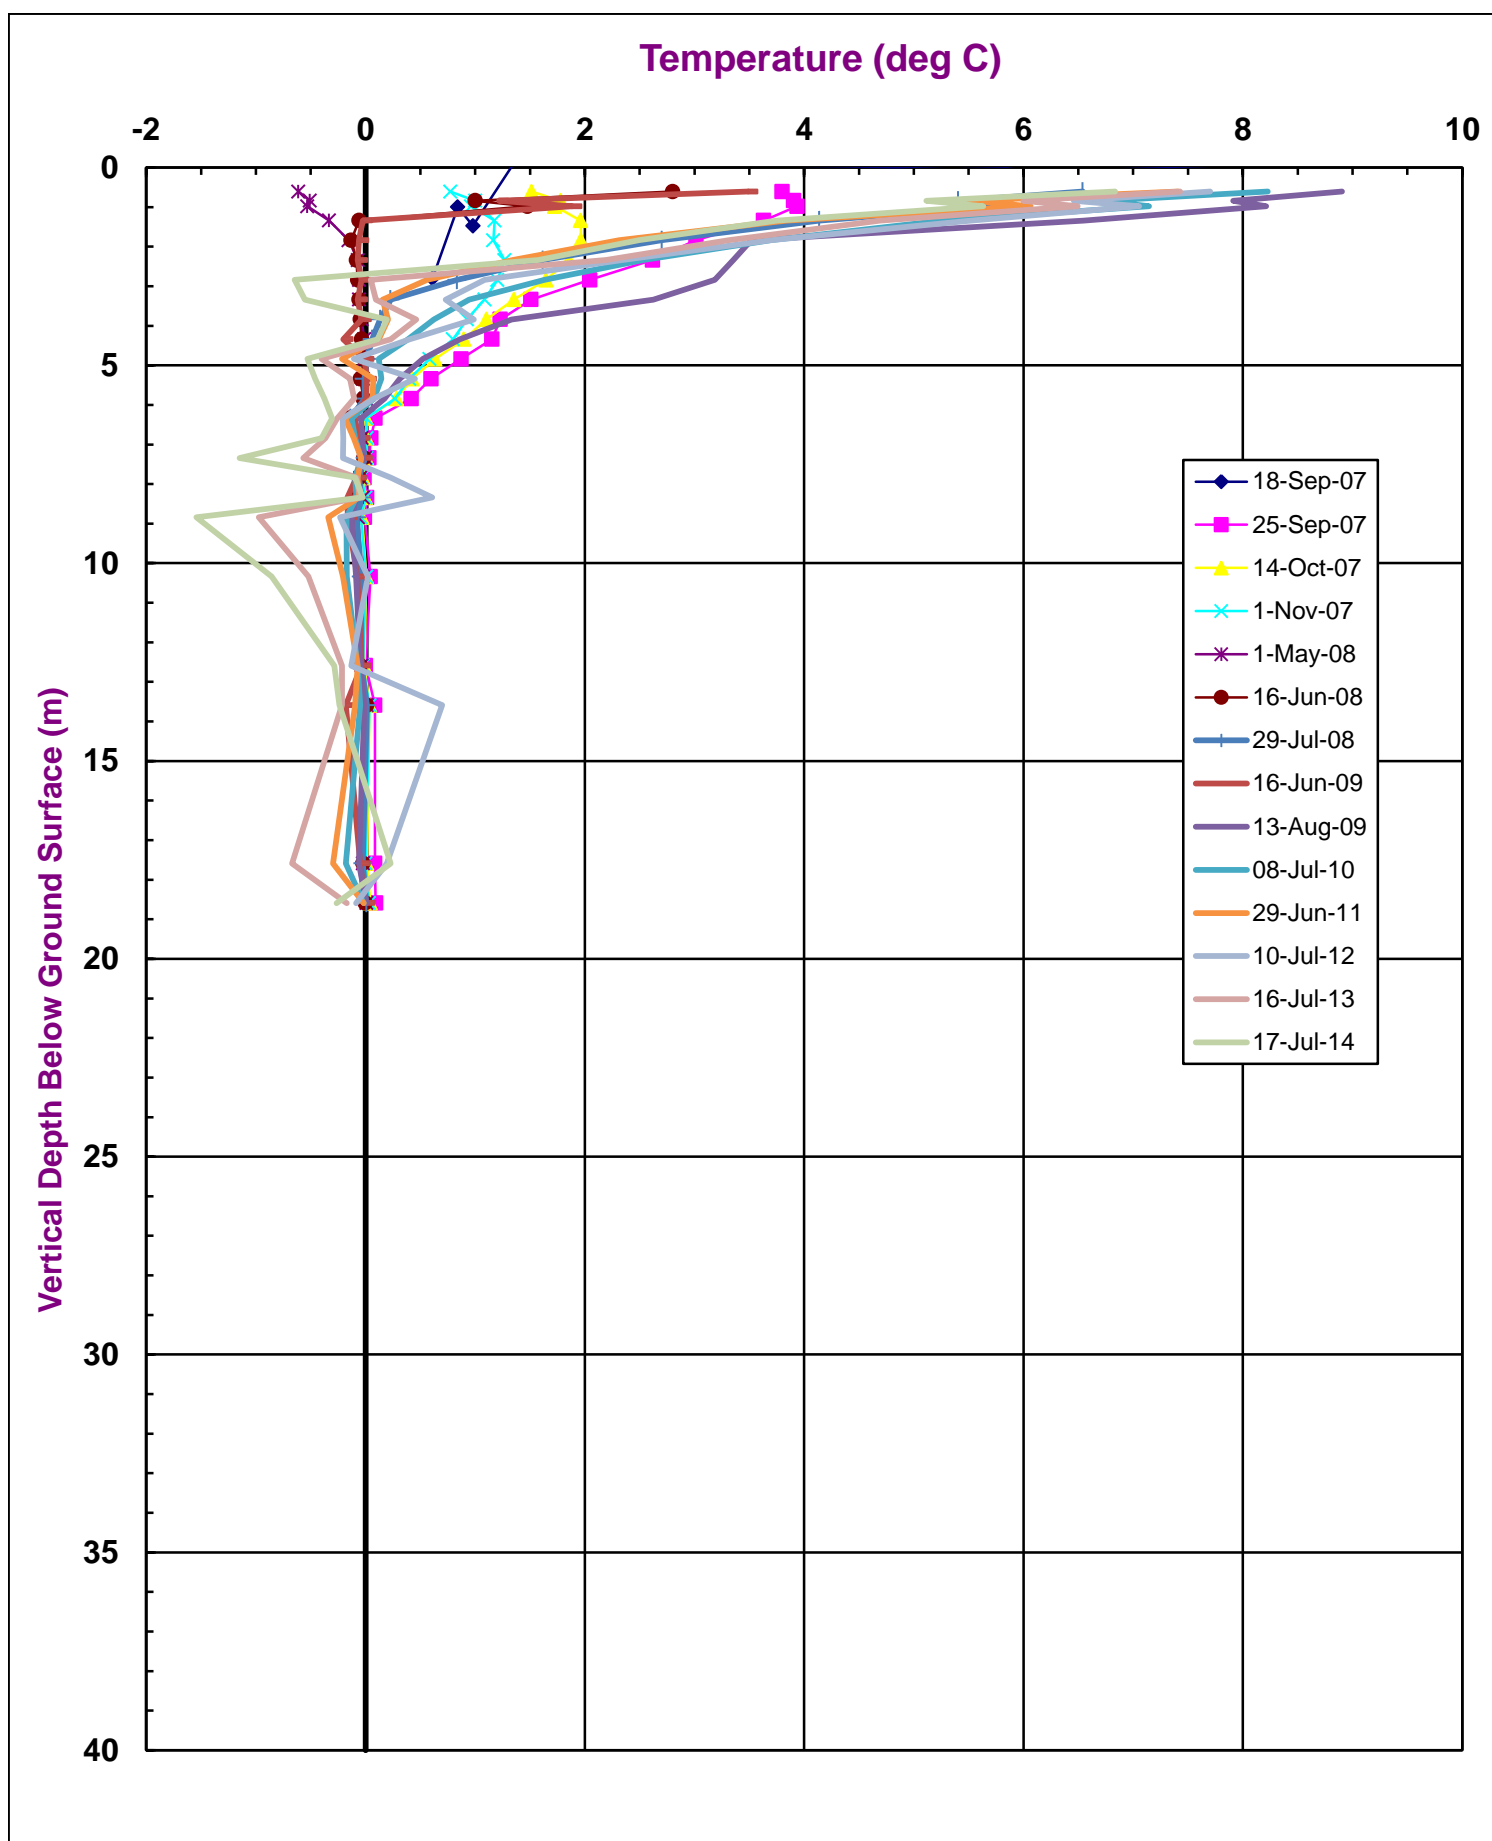
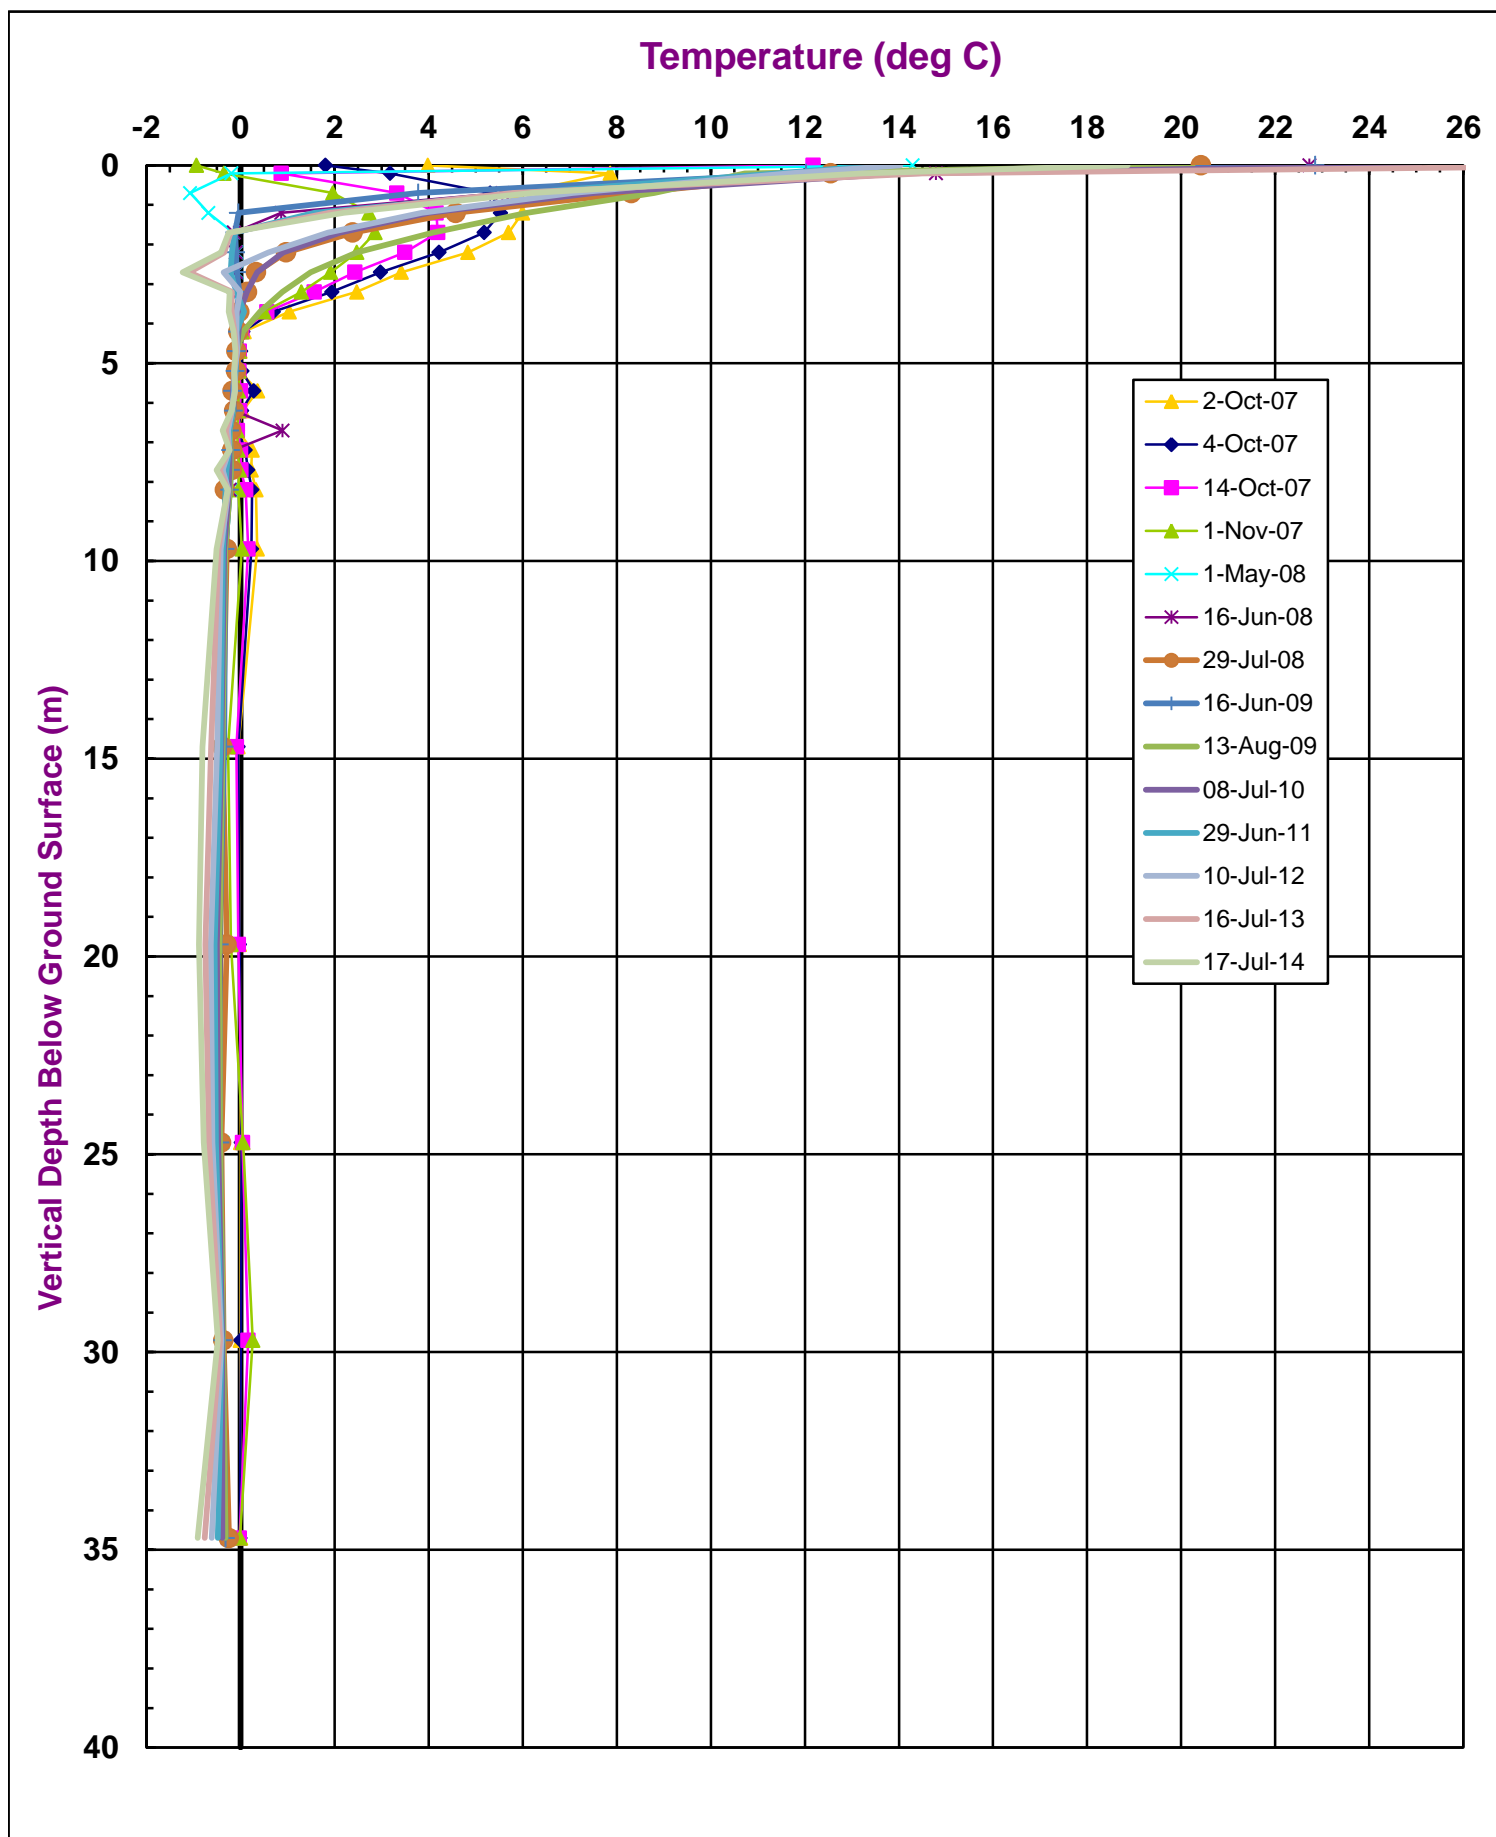
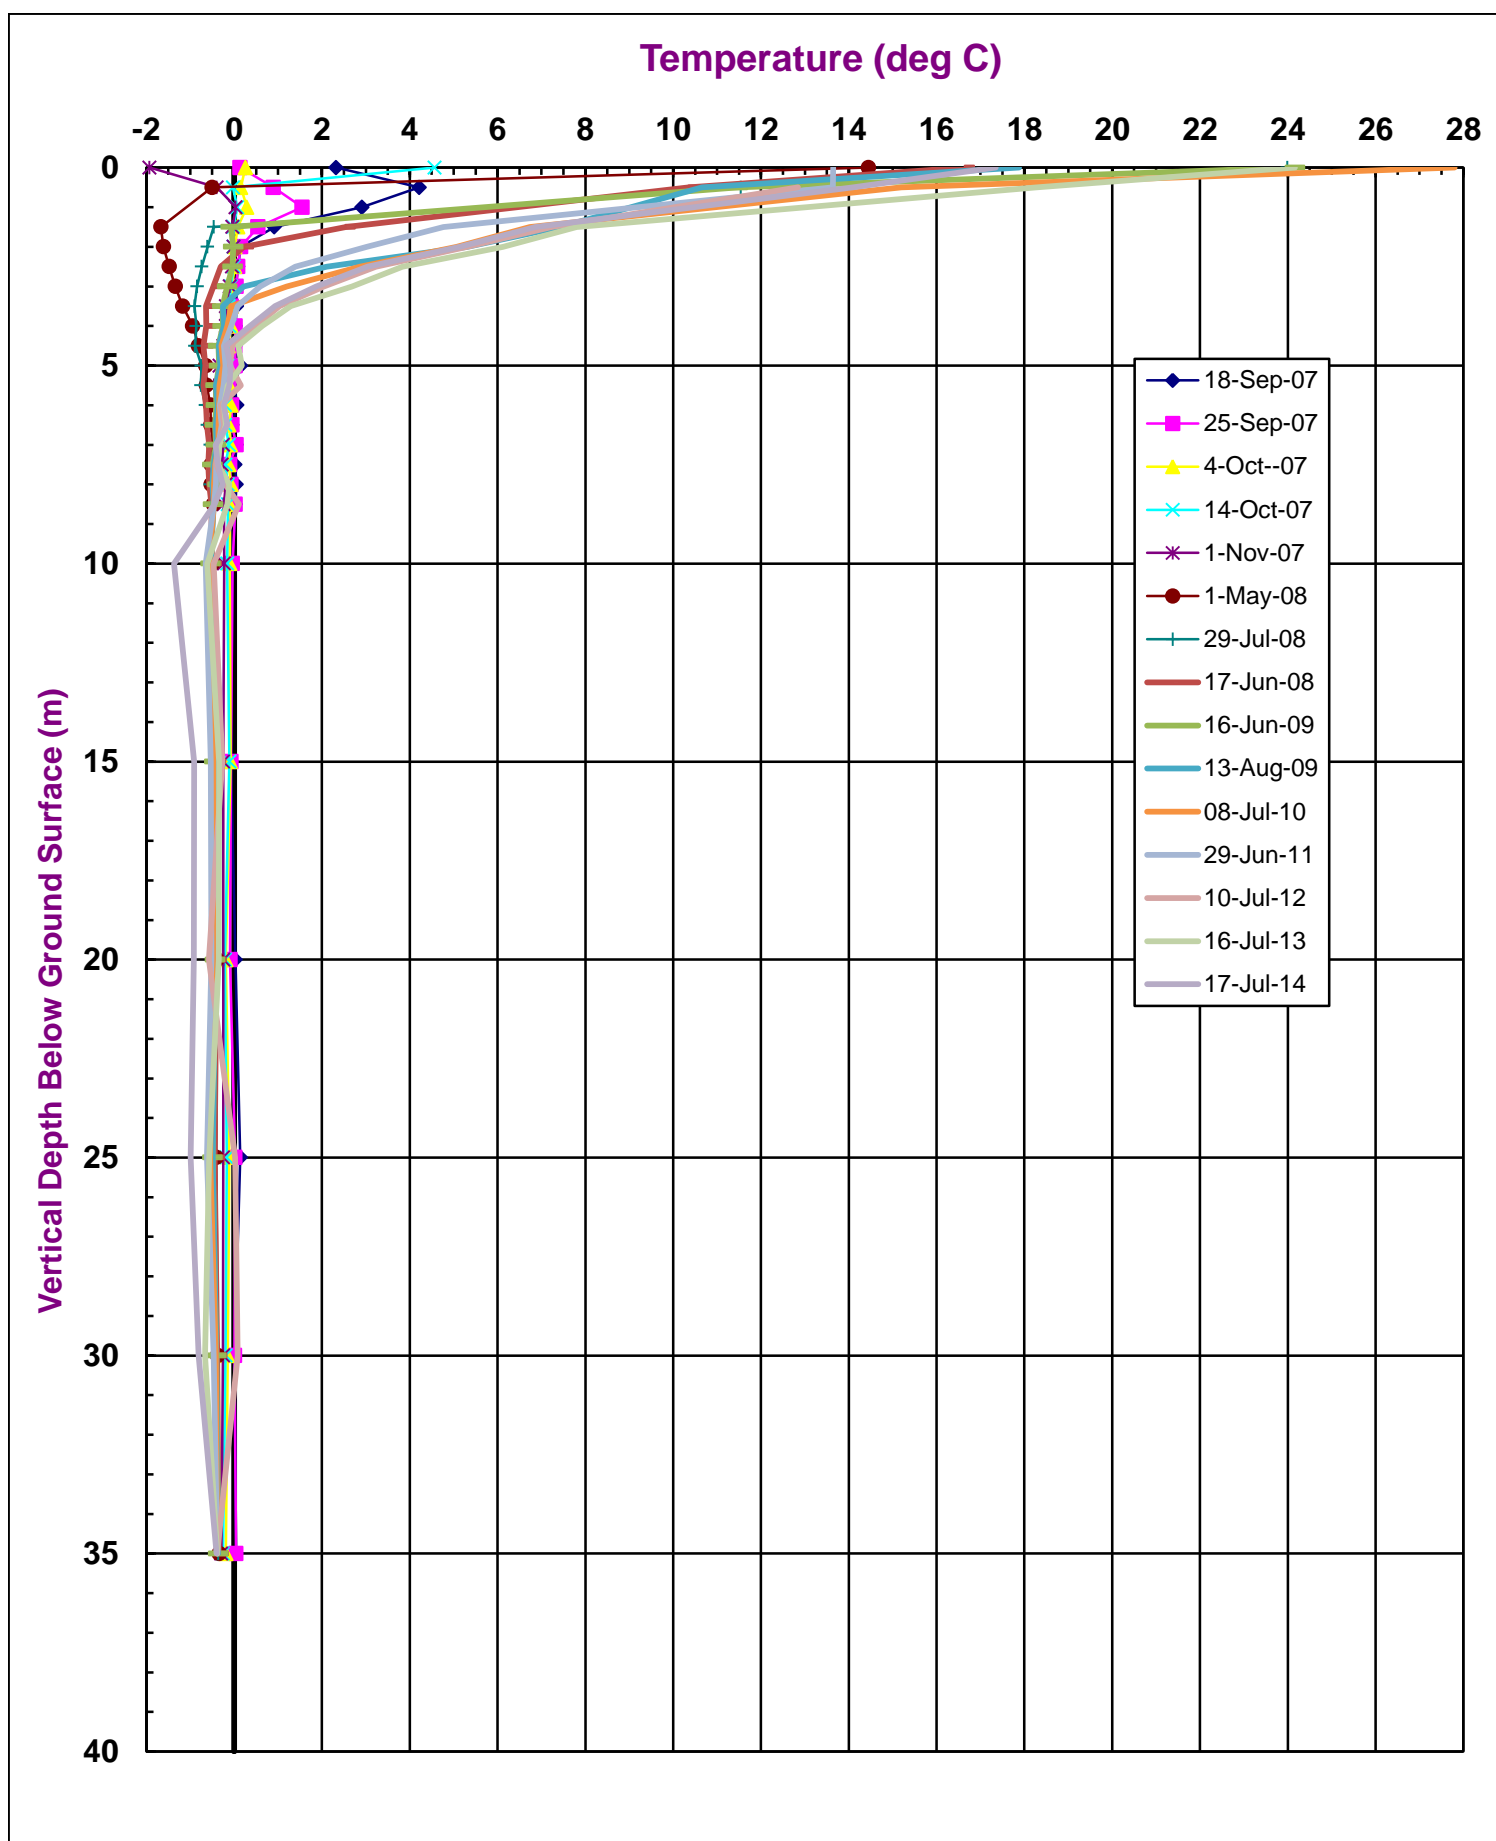
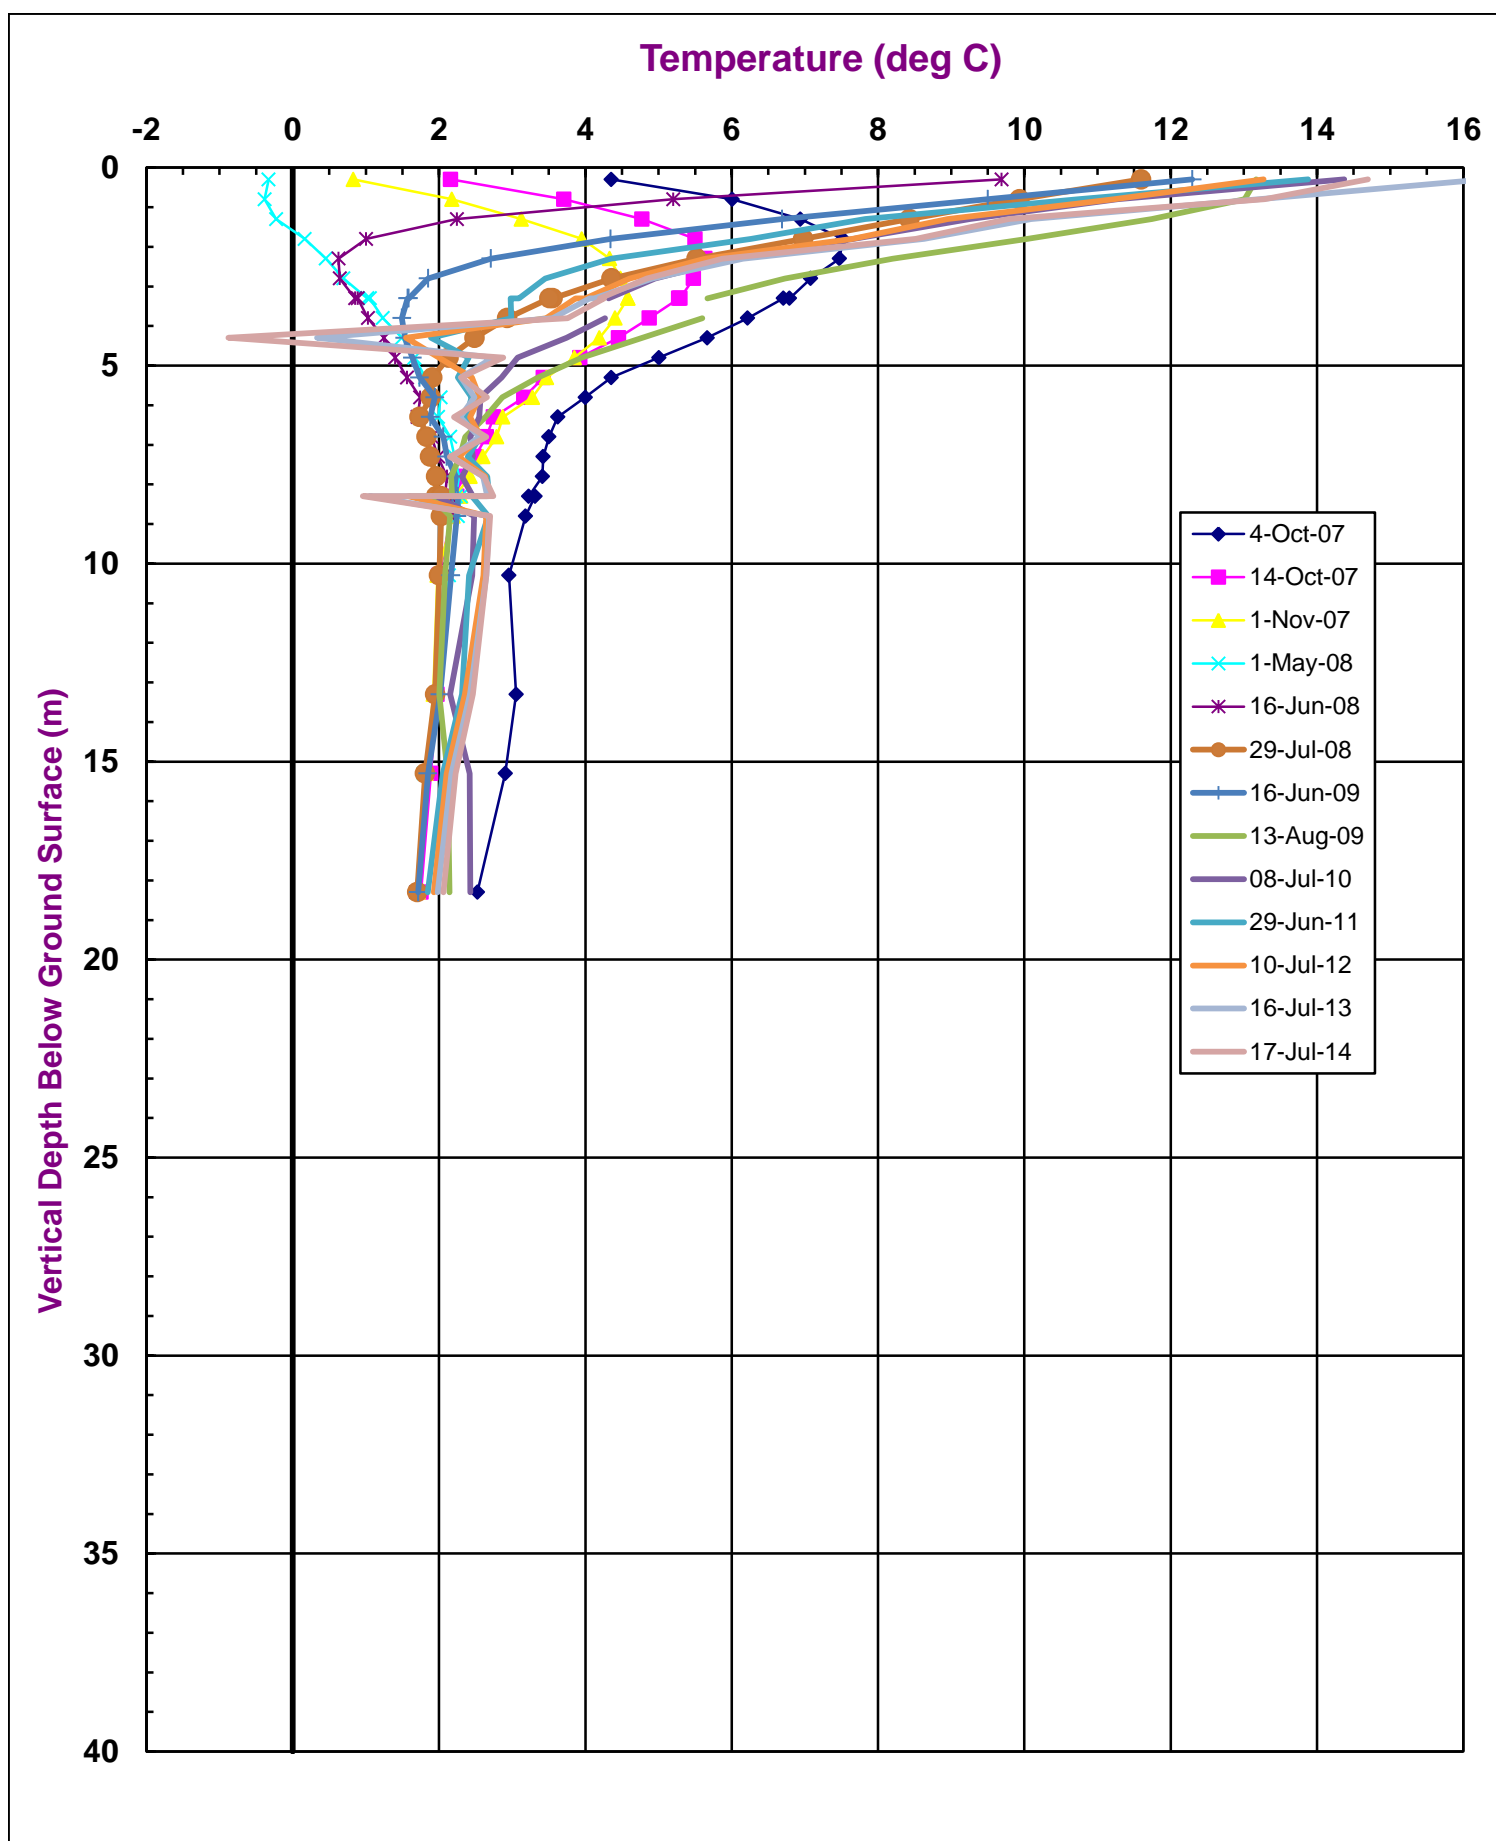
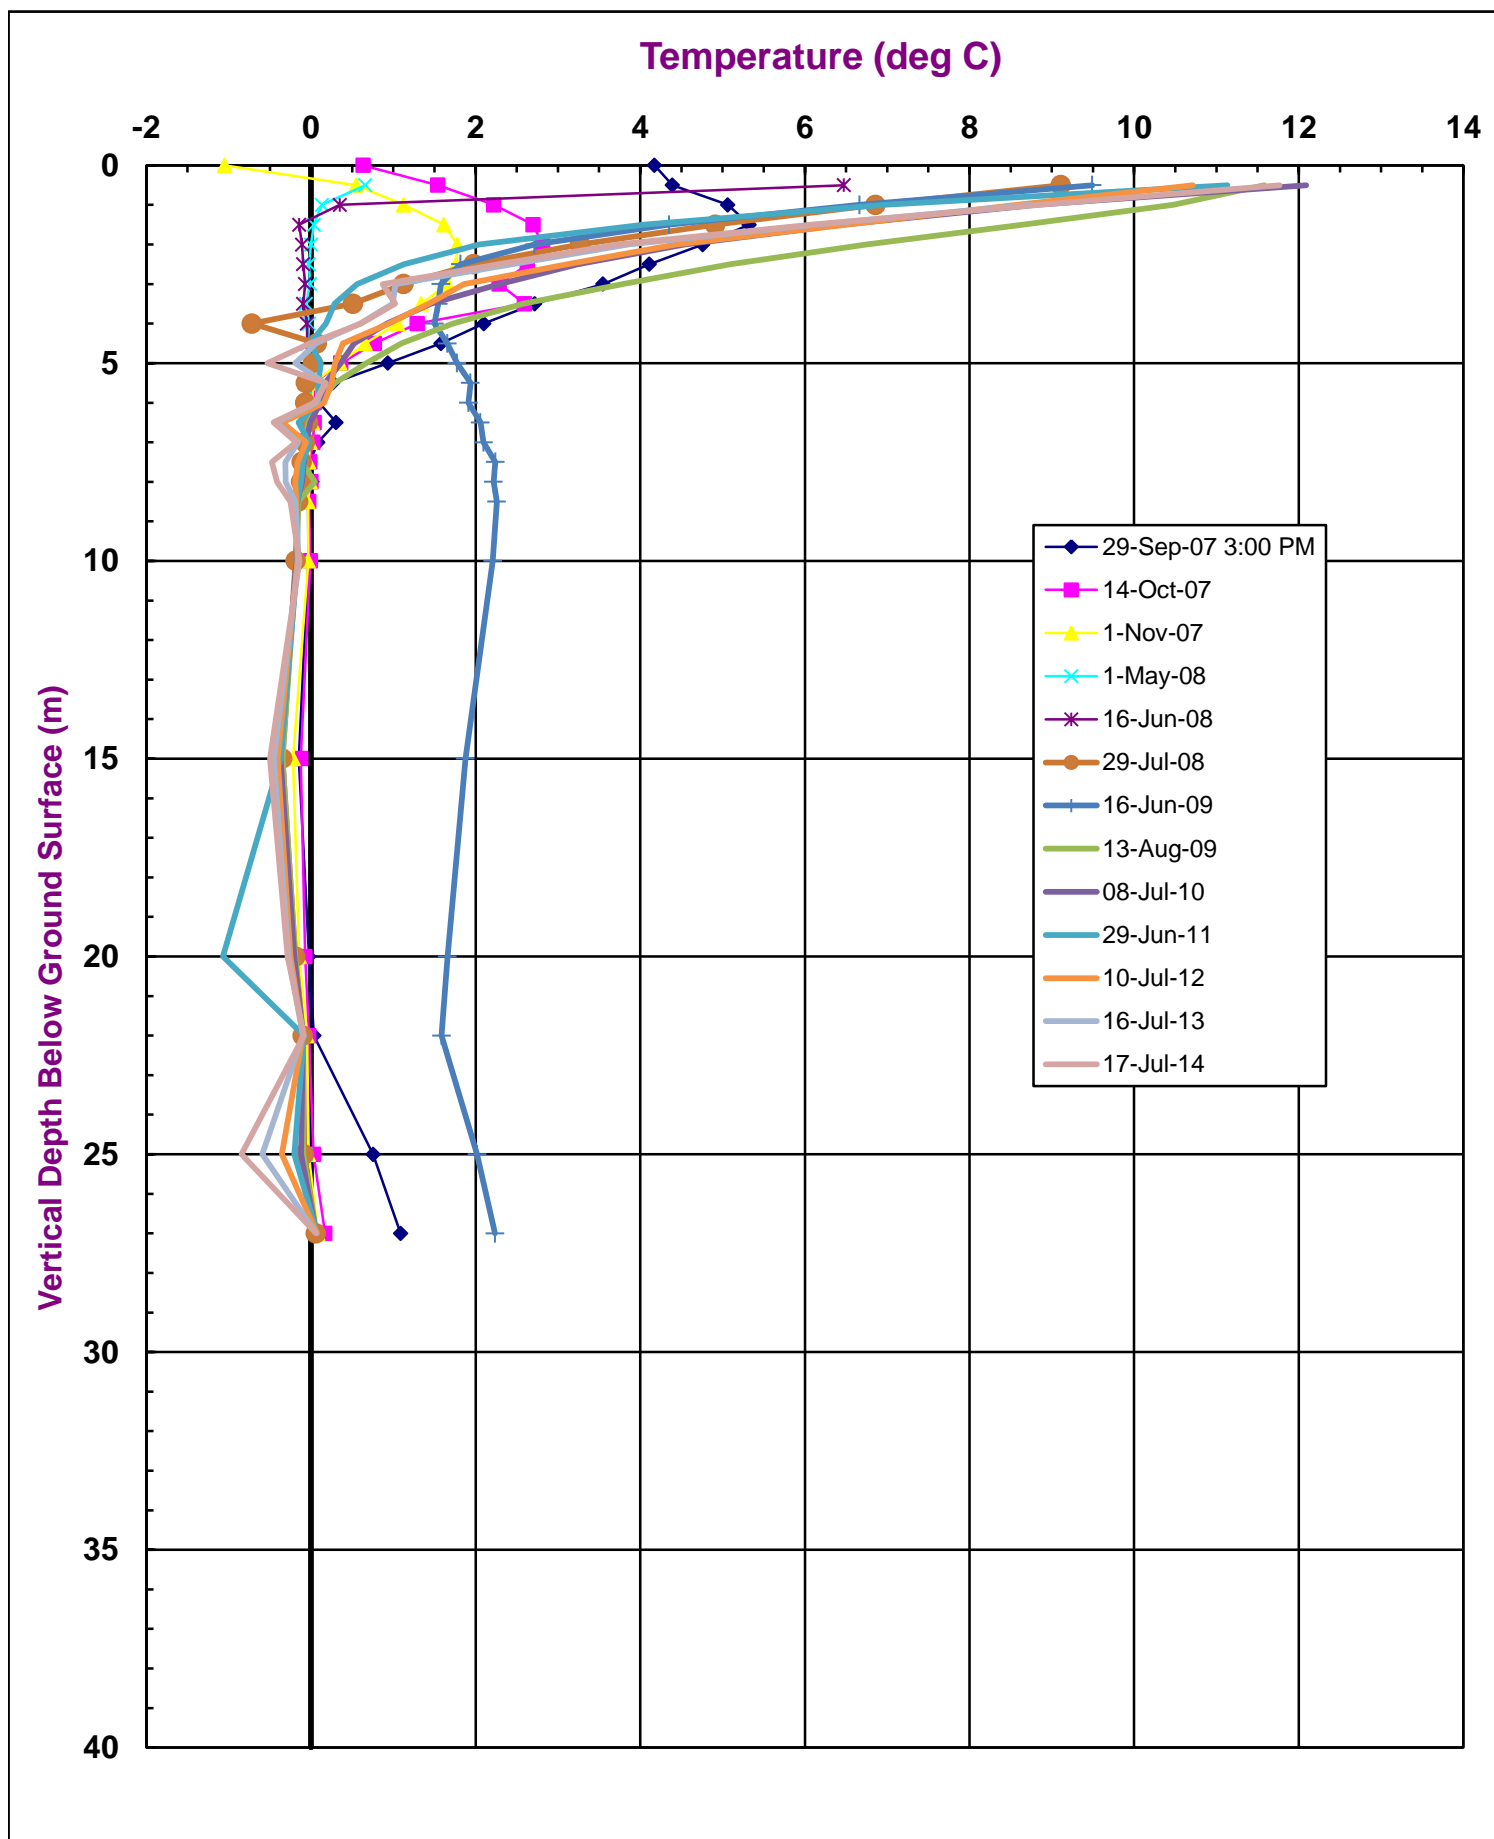
Thermistor Data

Ground temperatures derived from thermistor data collected during the site visit are presented in Attachment B. The thermistor plots indicate cooling of ground at the following locations:

It is recommended that vegetation in the lower footprint area of the Heap Leach Facility and Confining Embankment be re-cleared in 2014 or 2015 to promote thaw of permafrost ground prior to development of the area. Vegetation may allow the re-establishment of permafrost and ground ice and the vegetation should therefore be cleared to allow the ground to thaw over the warmer months.

- Clearing of vegetation in the footprint of the area of the lower Heap Leach Facility area and Confining Embankment to promote thaw of permafrost ground.
