October 27, 2017

Project No. 1786033_LT0001_Rev0

2017 ANNUAL INSPECTION OF THE CARMACKS COPPER PROJECT, CARMACKS, YUKON

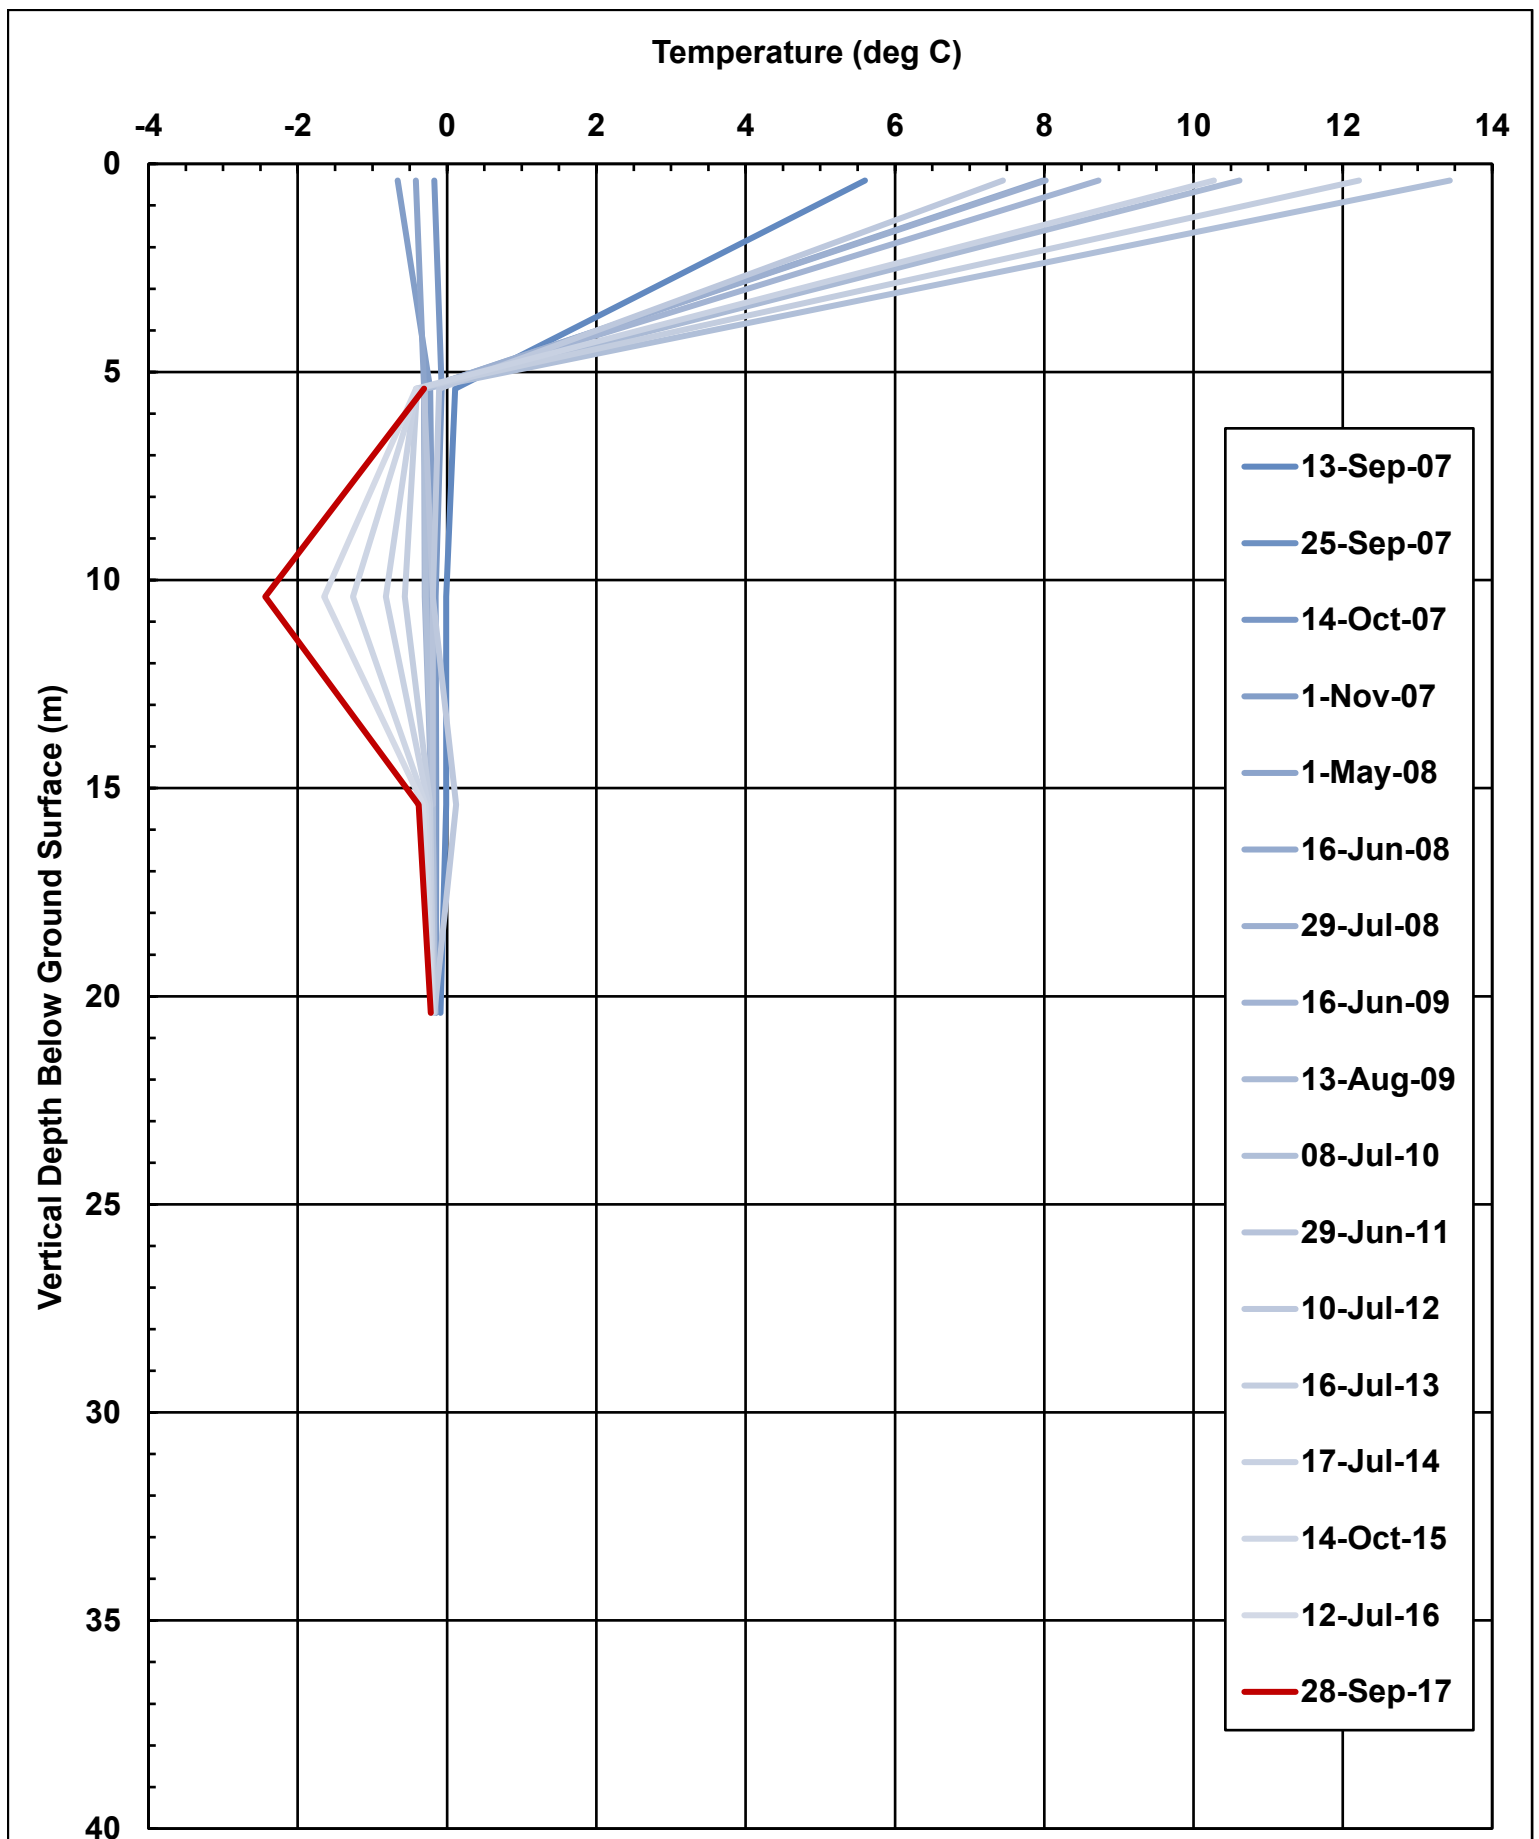
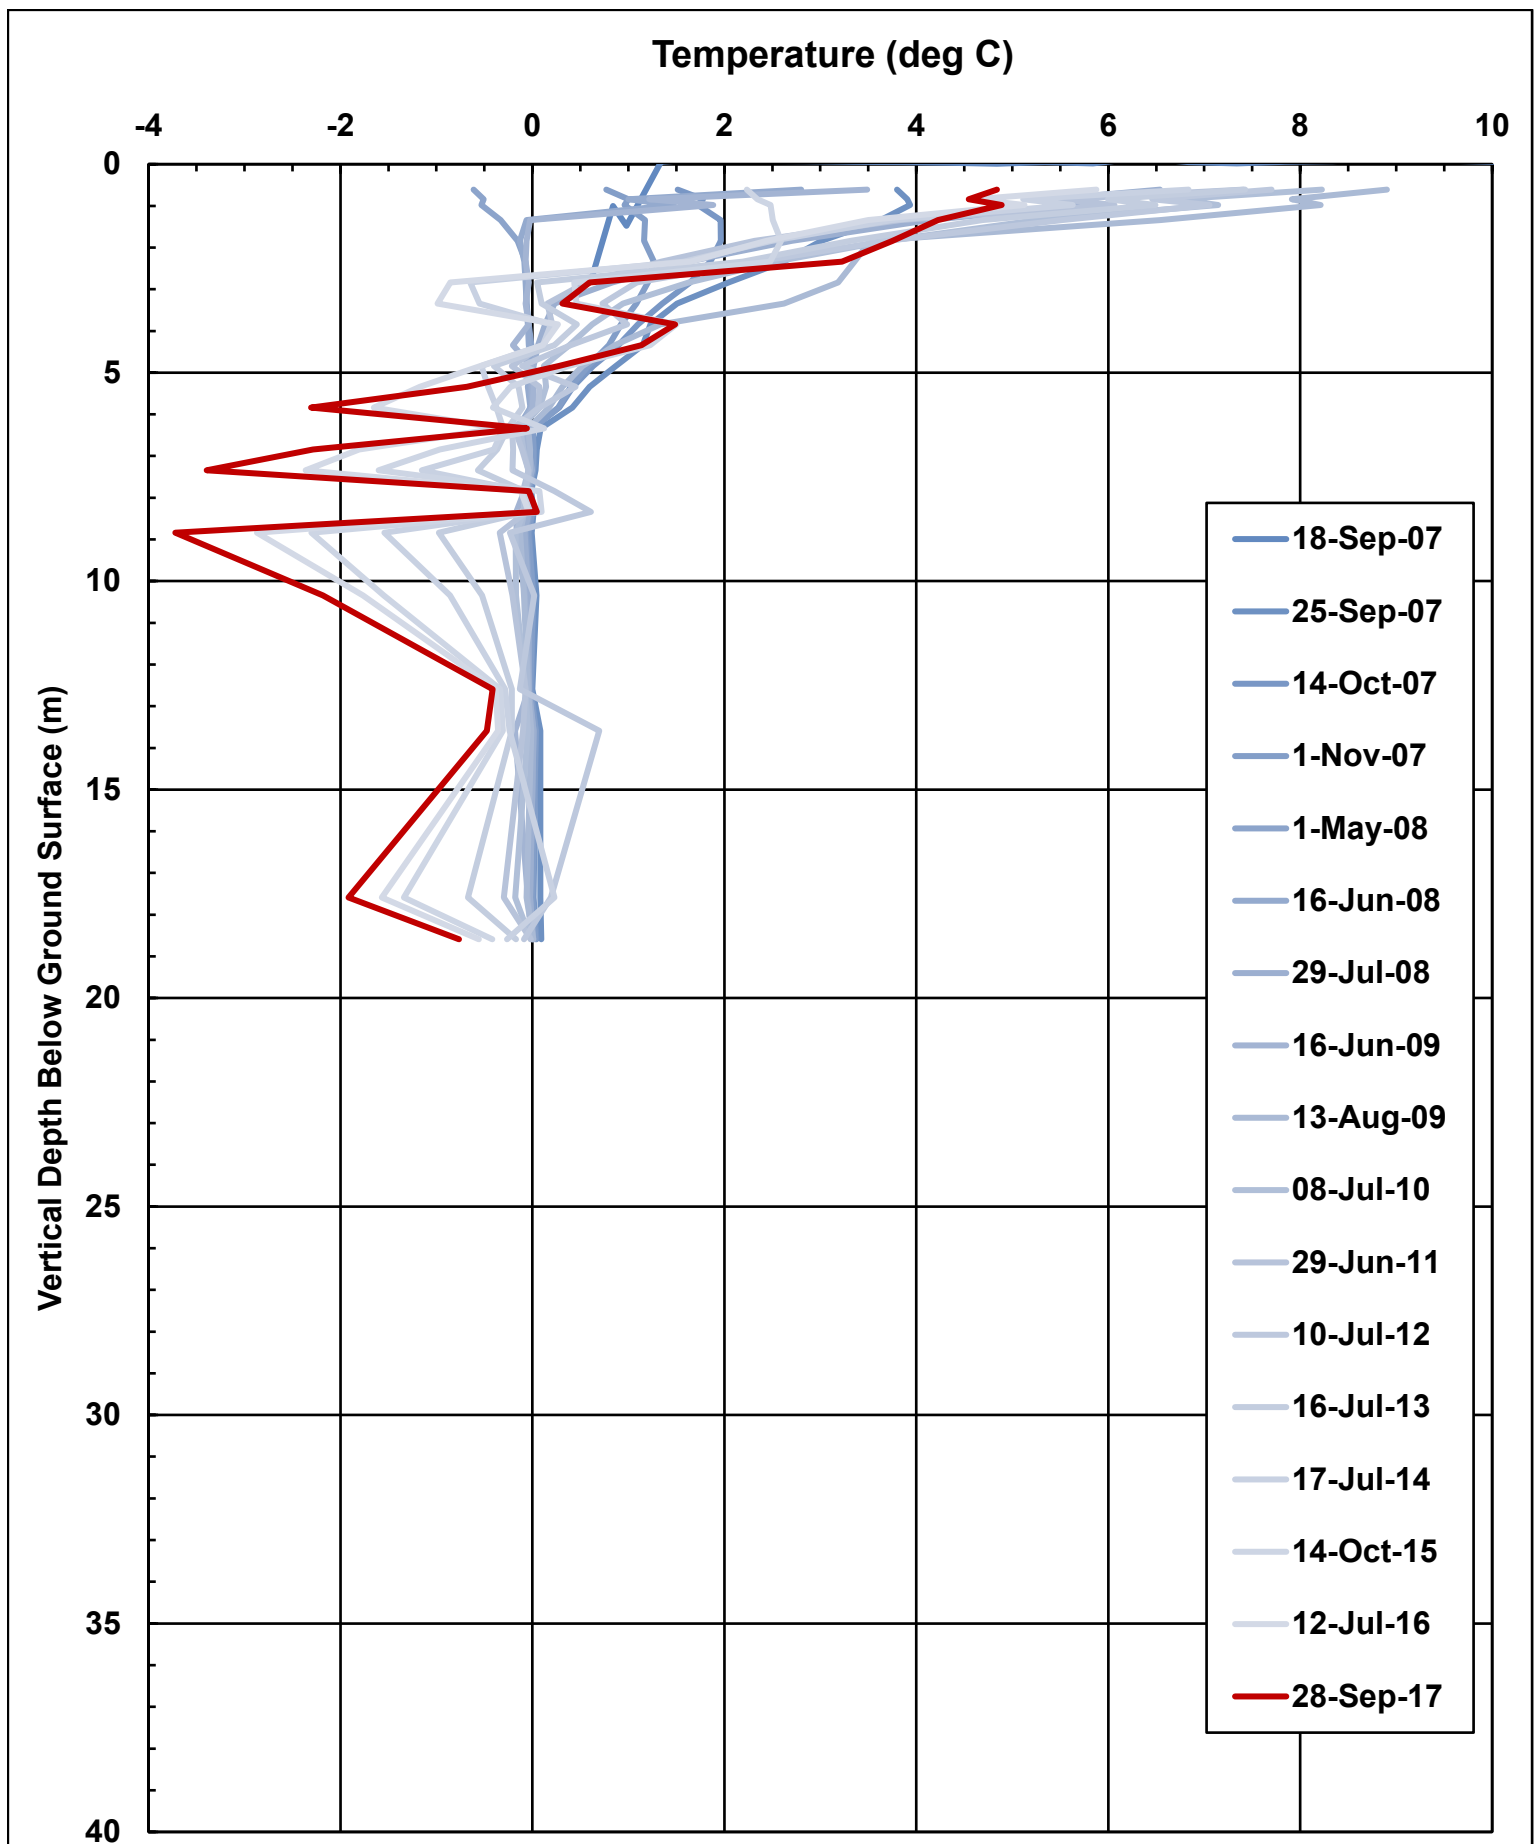
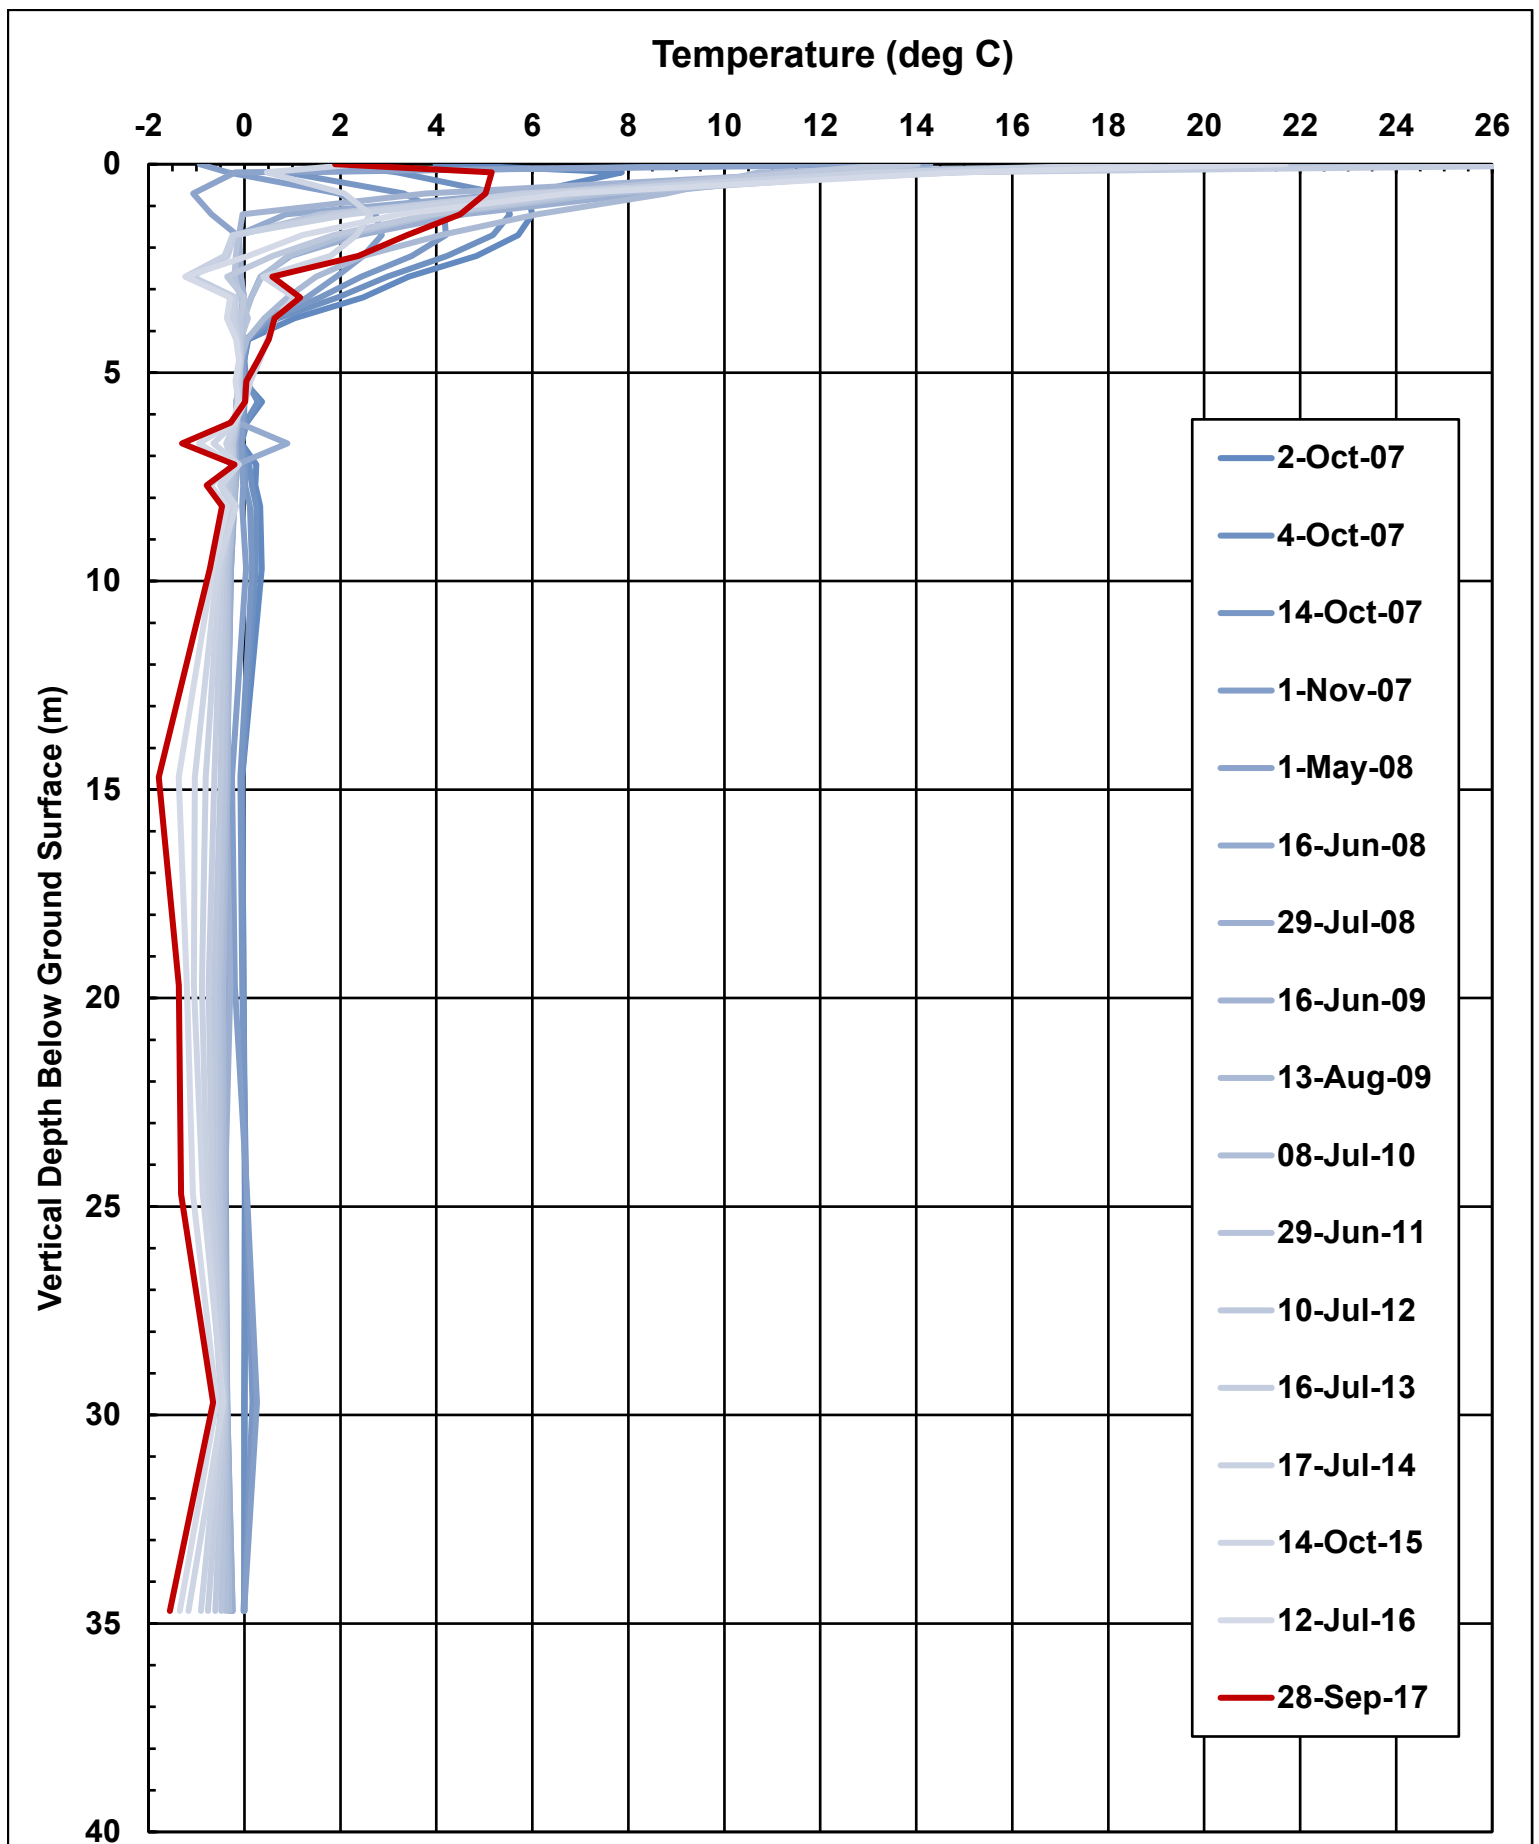
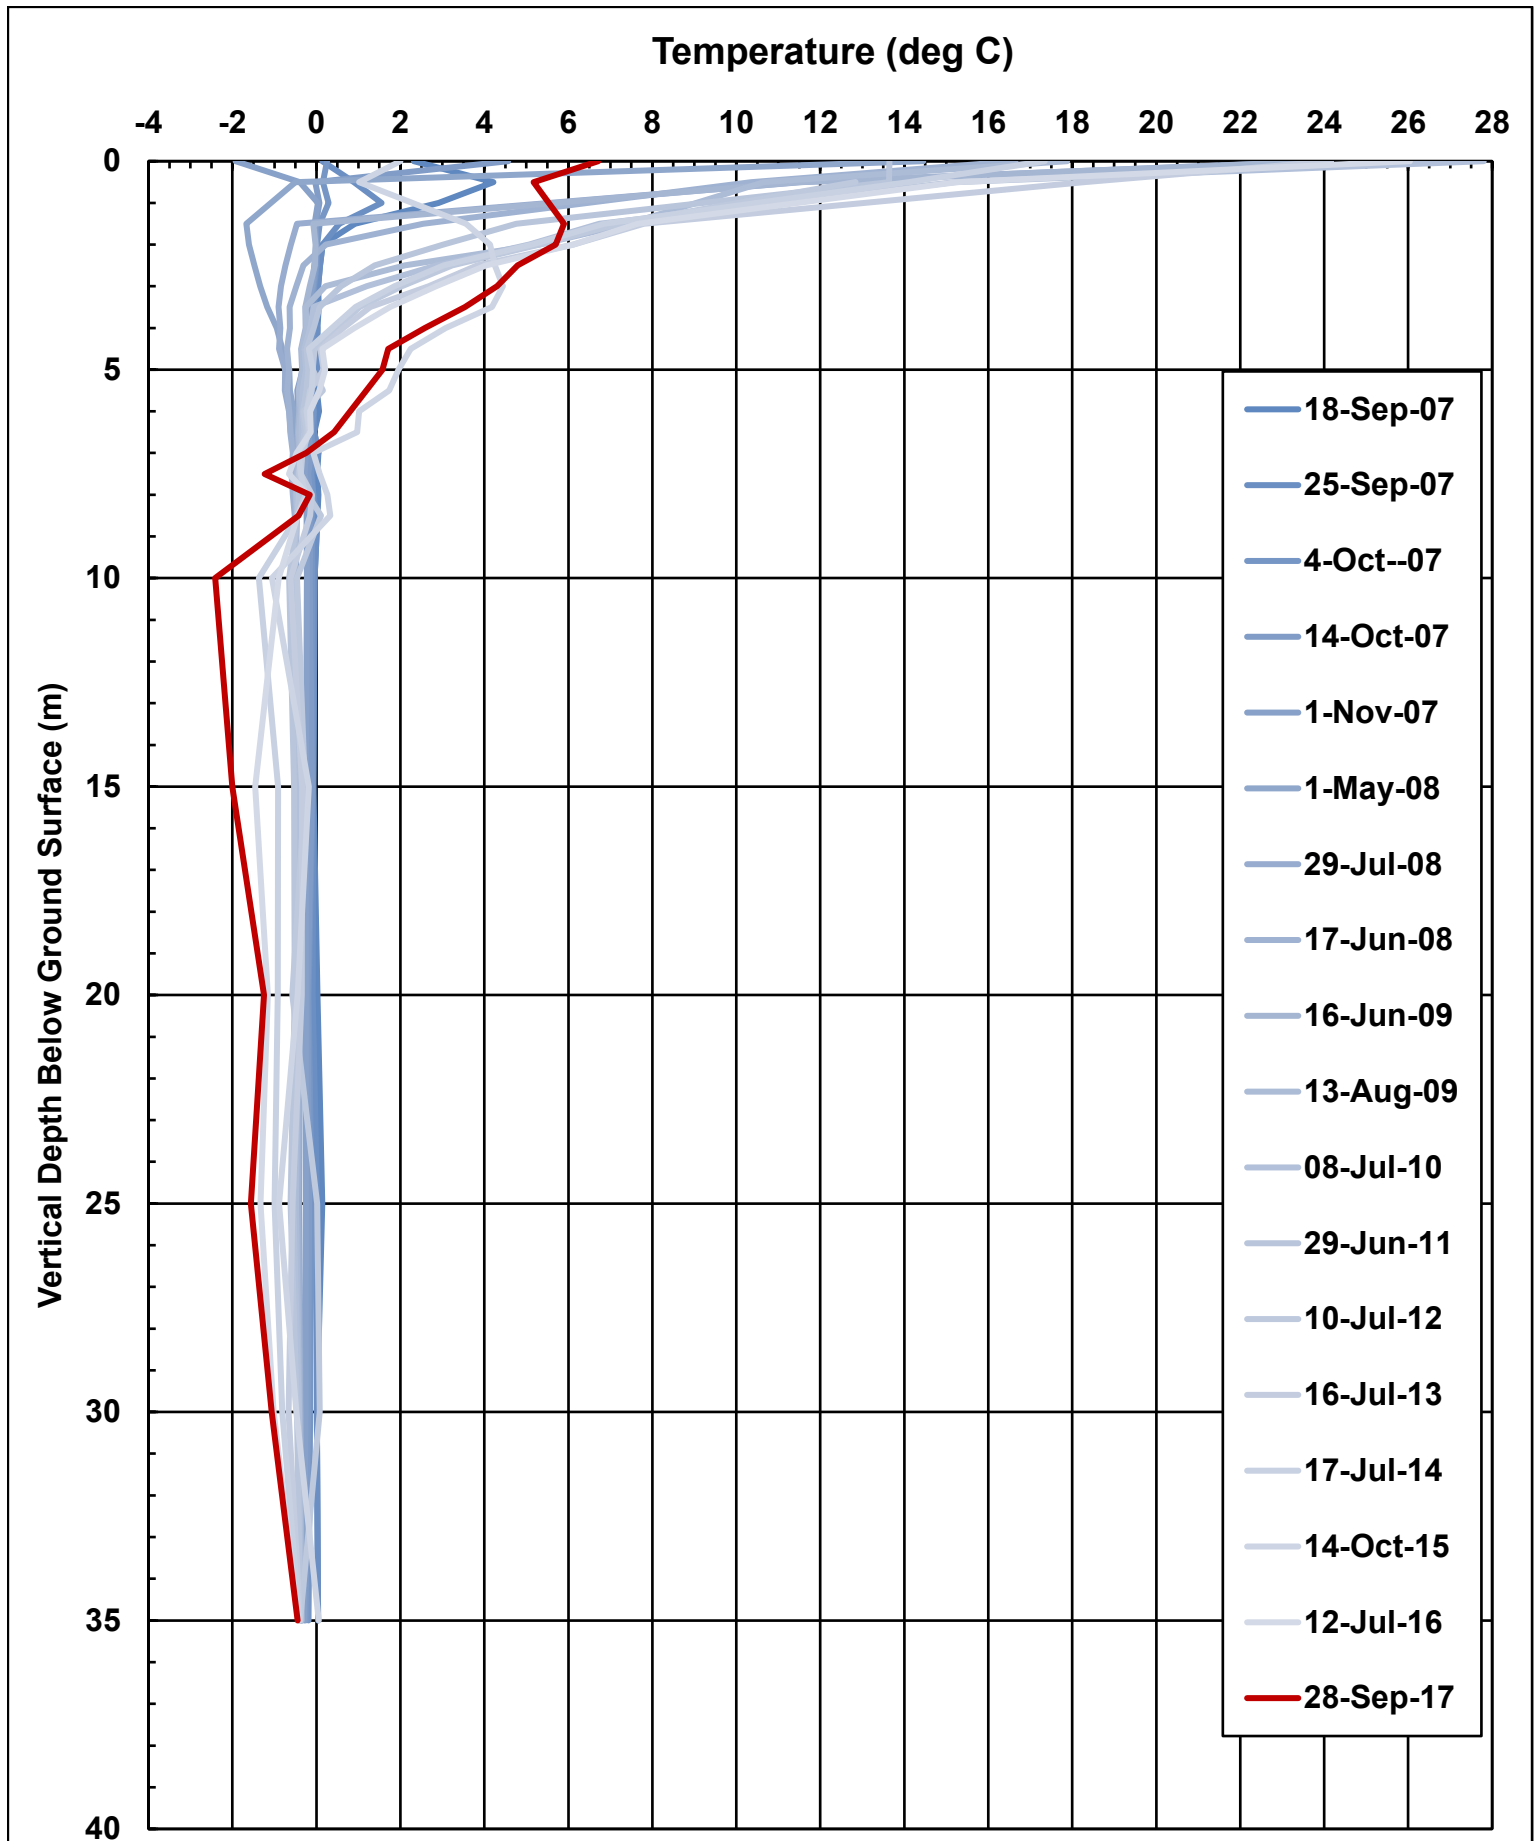
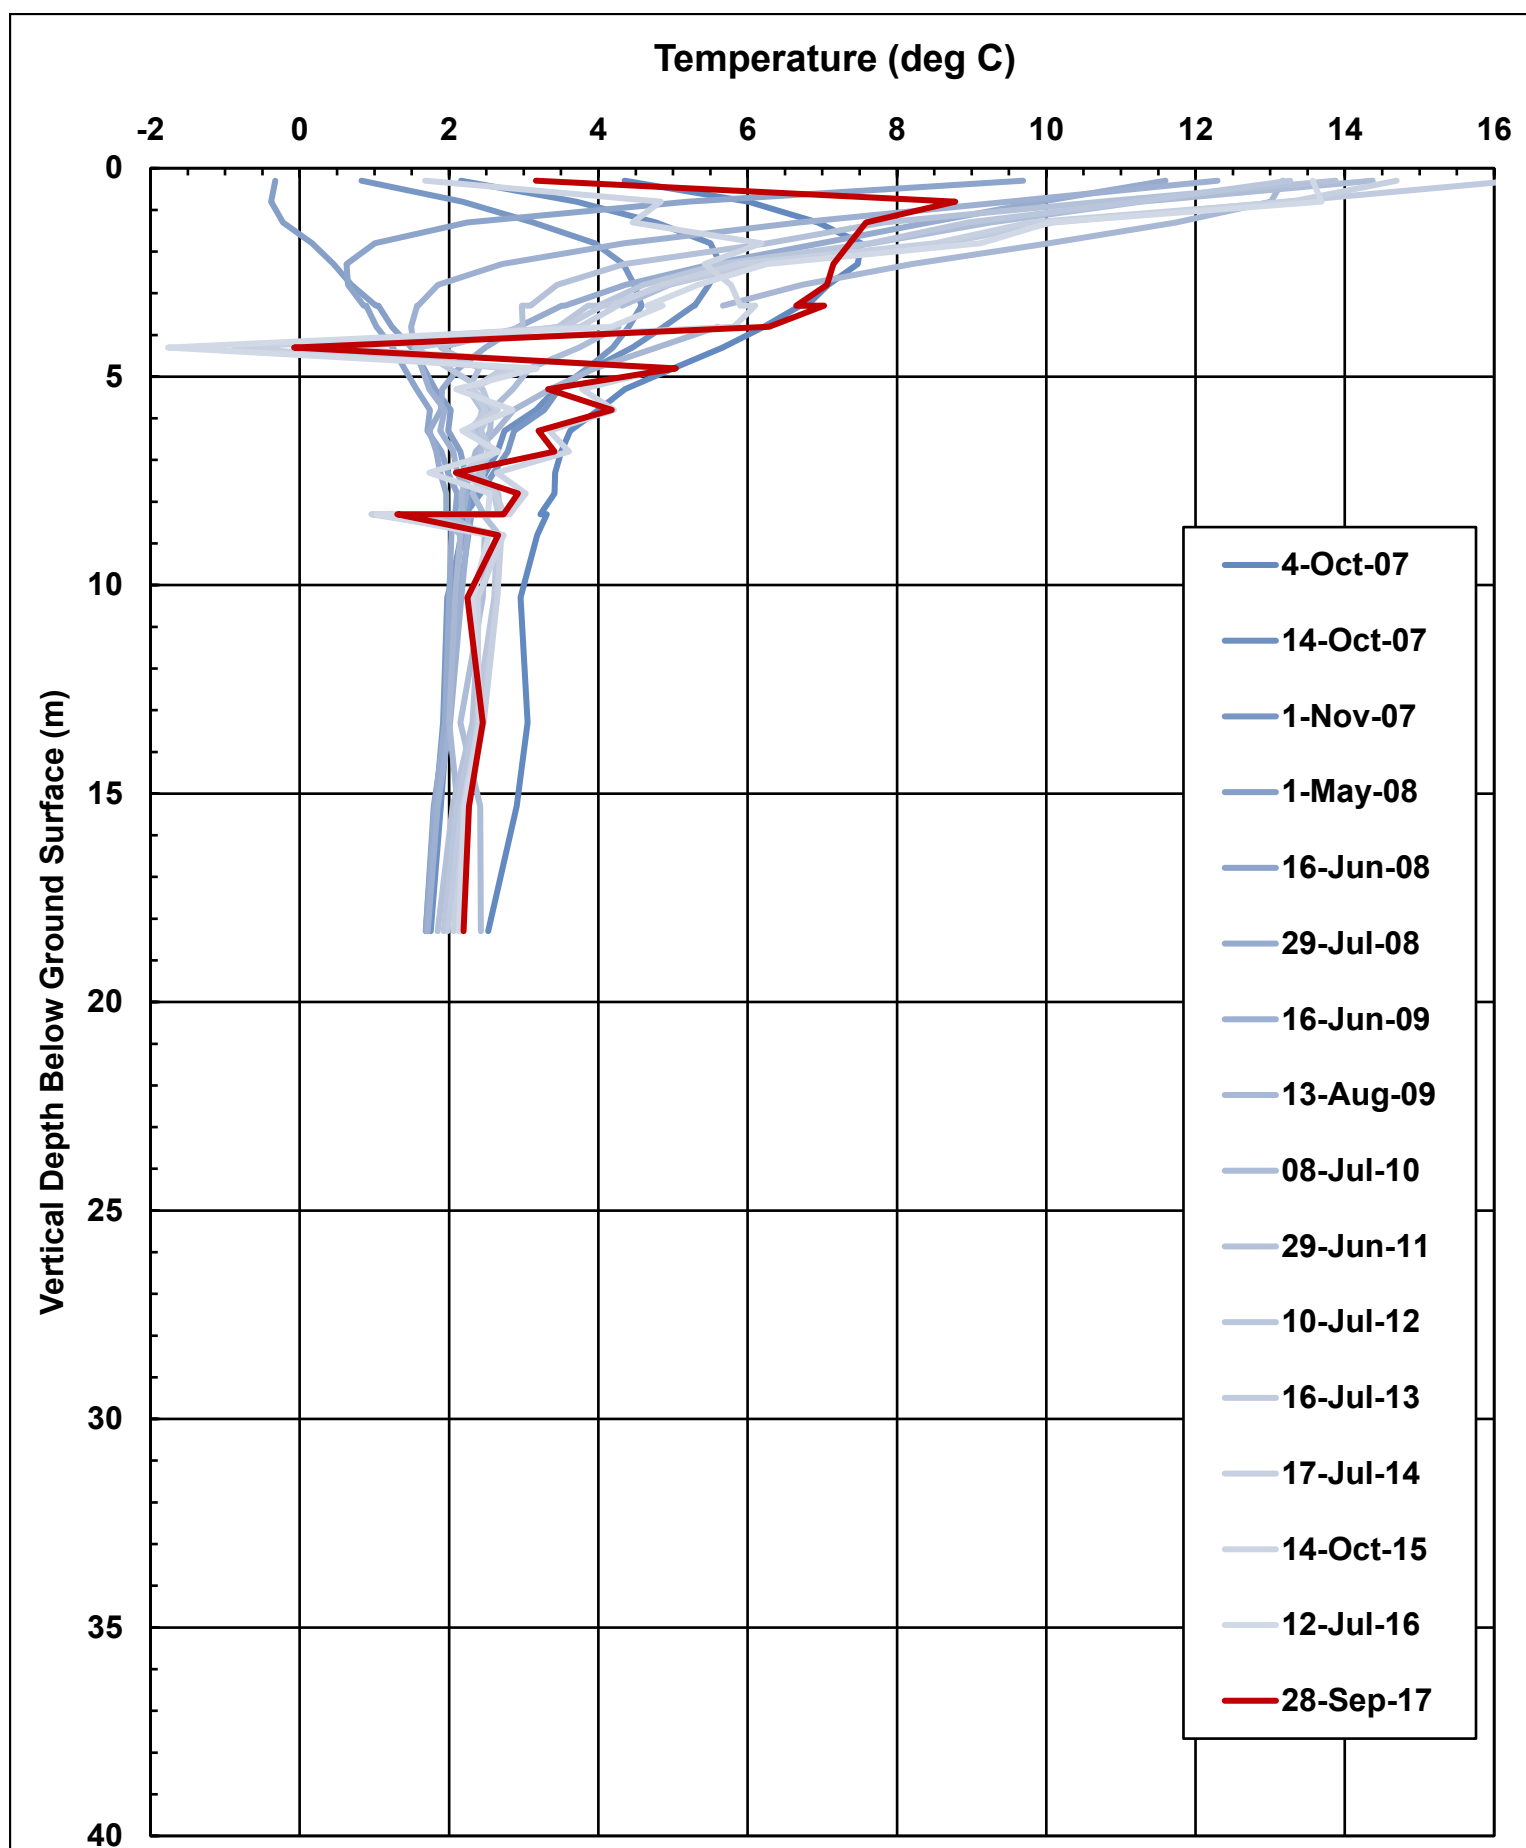
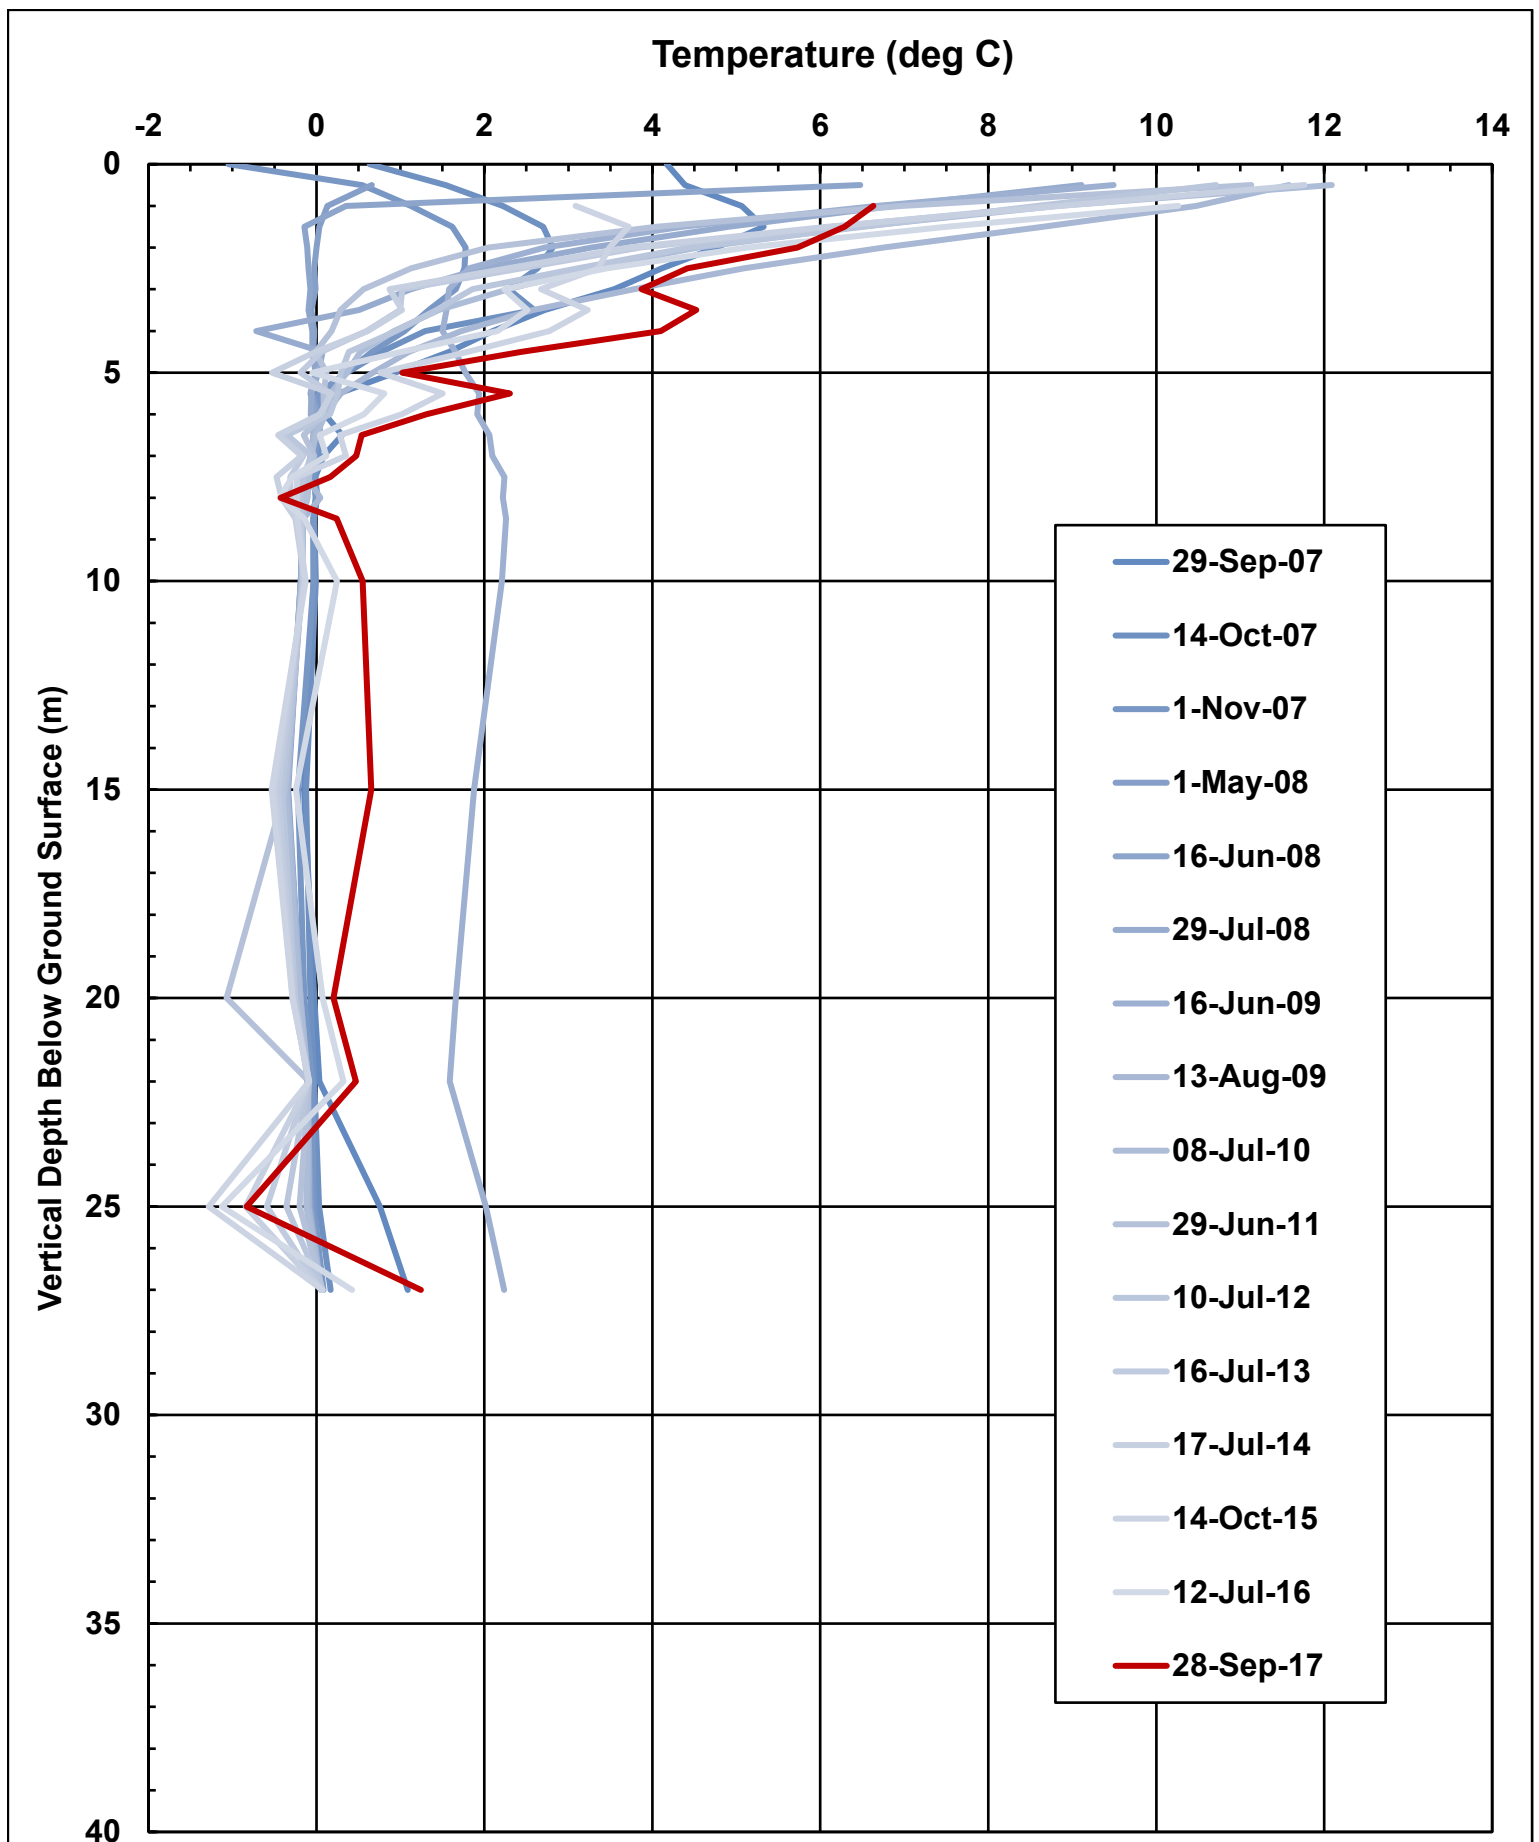
Thermistor Plots

No permafrost has been observed at thermistors BH-13-07, BH-23-07, and BH-26-07 over the depth monitored within the proposed heap leach facility area. Permafrost may exist below the depth monitored.
