November 6, 2015

Reference No. 1417183-006-L-Rev0-1000

**ANNUAL INSPECTION, OCTOBER 14, 2015
CARMACKS COPPER PROJECT, CARMACKS, YUKON**

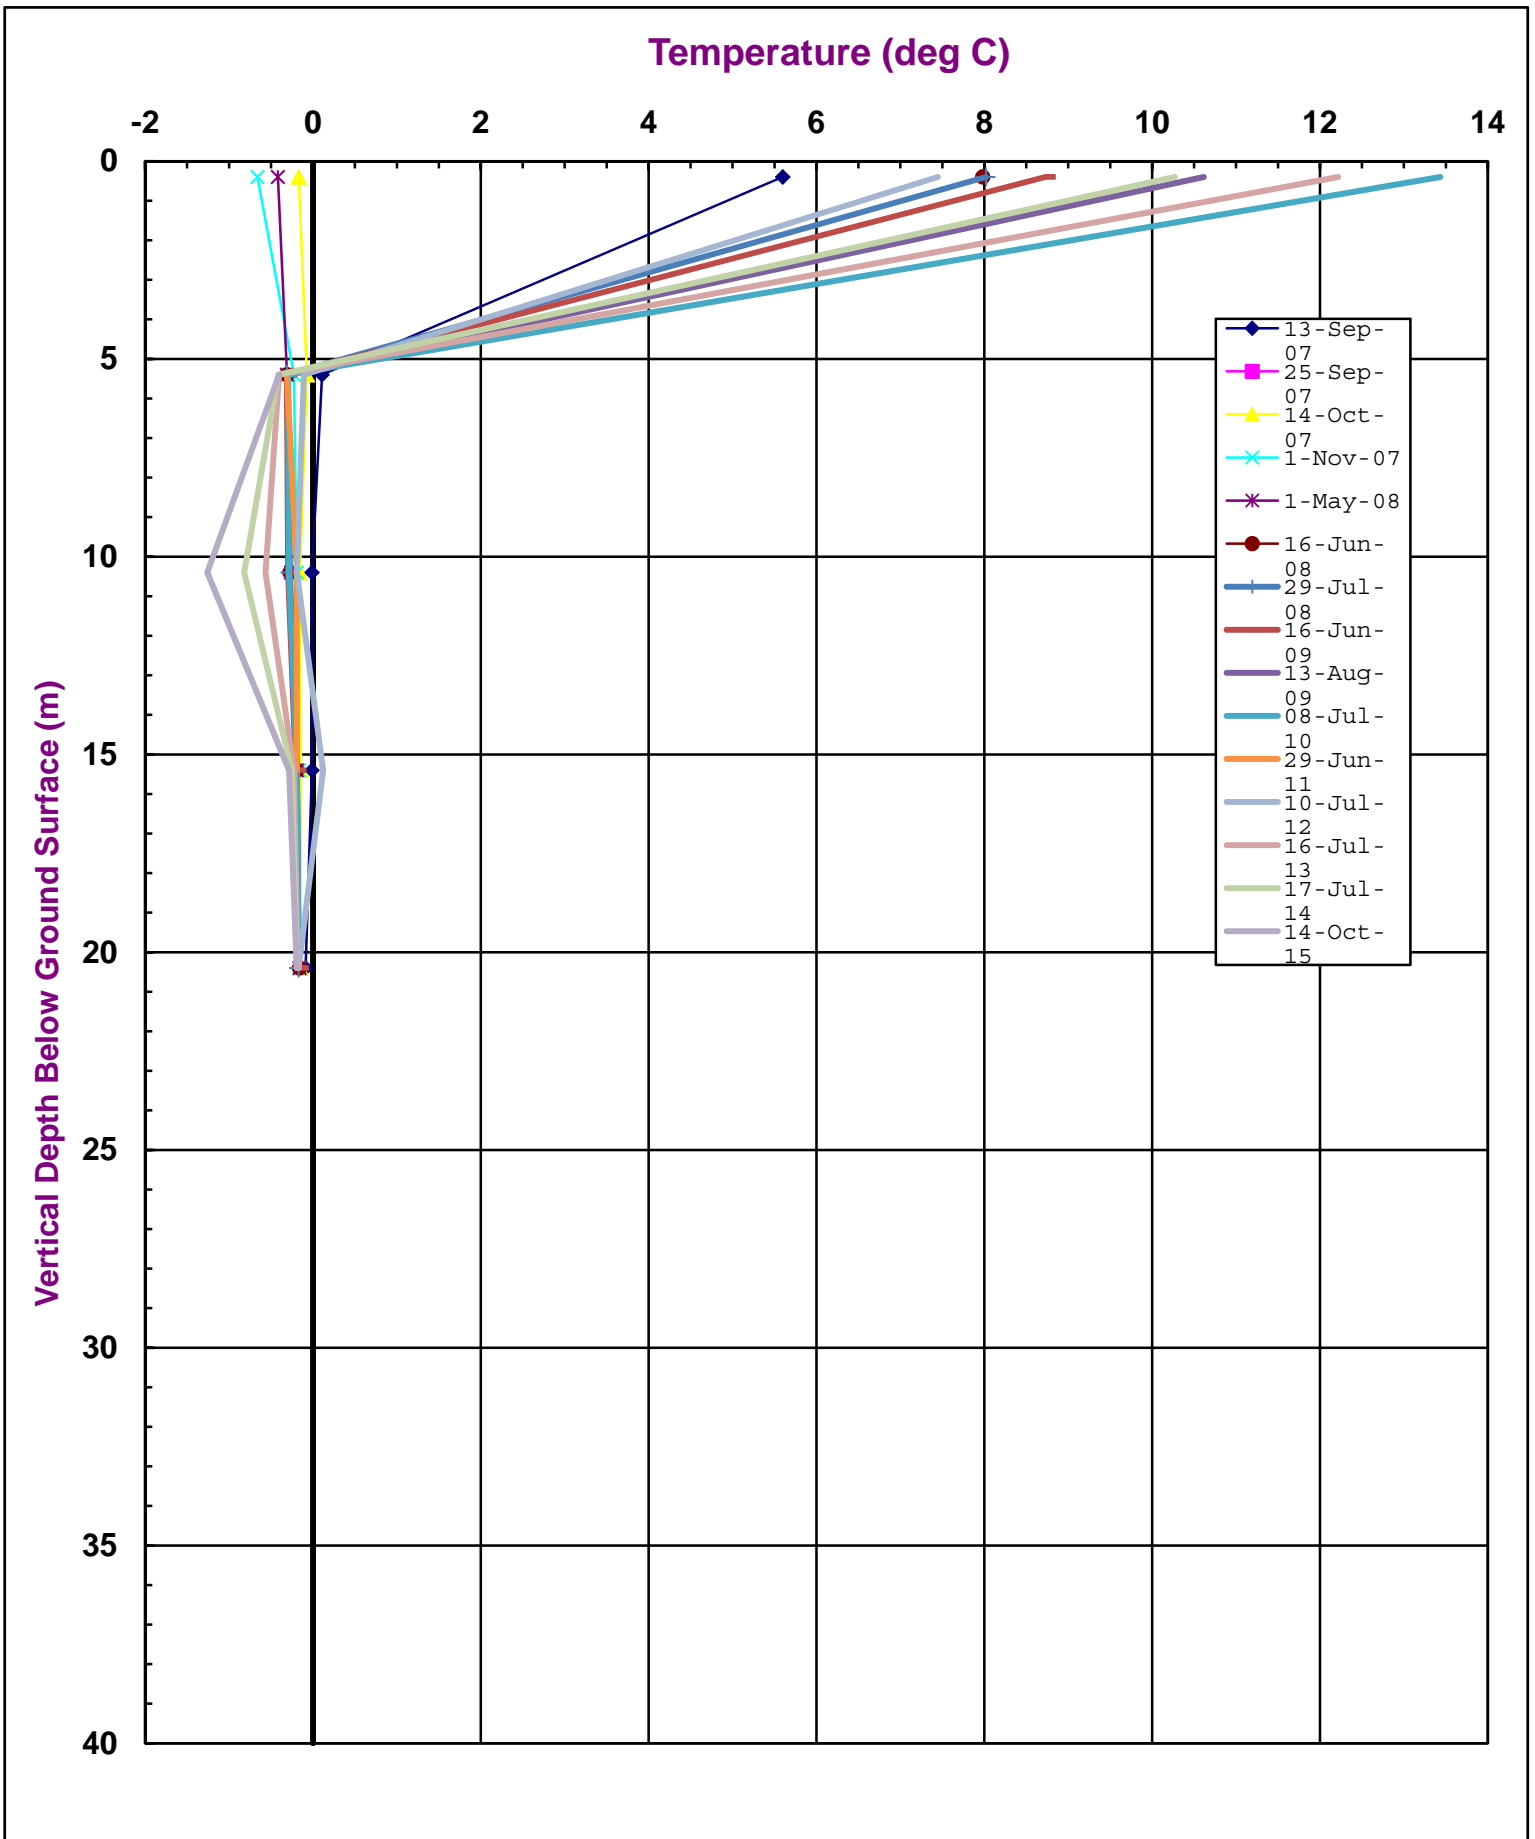
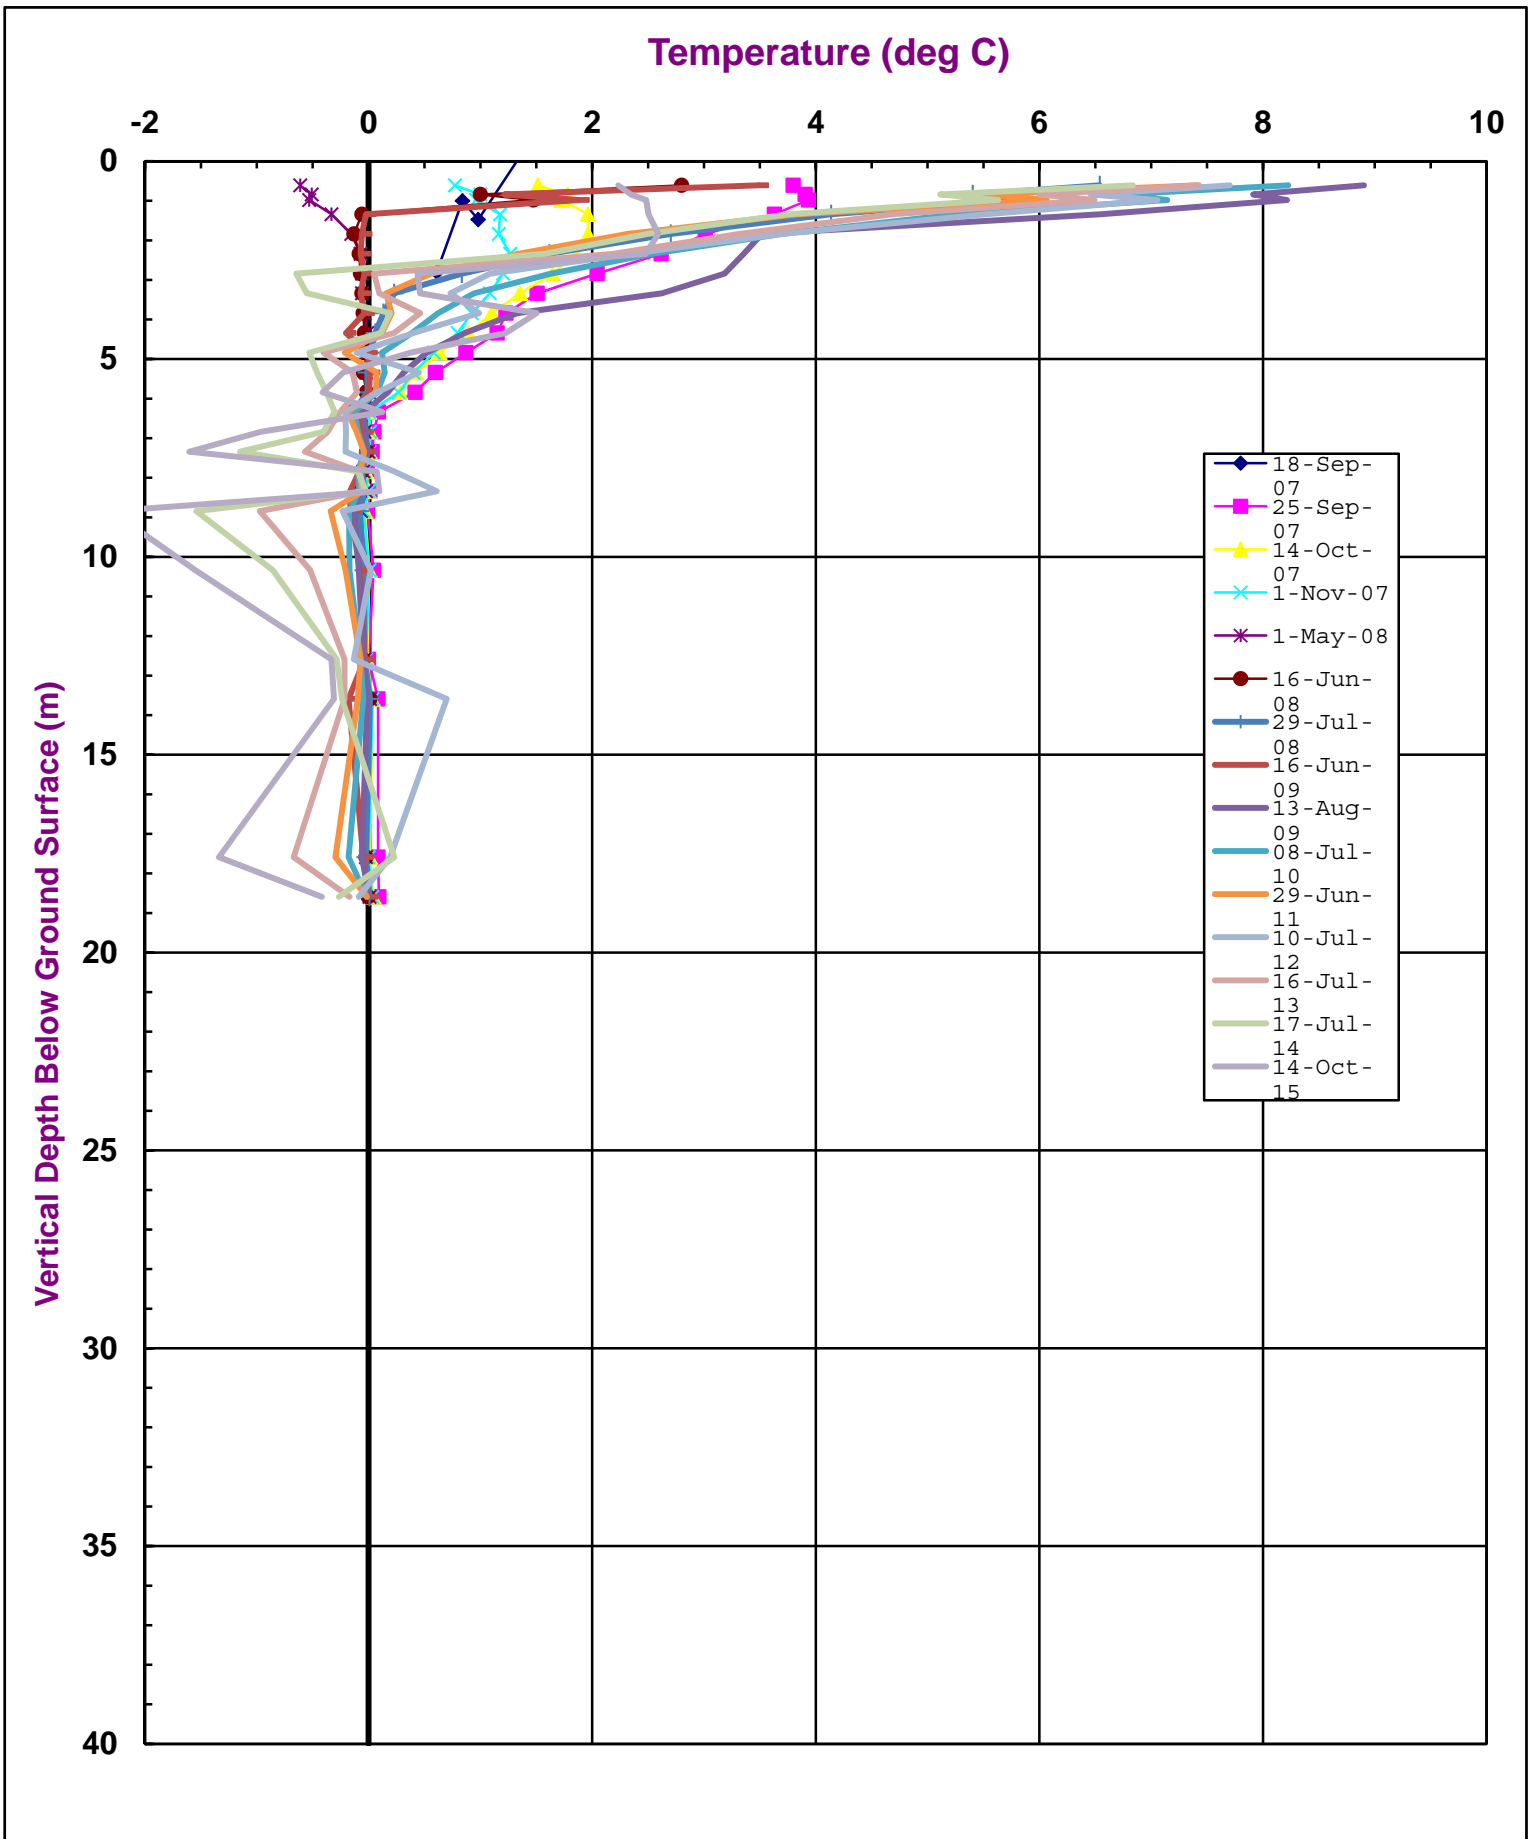
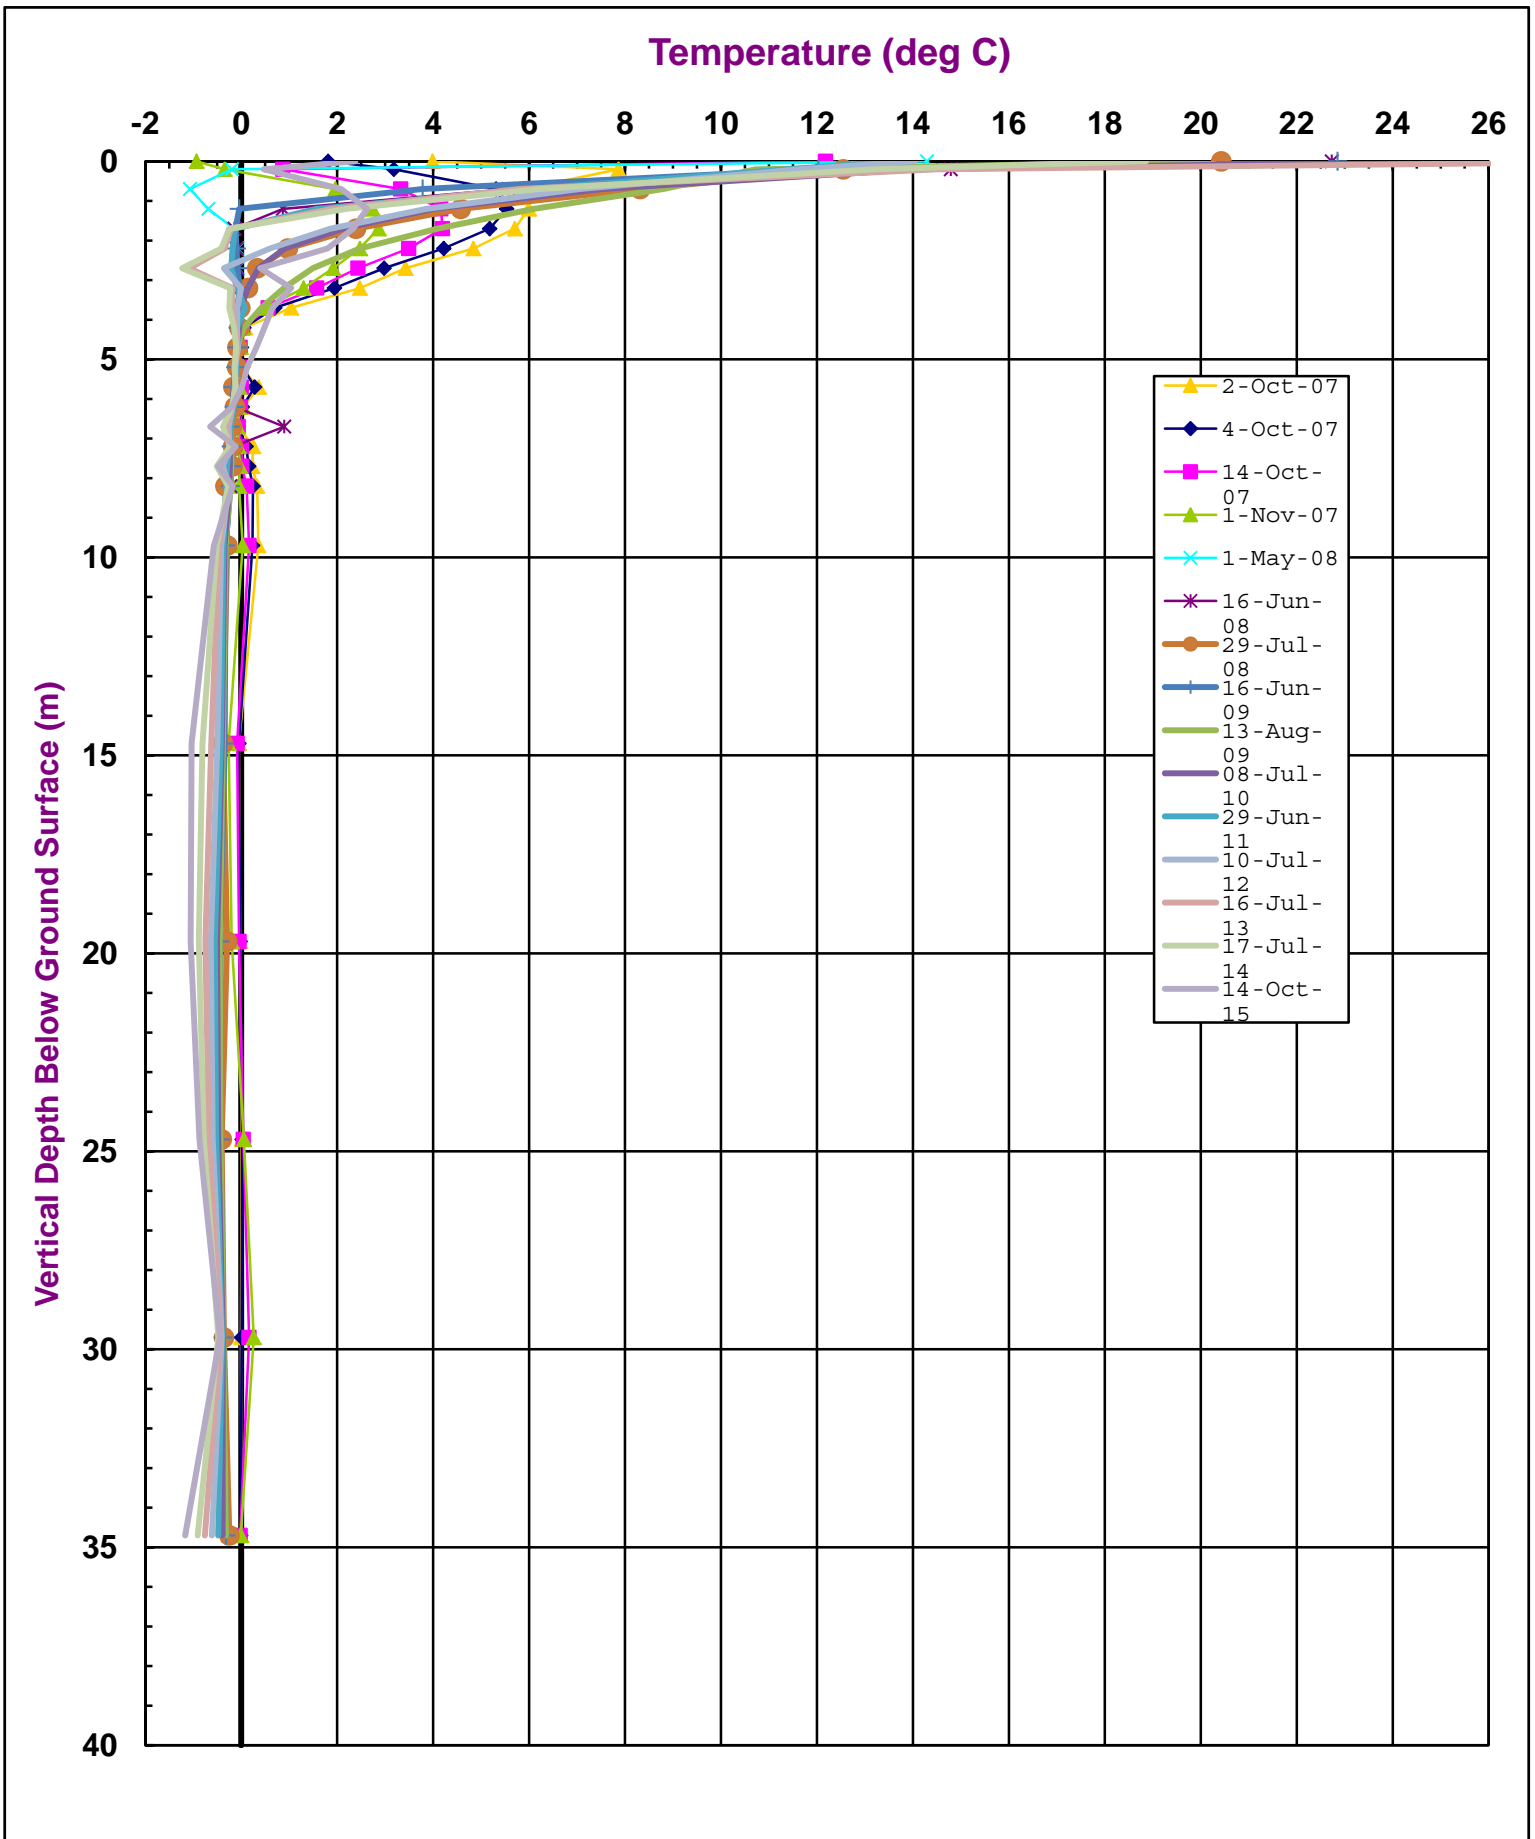
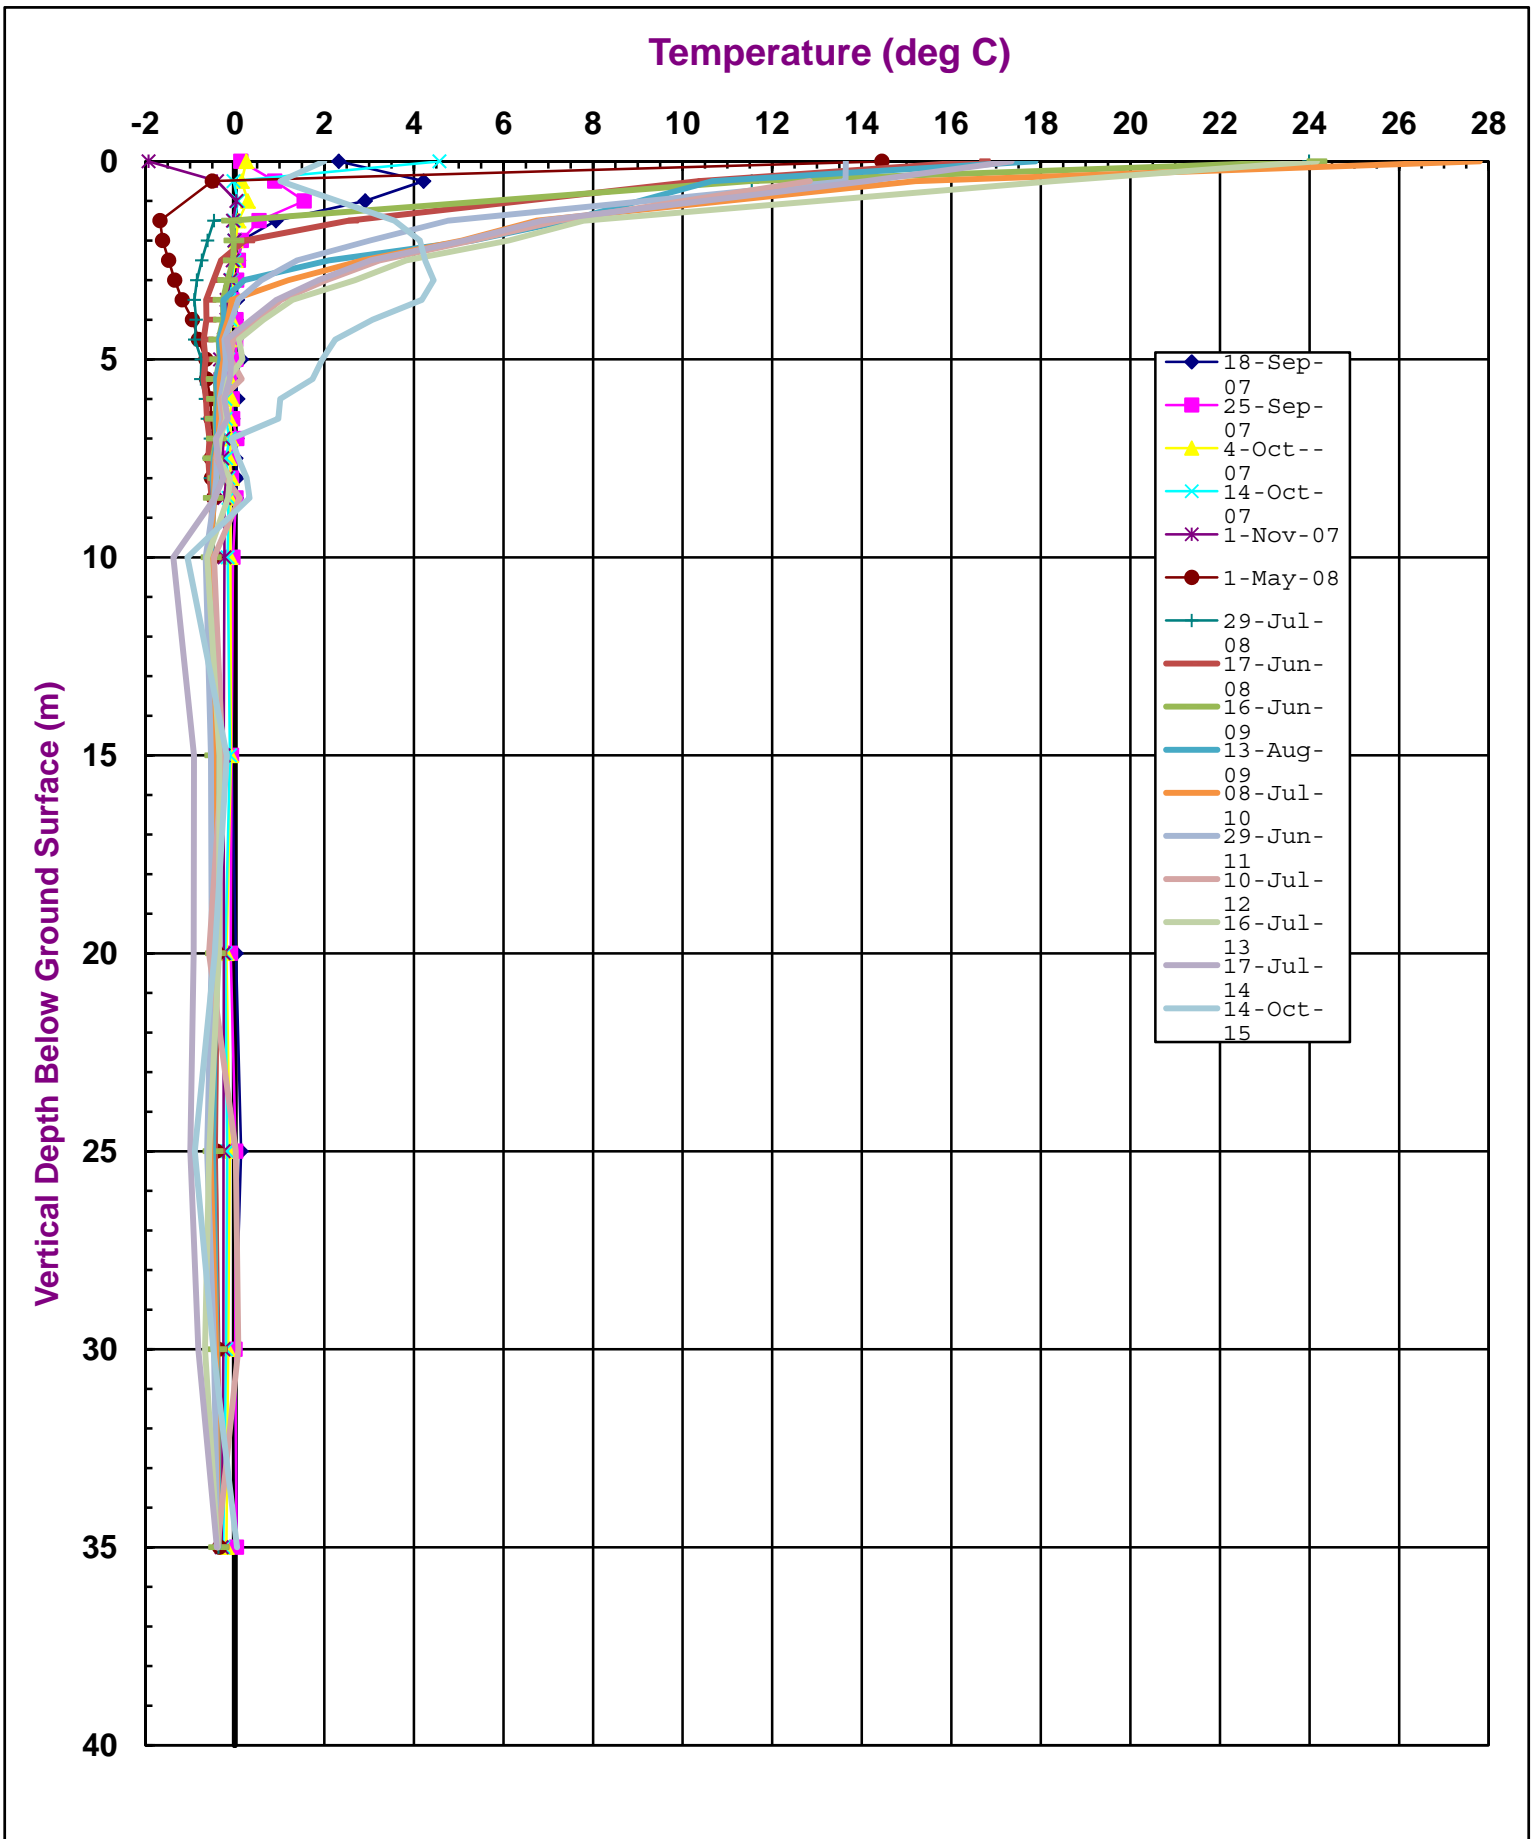
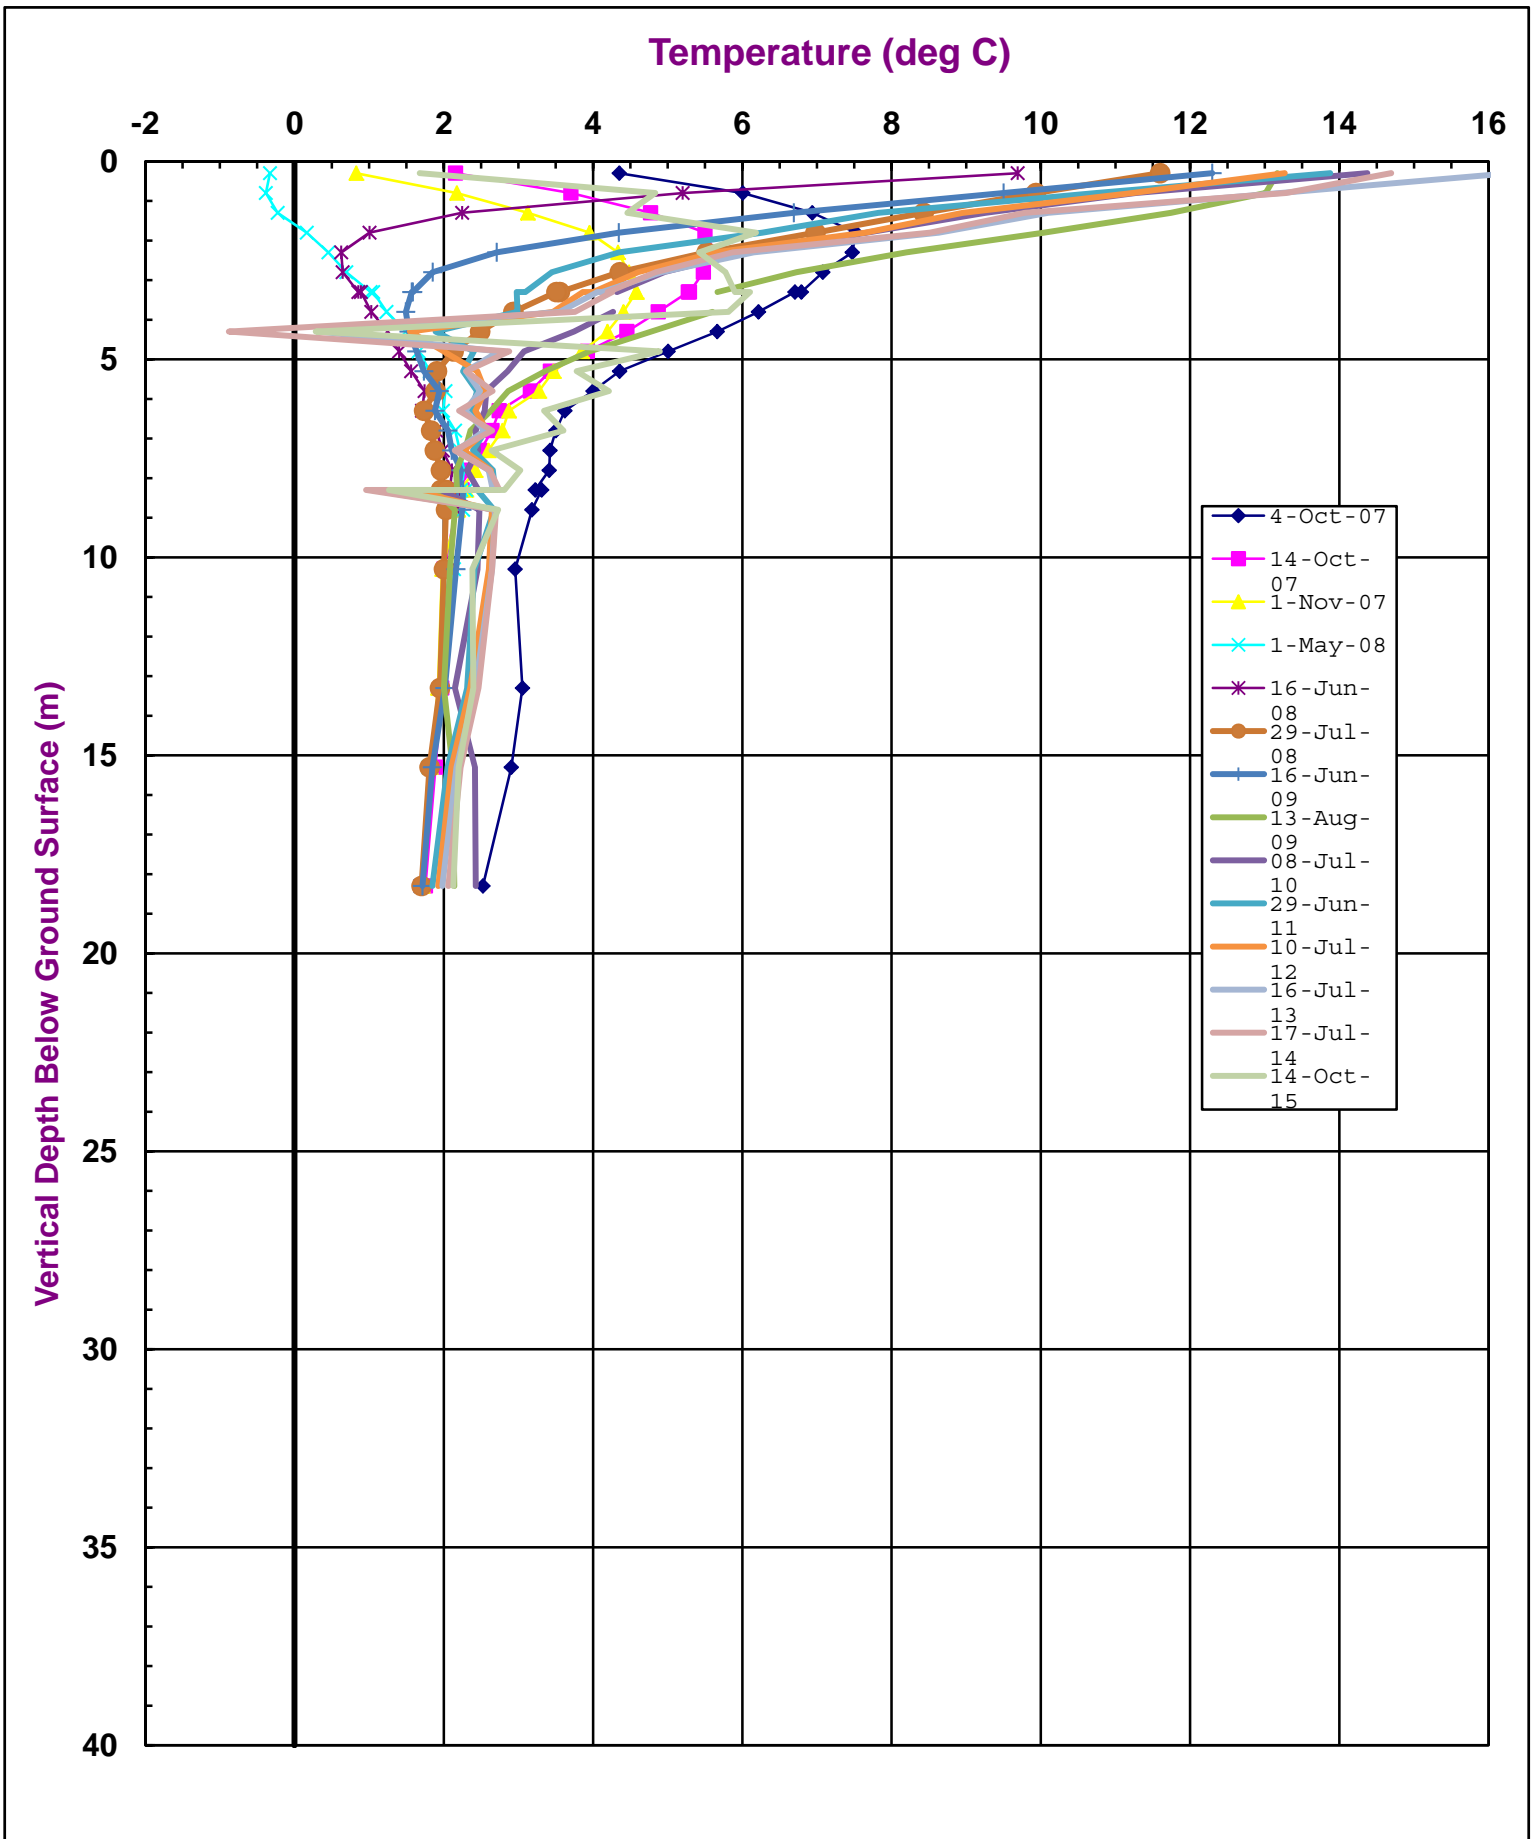
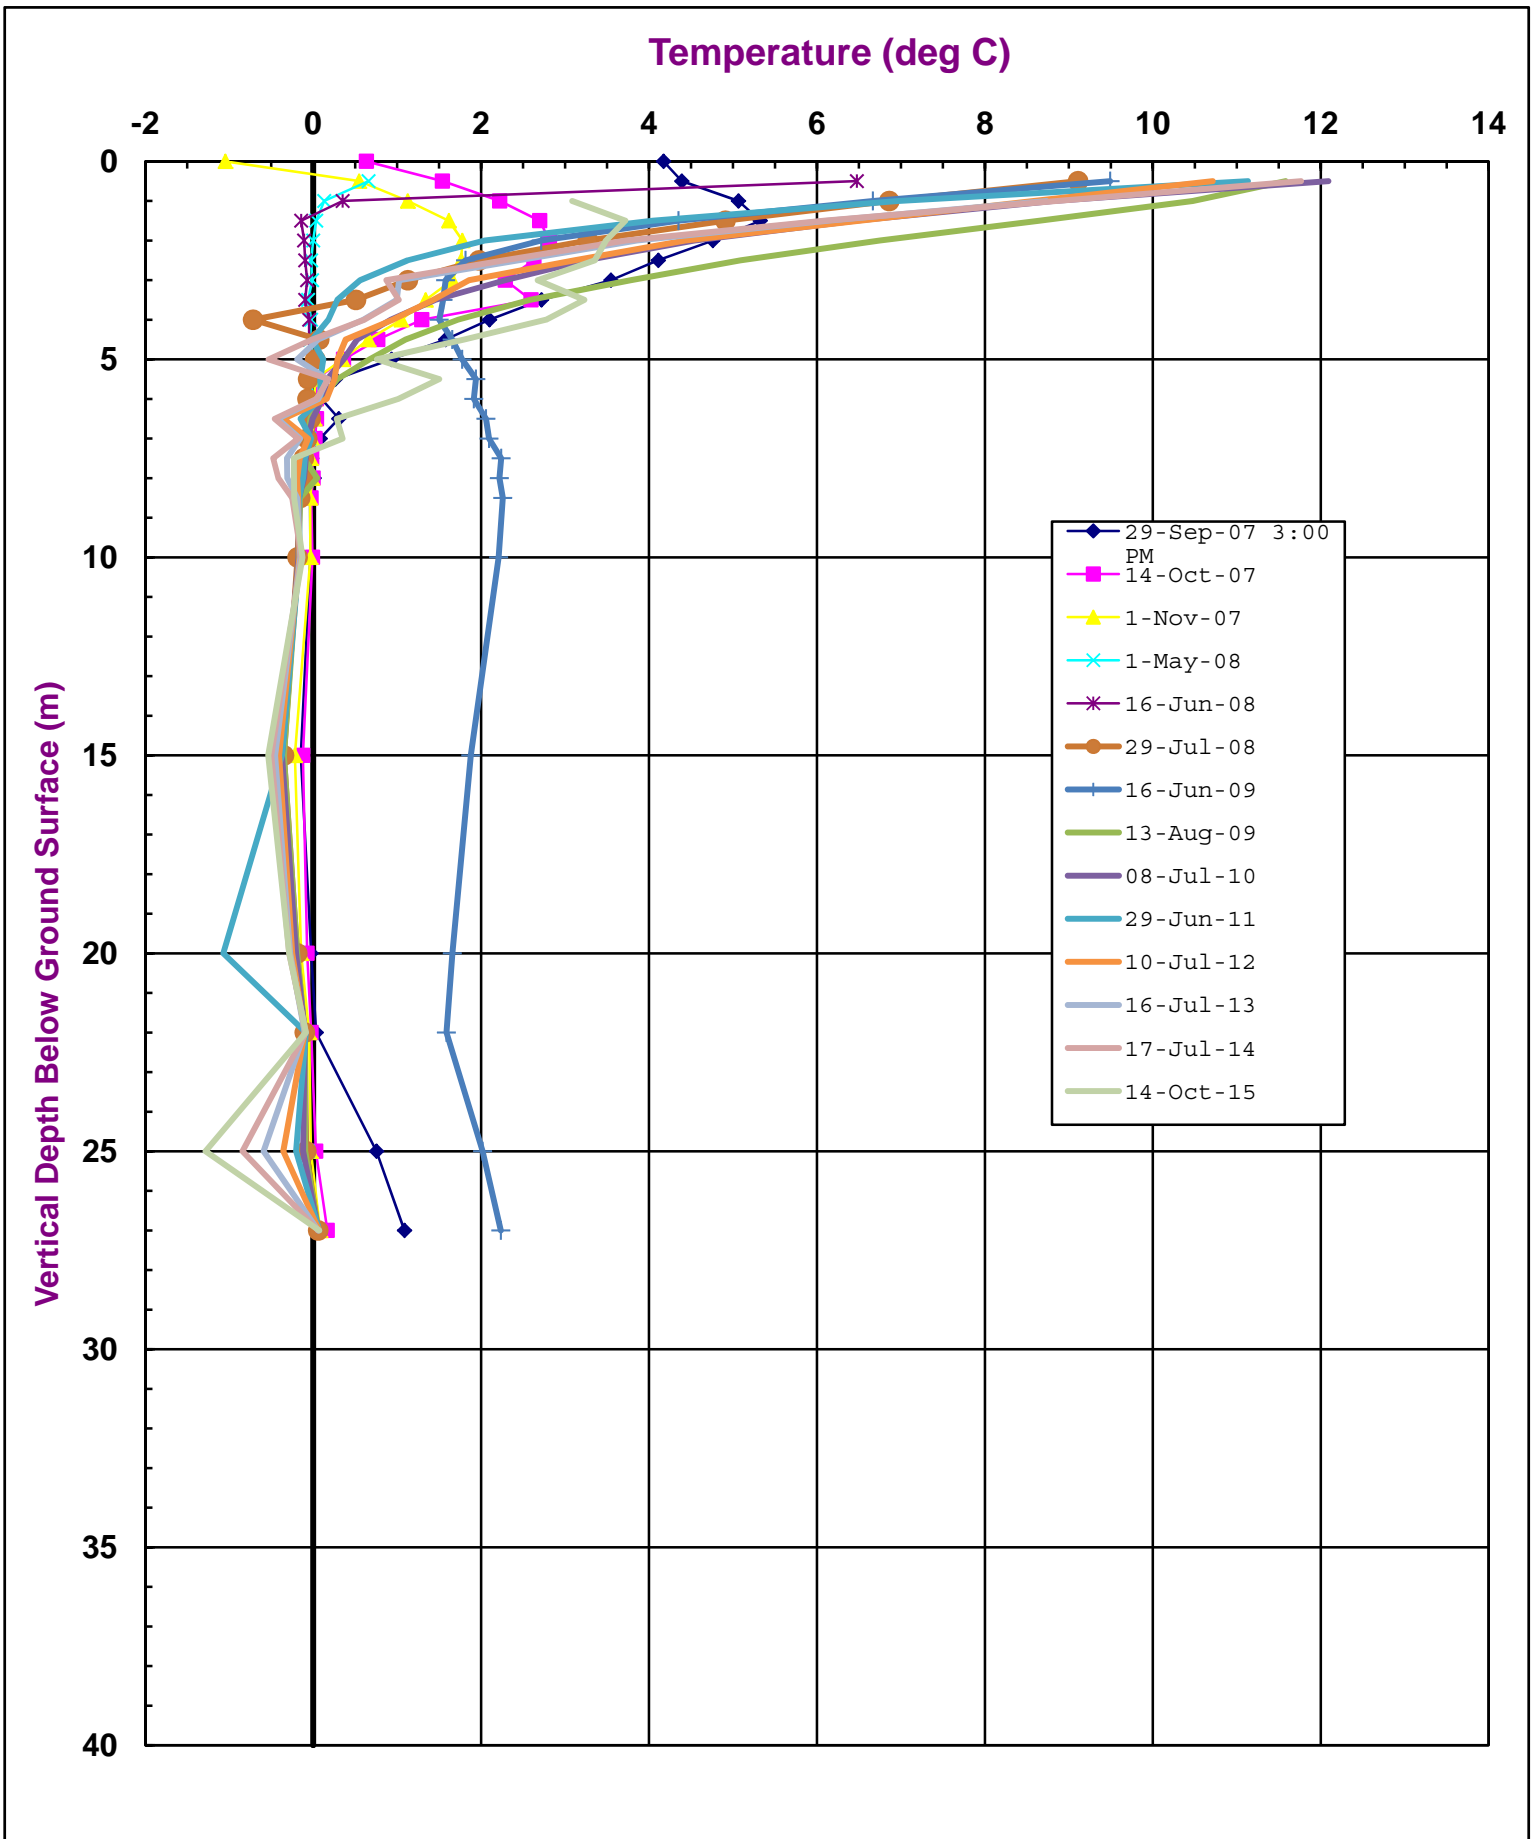
Thermistor Data

The depth of the active thaw layer is observed from the resulting thermistor plots. The difference in the plots can be attributed to the inspection occurring later in the year (October compared to previous readings in July), which is approaching the maximum thaw of the active layer. The thermistor plots indicate the thickness of the active thaw layer and permafrost in the following locations:

- Southwest of proposed heap leach facility area in BH-01-07 and BH-03-07 the active thaw layer is approximately 5 m thick with permafrost below 5 m;
- Proposed water management pond, south of the proposed heap leach facility area, in BH-06-07 the active thaw layer is approximately 5 m thick with permafrost below 5 m;
- Proposed heap leach facility area in BH-13-07, BH-23-07, and BH-26-07 there is no indication of permafrost and the bedrock ranged from a depth of 12 m to 17 m;
- Proposed heap leach facility area in BH-17-07 the active thaw layer is approximately 7 m with permafrost below 7 m; and
- Proposed waste rock storage area in BH-18-07 and BH-29-07 the active thaw layer is approximately 5 m thick with permafrost below 5 m.
