CASINO MINING CORPORATION CASINO COPPER-GOLD PROJECT

TERRAIN HAZARDS ASSESSMENT FOR PROPOSED MINE SITE

VA101-325/8-3
Rev 0
April 13, 2012

TERRAIN HAZARDS ASSESSMENT FOR PROPOSED MINE SITE (REF. NO. VA101-325/8-3)

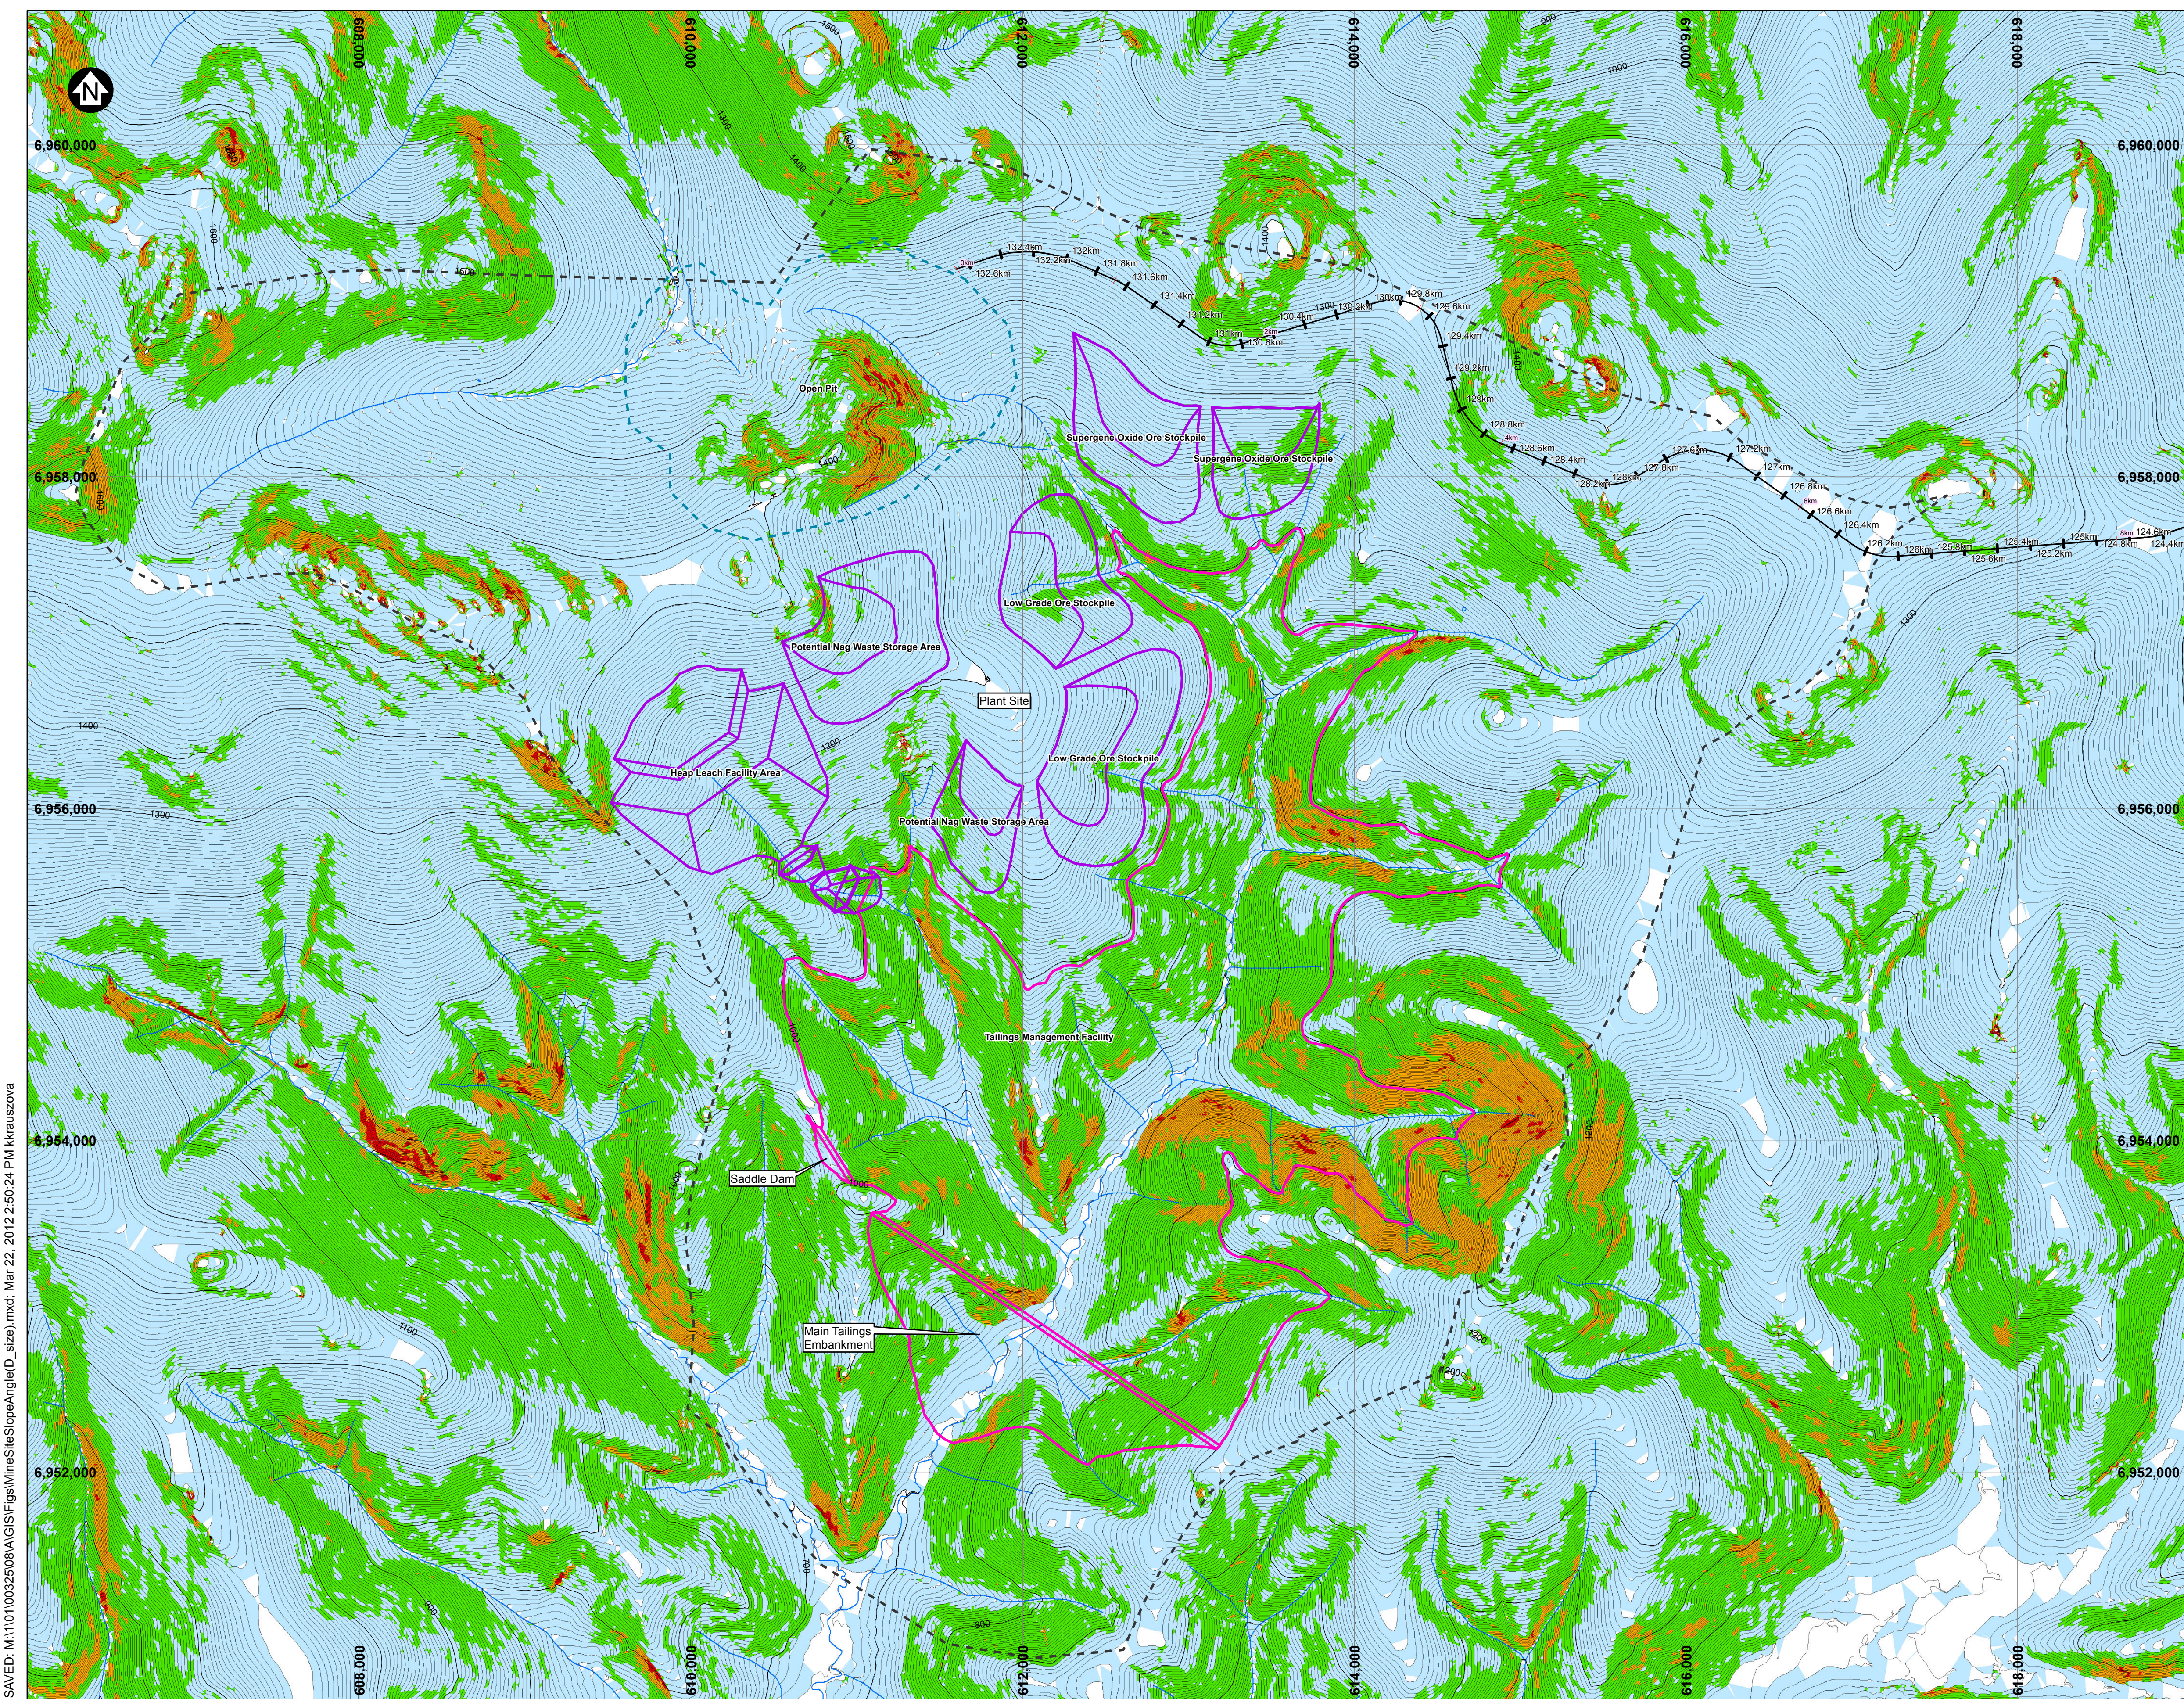
FIGURE 2

The site is located on the north slopes of the Dawson Mountain Range, within the Klondike Plateau Physiographic Area (Matthews, 1986). As shown in Figure 2, the elevation of the terrain ranges from approximately 1400 m above sea level at the site of the proposed Open Pit, in the northwest part of the Study Area to approximately 700 m above sea level (asl) on the floor of the Casino Creek Valley, in the south part of the Study Area, where it is proposed to construct the Tailings Management Facility (TMF).

The terrain in the Study Area typically comprises broad summits, gentle upper slopes, moderate to moderately steep mid-slopes and gentle colluvial aprons at the slope toes. Regionally, the east-west trending major valleys in the North Dawson Range tend to be asymmetric, with shallower north-facing slopes being the result of enhanced sheetwash and solifluction processes on these 'sheltered' slopes. This pattern does not, however, appear to be repeated in the tributary valleys within the Study Area; in fact, some of the north-facing slopes in the tributary catchments of Casino Creek are markedly steeper than the adjacent south facing slopes, as shown in Figure 2.

The slope angles increase on the mid-slopes, reaching a maximum of approximately 35°. Mid-colluvial slopes comprise the predominant terrain unit at the footprint of the proposed TMF. There are extensive moderately steep (27° to 35°) north-facing colluvial slopes in the east part of the proposed footprint area, as shown in Figure 2. The colluvium tends to form veneers, grading to blankets. The soils tend to be strongly cryoturbated.

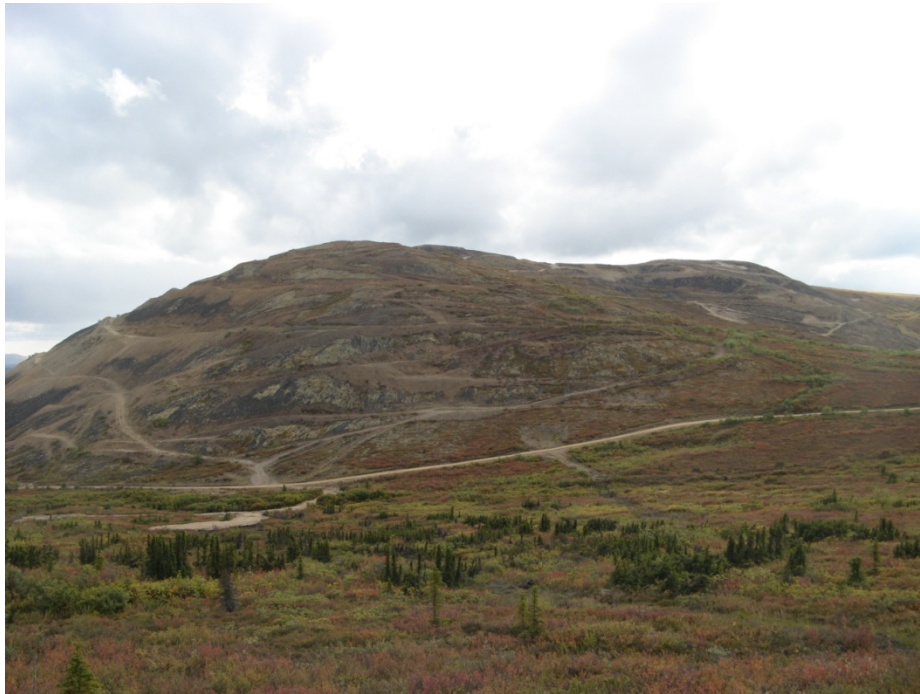
PHOTO 1 – Site of the proposed Open Pit

The Open Pit and the Plant Site are proposed to be located on hill tops, in the north part of the Study Area, as shown in Photos 1 and 2. The slope angles at the site of the proposed Open Pit are extremely variable due to the previous mining operations. The stockpiles and the Heap Leach Facility are proposed to be sited on the adjacent gently-inclined, south and east-facing, Upper Colluvial Slopes. The Tailings Management Facility (TMF) is proposed to be located in the Casino Creek Valley, as shown in Photo 3 and Figure 2. The proposed facility includes a Saddle Dam, as well as the Main Tailings Embankment, as shown in Figure 2. The valley side slopes are generally moderately inclined with gentle colluvial aprons at the toes of the valleys. The side slopes are moderately steep locally. There is a particularly extensive area of moderately steep terrain in a tributary valley, on the east side of the proposed footprint area of the TMF, as shown in Figure 2. At the site of the proposed Tailings Embankment, the side slopes are generally moderately inclined with gentle colluvial aprons at the slope toes, although the natural slopes are moderately steep, locally, particularly on the south side of the valley.

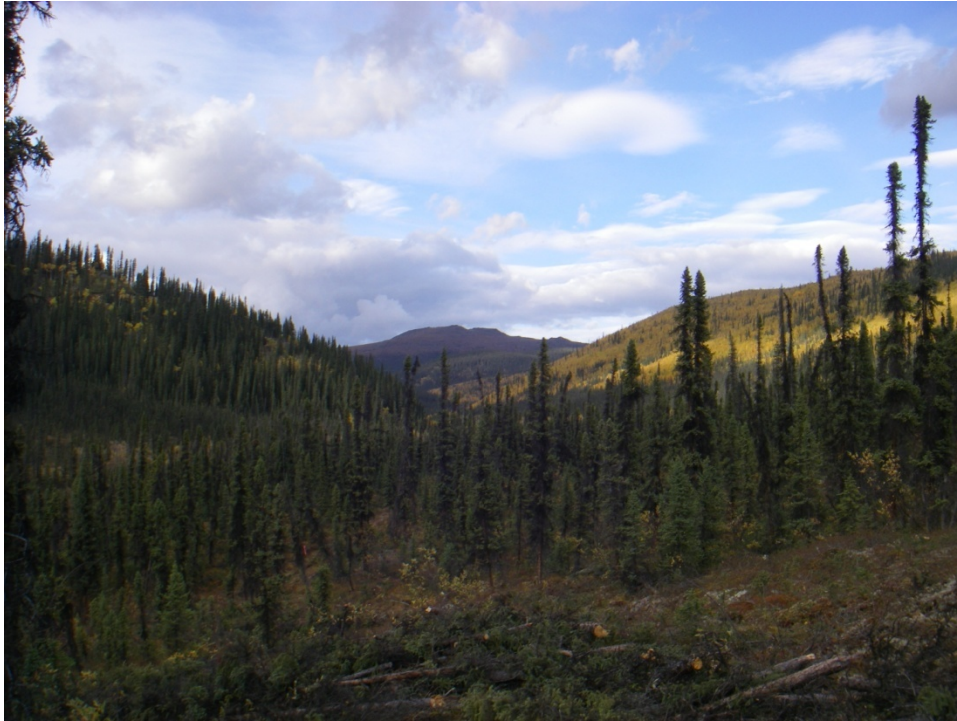
The terrain hazards assessment highlights extensive areas of permafrost terrain at the proposed mine site, with a generally shallow (within approximately 1 m of the ground surface) permafrost table. The terrain mapping identified extensive silt-rich soils at the site, in particular, the colluvial aprons at the slope toes along the Casino Creek Valley and local deposits of loess in the upland areas, including the proposed Open Pit site. These soils tend to be ice-rich and include beds of massive ground ice. Beds of massive ground ice, with a thickness of up to approximately 3 m, have been encountered in site investigation boreholes undertaken at the site of the proposed Tailings Embankment. The colluvial

slopes at the sites of the proposed Tailings Embankment, stockpiles and Heap Leach Facility have also been found to be silt and ice-rich, locally.

PHOTO 3 Site of the proposed Tailings Embankment (view to the north)
