**Fish and Aquatic Resources**

# Coffee Gold Project

## **Fish and Aquatic Resources Baseline Report:**

### **Mine Access Road**

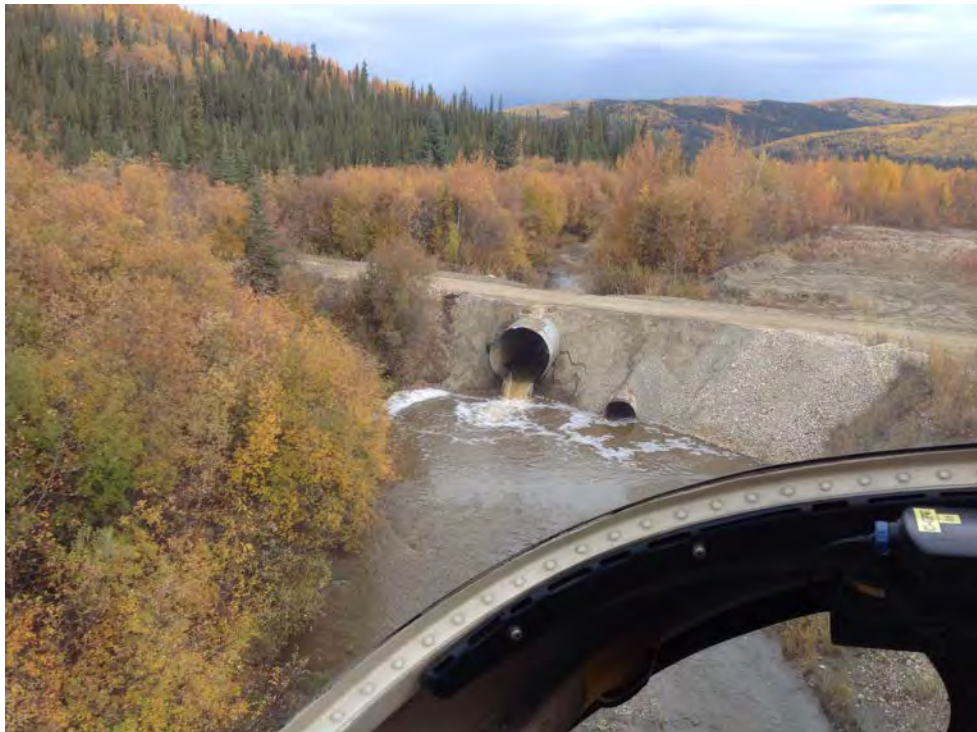
Sulphur Creek is considered fish bearing although the culvert crossing likely obstructs fish movement to upstream areas at certain times of the year.

**Photo 1 – Road crossing (#48) at Sulphur Creek on September 9, 2015. Showing hanging culvert and smaller overflow culvert.**

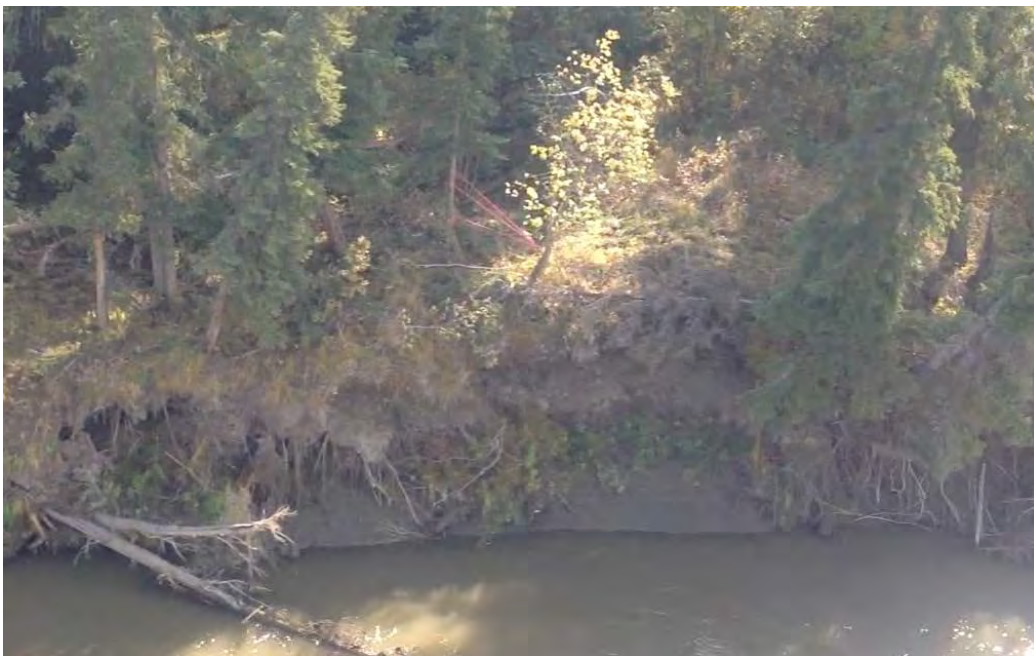
The proposed south barge landing location had a steep bank comprised of cobble, gravel, and fine substrates. Evidence of erosion was noted in the form of slumping riparian vegetation, exposed roots and undercutting along the top of the bank (Photo 6). Overhanging riparian vegetation and large woody debris along the shore was identified as providing potential fish habitat; however, it is likely that this material is mobile each year during high flows and ice flow. Habitat and channel physical characteristics were similar to those observed on the north side barge landing proposed location.

**Photo 6 – Proposed Barge Landing Location on the Stewart River (south side), on September 9, 2015.**

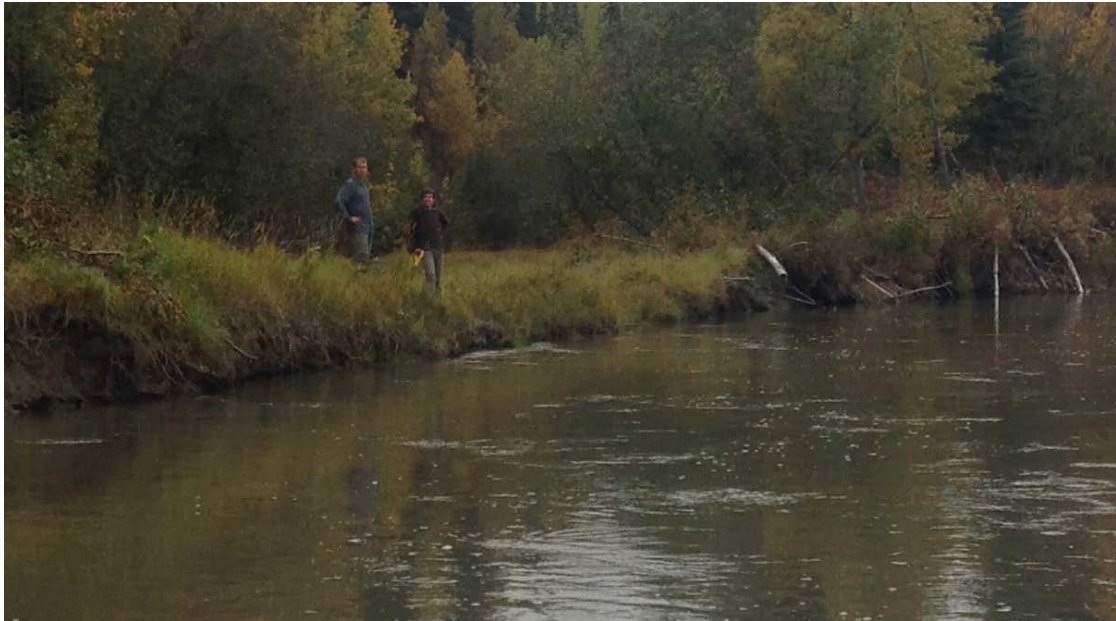
The proposed north barge landing location is at the downstream end of an alluvial terrace and immediately upstream of a rock bluff that extends to the shoreline. The location is approximately 1.6 km downstream of the existing Ballarat landing. The bank height was lower than at the other three proposed landing locations. The landing site was within a grassy open area, with relatively stable banks (mud, roots, and grasses) (Photo 7). The water depth at 1 to 1.5 m horizontal distance from the shoreline was approximately 2 m. Water level was high, with poor clarity. Thus, the substrate was inferred as being predominately fines, based on the bank material.

**Photo 7 – Proposed Barge Landing Location on the Yukon River (north side), on September 10, 2015.**

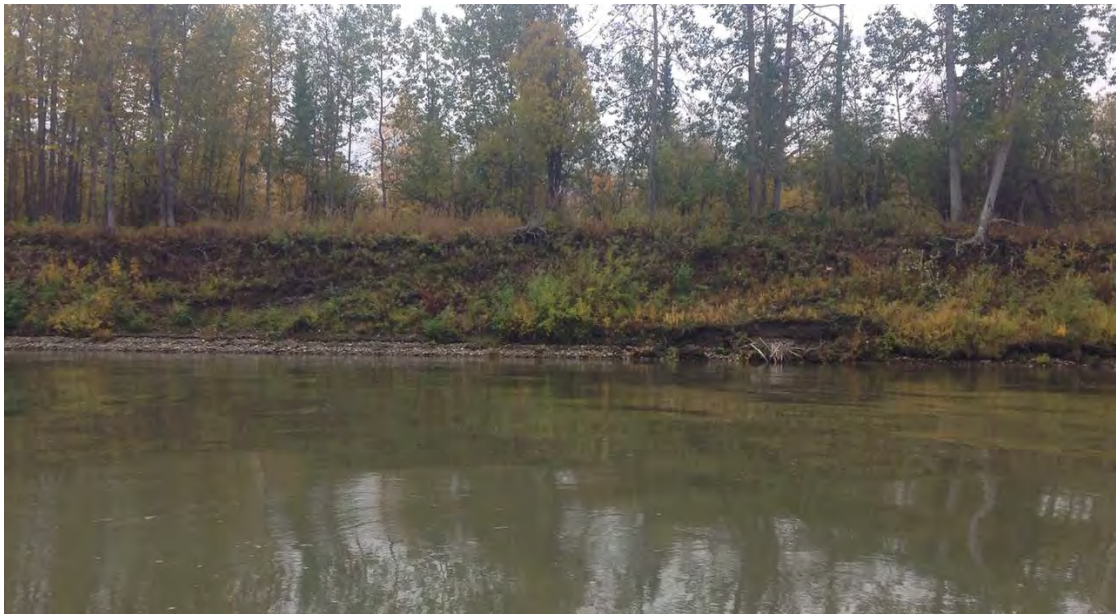
The proposed south barge landing location is approximately 1.6 km downstream of the mouth of Coffee Creek, and 500 m upstream from the existing barge landing near the Coffee camp. The proposed landing will descend from a low alluvial terrace. The specific location was at a steep bank (approximately 2 m high and composed of organic soil). The bank was unstable with signs of sloughing into the river (Photo 8). The site had gravel substrate. A fish finder (depth sounder) was used in the vicinity of the proposed landing location, and sonar returns consistent with chum salmon were detected. The specific area where the signals were detected was in slow moving water along the south bank. The depth sounder showed that the Yukon River thalweg was smooth from upstream of the north barge landing to downstream of the south landing, implying a lack of spawning dune or redd structures. Based on these observations, the geographical location of the landing sites relative to known spawning areas, and no observable spawning habitat, fish habitat at the landing sites and along the barging route was identified as likely limited to rearing and migratory functions for salmon.

**Photo 8 – Proposed Barge Landing Location on the Yukon River (south side), on September 10, 2015.**

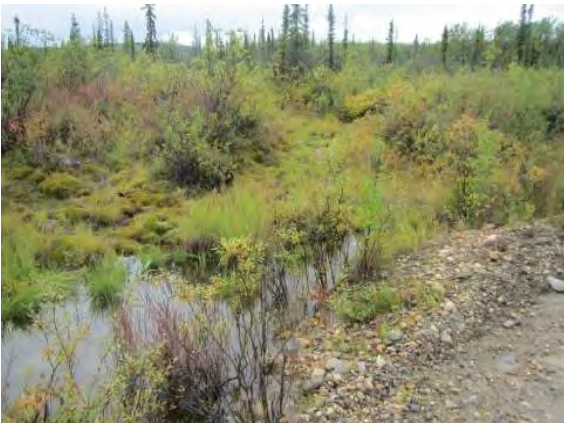
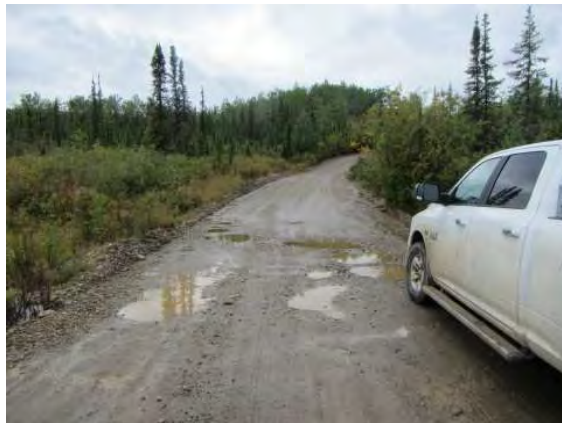
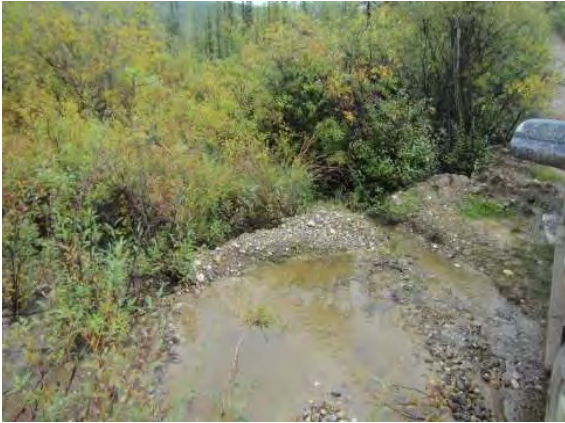
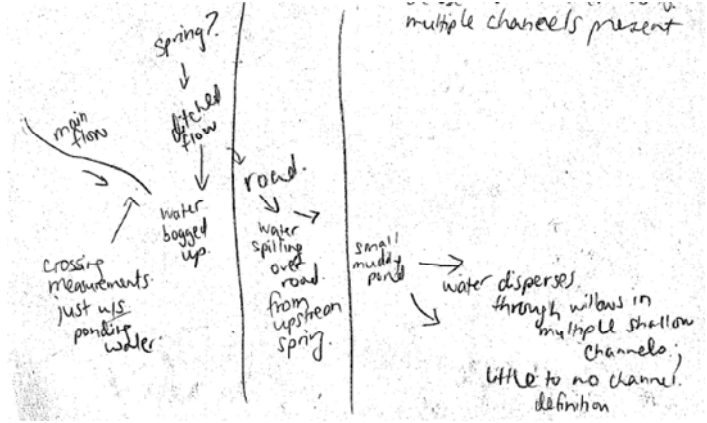
# Coffee Gold Road Northern Route Crossing #51

At D/S site: Channel not well defined; rusty colored water (turbid); denser willow cover 100%, multiple dispersed shallow channels present.					
at Xing: water spilling over road from upstream spring					
Xing measurements just upstream of ponding water on upstream side of road

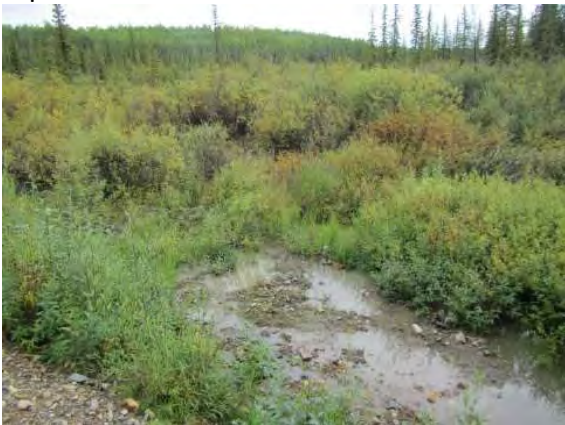
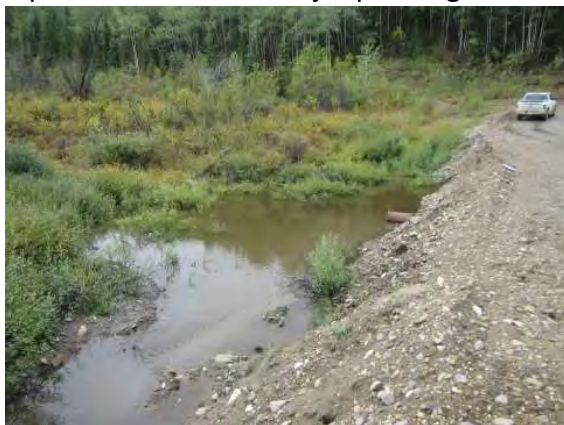
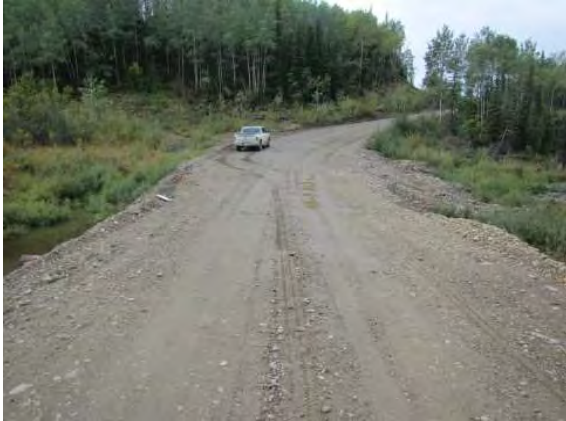
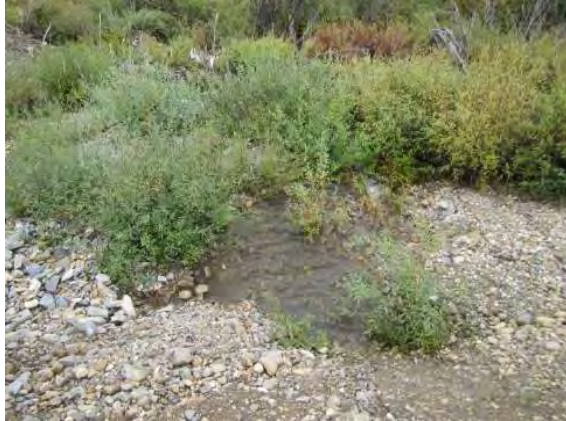
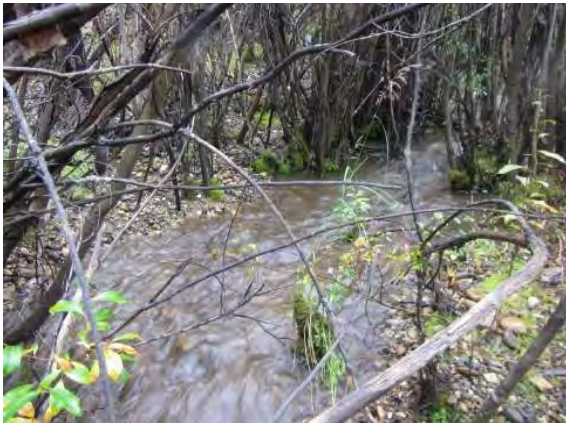
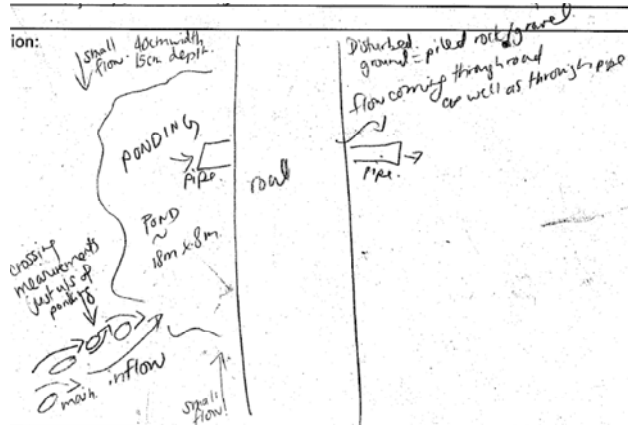
# Coffee Gold Road Northern Route Crossing #52

D/S (50m)	X	U/S (50m)	
Coordinates:	610129	Gradient (%):	3	5	5
	7055369	Bankfull Width (m):	1.4	2+	1.35
Site Visit Date:	18/08/15	Bankfull Depth (m):	0.08	0.09	0.22
Flow Conditions:	High	Wetted Widths (m):	1.4	2+	1.35
Barrier (Y/N):	N	Wetted Depth (m):	0.08	0.09	0.22
		Substrate Bed			
Electrofishing effort:	N	(Dom/SubDom):	G/C	F	F
Gee Trapping:	N	Substrate Bank:	G/F	F	F
Fish present?:	See below	Riparian Vegetation:	WI	WI	WI
Site Length:	100m	Meander Pattern:	IM	IR	IR
		Cover (%/Dom):	70/OV	100/OV	100/OV
Photo #s	20,21 u/s	22 x	23 d/s	pH:	7.9
Areas of Erosion:	-			Temperature:	5.2 (°C)
Locations:				Specific Conductivity:	295 (µs/cm) COND = 183
				Dissolved Oxygen	11.02 (mg/L) 94 (% Sat)
Comments:					
Indian River tributary					
Flow through metal pipe under road, major ponding occurring upstream (Photo #21)					
Turbid water before reaches road					
Disturbed areas; gravel rock piles					
Very unlikely to support fish

Photo #24, u/s at d/s site					
xing measurements just upstream of large pond on upstream side of road

Upstream view with major ponding

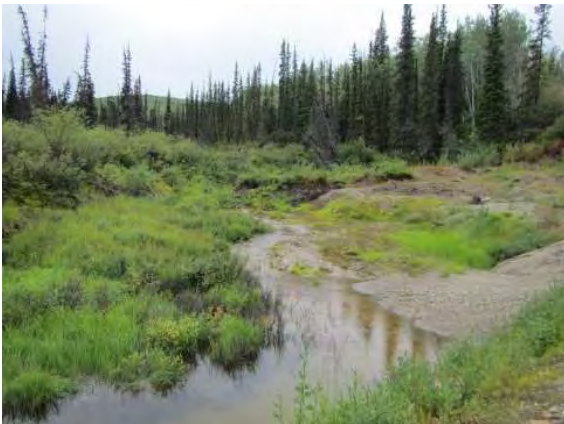
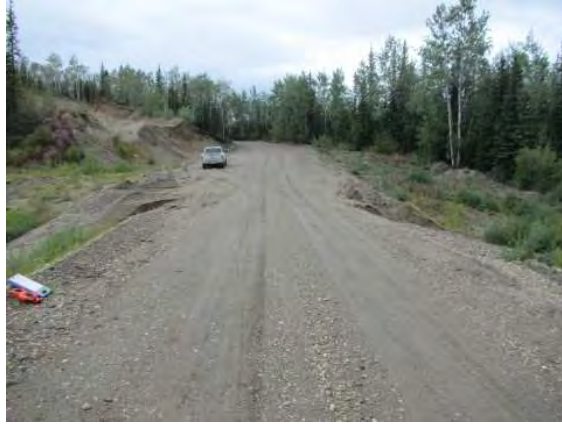
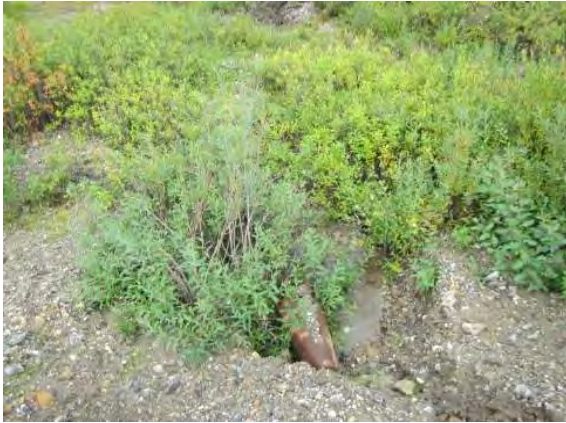
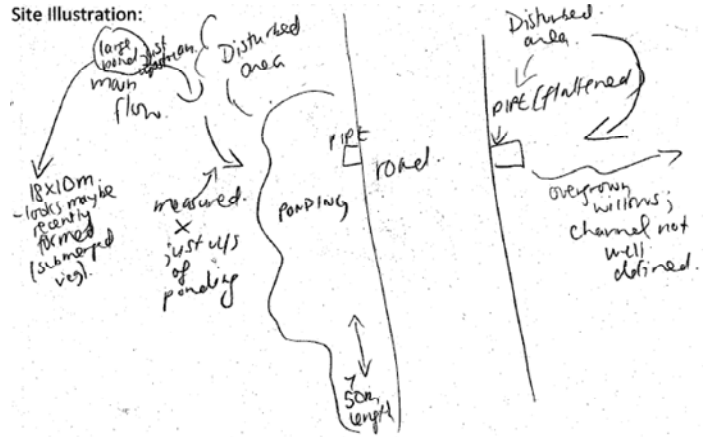
# Coffee Gold Road Northern Route Crossing #53

D/S (50m)	X	U/S (50m)	
Coordinates:	609658	Gradient (%):	2	2	2
	7055218	Bankfull Width (m):	1	2.5	1
Site Visit Date:	18/08/15	Bankfull Depth (m):	0.18	0.06	0.12
Flow Conditions:	High	Wetted Widths (m):	1	2.5	1
Barrier (Y/N):	N	Wetted Depth (m):	0.18	0.06	0.12
Electrofishing effort:	N	Substrate Bed (Dom/SubDom):	F/G	G/F	F
Gee Trapping:	N	Substrate Bank:	F/G	F	F
Fish present?:	See below	Riparian Vegetation:	WI	WI/GR	WI
Site Length:	100m	Meander Pattern:	IM	SI	IM
		Cover (%/Dom):	90%/OV	5%/OV	90%/OV
Photo #s	25 u/s	26 x	27 d/s	pH:	7.8
Areas of Erosion:	Y			Temperature:	6.4 (°C)
Locations:	Disturbed areas around channel near road.			Specific Conductivity:	1365 (µs/cm)
				Dissolved Oxygen	10.61 (mg/L)
					COND = 879
COND = 879					
Comments:	Indian River Trib				
Water clearer than previous two crossings.					
Large pond formed u/s of metal pipe					
marl observed					
xing measurements upstream of ponding on upstream side of road

downstream side: disturbed area, pipe is flattened, overgrowth of willows and channel not well defined					
upstream side: lots of disturbance and ponding					
very unlikely to support fish

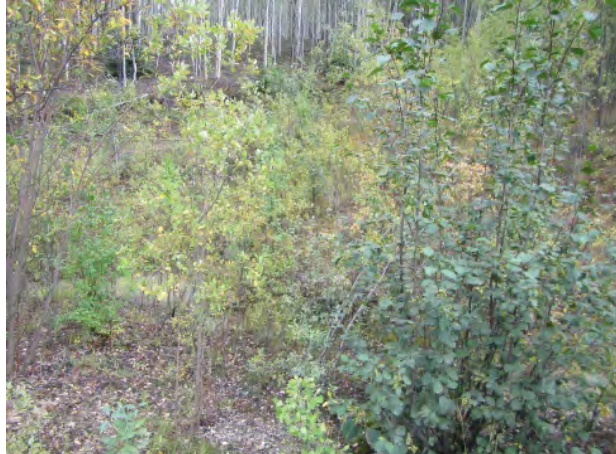
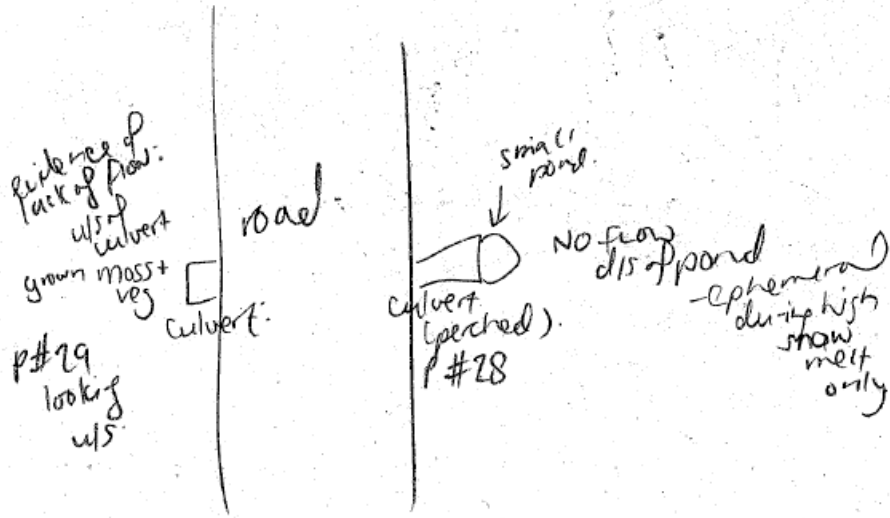
# Coffee Gold Road Northern Route Crossing #54

D/S (50m)	X	U/S (50m)
Coordinates:	609204	Gradient (%):	-	-
	7055294	Bankfull Width (m):	-	-
Site Visit Date:	18/08/15	Bankfull Depth (m):	-	-
Flow Conditions:	none	Wetted Widths (m):	-	-
Barrier (Y/N):	N	Wetted Depth (m):	-	-
		Substrate Bed		
Electrofishing effort:	N	(Dom/SubDom):	-	-
Gee Trapping:	N	Substrate Bank:	-	-
Fish present?:	see below	Riparian Vegetation:	-	-
Site Length:	100m	Meander Pattern:	-	-
		Cover (%/Dom):	-	-
Photo #s	29 u/s	28 x	d/s	pH:
Areas of Erosion:	-			Temperature:
Locations:				Specific Conductivity:
				Dissolved Oxygen
Comments:				
No flow; likely only flows during high snow melt.				
Very unlikely to support fish.				
Limited, poor channel definition.				
P#28 - perched culvert

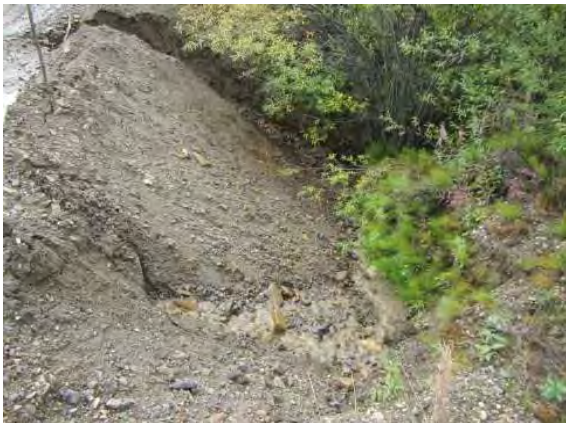
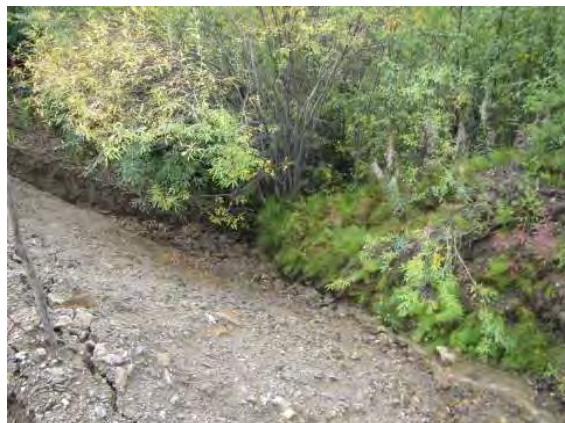
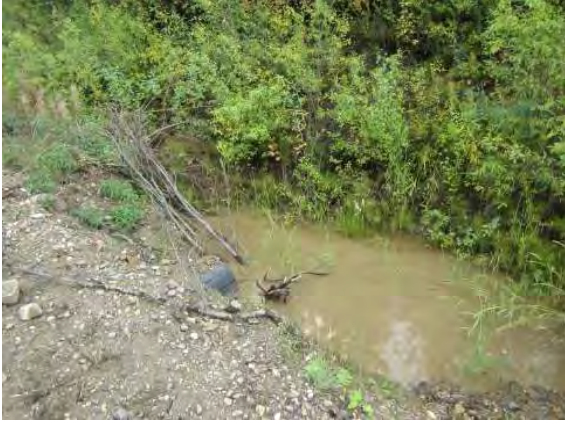
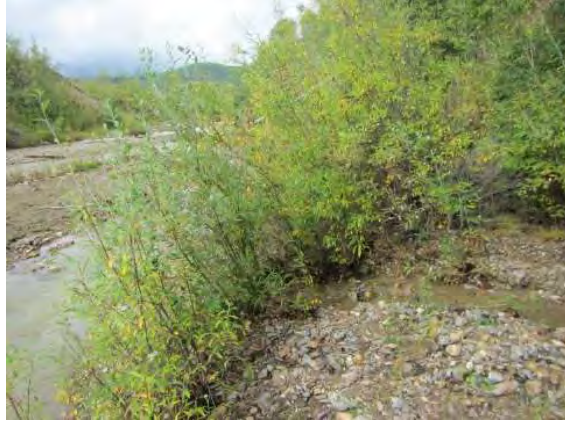
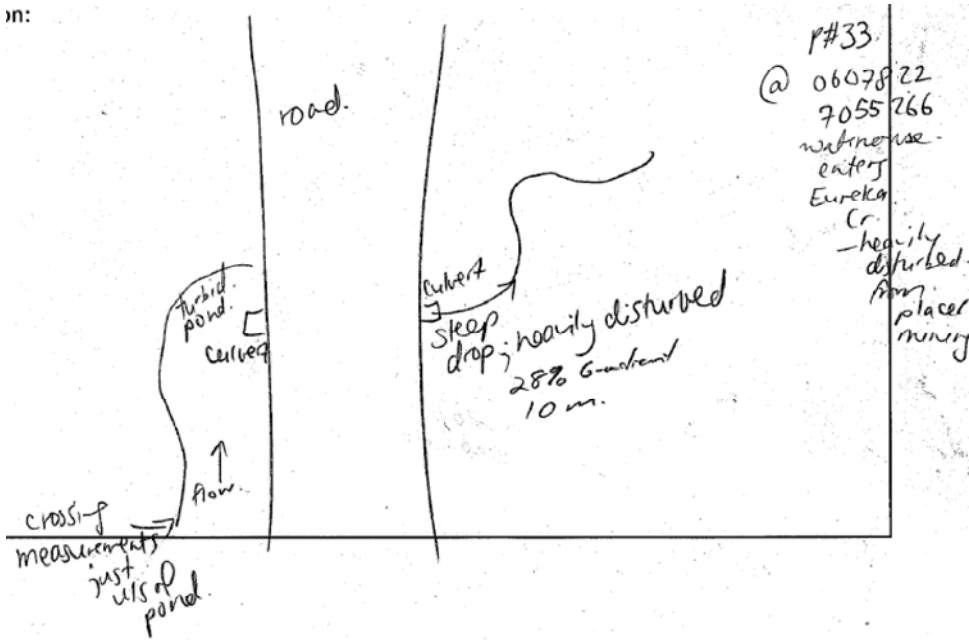
# Coffee Gold Road Northern Route Crossing #54.5

D/S (50m)	X	U/S (50m)	
Coordinates:	607870	Gradient (%):	16	1	1
	7055247	Bankfull Width (m):	1.2	0.55	1
Site Visit Date:	18/08/15	Bankfull Depth (m):	0.3	0.07	0.04
Flow Conditions:	High	Wetted Widths (m):	0.6	0.55	1
Barrier (Y/N):	Y - Outlet to culvert very steep.	Wetted Depth (m):	0.02	0.07	0.04
Electrofishing effort:	N	Substrate Bed (Dom/SubDom):	G/C	F	F
Gee Trapping:	N	Substrate Bank:	F	F	F
Fish present?:	N	Riparian Vegetation:	WI	WI/DEC	WI/DEC
Site Length:	100m	Meander Pattern:	SI	IM	IM
		Cover (%/Dom):	10/OV	30/OV	80/OV
Photo #s	32 u/s	n/a x	30, 31 d/s	pH:	7.62
Areas of Erosion:	Y			Temperature:	7.9 (°C)
Locations:	Dirt slope on d/s side of road is eroding.			Specific Conductivity:	81.2 (µs/cm)
				Dissolved Oxygen	10.03 (mg/L)

91.1 (% Sat)
Comments:	Eureka Creek Trib				
	High gradient barrier downstream (28%) over 10m				
	Enters Eureka downstream				
	very unlikely to support fish in downstream section				
	barrier present just d/s road				
	P#33 shows where tributary enters mainstem Eureka Creek

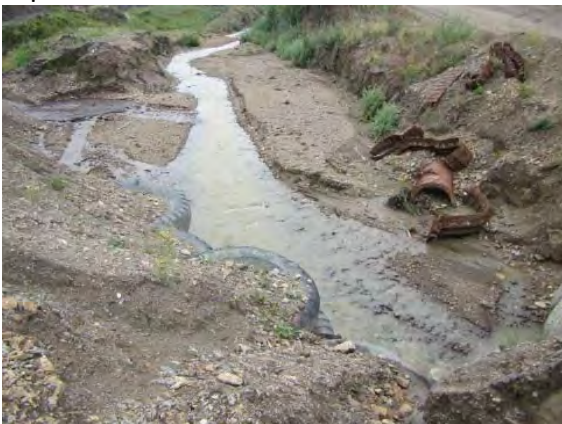
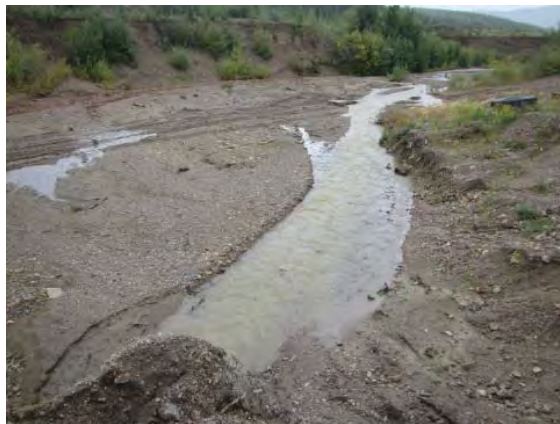
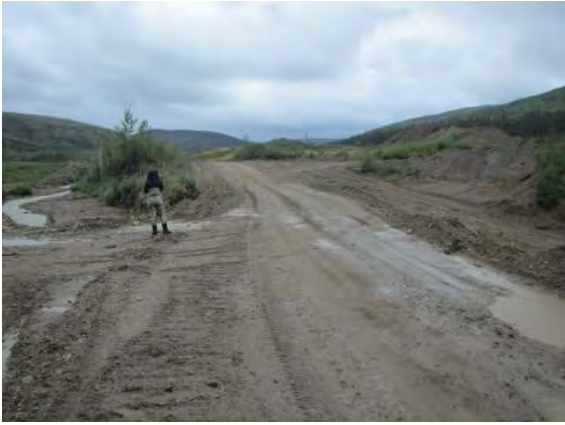
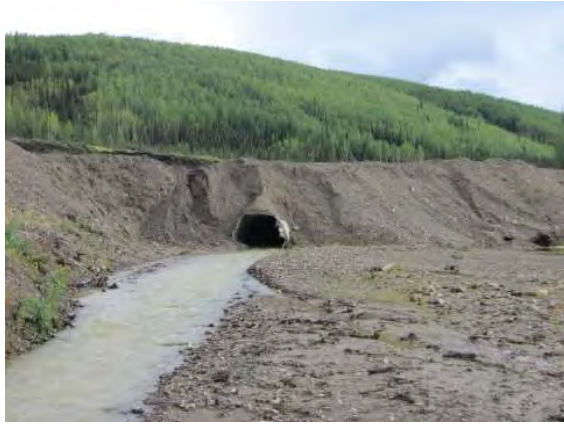
# Coffee Gold Road Northern Route Crossing # 55

Eureka Creek flows north into the Indian River. Overall Eureka Creek is heavily altered from placer mining activities, and the remaining habitat is low quality. Creek flow is altered along some sections, and riparian habitat is degraded (Photo 2). At the mainstem crossing site (#55), the creek was braided, shallow, and turbid. Flow was at mid- to low level. Channel width at the site ranged from 10 m (upstream), to approximately 30 m (at the crossing location). Average wetted width was 3 m. There was little to no in-stream cover, the banks and riparian vegetation were highly disturbed, and the substrate was embedded with fines making it unsuitable for Arctic grayling spawning. Depending on flow levels, site #55 has the potential to support marginal rearing, feeding, or migratory habitat for Arctic grayling. Pool habitat, which is preferred for rearing and feeding life stages of Arctic grayling (Stewart *et al.*, 2007) was absent at the time of assessment. The lack of pool habitat also precludes the potential for overwintering habitat at the crossing site.

D/S (50m)	X	U/S (50m)
Coordinates:	607647	Gradient (%):	2	2
	7054980	Bankfull Width (m):	16	~ 30 m
Site Visit Date:	18/08/15	Bankfull Depth (m):	0.4	~ 0.77
Flow Conditions:	mid-low	Wetted Widths (m):	4.3	3
Barrier (Y/N):	N	Wetted Depth (m):	0.1	0.18
	Y - see sampling data	Substrate Bed (Dom/SubDom):	G/F	G/C
Electrofishing effort:	N	Substrate Bank:	G/F	F
Gee Trapping:	see below	Riparian Vegetation:	WI	WI/GR
Fish present?:	100m	Meander Pattern:	IM	SI
Site Length:		Cover (%/Dom):	<5%/OV	<5%/OV
			<5%/OV	<5%/OV
Photo #s	34 u/s	36 x	35 d/s	pH:
Areas of Erosion:	Y			7.62
Locations:	placer claim			Temperature:

10.4 (°C)
				Specific Conductivity:
				512 (µs/cm)
				Dissolved Oxygen
				992 (mg/L)
				COND = 369
				95.7 (% Sat)
Comments:	Eureka Creek mainstem			
	Heavily disturbed from placer activity			
	Culvert - undersized and road eroding above it P#37			
	unlikely to support fish under current flows, very shallow, turbid, fast-flowing water.			
	no pool habitat and substrate quite embedded.			
	P#38 looking downstream from placer pond at road			
	Overall rank: likely fish-bearing

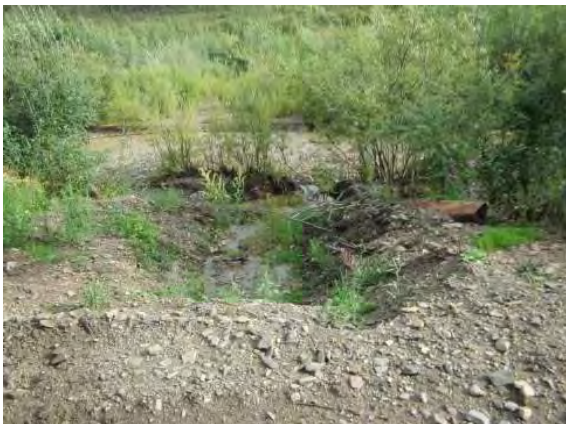
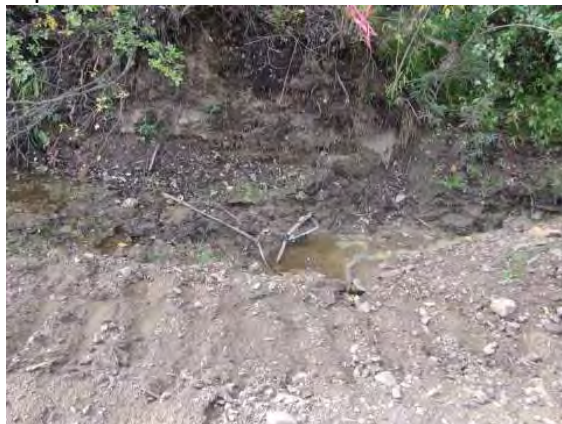
D/S (50m)	X	U/S (50m)
Coordinates:	606801	Gradient (%):	-	-
	7053676	Bankfull Width (m):	-	-
Site Visit Date:	18/08/15	Bankfull Depth (m):	-	-
Flow Conditions:	High	Wetted Widths (m):	0.3	0.25
Barrier (Y/N):	N	Wetted Depth (m):	0.14	0.02
		Substrate Bed		
Electrofishing effort:	N	(Dom/SubDom):	-	-
Gee Trapping:	N	Substrate Bank:	-	-
Fish present?:	see below	Riparian Vegetation:	-	-
Site Length:	100m	Meander Pattern:	-	-
		Cover (%/Dom):	-	-
Photo #s	40 u/s	x	39 d/s	pH:
Areas of Erosion:	-			Temperature:
Locations:				Specific Conductivity:
				Dissolved Oxygen
Comments:	Eureka Creek trib			
	No visible channel/ditch			
	very small trickle flowing through small culvert			
	spring off hillside, on u/s side follows road up for a while and then dries up -> no visible channel on u/s end			
	shallow dispersed muddy flow near main stem Eureka			
	very unlikely to support fish; not supporting fish at current flows

Eureka Creek will backflood up to 7m from d/s end of culvert in spring			
	Small drop at edge at 7m; marking floodplain of mainstem and will likely prohibit fish movement towards culvert (0.8m drop from road); Photo 46 shows Eureka Creek floodplain looking upstream towards road

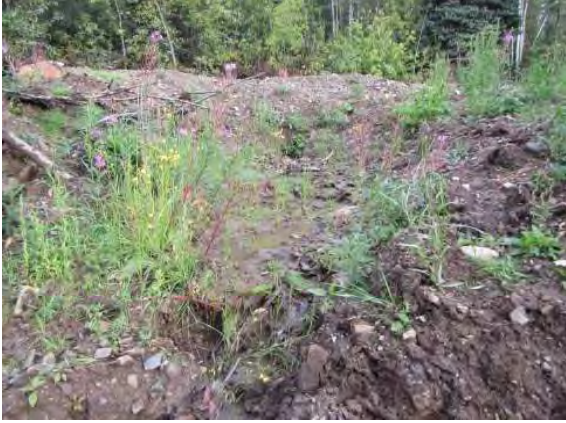
Standing in Eureka Creek floodplain looking u/s at road

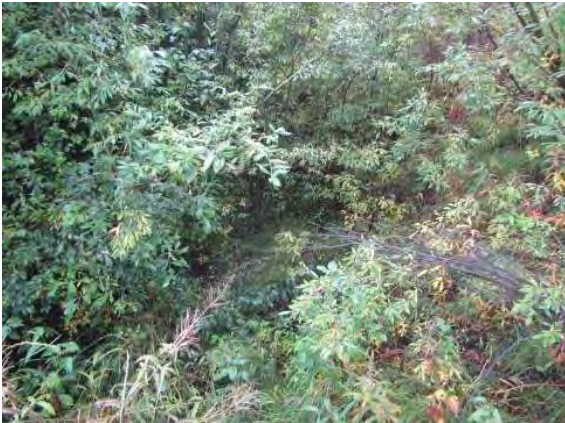
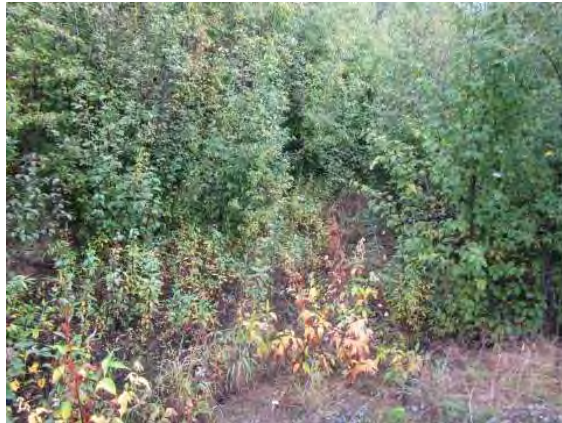
D/S (50m)	X	U/S (50m)
Coordinates:	606489	Gradient (%):	-	-
	7053226	Bankfull Width (m):	-	-
Site Visit Date:	19/08/15	Bankfull Depth (m):	-	-
Flow Conditions:	n/a	Wetted Widths (m):	-	-
Barrier (Y/N):	n/a	Wetted Depth (m):	-	-
		Substrate Bed		
Electrofishing effort:	n/a	(Dom/SubDom):	-	-
Gee Trapping:	n/a	Substrate Bank:	-	-
Fish present?:	N	Riparian Vegetation:	-	-
Site Length:	100m	Meander Pattern:	-	-
		Cover (%/Dom):	-	-
Photo #s	48 u/s	x	47 d/s	pH:
Areas of Erosion:	-		Temperature:	-
Locations:			Specific Conductivity:	-
			Dissolved Oxygen	-
Comments:				
Gully; no evidence of water scour.				
Not fish habitat.

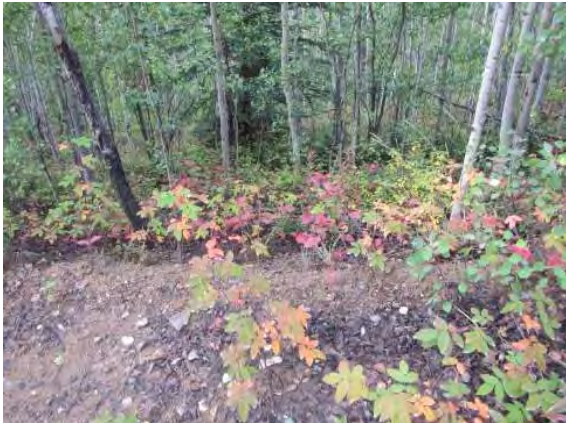
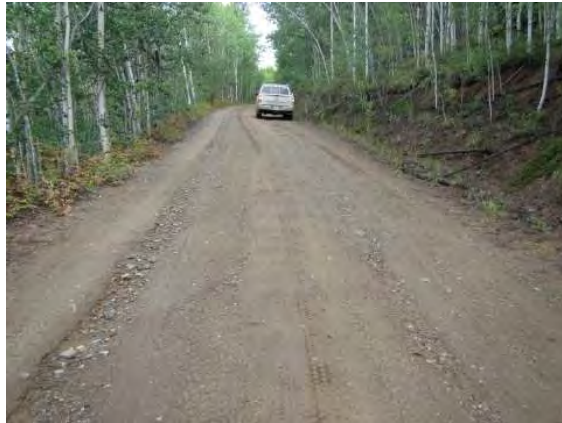
D/S (50m)	X	U/S (50m)
Coordinates:	605410	Gradient (%):	-	-
	7053301	Bankfull Width (m):	-	-
Site Visit Date:	19/08/15	Bankfull Depth (m):	-	-
Flow Conditions:	n/a	Wetted Widths (m):	-	-
Barrier (Y/N):	n/a	Wetted Depth (m):	-	-
		Substrate Bed		
Electrofishing effort:	n/a	(Dom/SubDom):	-	-
Gee Trapping:	n/a	Substrate Bank:	-	-
Fish present?:	N	Riparian Vegetation:	-	-
Site Length:	100m	Meander Pattern:	-	-
		Cover (%/Dom):	-	-
Photo #s	u/s	50 x	49 d/s	pH:
Areas of Erosion:	-			Temperature:
Locations:				Specific Conductivity:
				Dissolved Oxygen
Comments:				
No channel or visible flow.				
No fish habitat.

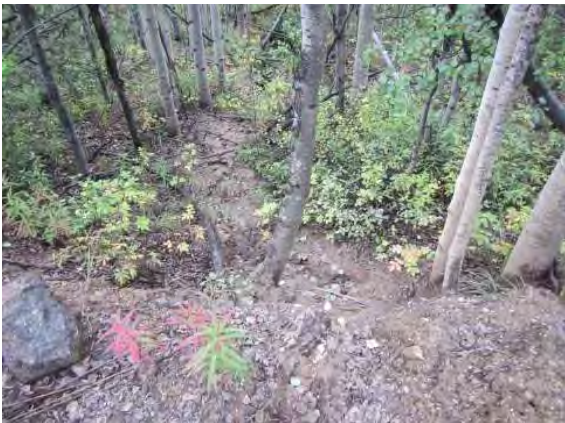
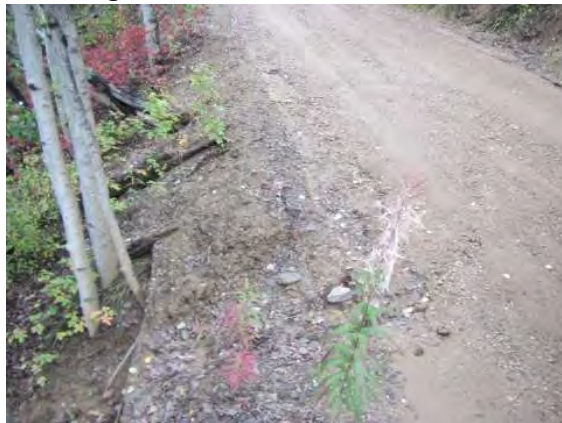
D/S (50m)	X	U/S (50m)
Coordinates:	605323	Gradient (%):	-	-
	7053389	Bankfull Width (m):	-	-
Site Visit Date:	18/08/15	Bankfull Depth (m):	-	-
Flow Conditions:	n/a	Wetted Widths (m):	-	-
Barrier (Y/N):	Y	Wetted Depth (m):	-	-
Electrofishing effort:	N	Substrate Bed (Dom/SubDom):	-	-
	N	Substrate Bank:	-	-
Fish present?:	N	Riparian Vegetation:	-	-
Site Length:	100m	Meander Pattern:	-	-
		Cover (%/Dom):	-	-
Photo #s	u/s      45 x      44 d/s	pH:	-	
Areas of Erosion:	-	Temperature:	-	
Locations:		Specific Conductivity:	-	
		Dissolved Oxygen	-	-
Comments:				
No flow				
No visible channel upstream				
Some evidence of scour downstream; steep drop off slope > 30% (barrier to fish passage)				
Not supporting fish

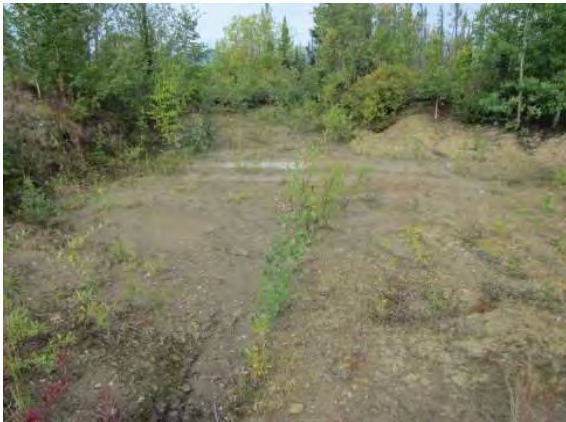
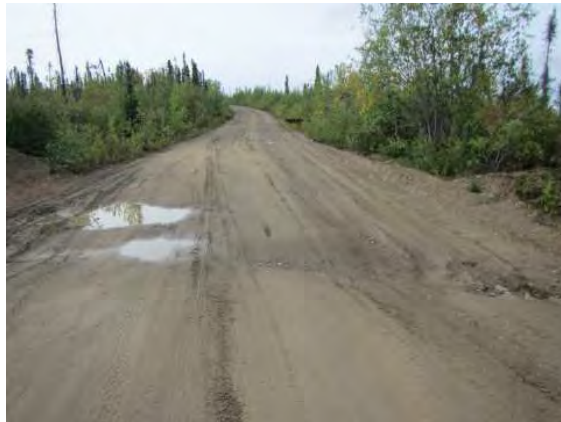
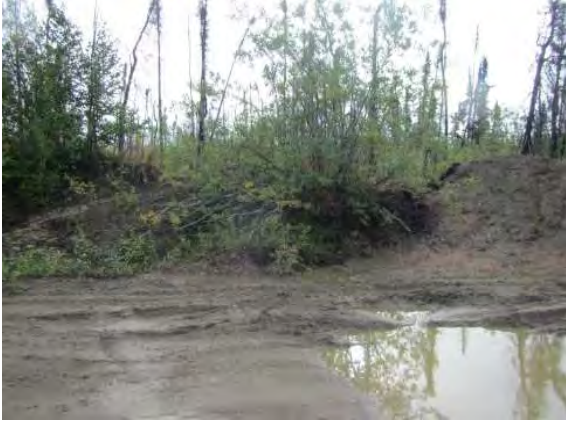
D/S (50m)	X	U/S (50m)
Coordinates:	601660	Gradient (%):	-	-
	7052521	Bankfull Width (m):	-	-
Site Visit Date:	19/08/15	Bankfull Depth (m):	-	-
Flow Conditions:	none	Wetted Widths (m):	-	-
Barrier (Y/N):	Y	Wetted Depth (m):	-	-
		Substrate Bed		
Electrofishing effort:	N	(Dom/SubDom):	-	-
Gee Trapping:	N	Substrate Bank:	-	-
Fish present?:	N	Riparian Vegetation:	-	-
Site Length:	100m	Meander Pattern:	-	-
		Cover (%/Dom):	-	-
Photo #s	53 u/s	52 x	51 d/s	pH:
Areas of Erosion:	-			Temperature:
Locations:				Specific Conductivity:
				Dissolved Oxygen
Comments:	Upper Eureka Creek drainage			
No visible channel upstream				
Some scour (minor) across road				
Very limited evidence of scour downstream; vegetation growing in channel, a couple of puddles.				
Not fish habitat; may conduct minor flow at snowmelt but not accessible to fish				
Noted high gradient barrier using mapping downstream

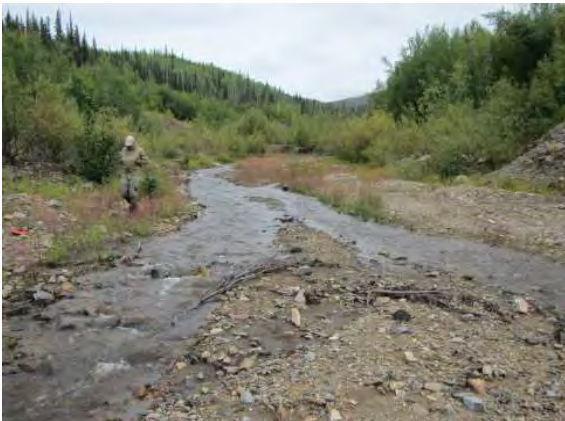
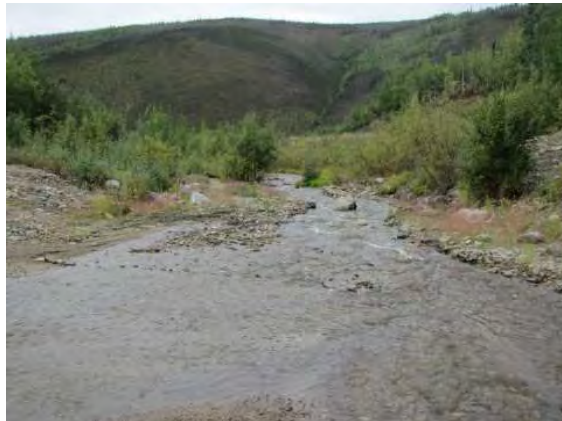
D/S (50m)	X	U/S (50m)	
Coordinates:	606433	Gradient (%):	4	4	4
	7042377	Bankfull Width (m):	6	10.5	4.8
Site Visit Date:	19/08/15	Bankfull Depth (m):	0.4	0.17	0.22
Flow Conditions:	mid-flow	Wetted Widths (m):	2.5	7.7	2.8
Barrier (Y/N):	N	Wetted Depth (m):	0.15	0.07	0.1
Electrofishing effort:	N	Substrate Bed (Dom/SubDom):	C/G	G/C	C/G
Gee Trapping:	N	Substrate Bank:	C/F	F/G	F
Fish present?:	see below	Riparian Vegetation:	WI/DEC	WI/DEC	WI/DEC
Site Length:	100m	Meander Pattern:	RM	IM	RM
		Cover (%/Dom):	<5%/OV	<5%/B	<5%/OV
Photo #s	56 u/s	58 x	57 d/s	pH:	7.85
Areas of Erosion:	Y			Temperature:	5.7 (°C)
Locations:	off of road/ford			Specific Conductivity:	229.6 µs/cm
				Dissolved Oxygen	11.85 (mg/L)
					COND = 145
					102 (% Sat)
Comments:	Black Hills Trib				
Note: Road did not cross at #63 as marked on mapping, but instead further south here.					
Shallow fast riffle; no pool habitat.					
Water too low under current flow conditions to permit adult, sub-adult grayling passage.

Note: evidence of old placer disturbance at upstream site, berms of large substrate forming banks with some shrub vegetation.					
Likely fish-bearing

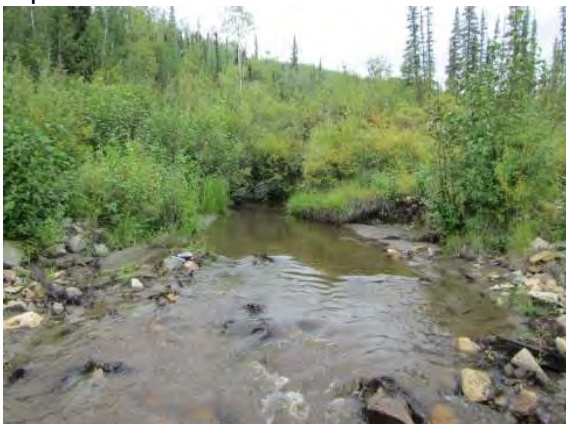
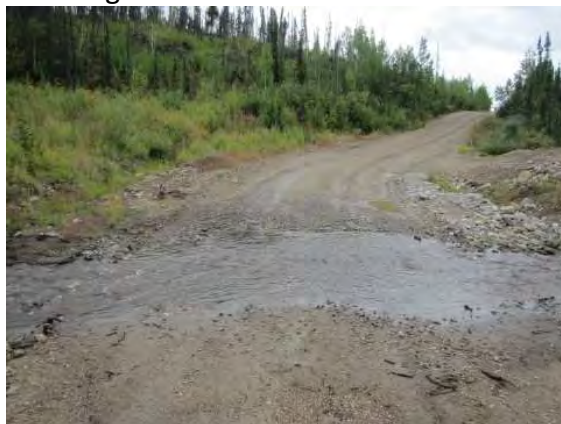
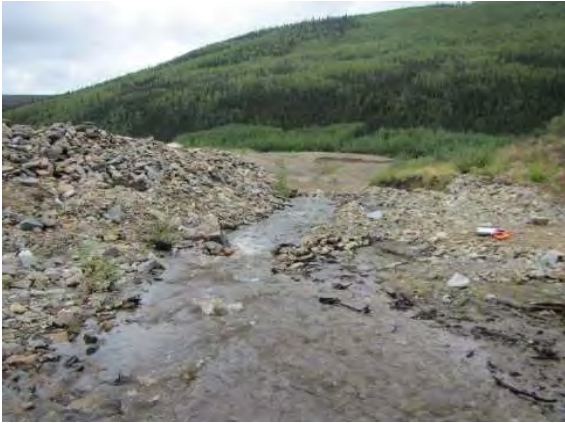
D/S (50m)	X	U/S (50m)	
Coordinates:	607817	Gradient (%):	22	2	2
	7040618	Bankfull Width (m):	4.6	4.5	1
Site Visit Date:	19/08/15	Bankfull Depth (m):	0.45	0.14	0.1
Flow Conditions:	mid-high	Wetted Widths (m):	2.1	6.7	1
Barrier (Y/N):	Y	Wetted Depth (m):	0.1	0.11	0.1
Electrofishing effort:	N	Substrate Bed (Dom/SubDom):	B/G	G/F	F/G
Gee Trapping:	N	Substrate Bank:	C/G	F	F
Fish present?:	N	Riparian Vegetation:	NONE	WI/SH	WI/SH
Site Length:	100m	Meander Pattern:	SI	SI	IM
		Cover (%/Dom):	5%/B	5%/OV	100%/OV
Photo #s	62 u/s	63 x	64 d/s	pH:	7.55
Areas of Erosion:	Y			Temperature:	2.9 (°C)
Locations:	at road and d/s			Specific Conductivity:	120.6 (µs/cm)
				Dissolved Oxygen	12.61 (mg/L)
					COND = 69.7

100.3 (% Sat)
Comments:	Black Hills trib - not fish habitat				
	Approx 20-30 m u/s flow goes underground ~ 10 m (fish barrier).				
	Photo #s 65-66 - from bottom high gradient barrier looking u/s (22%)				
	Some natural vegetation upstream				
	water fairly turbid				
	disturbed area with cobble/boulder pile downstream; no riparian vegetation				
	artificial channel d/s of ford with high gradient barrier

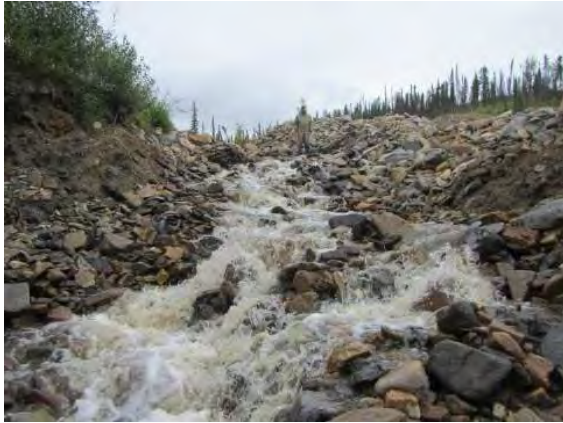
From bottom of high gradient barrier looking u/s

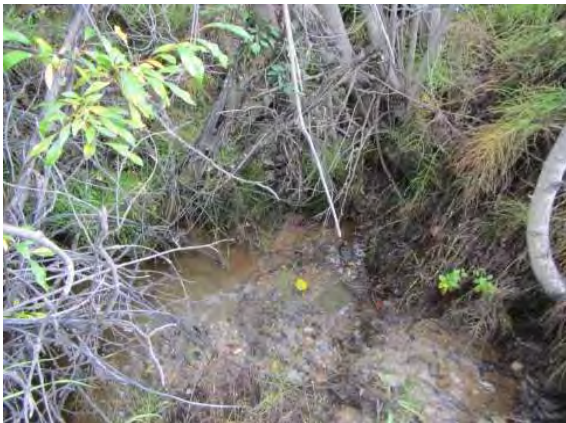
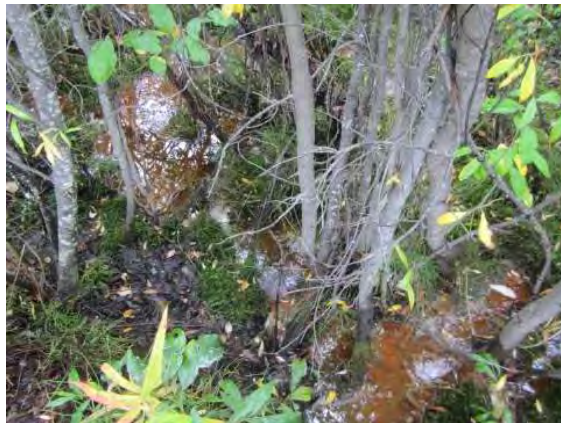
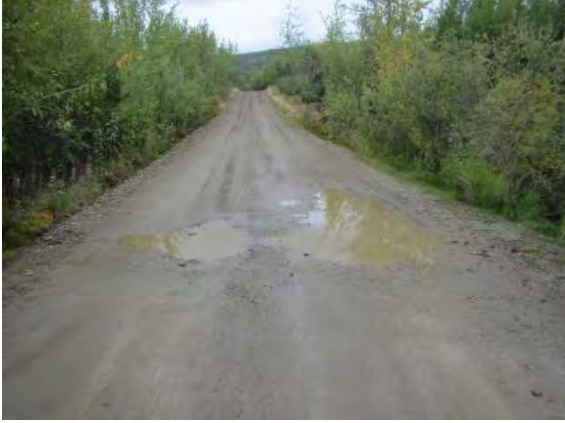
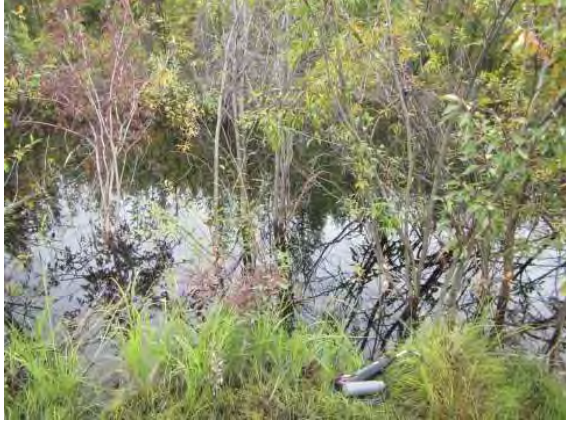
D/S (50m)	X	U/S (50m)
Coordinates:	608009	Gradient (%):	-	1
	7039938	Bankfull Width (m):	-	no defined channel (n/a)
Site Visit Date:	19/08/15	Bankfull Depth (m):	-	-
Flow Conditions:	mid-flow	Wetted Widths (m):	-	0.4
Barrier (Y/N):	Y	Wetted Depth (m):	-	0.2
Electrofishing effort:	N	Substrate Bed (Dom/SubDom):	-	F
Gee Trapping:	N	Substrate Bank:	-	F
Fish present?:	N	Riparian Vegetation:	-	WI/DEC
Site Length:	100m	Meander Pattern:	-	IM
		Cover (%/Dom):	-	100%/OV
Photo #s	70 u/s	69 x	67, 68 d/s	pH:
Areas of Erosion:	N			Temperature:
Locations:				Specific Conductivity:
				Dissolved Oxygen

6.58
				8.5 (°C)
				82.7 (µs/cm)
				2.85 (mg/L)
				COND = 56.7
				24.2 (% Sat)
Comments:	Black Hills Drainage - Not fish habitat			
No culvert; draining through road; stagnant pond forming upstream.				
Photo # 67 shows where water comes through ground under the road. 68 shows slow flow looking d/s				
Downstream: No defined channel; flow disperses and runs through grass, not passable to fish.				
Photo #71

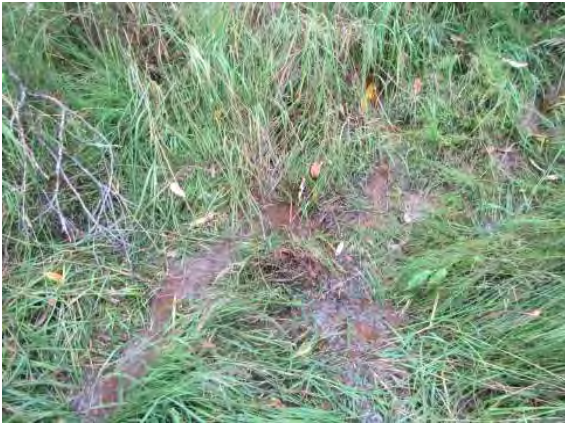
Downstream - no defined channel

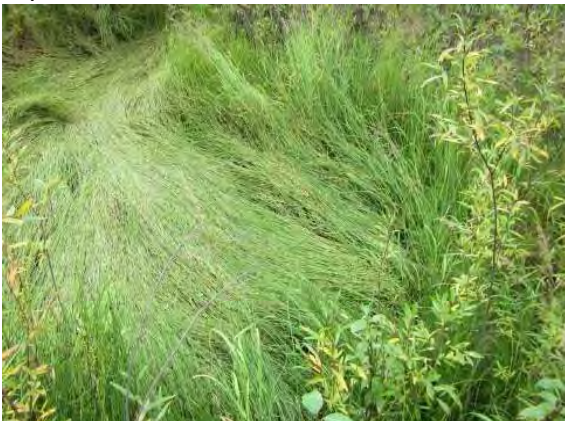
D/S (50m)	X	U/S (50m)	
Coordinates:	608013	Gradient (%):	2	2	WETLAND
	7039540	Bankfull Width (m):	0.4	0.65	-
Site Visit Date:	19/08/15	Bankfull Depth (m):	0.05	0.15	-
Flow Conditions:	mid to high	Wetted Widths (m):	0.4	0.65	-
Barrier (Y/N):	N	Wetted Depth (m):	0.05	0.15	-
		Substrate Bed			
Electrofishing effort:	N	(Dom/SubDom):	F/G	G/F	-
Gee Trapping:	N	Substrate Bank:	F	F	-
Fish present?:	see below	Riparian Vegetation:	WI/MI	WI/DEC	-
Site Length:	100m	Meander Pattern:	IM	IM	-
		Cover (%/Dom):	80/OV	80/OV	-
Photo #s	72 u/s	73 x	74, 75 d/s	pH:	7.1
Areas of Erosion:	N			Temperature:	7.10 (°C)
Locations:				Specific Conductivity:	126.9 (µs/cm)
				Dissolved Oxygen	9.18 (mg/L)    82.2 (% Sat)
Comments:					
Photo#72 - Flow unobservable under horsetails u/s.					
Photo #74 - D/S view					
Photo #75 - Water originating under road; no culvert.					
Very unlikely to support fish; not passable to fish at current flow

No pools, very shallow, low channel definition.					
crossing measurements taken just downstream of road					
P #76 at downstream site looking d/s; water orange coloured

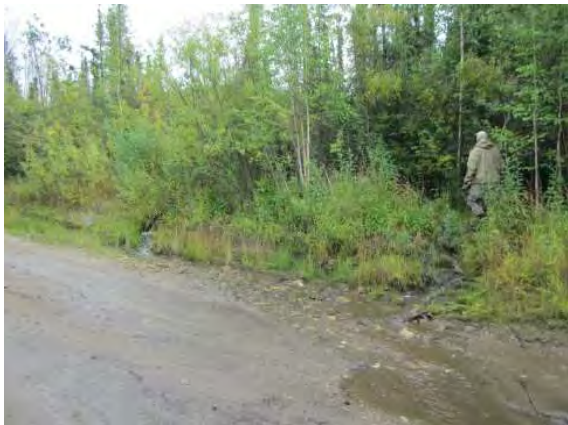
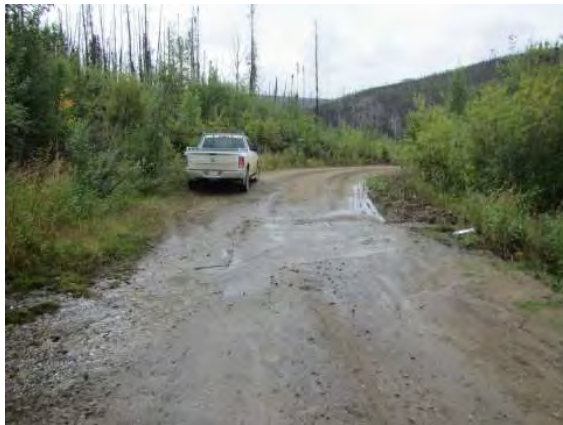
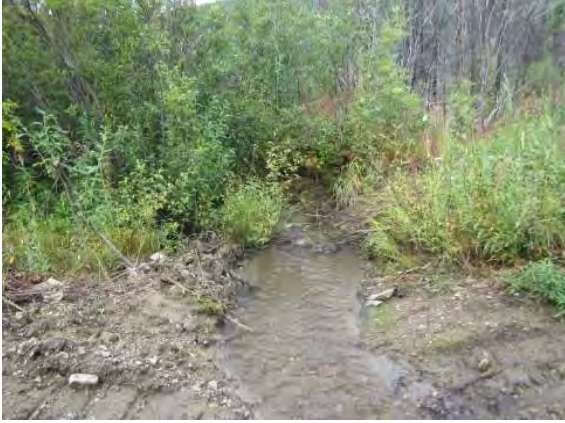
# Coffee Gold Road Northern Route Crossing #70

D/S (50m)	X	U/S (50m)
Coordinates:	608063	Gradient (%):	3	2
	7039220	Bankfull Width (m):	1.14	0.85
Site Visit Date:	19/08/15	Bankfull Depth (m):	0.18	0.22
Flow Conditions:	Mid to High	Wetted Widths (m):	0.42	0.5
Barrier (Y/N):	Y	Wetted Depth (m):	0.1	0.12
Electrofishing effort:	N	Substrate Bed (Dom/SubDom):	F	F
Gee Trapping:	N	Substrate Bank:	F	F
Fish present?:	N	Riparian Vegetation:	WI/MI	WI/MI
Site Length:	100m	Meander Pattern:	IM	IM
		Cover (%/Dom):	80/OV	80/OV
Photo #s	77 u/s	78 x	79 d/s	pH: 7.21
Areas of Erosion:	Y			Temperature: 4.9 (°C)
Locations:	ford			Specific Conductivity: 124.2 (µs/cm)
				Dissolved Oxygen: 11.75 (mg/L)
				COND = 76.3
				98.6 (% Sat)
Comments:	Black Hills Trib			
High gradient drop just d/s of road barrier to fish passage - 34%				
No habitat definition, pools not present, muddy substrate.

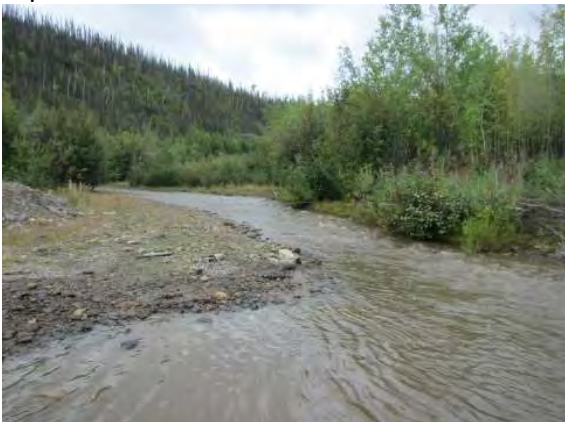
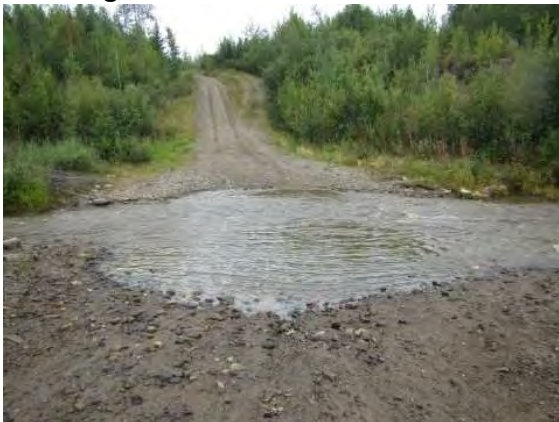
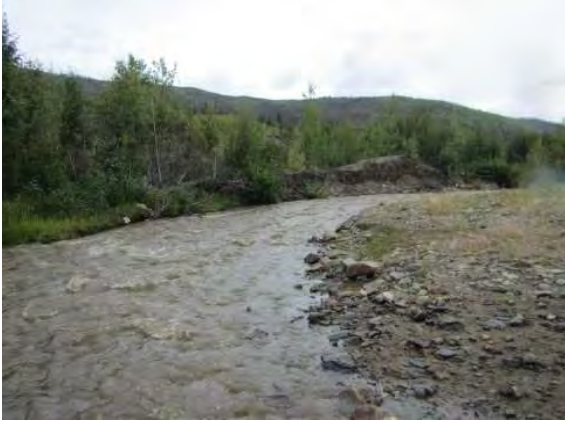
# Coffee Gold Road Northern Route Crossing #71

D/S (50m)	X	U/S (50m)	
Coordinates:	607960	Gradient (%):	2	2	2
	7038666	Bankfull Width (m):	8	13	9.5
Site Visit Date:	19/08/15	Bankfull Depth (m):	0.3	0.25	0.37
Flow Conditions:	Mid to High	Wetted Widths (m):	6.6	11	5.7
Barrier (Y/N):	N	Wetted Depth (m):	0.26	0.2	0.23
Electrofishing effort:	Y	Substrate Bed (Dom/SubDom):	G/C	F/G	C/B
Gee Trapping:	Y	Substrate Bank:	G/F	F	F/C
Fish present?:	Y	Riparian Vegetation:	WI/DEC	WI/DEC	WI/DEC
Site Length:	100m	Meander Pattern:	IM	RM	SI
		Cover (%/Dom):	10/OV	<5%/OV	10%/OV
Photo #s	80 u/s	81 x	82 d/s	pH:	7.87
Areas of Erosion:	Y			Temperature:	7.8 (°C)
Locations:	ford, banks made of bermed material			Specific Conductivity:	213 (µs/cm)
				Dissolved Oxygen	10.84 (mg/L)
					COND = 143.2

97.4 (% Sat)
Comments:	Mainstem Black Hills Creek				
	Water very turbid - visibility poor and high flows				
	Potential migratory corridor for GR if good pool habitat upstream.				
	Pool habitat scarce.				
	Fast shallow riffles uniform along site.				
	sand, gravel debris piles make up some stream banks; previously disturbed areas
