**Fish and Aquatic Resources**

# Coffee Gold Project

## **Fish and Aquatic Resources Baseline Report:**

### **Mine Access Road**

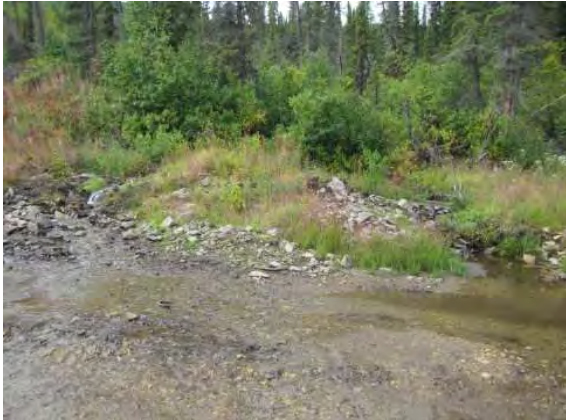
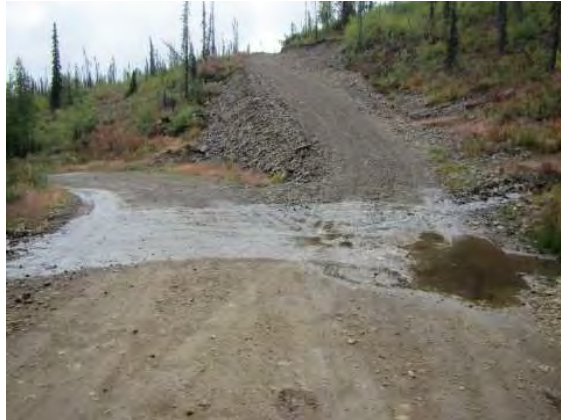
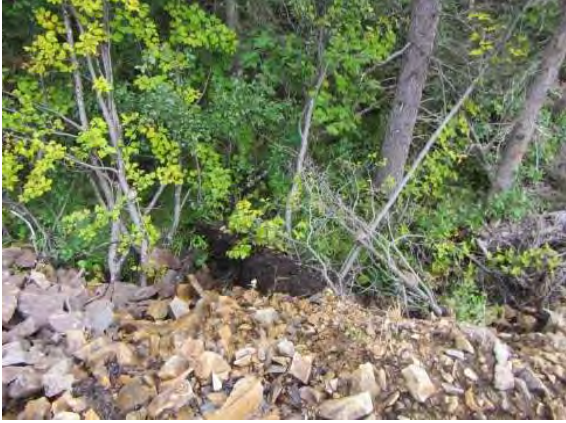
# Coffee Gold Road Northern Route Crossing #72

D/S (50m)	X - across rd	U/S (50m)	
Coordinates:	598186	Gradient (%):	-	68	-
	7038992	Bankfull Width (m):	-	6	-
Site Visit Date:	19/08/15	Bankfull Depth (m):	-	0.01	-
Flow Conditions:	Mid	Wetted Widths (m):	-	6	-
Barrier (Y/N):	Y - high gradient d/s road, 68%	Wetted Depth (m):	-	0.01	-
Electrofish effort:	N	Substrate Bed (Dom/SubDom):	-	-	-
Gee Trapping:	N	Substrate Bank:	-	-	-
Fish present?:	N	Riparian Vegetation:	-	-	-
Site Length:	100m	Meander Pattern:	-	-	-
		Cover (%/Dom):	-	-	-
Photo #s	83 u/s	84 x	85 d/s	pH:	7.63
Areas of Erosion:	-			Temperature:	1.2 (°C)
Locations:				Specific Conductivity:	127.2 (µs/cm) COND = 69.3
				Dissolved Oxygen	12.48 (mg/L) 99 (% Sat)
Comments:	Dome Creek trib - Black Hills watershed				
Not fish habitat; steep gradient drop d/s of road

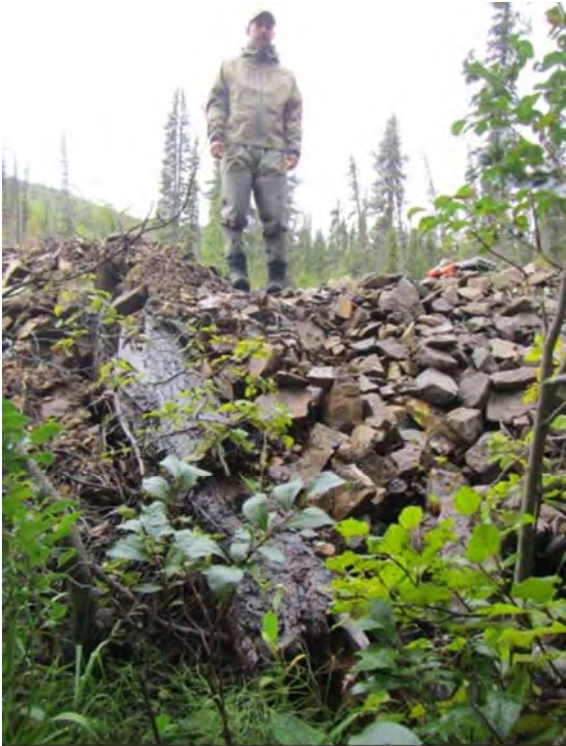
Showing steep drop 68% barrier

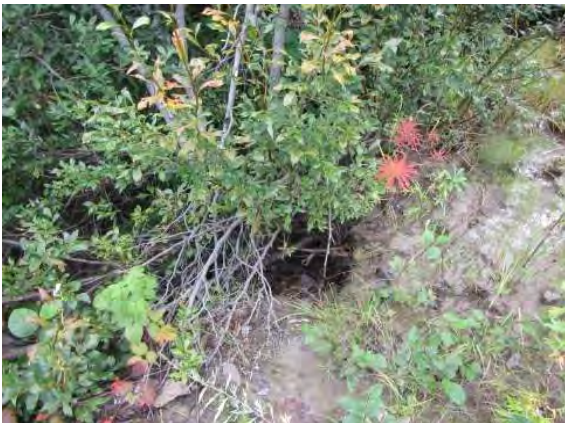
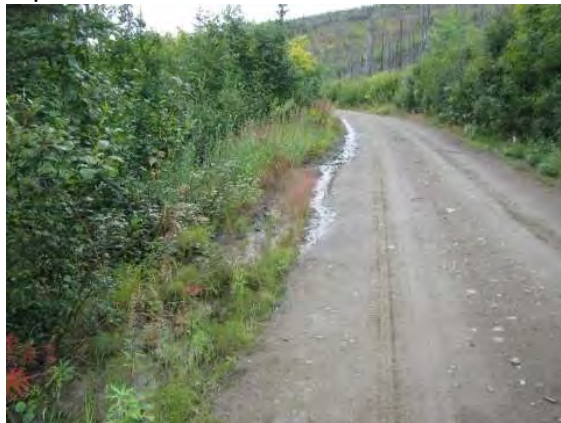
## Coffee Gold Road Northern Route Crossing #73

D/S (50m)	X	U/S (50m)
Coordinates:	597985	Gradient (%):	-	-
	7087893	Bankfull Width (m):	-	-
Site Visit Date:	19/08/15	Bankfull Depth (m):	-	-
Flow Conditions:	mid	Wetted Widths (m):	-	0.2
Barrier (Y/N):	Y - 38% gradient	Wetted Depth (m):	-	0.04
Electrofishing effort:	N	Substrate Bed (Dom/SubDom):	-	-
Gee Trapping:	N	Substrate Bank:	-	-
Fish present?:	N	Riparian Vegetation:	-	-
Site Length:	100m	Meander Pattern:	-	-
		Cover (%/Dom):	-	-
Photo #s	89 u/s	x	88 d/s	pH:
Areas of Erosion:	-			Temperature:
Locations:				Specific Conductivity:
				Dissolved Oxygen
Comments:				
Not fish habitat				
High gradient barrier 38% d/s of road.				
Water flows along road ditch ~ 80 m.				
No culvert.				
measurements taken where water comes in from upstream next to road (P#90)

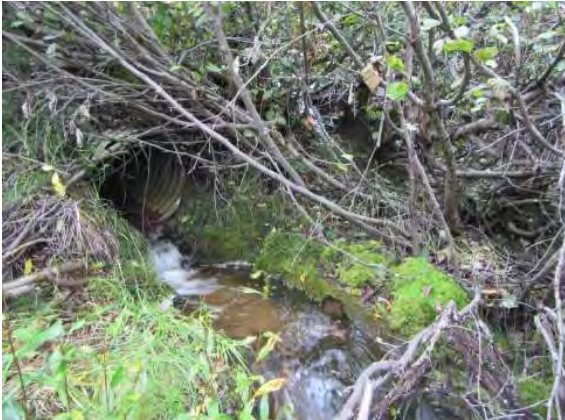
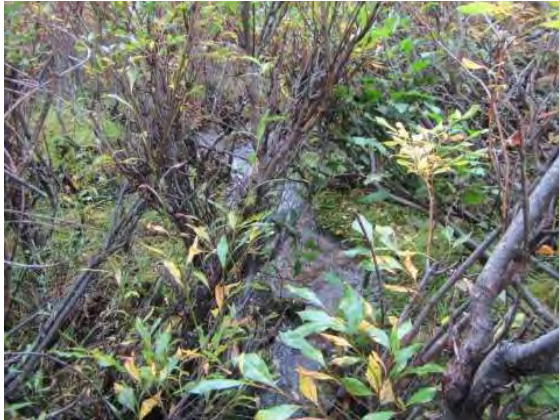
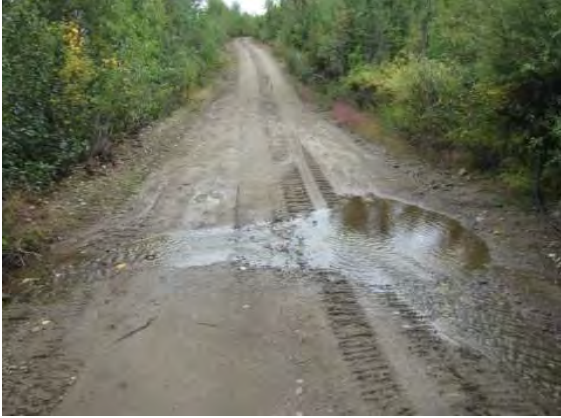
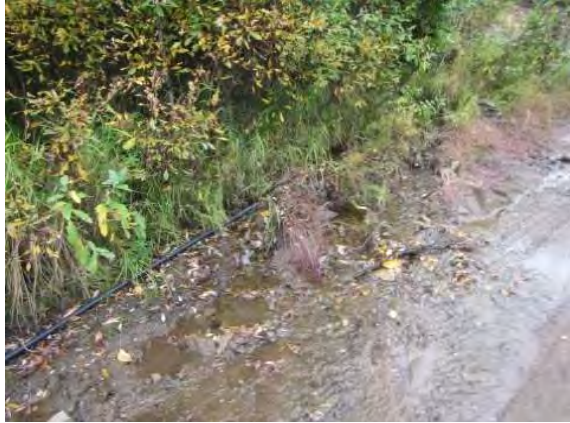
## Coffee Gold Road Northern Route Crossing #74

D/S (50m)	X	U/S (50m)
Coordinates:	598743	Gradient (%):	35-38%	-
	7029092	Bankfull Width (m):	-	-
Site Visit Date:	19/08/15	Bankfull Depth (m):	-	-
Flow Conditions:	n/a	Wetted Widths (m):	0.37	-
Barrier (Y/N):	Y	Wetted Depth (m):	0.08	-
Electrofishing effort:	N	Substrate Bed (Dom/SubDom):	-	-
Gee Trapping:	N	Substrate Bank:	-	-
Fish present?:	N	Riparian Vegetation:	-	-
Site Length:	100m	Meander Pattern:	-	-
		Cover (%/Dom):	-	-
Photo #s	97 u/s	98 x	94, 95 d/s	pH: 7.17
Areas of Erosion:	-			Temperature: 3.3 (°C)
Locations:				Specific Conductivity: 74.6 (µs/cm)
				Dissolved Oxygen: 12.10 (mg/L)
				COND = 43.6
				98.8 (% Sat)
Comments:	Maisy May tributary			
	Photo # 94 - U/S view at culvert downstream			
	Photo # 95 - d/s view d/s of road			
	Shallow high gradient barrier (> 30%) downstream.			
	Not fish habitat

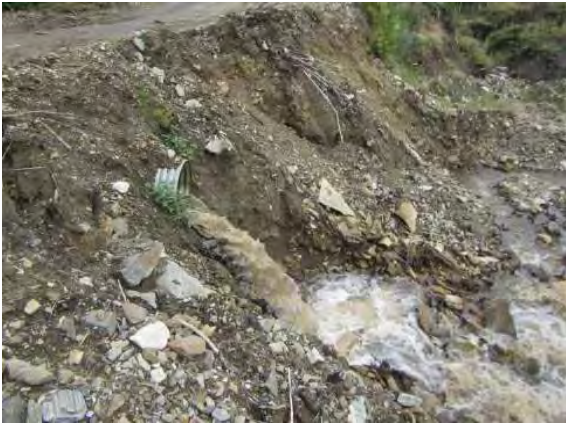
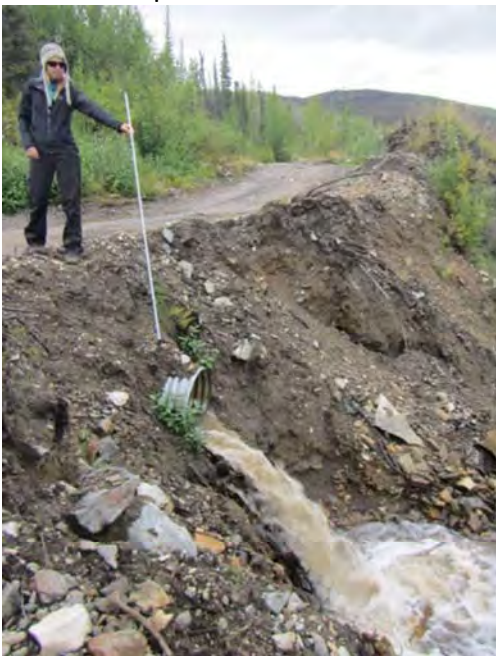
Perched culvert drop

Culvert drop with metre stick

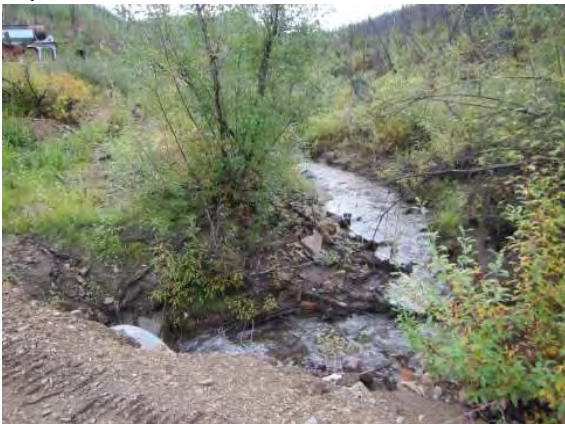
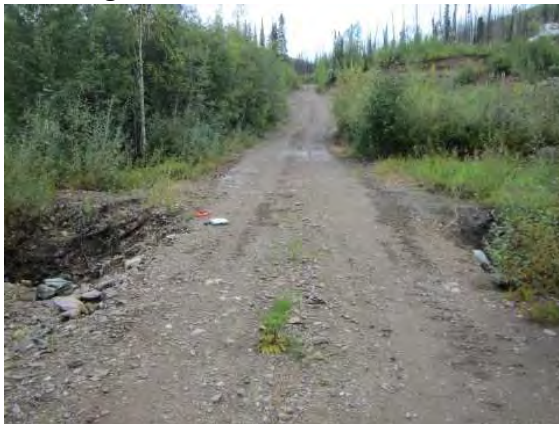
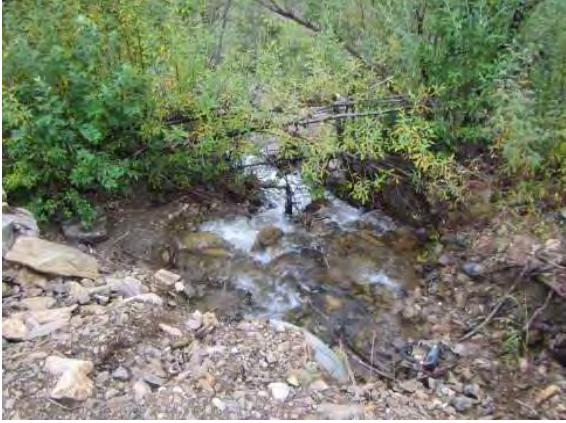
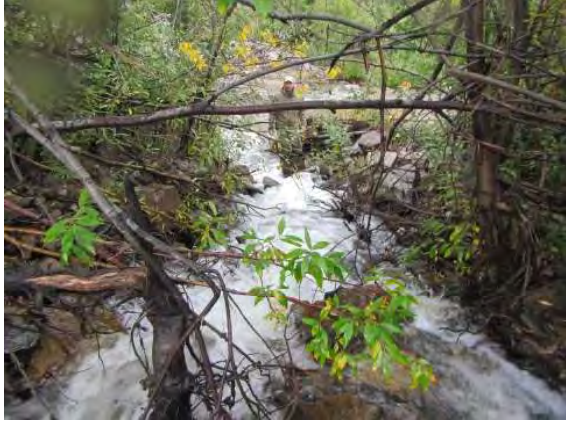
# Coffee Gold Road Northern Route Crossing #76

D/S (50m)	X	U/S (50m)
Coordinates:	599266	Gradient (%):	37	-
	7027499	Bankfull Width (m):	-	2.6
Site Visit Date:	20/08/15	Bankfull Depth (m):	-	0.18
Flow Conditions:	Mid	Wetted Widths (m):	-	2.1
Barrier (Y/N):	Y	Wetted Depth (m):	-	0.1
		Substrate Bed		
Electrofishing effort:	N	(Dom/SubDom):	-	-
Gee Trapping:	N	Substrate Bank:	-	-
Fish present?:	N	Riparian Vegetation:	-	-
Site Length:	100m	Meander Pattern:	-	-
		Cover (%/Dom):	-	-
Photo #s	105 u/s	106 x	107-108 d/s	pH: 7.9
Areas of Erosion:	Y		Temperature:	2.9 (°C)
Locations:	Placer disturbance and road		Specific Conductivity:	180 (µs/cm)
			Dissolved Oxygen	12.88 (mg/L)
				COND = 105
				102 (% Sat)
Comments:	Maisy May trib			
	Not fish habitat - high gradient barrier just below road, and continues steeply down to Maisy May.

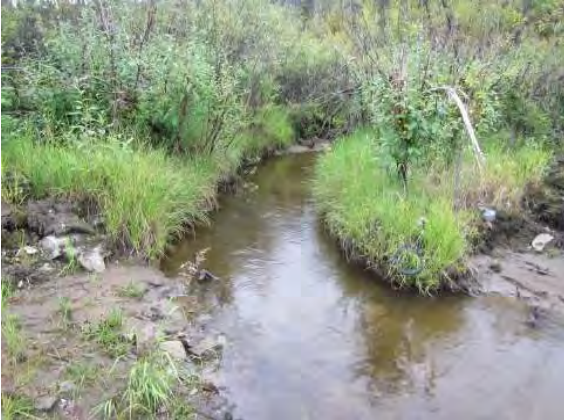
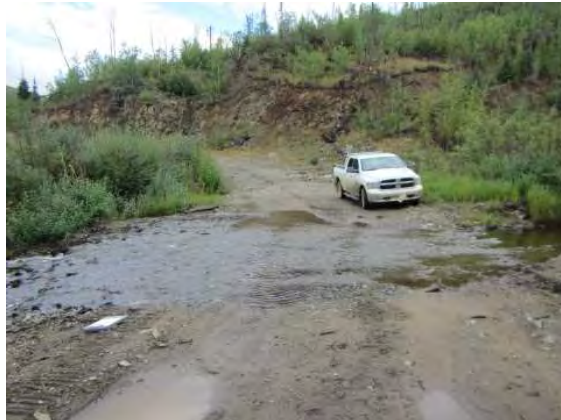
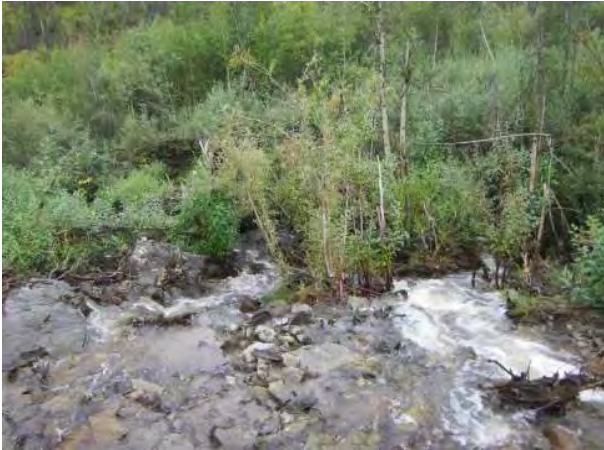
# Coffee Gold Road Northern Route Crossing #77

D/S (50m)	X	U/S (50m)
Coordinates:	599646	Gradient (%):	46	-
	7027033	Bankfull Width (m):	-	1.9
Site Visit Date:	20/80/15	Bankfull Depth (m):	-	0.36
Flow Conditions:	Mid	Wetted Widths (m):	-	1.7
Barrier (Y/N):	Y	Wetted Depth (m):	-	0.26
Electrofishing effort:	N	Substrate Bed (Dom/SubDom):	-	-
Gee Trapping:	N	Substrate Bank:	-	-
Fish present?:	N	Riparian Vegetation:	-	-
Site Length:	100m	Meander Pattern:	-	-
		Cover (%/Dom):	-	-
Photo #s	109 u/s	110 x	111 d/s	pH: 7.56
Areas of Erosion:	Y			Temperature: 2.3 (°C)
Locations:	Road			Specific Conductivity: 171.6 (µs/cm)
				Dissolved Oxygen 12.75 (mg/L) 99.8 (% Sat)
Comments:	Maisy May trib			
Not fish habitat; high gradient barrier downstream				
P#112 from bottom of barrier looking upstream

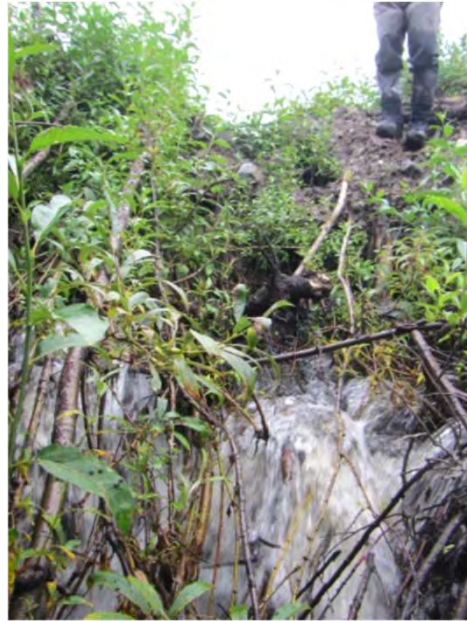
From bottom barrier looking upstream

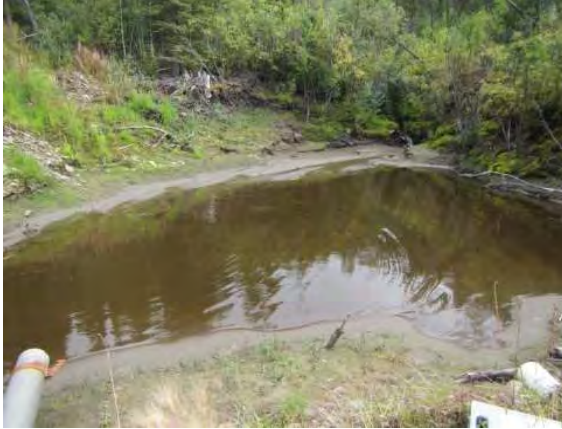
Potentially old reservoir

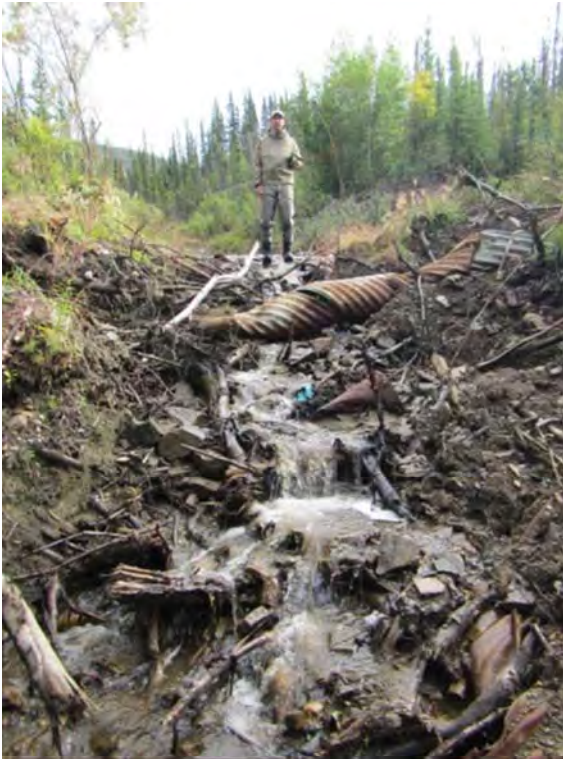
D/S (50m)	X	U/S (50m)
Coordinates:	600659	Gradient (%):	26	-
	7025479	Bankfull Width (m):	-	1
Site Visit Date:	20/08/15	Bankfull Depth (m):	-	0.19
Flow Conditions:	Mid	Wetted Widths (m):	-	0.76
Barrier (Y/N):	Y	Wetted Depth (m):	-	0.07
		Substrate Bed		
Electrofishing effort:	N	(Dom/SubDom):	-	-
Gee Trapping:	N	Substrate Bank:	-	-
Fish present?:	N	Riparian Vegetation:	-	-
Site Length:	100m	Meander Pattern:	-	-
		Cover (%/Dom):	-	-
Photo #s	120 u/s	119 x	121 d/s	pH:
Areas of Erosion:	Y			Temperature:
Locations:	Road; old gravel/sand piles.			Specific Conductivity:
				284.5 (µs/cm)
				Dissolved Oxygen
				12.54 (mg/L)
				100.8 (% Sat)
Comments:	Maisy May trib			
Not fish habitat - high gradient barrier d/s				
P#122 high gradient barrier 26%				
P#123 potentially old reservoir upstream, <1m deep and heavily silted in				
Creek above reservoir is steep and small

High gradient barrier 26%

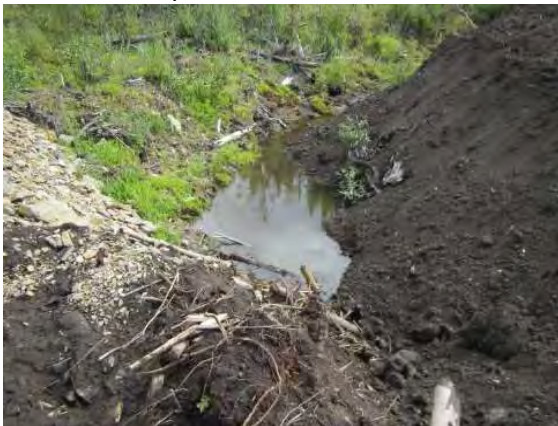
Overburden pile

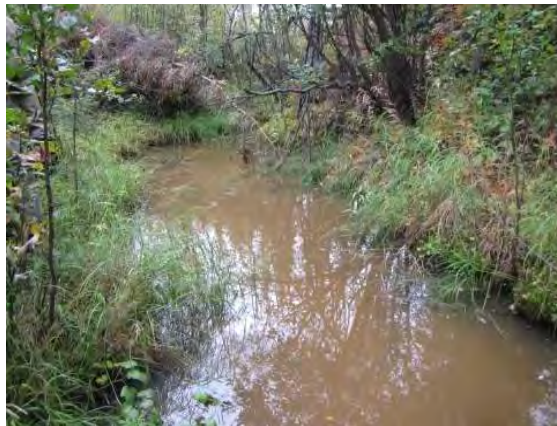
D/S (50m)	X	U/S (50m)
Coordinates:	606584	Gradient (%):	-	-
	7017635	Bankfull Width (m):	-	-
Site Visit Date:	20/08/15	Bankfull Depth (m):	-	-
Flow Conditions:	mid-high	Wetted Widths (m):	0.45	-
Barrier (Y/N):	Y	Wetted Depth (m):	0.17	-
		Substrate Bed		
Electrofishing effort:	N	(Dom/SubDom):	-	-
Gee Trapping:	N	Substrate Bank:	-	-
Fish present?:	N	Riparian Vegetation:	-	-
Site Length:	100m	Meander Pattern:	-	-
		Cover (%/Dom):	-	-
Photo #s	141 u/s	140 x	139 d/s	pH:
Areas of Erosion:	-			Temperature:
Locations:				Specific Conductivity:
				Dissolved Oxygen
Comments:	Maisy May drainage			
	~ 30 - 40 m d/s of road, no more visible pond/channel. Photo #137 - does not connect to Maisy May			
	Photo #138 - showing pond d/s of road (u/s view) before it dries up.			
	No fish habitat			
	No culvert

Pond d/s of road

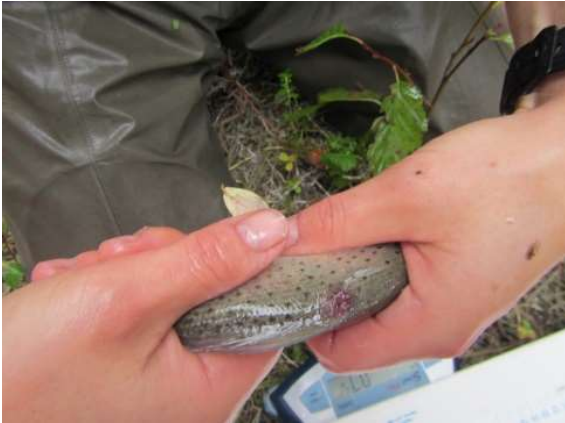
Arctic grayling with injury to dorsal area

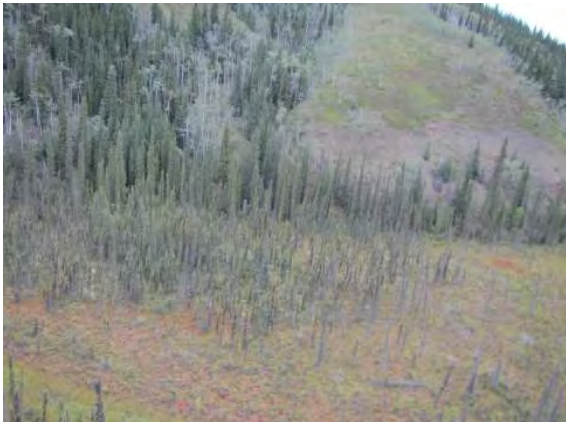
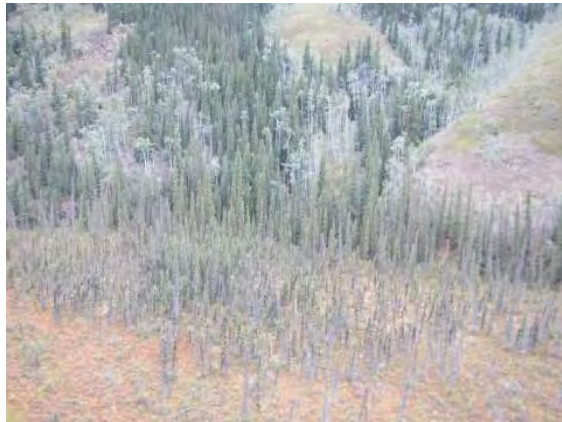
D/S (50m)	X	U/S (50m)
Coordinates:	609258.304	Gradient (%):	-	-
	7013777.13	Bankfull Width (m):	-	-
Site Visit Date:	22/08/15	Bankfull Depth (m):	-	-
Flow Conditions:	none	Wetted Widths (m):	-	-
Barrier (Y/N):	n/a	Wetted Depth (m):	-	-
		Substrate Bed		
Electrofishing effort:	n/a	(Dom/SubDom):	-	-
Gee Trapping:	n/a	Substrate Bank:	-	-
Fish present?:	N	Riparian Vegetation:	-	-
Site Length:	100m	Meander Pattern:	-	-
		Cover (%/Dom):	-	-
Photo #s	u/s	x	d/s	pH:
Areas of Erosion:	-			Temperature:
Locations:				Specific Conductivity:
				Dissolved Oxygen
Comments:	Stewart River drainage			
Onsite provided information regarding no connected drainage at this site				
Verified by flyover; Photo #165-166				
very small pond wetland not connected to Stewart River. Swale goes downstream and is discontinuous				
not fish habitat

Photo from air; no visible channel

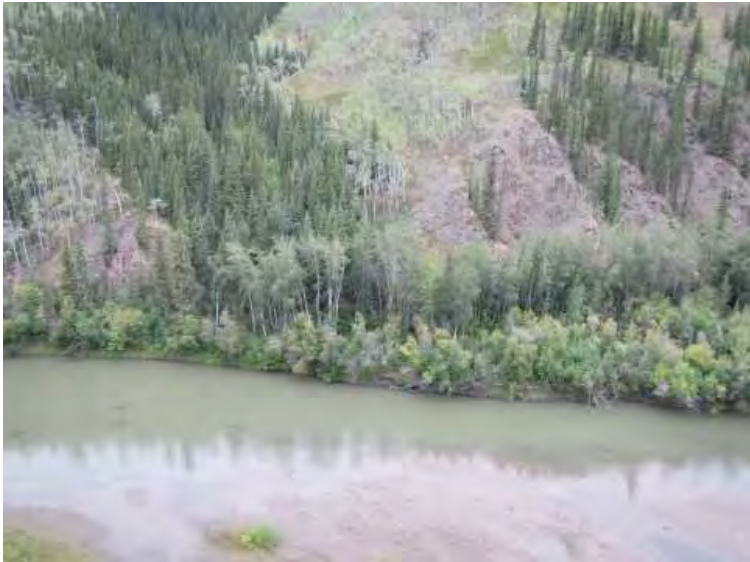
D/S (50m)	X	U/S (50m)
Coordinates:	608907.247	Gradient (%):	-	-
	7012376.35	Bankfull Width (m):	-	-
Site Visit Date:	22/08/15	Bankfull Depth (m):	-	-
Flow Conditions:	none	Wetted Widths (m):	-	-
Barrier (Y/N):	n/a	Wetted Depth (m):	-	-
Electrofishing effort:	n/a	Substrate Bed		
		(Dom/SubDom):	-	-
Gee Trapping:	n/a	Substrate Bank:	-	-
Fish present?:	N	Riparian Vegetation:	-	-
Site Length:	100m	Meander Pattern:	-	-
		Cover (%/Dom):	-	-
Photo #s	u/s	x	d/s	pH:
Areas of Erosion:	-			Temperature:
Locations:				Specific Conductivity:
				Dissolved Oxygen
Comments:	Stewart River drainage			
Onsite provided information regarding no drainage at this site				
Verified by flyover; Photo #159

Photo from air; no visible channel

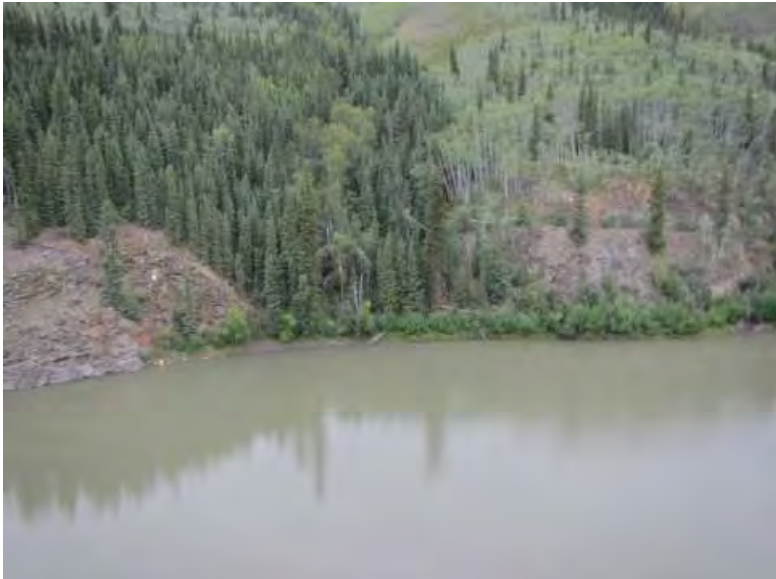
D/S (50m)	X	U/S (50m)
Coordinates:	608837.181	Gradient (%):	-	-
	7012183.67	Bankfull Width (m):	-	-
Site Visit Date:	22/08/15	Bankfull Depth (m):	-	-
Flow Conditions:	none	Wetted Widths (m):	-	-
Barrier (Y/N):	n/a	Wetted Depth (m):	-	-
		Substrate Bed		
Electrofishing effort:	n/a	(Dom/SubDom):	-	-
Gee Trapping:	n/a	Substrate Bank:	-	-
Fish present?:	N	Riparian Vegetation:	-	-
Site Length:	100m	Meander Pattern:	-	-
		Cover (%/Dom):	-	-
Photo #s	u/s	x	d/s	pH:
Areas of Erosion:	-			Temperature:
Locations:				Specific Conductivity:
				Dissolved Oxygen
Comments:	Stewart River drainage			
Onsite provided information regarding no drainage at this site				
Verified by flyover; Photo #158

Photo from air; no visible channel

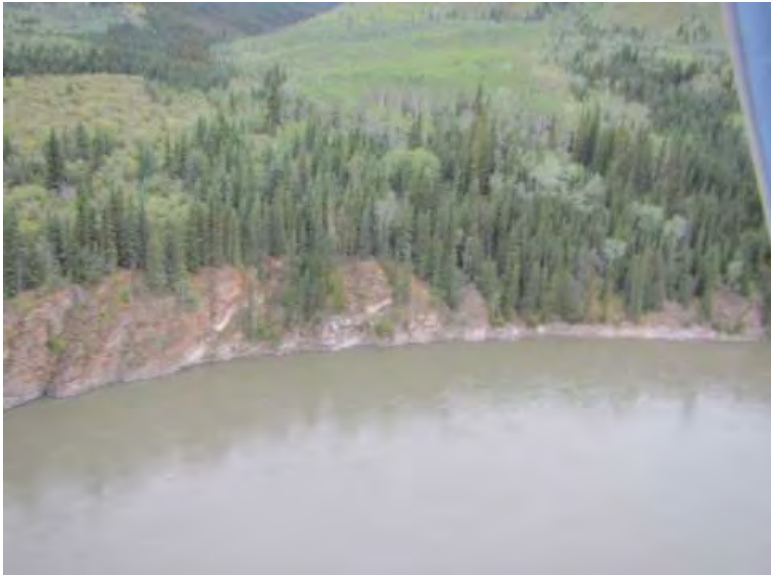
D/S (50m)	X	U/S (50m)
Coordinates:	608588.083	Gradient (%):	-	-
	7011441.37	Bankfull Width (m):	-	-
Site Visit Date:	22/08/15	Bankfull Depth (m):	-	-
Flow Conditions:	none	Wetted Widths (m):	-	-
Barrier (Y/N):	n/a	Wetted Depth (m):	-	-
		Substrate Bed		
Electrofishing effort:	n/a	(Dom/SubDom):	-	-
Gee Trapping:	n/a	Substrate Bank:	-	-
Fish present?:	N	Riparian Vegetation:	-	-
Site Length:	100m	Meander Pattern:	-	-
		Cover (%/Dom):	-	-
Photo #s	u/s	x	d/s	pH:
Areas of Erosion:	-			Temperature:
Locations:				Specific Conductivity:
				Dissolved Oxygen
Comments:	Stewart River drainage			
Onsite provided information regarding no drainage at this site				
Verified by flyover; Photo #157

Photo from air; no visible channel

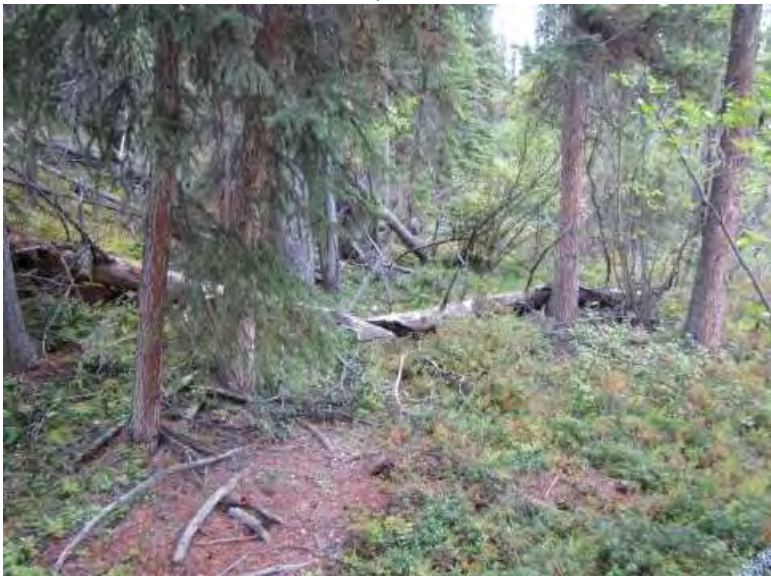
D/S (50m)	X	U/S (50m)
Coordinates:	607267	Gradient (%):	-	-
	7009765	Bankfull Width (m):	-	-
Site Visit Date:	22/08/15	Bankfull Depth (m):	-	-
Flow Conditions:	none	Wetted Widths (m):	-	-
Barrier (Y/N):	n/a	Wetted Depth (m):	-	-
		Substrate Bed		
Electrofishing effort:	n/a	(Dom/SubDom):	-	-
Gee Trapping:	n/a	Substrate Bank:	-	-
Fish present?:	N	Riparian Vegetation:	-	-
Site Length:	100m	Meander Pattern:	-	-
		Cover (%/Dom):	-	-
Photo #s	u/s	x	d/s	pH:
Areas of Erosion:	-			Temperature:
Locations:				Specific Conductivity:
				Dissolved Oxygen
Comments:	Stewart River drainage			
No visible channel ~ 100 m d/s of road coordinate				
No fish habitat				
Photo #156

No visible channel ~ 100 m d/s of road coordinate

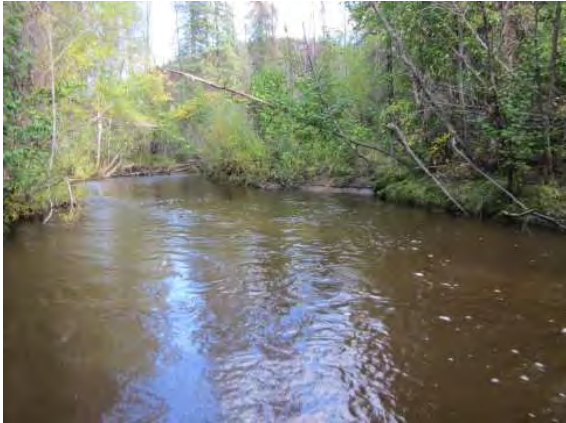
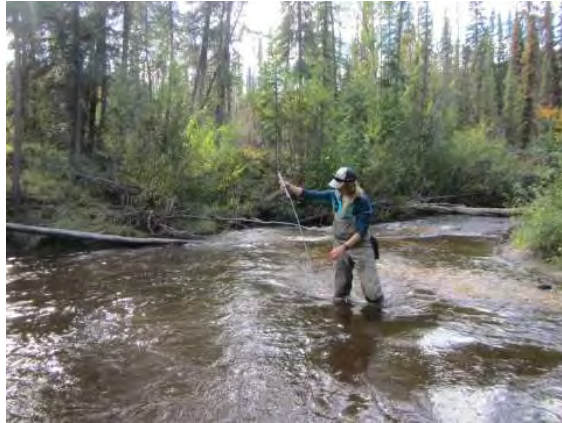
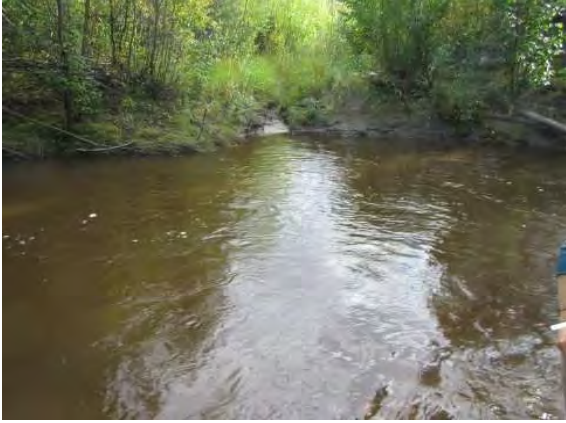
## Coffee Gold Road Northern Route Crossing #100

D/S (50m)	X	U/S (50m)
Coordinates:	605754	Gradient (%):	2	2
	7007136	Bankfull Width (m):	~12	~10
Site Visit Date:	25/08/15	Bankfull Depth (m):	~1.4	0.9
Flow Conditions:	Mid	Wetted Widths (m):	~11	~9
Barrier (Y/N):	N	Wetted Depth (m):	1.2	0.6
		Substrate Bed		
Electrofishing effort:	N	(Dom/SubDom):	F/G	G/C
Gee Trapping:	Y	Substrate Bank:	F	F
Fish present?:	Y	Riparian Vegetation:	MI	MI
Site Length:	100m	Meander Pattern:	RM	SI
		Cover (%/Dom):	20/DP, LWD	15/DP
Photo #s	248 u/s	250 x	249 d/s	pH: 7.84
Areas of Erosion:	Y			Temperature: 6.2 (°C)
Locations:	Ford; one bank u/s			Specific Conductivity: 207.5 (µs/cm)
				Dissolved Oxygen: 11.61 (mg/L)
				COND = 132.9
				97.4 (% Sat)
Comments:	Barker Cr mainstem			
Water turbid				
Note widths estimated - too deep to wade across.				
Deep pools noted

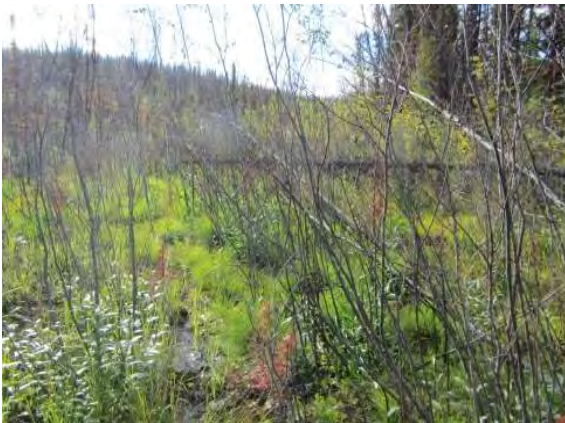
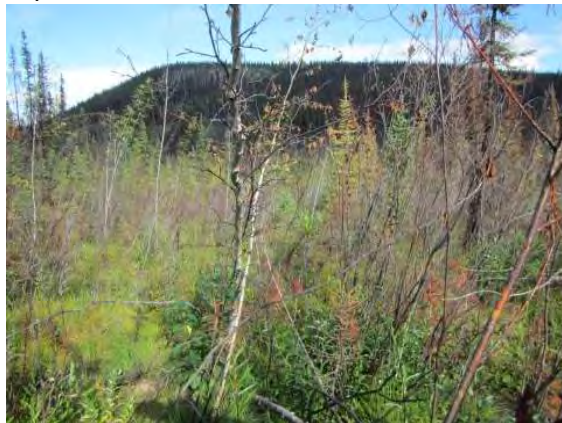
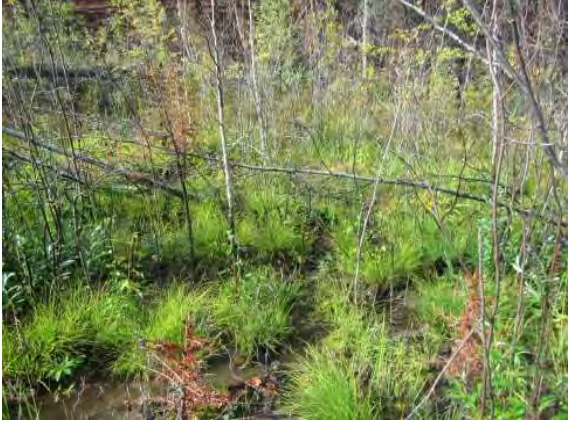
# Coffee Gold Road Northern Route Crossing #101

D/S (50m) - 2 channels	X - 3 channels	U/S (50m) - 2 channels	
Coordinates:	605703	Gradient (%):	7	5	10
	7006526	Bankfull Width (m):	N/A - new channel		
Site Visit Date:	25/08/15	Bankfull Depth (m):	N/A - new channel		
Flow Conditions:	mid to high	Wetted Widths (m):	0.58	0.59	0.9
Barrier (Y/N):	N	Wetted Depth (m):	0.03	0.17	0.11
		Substrate Bed (Dom/SubDom):	F	F	F
Electrofishing effort:	N	Substrate Bank:	F	F	F
Gee Trapping:	N	Riparian Vegetation:	WI/SP	WI/SP	WI/SP
Fish present?:	see below	Meander Pattern:	IM	IM	IM
Site Length:	100m	Cover (%/Dom):	30/OV	30/OV	20/OV
Photo #s	246 u/s	247 x	245 d/s	pH:	7.41
Areas of Erosion:	Y			Temperature:	8.7 (°C)
Locations:	upstream burn area			Specific Conductivity:	89.3 (µs/cm) COND = 61.5
				Dissolved Oxygen	10.65 (mg/L) 95.5(% Sat)
Comments:	Barker Cr trib - muddy /turbid water				
Water flowing through what appears to be recently new areas					
Muddy small discontinuous stream at current flow - natural obstructions to fish passage.

Very unlikely to support fish - no pool habitat, very small, discontinuous					
dispersed undefined channels through grass

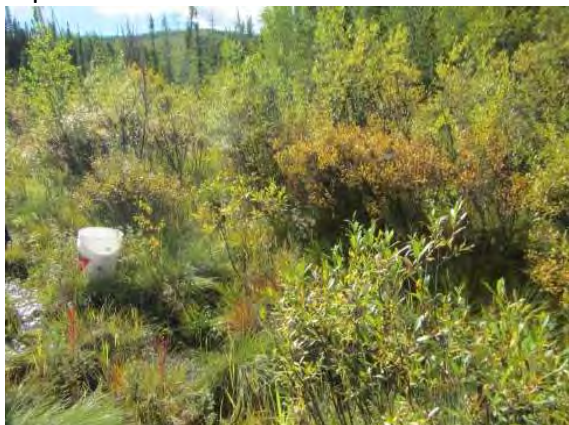
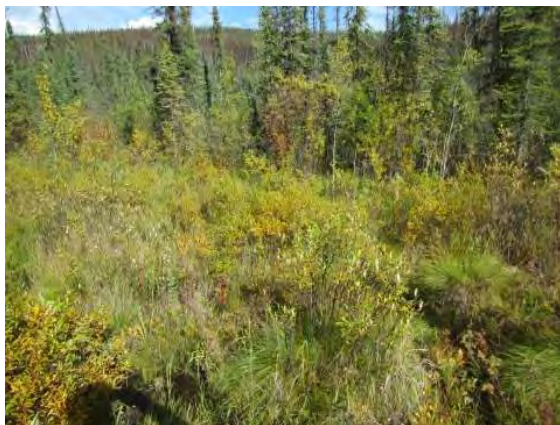
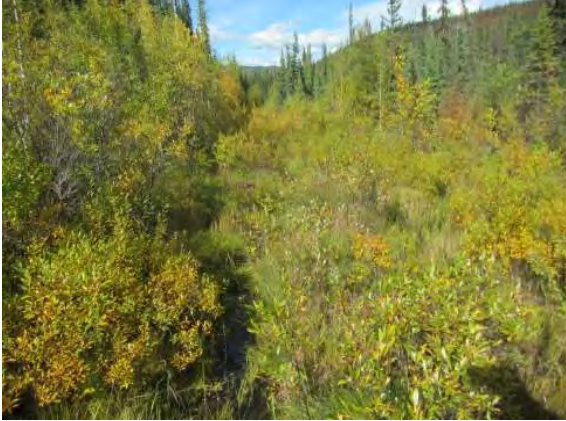
## Coffee Gold Road Northern Route Crossing #102

D/S (50m)	X	U/S (50m)
Coordinates:	605802	Gradient (%):	3	2
	7005863	Bankfull Width (m):	0.38	0.55
Site Visit Date:	25/08/15	Bankfull Depth (m):	0.2	0.2
Flow Conditions:	High	Wetted Widths (m):	0.38	0.55
Barrier (Y/N):	N	Wetted Depth (m):	0.2	0.2
Electrofishing effort:	N	Substrate Bed (Dom/SubDom):	F	F
Gee Trapping:	N	Substrate Bank:	F	F
Fish present?:	see below	Riparian Vegetation:	WI/MI	WI/SP
Site Length:	100m	Meander Pattern:	IM	IM
		Cover (%/Dom):	80/OV	80/OV
Photo #s	242 u/s	244 x	243 d/s	pH: 7.56
Areas of Erosion:	N			Temperature: 5.5 (°C)
Locations:				Specific Conductivity: 129.5 (µs/cm)
				Dissolved Oxygen: 10.53 (mg/L)
				COND = 81.4
				87 (% Sat)
Comments:	Barker Creek trib			
	Poorly defined channel; disconnected areas.			
	Water flowing through grass is dispersed and discontinuous			
	Very unlikely to support fish; natural fish passage obstructions present; muddy small creek no pool habitat.

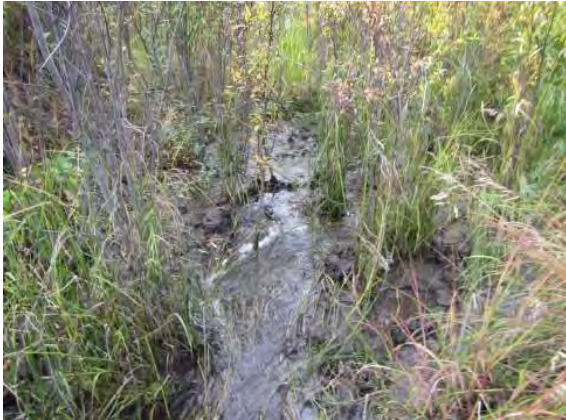
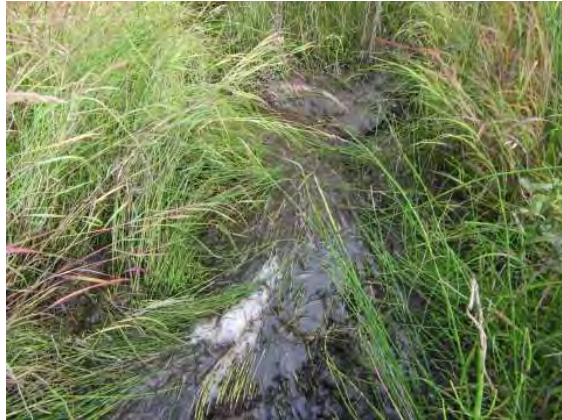
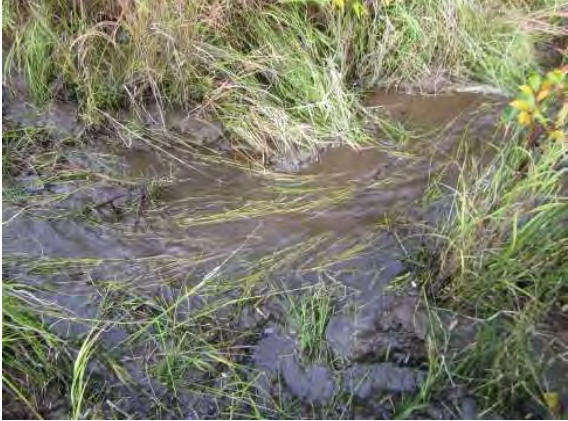
## Coffee Gold Road Northern Route Crossing #103

D/S (50m)	X	U/S (50m)	
Coordinates:	605666	Gradient (%):	16	1	5
	7005507	Bankfull Width (m):	0.75	1.25	1.2
Site Visit Date:	24/08/15	Bankfull Depth (m):	0.33	0.15	0.18
Flow Conditions:	Mid	Wetted Widths (m):	0.4	0.42	0.54
Barrier (Y/N):	N	Wetted Depth (m):	0.25	0.02	0.08
Electrofishing effort:	N	Substrate Bed (Dom/SubDom):	F	F	F
Gee Trapping:	N	Substrate Bank:	F	F	F
Fish present?:	see below	Riparian Vegetation:	WI/burn	WI/DEC	WI/burn
Site Length:	100m	Meander Pattern:	SI	IM	SI
		Cover (%/Dom):	70/OV, LWD	70/OV	70/OV
Photo #s	191 u/s	193 x	192 d/s	pH:	7.77
Areas of Erosion:	Y		Temperature:	5.2 (°C)	
Locations:	around burn/permafrost melt.		Specific Conductivity:	125 (µs/cm)	COND = 70
			Dissolved Oxygen	12.8 (mg/L)	105 (% Sat)
Comments:	Barker Creek trib				
	Some small vertical drops, increased gradient in stretches.				
	Note: Crossing coordinates d/s of assessment, but road crossed higher up,				
	Very unlikely to support fish - small muddy channel - not passable to fish at current flow level

No pool habitat or gravel substrate noted				
	Note: Many small permafrost melt channels crossing rd between 103 and 104 due to u/s burn area.

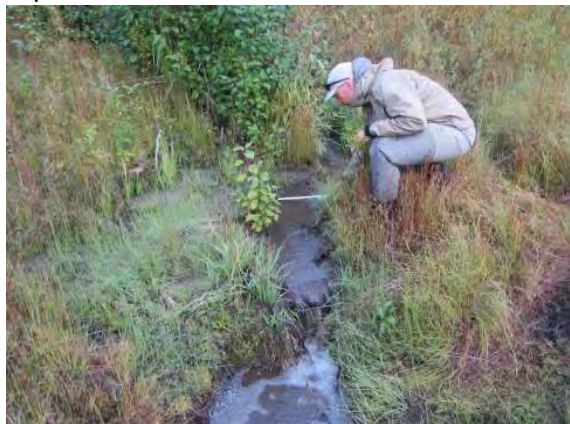
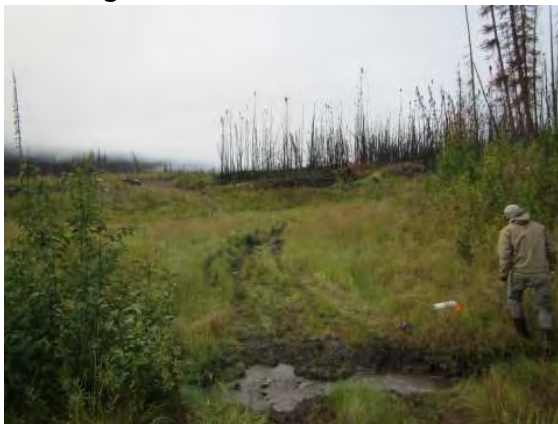
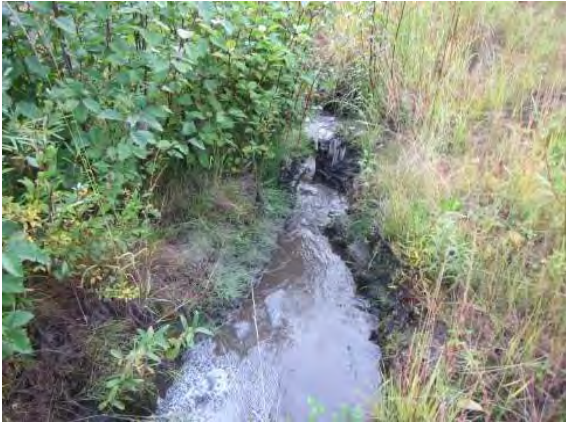
## Coffee Gold Road Northern Route Crossing #104

D/S (50m)	X (2 channels)	U/S (50m)	
Coordinates:	605661	Gradient (%):	5	8	5
	7004399	Bankfull Width (m):	1.6	0.62	0.47
Site Visit Date:	25/08/15	Bankfull Depth (m):	0.08	0.22	0.12
Flow Conditions:	Mid	Wetted Widths (m):	0.7	0.62	0.32
Barrier (Y/N):	N	Wetted Depth (m):	0.06	0.13	0.05
Electrofishing effort:	N	Substrate Bed (Dom/SubDom):	F	F	F
Gee Trapping:	N	Substrate Bank:	F	F	F
Fish present?:	see below	Riparian Vegetation:	SH/DEC	GR	WI
Site Length:	100m	Meander Pattern:	SI	IM	IM
		Cover (%/Dom):	50/OV	20/OV	50/OV
Photo #s	197 u/s	198 x	199 d/s	pH:	7.36
Areas of Erosion:	Y			Temperature:	1.8 (°C)
Locations:	burn area u/s			Specific Conductivity:	118.2 (µs/cm)
				Dissolved Oxygen	12.54 (mg/L)    94.0 (% Sat)
Comments:	Barker Cr. Trib				
	Photos of more northern (larger) branch - photo #s 197 - 199				
	Small muddy; no pool habitat				
	Very unlikely to support fish

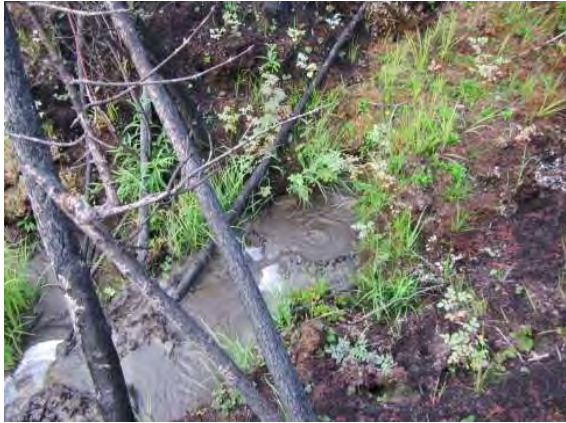
Southern channel disappears

S. channel disappears underground ~ 20 m u/s of road - photo#200				
	N. channel - small muddy irregular channel with some natural obstructions to fish passage (steep drops and underground flow)

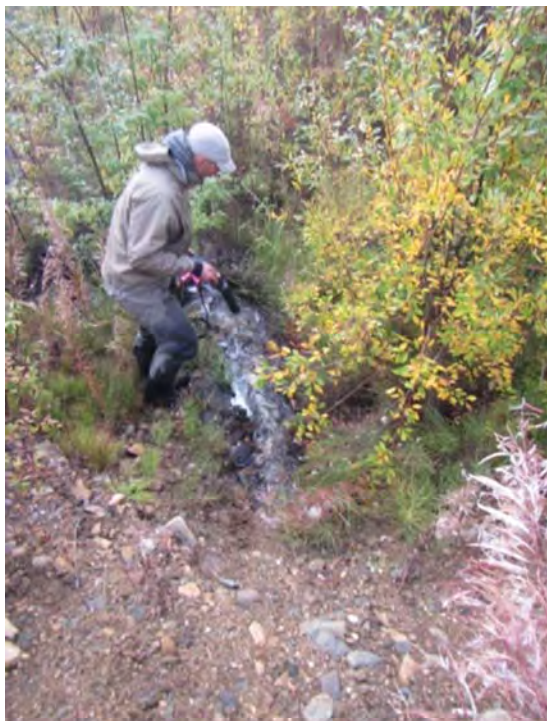
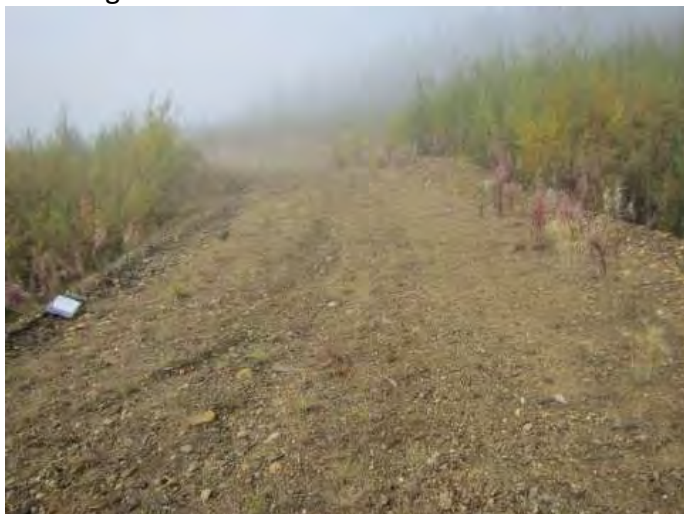
## Coffee Gold Road Northern Route Crossing #105

D/S (50m)	X	U/S (50m)	
Coordinates:	605378	Gradient (%):	2	8	14
	7003446	Bankfull Width (m):	0.7	0.42	0.58
Site Visit Date:	25/08/15	Bankfull Depth (m):	0.07	0.12	0.16
Flow Conditions:	Mid	Wetted Widths (m):	0.32	0.22	0.35
Barrier (Y/N):	N	Wetted Depth (m):	0.05	0.06	0.06
		Substrate Bed			
Electrofishing effort:	N	(Dom/SubDom):	F	C/F	F
Gee Trapping:	N	Substrate Bank:	F	C/F	F
Fish present?:	see below	Riparian Vegetation:	WI	WI	WI/burn
Site Length:	100m	Meander Pattern:	IM	IM	IM
		Cover (%/Dom):	50/OV	20/OV	50/OV
Photo #s	203, 204 u/s	202 x	201 d/s	pH:	7.97
Areas of Erosion:	Y			Temperature:	3.5 (°C)
Locations:	road; burn areas			Specific Conductivity:	259.7 (µs/cm)
				Dissolved Oxygen	12.45 (mg/L)

99.1(% Sat)
Comments:	Barker Cr. Trib				
	P#203 - shows where water disappears vertically into connection to culvert.				
	P#204 - shows channel looking upstream, vertical drop is obstruction to fish passage.				
	Not passable to fish at current flows - very shallow and obstruction present.				
	Very unlikely to support fish - muddy, small, many natural obstructions to fish passage; no pool habitat; no gravel substrate.

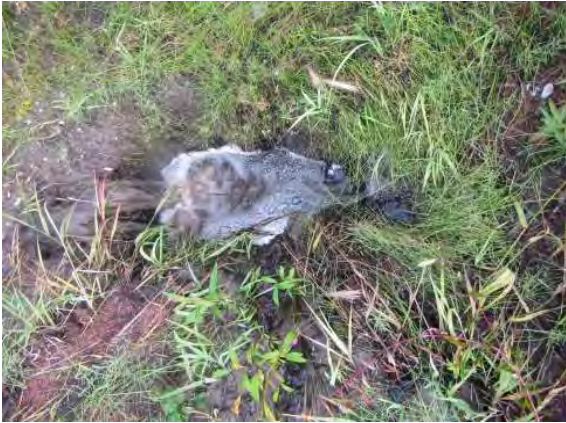
Upstream - water disappears

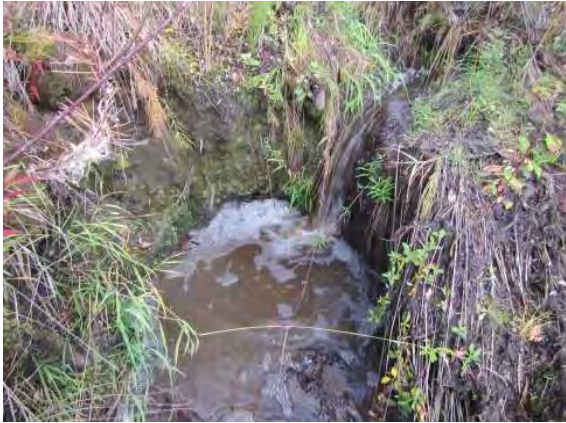
Upstream - vertical drop

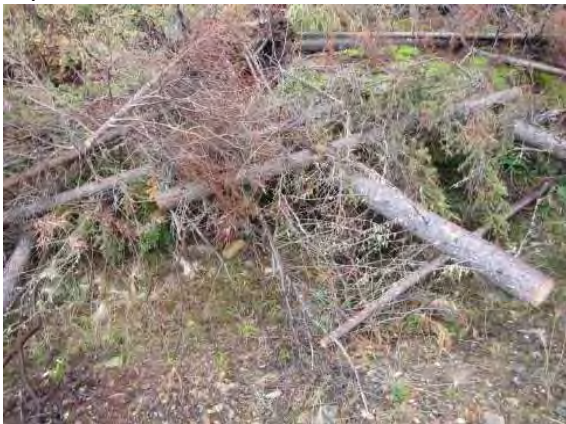
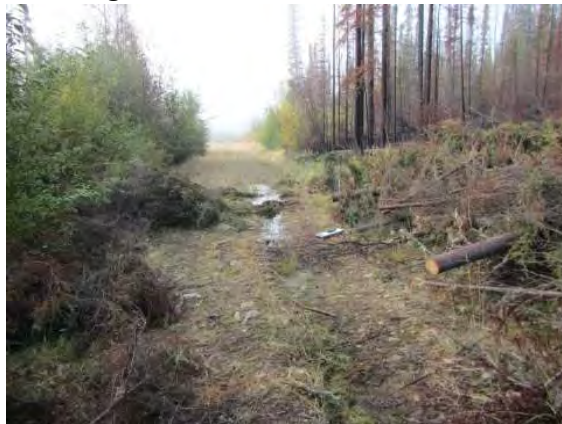
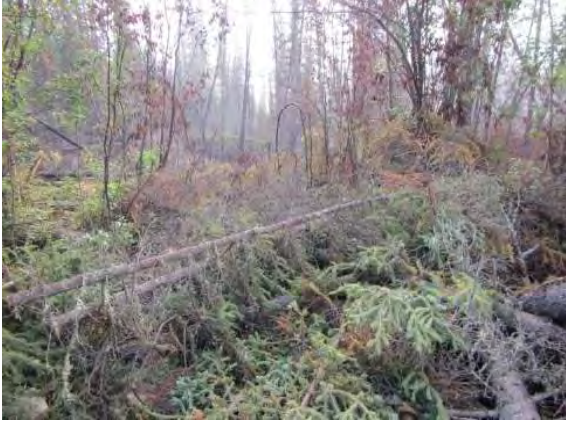
## Coffee Gold Road Northern Route Crossing #106

D/S (50m)	X	U/S (50m)
Coordinates:	605172	Gradient (%):	-	-
	7002703	Bankfull Width (m):	-	-
Site Visit Date:	25/08/15	Bankfull Depth (m):	-	-
Flow Conditions:	none	Wetted Widths (m):	-	-
Barrier (Y/N):	n/a	Wetted Depth (m):	-	-
		Substrate Bed		
Electrofishing effort:	n/a	(Dom/SubDom):	-	-
Gee Trapping:	n/a	Substrate Bank:	-	-
Fish present?:	N	Riparian Vegetation:	-	-
Site Length:	100m	Meander Pattern:	-	-
		Cover (%/Dom):	-	-
Photo #s	205 u/s	206 x	207 d/s	pH:
Areas of Erosion:	-			Temperature:
Locations:				Specific Conductivity:
				Dissolved Oxygen
Comments:	Barker Cr drainage			
No visible flow/channel

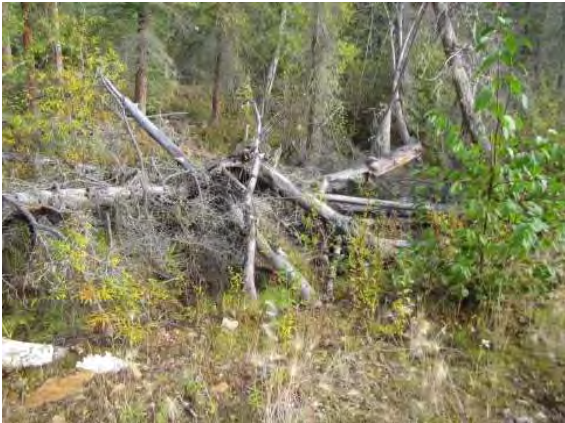
Upstream

D/S (50m)	X	U/S (50m)
Coordinates:	604784	Gradient (%):	-	-
	7002121	Bankfull Width (m):	-	-
Site Visit Date:	25/08/15	Bankfull Depth (m):	-	-
Flow Conditions:	n/a	Wetted Widths (m):	-	-
Barrier (Y/N):	n/a	Wetted Depth (m):	-	-
		Substrate Bed		
Electrofishing effort:	n/a	(Dom/SubDom):	-	-
Gee Trapping:	n/a	Substrate Bank:	-	-
Fish present?:	N	Riparian Vegetation:	-	-
Site Length:	100m	Meander Pattern:	-	-
		Cover (%/Dom):	-	-
Photo #s	208 u/s	209 x	210 d/s	pH:
Areas of Erosion:	-			Temperature:
Locations:				Specific Conductivity:
				Dissolved Oxygen
Comments:	Barker drainage			
No visible channel				
Minor scour evidence across road

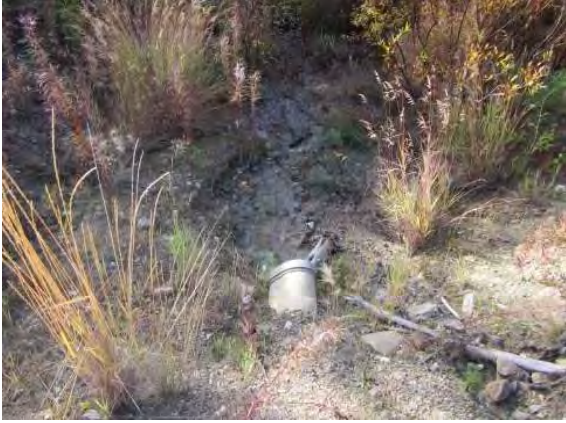
P#223 shows 30% gradient drop over 8m horizontal downstream of road					
P#220 - dry culvert in abandoned channel on d/s side road

Dry culvert in abandoned channel (#220)

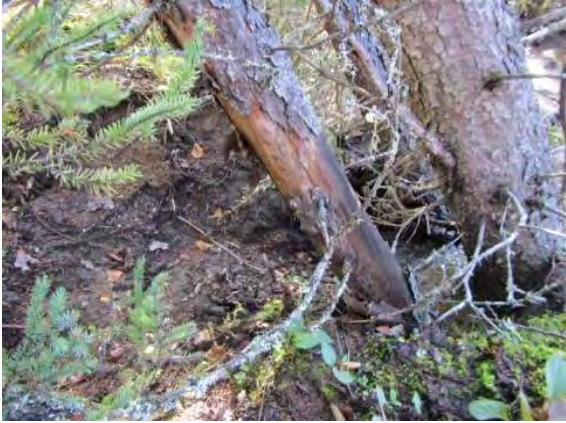
D/S (50m)	X	U/S (50m)	
Coordinates:	603702	Gradient (%):	30	3	-
	7000405	Bankfull Width (m):	1	0.81	-
Site Visit Date:	25/08/15	Bankfull Depth (m):	0.15	0.1	-
Flow Conditions:	Mid	Wetted Widths (m):	0.4	0.36	-
Barrier (Y/N):	Y	Wetted Depth (m):	0.05	0.02	-
		Substrate Bed			
Electrofishing effort:	N	(Dom/SubDom):	F	G/F	-
Gee Trapping:	N	Substrate Bank:	F	F	-
Fish present?:	N	Riparian Vegetation:	WI	WI/AL	-
Site Length:	100m	Meander Pattern:	IM	IM	-
		Cover (%/Dom):	50/OV	50/OV	-
Photo #s	218 u/s	219 x	221 d/s	pH:	7.3
Areas of Erosion:	Y			Temperature:	3.0 (°C)
Locations:	road/burn areas			Specific Conductivity:	142.4 (µs/cm)
				Dissolved Oxygen	12.18 (mg/L)    94.8 (% Sat)
Comments:	Barker Cr trib				
High gradient barrier downstream to fish passage					
Not accessible to fish					
Habitat quality low - muddy, shallow, steep, no pools					
P#222 shows where flow goes underground immediately upstream of road

Flow goes underground (#222)

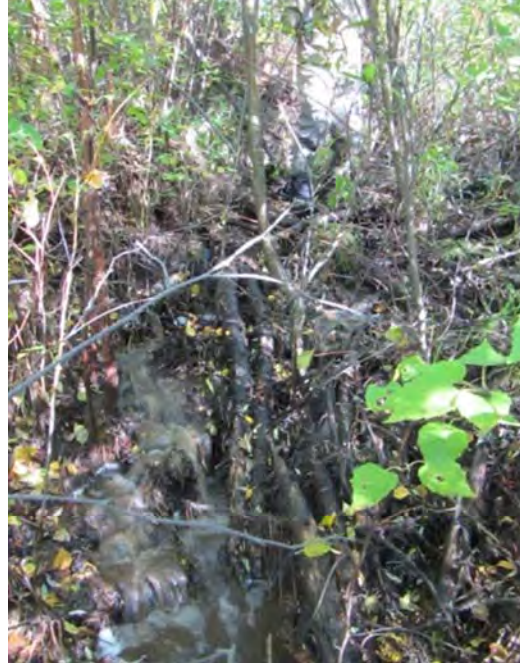
30% gradient drop (#223)

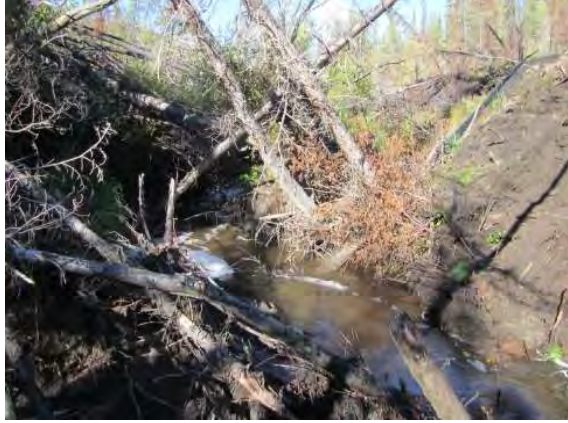
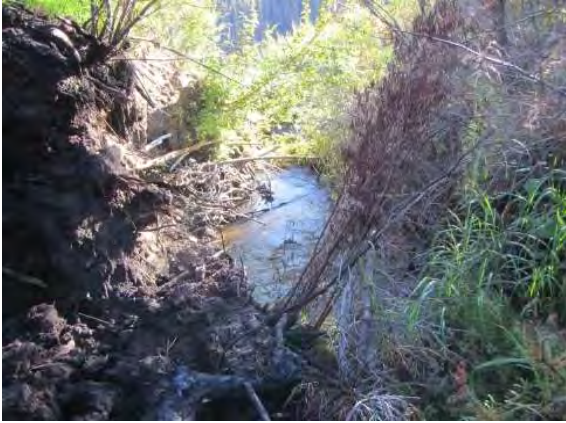
98.2 (% Sat)
Comments:	Barker Cr trib				
	burn area upstream				
	Water moderately turbid				
	Upstream site: trees are falling into creek; lots of woody debris; some small pool habitat available; no deep pools.				
	Some natural obstructions to fish passage at current flow; shallow extended riffles and some vertical drops.				
	Likely fish-bearing

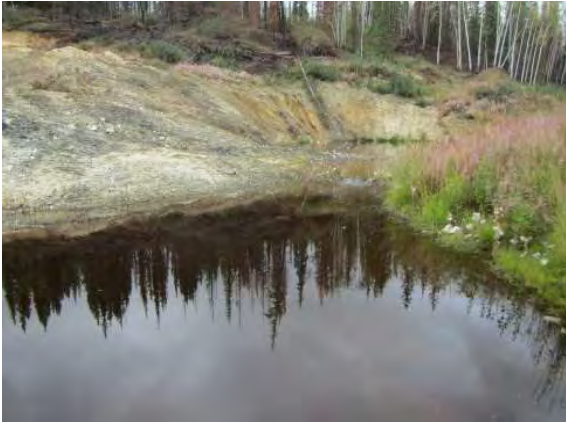
Disturbed overburden piles; little to no riparian vegetation			
	Note: ~ 150 m u/s of pond is high gradient cascade > 50%; Photo #190.			
	Pond at u/s site: P#189 -> shallow, stagnant, fairly shallow (< 1 m).

Pond at upstream site

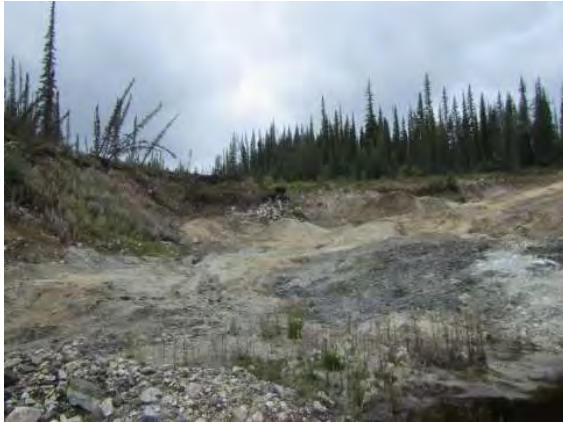
Approximately 150 m upstream of pond

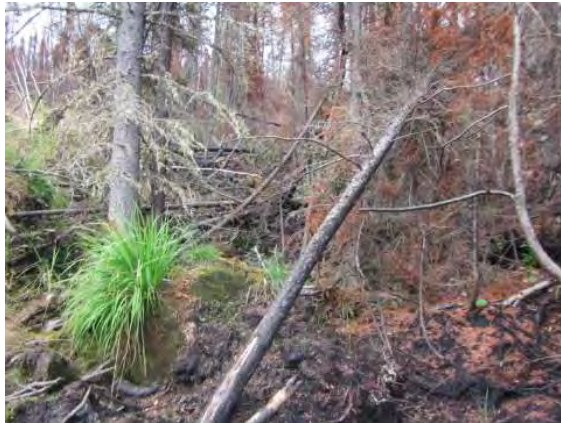
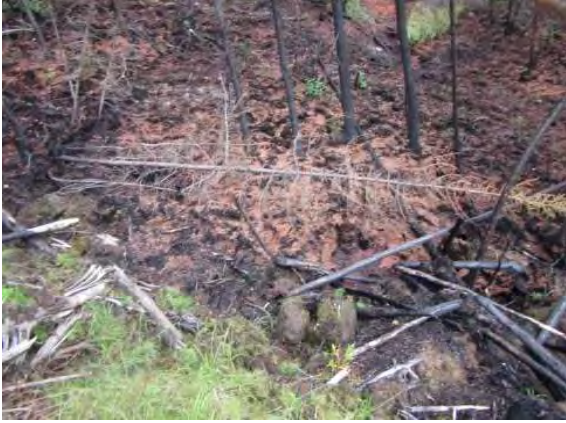
D/S (50m)	X	U/S (50m)
Coordinates:	603541	Gradient (%):	30	-
	6996485	Bankfull Width (m):	-	-
Site Visit Date:	24/08/15	Bankfull Depth (m):	-	-
Flow Conditions:	low-mid	Wetted Widths (m):	-	-
Barrier (Y/N):	Y	Wetted Depth (m):	-	-
		Substrate Bed		
Electrofishing effort:	n/a	(Dom/SubDom):	-	-
Gee Trapping:	n/a	Substrate Bank:	-	-
Fish present?:	N	Riparian Vegetation:	-	-
Site Length:	100m	Meander Pattern:	-	-
		Cover (%/Dom):	-	-
Photo #s	181 u/s	182 x	180 d/s	pH:
Areas of Erosion:	-			Temperature:
Locations:				Specific Conductivity:
				Dissolved Oxygen
Comments:	Barker Creek trib			
Water goes underground >50 m at site and is high gradient (not passable to fish)				
Not fish habitat
