**Fish and Aquatic Resources**

# Coffee Gold Project

## **Fish and Aquatic Resources Baseline Report:**

### **Mine Access Road**

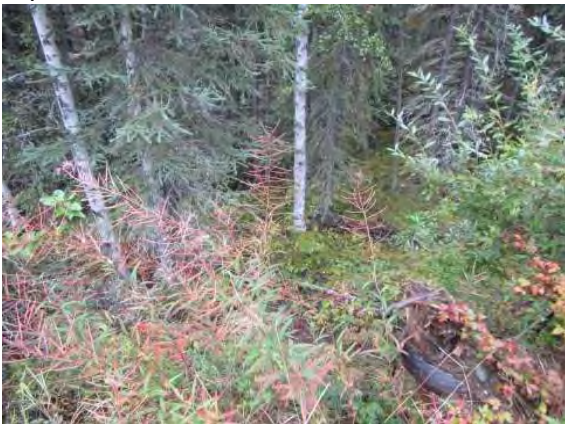
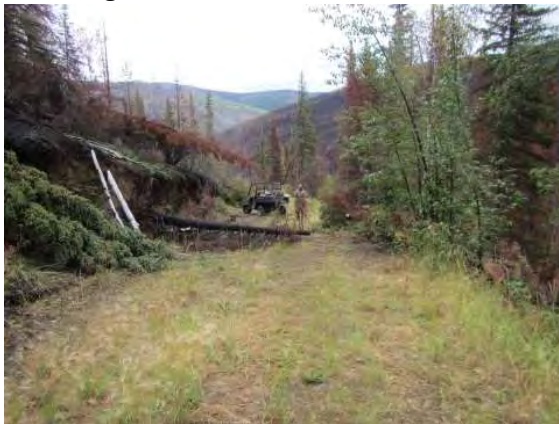
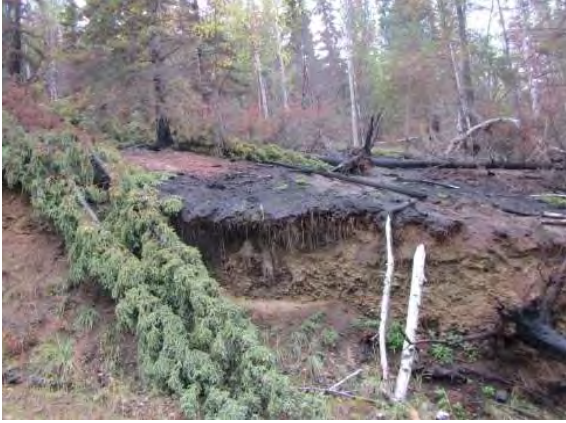
## Coffee Gold Road Northern Route Crossing #116

D/S (50m)	X	U/S (50m)
Coordinates:	603368	Gradient (%):	-	-
	6995151	Bankfull Width (m):	-	-
Site Visit Date:	24/08/15	Bankfull Depth (m):	-	-
Flow Conditions:	none	Wetted Widths (m):	-	-
Barrier (Y/N):	n/a	Wetted Depth (m):	-	-
		Substrate Bed		
Electrofishing effort:	n/a	(Dom/SubDom):	-	-
Gee Trapping:	n/a	Substrate Bank:	-	-
Fish present?:	N	Riparian Vegetation:	-	-
Site Length:	100m	Meander Pattern:	-	-
		Cover (%/Dom):	-	-
Photo #s	173 u/s	174 x	175 d/s	pH:
Areas of Erosion:	-			Temperature:
Locations:				Specific Conductivity:
				Dissolved Oxygen
Comments:	Barker Creek drainage			
No visible channel

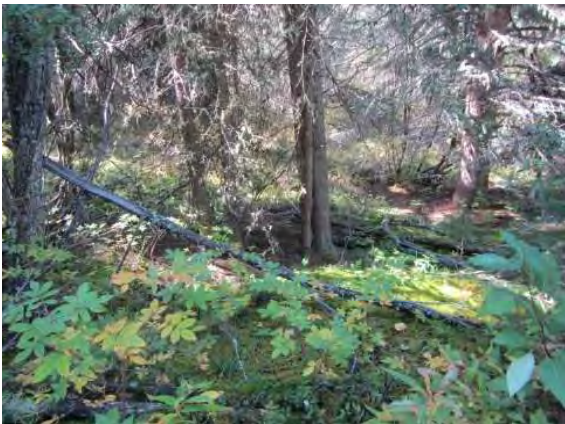
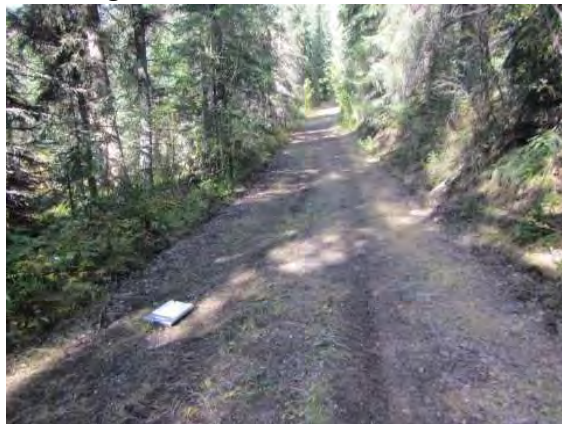
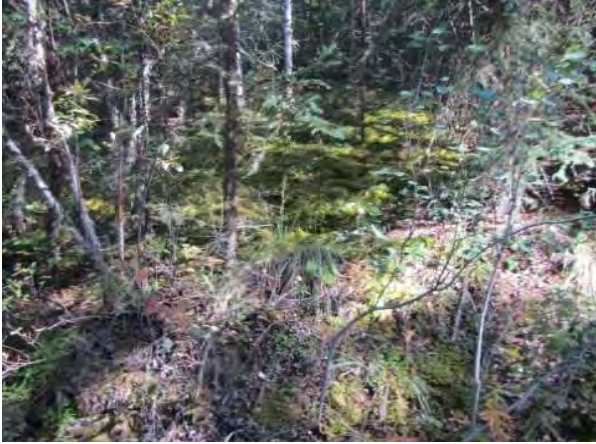
## Coffee Gold Road Northern Route Crossing #117

D/S (50m)	X	U/S (50m)
Coordinates:	603541	Gradient (%):	-	-
	6979534	Bankfull Width (m):	-	-
Site Visit Date:	25-Aug-15	Bankfull Depth (m):	-	-
Flow Conditions:	none	Wetted Widths (m):	-	-
Barrier (Y/N):	n/a	Wetted Depth (m):	-	-
		Substrate Bed		
Electrofishing effort:	n/a	(Dom/SubDom):	-	-
Gee Trapping:	n/a	Substrate Bank:	-	-
Fish present?:	N	Riparian Vegetation:	-	-
Site Length:	100m	Meander Pattern:	-	-
		Cover (%/Dom):	-	-
Photo #s	235 u/s	234 x	233 d/s	pH:
Areas of Erosion:	-			Temperature:
Locations:				Specific Conductivity:
				Dissolved Oxygen
Comments:	Ballarat Cr drainage			
No visible channel

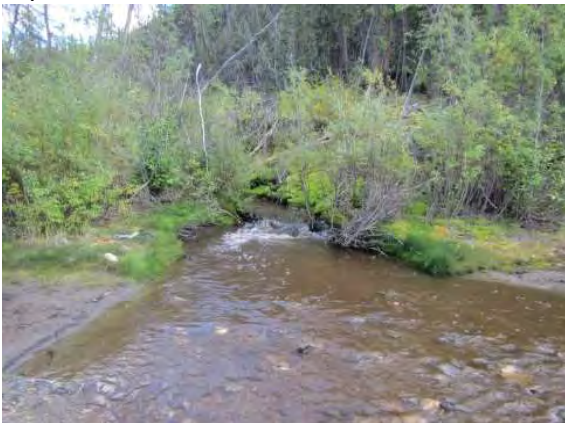
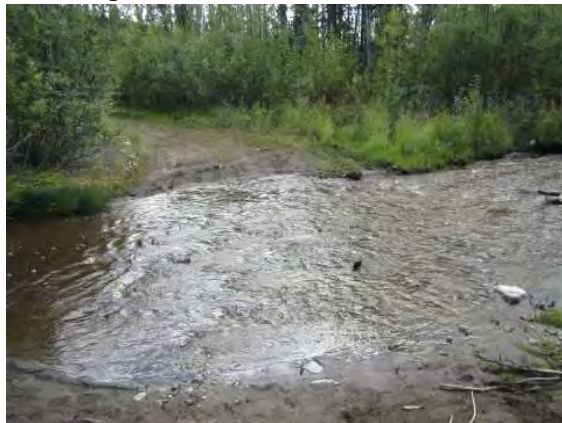
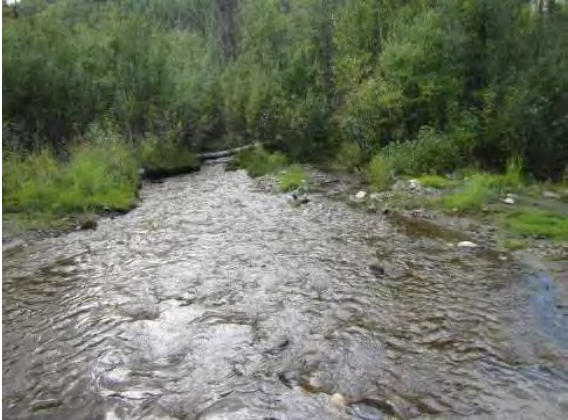
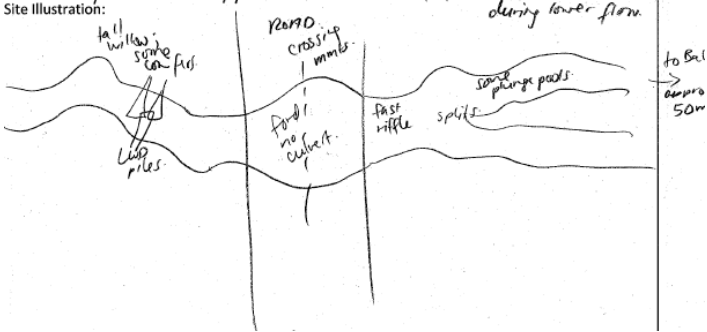
# Coffee Gold Road Northern Route Crossing #118

D/S (50m)	X	U/S (50m)	
Coordinates:	603925	Gradient (%):	16	5	10
	6978337	Bankfull Width (m):	1.8	11	1.45
Site Visit Date:	25/08/15	Bankfull Depth (m):	0.32	0.1	0.43
Flow Conditions:	Mid	Wetted Widths (m):	1.42	6	1.32
Barrier (Y/N):	N	Wetted Depth (m):	0.2	0.07	0.33
		Substrate Bed			
Electrofishing effort:	Y	(Dom/SubDom):	G/F	G/C	F
Gee Trapping:	Y	Substrate Bank:	F	F	F
Fish present?:	see below	Riparian Vegetation:	WI/SP	WI/SP	WI/SP
Site Length:	100m	Meander Pattern:	IM	IM	IM
		Cover (%/Dom):	70/LWD,OV, U	<5%/OV	70/LWD,OV, U
Photo #s	236 u/s	237 x	238 d/s	pH:	7.97
Areas of Erosion:	Y			Temperature:	2.7 (°C)
Locations:	ford			Specific Conductivity:	25.9 (µs/cm) COND = 148
				Dissolved Oxygen	12.95 (mg/L) 99.8 (% Sat)
Comments:	Ballarat Cr - water moderately turbid				
Upstream: heavily incised; some deep run-pool area					
Fast water, little to no pool habitat					
No deep pools					
Close to Ballarat mainstem

Likely fish-bearing

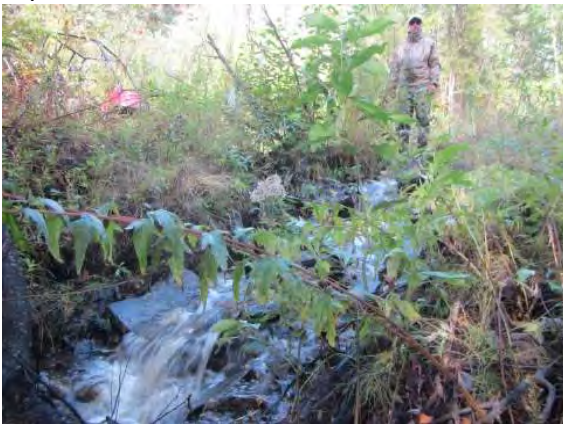
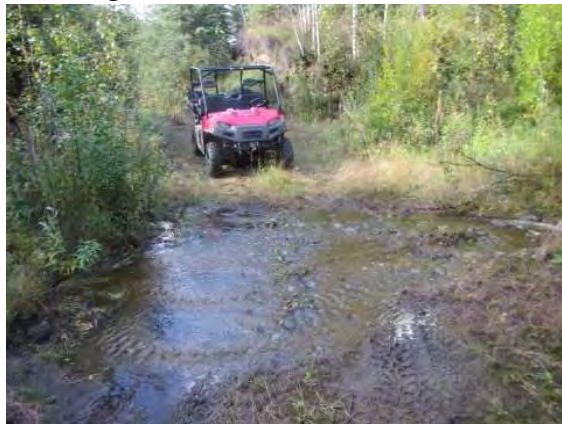
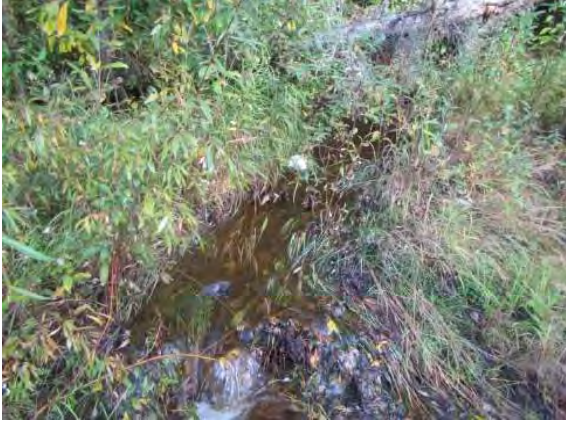
## Coffee Gold Road Northern Route Crossing # 119

D/S (50m)	X	U/S (50m)
Coordinates:	604279.725	Gradient (%):	-	-
	6977495.38	Bankfull Width (m):	-	-
Site Visit Date:	24-Aug-15	Bankfull Depth (m):	-	-
Flow Conditions:	low-mid	Wetted Widths (m):	-	-
Barrier (Y/N):	Y	Wetted Depth (m):	-	-
		Substrate Bed		
Electrofishing effort:	N	(Dom/SubDom):	-	-
Gee Trapping:	N	Substrate Bank:	-	-
Fish present?:	N	Riparian Vegetation:	-	-
Site Length:	100m	Meander Pattern:	-	-
		Cover (%/Dom):	-	-
Photo #s	196 u/s	195 x	194 d/s	pH:
Areas of Erosion:	-			Temperature:
Locations:				Specific Conductivity:
				Dissolved Oxygen
Comments:	Ballarat Creek tributary			
high gradient barrier downstream of road 35%; not passable to fish; not fish habitat

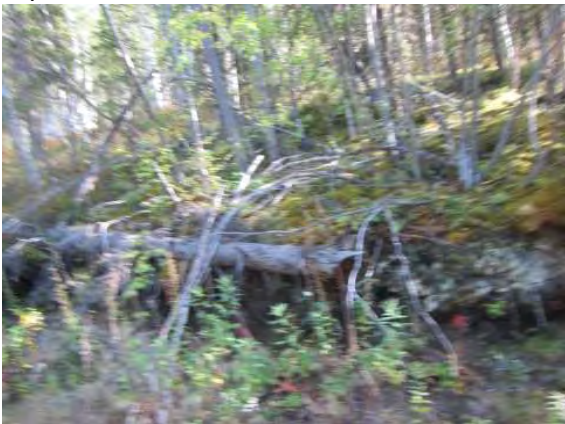
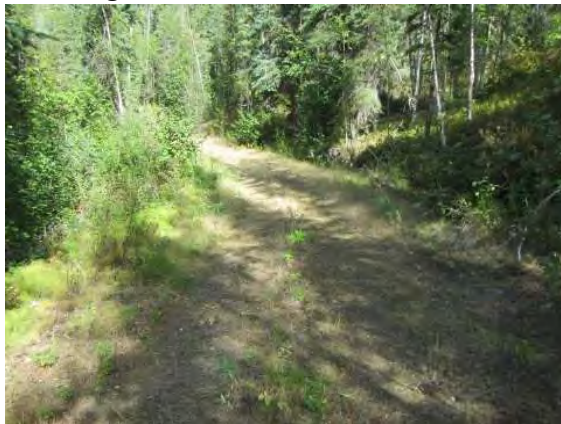
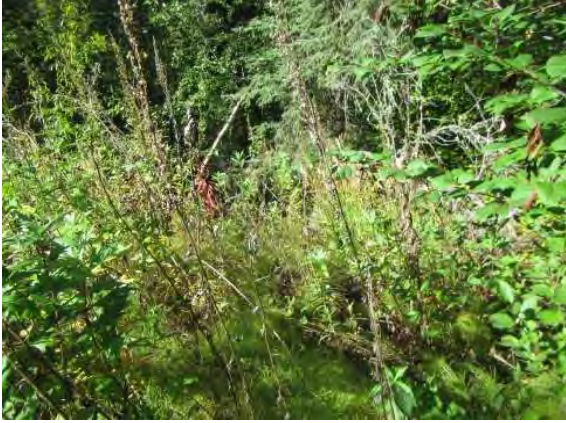
## Coffee Gold Road Northern Route Crossing #120

D/S (50m)	X	U/S (50m)
Coordinates:	604514	Gradient (%):	-	-
	6976425	Bankfull Width (m):	-	-
Site Visit Date:	25/08/15	Bankfull Depth (m):	-	-
Flow Conditions:	none	Wetted Widths (m):	-	-
Barrier (Y/N):	n/a	Wetted Depth (m):	-	-
		Substrate Bed		
Electrofishing effort:	n/a	(Dom/SubDom):	-	-
Gee Trapping:	n/a	Substrate Bank:	-	-
Fish present?:	N	Riparian Vegetation:	-	-
Site Length:	100m	Meander Pattern:	-	-
		Cover (%/Dom):	-	-
Photo #s	239 u/s	240 x	241 d/s	pH:
Areas of Erosion:	-			Temperature:
Locations:				Specific Conductivity:
				Dissolved Oxygen
Comments:	Ballarat Cr drainage			
No visible channel

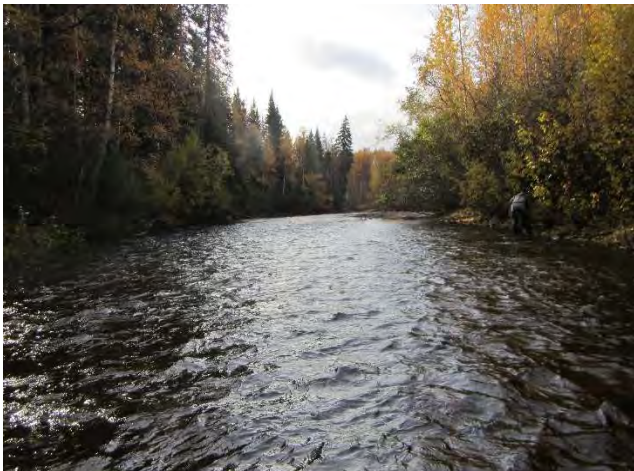
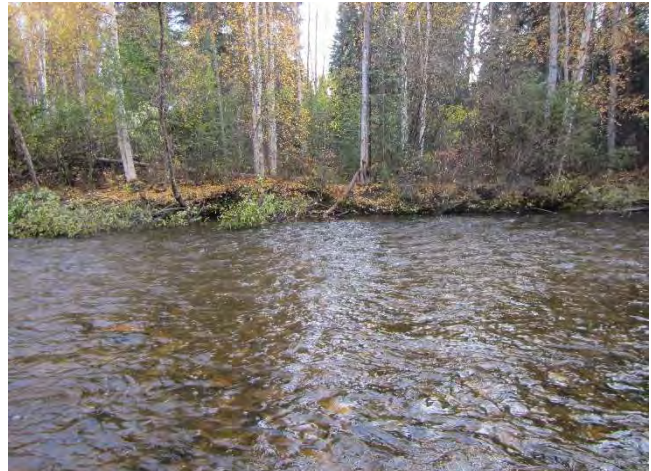
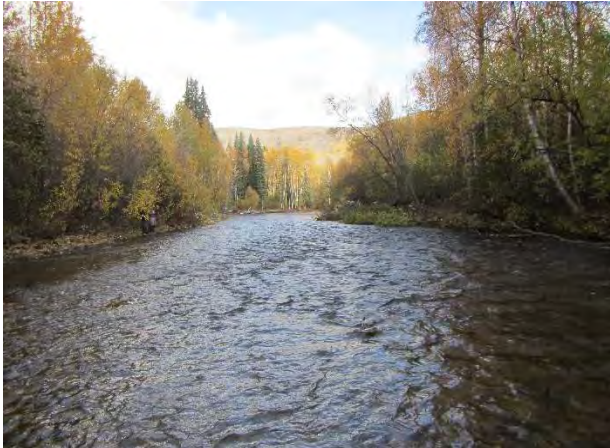
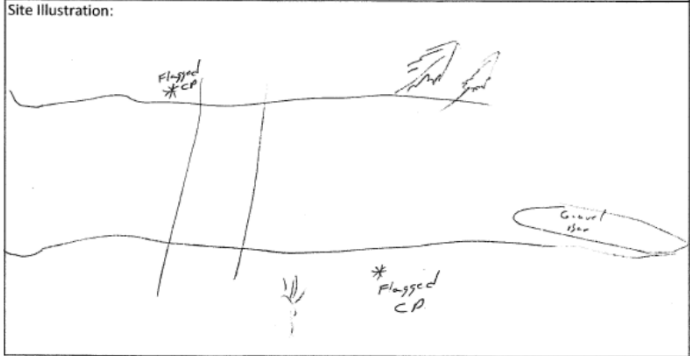
# Coffee Gold Road Northern Route Crossing #125

D/S (50m)	X	U/S (50m)
Coordinates:	598904	Gradient (%):	1	1
	6976194	Bankfull Width (m):	19	19
Site Visit Date:	15/09/15	Bankfull Depth (m):	0.7	0.7
Flow Conditions:	Low	Wetted Widths (m):	18.2	18.2
Barrier (Y/N):	N	Wetted Depth (m):	0.4	0.4
Electrofishing effort:	N	Substrate Bed (Dom/SubDom):	C/G	C/G
Gee Trapping:	N	Substrate Bank:	F	F
Fish present?:	Y	Riparian Vegetation:	MI	MI
Site Length:	100m	Meander Pattern:	RM	RM
		Cover (%/Dom):	5/LWD	5/LWD
Photo #s	209 u/s	208 x	210 d/s	pH: 7.81
Areas of Erosion:				Temperature: 4.2 (°C)
Locations:				Specific Conductivity: 143.0 (µs/cm)
				Dissolved Oxygen: 12.57 (mg/L)
				COND = 86.2
				102.4 (% Sat)
Comments:	Coffee Creek mainstem			
Long straight riffle section				
Moved crossing location 100 m d/s to area flagged by engineers.

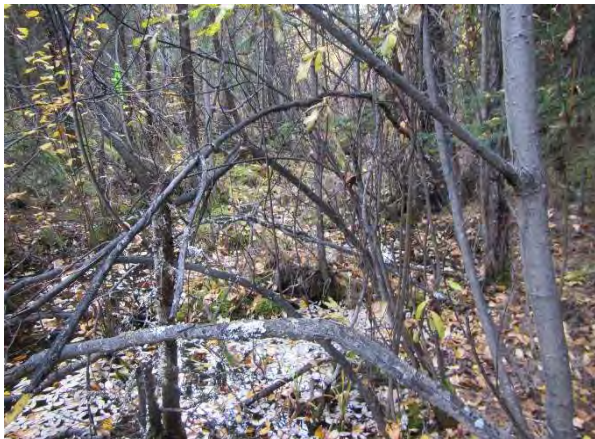
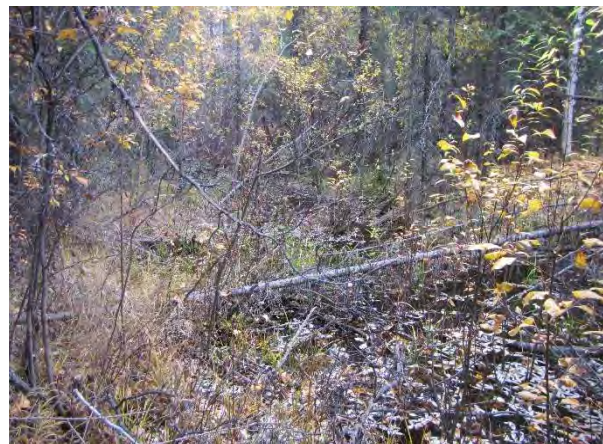
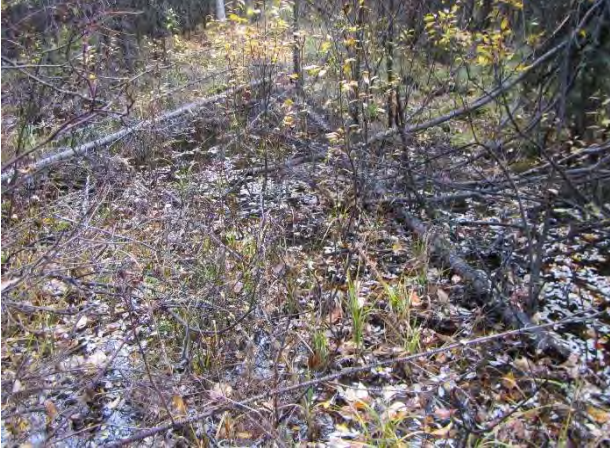
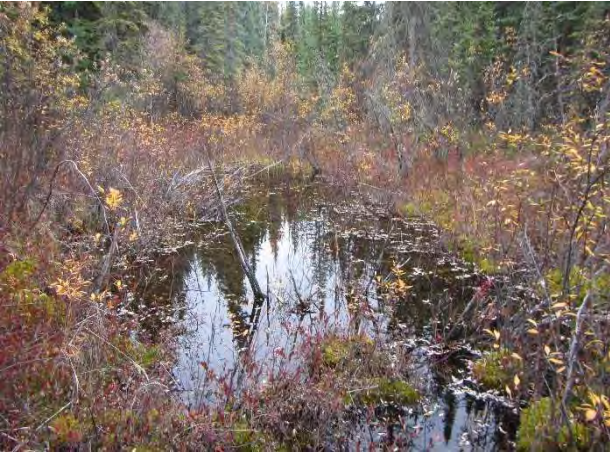
## Coffee Gold Road Northern Route Crossing #126

D/S (50m)	X	U/S (50m)	
Coordinates:	598836	Gradient (%):	-	0	-
	6976567	Bankfull Width (m):	-	-	-
Site Visit Date:	14/09/15	Bankfull Depth (m):	-	-	-
Flow Conditions:	Low	Wetted Widths (m):	-	4	-
Barrier (Y/N):	N	Wetted Depth (m):	-	0.15	-
Electrofishing effort:	N	Substrate Bed (Dom/SubDom):	-	F	-
Gee Trapping:	N	Substrate Bank:	-	F	-
Fish present?:	see below	Riparian Vegetation:	-	MI	-
Site Length:	100m	Meander Pattern:	-	-	-
		Cover (%/Dom):	-	80/OV	-
Photo #s	197 u/s	196 x	198 d/s	pH:	-
Areas of Erosion:	N			Temperature:	-
Locations:				Specific Conductivity:	-
				Dissolved Oxygen	-
Comments:	Yukon River tributary drainage - disconnected oxbow with potential connection at high flow				
Only crossing on new road route to winter road (to be built as permanent road)					
Photos 196-198					
4 m across average, 0.15 m depth					
No flow - may handle some surface run-off, copious debris, wetland grasses.

Drains to pond (photo 199), 07V 0598782 6976559.					
Channel on other end drains to same pond -> no access to Coffee Ck.					
Very unlikely to support fish

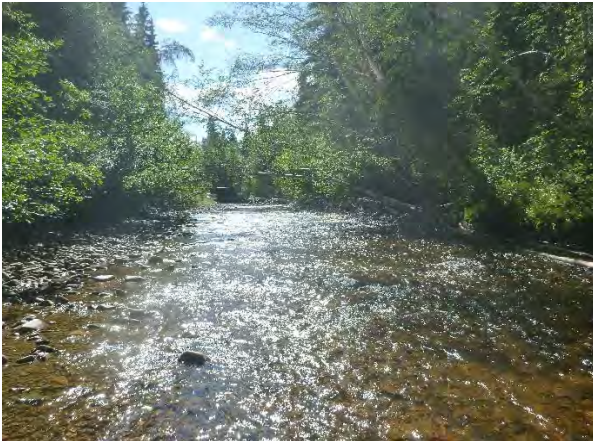
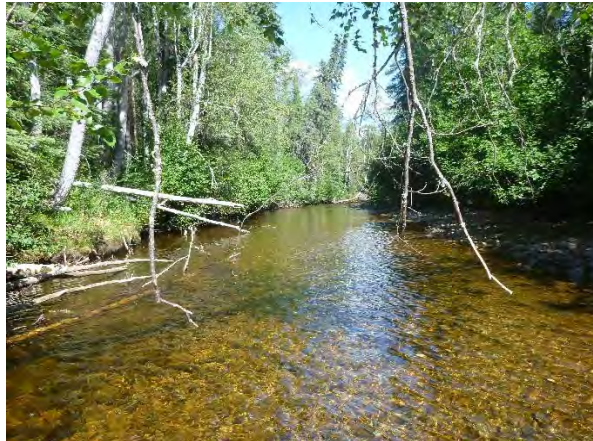
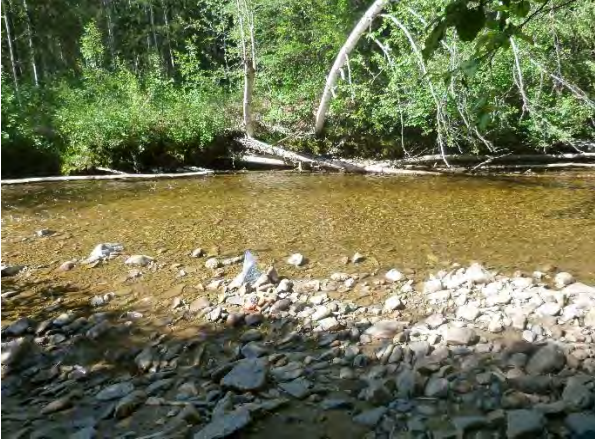
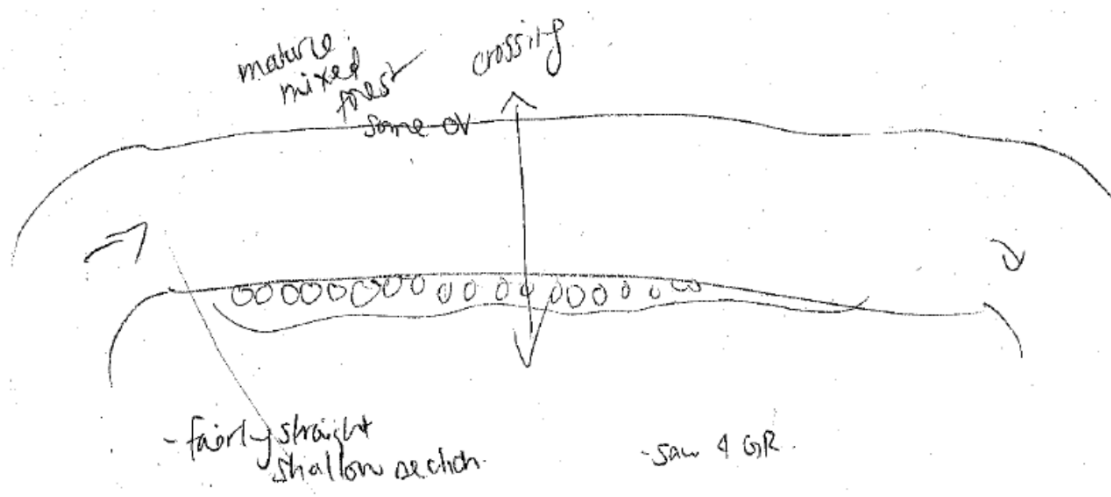
# Coffee - Casino Road Crossing # 1

D/S (50m)	X	U/S (50m)
Coordinates:	598086	Gradient (%):	0.5	0.5
	6975054	Bankfull Width (m):	14.8	17.9
Site Visit Date:	19/06/15	Bankfull Depth (m):	1	1
Flow Conditions:	Low	Wetted Widths (m):	11	9.7
Barrier (Y/N):	N	Wetted Depth (m):	0.25	0.33
Electrofishing effort:	N	Substrate Bed (Dom/SubDom):	C/G	C/G
Gee Trapping:	N	Substrate Bank:	F	F
Fish present?:	Y	Riparian Vegetation:	Mature mixed forest, some alder	
Site Length:	100m	Meander Pattern:	SI	IM
		Cover (%/Dom):	10/OV	10/OV
Photo #s	19 u/s	20 x	18 d/s	pH: 7.32
Areas of Erosion:	Y		Temperature:	10.2 (°C)
Locations:	some at left bank at crossing, undercut bank		Specific Conductivity:	233 (µs/cm) COND = 167
			Dissolved Oxygen	10.1 (mg/L) 94.9 (% Sat)
Comments:	Mainstem Coffee Creek			
	Area of proposed crossing is fairly straight, shallow section			
	Observed four adult Arctic grayling

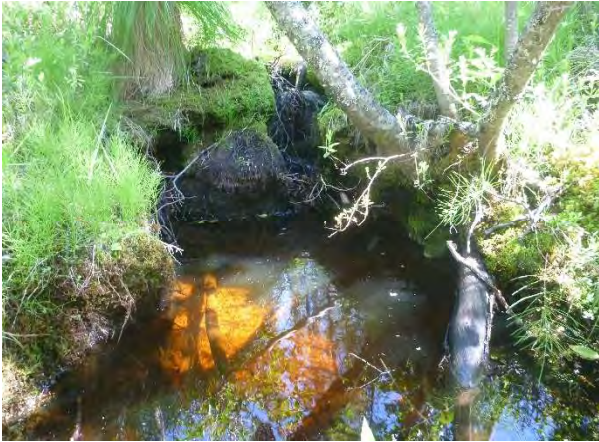
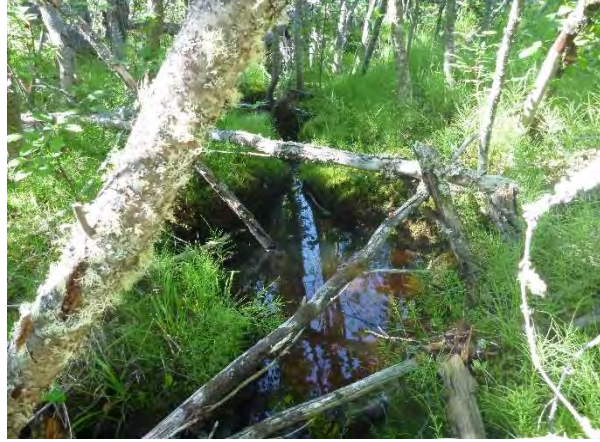
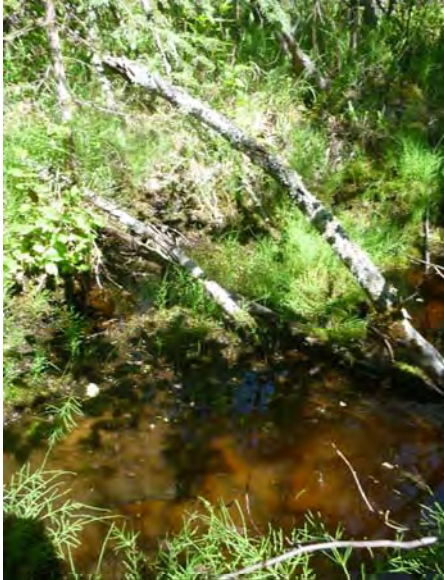
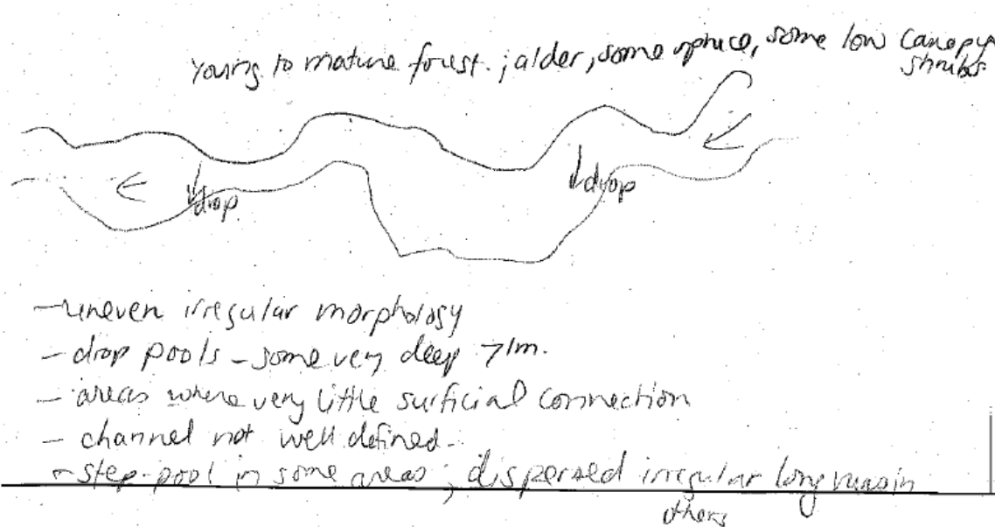
## Coffee - Casino Road Crossing # 2

D/S (50m)	X	U/S (50m)	
Coordinates:	597985	Gradient (%):	0-5	5	3
	6974486	Bankfull Width (m):	2.2	2.7	0.7
Site Visit Date:	19/06/15	Bankfull Depth (m):	0.4	0.85	0.7
Flow Conditions:	Low	Wetted Widths (m):	1.6	0.8	0.4
Barrier (Y/N):	Y	Wetted Depth (m):	0.25	0.51	0.54
Electrofishing effort:	Y	Substrate Bed (Dom/SubDom):	F/C	F/C	F/C
Gee Trapping:	N	Substrate Bank:	F	F	F
Fish present?:	N	Riparian Vegetation:	AL	AL	AL
Site Length:	100m	Meander Pattern:	IM	IM	IM
		Cover (%/Dom):	50/SWD	50/SWD	50/SWD
Photo #s	007 u/s	009 x	010 d/s	pH:	7.05
Areas of Erosion:	Y			Temperature:	6.6 (°C)
Locations:	minor undercut banks			Specific Conductivity:	162 (µs/cm)
				Dissolved Oxygen	11.4 (mg/L) 96.5 (% Sat)
Comments:	Coffee Creek tributary				
Photos 103-004, and 103-005 looking downstream and upstream respectively approximately 50m upstream of crossing and showing disconnect in creek flows (0598010 6974431).					
uneven irregular morphology

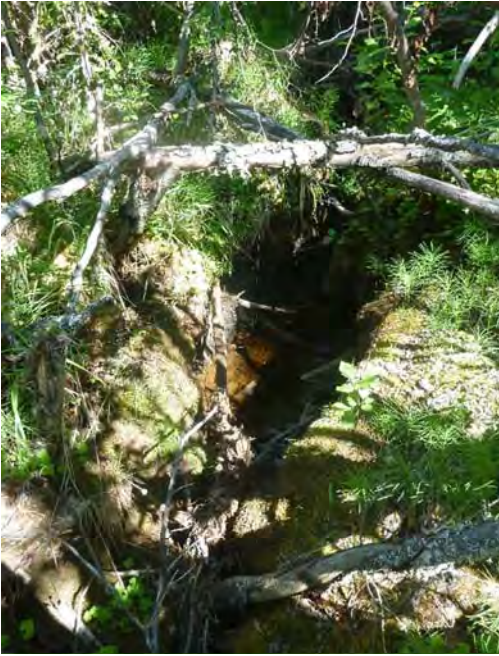
Area of subterranean flow

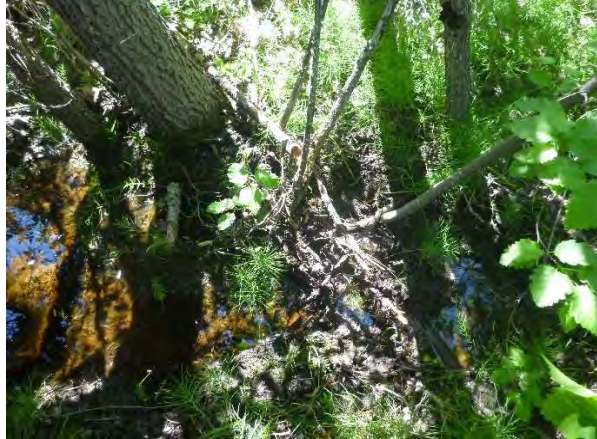
Downstream of subterranean flow (small trickle)

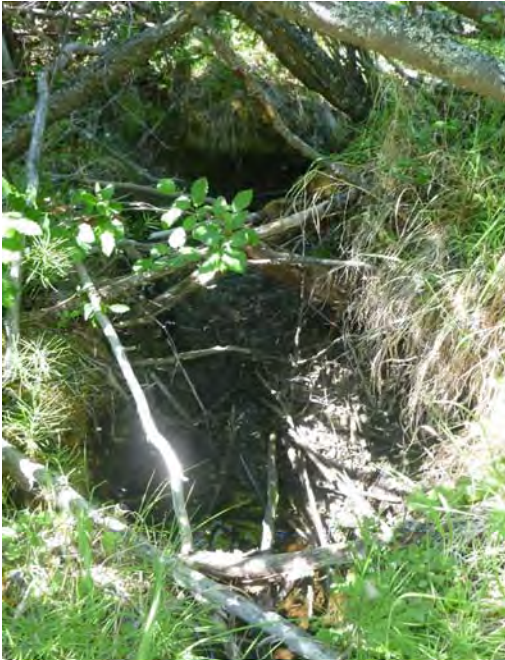
Dry creek channel

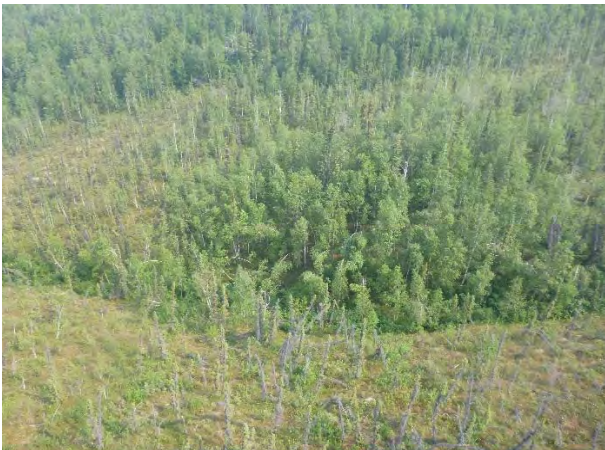
### Coffee - Casino Road Crossing # 3

D/S (50m)	X	U/S (50m)
Coordinates:	596893	Gradient (%):	-	-
	6972743	Bankfull Width (m):	-	-
Site Visit Date:	20/06/15	Bankfull Depth (m):	-	-
Flow Conditions:	-	Wetted Widths (m):	-	-
Barrier (Y/N):	Y (likely)	Wetted Depth (m):	-	-
		Substrate Bed		
Electrofishing effort:	-	(Dom/SubDom):	-	-
Gee Trapping:	-	Substrate Bank:	-	-
Fish present?:	See below	Riparian Vegetation:	-	-
Site Length:	-	Meander Pattern:	-	-
		Cover (%/Dom):	-	-
Photo #s	See below		pH:	-
Areas of Erosion:	-		Temperature:	-
Locations:			Specific Conductivity:	-
			Dissolved Oxygen	-
Comments:				
Coffee Creek tributary				
No good landing area; flew the creek from crossing location down towards Coffee Creek				
Photo #s 100-0025 to 100-0027				
Channel meanders; noted several dispersed channels and then flow seems to dissipate completely at 07V 0596730 6973183				
Could not locate outlet to Coffee Creek; the trib is likely non-fish bearing

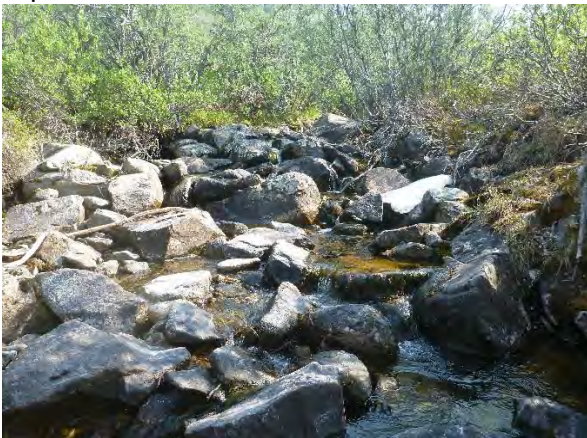
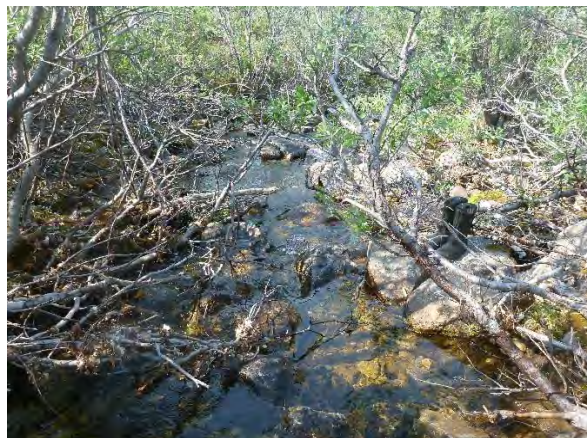
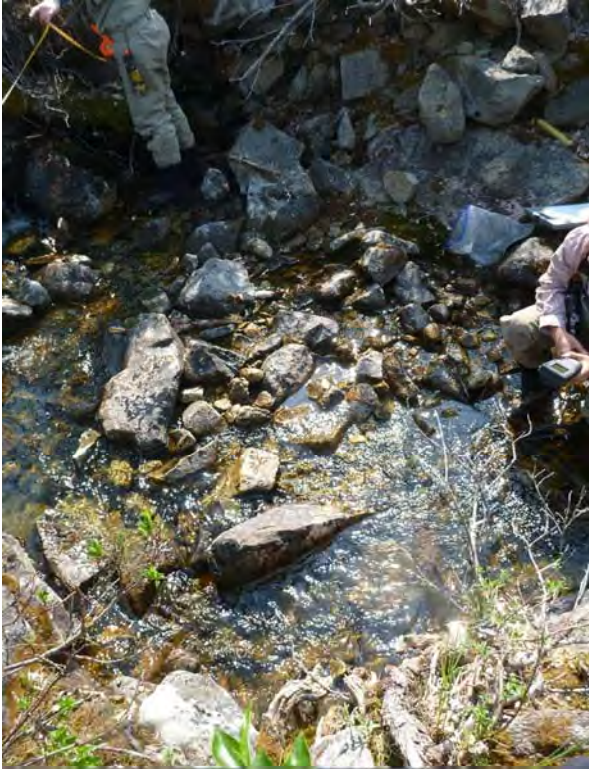
Coffee - Casino Road Crossing # 5

D/S (50m)	X	U/S (50m)	
Coordinates:	603927	Gradient (%):	14	18	13
	6959320	Bankfull Width (m):	4.5	3.9	5.8
Site Visit Date:	20/06/15	Bankfull Depth (m):	0.7	0.85	0.6
Flow Conditions:	Low	Wetted Widths (m):	4.1	3.5	4.9
Barrier (Y/N):	N	Wetted Depth (m):	0.26	0.2	0.14
Electrofishing effort:	-	Substrate Bed (Dom/SubDom):	B/C	B/C	B/C
Gee Trapping:	-	Substrate Bank:	B/F	B/F	B/F
Fish present?:	See below	Riparian Vegetation:	WI	WI	WI
Site Length:	100m	Meander Pattern:	SI	SI	SI
		Cover (%/Dom):	>20/B and OV	20/B	>20/B
Photo #s	103-0021 u/s	23, 24 x	22 d/s	pH:	7.59
Areas of Erosion:	N			Temperature:	4.2 (°C)
Locations:				Specific Conductivity:	86.5 (µs/cm)
				Dissolved Oxygen	12.47 (mg/L) 109.3 (% Sat)
Comments:	Upper Coffee Creek tributary				
	medium to high gradient cascade upstream				
	lower gradient downstream				
	step-pool morphology; large substrate				
	some ice still present; water quite low				
	Unlikely fish presence based on the quality of habitat (lack of deep pools for adult Arctic grayling feeding and resting, steepness of the channel) and long distance to good quality habitat downstream

No spawning or overwintering habitat present for Arctic grayling				
	However; no barriers to passage noted so it is potentially fish bearing
