Allnorth Information		VICTORIA GOLD CORP.	
Project #:	2002684	Client Project #:	
Document #:	201215	Client Document #:	
Document Rev. #:	1	Client Doc. Rev.#:	
Prepared By:	Spencer Bergin, EIT	Client Contact:	Richard Tuohey
Reviewed By:	Don Williams, P.Eng.

Document Description
Annual Physical Stability Assessment Report – Victoria Gold – Eagle Gold Project
<p>Project Description:</p> <p>Visual inspection of the following structures: Open Pit, Platinum Gulch Dump, Lower Dublin South (Control) Pond, Secondary Crusher, Primary Crusher, Secondary Stockpile, Adsorption, Desorption and Recovery Plant, Heap Leach Facility, Events Pond, Ditches A, B, and C, Former Nuway Crusher Pad, Orica Laydown, Various Un-named Stockpiles.</p>

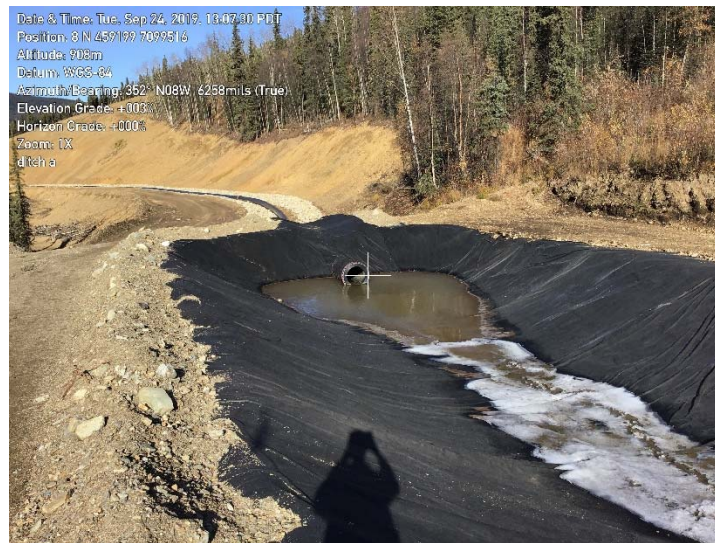
Figure 53: Flow into collection sump (2019)

1. Ditch A carries flow from the Platinum Gulch Dump down to the Control Pond. The ditch formerly (2019) collected flow in a collection sump (Figure 53) which was then transferred in gravity drain HDPE piping down to the LDSP. The sump and all piping (other than sections acting as temporary culverts at road crossings) has since been removed and the ditch is being reconstructed with liner and armoring as seen in Figure 54 and 55.

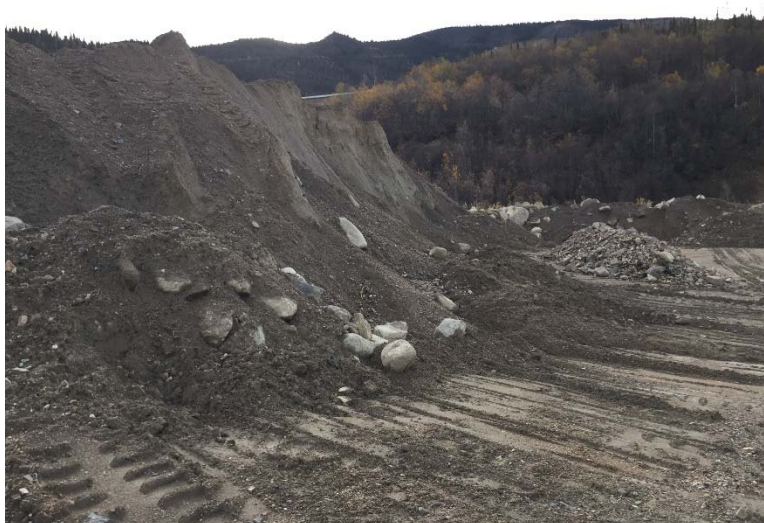
Figure 69: Some stockpiles with steep side slopes

1. Several un-named overburden stockpiles have been placed to the south of the HLF and Event Pond (Figure 69). Some of the stockpiles have over-steepened sides, but there is little risk to other infrastructure. The area is currently mostly un-used.
