Allnorth Information		VICTORIA GOLD CORP.	
Project #:	2102059	Client Project #:	
Document #:	211208	Client Document #:	
Document Rev. #:	0	Client Doc. Rev.#:	
Prepared By:	Spencer Bergin, EIT	Client Contact:	Richard Tuohey
Reviewed By:	Don Williams, P.Eng.

Annual Physical Stability Assessment Report – Victoria Gold – Eagle Gold Project

Visual inspection of the following structures: Open Pit, Platinum Gulch Dump, Eagle Pup Dump, Lower Dublin South (Control) Pond, Primary Crusher, Secondary & Tertiary Crushers, Secondary Stockpile, Adsorption, Desorption and Recovery (ADR) Plant, Heap Leach Facility, Heap Leach Overburden Stockpile, Event Pond, Ditches A, B, and C, Truck Shop, Orica Laydown, Various Un-named Stockpiles.

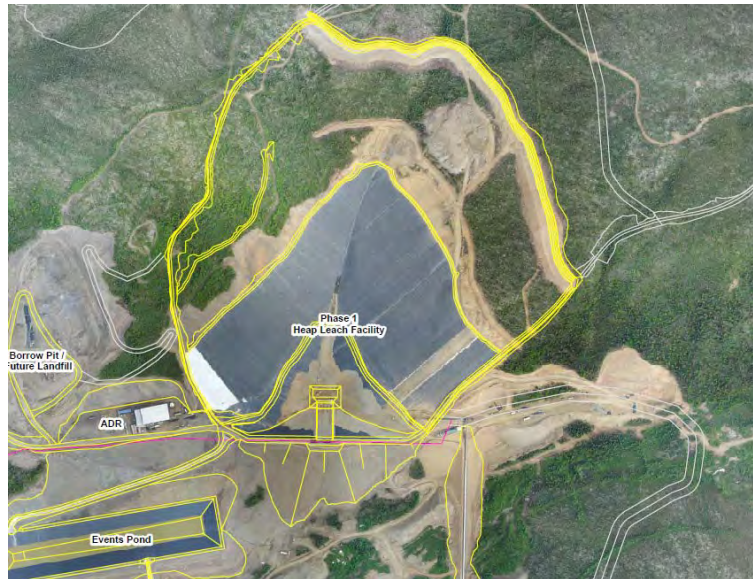
**Figure 19: Heap Leach Facility Overview 2019**

1. The Heap Leach Facility (HLF) is currently operational. In 2019 the Phase 1A expansion had been constructed as shown in Figure 19. By the time of the 2020 inspection the Phase 1B

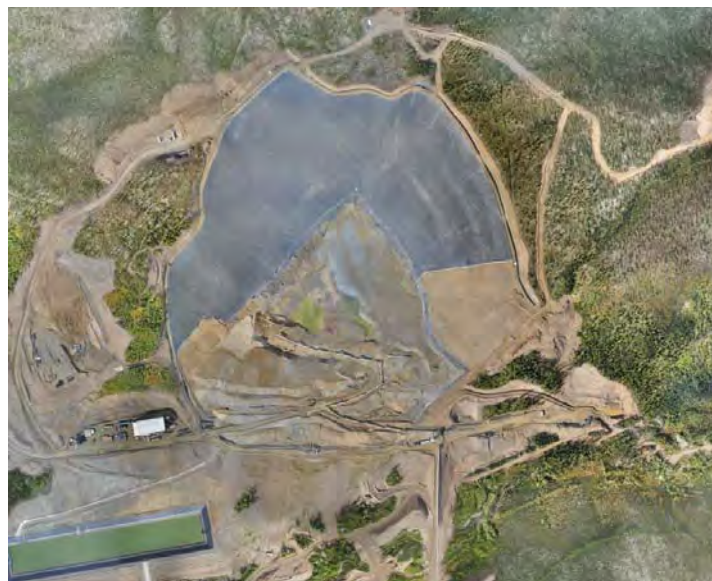
**Figure 20: Heap Leach Facility Overview 2020**

expansion was largely complete as shown in Figure 20. During the 2021 inspection land was being cleared and graded for the Phase 2 expansion as shown in Figure 21.

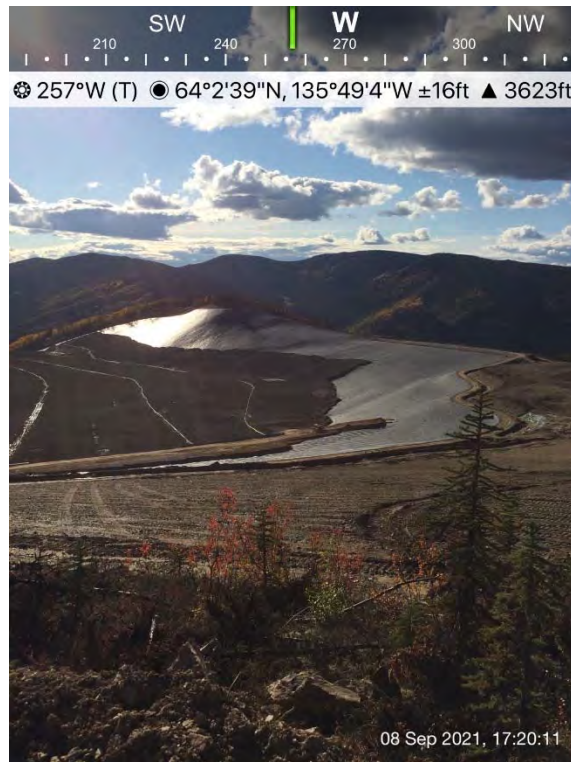
1. The Phase 2 of the HLF was mostly cleared at the time of inspection with grading nearly finished as well (Figure 26, Figure 27). No issues noted for the cleared area.

**Figure 26: Phase 2 graded area (in foreground)**

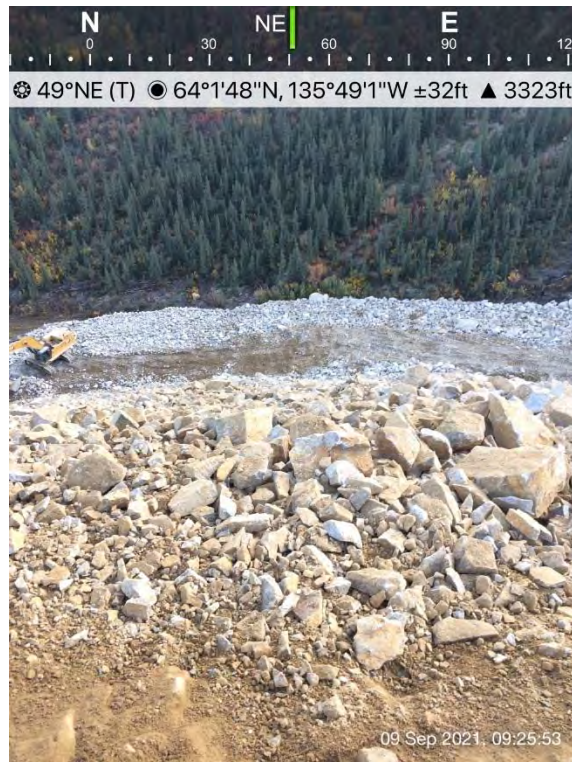
**Figure 34: Eagle Pup Dump drain rock**

1. The Eagle Pup Dump was under construction during the 2021 inspection, with drain rock being placed at the base of the slope as shown in Figure 34. No issues noted.

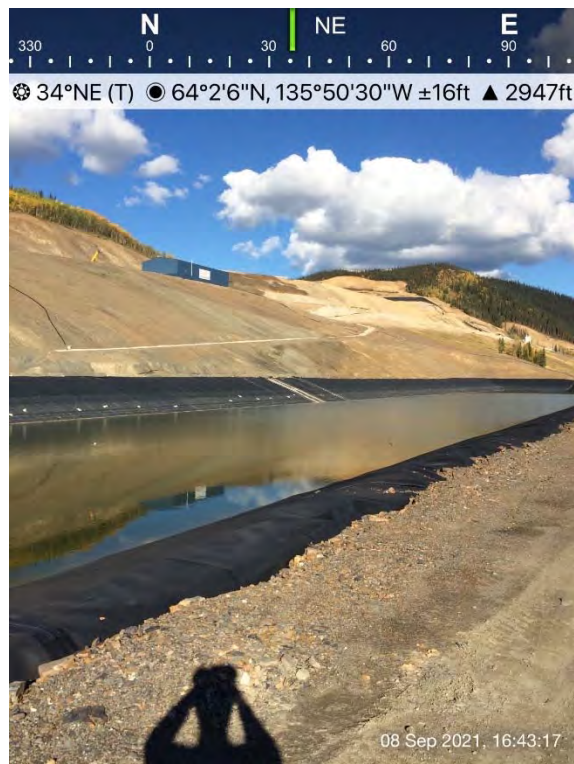
**Figure 46: Overall view of event pond**

1. The event pond was constructed between the 2018 and 2019 inspections, with hillslope unraveling noted in the 2019 inspection.
