Allnorth Information		VICTORIA GOLD CORP.	
Project #:	2202179	Client Project #:	
Document #:	221207	Client Document #:	
Document Rev. #:	1	Client Doc. Rev.#:	
Prepared By:	Spencer Bergin, EIT	Client Contact:	Reanna Roberts
Reviewed By:	Don Williams, P.Eng.

Annual Physical Stability Assessment Report – Victoria Gold – Eagle Gold Project

Visual inspection of the following structures: Open Pit, Platinum Gulch Dump, Eagle Pup Dump, Lower Dublin South (Control) Pond, Primary Crusher, Secondary & Tertiary Crushers, Secondary Stockpile, Adsorption, Desorption and Recovery (ADR) Plant, Heap Leach Facility, Heap Leach Overburden Stockpile, Event Pond, Emergency Pond, Ditches A, B, and C, Heavy Duty Truck Shop, Warehouse Pad, Water Treatment Plant, Orica Laydown, Various Un-named Stockpiles.

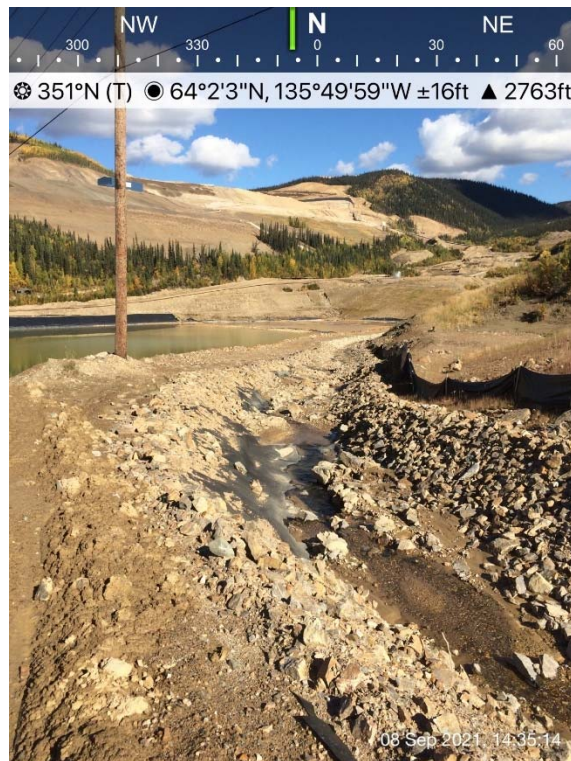
**Figure 3: LDSP – Erosion rectified on the Southwest slope 2021**

1. Some saturated material and erosion was noted on the slope of the southwest corner of the Control Pond over the width of the narrow access road in 2019 and 2020 (Figure 2,) but this erosion was rectified with the completion of Ditch A between the 2020 and 2021 inspections (Figure 3). The area is showing signs of cracking as of the 2022 inspection (Figure 4).

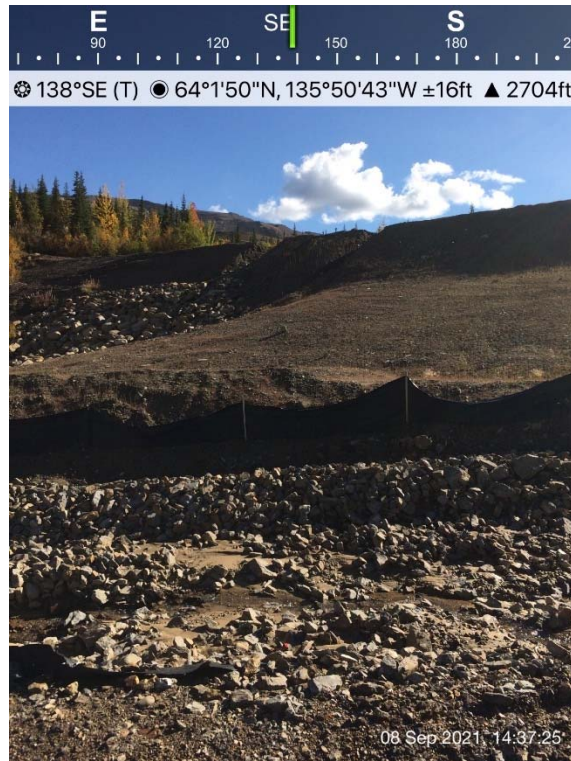
**Figure 7: LDSP – Some flow from adjacent culvert 2021**

2. There was some flow into Ditch A on the Southwest corner of the LDSP from a culvert crossing a former construction access road, which was observed in 2019, 2020 and 2021 (Figure 5, Figure 6, Figure 7) and still present as of this inspection (Figure 8). Liner was installed under the culvert outlet at the time of this inspection to alleviate erosion (Figure 8).

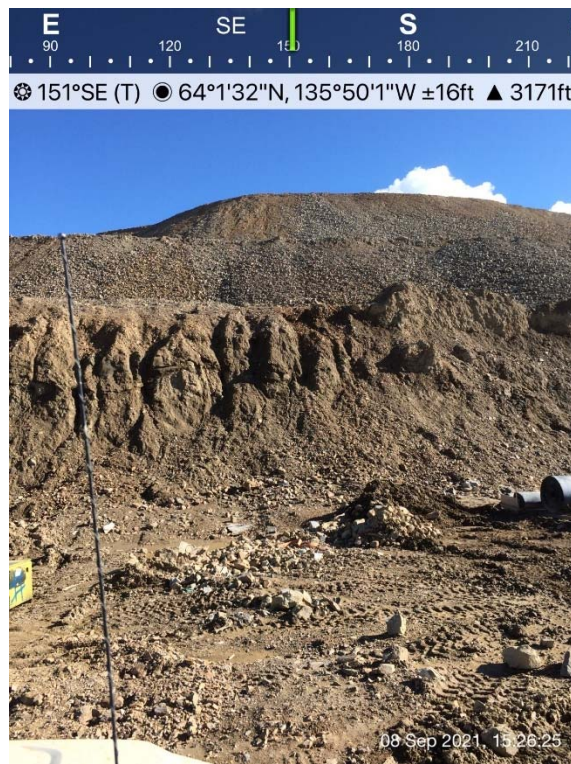
**Figure 10: Secondary Stockpile Cut Slopes 2021**

1. The Secondary Stockpile (also known as the 90 Day Stockpile) was completed in 2020 (Figure 9). Some over-steepened cut slopes were observed during the 2021 inspection where the slopes had begun to collapse/erode and material was collecting at the base of the slope (Figure 10). This was also the case during this years inspection (Figure 11).

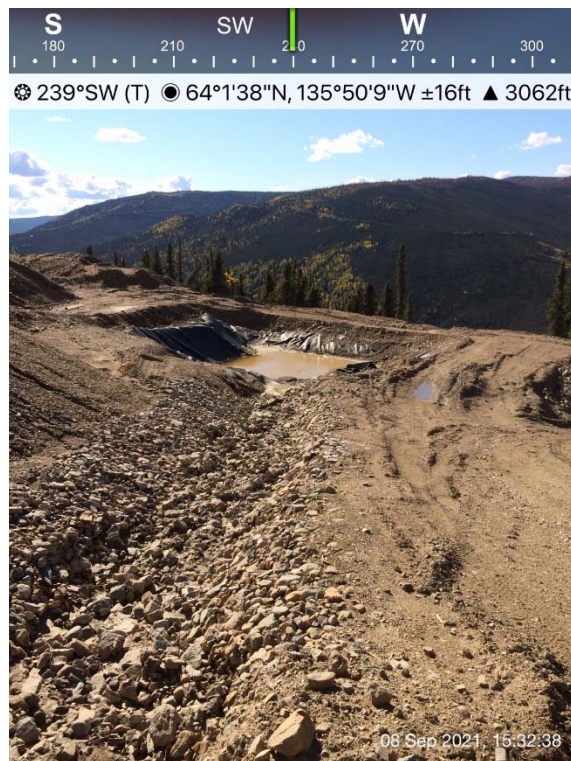
**Figure 13: Perimeter Ditching 2021**

1. A perimeter interception ditch extends around the downhill toe of the Secondary Stockpile area. The construction of this ditch was not complete in 2020 but has since had rock armoring installed (Figure 12, Figure 13). Issues noted in the 2020 inspection including over-steepened and sloughing slopes on the interception ditch appear to have since been addressed. The ditch appears in good condition as of this years inspection (Figure 14).

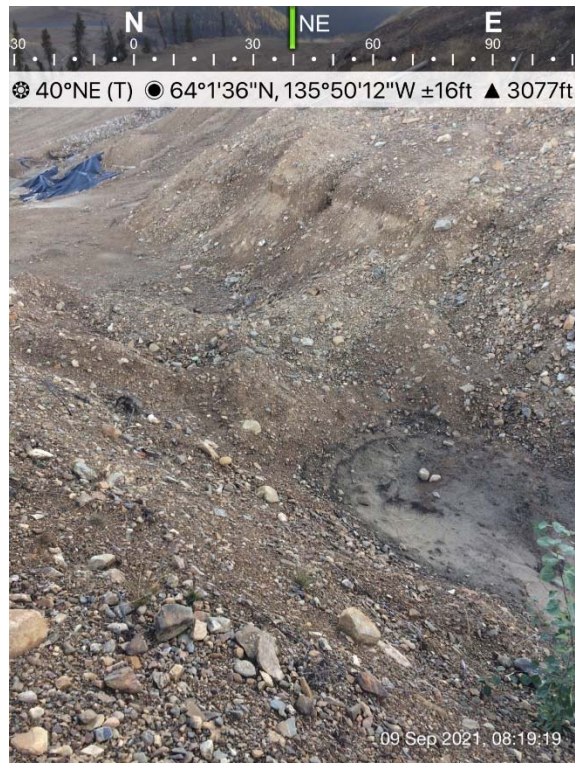
**Figure 16: Unconnected Ditch Section 2021**

2. The outlet of one side of the perimeter ditch does not currently tie into the collection sump, this was observed in 2020 as well. (Figure 15, Figure 16, Figure 17).

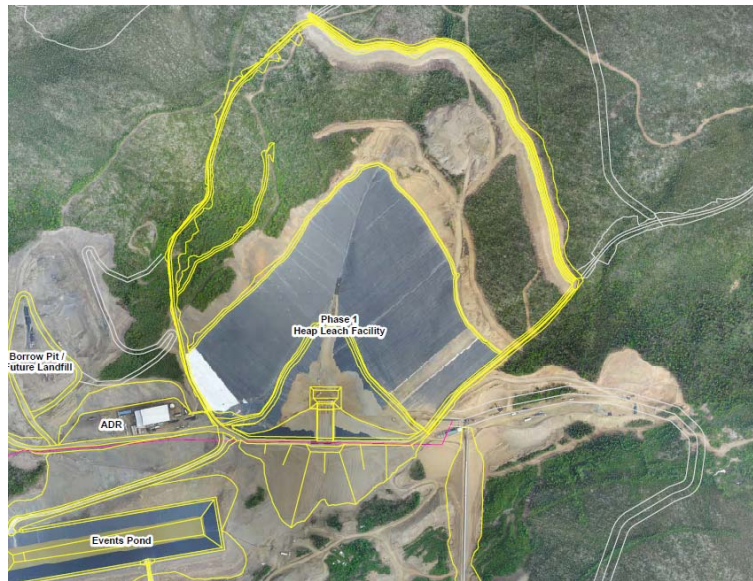
**Figure 18: Heap Leach Facility Overview 2019**

1. The Heap Leach Facility (HLF) is currently operational. In 2019 the Phase 1A expansion had been constructed as shown in Figure 18. By the time of the 2020 inspection the Phase 1B expansion was largely complete as shown in Figure 19. During the 2021 inspection land was being cleared and graded for the Phase 2 expansion as shown in Figure 20, and for the 2022 inspection liner was installed on part of the cleared area (Figure 21).

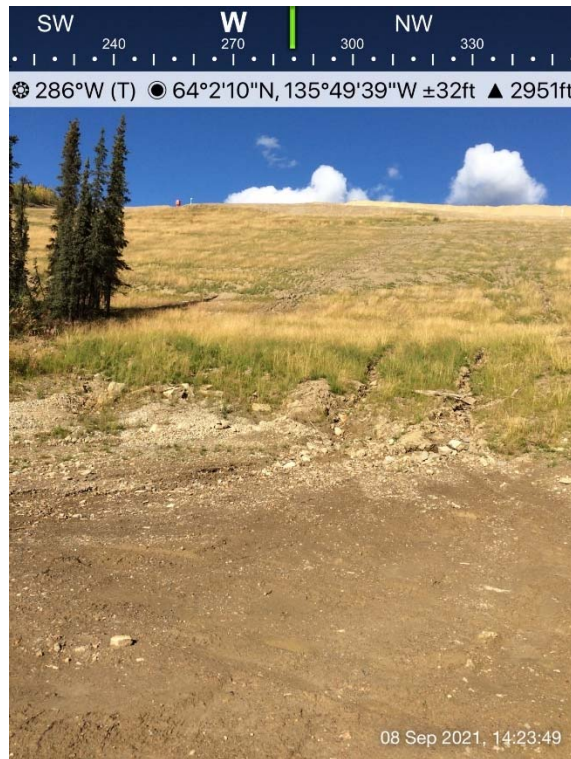
**Figure 23: Seeded grass on toe slope of HLF (2021)**

1. Some scouring and rilling was noted along the toe slope below the HLF and above the unnamed stockpile area and HLF Underdrain Monitoring Vault in the 2020 inspection (Figure 22). The slope has since been seeded and there appears to be less scouring of material off the toe slope as inspected in 2021 (Figure 23) and 2022 (Figure 24).

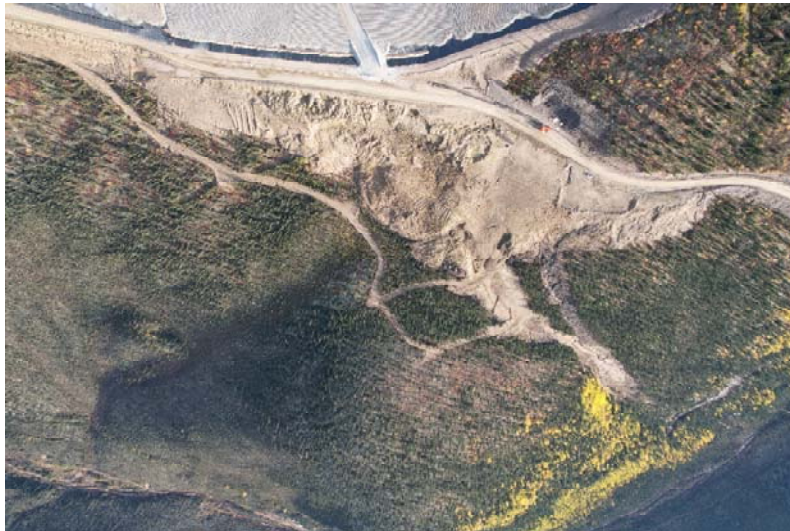
**Figure 28: HLF Overburden Stockpile collapse – plan view 2022**

1. Overburden from clearing and grading of the HLF expansions has been placed along the North-West back slope of the HLF. Site representatives stated that the HLF overburden pile had shifted and partially collapsed some time in the late summer of 2021, roughly 4 – 5 weeks prior to the 2021 inspection (Figure 27). Since the 2021 inspection the collapsed area has been re-sloped (Figure 28). Some minor cracking was noted on the re-sloped surface (Figure 29). The area had also been seeded with grass by helicopter and the grass was starting to sprout at the time of this inspection.

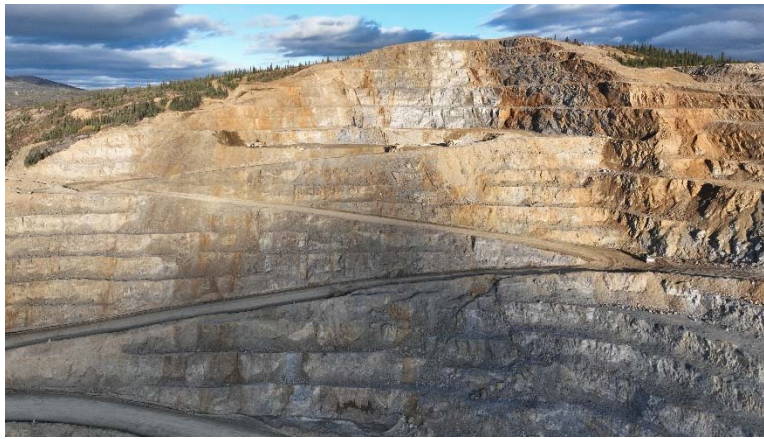
**Figure 32: Open Pit Walls**

1. The pit walls appear stable, and largely constructed in competent rock (Figure 32). There are some areas with erosion visible from an aerial drone (Figure 33).

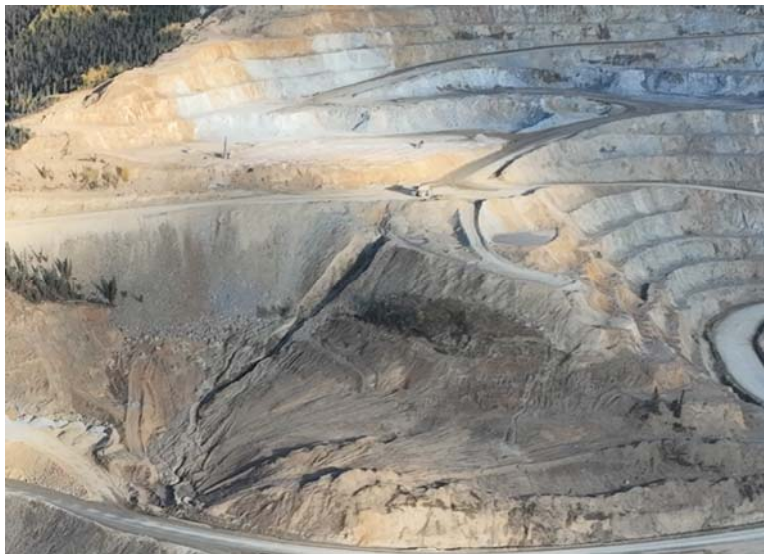
**Figure 35: Open Pit Erosion – Aerial View**

3. There is a section between the open pit and the eagle pup dump where run-off has eroded a cut into the slope above the primary crusher access road (Figure 35, Figure 36).

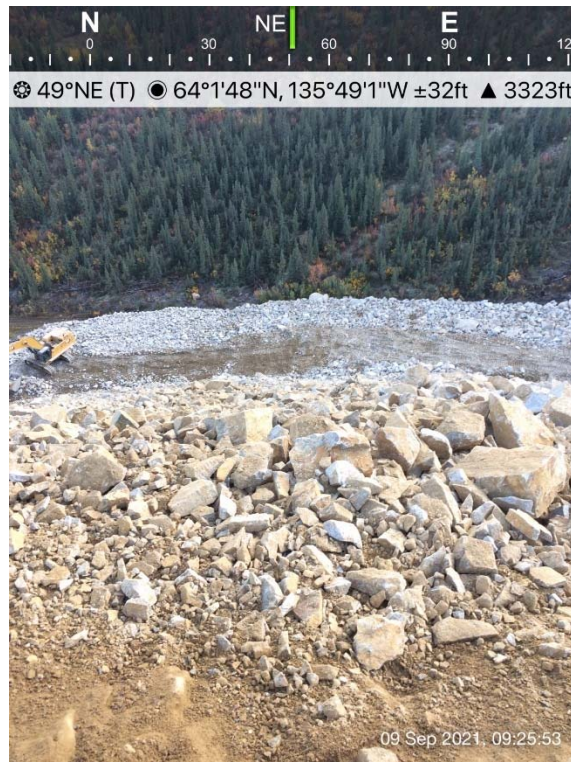
**Figure 41: Eagle Pup Dump drain rock 2021**

1. The Eagle Pup Dump was under construction during the 2021 inspection, with drain rock being placed at the base of the slope as shown in Figure 41. The rock drain has since been completed and the dump is in use. Some areas of water pooling can be seen in Figure 42.

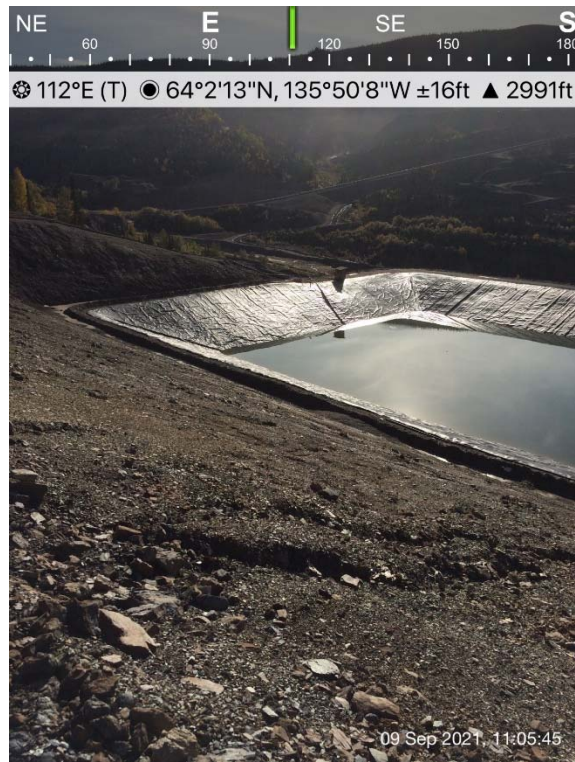
**Figure 57: Pooling water above Event Pond 2021**

1. Pooling water appeared to be forming above the North-East corner of the Event Pond at the time of this inspection (Figure 56). Pooling water had also been noted in this location on the 2021 and 2020 inspections (Figure 57, Figure 58).
